HW-67370

MECHANISMS AND KINETICS OF URANIUM CORROSION AND  
URANIUM CORE FUEL ELEMENT RUPTURES IN WATER AND STEAM

Materials Development  
Reactor and Fuels Research and Development  
Hanford Laboratories Operation

July 21, 1960

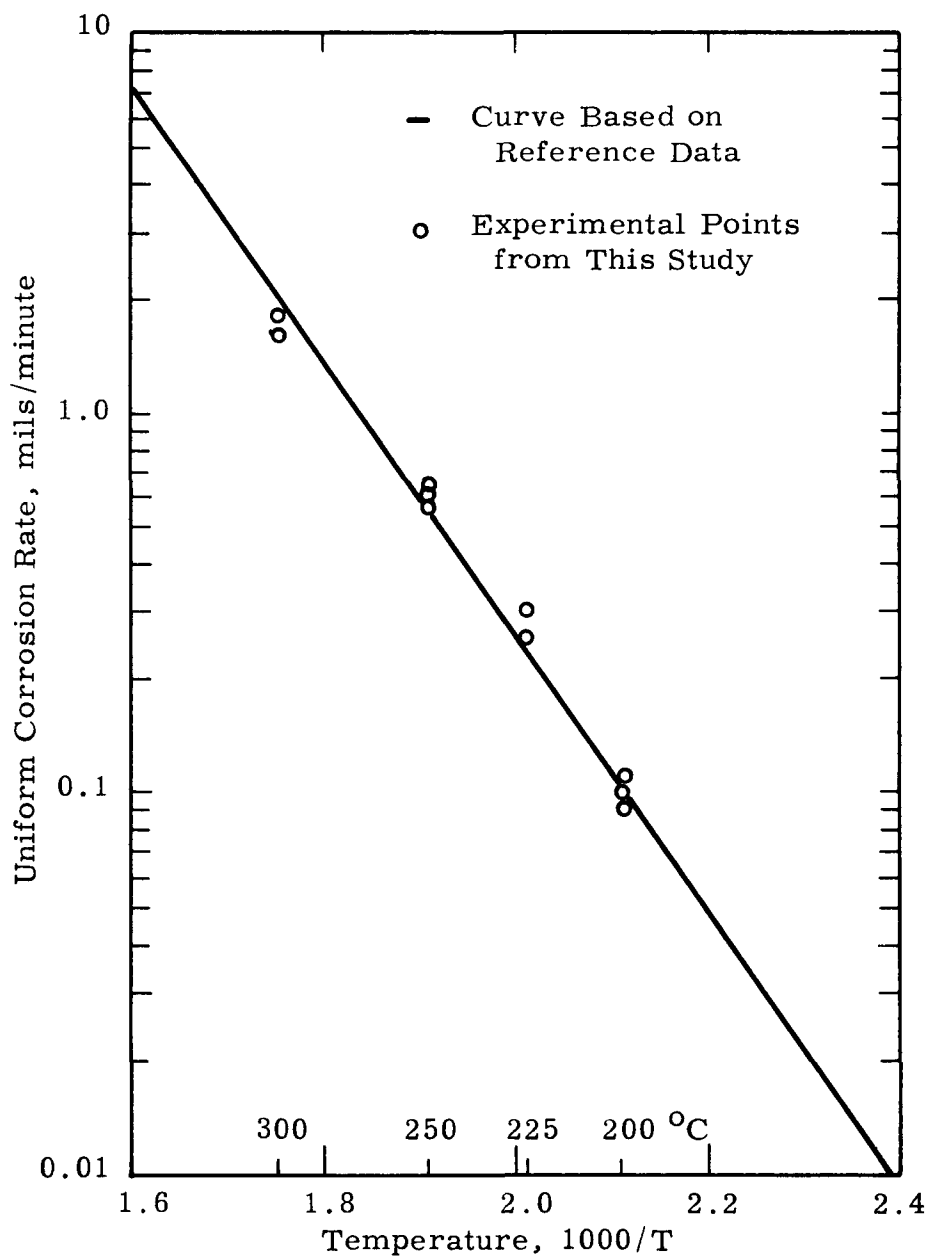
FIGURE 1

Uniform Aqueous Corrosion Rates of Uranium

The uniform penetration rates measured at 300 C, 1500 psig, range from 1.38 to 1.59 mils/minute (see Tables I and II). The rate predicted from the literature data in Figure 1 is 2.0 mils/minute which is somewhat higher than the rates observed. Since there was little or no pitting at 300 C, the apparent acceleration of corrosion shown by the curves in Figure 17 is perplexing. If the uniform linear penetration is preceded by a 10 to 15 minute induction period, then the curves of Figure 17 would truly show the course of corrosion. That is, a 10 to 15 minute induction period with very little corrosion followed by a high linear corrosion rate. The penetration rate calculated from the curves after 15 minutes is 2.0 mils/minute, in excellent agreement with the predicted value.

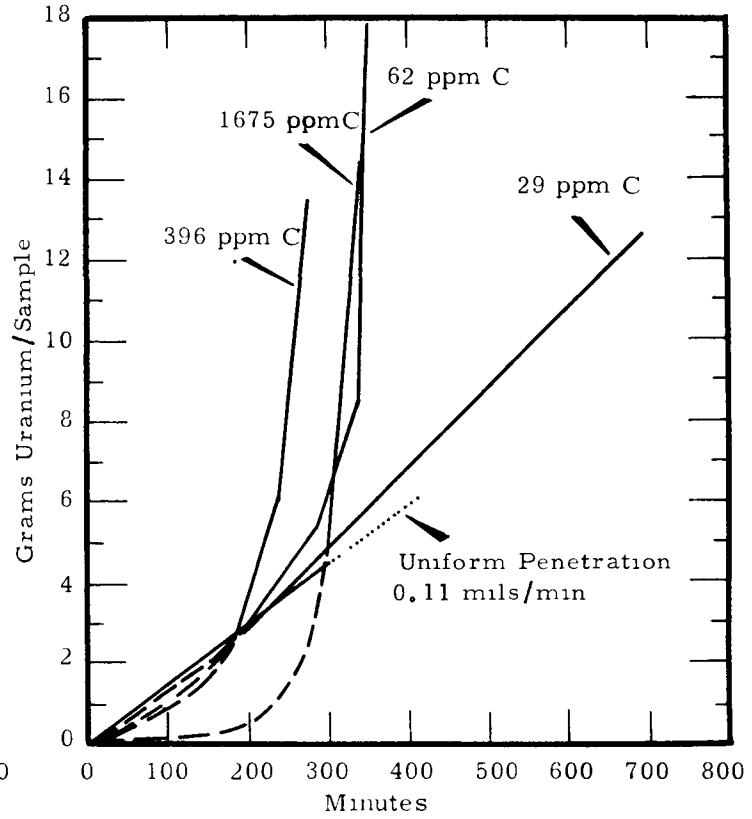
FIGURE 18

The results obtained with uranium containing from 29 to 1675 ppm carbon, corroded at 300 C and 200 C, are shown in Figures 15 and 16, and in Table II. Corrosion curves, based on corrosion product hydrogen collection, are given in Figures 17 and 18.

Effect of Carbon Content on Corrosion  
at 200 C, 1500 psig

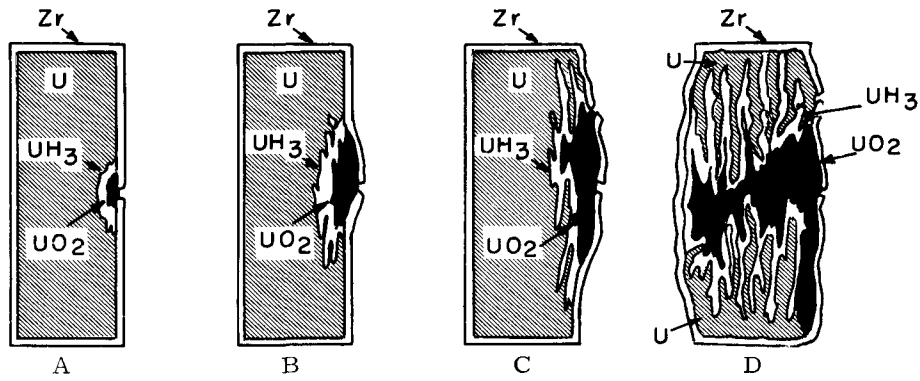
FIGURE 30

High Carbon Rupture Mechanism at 200 C

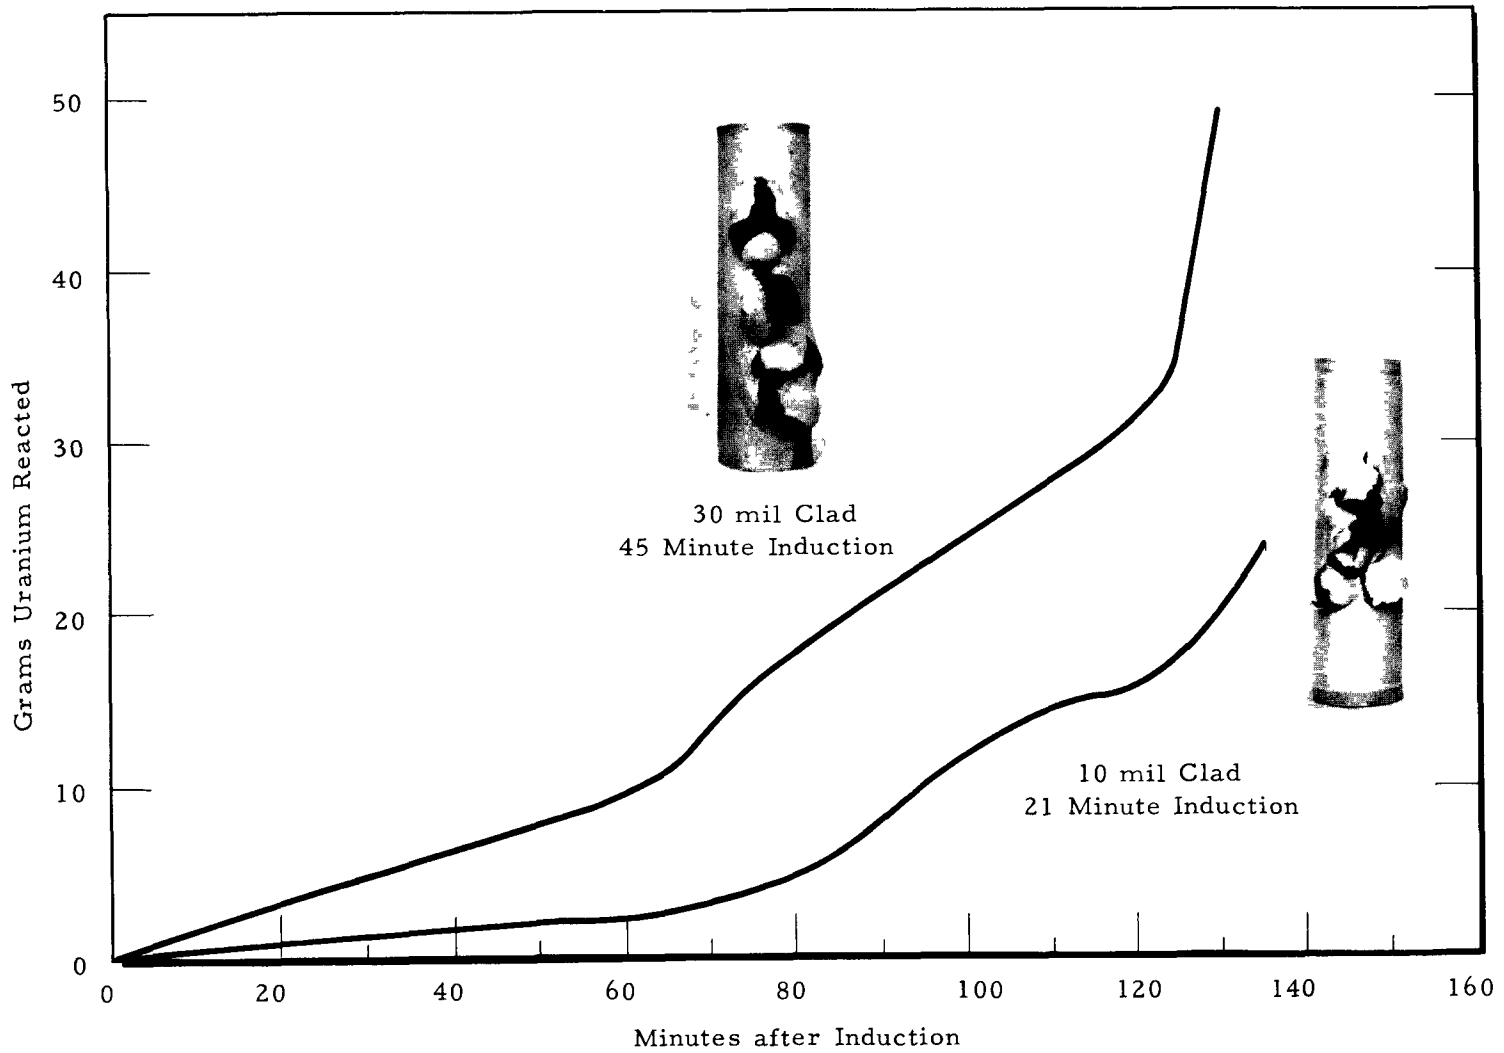
FIGURE 32

Effect of Cladding Thickness

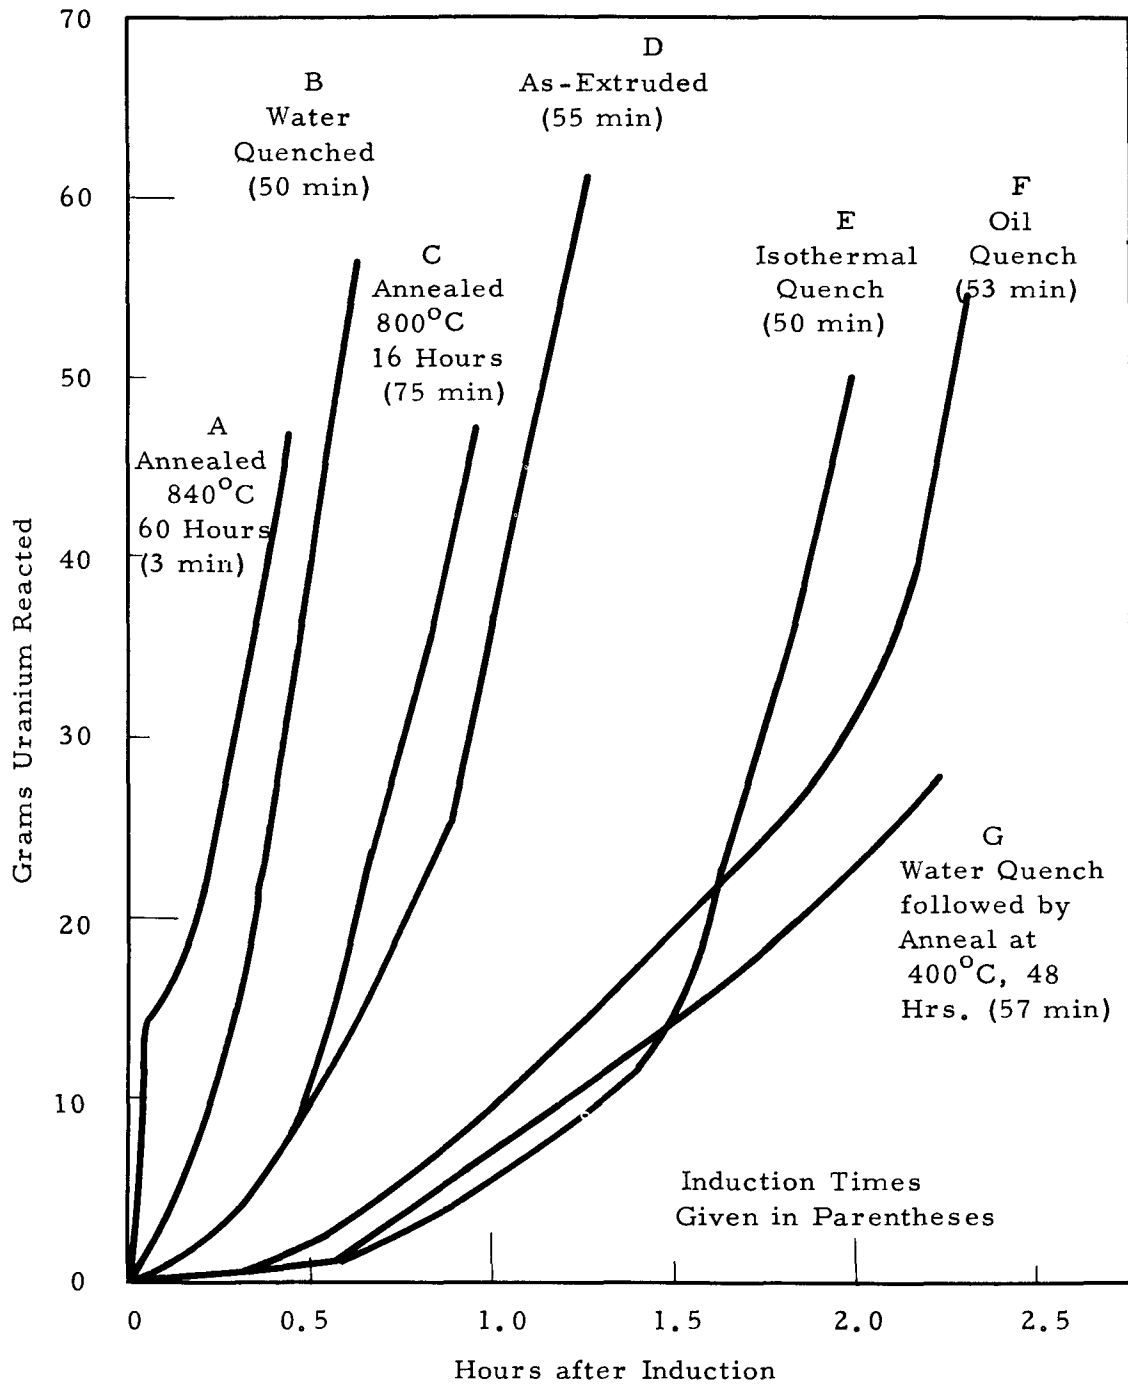
**FIGURE 33**

Rupture curves for samples given various heat treatments prior to exposure at 300 C, 1500 psig, are given in Figure 33. Samples after rupture are shown in Figure 34. Water quenching after  $\beta$  heat treatment (10 minutes at 720-730 C) gives a more rapid rupture than the as-extruded condition. Various slow cooling quench cycles after  $\beta$  treatment were tried which reduced the rate of rupture markedly. The interrupted or "isothermal" quench, and oil quench are shown as examples. It was later found that annealing after water quenching also reduced the rate of rupture. The example shown is a water-quenched sample which was annealed at 400 C for 48 hours. Its

Effects of Heat Treatment on Rod Ruptures  
at 300 C, 1500 psig

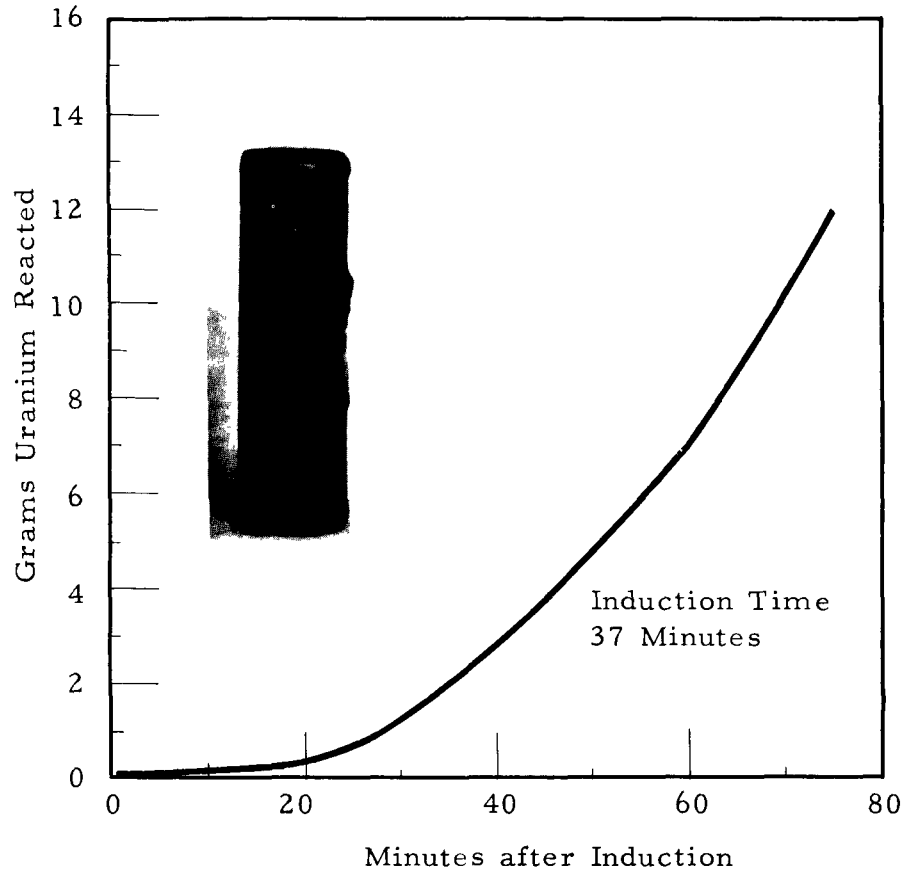
FIGURE 36

Slot Defect Rupture at 300 C, 1500 psig

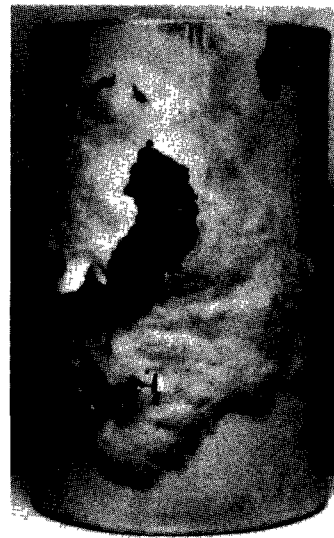
FIGURE 38

The small tube elements were ruptured in 300 C water at 1500 psig and 2500 psig. A sample after rupture is shown in Figure 38C. Their rupture curves are shown in Figure 39. Rupture curves of rod and large tube elements are included for comparison. Increasing pressure increases the rupture rate and decreases the induction period.

A. Large Diameter  
Tube Ruptured at  
300 C, 1500 psig

B. Large Diameter  
Tube Ruptured at  
200 C, 1500 psig

C. Small Diameter  
Tube Ruptured at  
300 C, 1500 psig

Ruptured Tube Elements

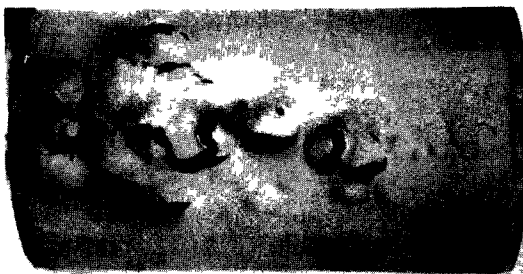
FIGURE 43

43A. After 1 liter of H<sub>2</sub>

43B. Additional 2 Hours

43C. Process Tube Removed

Unrestrained Rupture

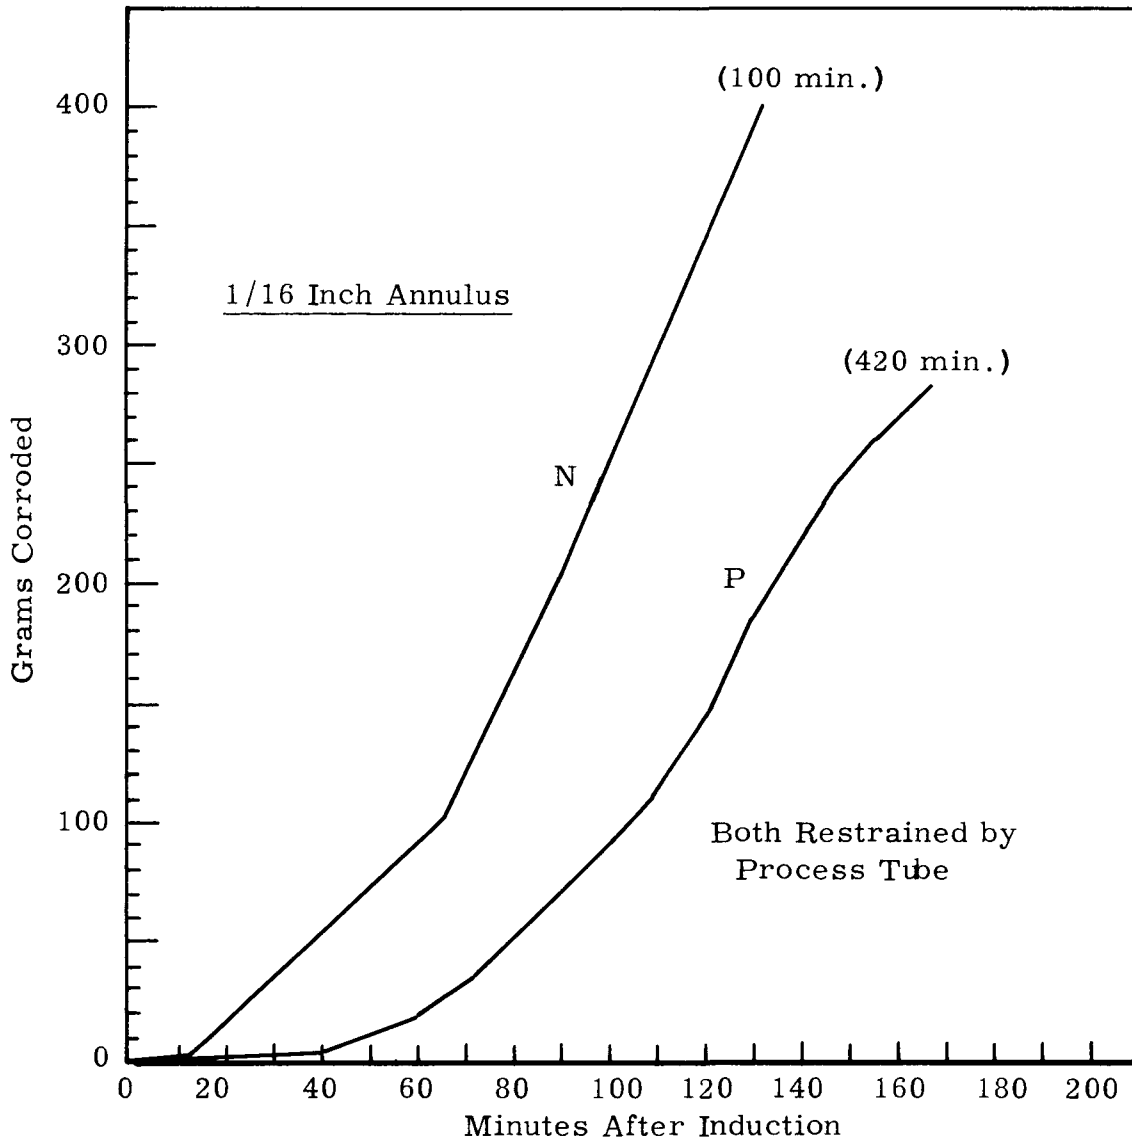
FIGURE 49

Tube Element Ruptures with 1/16-inch Annulus

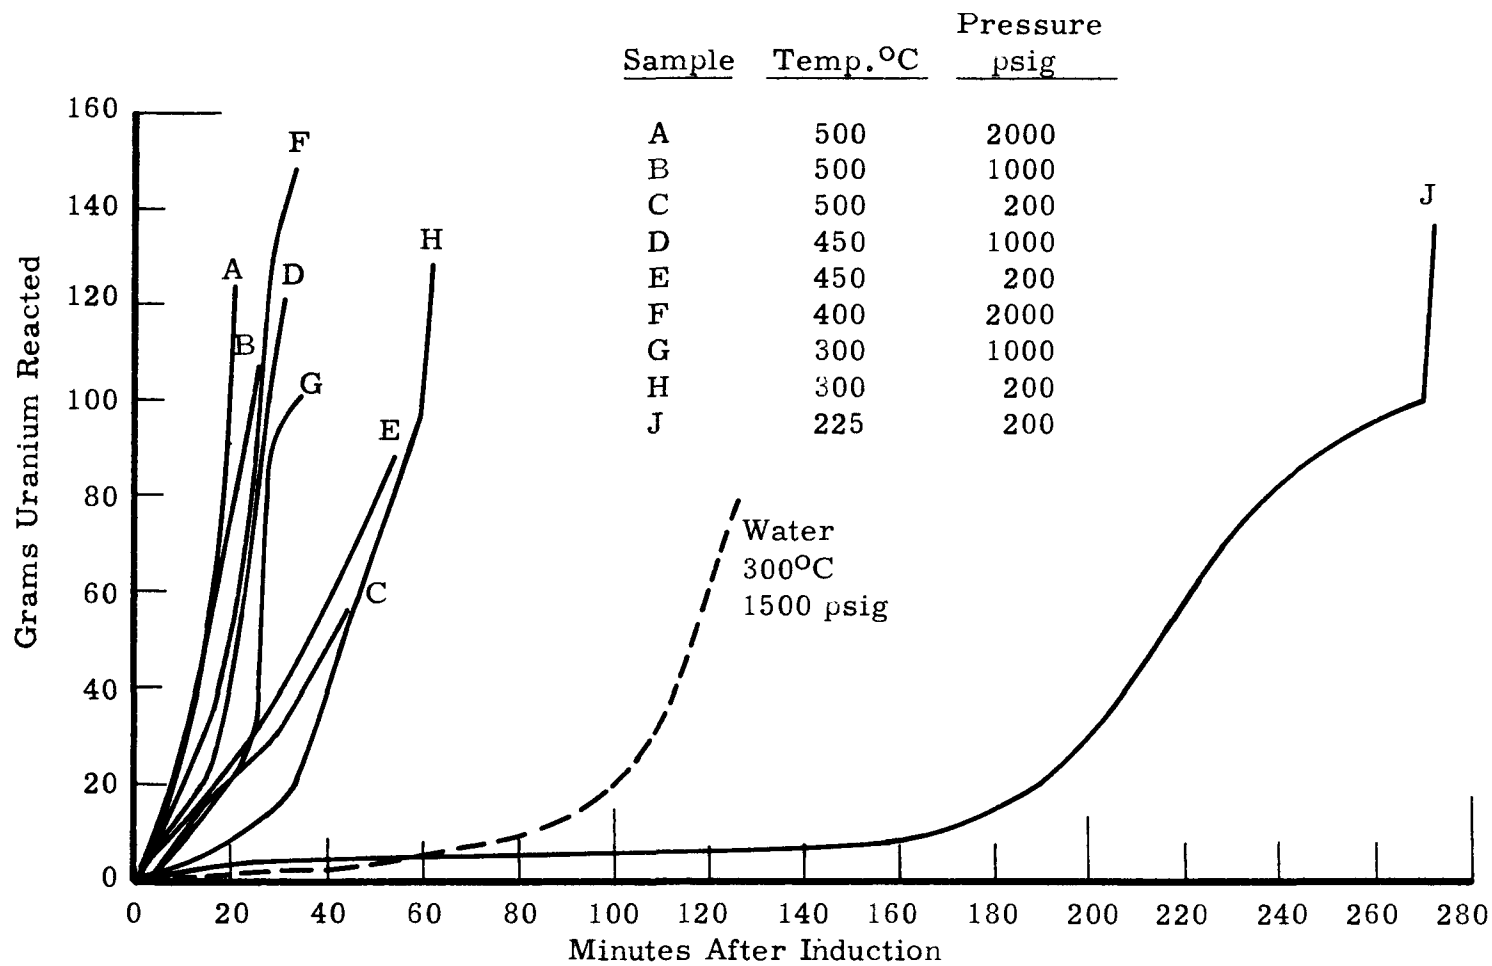
FIGURE 53

Pinhole-defected rod elements (coextruded, 0.6-inch OD, 2 inches long) were ruptured in steam at temperatures from 225 to 500 C and pressures from 200 to 2000 psig. The ruptured samples are shown in Figure 52. The conditions of exposure and the induction periods are listed in Table VIII. Rupture rate curves, based on hydrogen collection, are shown in Figure 53.

Rupture Curves for Rod Elements in Steam
