LA-4669-MS
UC-80, REACTOR
TECHNOLOGY
TID-4500

LOS ALAMOS SCIENTIFIC LABORATORY
of the
University of California
LOS ALAMOS • NEW MEXICO

**Behavior of
Sodium-Bonded (U,Pu)C Fuel Elements after
Moderate Burnup**

BEHAVIOR OF SODIUM-BONDED (U, Pu)C FUEL ELEMENTS
AFTER MODERATE BURNUP

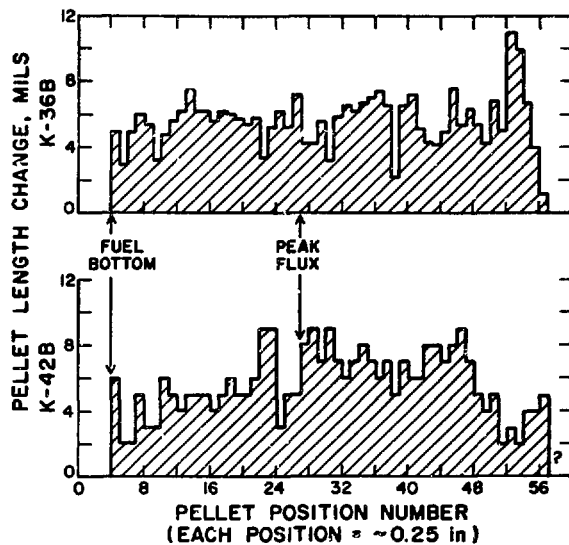
Fig. 3. Typical section from the precision gamma scan of capsule 42B. Note pellet-to-pellet interfaces.

Both capsules were also gross gamma scanned over the fueled length in 0.030-in. steps with a 0.004-in. collimator. Examples of this type of scan are shown in Figs. 3 and 4. Figure 3 illustrates a typical region from capsule 42B. The pellet-to-pellet interfaces are easily detected. Figure 4 shows the interface at the capped pellet in capsule 36B. Data of this type were used to determine individual pellet length increases in both capsules. The results are shown in Fig. 5. The fuel movement caused by the capped pellet in capsule 36B is apparent at position 53. The fuel swelling rate for capsule 36B based on the maximum length change, excluding the capped pellet and assuming isotropic swelling, was 2.4 vol% per at. % burnup. The average isotropic swelling rate was 2.0 vol% per at. % burnup. Also shown in Fig. 5 are the individual pellet length changes for capsule 42B. The maximum isotropic swelling rate was 2.2 vol% per at. % burnup. The average isotropic swelling rate was 1.5 vol% per at. % burnup. It is apparent that the damage rate in both capsules is higher in the high fuel temperature, high burnup regions.

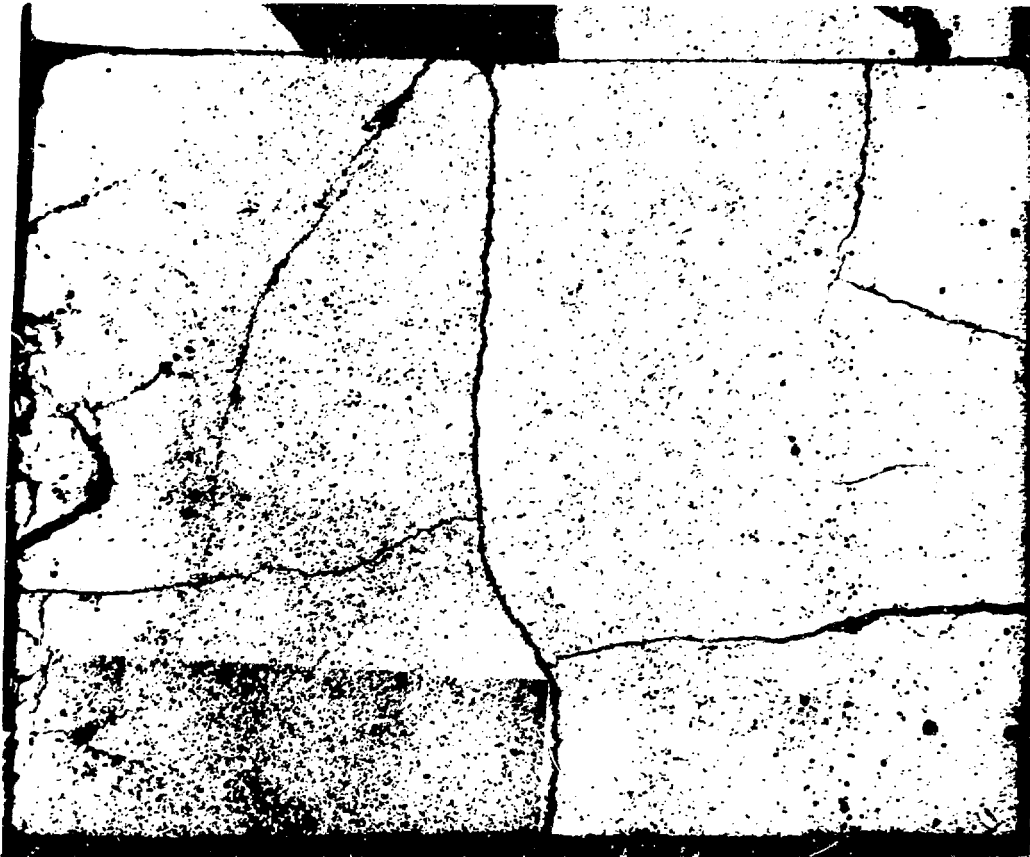
Fig. 10. As-polished mosaic of section 126.

The as-polished macrophotograph of the high fuel temperature section 126 (Fig. 8) and the as-polished mosaics of all four sections (Figs. 9, 10, 11, and 12) illustrate the overall mechanical behavior of the fuel. Axial splitting of the pellets due to thermal stresses was evident in all sections. Further fuel

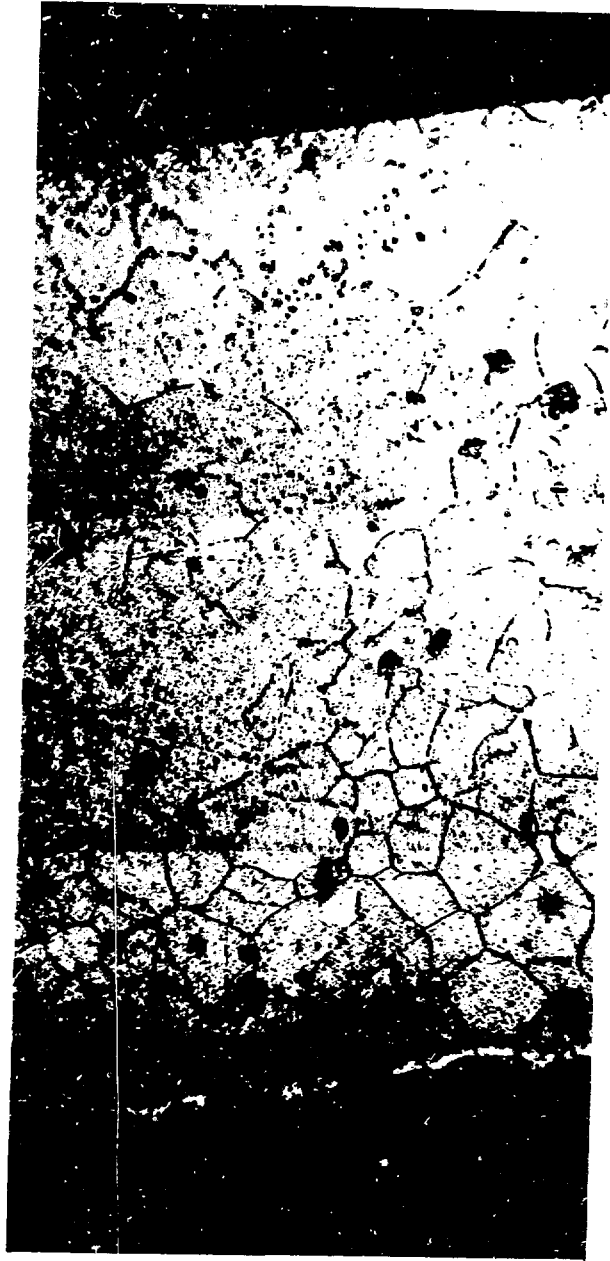
Fig. 21. Etched radial strip of fuel in section 124.

Photomicrographs of etched fuel were prepared for all sections. Figures 18, 19, 20, and 21 illustrate the fuel condition in radial strips of the four sections. No new phases were observed in the single phase fuel.
