ANL-6230  
Metals, Ceramics,  
and Materials  
(TID-4500, 16th Ed.)  
AEC Research and  
Development Report

FILM GROWTH ON ALUMINUM IN HIGH-TEMPERATURE WATER

Raymond K. Hart and Westly E. Ruther

April 1961

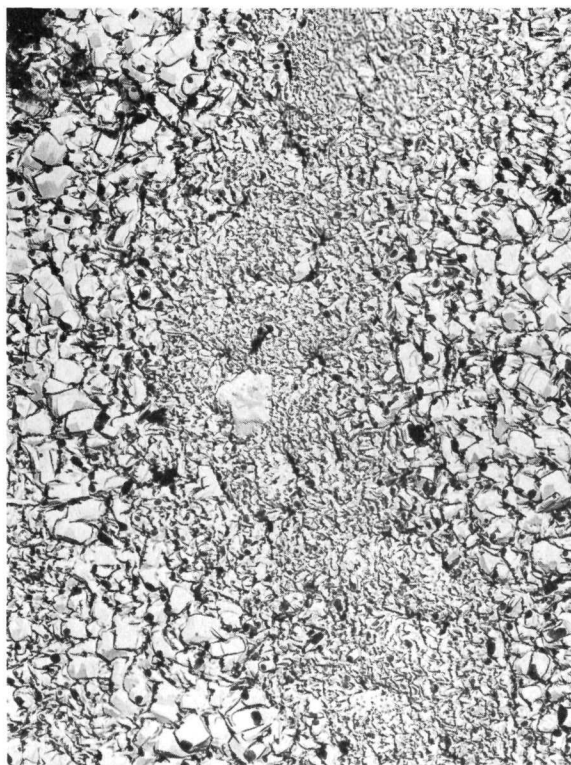
Figure 6

Carbon replica, preshadowed with Pt-Pd, of A255 alloy after corrosion for 12 min. at 250°C.

Two-stage preshadowed carbon replicas from the corroded alloy surfaces (less than 12-min immersion) showed that the particle size of the oxide was not uniform and appeared to be controlled by the underlying metal structure. For instance, Fig. 6 shows that the particle size of film over a grain boundary was significantly smaller than over metal grains.

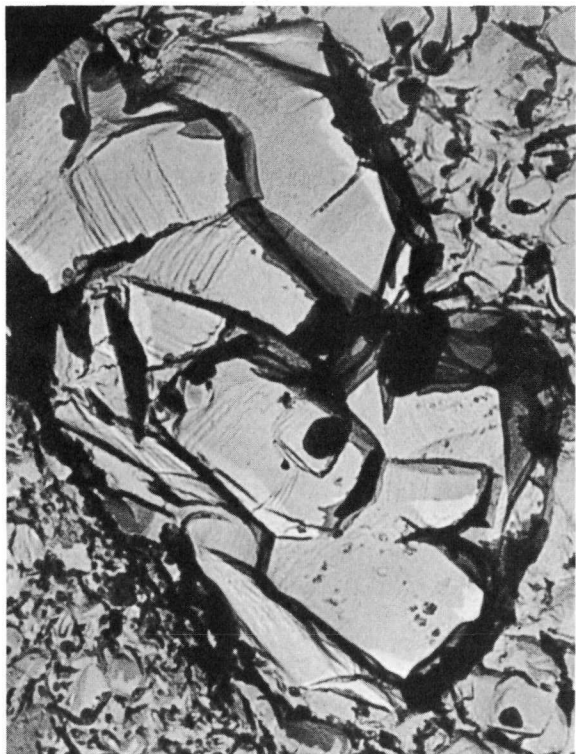
Figure 7. Carbon replica, pre-shadowed with Pt-Pd, of A255 alloy after corrosion for 12 min at 250°C.

Also, one often observed oxide crystals of much larger dimensions, as is shown in Fig. 7 and Fig. 8. Both of these figures were obtained from replicas taken after 12-min corrosion. The black areas in Fig. 8 are oxide outcrops which were extracted from the surface with the plastic impression. Such outcrops appear to be located at the junction in the film between grains of different size. A selected area diffraction examination was done on these particles and they were found to be boehmite.

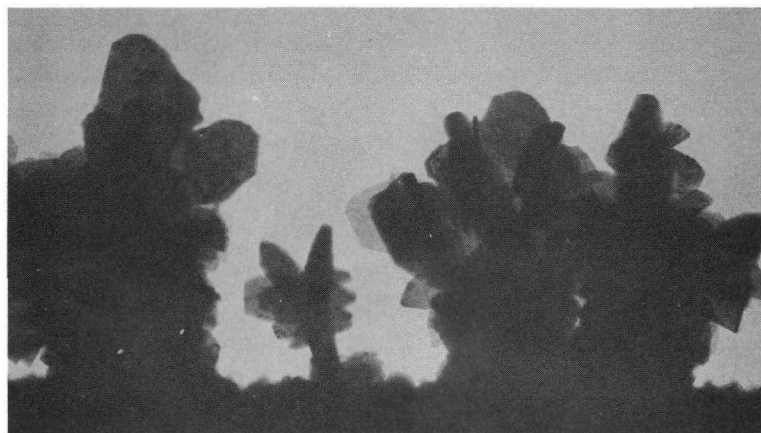
Figure 9. Outcropping on A255 alloy disc after corrosion for 4 min at 250°C.

Examination of disc specimens showed the general surface to be less evenly corroded than the high-purity aluminum; it contained many oxide outcrops which were reasonably closely spaced around the periphery (see Fig. 9). On discs that had been corroded for 200 minutes, boehmite "whiskers" were observed in addition to the other outcrops. Data on whiskers which could be measured with reasonable accuracy are given in Table II.

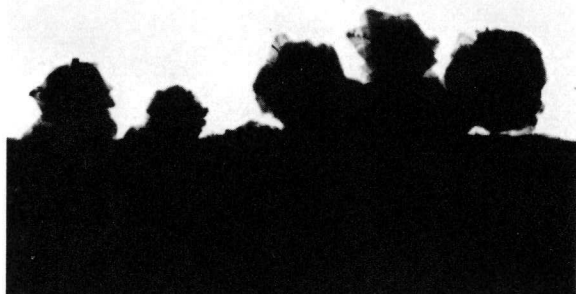
Figure 11. Outcropping on X8001 alloy disc after corrosion for 5 min at  $250^{\circ}\text{C}$ .

Disc specimens after immersion for 5 minutes showed that the free surface of the corrosion product was slightly smoother than in the case of the A255 alloy. Its topography was still saw-tooth, broken by an occasional outcrop, as shown in Fig. 11. A few whiskers in the grouping  $L/D = 20$  were also observed in electron micrographs.

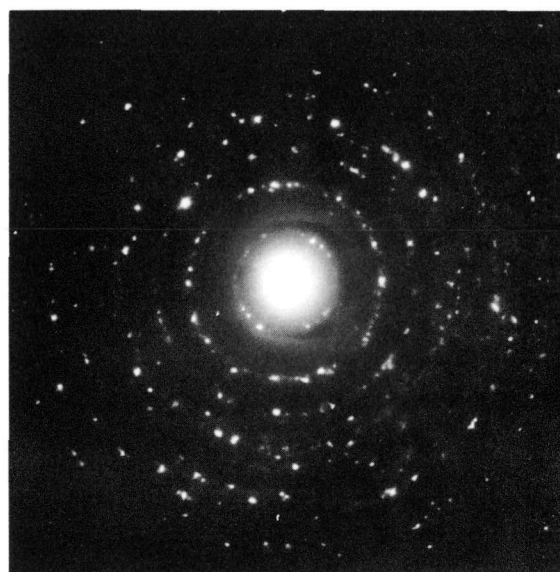
Figure 15.

(a) Outcropping on A255 alloy disc after corrosion for 10 min at 350° C. (b) Diffraction pattern from the surface.

It is quite possible that these "nucleation centers" are small metallic particles which have been transported outwards by the growing oxide. An example of outcropping which was prevalent on specimens corroded for 10 minutes or longer is shown in Fig. 15(a). Selected area diffraction patterns similar to Fig. 15(b) were obtained from these surfaces, showing the material to be boehmite.

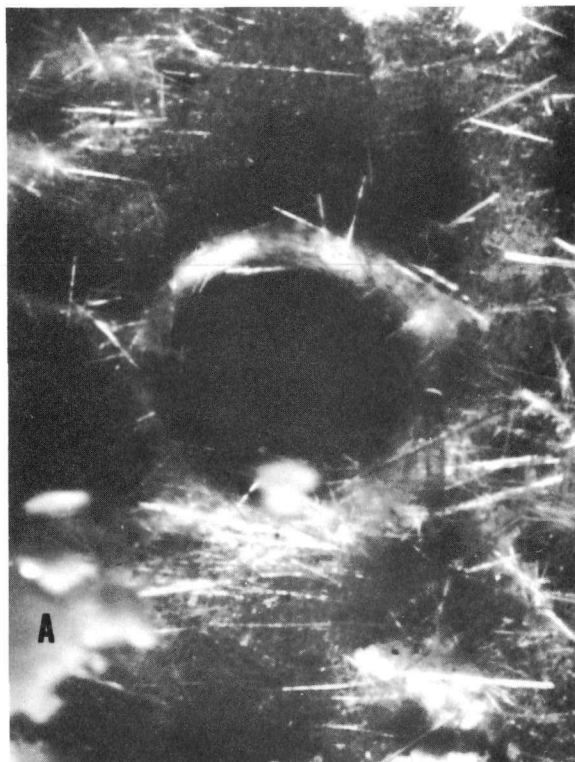
Figure 19.  
Optical micrograph of an A255 alloy disc after corrosion for 32 days at 350°C.

Some aspects of films produced after 32-day corrosion have been mentioned above. The outer surface was found to contain many clusters of filamentary growth, as well as a considerable quantity of loosely adhering flocculent material, shown at A in Figs. 19 and 20. The nature of this flocculent material was not positively identified, but it is believed to be some form of alumina gel. The oxide filaments were identified by both electron diffraction and X rays as diaspore, the c-axis direction being parallel to the major filament axis. This growth habit for diaspore has previously been reported by Ervin and Osborn.<sup>(9)</sup>
