# Evaluation of Tank 241-T-111 Level Data and In-Tank Video Inspection

**John Schofield, Columbia Energy and Environmental Services**

Amie Feero, Washington River Protection Solutions, LLC

**Abstract:** This document summarizes the status of tank T-111 as of January 1, 2014 and estimates a leak rate and post-1994 leak volume for the tank.

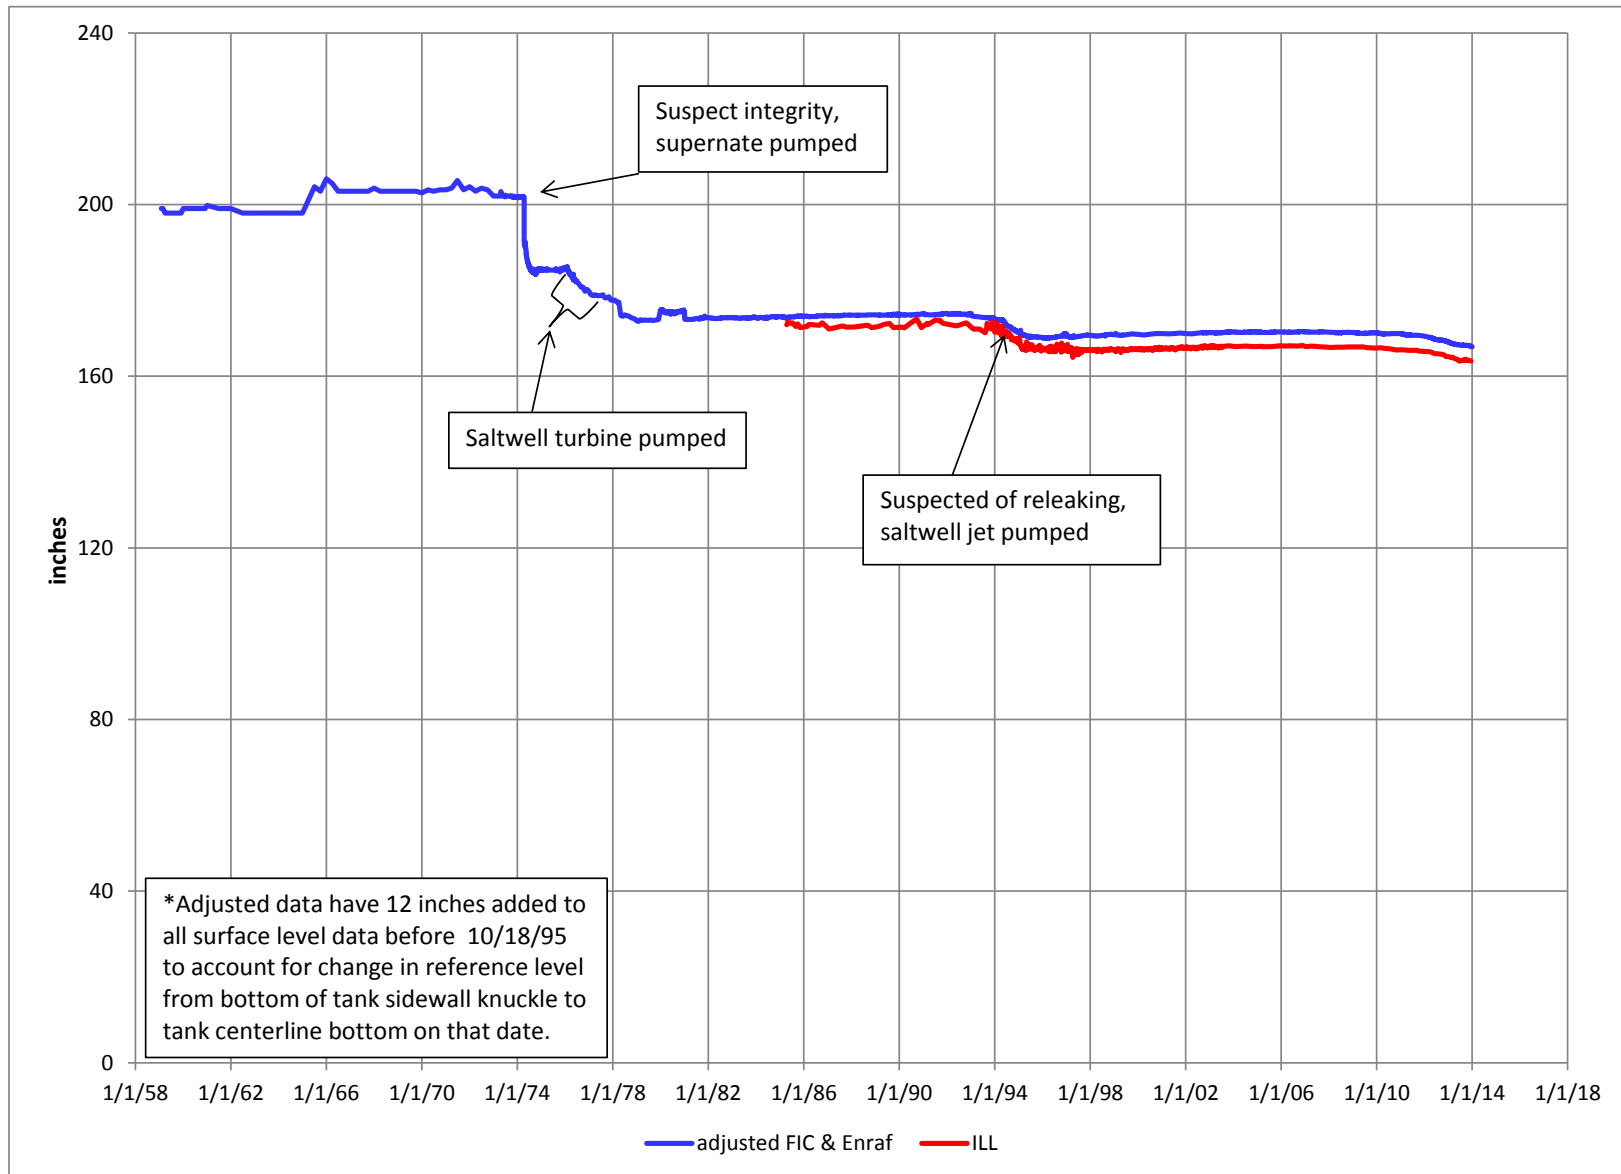
Figure 1 Tank T-111 Interstitial Liquid Level and Adjusted\* Surface Level Data

Figure 1 is a plot of the tank T-111 waste level from 1959 to January 2014. See Table 7 at the end of Section 6.0 for list of level data sources. Although the plot shows a number of minor level changes between 1959 and 1974, these changes are likely due to instrument maintenance or errors in reporting volumes or level data. There are no recorded transfers in or out of the tank from 1956 until the liquid level began to decrease slowly in 1973. The tank was suspected of leaking and most of the supernatant was pumped from tank T-111 in April and May of 1974 (SD-WM-TI-356, *Waste Storage Tank Status and Leak Detection Criteria*, Rev. 0). The level continued to drop at a decreasing rate from May to October 1974, at which time the waste surface level gauge reading stabilized between 172 and 173 inches and remained there until early 1976. Saltwell pumping using a turbine pump began in 1976 and continued periodically until 1978 (SD-WM-TI-356).

Shortly after pumping was halted the waste level began to rise slowly. The increase continued from 1979 until 1993. In 1993 the level began to decrease and it appeared that the tank was leaking again so a saltwell jet pump was installed and operated beginning in May 1994. Interim stabilization (IS) using the jet pump was complete in 1995 (HNF-SD-RE-TI-178, *Single-Shell Tank Interim Stabilization Record*, Rev 9A). Following IS pumping the tank T-111 waste level again began to rise slowly. The surface level (SL) increase rate was linear from late 1995 until between 2000 to 2002 when the increase rate began to slow. From 2004 until late 2006 the tank liquid level was essentially constant except for normal annual temperature-influenced fluctuations in the waste surface level. The liquid level began to decrease after 2006 and was still decreasing on April 1, 2013.

The ILL and SL level data for tank T-111 both peaked in late 2006 and have shown decreasing trends since the December 2007 ILL and March 2008 SL, with the negative change rate increasing with time to April 1, 2013.

The highest ILL reading was in November 2006. The ILL was being measured quarterly, with the highest reading for 2007 obtained in July. No third quarter 2007 ILL reading was recorded and the ILL measurement in December 2007 showed a 0.096 inch decrease from July. The December reading began a progression of decreasing ILLs.

The highest SL reading was in December 2006 when the waste level was at the peak of its annual cycle. The highest SL reading for 2007 was in September, after which the Honeywell Enraf (Enraf) gauge was out of service until March of 2008. When the Enraf was put back in service the reading was 0.16 inches lower than in September 2007, the reading began the progression of decreasing SLs.

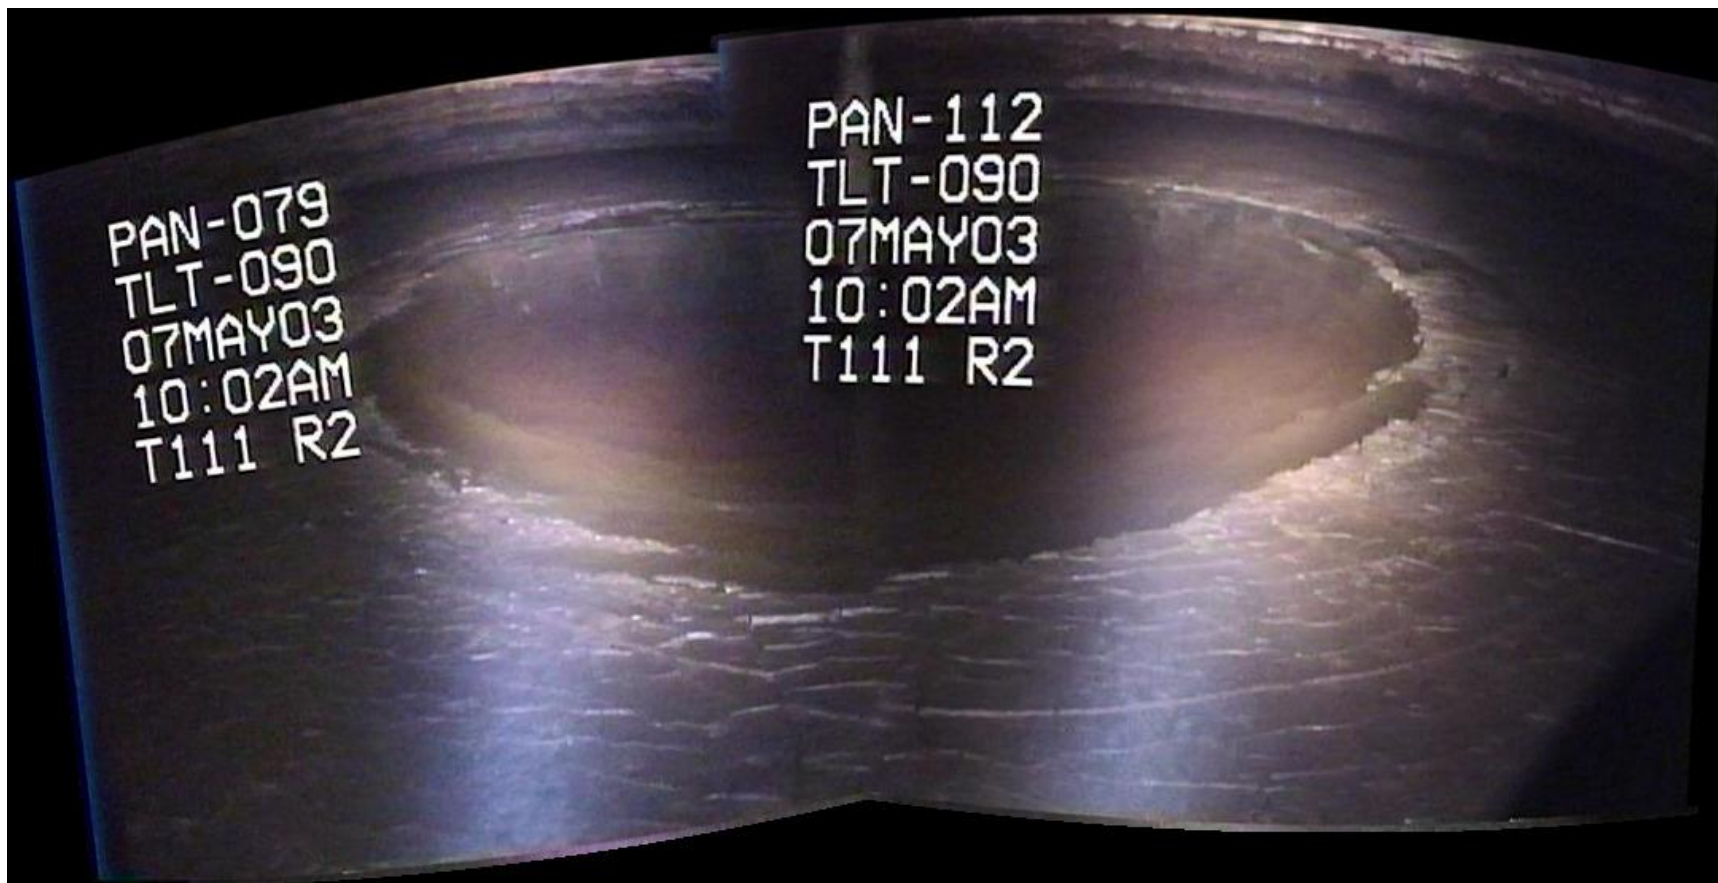
Figure 3 Tank T-111 May 7, 2003 Video Waste Surface Composite

- No intrusions were noted. The waste surface was observed closely throughout the video and no drops were noted falling onto the pool surface. Figure 3 shows the pool surface, the placid appearance is typical of the pool during the video.
- The Enraf plummet is sitting in a small pool of liquid, as shown in Figure 4. A small accumulation of liquid is also seen under adjacent riser 3.
- The strange anomaly noted on the east wall of the tank in the February and March 2013 videos from riser 6 (see Section 3.2) is shown in Figure 5. Note what appears to be a black rod and thin rods or wires leading from the anomaly. See Section 3.3 for further discussion and a closer view of the anomaly from riser 2 in December 2013.

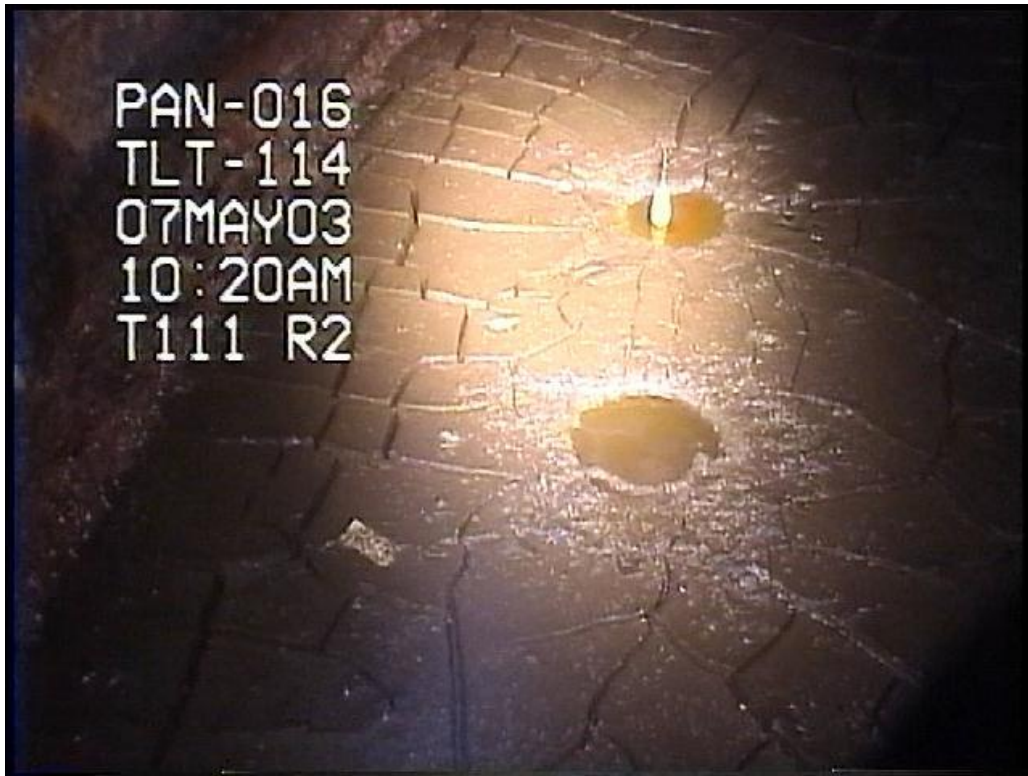
Figure 4 Tank T-111 Enraf Plummet on May 7, 2003

In-tank videos were obtained from tank T-111 on May 7, 2003, February 11, 2013, and March 20, 2013. The May 7, 2003 and February 11, 2013 videos show the Enraf plummet to be providing valid data from a liquid pool in a small depression under the Enraf riser. The ILL can also be observed in a little depression around the LOW in the 2013 videos. The central pool around the saltwell screen was estimated at 20 ft. diameter. The liquid level observed by the SL and the ILL calculated by the LOW data are essentially the same surface.

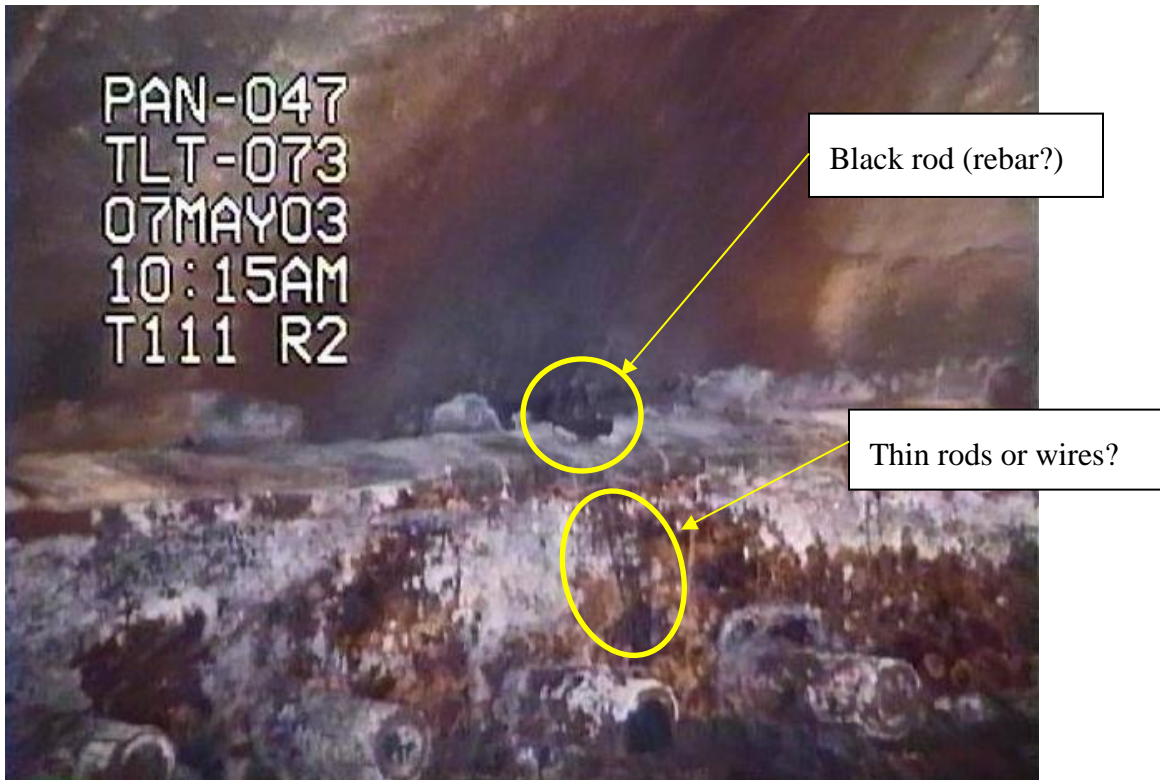
Figure 5 Anomaly on East Wall of Tank T-111 on May 7, 2003

Figure 9 is the same anomaly shown in Figure 5 located on the southeast area of the dome just above the flashing. The area is black, unlike other dome areas. There appear to be thin black wires directly underneath the anomaly, and there appears to be a greater accumulation of salts under the anomaly than elsewhere along the lip. At full zoom the camera image was too vague to make out clearly what could have caused the discoloration. See Section 3.3 for a later description of the anomaly and better images.

A video was performed again in December 2013 to try and ascertain what the anomaly was on the east wall of the tank (shown in Figure 5 and Figure 9) and to try and determine if an intrusion was the reason for the change in the tank liquid level since the summer.

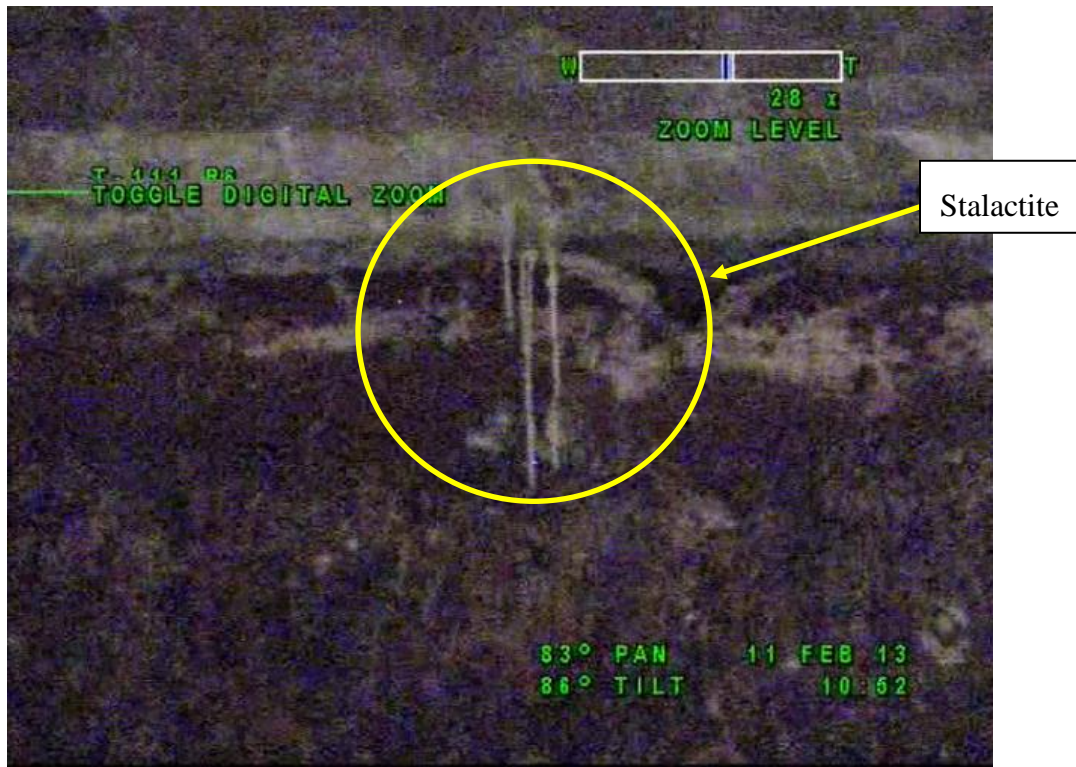
Figure 6 Typical Stalactite on Tank T-111 Top Stiffener Ring Flashing

No active intrusion drips were observed during the February 11 and March 20, 2013 videos, but there was evidence of past intrusion into the tank. Figure 6 shows what appear to be white crystalline ‘stalactites’ that have formed around the tank circumference on the lip of the lead flashing on the top stiffener ring. There are many of these; all appear to have a white drip line in back of them coming from the edge of the lead flashing where it goes into the concrete wall. The ‘stalactites’ could be carbonate or sulfate salts similar to what is formed in caves from liquid passing through soil before dripping and evaporating, leaving the crystalline residue behind. These ‘stalactites’ could also be run-off from the multiple applications of the magnesium zinc-fluosilicate wash required to be applied to the dome surface per pages 12-13 of the construction specification (BPF-73550, *Specifications for Construction of Composite Storage Tanks Bldg. No. 241, Hanford Engineer Works, Project 9536*, January 11, 1944) for the tanks. These drip points are seen in some other SST in-tank videos and are evident in the 1994 tank T-111 photos, but do not appear to be as numerous in the latter as in the February 11 and March 20, 2013 videos.

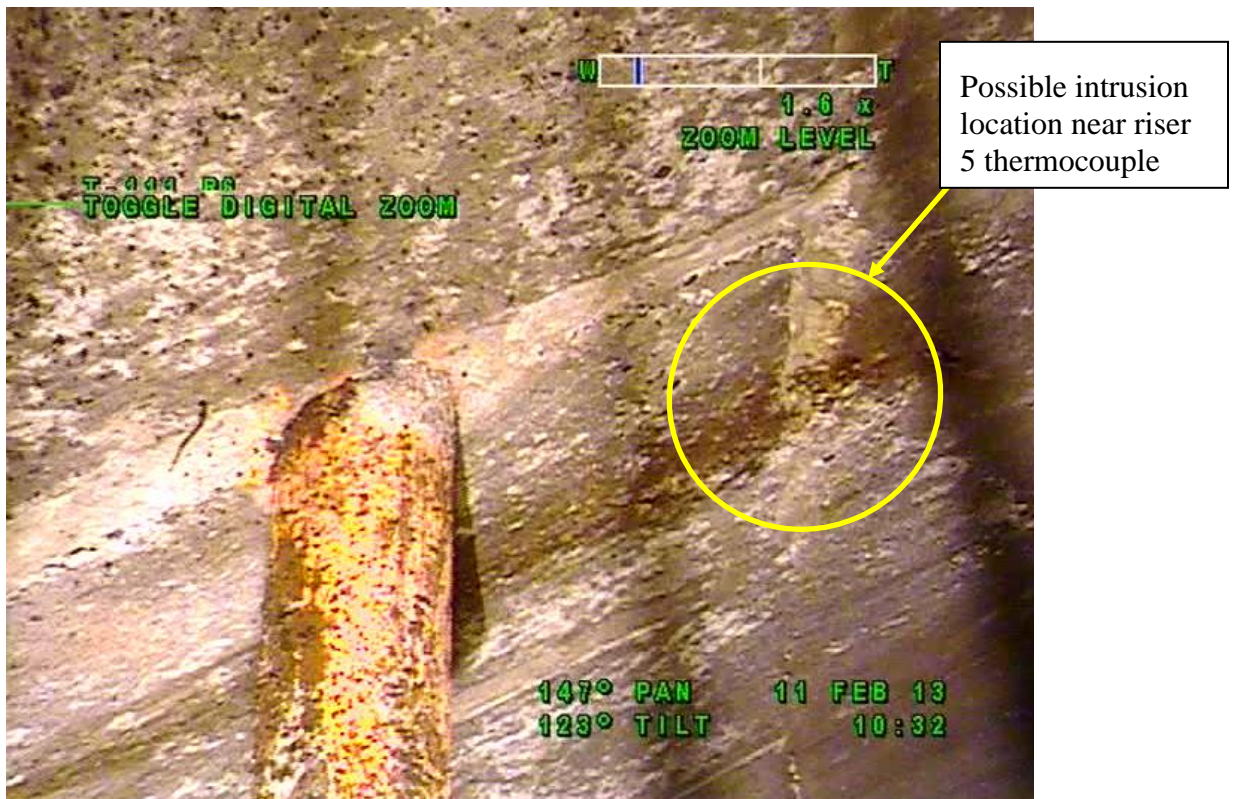
Figure 7 Possible Past Intrusion Location in Tank T-111 Dome

Figure 7 shows a possible intrusion location in the dome. Figure 8 is an image of the waste directly below the Figure 7 location that shows minor depressions which could be from drips from the discolored ceiling area. The video also shows a stain from the Figure 7 location going down the tank dome to the lead flashing above the top stiffener ring.

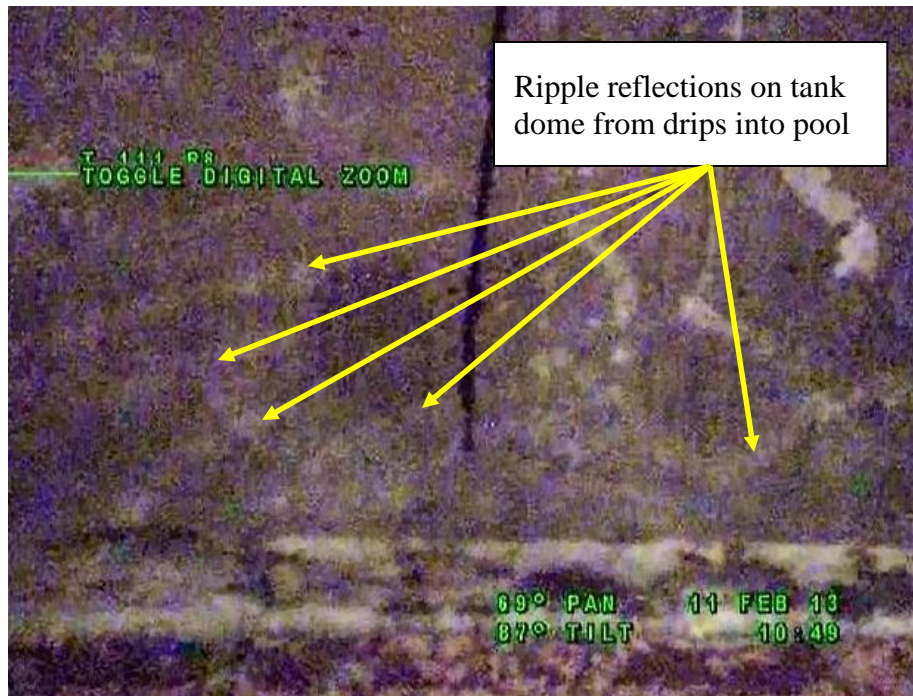
**Figure 10 Reflections of Drip Ripples from Pool onto Tank T-111 Dome**

During the initial review of the February 2013 videos there was insufficient time spent looking at the waste liquid pool surface up close to see ripples in the surface. When reviewing the February video again following the December 2013 videos, at the 10:49 time stamp on the video when the camera was only looking at the dome, reflections of ripples were visible on the tank dome. There were at least three different moving ripple reflections, originating from different locations on the pool surface. These ripple reflections were not noticed during the initial video review. Figure 10 shows the reflections from one of the likely ripples. The clarity in Figure 10 is poor, but the reflections are noticeable on the video and are believed to be from drops falling onto the pool surface. The lines are not believed to be shadows from the protective covering around the light used for the video due to their orientation and movement across the dome surface.

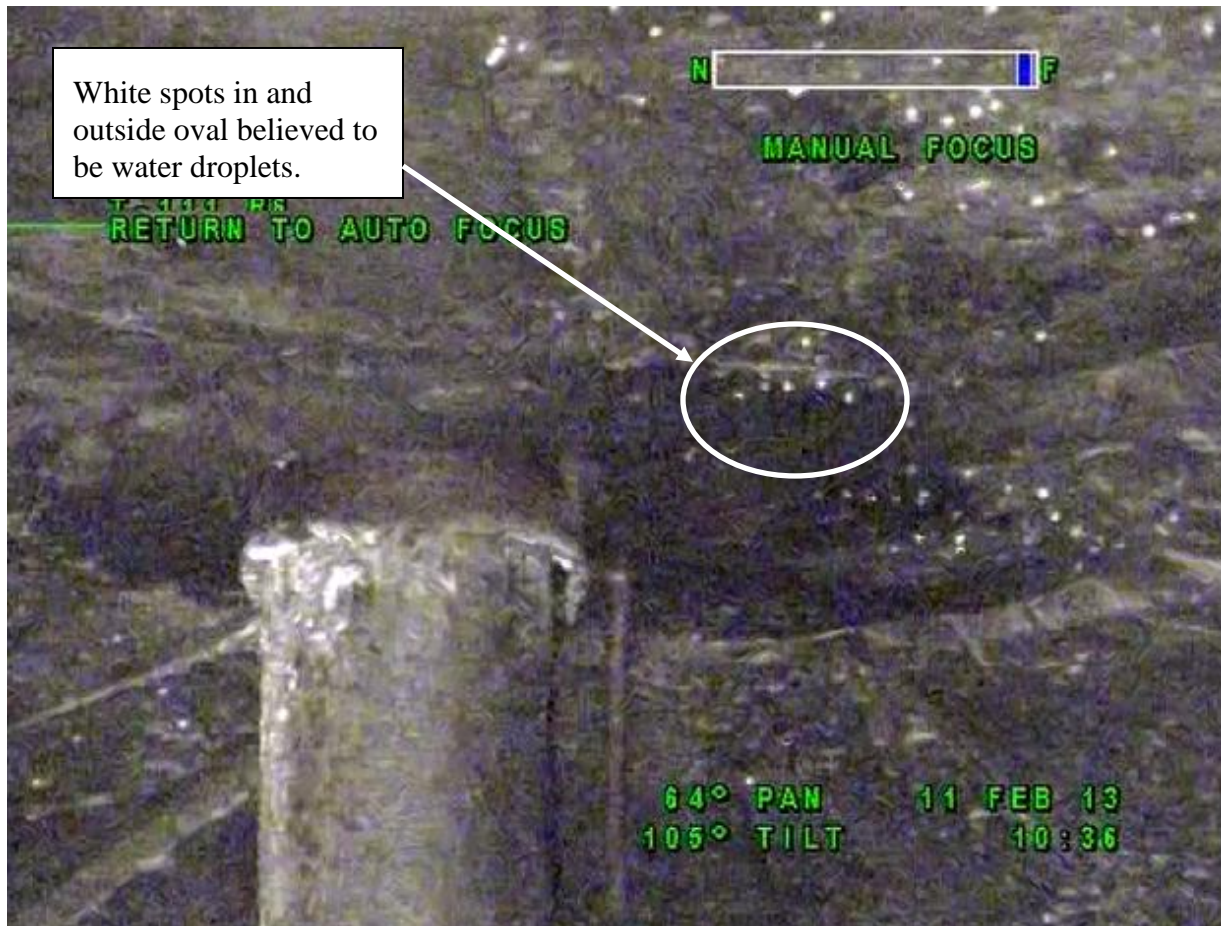
**Figure 11 Tank T-111 Central Dome Area Showing Probable Water Droplets**

Figure 11 is a screenshot of the tank T-111 central dome area. The white spots are believed to be water droplets. During the initial review of the February 2013 video these spots were assumed to be small bits of salt or something reflective that couldn't be clearly seen with the camera. In the December 2013 videos (see Figure 17 and Figure 18) more of these spots were observed and most of them determined to be water droplets.

Based upon the reflections on the dome ceiling believed to be from water drops falling into the central pool and the probable water droplets observed on the tank dome it appears there was an intrusion occurring during the February 2013 video that was not noted at that time.

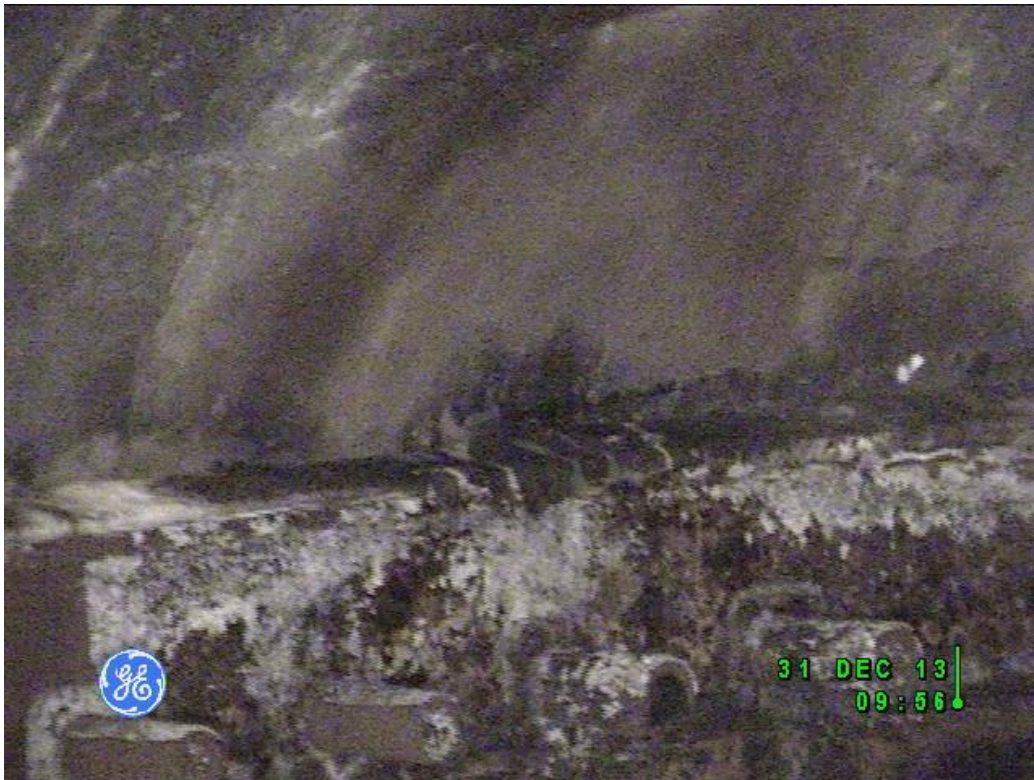
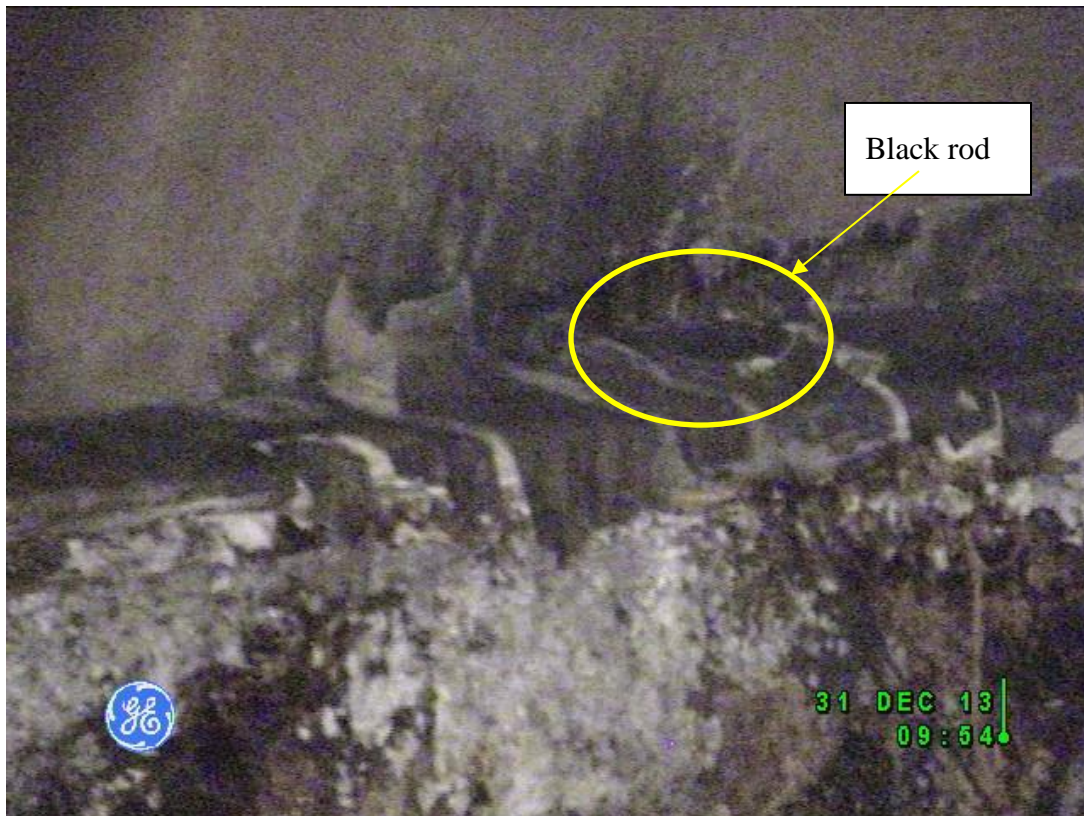
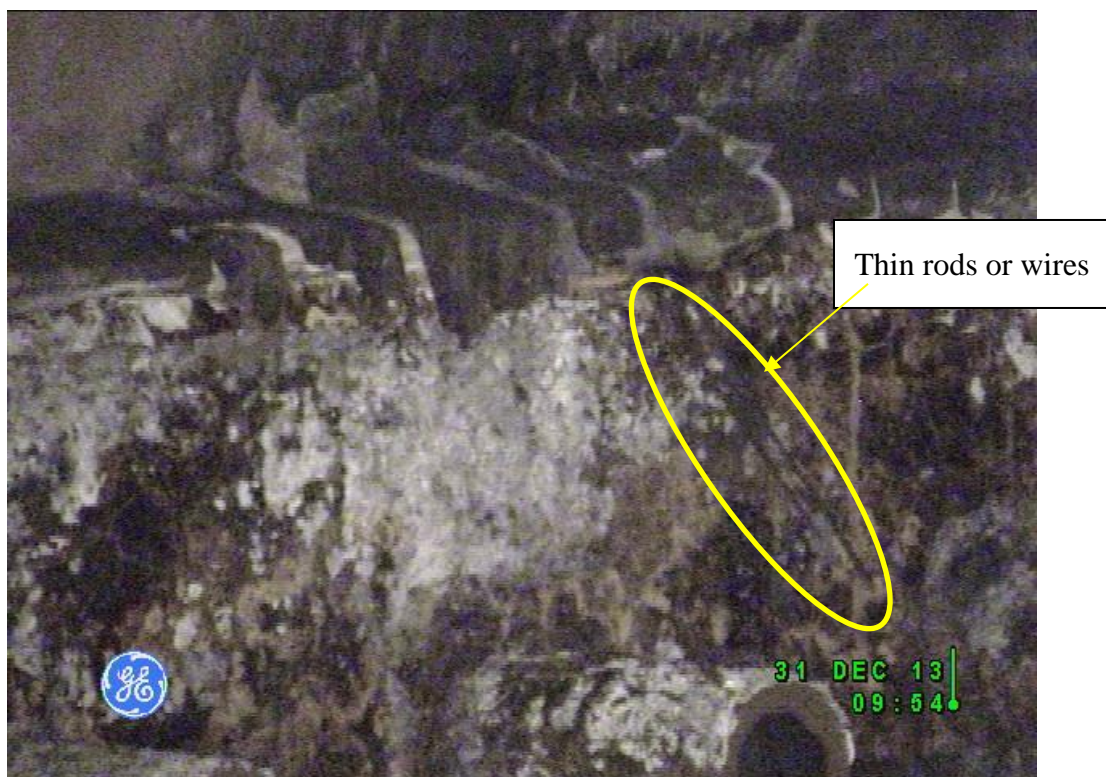
Figure 14, Figure 15, and Figure 16 are close-ups of the anomaly on the east wall of the tank. It appears the anomaly may be some sort of minor wall repair made at the time the tank was constructed. The strips with the apparent stripes on each edge look like thin metallic strips or tape, although tape usage would be unlikely in 1943. Comparing Figure 4 with Figure 16 it appears the strips were more wrapped under the lead flashing on the top stiffener ring in 2003 than in 2013. The white salts under the anomaly appear more prevalent than in other areas around the flashing in the tank, which implies there may be an intrusion of liquid from the soil around the tank at this location, but the amount of salt present probably doesn't indicate a significant intrusion.

**Figure 14 Closeup #1 of Anomaly on Tank T-111 East Wall, December 31, 2013**

**Figure 15 Closeup #2 of Anomaly on Tank T-111 East Wall, December 31, 2013**

**Figure 16 Closeup #3 of Anomaly on Tank T-111 East Wall, December 31, 2013**

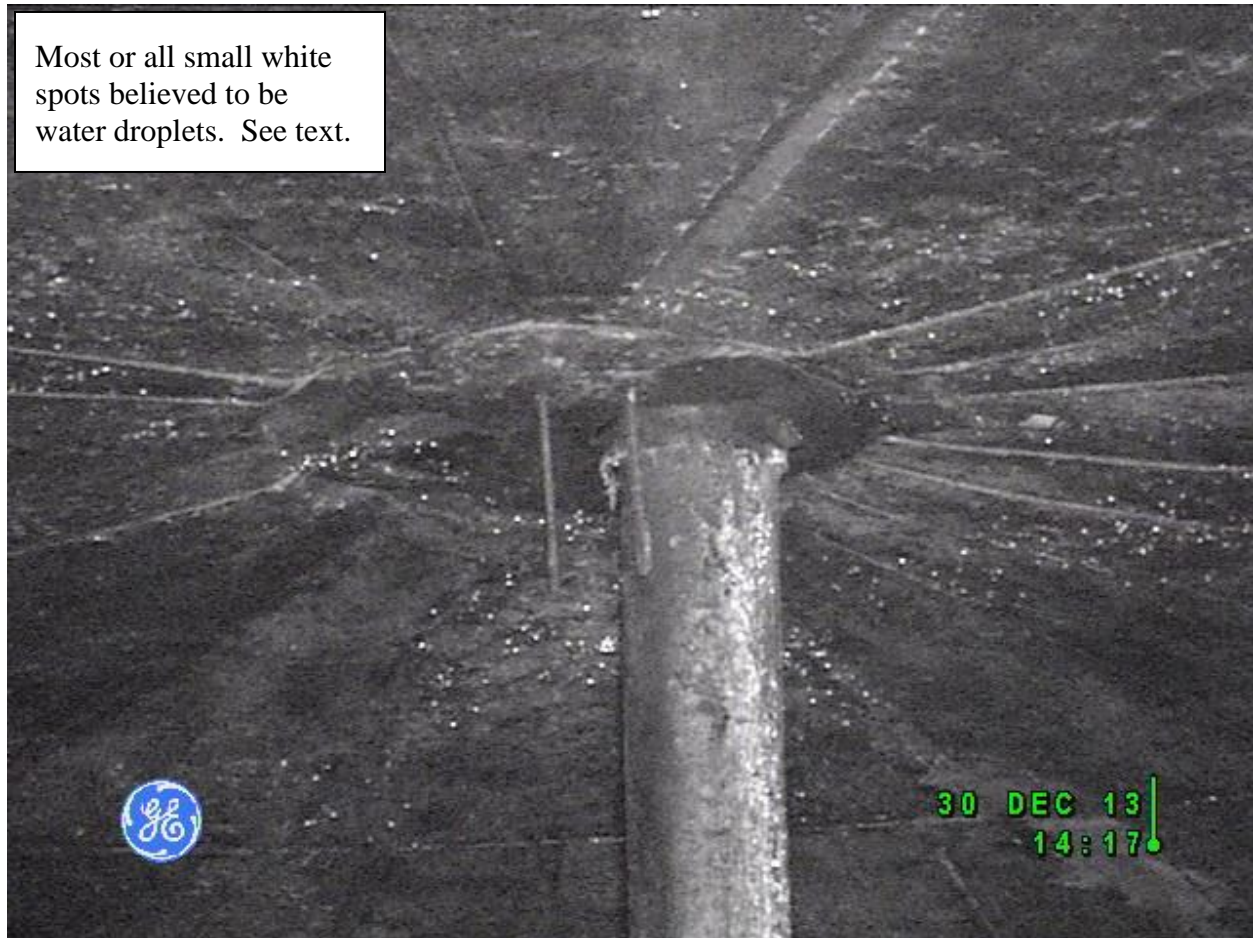
**Figure 17 Tank T-111 Showing Water Droplets on Central Dome Area, December 30, 2013**

Figure 17 is an image from December 30 showing the central dome area of the tank. Note the small reflective white spots. Camera resolution did not enable clear viewing of these spots, but at least one of them was a water droplet. Figure 18 shows two close-up views of an area on the tank dome. In the first view five of the reflective spots are present in the circled area. In the second view only four are present. On the video the drop can be clearly seen to fall, it wasn't practical to get an image of it at the exact instant the drop fell.

The similar reflective nature of the white spots implies they are all water droplets. The area of the white spots roughly corresponds to the area of the central pool in the tank where most of the ripples were noted.

A possible explanation for the ceiling droplets is they are condensate formed when liquid from the central pool evaporates and condenses on a cooler tank dome. The last winter temperature data available (February 2013) shows the waste temperature about 64°F and the upper headspace air about 60°F. The tank dome should be the same temperature as the soil, about 60°F since it is approximately eight feet below grade. Condensation cannot be ruled out, but is not likely, and similar drops have not been seen in other SSTs to date with liquid present.

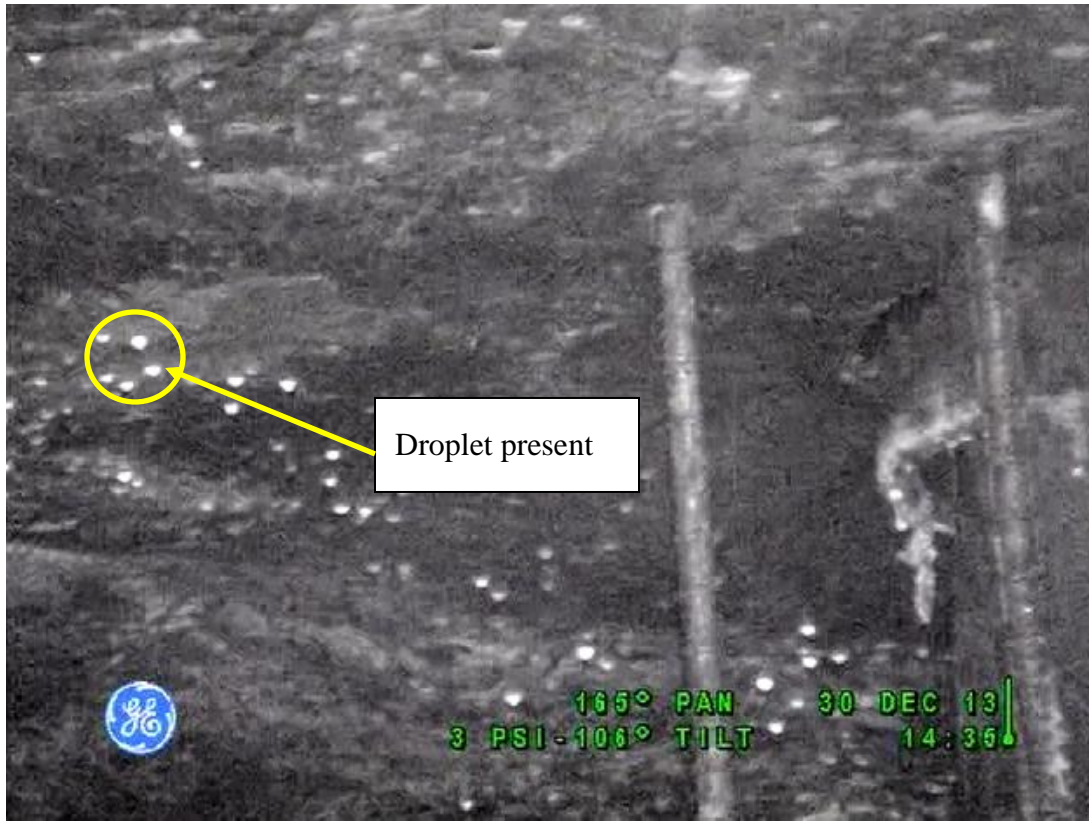
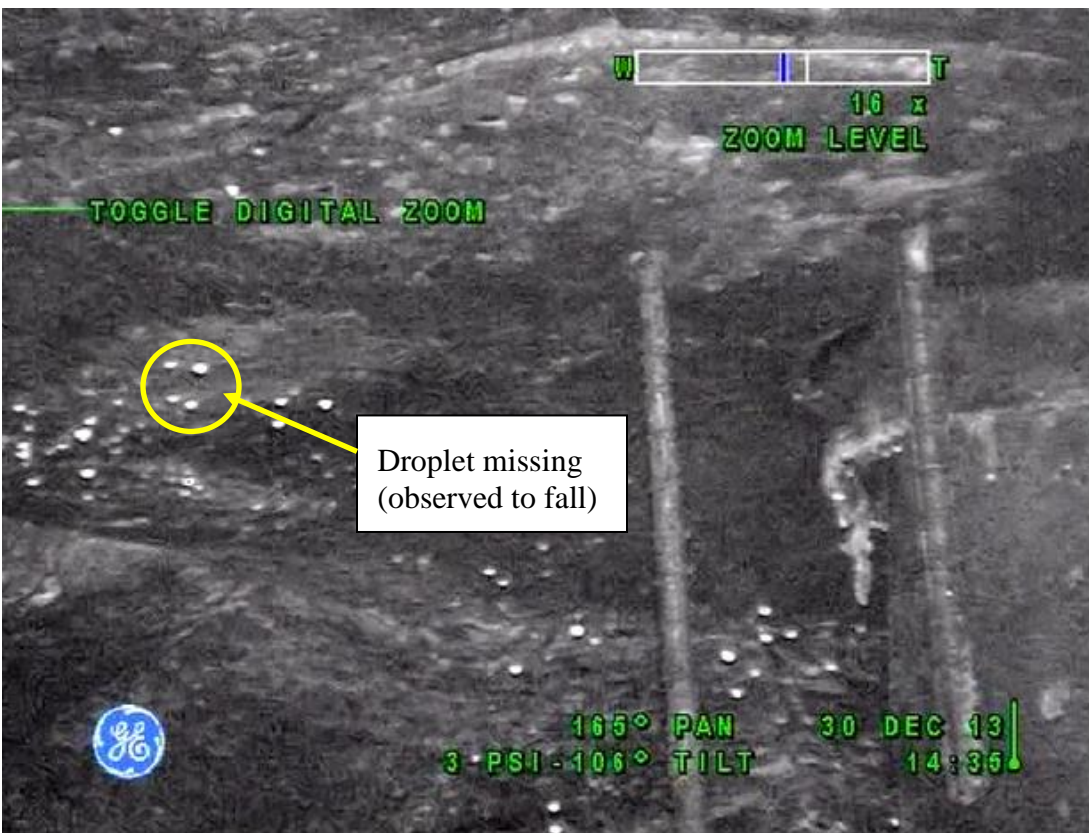
Figure 18 Water Drop from Tank T-111 Dome

Intrusion from the central dome area of the tank was observed on both December 30 and December 31, 2013. Ripples were observed on the central pool surface from drops. The ripples are difficult to see in the stills but are readily apparent in the video.

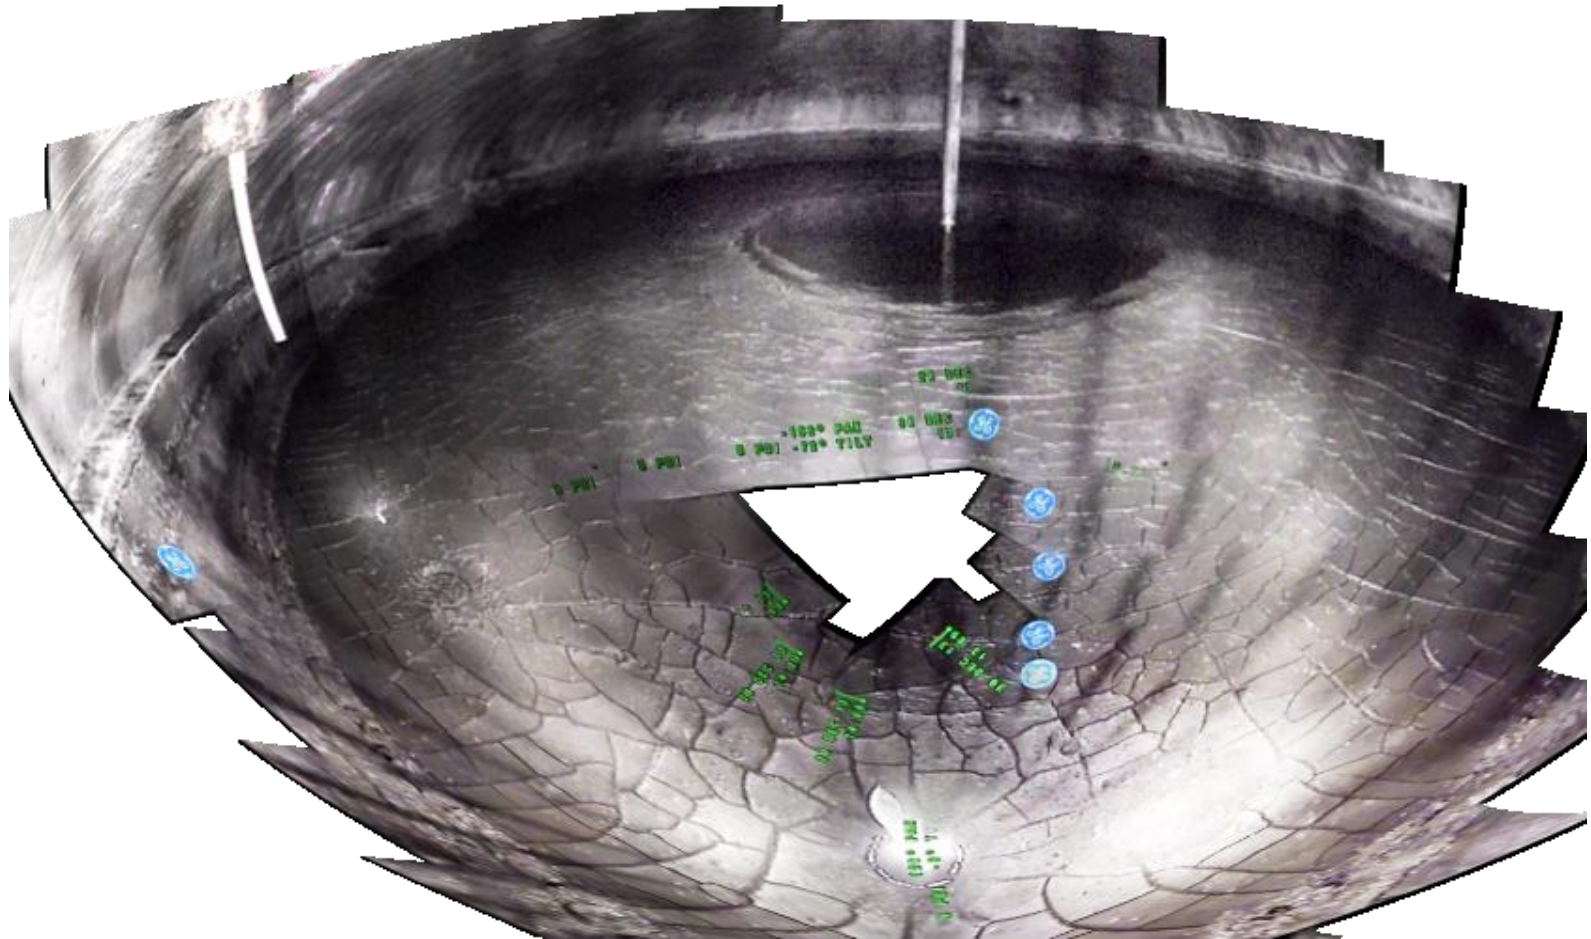
Figure 19 Tank T-111 Waste Surface Panorama from December 31, 2013

Figure 19 shows a panorama of the tank T-111 waste surface.

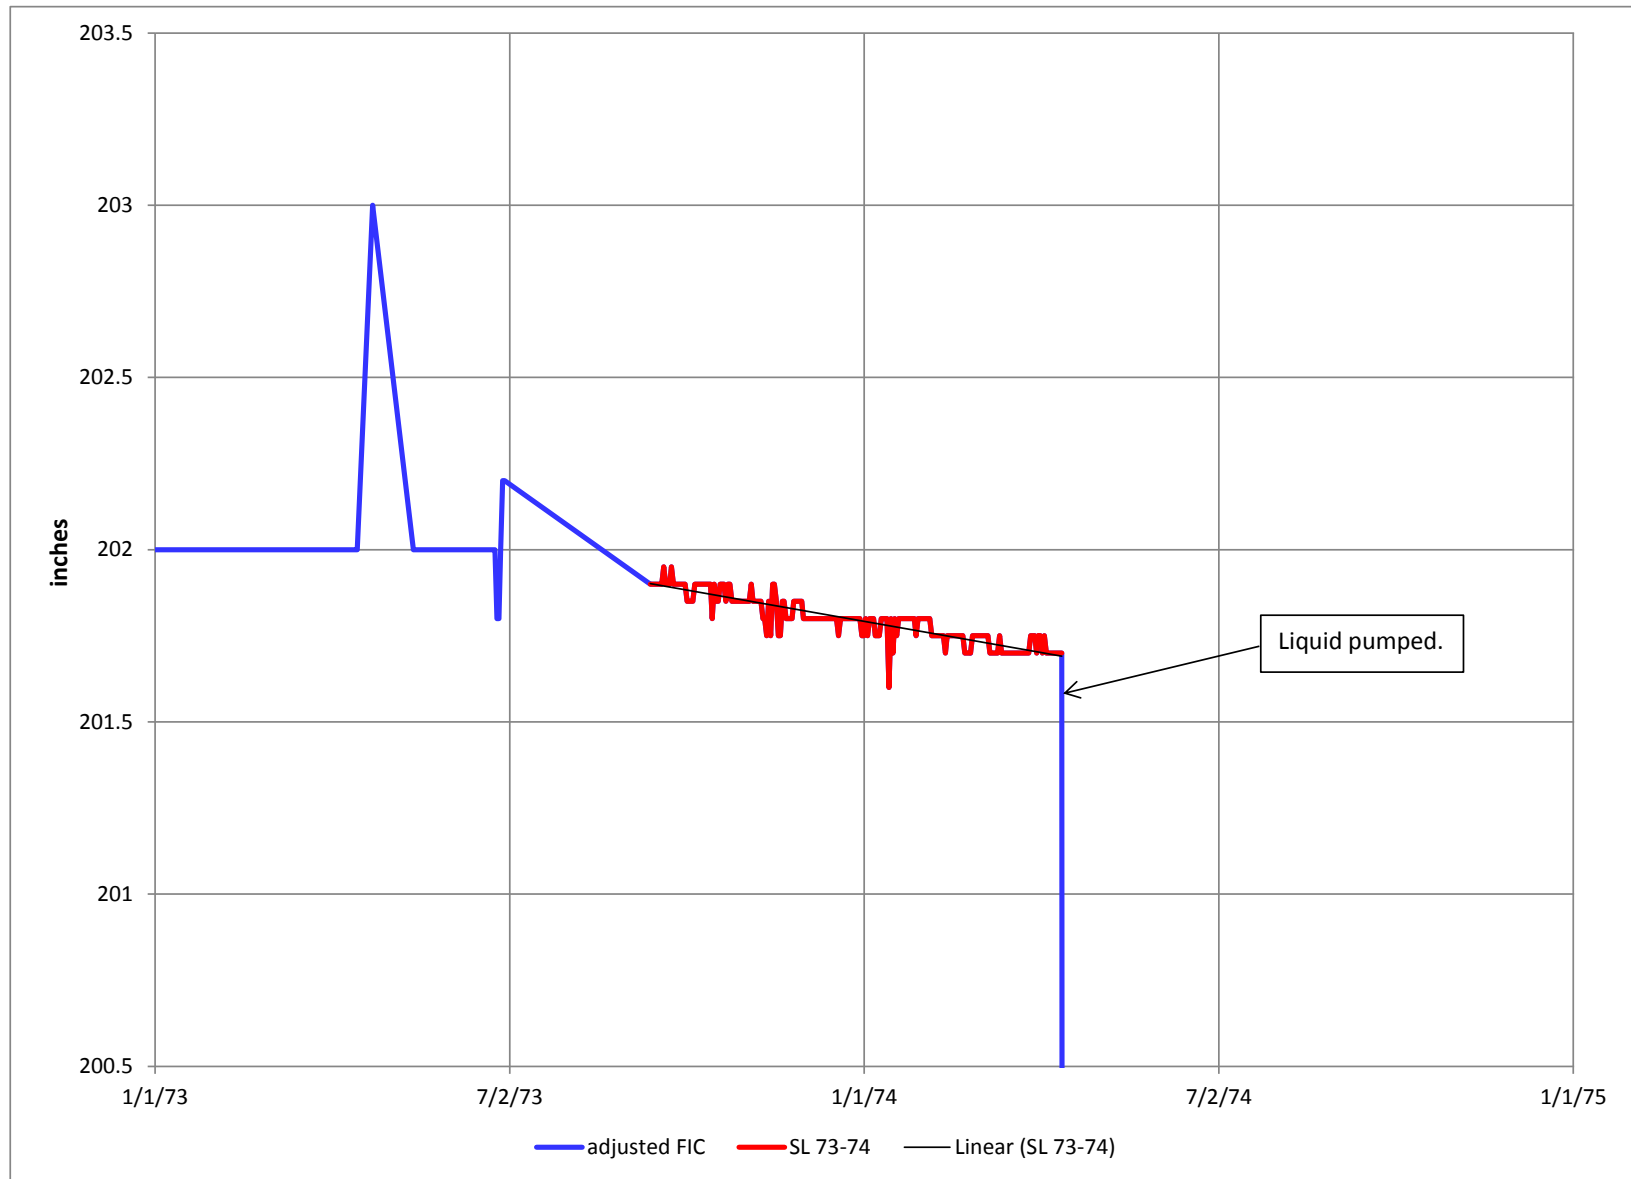
Figure 20 Tank T-111 Initial Level Decrease 1973 - 1974

**Surface Level Change Rate from 1973 to 1974** – Tank T-111 was first suspected of leaking due to a level decrease noted in 1974. Figure 20 plots the data from that period on an expanded x-axis and y-axis and uses Excel to calculate a linear regression line for the decrease. The level change rate in inches per year is equal to 365.25 times the slope of the regression line formula. The decrease rate was -0.364 in./yr.
