# Evaluation of Tank 241-T-111 Level Data and In-Tank Video Inspection

**John Schofield, Columbia Energy and Environmental Services**

Amie Feero, Washington River Protection Solutions, LLC

**Abstract:** This document summarizes the status of tank T-111 as of January 1, 2014 and estimates a leak rate and post-1994 leak volume for the tank.

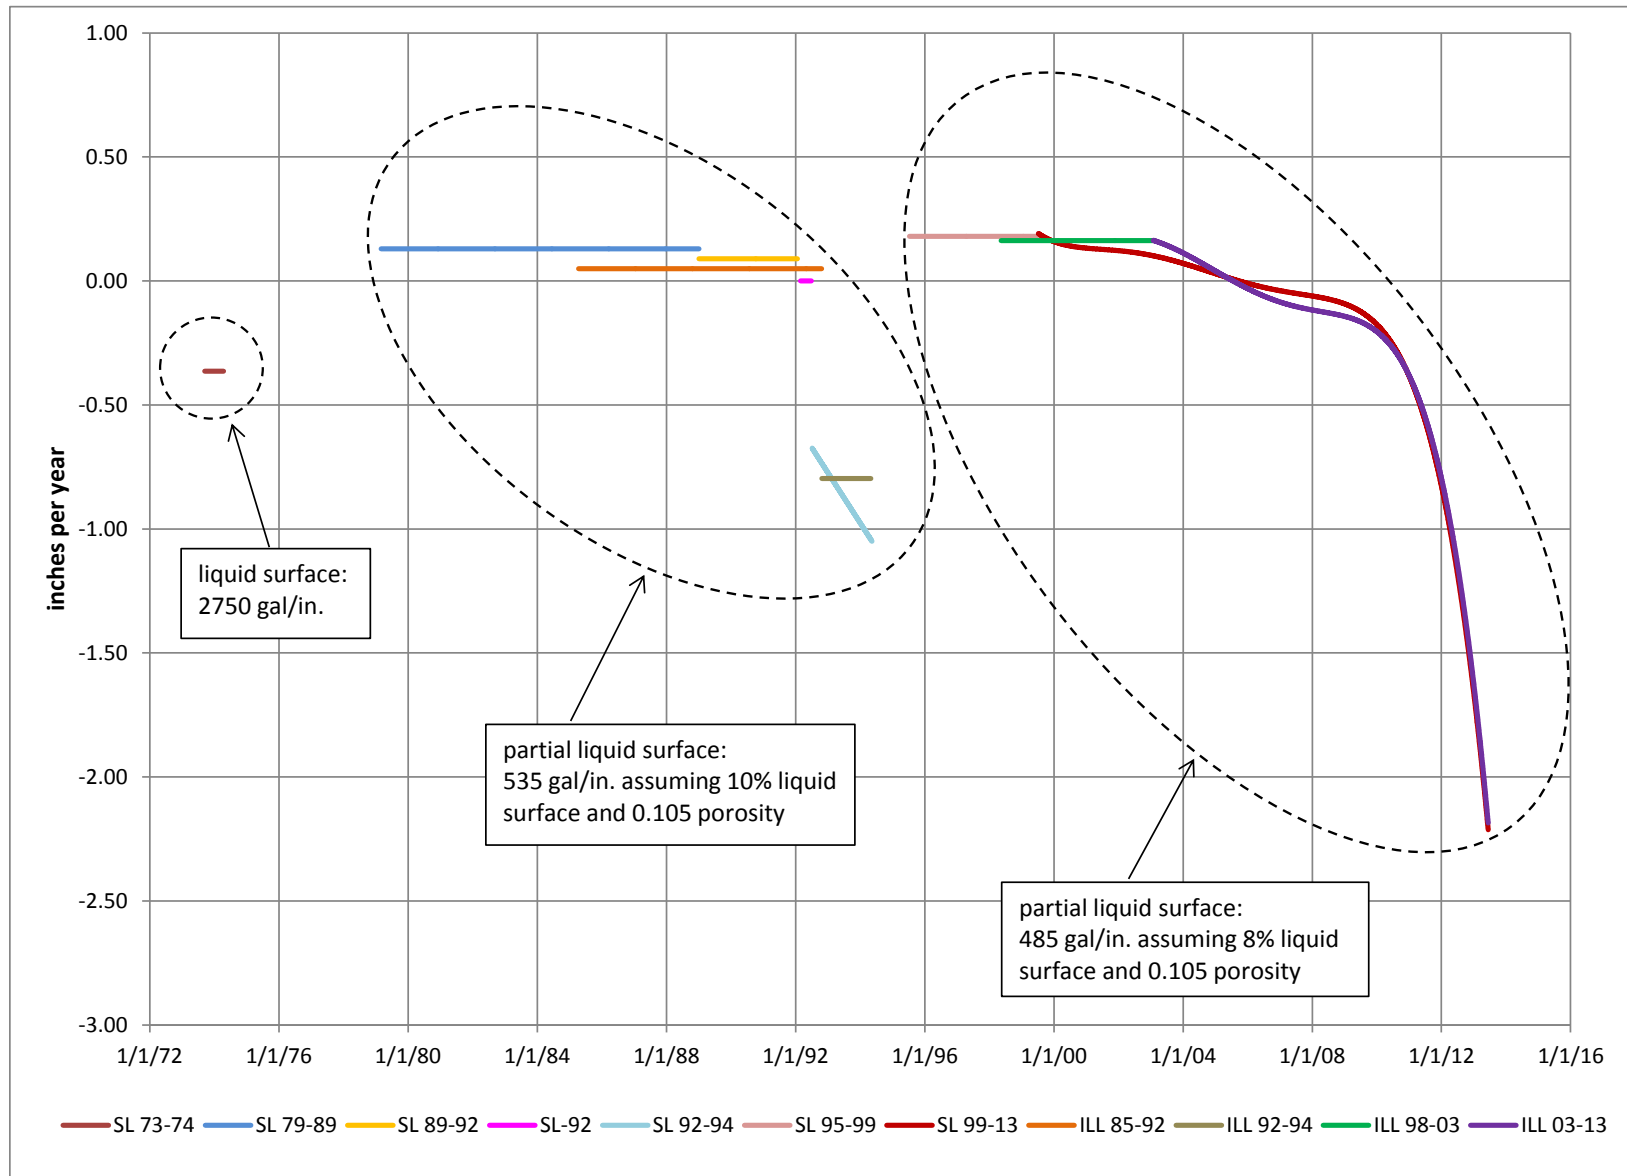
Figure 22 Tank T-111 Surface and Interstitial Liquid Level Change Rates to June 13, 2013

Figure 22 shows the level change rates in inches per year. Due to the varying amount of liquid on the surface the change rates are not directly comparable for the periods 1973-1974, 1979-1994, and 1995-2014. The 1973-1974 period had a 100% liquid surface which correlates to 2,750 gal/in. Per Section 4.2 the 1979-1994 period is roughly estimated to average about 535 gal/in. and the 1995-2013 period about 485 gal/in.

Tank T-111 is one of several tanks where the SL and ILL data track each other. This is due to the ILL being at or near the surface and the Enraf plummet is resting in liquid. The LOW and Enraf are on opposite sides of the tank for tank T-111 but the ILL and SL data track each other, as do the calculated ILL and SL change rates in Figure 22.

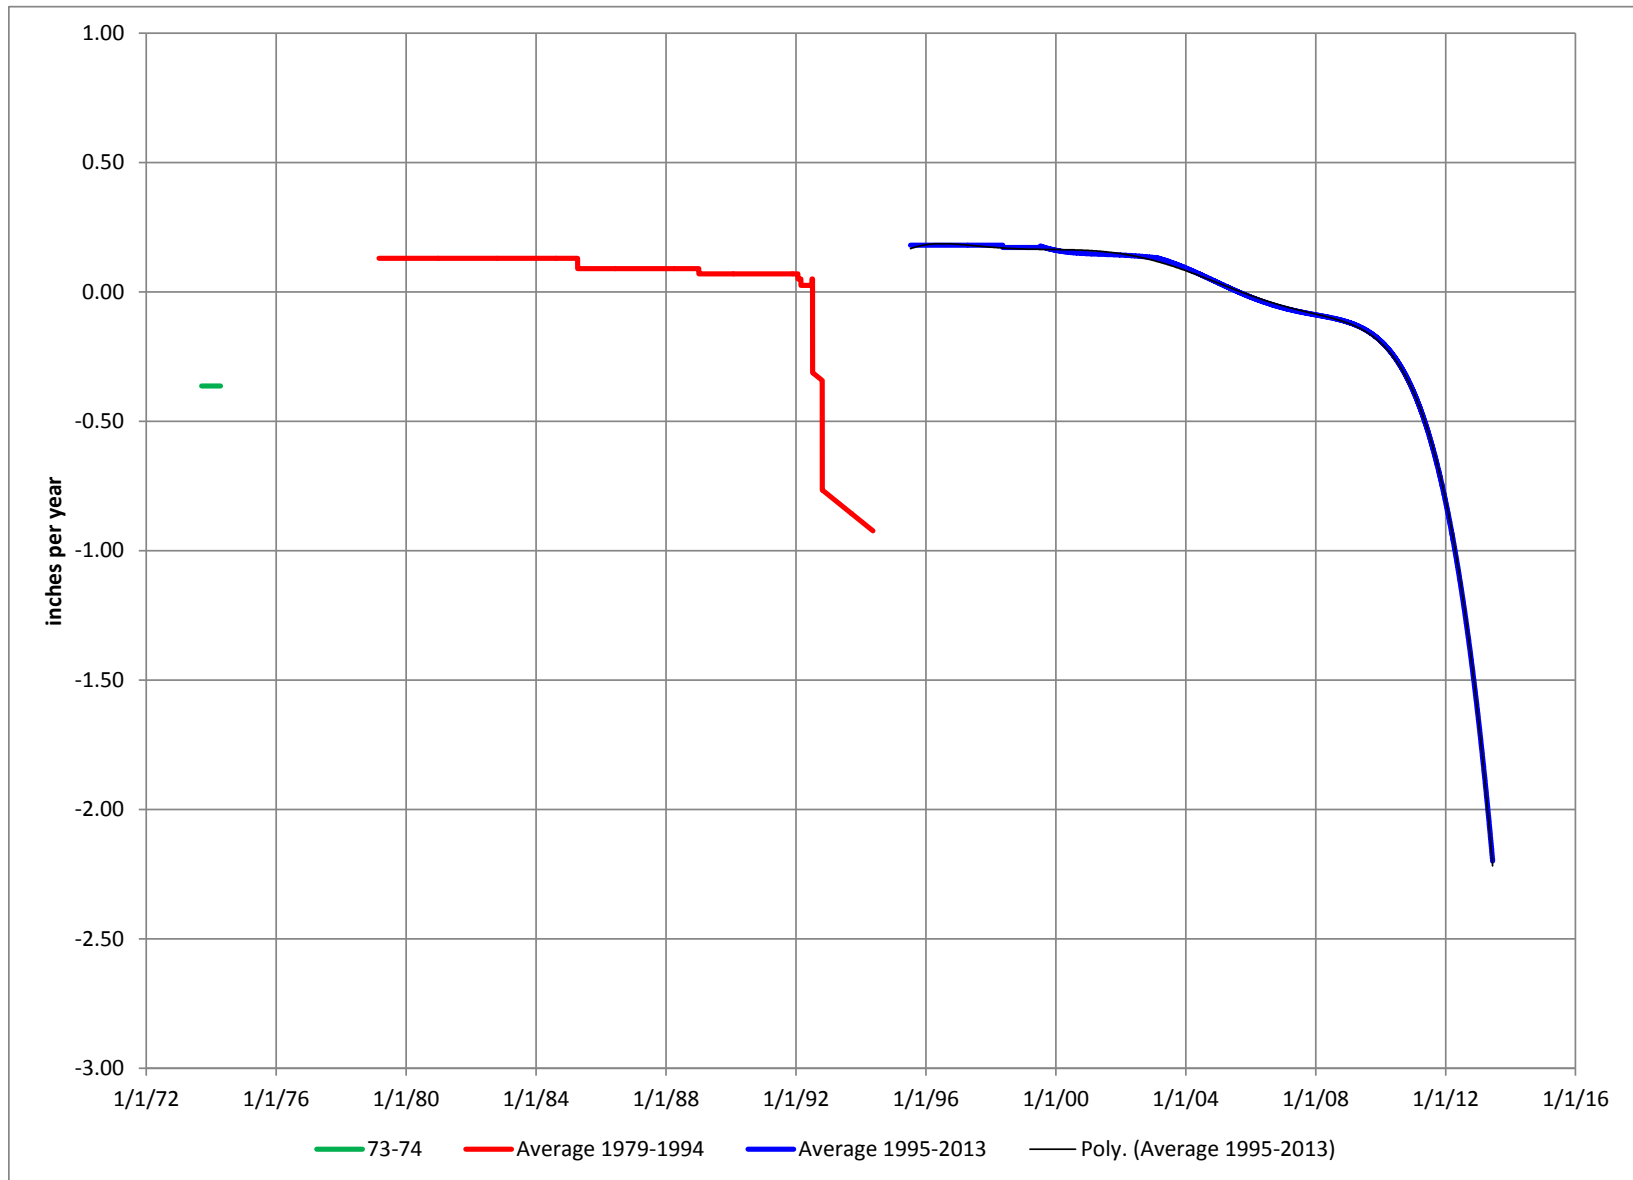
Figure 23 Tank T-111 Average Liquid Level Change Rates 1973 to June 13, 2013

The calculated SL and ILL change rates for tank T-111 were averaged for each day from March 1, 1979 to June 13, 2013 and the resulting values plotted in Figure 23. A regression line through the post-1994 values was calculated in Excel to provide a formula for the tank T-111 level change rate between July 13, 1995 and June 13, 2013.

Values for  $\Delta L$  obtained from the regression line formula for the plot in Figure 23 are used in the above equation to estimate a daily volume change rate from 1995 to June 13, 2013. Figure 25 gives the results.

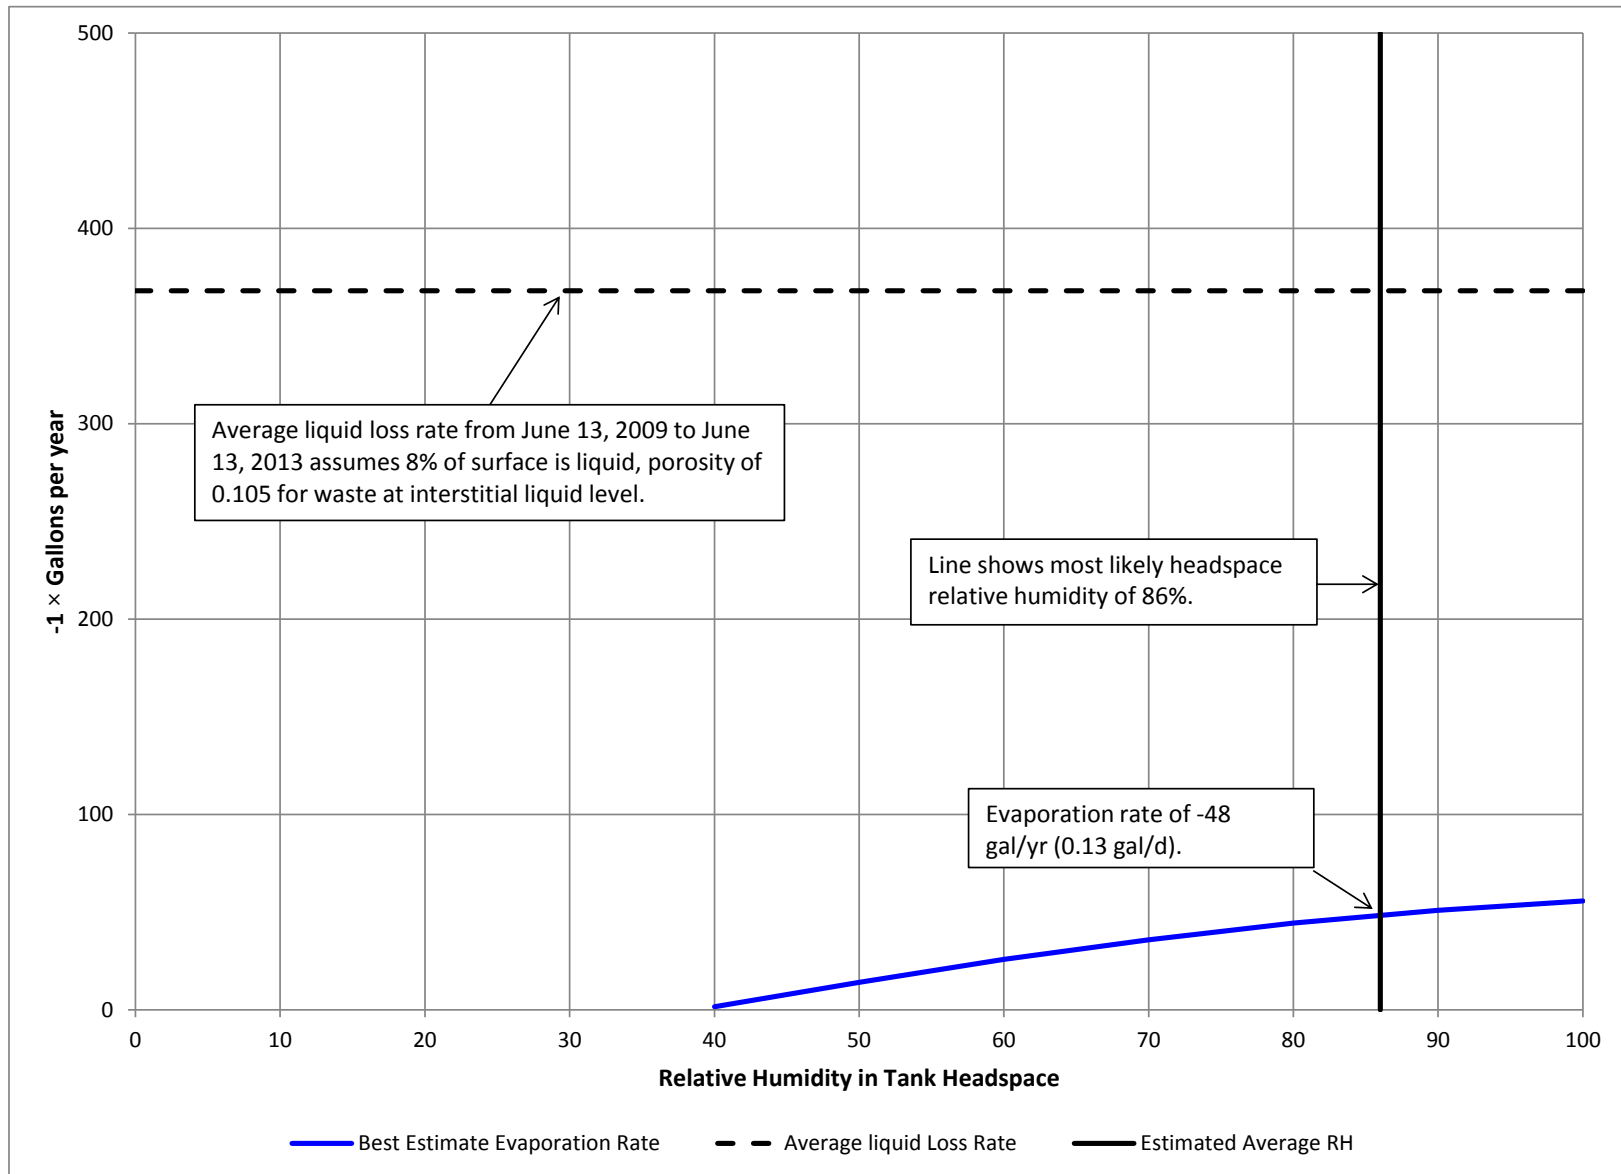
Figure 27 Tank T-111 Estimated Evaporation Rate

The 223 British Thermal Unit (BTU)/hr radiolytic heat generation rate for the tank is very low, and has negligible effect on the volume of water evaporated since most of this heat is lost to the surrounding soil. Although a -48 gal/yr evaporation rate will only require ~44 BTU/hr of heat input, the heat to evaporate the water in tank T-111 comes primarily from latent heat in the incoming air and the top few inches of the tank waste.

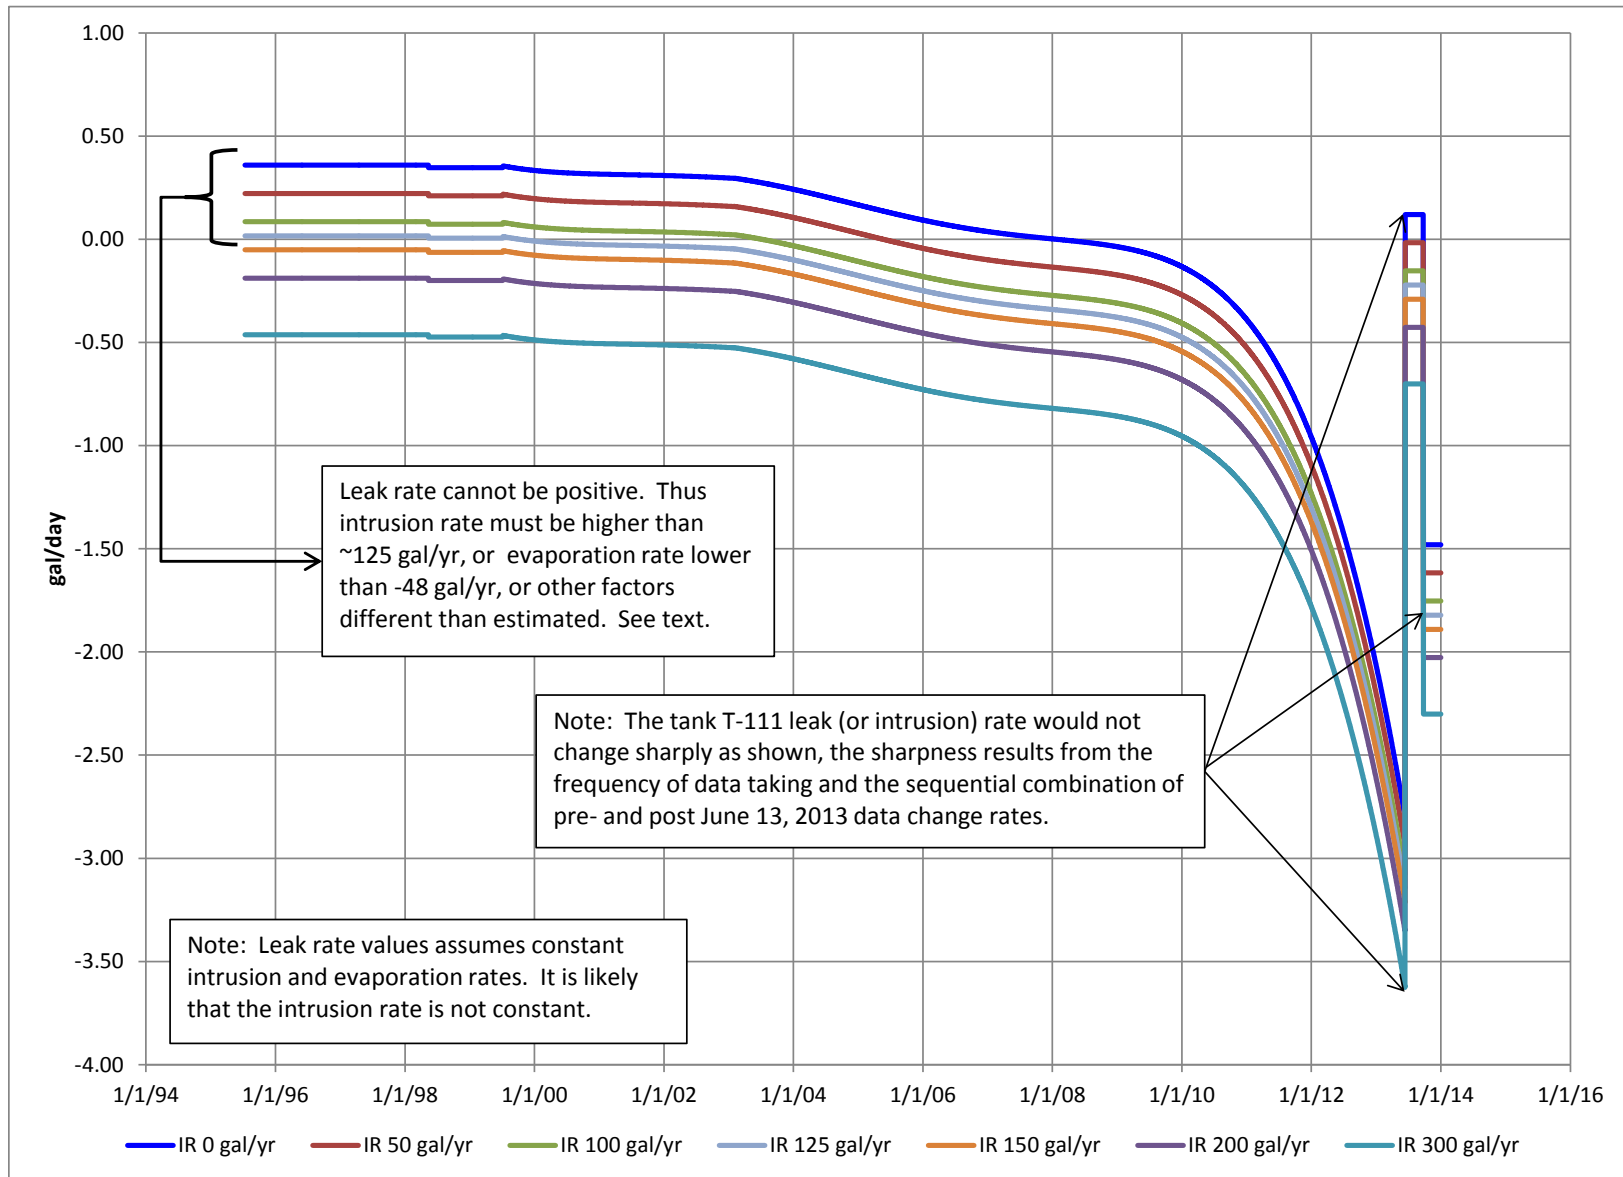
**Figure 28 Calculated Tank T-111 Leak Rate as Function of Assumed Intrusion Rate**

- The average intrusion rate into tank T-111 has been around 130 gal/yr, but has probably varied widely.
- The leak from tank T-111 appears to have restarted in the 2000 to 2003 time frame, assuming there was not a major decrease in the intrusion rate at that time. If there was a major decrease in the intrusion rate the current tank leak period may have begun earlier.
- The leak rate progressively increased, reaching a maximum rate of about -3 gal/d (-1,100 gal/yr) in June 2013. The intrusion rate and leak rate balanced each other (after accounting for evaporation and other factors) from July to September 2013. The leak rate then averaged about -1.8 gal/d (-660 gal/yr) from September to January 2014. The -1.8 gal/d is the value from Figure 28 for a 125 gal/yr intrusion rate.

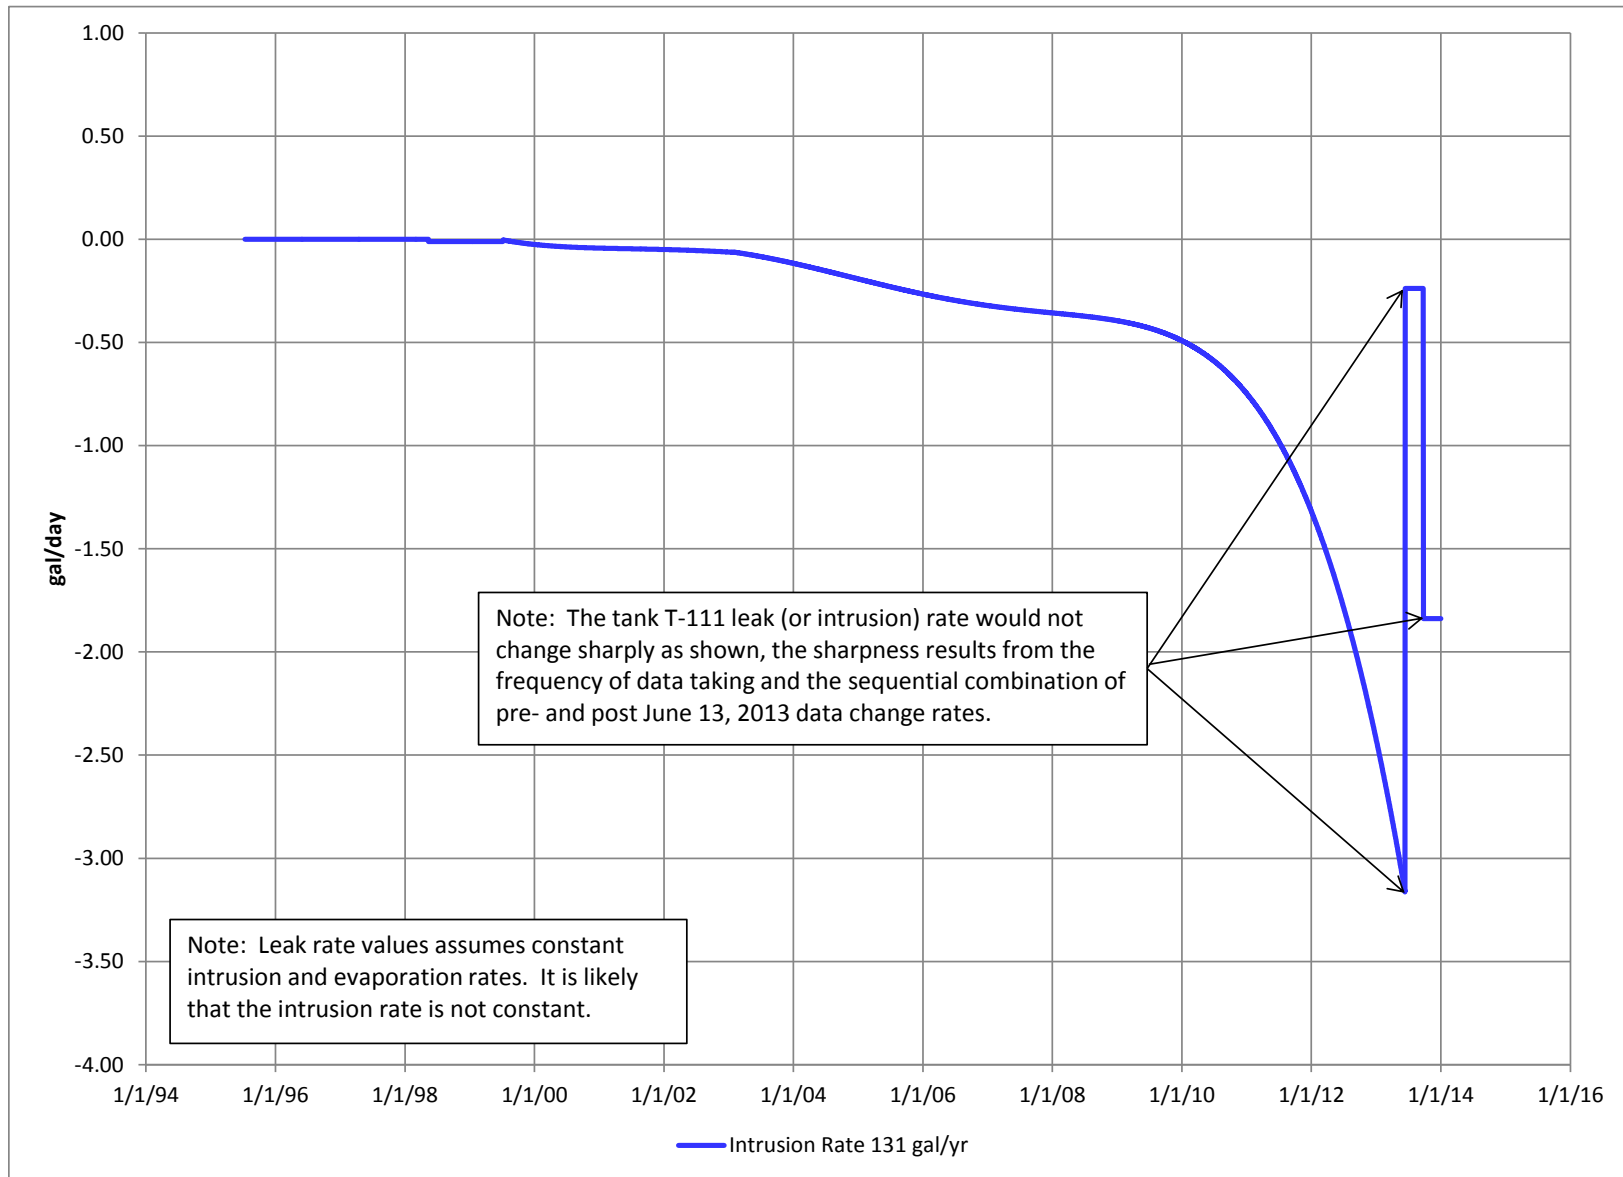
Figure 29 Calculated Tank T-111 Leak Rate for An Average 131 gal/yr Intrusion Rate

An estimated post-July 1995 leak volume was estimated by assuming a constant 131 gal/yr intrusion rate, calculating a daily leak rate, and then summing up the daily leak volumes. An intrusion rate of 131 gal/yr is the minimum necessary to calculate a non-positive leak rate in 1995 using a -48 gal/yr evaporation rate and +5 gal/yr for [ $\Sigma$  other].
