# Effects from the Reduction of Air Leakage on Energy and Durability

**October 2013**

Prepared by  
OAK RIDGE NATIONAL LABORATORY  
Oak Ridge, Tennessee 37831-6283  
managed by  
UT-BATTELLE, LLC  
for the  
U.S. DEPARTMENT OF ENERGY  
under contract DE-AC05-00OR22725

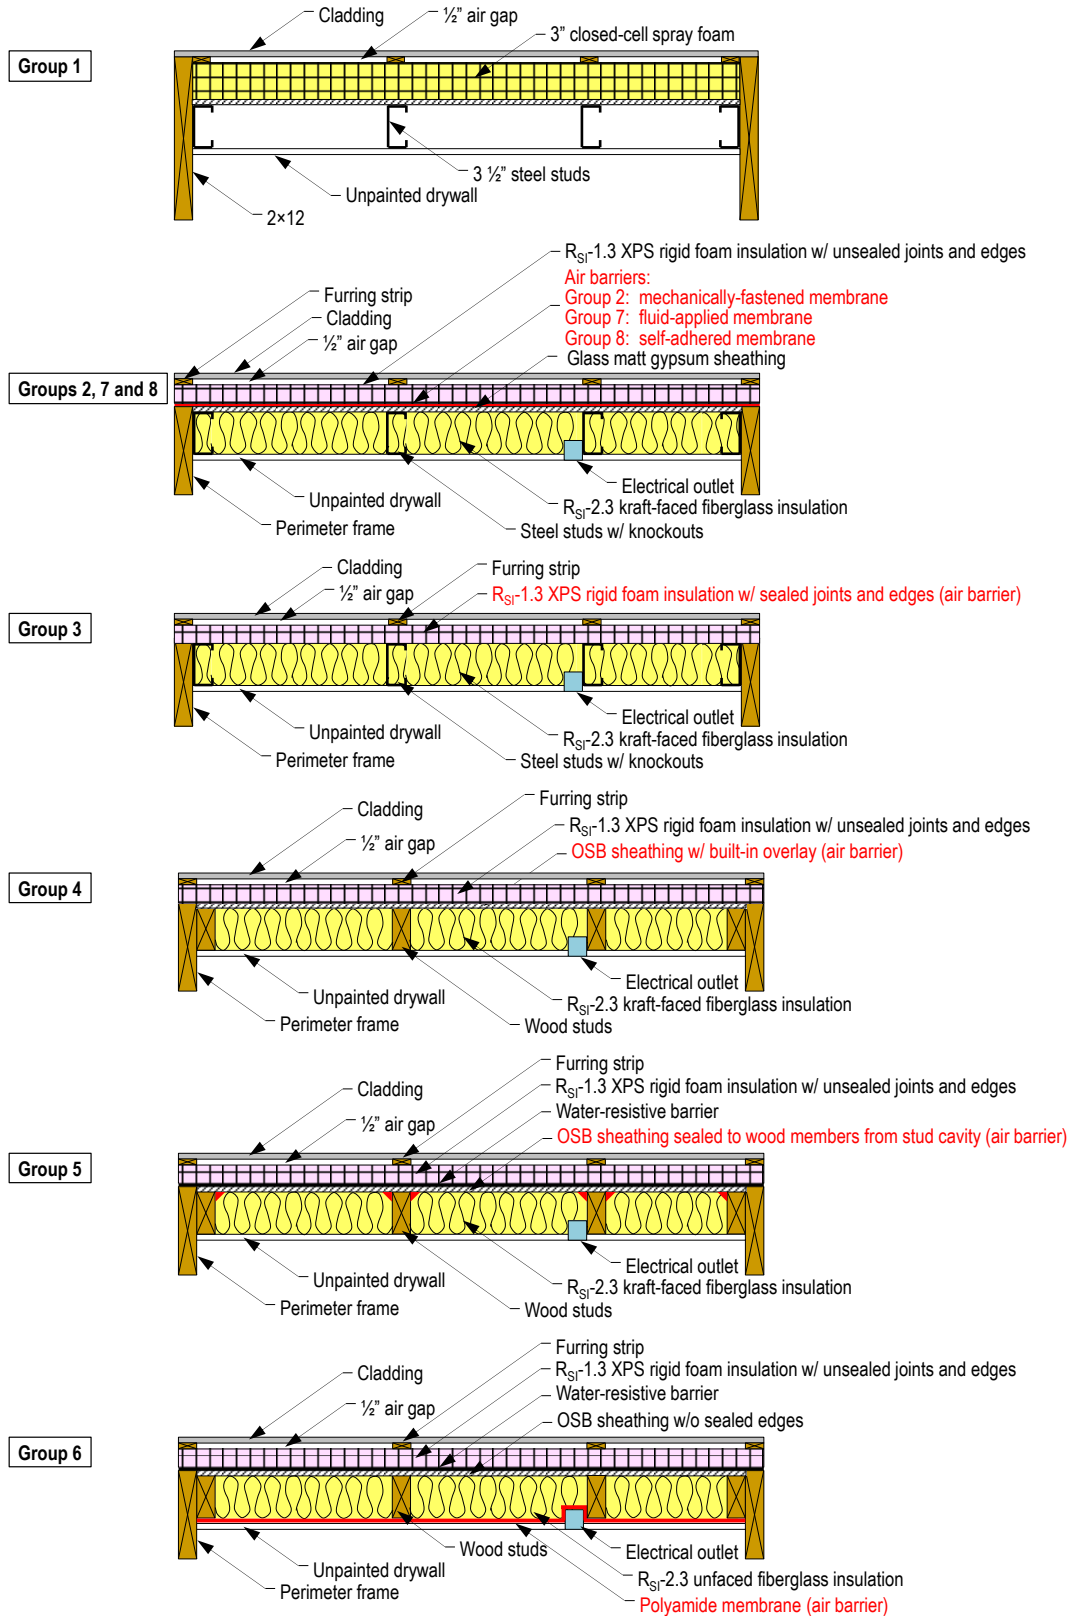
Figure ES 1. Material layout in test walls.

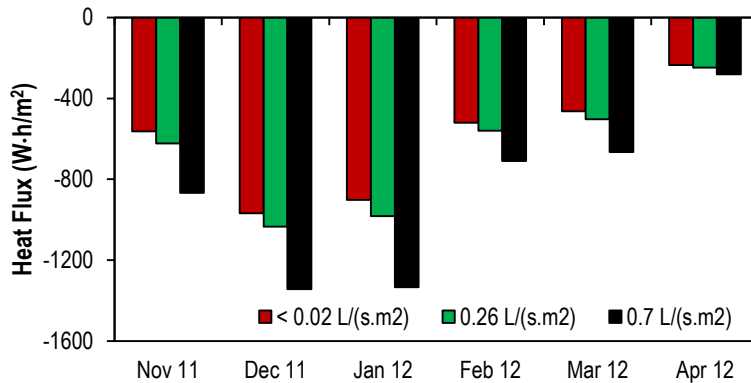
Figure ES 2. Average heat flux through the Group 4 panels during the heating season and infiltration.  
a. Fluxes were measured at mid-height of the wall, between the facing of the fiberglass insulation and the interior drywall.  
b. Air leakage rates shown were measured at  $\Delta P = 75$  Pa.

Effects on energy loads from the reduction of air leakage were most noticeable on walls that were facing south because wind from this direction was dominant. Furthermore, heat flux measurements were the highest during the winter because of larger indoor-to-outdoor temperature differentials. Figure ES2 shows data from the south-facing Group 4 panels that were gathered during infiltration (i.e., outdoor pressure > indoor pressure). Heat fluxes in the Level 1 panel were mostly due to conduction because of its high airtightness (i.e., < 0.02 L/(s·m<sup>2</sup>) at 75 Pa). Therefore, increases in flux in the Level 2 and Level 3 walls, when compared to the Level 1 panel, were due to air leakage. Maximum differences between the Level 3 (1340 W·h/m<sup>2</sup>) and Level 1 (930 W·h/m<sup>2</sup>) walls occurred in December and January. During these months, the average indoor-to-outdoor temperature difference was 20°C, and the 95<sup>th</sup> percentile outdoor-to-indoor pressure was about 19 Pa. Table ES2 summarizes the percent increases and indicates that the Level 3 panel had fluxes that were up to 54% higher than those from the Level 1 wall. In contrast, differences between the Level 2 (1010 W·h/m<sup>2</sup>) and the Level 1 panels did not exceed 11%, which indicates that the energy-related benefits from decreasing air leakage from 0.2 to 0.02 L/(s·m<sup>2</sup>) at 75 Pa may not be sufficient to justify the additional effort. These percent differences were influenced by the relatively high insulation in the walls; that is, if a lower R-value had been used, then the relative contribution from airflow to heat flux would have been less.

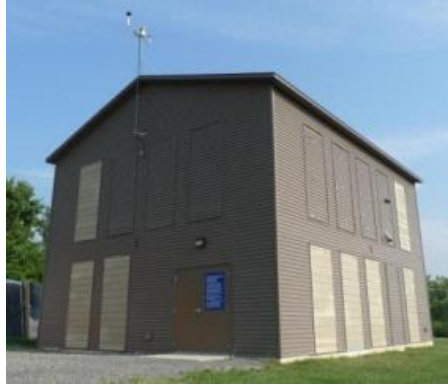
Figure 2. Building Envelope Systems Testing (BEST) lab.

The BEST lab is a two-story facility, with an approximate 9.1m × 11m footprint, located in the Syracuse University campus in Syracuse, NY (Figure 2). Indoor temperature and relative humidity were set to 20°C and 40%, respectively, throughout the test period. This high relative humidity could occur during the winter in buildings with tight envelopes and inadequate mechanical ventilation, and that are located in a cold climate. Throughout the cooling season, indoor air was conditioned with an air source heat pump and a dedicated dehumidifier, while a gas heater and a humidifier were during the heating season.

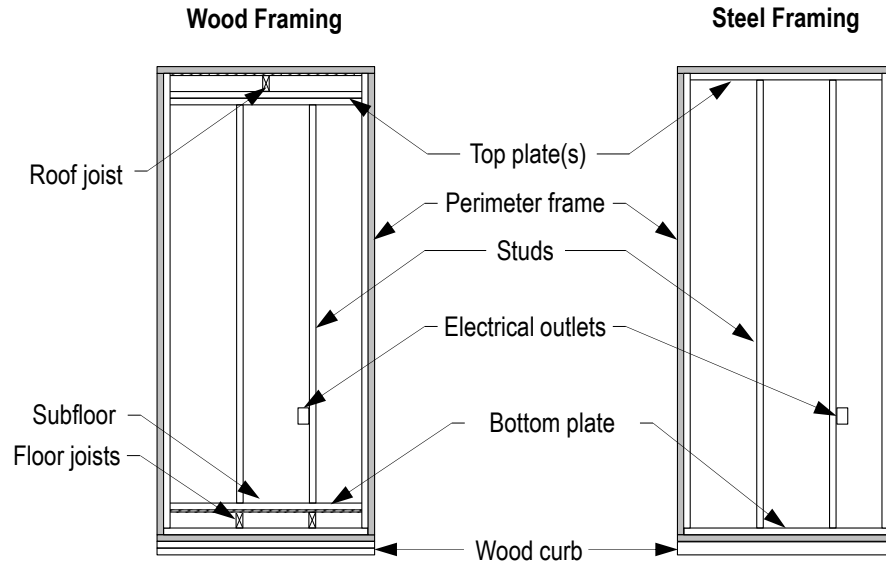
Figure 4. Wall elevations.

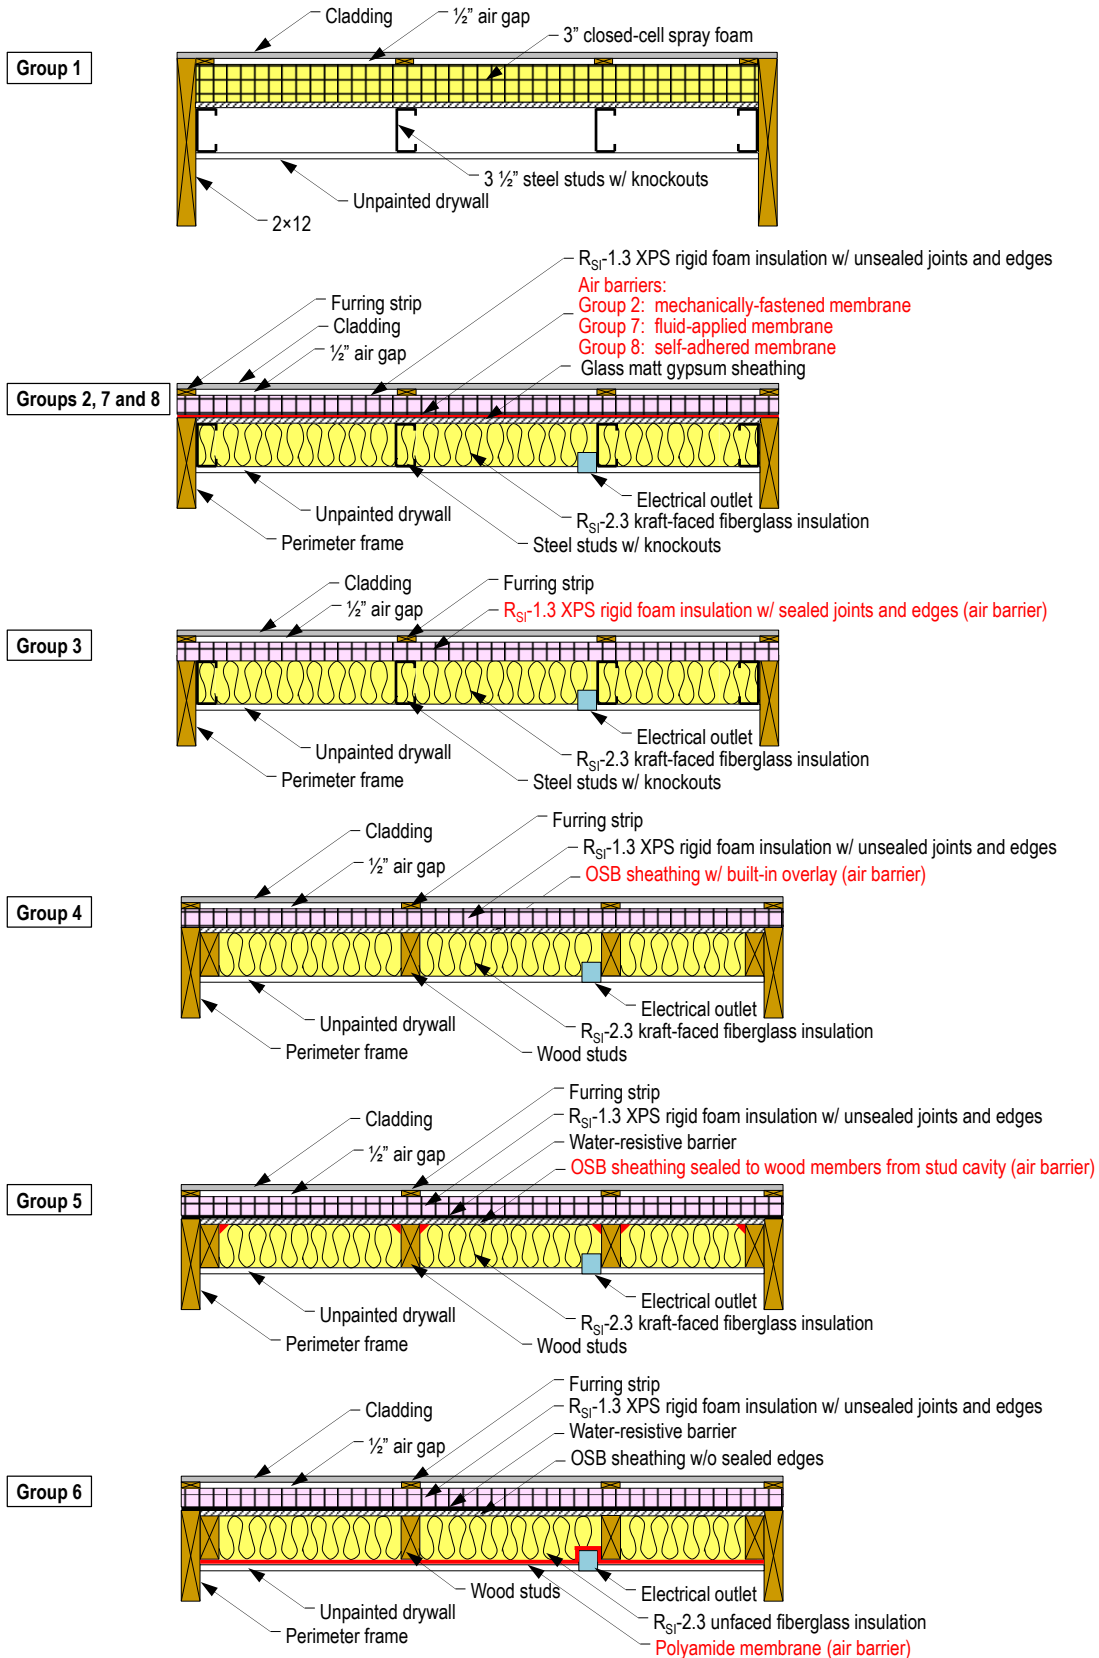
Figure 5. Material layout in test walls.

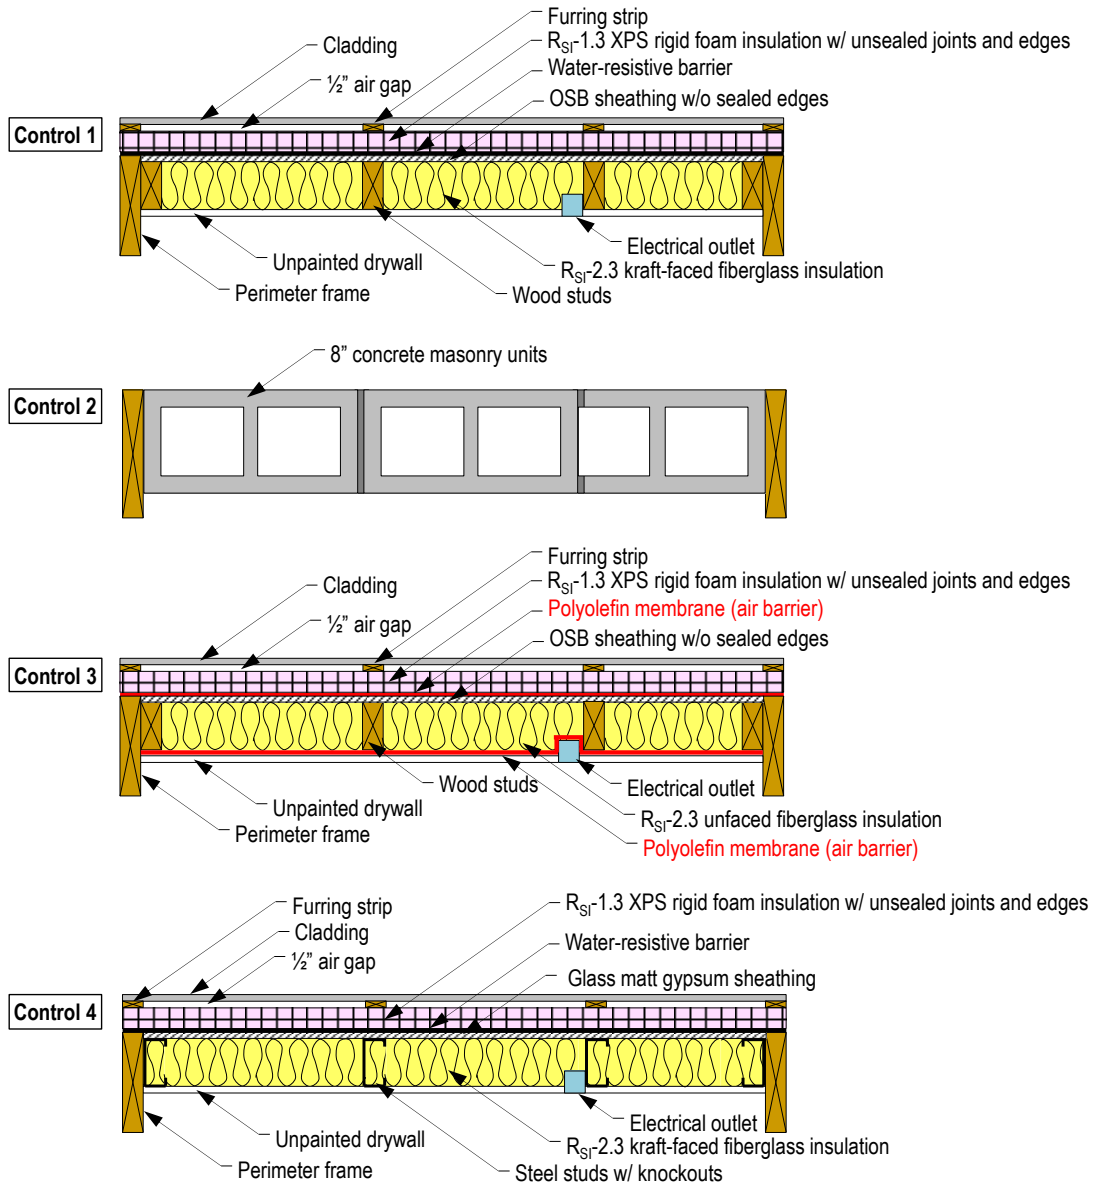
Figure 6. Material layout in control walls.

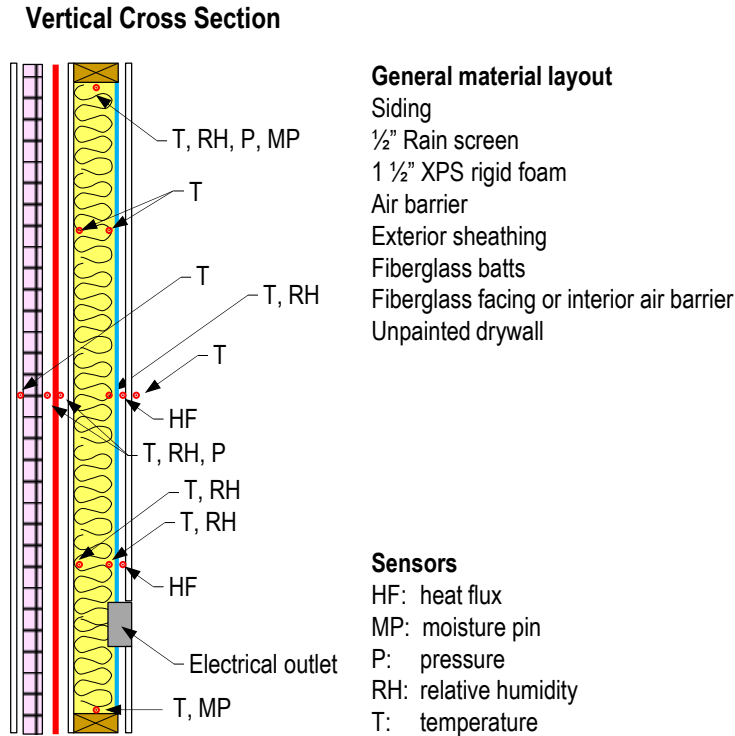
Figure 8. General sensor layout within the center-stud cavity of test walls.

Figure 8 illustrates the general layout of the temperature (T), relative humidity (RH), heat flux (HF), pressure (P), and moisture pins (MP) sensors in the panels. The location of these instruments varied somewhat depending on the air barrier type and the placement of the air barrier in the wall assembly.

Heat flux measurements were used to examine the effects of air leakage on energy loads. Two sensors were installed in each wall between the facing of the fiberglass insulation and the interior drywall (Figure 8). One sensor was located in the middle of the panel to represent the average flux through the wall. The second sensor was close to the electrical outlet opening through the interior drywall to increase its exposure to airflows in the wall cavity, and measure the potential maximum fluxes. To isolate the effects from air leakage, heat fluxes from the Level 2 and Level 3 walls were compared against those from the Level 1 panel, where measurements were mostly due to conduction because of its airtight construction (i.e.,  $\sim 0.02 \text{ L}/(\text{s}\cdot\text{m}^2)$  at 75 Pa). Although not perfect, this technique was selected as an intermediate method to estimate the contribution from air leakage to energy loads because the other two typically used alternatives had their own limitations. The ideal setup to quantify the effects of airflow would have been similar to that of a hot box; however, this is a cost-prohibitive approach. The conventional method to estimate the effects of air leakage is to use the product of the airflow rate times the enthalpy difference between indoors and outdoors; however, this method does not take into account heat exchanges between the infiltrating/exfiltrating air and the wall cavity materials that are in the airflow path (Sherman and Walker 2001).

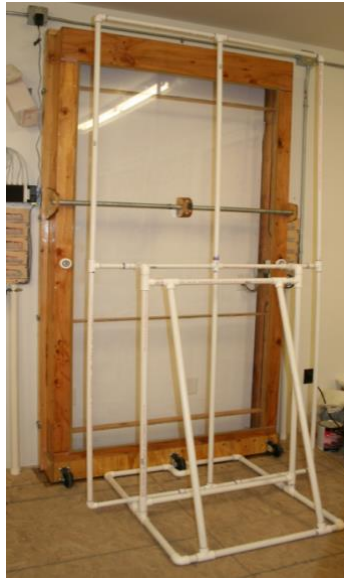
Figure 9. Test wall pressurization setup.

Syracuse University characterized the air leakage of each of the panels every two months from September 2011 until July 2012 using a procedure similar to the blower door fan pressurization technique. An airtight portable box that sealed against the perimeter of a test wall was built to create a pressure differential across the specimen (Figure 9). The pressurizing box was connected to a variable speed blower that regulated the  $\Delta P$  across the wall, and a TSI flow meter (minimum flow rate = 4 L/min) measured the airflow rate required to generate pressure differentials of 25, 50 and 75 Pa. A second blower was used to pressurize the building and maintain a zero  $\Delta P$  across the portable box, which ensured that airflow measurements were due to leakage through the test panel and not through the box.

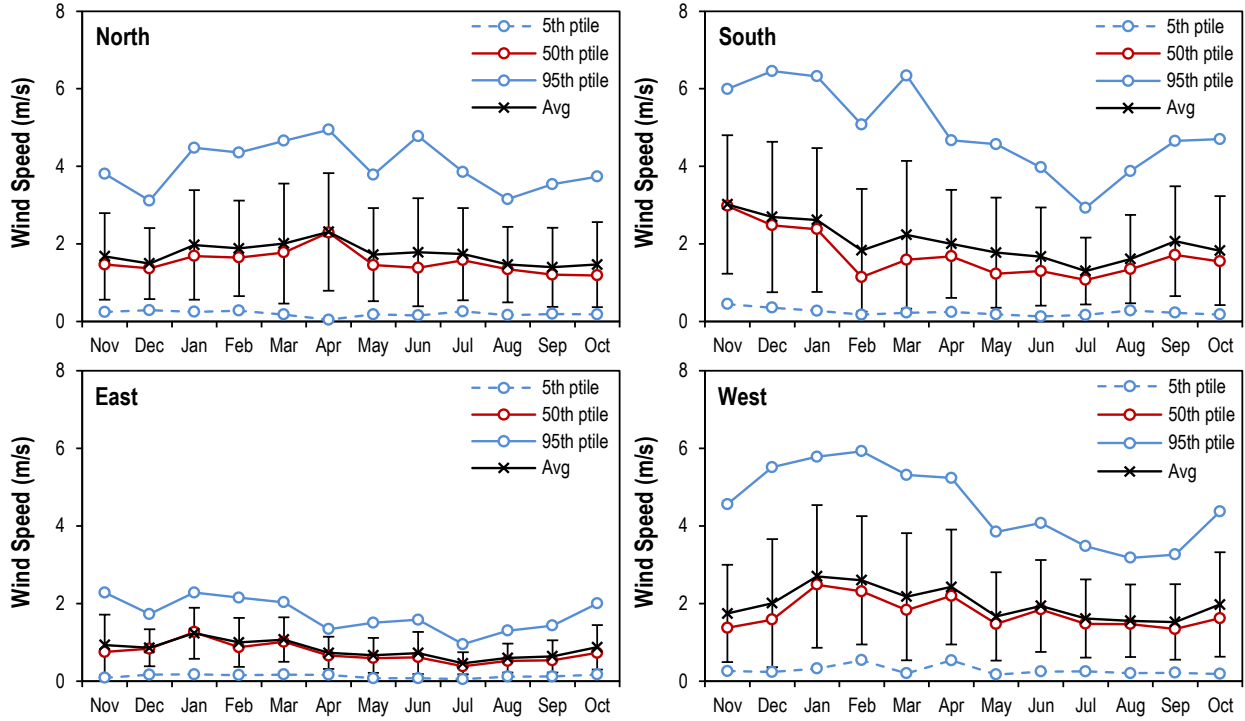
Figure 12. Monthly average wind speeds measured at the weather station located in the grounds of the test facility.

Figure 12 shows the monthly average and distribution of the wind speeds. South and west winds were dominant, especially during the winter months, while east winds were typically the weakest throughout the entire year. Monthly average outdoor-to-indoor pressure differentials for the four building sides and their distributions are described in Figure 13. These differentials were mostly obtained through pressure transducers, but some values were estimated using the measured wind speeds and the procedure reported by Swami and Chandra (1987) when sensors failed. Monthly average pressure differential values from all building sides spanned from -3.7 to 5.1 Pa; however, their distribution covered a large range. For example, the south side of the facility experienced pressure values that spanned from -17 Pa (5<sup>th</sup> percentile) to 21 Pa (95<sup>th</sup> percentile). Additionally, Figure 13 shows that the south and west facing panels experienced both positive (i.e.,  $P_{out} > P_{in}$ ) and negative (i.e.,  $P_{out} < P_{in}$ ) pressure differentials. In contrast, the east and north facing panels were subjected primarily to negative pressure differentials that led to exfiltration.

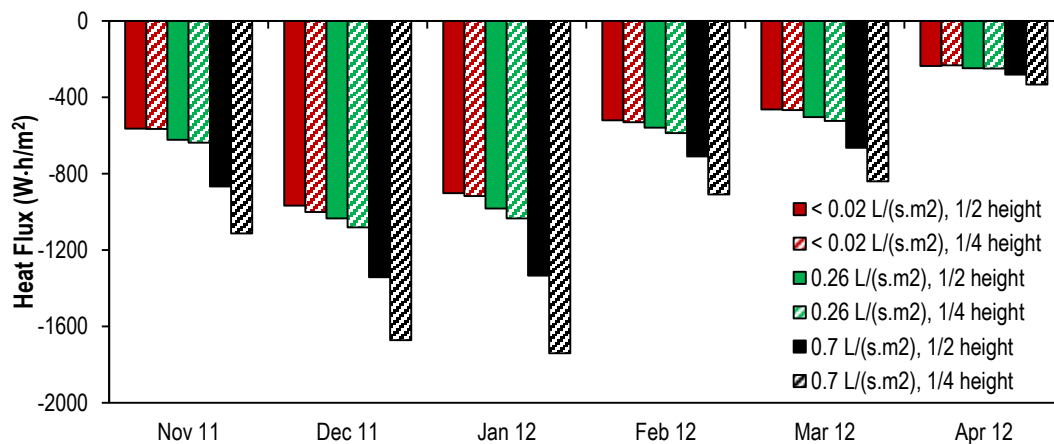
Figure 14. Heat flux at  $\frac{1}{4}$  height and  $\frac{1}{2}$  height of the Group 4 panels during the heating season and infiltration.

- b. Fluxes were measured between the facing of the fiberglass insulation and the interior drywall.
- c. Air leakage rates shown were measured at  $\Delta P = 75 \text{ Pa}$ .

Heat fluxes varied with indoor-to-outdoor temperature ( $T_{in} - T_{out}$ ) differentials and outdoor-to-indoor pressure differentials ( $P_{out} - P_{in}$ ). Figure 14 shows the monthly heat fluxes that were collected while windward pressure occurred on the south side of the building (i.e.,  $P_{out} > P_{in}$ ). Differences between the fluxes at  $\frac{1}{4}$  height ( $HF_{1/4}$ ) and  $\frac{1}{2}$  height ( $HF_{1/2}$ ) were minimal in the Level 1 and Level 2 walls because of their relatively low air leakage rates. In contrast,  $HF_{1/4}$  measurements were typically about 25% higher than  $HF_{1/2}$  values in the Level 3 panel, given that the former was more exposed to airflows due to its close proximity to the electrical outlet opening. Maximum heat fluxes occurred in January 2012 when the average  $T_{in} - T_{out}$  was  $21.6^{\circ}\text{C}$  and  $P_{out} - P_{in}$  measurements were: monthly average = 1.9 Pa, 5<sup>th</sup> percentile = -17 Pa, 95<sup>th</sup> percentile = 21 Pa. During this month,  $HF_{1/2}$  values from the Level 1, Level 2 and Level 3 panels were 900, 980, and  $1330 \text{ W}\cdot\text{h}/\text{m}^2$ , respectively. The corresponding  $HF_{1/4}$  measurements were 920, 1030, and  $1740 \text{ W}\cdot\text{h}/\text{m}^2$ .

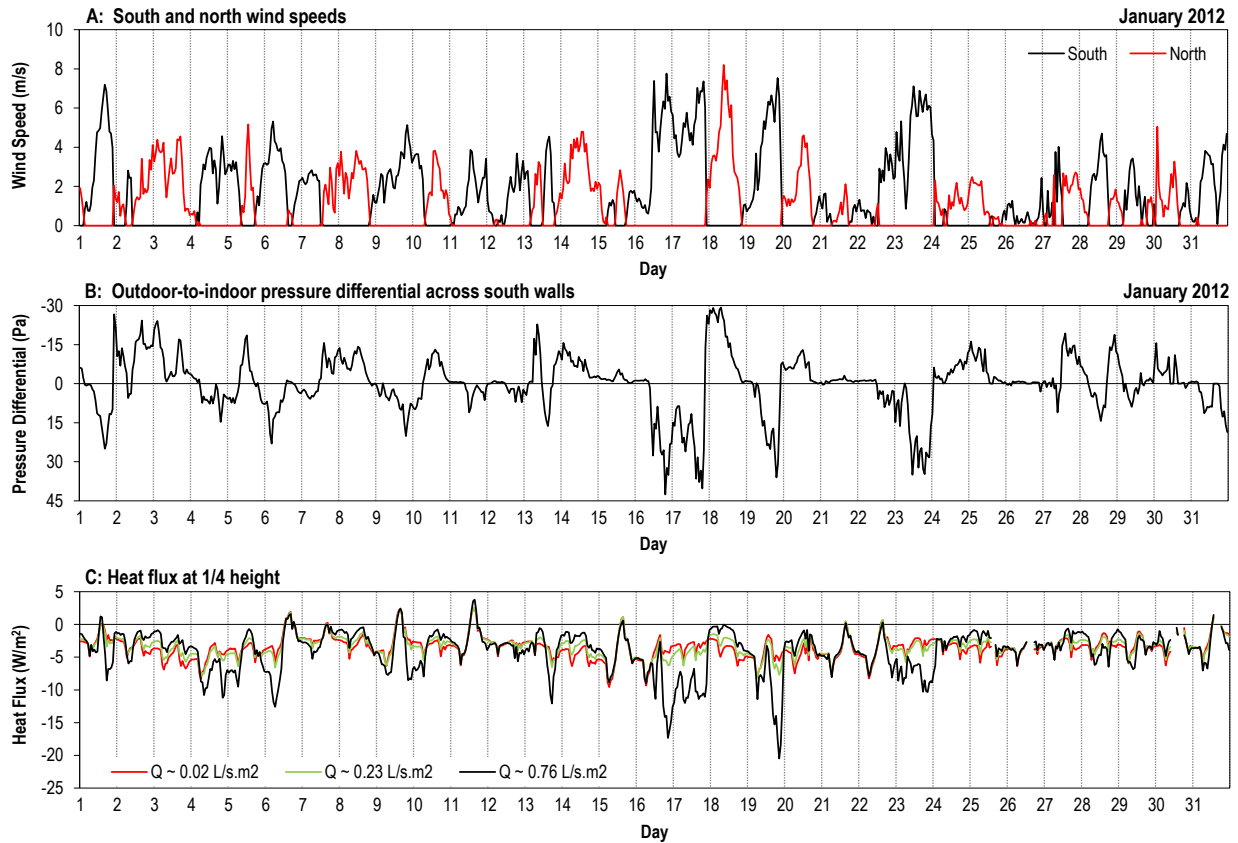
Figure 15. January measurements. A: South and north wind speeds; B: Outdoor-to-indoor pressure differentials (positive values =  $P_{out} > P_{in}$ ); C: Heat flux from Group 4 walls measured between facing of fiberglass insulation and interior drywall and at 1/4 height of wall.

- Positive pressure differentials indicate that outdoor pressure was higher than indoor pressure.
- Air leakage rates were measured at  $\Delta P = 75$  Pa.

January data were plotted in Figure 15 to provide more details on the effects that wind has on infiltration/exfiltration and heating loads. Figures 15A and 15B illustrate the correlation between the south winds and the windward pressure on the south side of the test facility, as well as between the north wind and the leeward pressures.  $HF_{1/4}$  data in Figure 15C demonstrates how infiltration and exfiltration influence heat flux. For example, south winds were dominant from late afternoon on January 16<sup>th</sup> until late at night on the 17<sup>th</sup>. The average south wind speed and outdoor-to-indoor pressures during this period were 5.5 m/s and 22 Pa, respectively. These pressures led to infiltration loads that caused the average  $HF_{1/4}$  data from the Level 3 wall to be three times higher than the heat fluxes from the Level 1 specimen and two times higher than those from the Level 2 panel (Figure 16A). The average indoor-to-outdoor temperature differential during this period was 16.6°C.

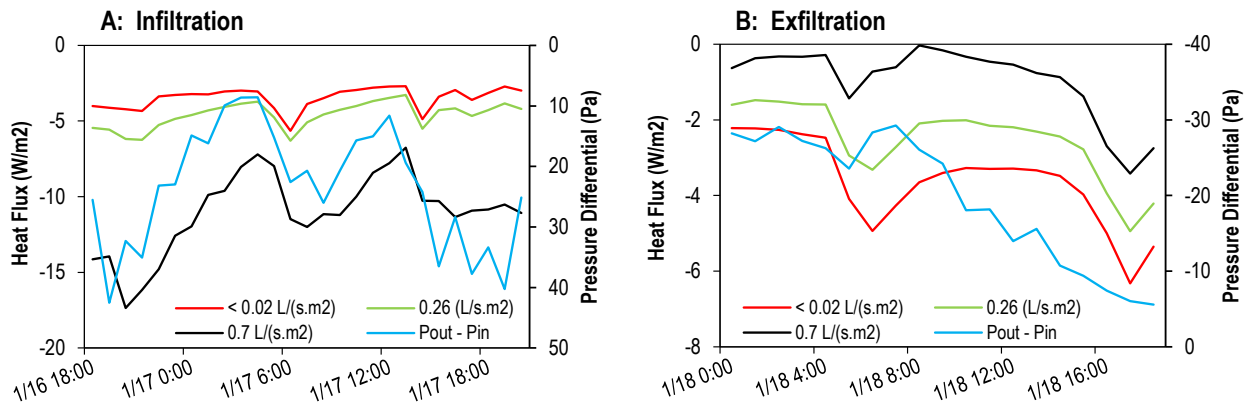
Figure 16. Heat fluxes between facing of fiberglass insulation and interior drywall of the Group 4 walls. A: Effect of infiltration on heat flux. B: Effect of exfiltration on heat flux.

- Positive pressure differentials indicate that outdoor pressure was higher than indoor pressure.
- Air leakage rates were measured at  $\Delta P = 75$  Pa.

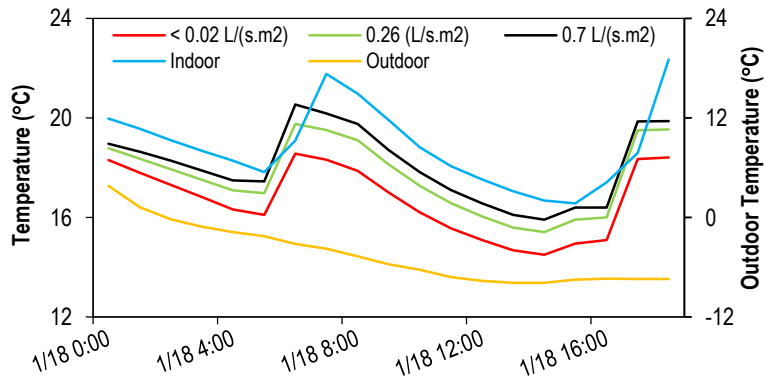
Figure 17. Temperatures measured between the fiberglass insulation and its facing in the Group 4 walls while under leeward pressure.

a. Positive pressure differentials indicate that outdoor pressure was higher than indoor pressure.

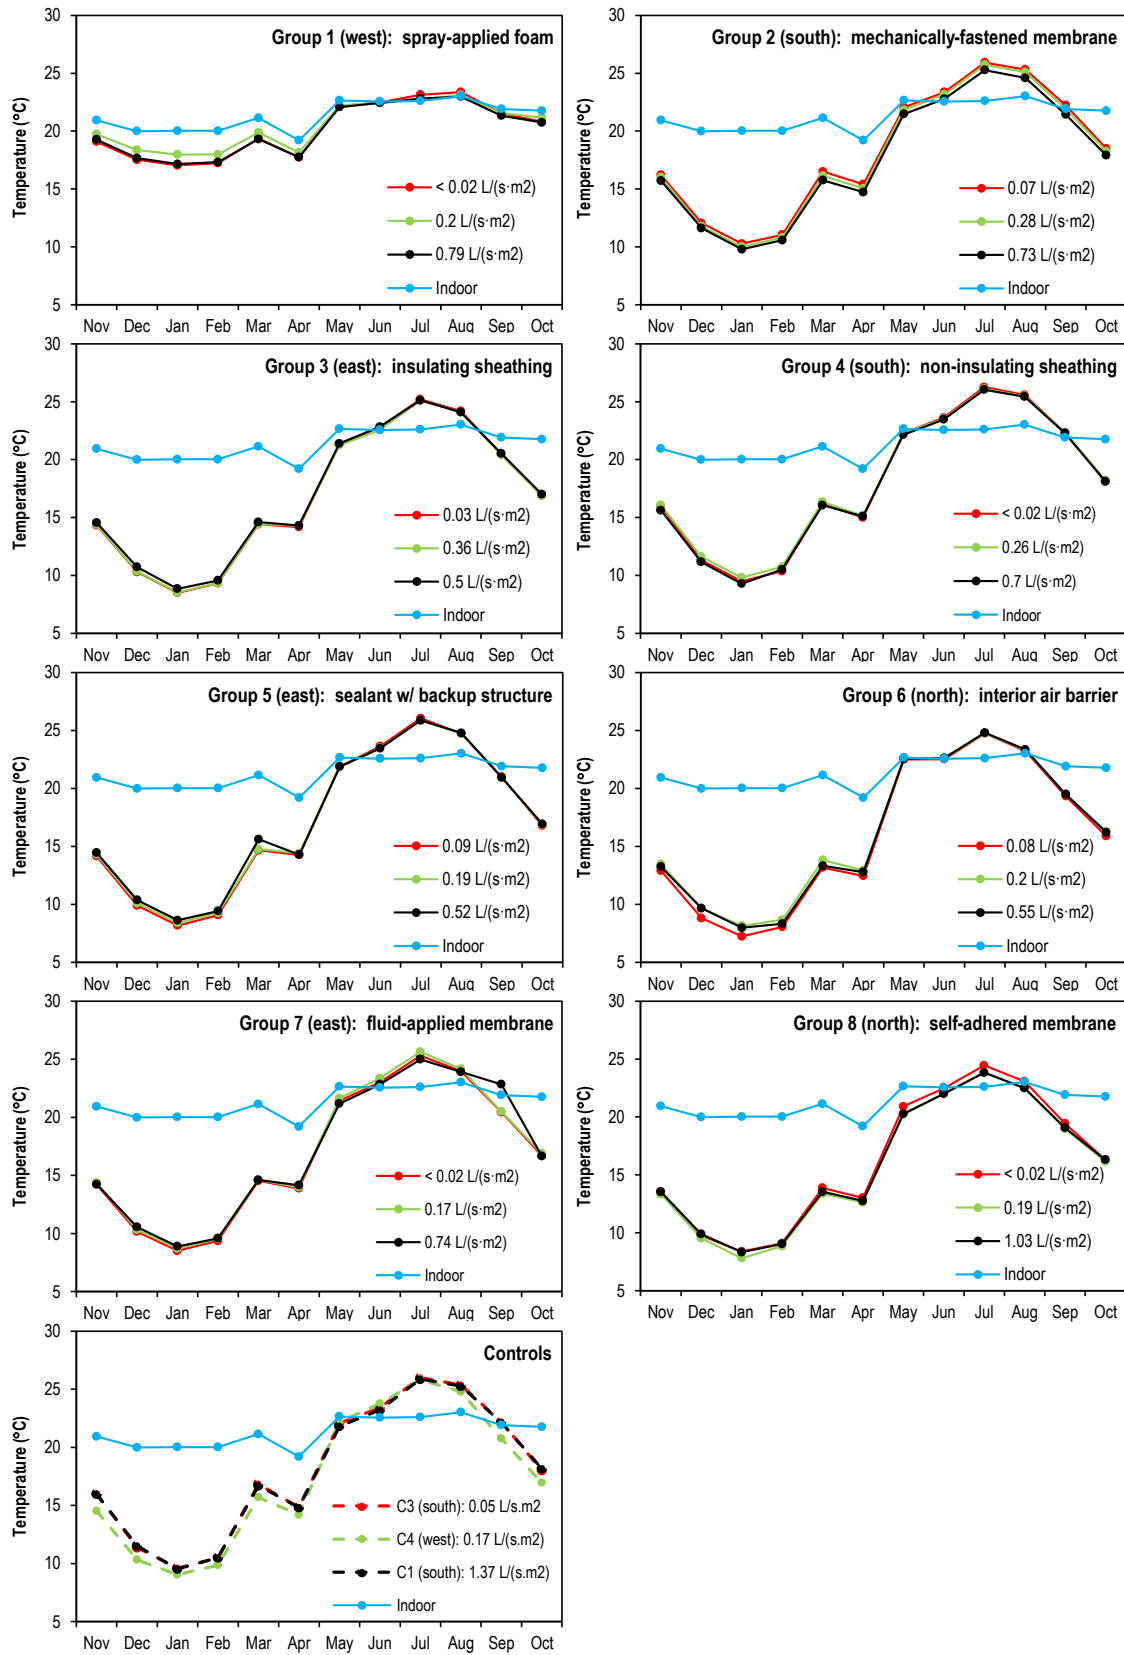
Figure 18. Monthly average temperatures at the inner surface of exterior sheathings.

a. Air leakage rates shown were measured at  $\Delta P = 75$  Pa.

Figure 18 shows that the monthly average  $T_{\text{ext sheath}}$  data followed outdoor temperature trends: lowest in January and highest in July. January averages in the east and north-facing walls ranged from  $7.2$  to  $8.8^{\circ}\text{C}$ , while the south-facing panels had warmer temperatures ( $\sim 9.5^{\circ}\text{C}$ ) because of their higher exposure to solar radiation. The Group 1 wall temperatures of  $\sim 17^{\circ}\text{C}$  were closest to indoor conditions ( $\sim 20^{\circ}\text{C}$ ) because their exterior continuous insulation (7.6 cm closed-cell foam) had an R-value that was about 3 times greater than in the other wall groups (3.8 cm XPS rigid foam). Figure 18 indicates that the exterior continuous insulation helped maintain  $T_{\text{ext sheath}}$  above  $5^{\circ}\text{C}$  in all the test walls, and therefore, warm enough to allow potential mold growth.

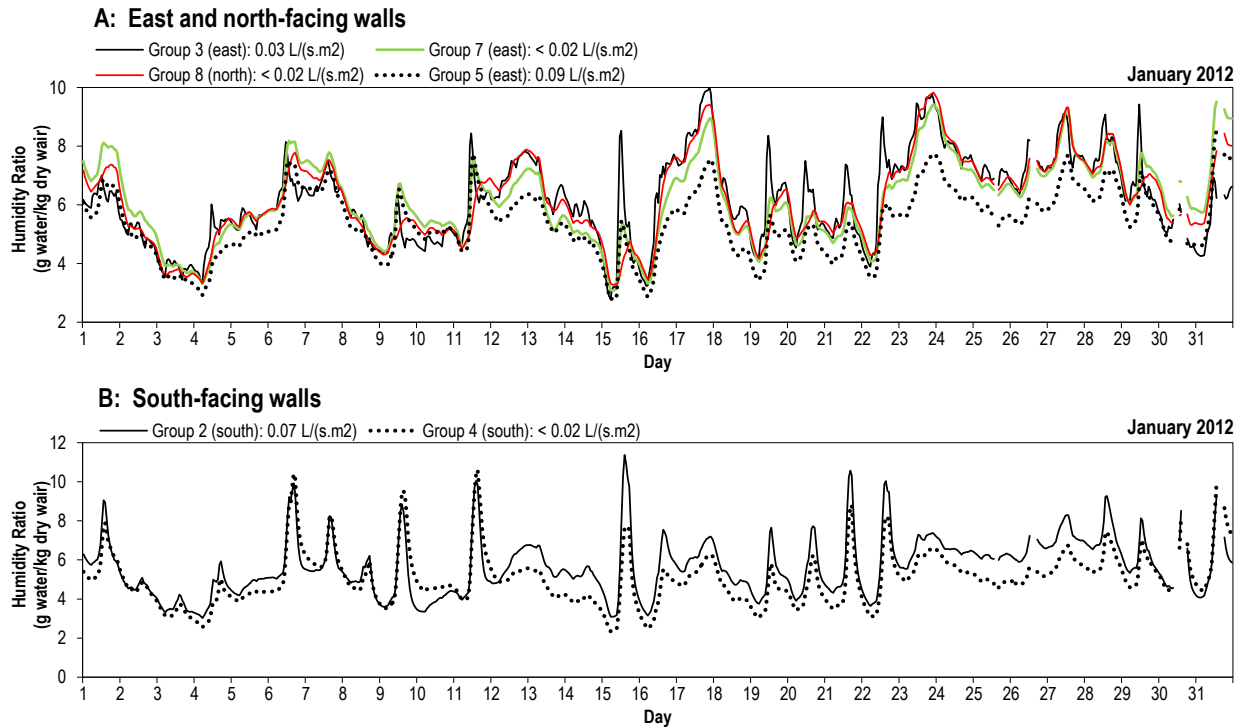
Figure 20. January hourly average humidity ratio at the inner surface of exterior sheathings in Level 1 walls. A: East and north-facing walls: Groups 3, 5, 7 and 8. B: South-facing walls: Groups 2 and 4.

- Air leakage rates shown were measured at  $\Delta P = 75$  Pa.
- Walls from Groups 2, 3, 7 and 8 were built with materials used in commercial construction: steel framing and glass mat gypsum or XPS rigid insulation (Group 3) as the exterior sheathing. Walls from Groups 4 and 5 were framed with wood to simulate residential construction.

Construction materials also affected the humidity ratio within the wall cavities. Figure 20A shows the January  $HR_{\text{ext sheath}}$  values from Level 1 walls that were facing either east or north. This figure indicates that  $HR_{\text{ext sheath}}$  from the commercial walls (Groups 3, 7 and 8) were somewhat similar, and about 15% higher than the measurements from the residential wall (Group 5). This 15% difference was also observed in the south-facing Level 1 walls per Figure 20B, where the Group 2 and 4 panels represented commercial and residential construction, respectively.

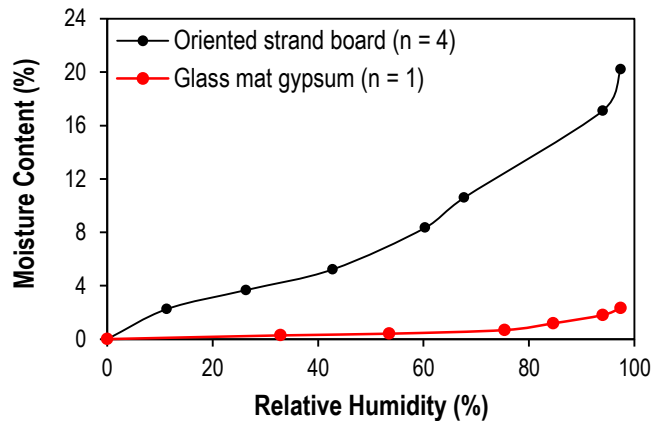
Figure 21. Adsorption isotherms of oriented strand board sheathing and glass mat gypsum sheathing.

- Average from four oriented strand board sheaths.

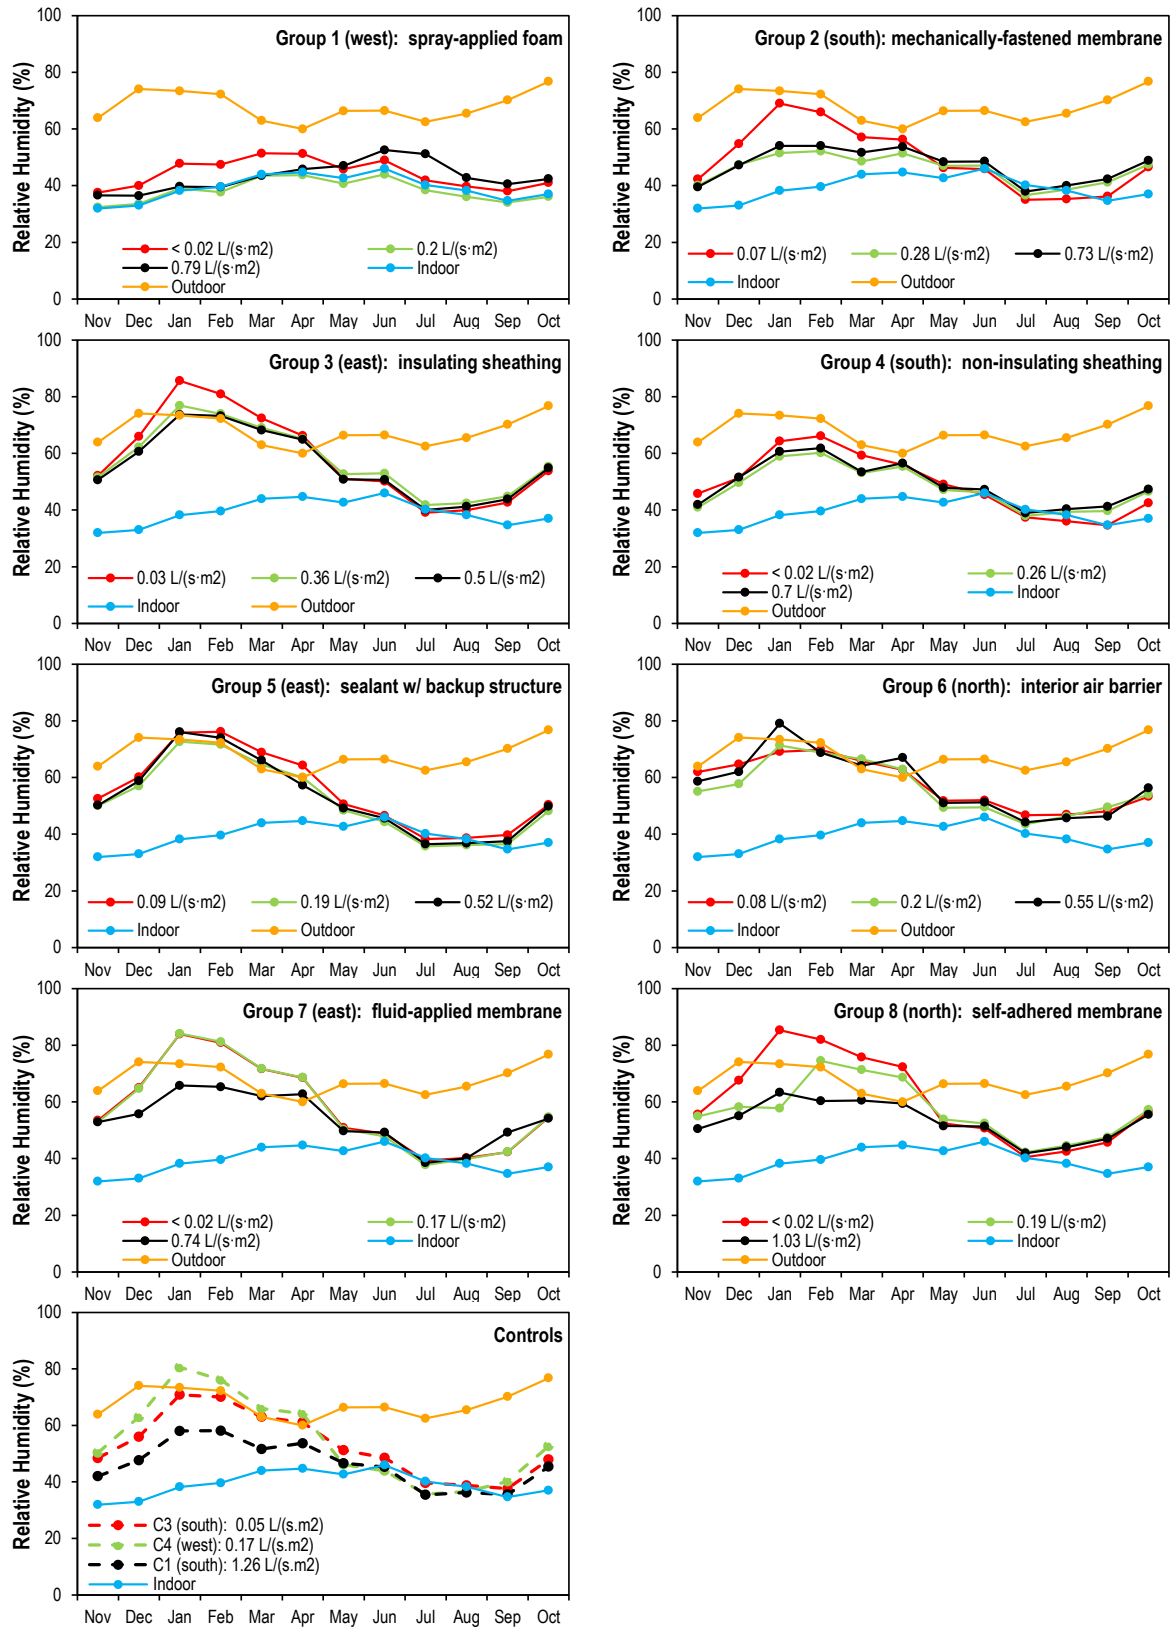
Figure 22. Monthly average relative humidity at the inner surface of exterior sheathings.

a. Air leakage rates shown were measured at  $\Delta P = 75$  Pa.

Figure 22 describes the monthly average relative humidity at the inner surface of the exterior sheathing ( $RH_{\text{ext sheath}}$ ) of all panels.  $RH_{\text{ext sheath}}$  was highest in the winter and lowest during the summer in all walls, which is expected given the aforementioned temperature and humidity ratio trends at these locations. The walls in Group 1 had the lowest  $RH_{\text{ext sheath}}$  values during the heating season because of the higher R-value of its exterior insulation. The Level 1 panels

According to Figure 22, the Level 1 panels in Groups 3, 7 and 8 had average  $RH_{\text{ext sheath}}$  values for the months of January and February that were higher than 80%. Therefore, these walls may have had adequate conditions for mold growth in their stud cavities. Figure 23 provides a closer look at the January and February  $RH_{\text{ext sheath}}$  data of these Level 1 walls. Condensation occurred in the Group 3 wall for about a third of the month in January. During these same dates,  $RH_{\text{ext sheath}}$  was also high in the Group 7 and 8 walls, but condensation only occurred a few times in the Group 8 panel. In February, condensation was much less frequent than in January. For comparison purposes, Figure 23 also shows measurements from the Group 5, Level 1 wall and indicates that it had RH values that were about 10% lower than in the previously described test specimens because its wood-frame construction stored moisture that dampened increases in humidity.

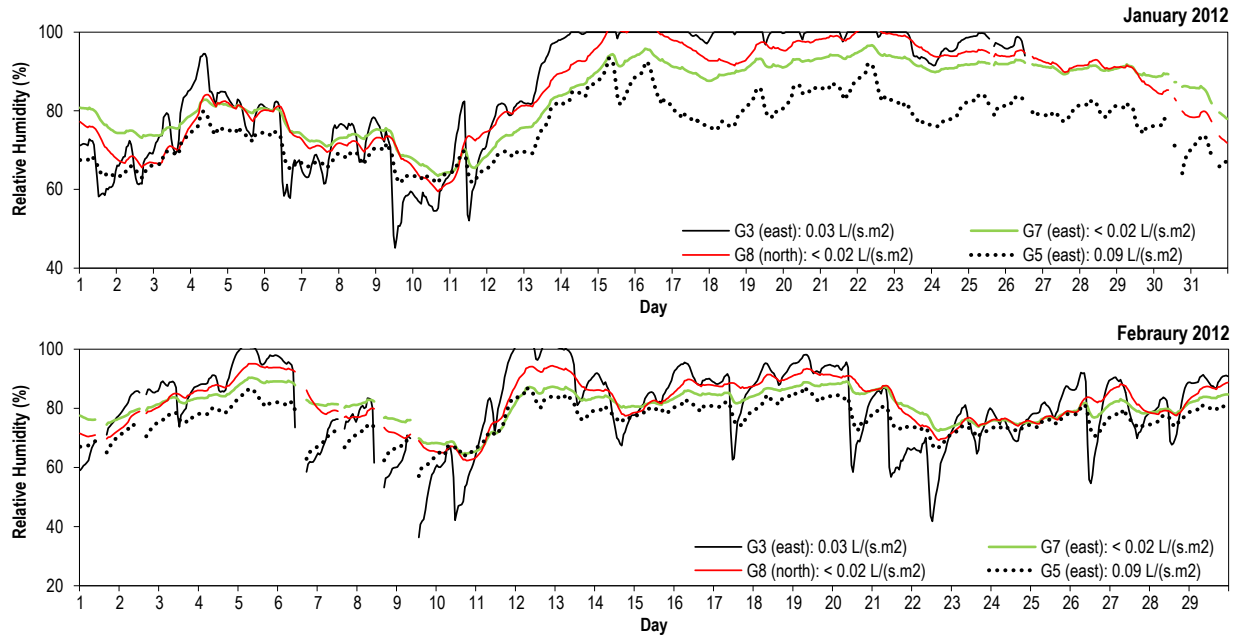
Figure 23. January hourly average relative humidity at the inner surface of the exterior sheathings in the Group 3, 5, 7 and 8 panels.

- a. Air leakage rates shown were measured at  $\Delta P = 75$  Pa.
- b. Walls from Groups 3, 7 and 8 were built with materials used in commercial construction: steel framing and glass mat gypsum or XPS rigid insulation sheathing. Wall from Group 5 was framed with wood to simulate residential construction.

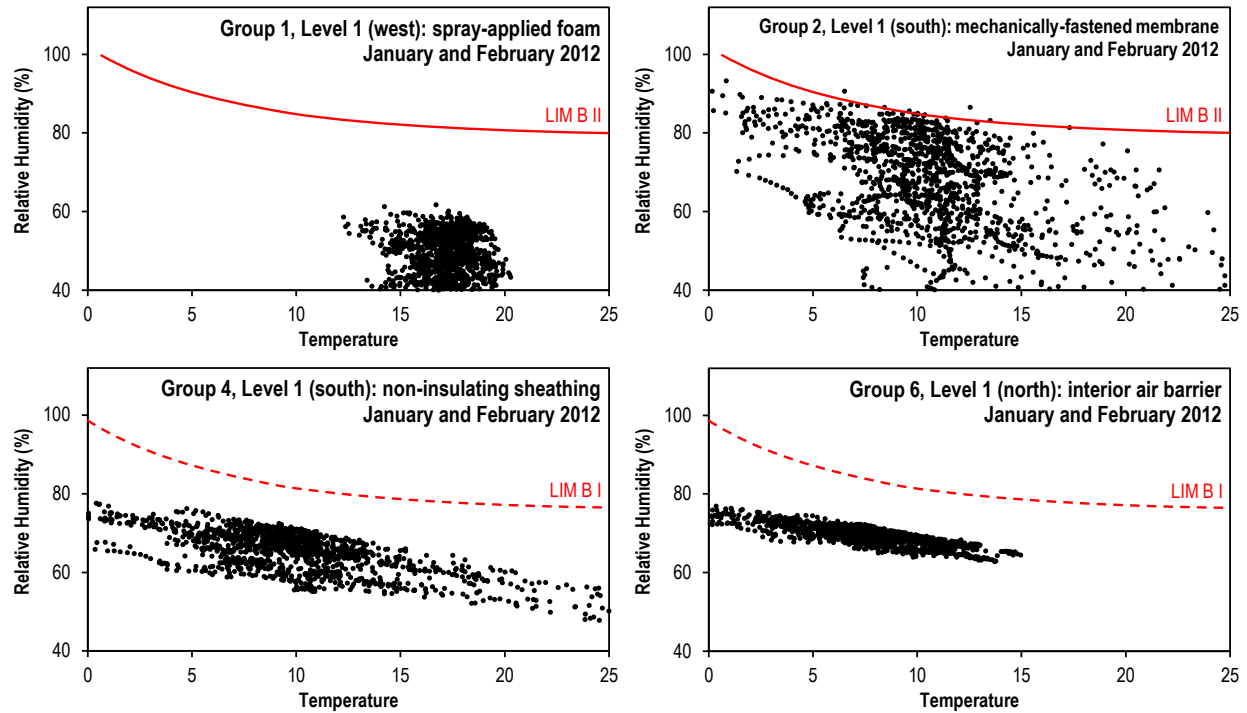
Figure 25. January and February hourly averages from Level 1 walls from Groups 1, 2, 4 and 6 with respect to the lowest isopleth for mold growth on organic substrates (LIM B I) and inorganic substrates (LIM B II).
