WANL-TME-1149
May 1, 1965

Westinghouse Astronuclear Laboratory
Contribution to the
Twentieth High Temperature Fuel Committee Meeting
May 18, 19, and 20, 1965 (Unclassified)

I. EXAMINATION OF NRX-A2 ELEMENTS AFTER HOT TEST
(M. Vogel, R. Simmons, D. Jacobs, R. Fiore, and C. Glassmire)

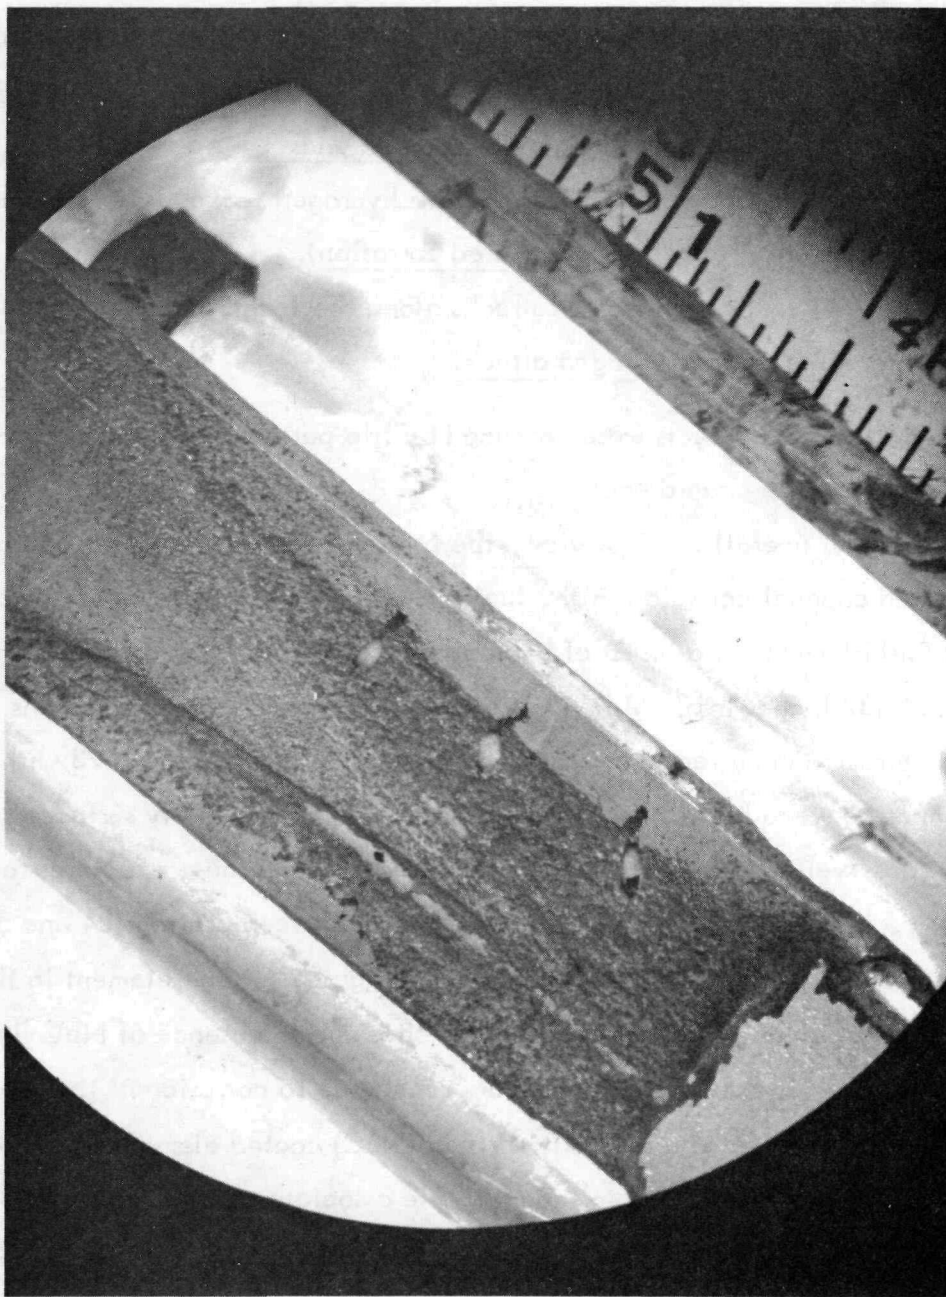
Figure 2 - Liner Exposure Produced by Tile Pattern Corrosion at Stations 49-51
on the D Flat of Element 32-11765, Core Position 1J7J

1. Tile Pattern Corrosion - The peripheral elements in NRX-A2 displayed surface corrosion patterns on exterior flats which corresponded to the hydrogen leakage at the pyrotile joints. This corrosion occurred in 10 distinct transverse bands extending from Station 23 to 51; the bands having an axial separation of approximately 3 inches. Typical tile pattern corrosion effects are shown in Figures 1 and 2.

Tile pattern corrosion produced liner exposures at 31 positions on 17 peripheral elements. The axial range of exposure was from Stations 24 to 51; of the total number of exposures, 45 per cent occurred at Stations 35 to 45 and 35 per cent occurred at Stations 49 to 51. The length of channel exposure due to this effect varied from less than 1-inch to 3 inches. Figure 2 shows the typical appearance of liner exposure associated with tile pattern corrosion.

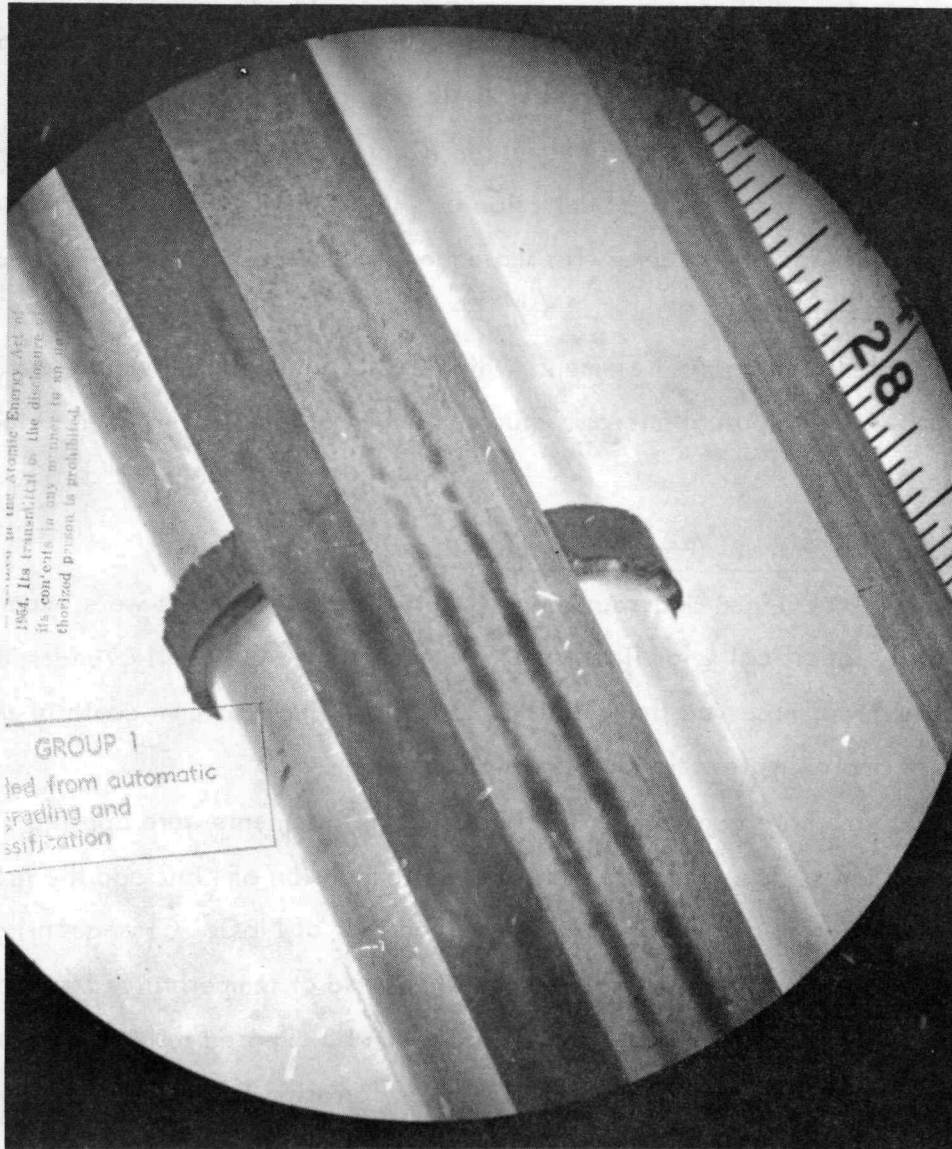
4. Streaking - Dark streaks were observed on the flats on all but 270 of the NRX-A2 fuel elements occurring generally at about mid-length positions. The streaks occurred on one or more flats of each element and were typically displayed as two parallel dark lines located on the flats at positions between the underlying coolant channels as

shown in Figure 5. The streaks were not always continuous, some being interrupted in the axial direction. Detailed visual examinations of the phenomena indicated that no significant depth of corrosion was involved. These data indicate that the major occurrence was at Stations 24 to 33 with very little change in axial location as a function of core radius. Although the exact mechanism is not known, the streaks observed are believed to be the result of light corrosion by interstitial leakage of hydrogen at the upstream positions of the streaks with subsequent soot deposition on downstream portions of the fuel element flats.

Figure 5 - Striking on the C and D Flats of Element 89-11877
Core Position 1J5G, at Stations 27-29

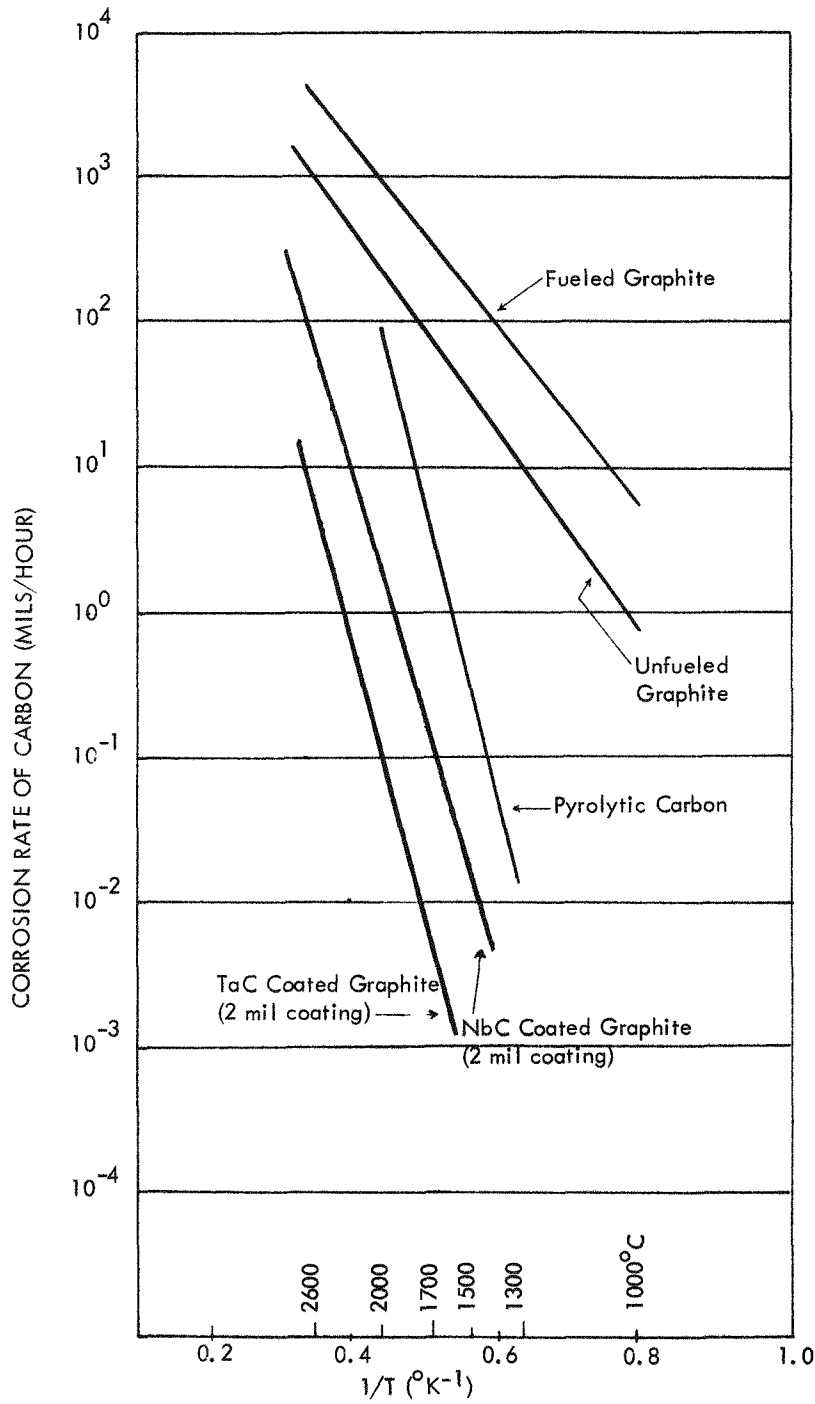
CORROSION RATE DATA

Figure 20 provides the basic corrosion rate data used in the analysis of corrosion behavior of NERVA fuel elements. The data given for fueled graphite, unfueled graphite, and pyrolytic carbon were obtained from hydrogen corrosion experiments at 40 atmospheres. The corrosion rate data shown for NbC and TaC coated graphite were obtained from calculations based on the measured diffusion rates of carbon in NbC and TaC, respectively.

Figure 20 - Corrosion Rate Data
