UCRL-51869

EXPOSURE OF HIGH-TEMPERATURE ALLOYS IN CARBONACEOUS GAS ATMOSPHERES

A. Goldberg
A. J. Perkins

September 9, 1975

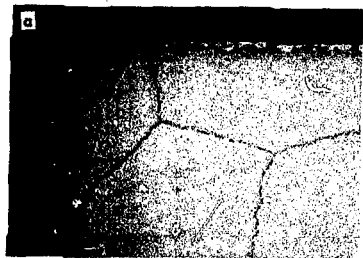
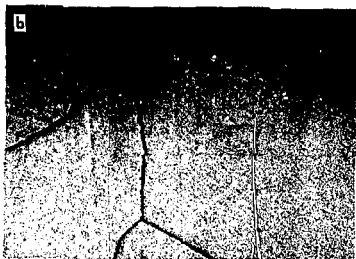
Fig. 7. Photomicrographs of Inconel 601 samples exposed to three different 700°C treatments, a) 100 h in air at 700°C, b) Run No. 10 only, c) 100 h in air at 700°C followed by exposure in Run No. 10.

We next examined whether preoxidation of Inconel 601 at the same temperature as that used in the subsequent carbonaceous exposure would minimize the carbonaceous atmosphere attack. Figure 7 shows views of three samples of Inconel 601 exposed to three different 700°C treatments: (a) 100 h in air, (b) run No. 10 (100 h in CO charge at 700°C, 6.2 MPa), and (c) 100 h in air followed by run No. 10.

Very little difference is seen in the microstructures between the preoxidized and carbonaceous exposures (views 7a, b). The two successive exposures (view 7c) resulted in additional penetration by corrosion products especially with respect to the degree of precipitation. Thus, in contrast to the beneficial effects obtained with the 700°C preoxidation treatment for 310 SS, no visual evidence of improvement appeared for Inconel 601.

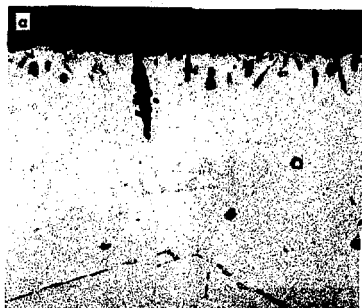
Fig. 9. Photomicrographs of Inconel 601 samples, a) as preoxidized at 1000°C in air for 24 h, b) preoxidized at 1000°C in air for 24 h and exposed to Run No. 1.

The effects of a preoxidation treatment are further illustrated in Fig. 9. Exposure for 24 h at 1000°C in air resulted in the formation of a thick, irregular, grey film (view 9a) which was partially reduced and/or fragmented on subsequent exposure to the CH_4/H_2 gas mixture of run No. 1 (view 9b). In comparing the two samples, several interesting features may be seen. In both samples, intrusions from

the grey oxide film into the substrate were noted, especially at the austenite grain boundaries. In comparing views (9a) and (9b), these intrusions obviously occurred during the preoxidation treatment. The austenite grain boundaries could not readily be detected in the preoxidized sample for a depth of about 30 μm below
