Report No. BMI-1374
UC-25 Metallurgy and Ceramics
(TID-4500, 14th Ed.)

GAS-PRESSURE BONDING OF ZIRCALOY-CLAD FLAT-PLATE
URANIUM DIOXIDE FUEL ELEMENTS

August 28, 1959

BATTELLE MEMORIAL INSTITUTE
505 King Avenue
Columbus 1, Ohio

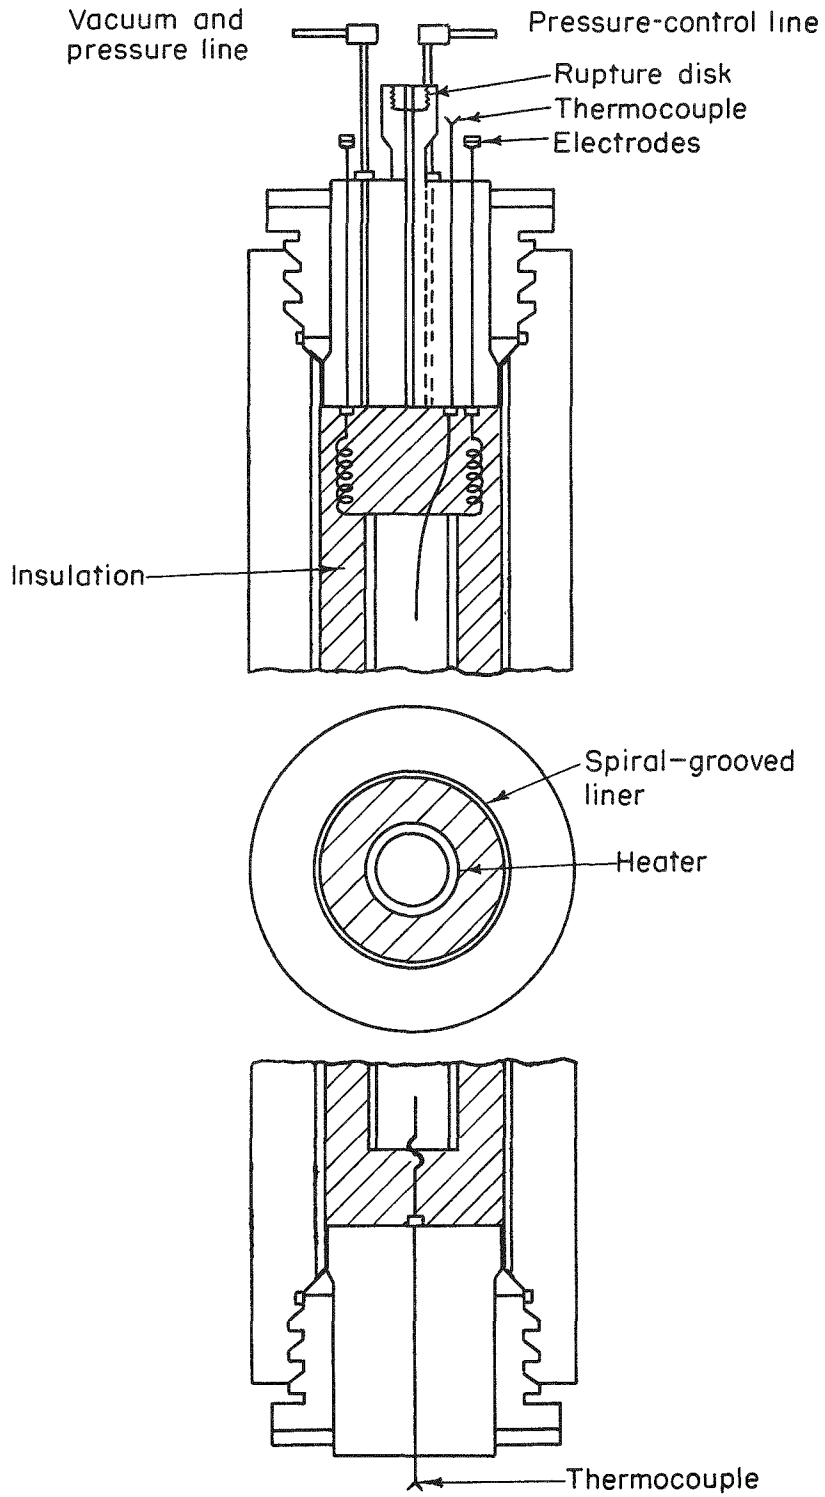
A 27437

FIGURE 1. SECTIONAL VIEW OF A HIGH-PRESSURE COLD-WALL AUTOCLAVE

The specimens, except for those in the final process-development study of edge-welded elements, were pressure bonded in a 9-in.-ID cold-wall autoclave obtained from the Autoclave Engineering Company. A schematic drawing of the autoclave is shown in Figure 1. The vessel was machined from a billet of Type 410 stainless steel and is equipped with modified Bridgeman closures. The large-scale edge-welded elements were bonded in a similar 14-in.-ID autoclave. These autoclaves are described elsewhere in the literature. (6)

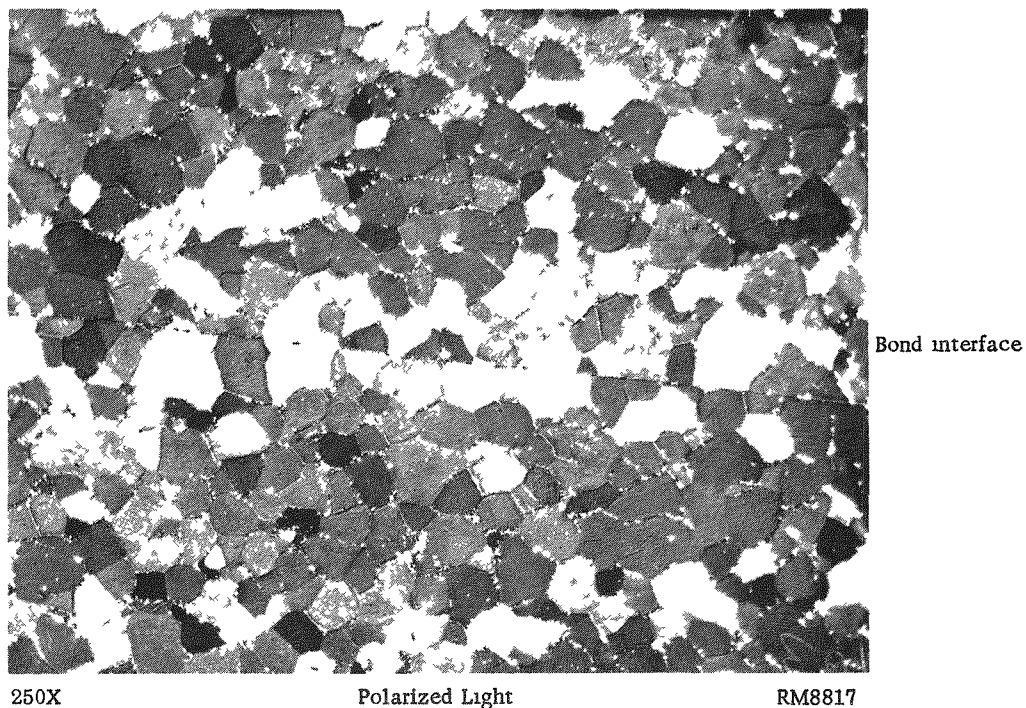
FIGURE 4. ZIRCALOY-TO-ZIRCALOY BOND OF SPECIMEN PREPARED BY GAS-PRESSURE BONDING AS-COLD-ROLLED ZIRCALOY

This specimen was bonded at 1550 F and 10,000 psi for 4 hr. Note the apparent presence of contamination and lack of grain growth.

From a cost standpoint, the most desirable surface for bonding would be one which is cold rolled and cleaned without metal removal. Specimens prepared using cold-rolled stock fabricated from vapor blasted and washed hot-rolled stock were cleaned by a standard degreasing and washing treatment and pressure bonded. None of the bonds obtained with such surfaces were satisfactory. A typical bond is shown in Figure 4. The interface is contaminated and there is no grain growth across it. While such bonds are relatively strong and usually corrosion resistant, they are not considered acceptable because the interface is a possible plane of weakness.

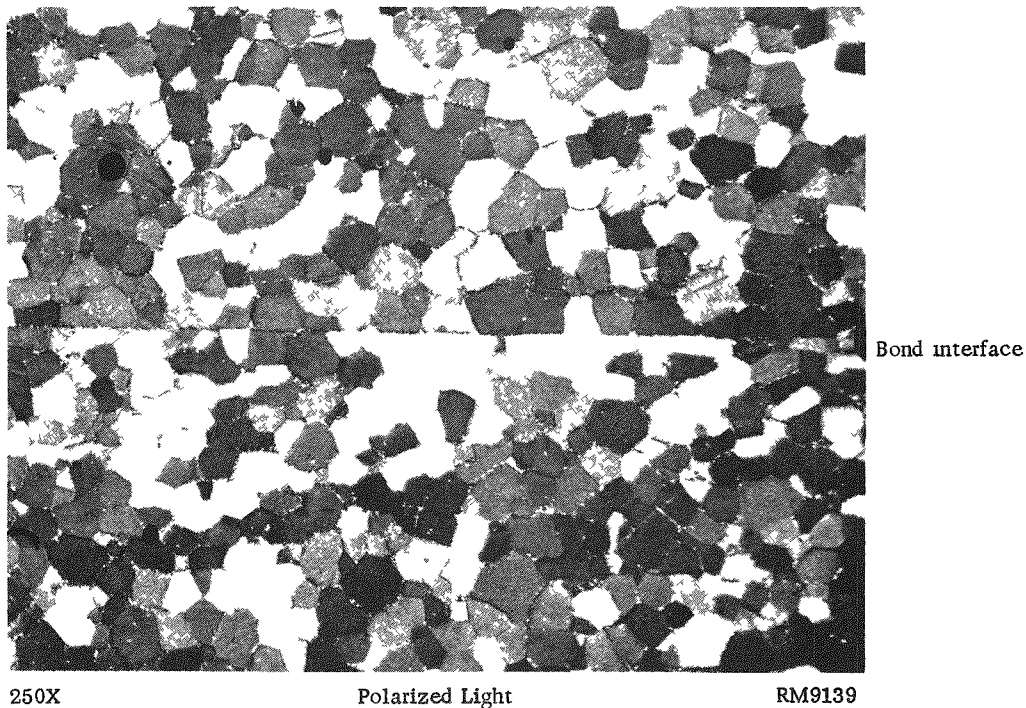
FIGURE 5. ZIRCALOY-TO-ZIRCALOY BOND OBTAINED BY PRESSURE BONDING ACID-PICKLED ZIRCALOY

To determine whether the pickled surfaces were contaminated prior to bonding, they were examined by electron diffraction. Tin, tin oxide, and zirconium oxide were found on the surfaces. During pickling of Zircaloy, tin presumably redeposits on the

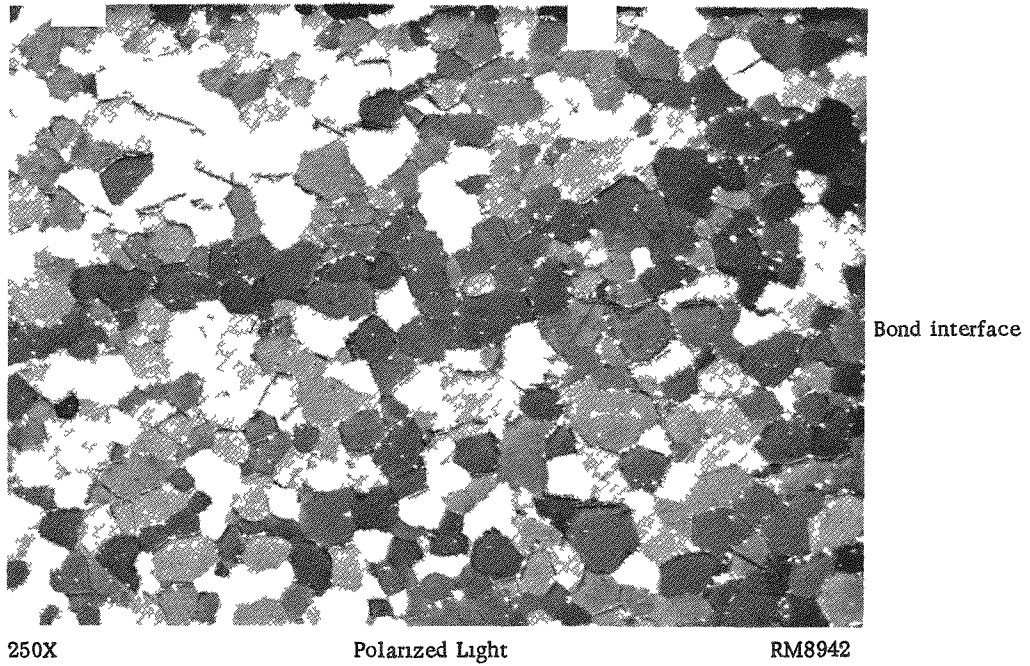
FIGURE 6. ZIRCALOY-TO-ZIRCALOY BOND ACHIEVED BY PRESSURE BONDING PROPERLY MACHINED ZIRCALOY

Specimen was bonded at 1550 F and 10,000 psi for 4 hr

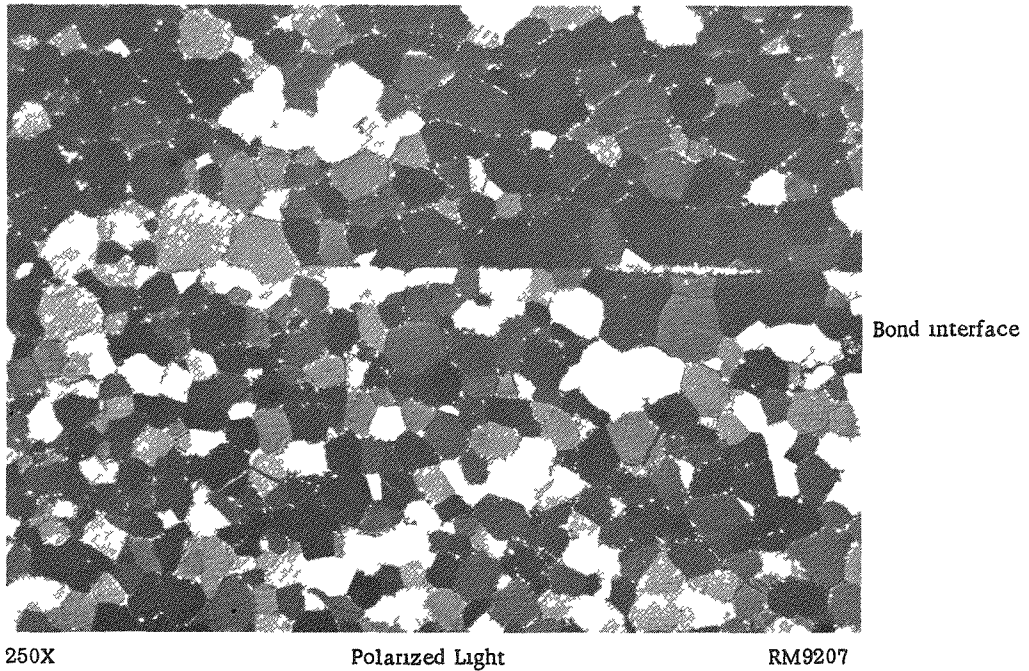
FIGURE 7. ZIRCALOY-TO-ZIRCALOY BOND ACHIEVED BY PRESSURE BONDING IMPROPERLY MACHINED ZIRCALOY

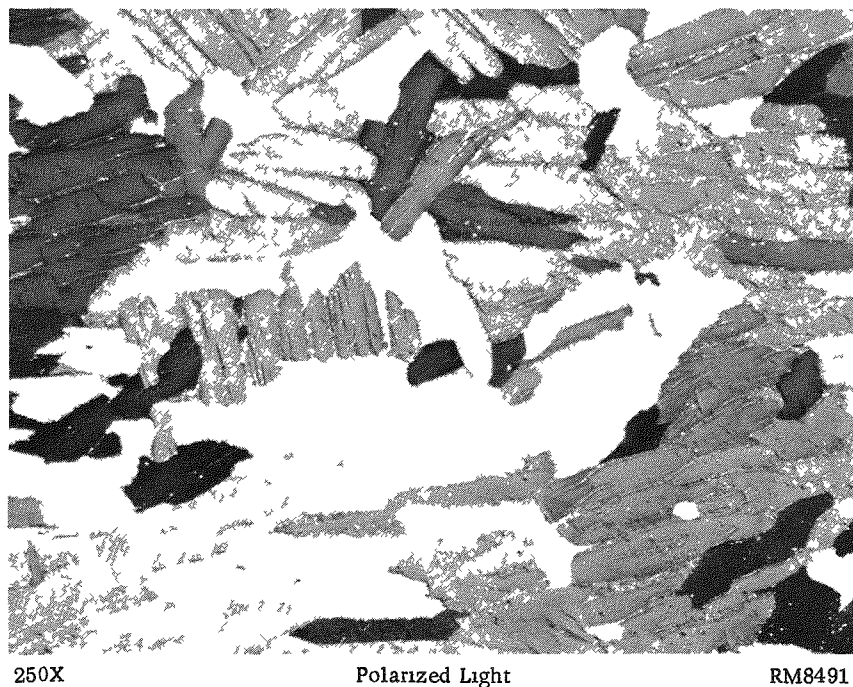
FIGURE 11. SAME SPECIMEN SHOWN IN FIGURE 10 AFTER AN ADDITIONAL HEAT TREATMENT OF 15 MIN AT 1850 F

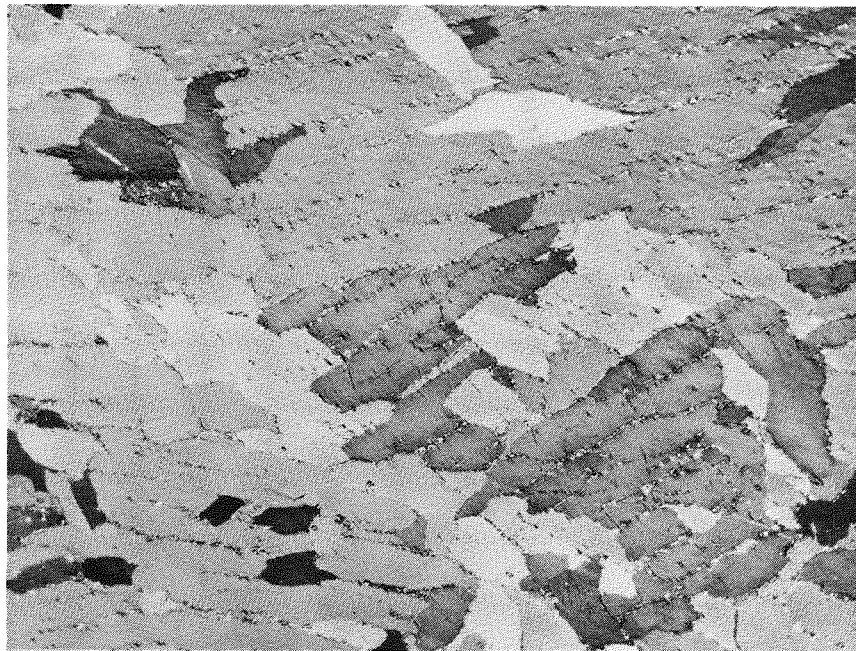
FIGURE 13. SAME SPECIMEN SHOWN IN FIGURE 12 AFTER AN ADDITIONAL HEAT TREATMENT OF 15 MIN AT 1850 F

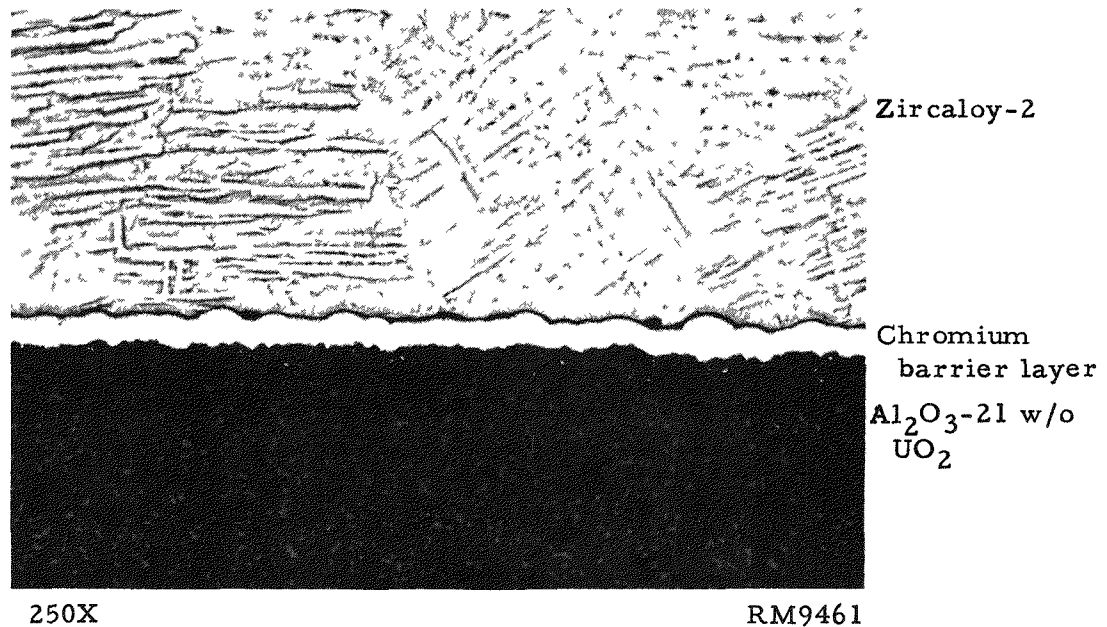
FIGURE 20. PRESSURE-BONDED AND HEAT-TREATED SPECIMEN WITH CHROMIUM BARRIER LAYER

Techniques were developed, therefore, for electroplating coatings of chromium on the oxide cores. Plating was accomplished by first applying a 0.003-mil coating of silver, followed by a 0.1-mil electrodeposited iron or nickel coating upon which a 0.5-mil coating of chromium was electroplated.

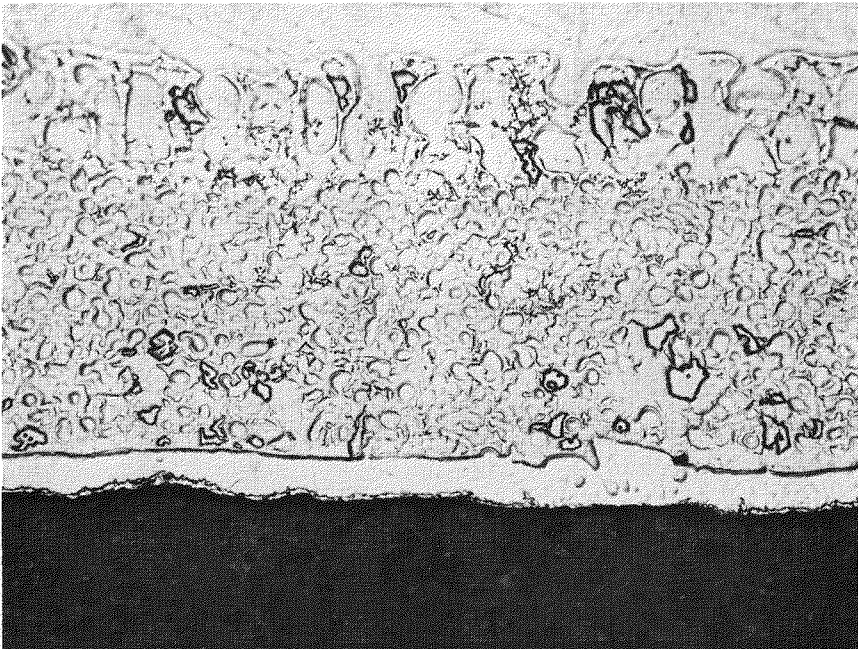
RM9462

Iron barrier layer (overetched)

100 per cent UO_2

250X

The potentiality of iron as a barrier layer was initially studied using 1-mil iron foil. Later, specimens containing 0.5-mil electroplated iron barrier layers were pressure bonded using temperatures of 1500 and 1550 F. Table 11 lists only slight or no growth in 750 F steam and 680 F water for specimens purposely defected with a 0.040-in. hole. Sectioned specimens in 750 F steam showed a slight amount of swelling, although severe rusting of the iron barrier occurred. During pressure bonding at 1500 F, the iron diffused only slightly into the cladding, and there was no visible core-barrier reaction. When pressure bonded at 1500 F, there was a large amount of diffusion of iron into the Zircaloy (Figure 21). As shown in Figure 22, the barrier diffused away entirely during a 15-min beta-phase anneal at 1850 F, leaving a zirconium-rich layer containing oxygen adjacent to the core. A thin uranium-rich layer can also be noted.

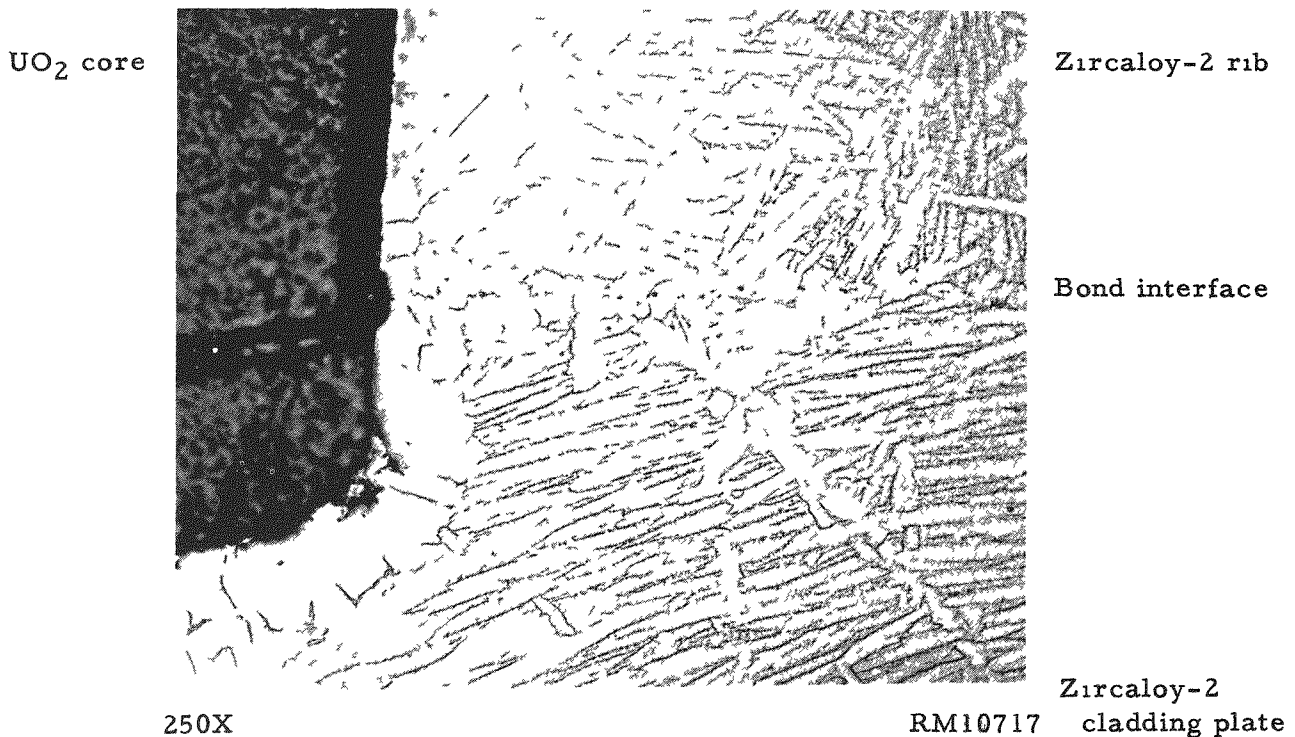
FIGURE 30. CORE-CLADDING REACTION AT CORNER OF GRAPHITE-COATED UO_2 CORE

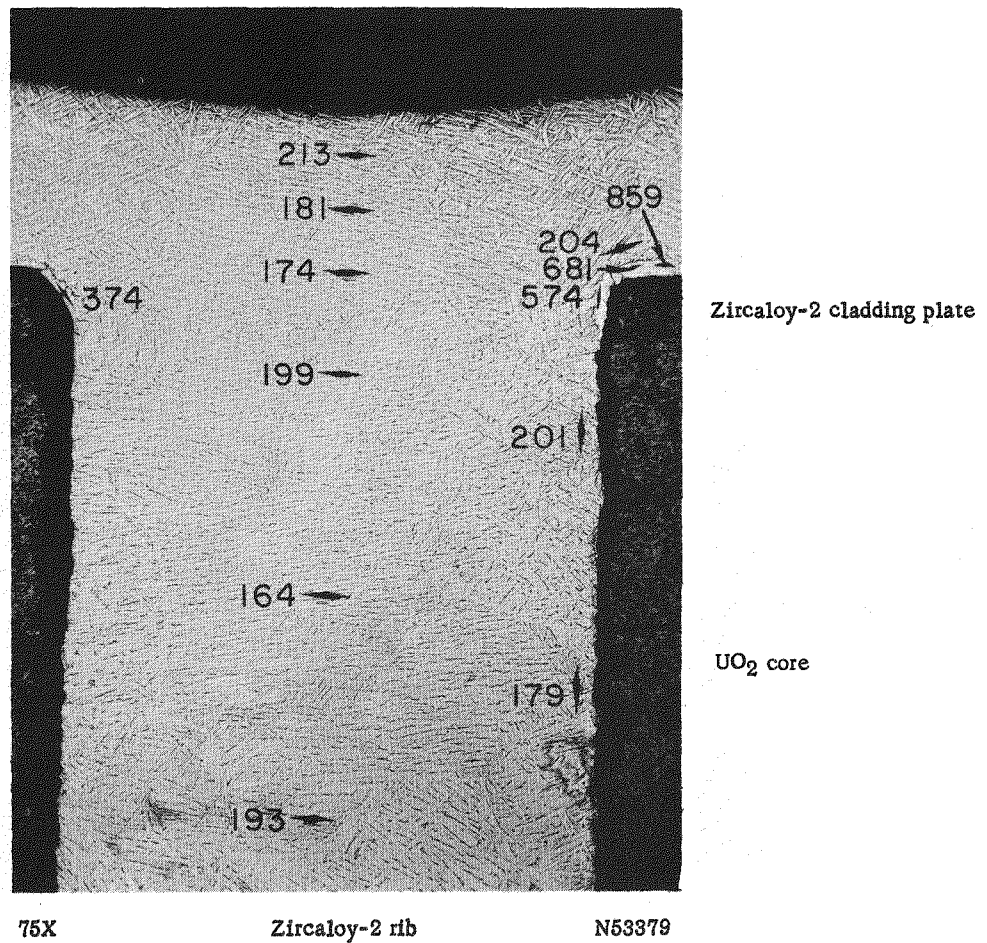
FIGURE 31. KNOOP HARDNESS VALUES AT RIB OF ELEMENT CONTAINING GRAPHITE-COATED CORES

Note high hardness of oxygen-rich zone at corners of cores.

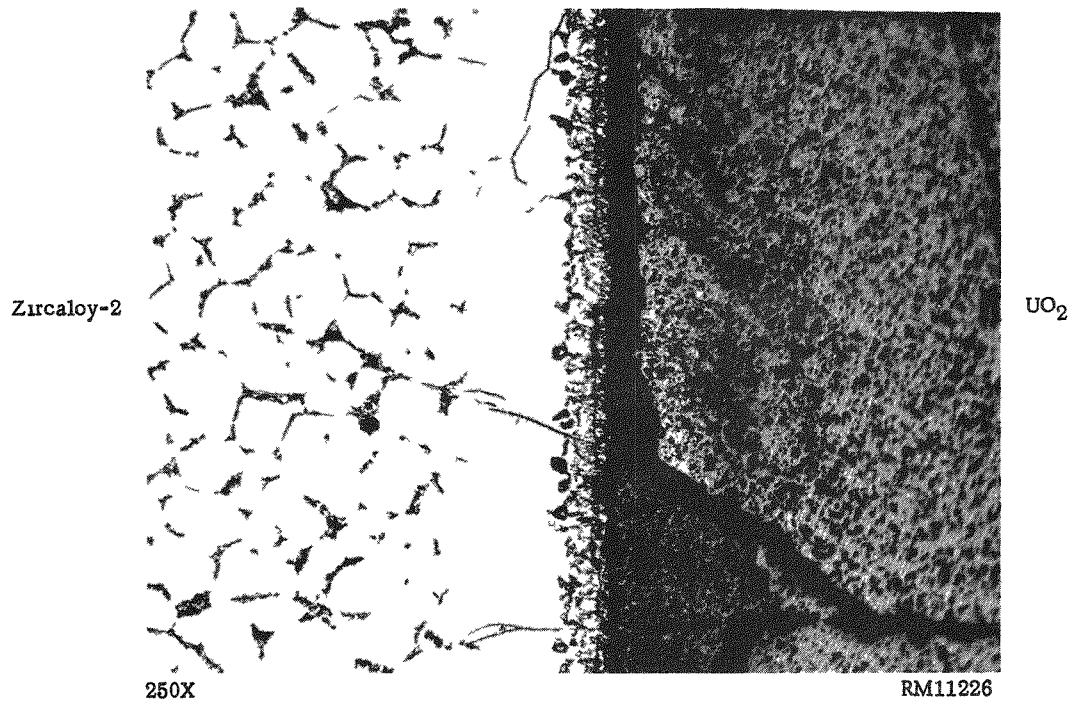
FIGURE 32. CRACKS IN BRITTLE OXYGEN-RICH ZONE OF ZIRCALOY AT CORE-CLADDING INTERFACE OF PRESSURE-BONDED ELEMENT CONTAINING UNCOATED UO₂ CORES

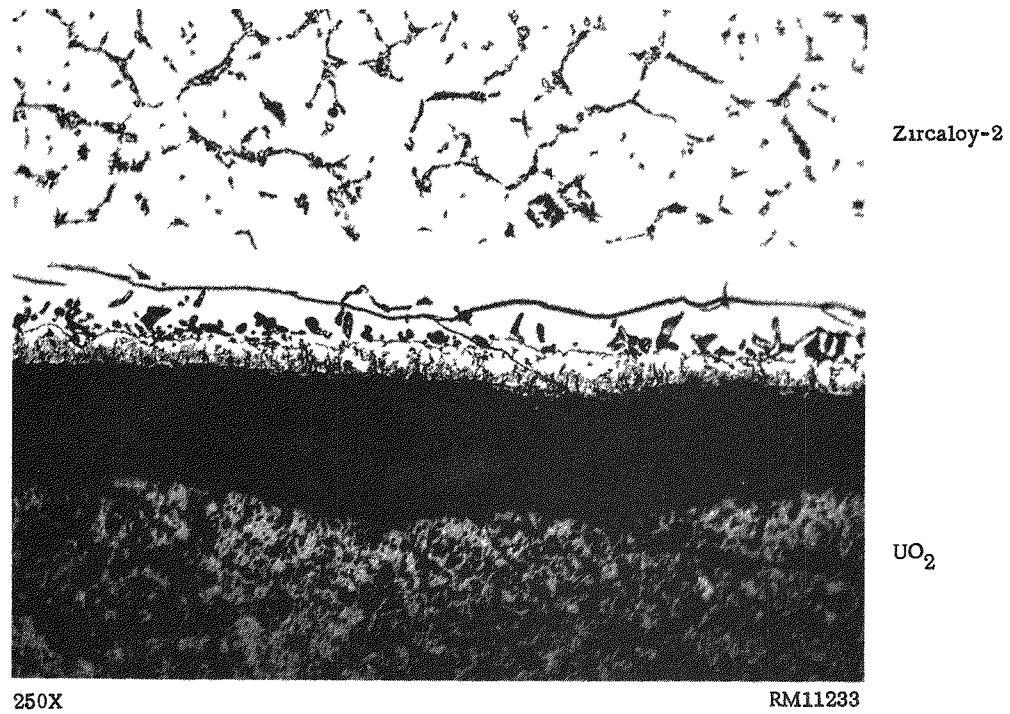
FIGURE 33. CRACKS SHOWING BRITTLINESS OF OXYGEN-RICH ZONE RESULTING FROM REACTION BETWEEN UNCOATED UO₂ CORE AND THE ZIRCALOY CLADDING

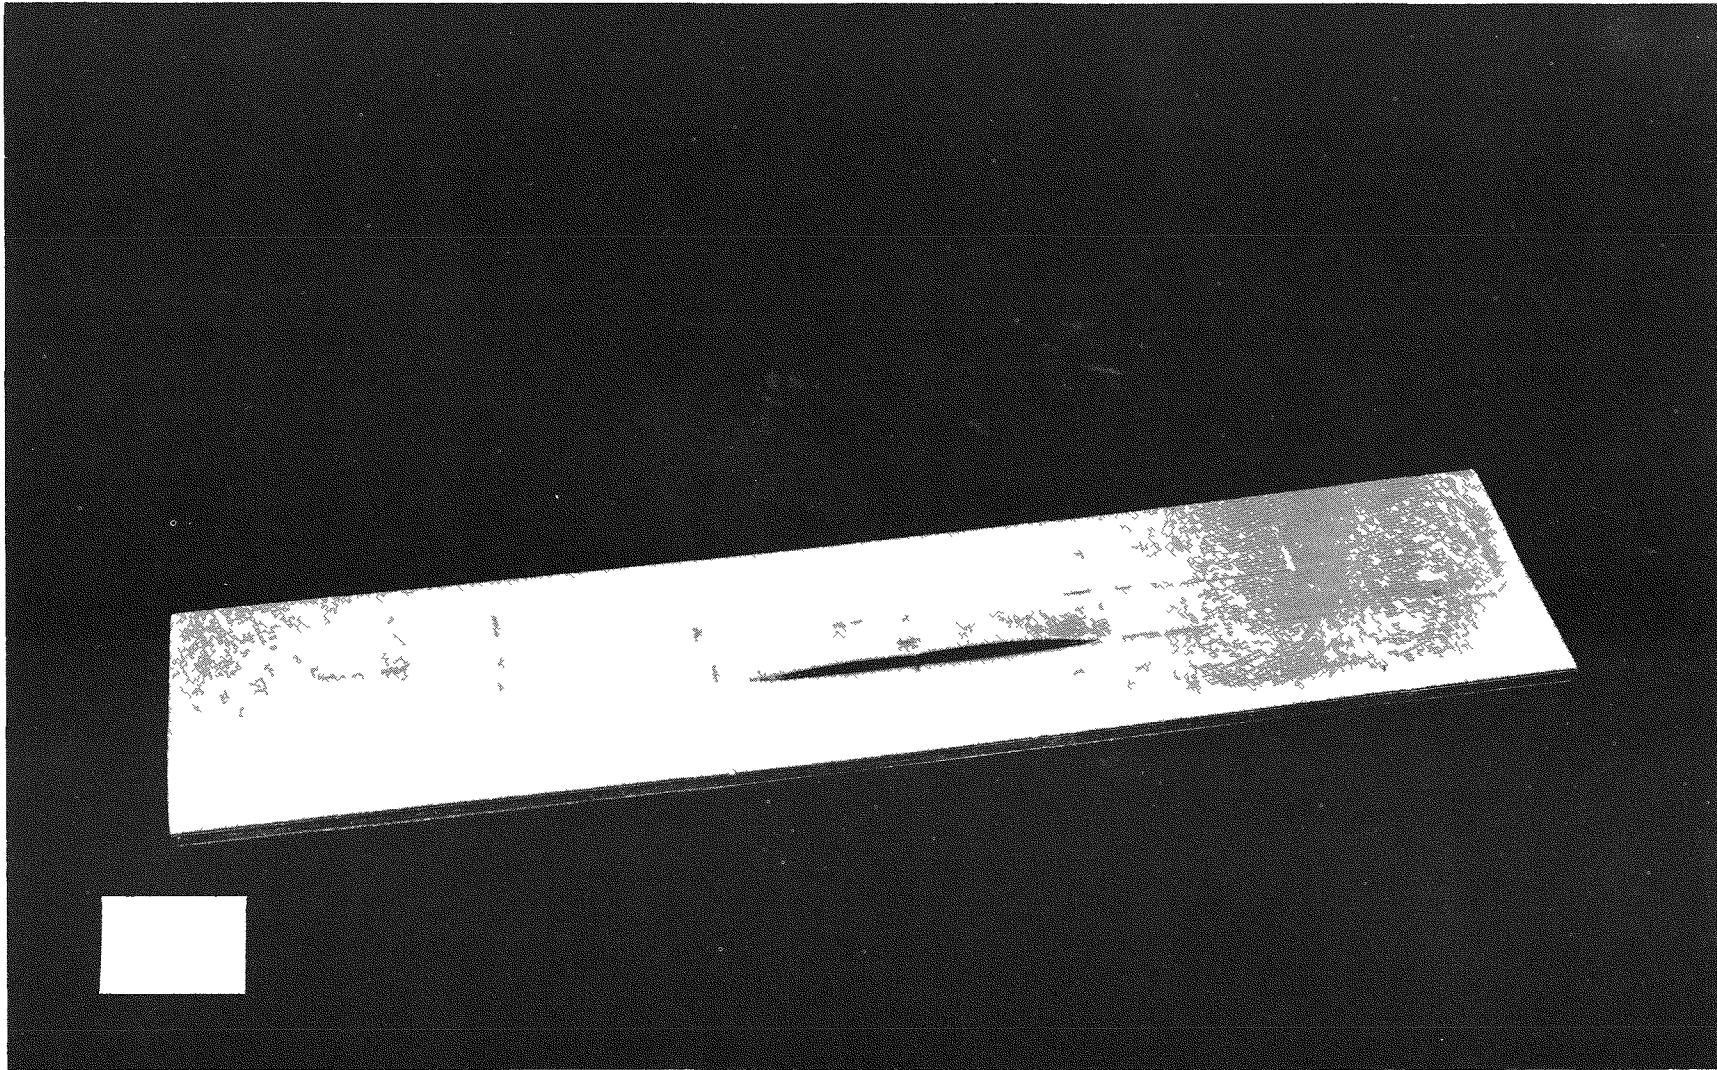
3/4X

Failure of cladding occurred along the edge of a compartment at 1100 psi after 0.044 in. of deflection. This element contained graphite-coated cores. It was pressure bonded at 1500 F and 10,000 psi for 4 hr and was not heat treated.

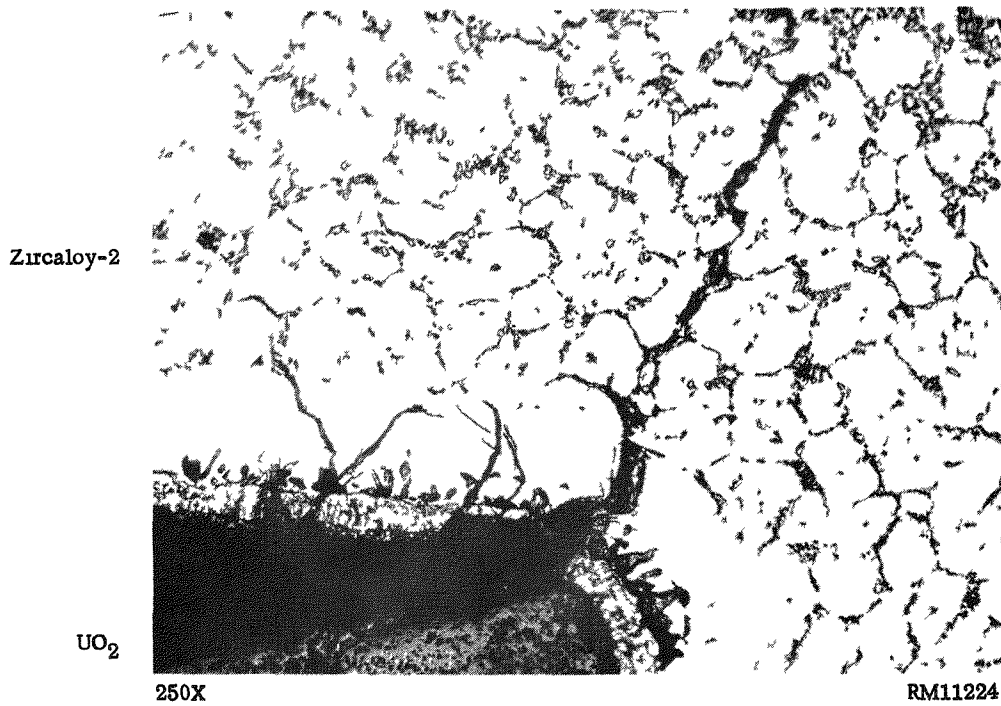
FIGURE 35. PROGRESSION OF CRACKING AT THE CORNER OF A CORE ADJACENT TO CORNER WHERE TOTAL FAILURE OCCURRED DURING BURST TESTING

This core was not graphite coated. Part of the core was removed during sectioning.

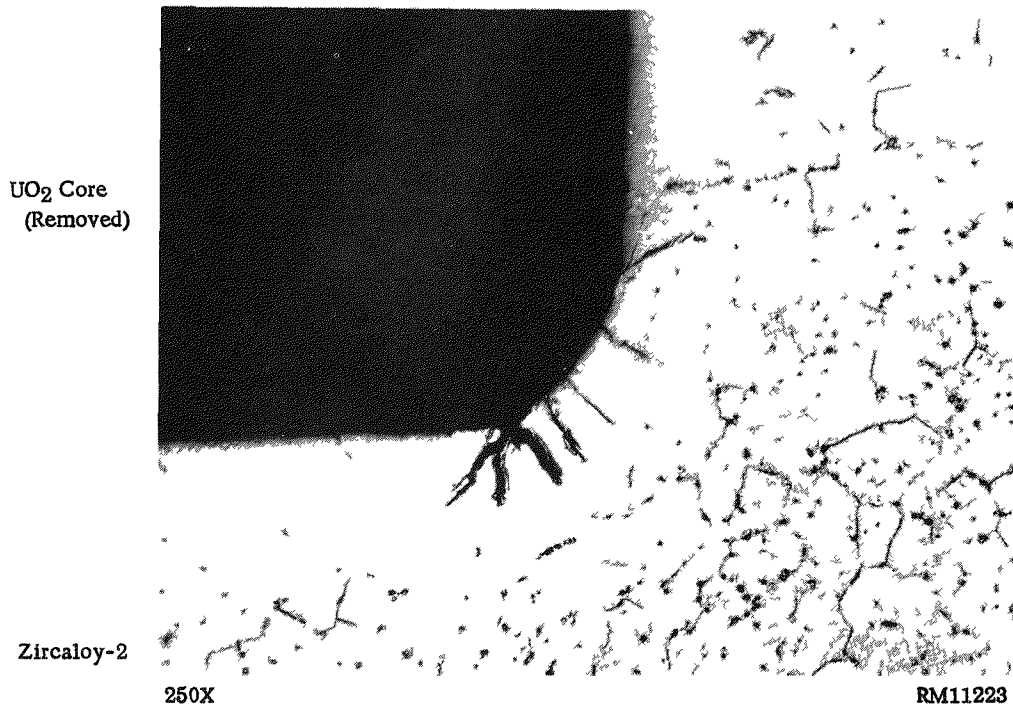
FIGURE 36. CRACKS AT A CORNER OF A GRAPHITE-COATED CORE

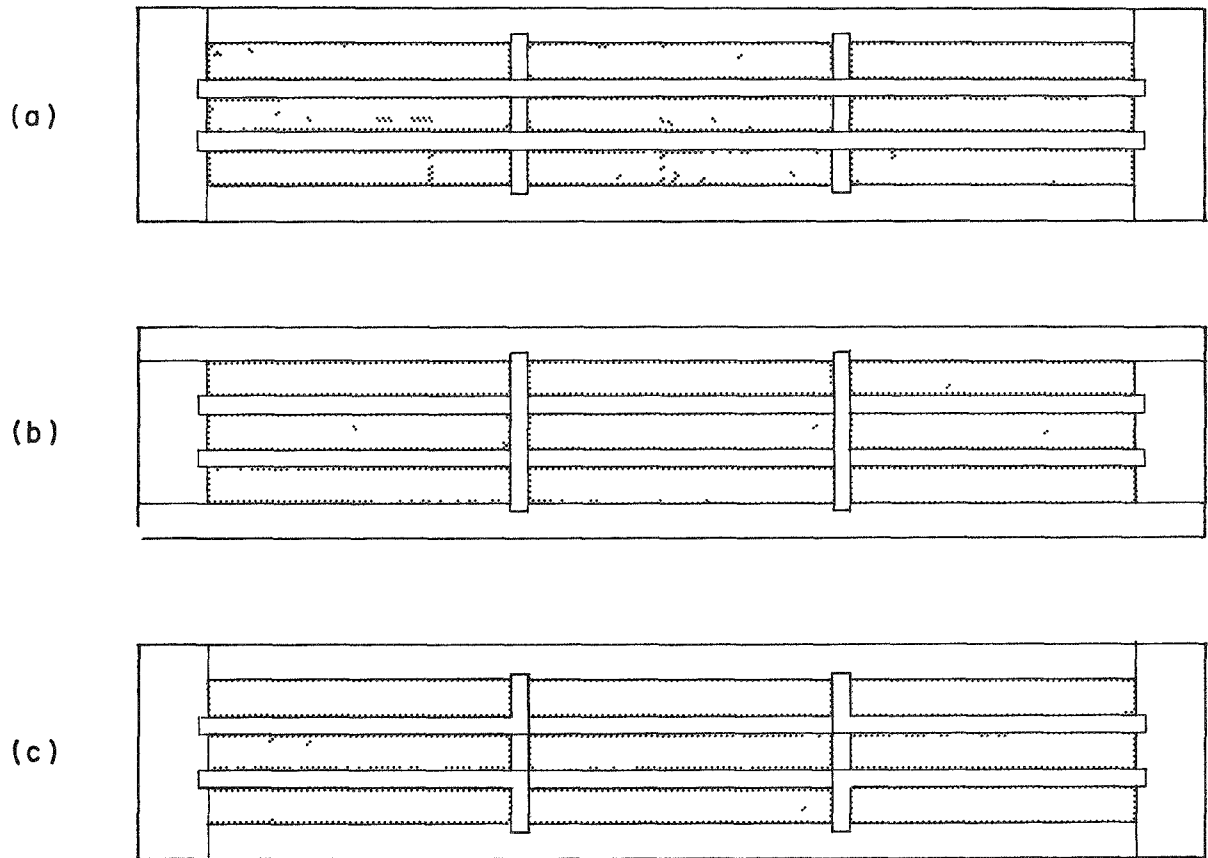
A-31518

FIGURE 38. CONFIGURATIONS OF PIECE-COMPONENT PICTURE FRAMES
USED IN THREE PRESSURE-BONDED FUEL ELEMENTS
PREPARED IN PROTECTIVE CONTAINERS

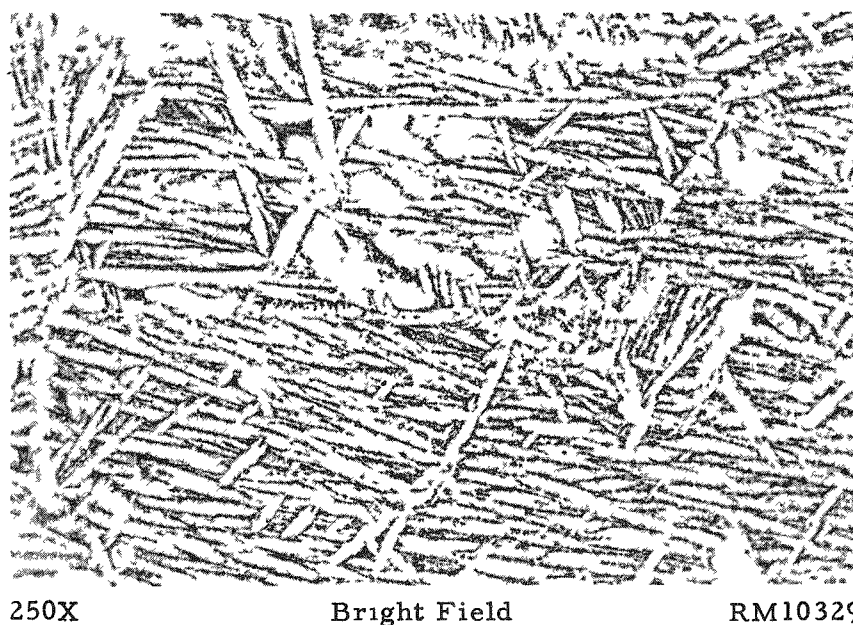
FIGURE 40. ZIRCALOY-TO-ZIRCALOY BOND IN ELEMENT PREPARED BY EDGE WELDING THE COMPONENTS PRIOR TO PRESSURE BONDING INSTEAD OF INSERTING THEM INTO A PROTECTIVE CONTAINER

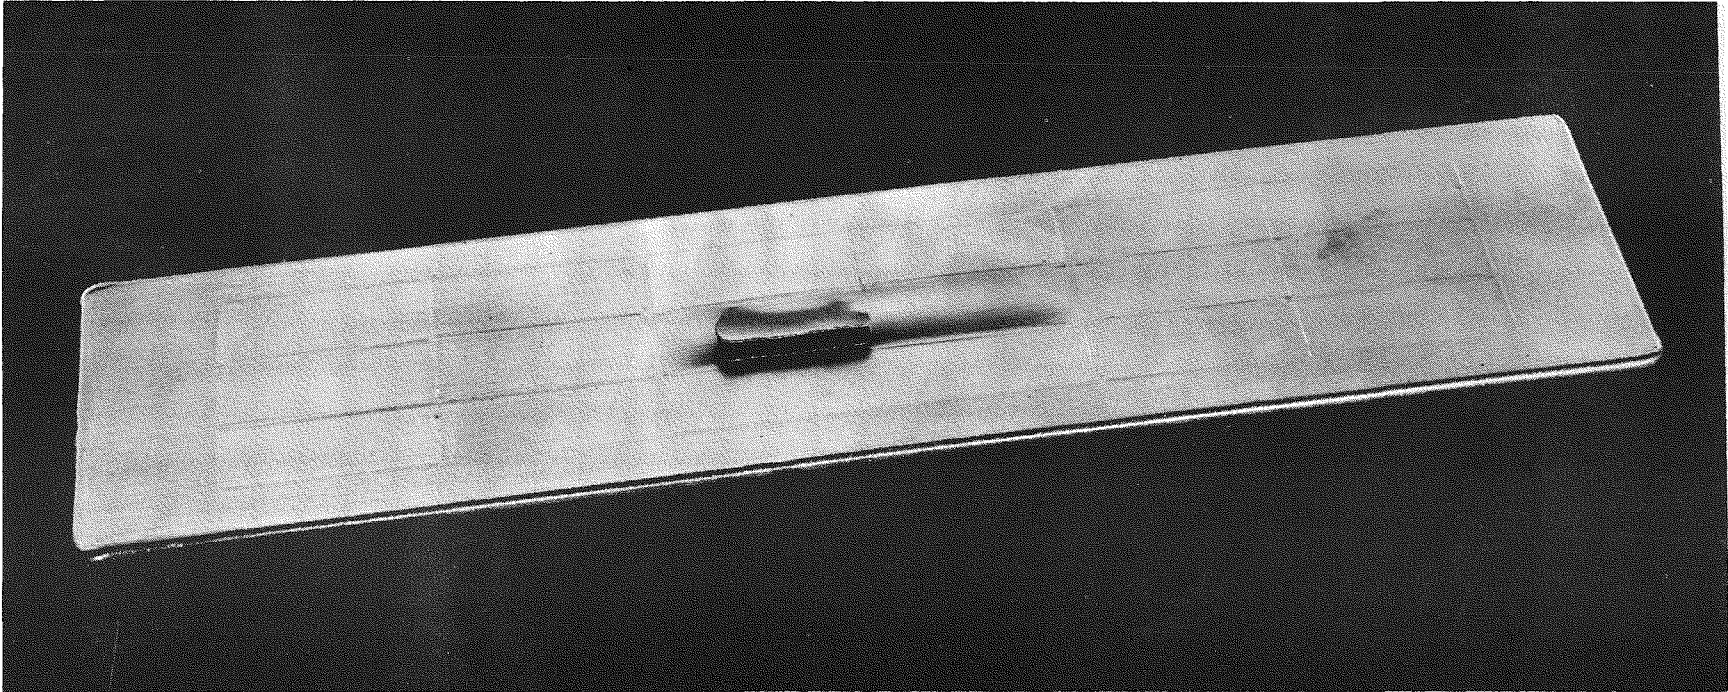
3/4X

Failure of cladding occurred along edge of compartment and across it at 2500 psi after 0.019 in. of deflection. The element contained a one-piece picture frame and bare cores, and was heat treated at 1850 F for 5 min after pressure bonding at 1550 F and 10,000 psi for 4 hr.

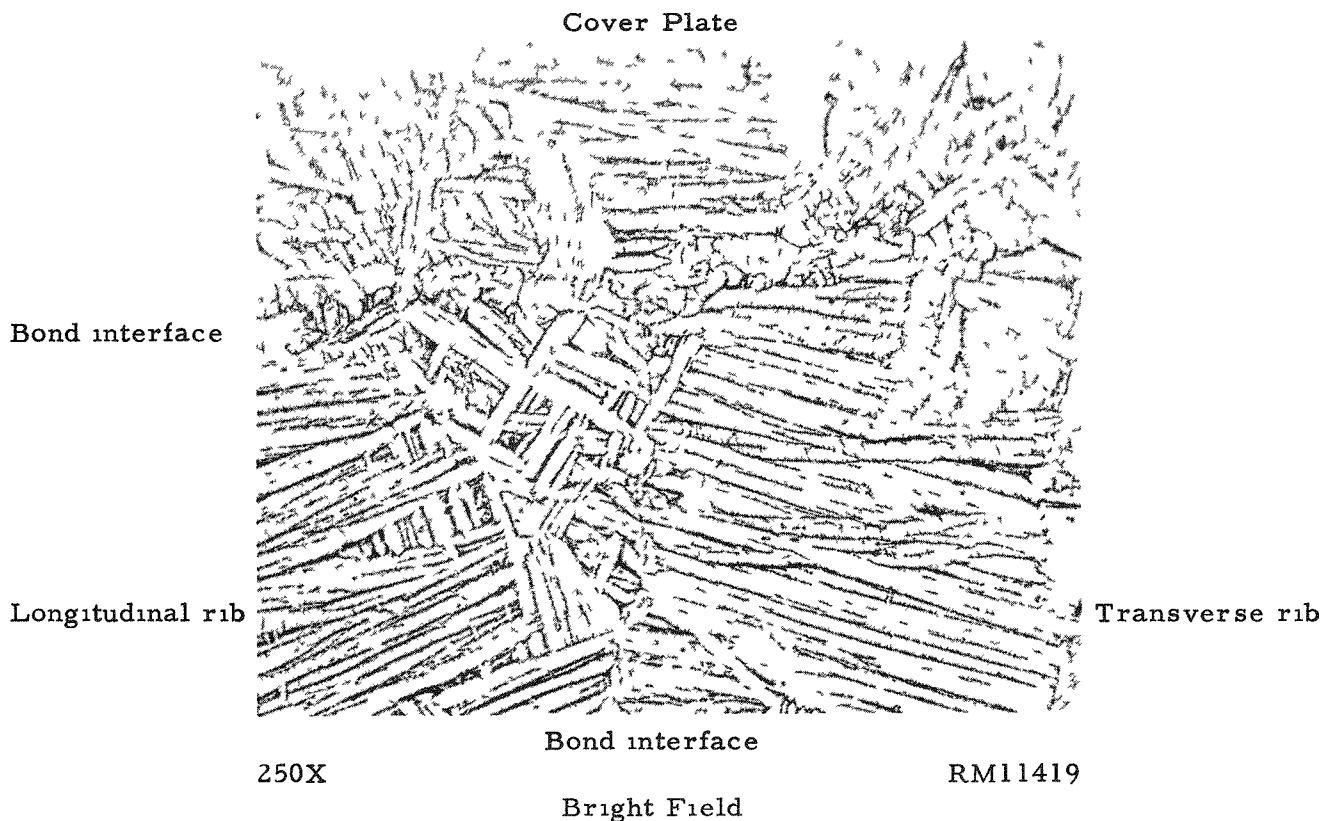
FIGURE 43. ZIRCALOY-TO-ZIRCALOY BONDS IN ELEMENT PREPARED UTILIZING EDGE WELDING AND A PIECE-COMPONENT PICTURE FRAME

illustrated in Figure 43. The specimen with abraded cladding plates and pickled frame components which was bonded at 1750 F and heat treated showed good bonding also. However, the lower bonding temperature of 1550 F, which produced satisfactory bonds between all belt-abraded components, is more desirable to minimize core-cladding reaction. The bond areas listed as Type B in Table 22 exhibited small spherical voids along the bond interfaces, indicating entrapped air or entrapped residual helium. No contamination of the bonds by graphite or UO_2 was observed metallographically in this series of specimens. Also, radiographic examination of these specimens revealed no UO_2 in the bond interfaces. Narrow zones of oxygen-rich Zircaloy were observed along some of the bond interfaces. The cause for these zones could not be isolated; possible causes are discussed in a subsequent section. The metallographic examination revealed no visible uranium-zirconium reaction zones in the specimens, but bands of oxygen-rich Zircaloy were present in some areas around the cores in all specimens. These bands, which were about 0.001 to 0.002 in. wide, were most prevalent at the corners and edges of cores and in the specimens bonded at 1750 F.

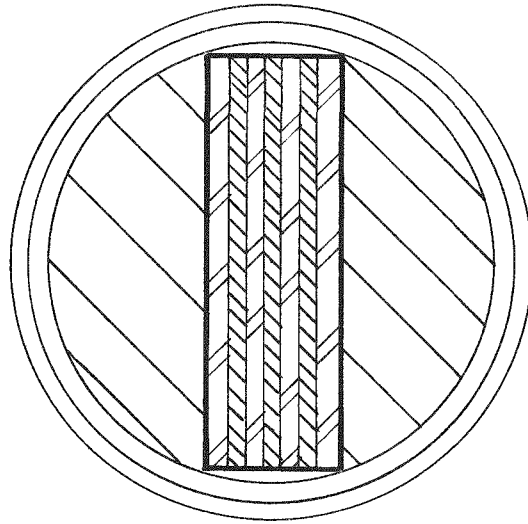
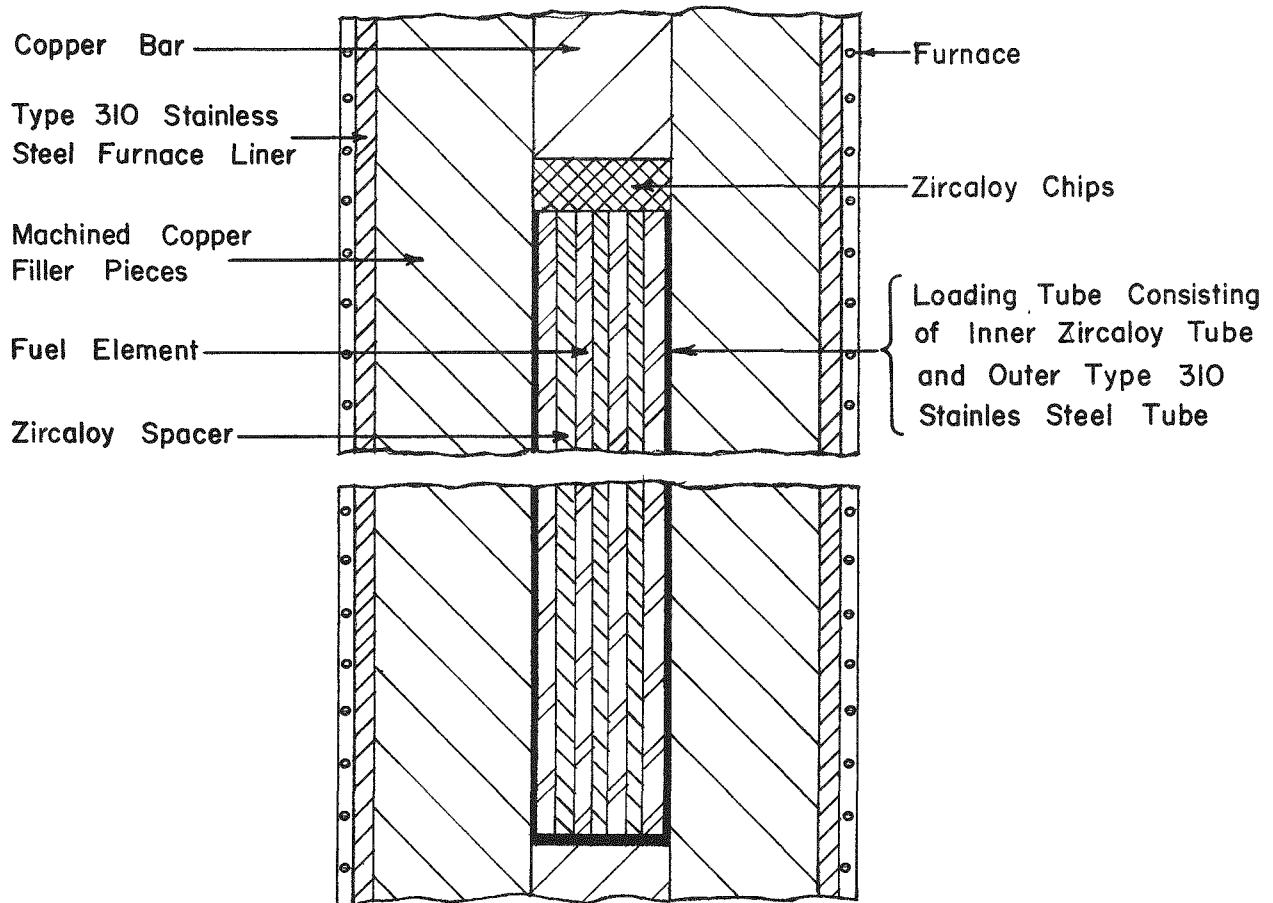
(a) Cross Section of Autoclave Loading Assembly

(b) Longitudinal Section of Autoclave Loading Assembly

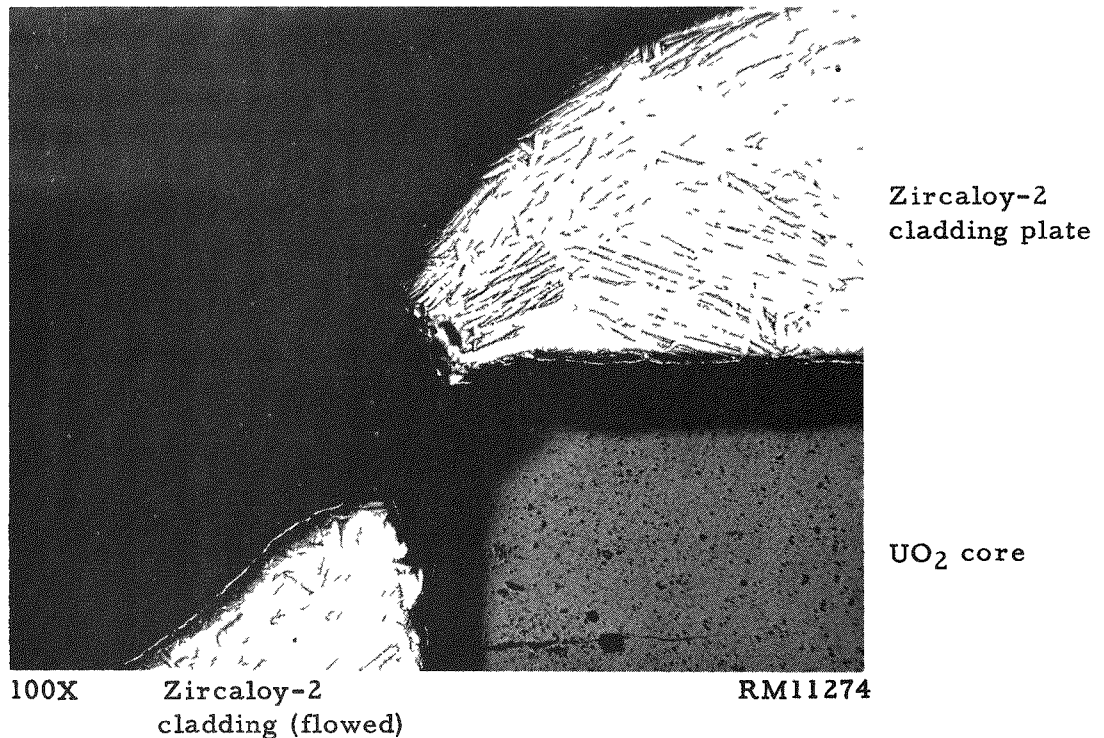
FIGURE 47. AREA OF AN ELEMENT IN WHICH THE CLADDING PLATE FLOWED EXCESSIVELY DURING PRESSURE BONDING INTO A LARGE VOID SPACE BETWEEN TWO CORES CAUSED BY A CHIP IN ONE OF THE CORES

Void space due to assembly tolerances in the longitudinal direction was minimized by placing a sufficient number of the 0.005-in.-thick shims at the end of the row of cores to fill the space. Void space less than 0.005 in. in one location did not result in any depression, even when located between two cores not separated by a rib. Void space in the picture frame due to chipped cores can be eliminated only by selection of unchipped cores for assembly. It would be desirable to determine the maximum amount of void space of both types which is permissible in the frame assembly of elements to be pressure bonded, and also to determine a method of minimizing this effect in a manner such that elimination of void space is not as critical. These aspects are being investigated in a newly initiated study.

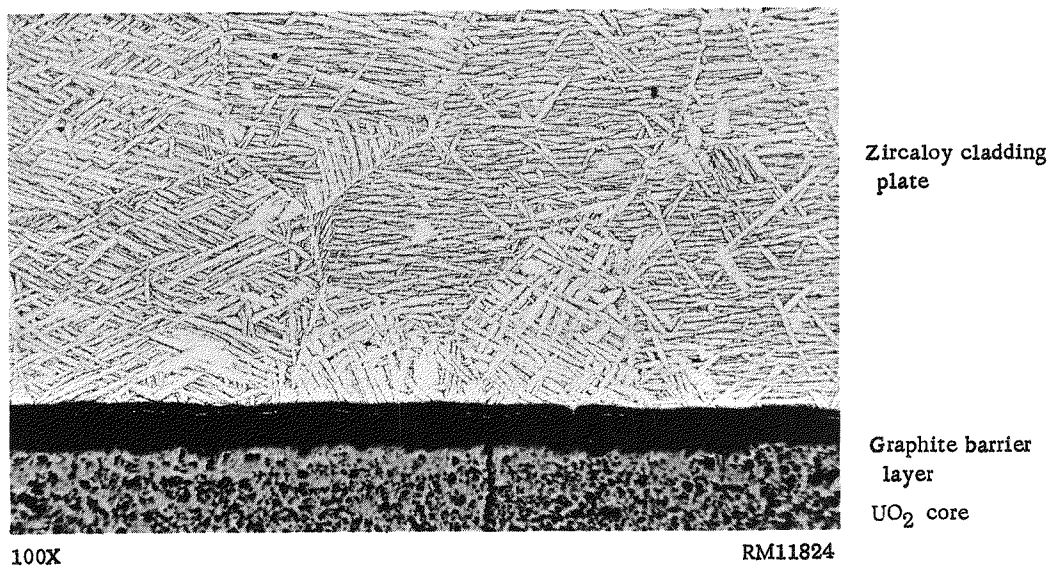
FIGURE 50. REPRESENTATIVE AREA OF INTERFACE BETWEEN CLADDING AND GRAPHITE-COATED CORE SHOWING NO EVIDENCE OF REACTION

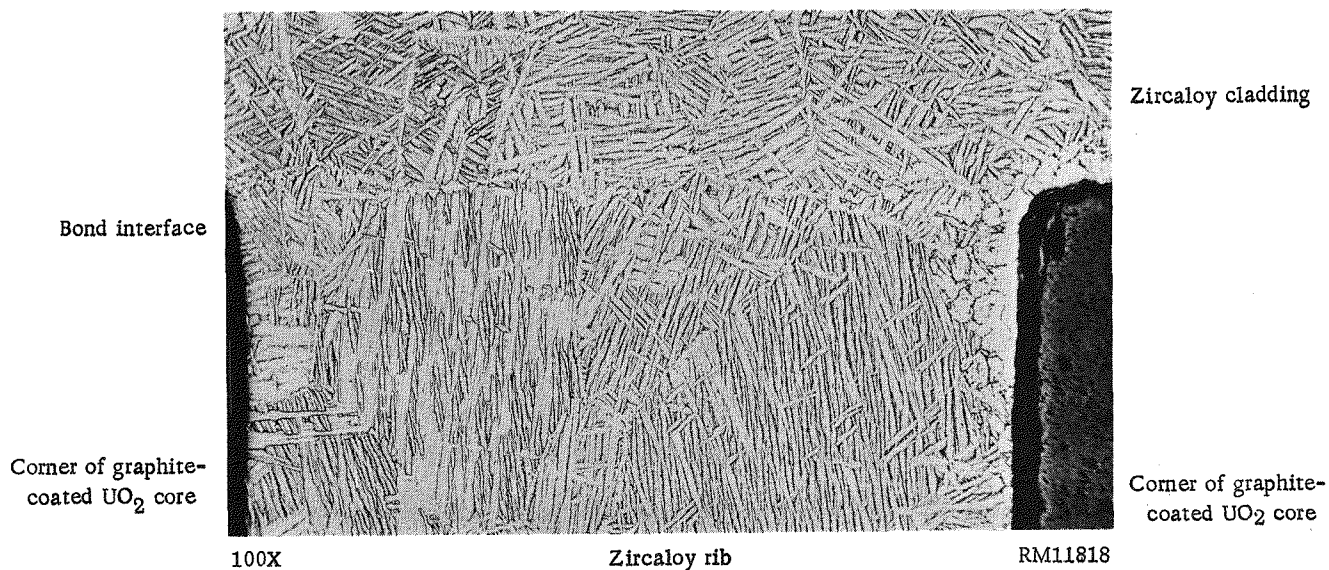
FIGURE 51. TWO CORNERS OF GRAPHITE-COATED CORES, ONE OF WHICH HAS AN ADJACENT ZONE OF ALPHA GRAINS IN THE ZIRCALOY INDICATING SLIGHT CORE-CLADDING REACTION
