Report No. BMI-1374
UC-25 Metallurgy and Ceramics
(TID-4500, 14th Ed.)

GAS-PRESSURE BONDING OF ZIRCALOY-CLAD FLAT-PLATE
URANIUM DIOXIDE FUEL ELEMENTS

August 28, 1959

BATTELLE MEMORIAL INSTITUTE
505 King Avenue
Columbus 1, Ohio

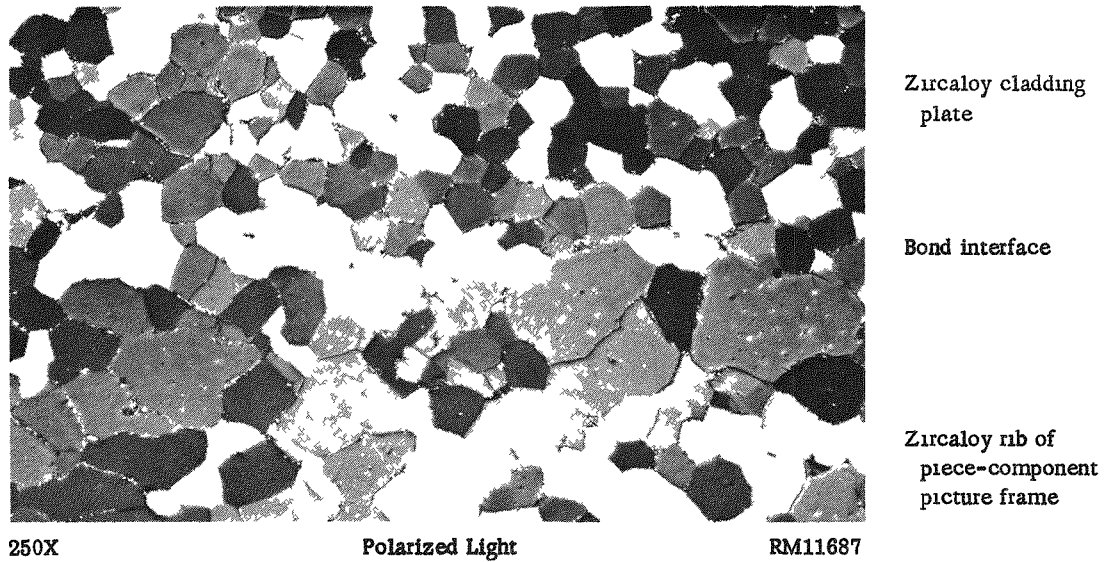
FIGURE 52. ZIRCALOY-TO-ZIRCALOY BOND IN AS-PRESSURE-BONDED ELEMENT WHICH WAS PREPARED UTILIZING THE EDGE-WELDING TECHNIQUE, PIECE-COMPONENT PICTURE FRAME, AND BUFFED GRAPHITE-SPRAYED CORES. This element was pressure bonded at 1550 F and 10,000 psi for 4 hr. Note that the approximate location of the bond interface can be observed by the difference in grain size of the components, which originated in the different materials from which the various components were prepared.

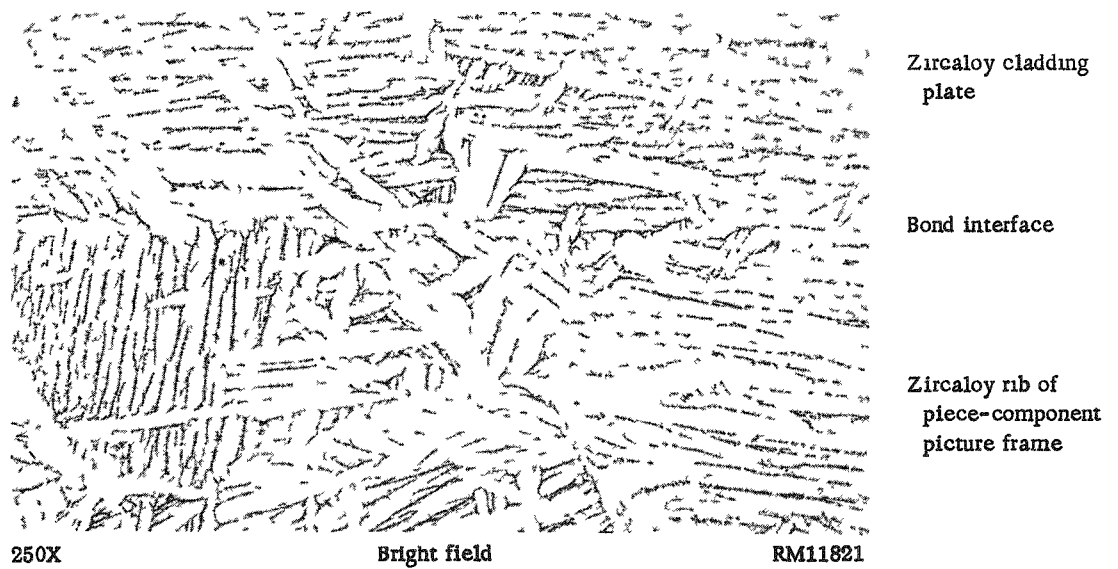
FIGURE 53. ZIRCALOY-TO-ZIRCALOY BOND IN 1850 F HEAT-TREATED PORTION OF ELEMENT SHOWN IN FIGURE 52. Subsequent to pressure bonding, this portion of element was heat treated for 5 min in an 1850 F salt bath.
