Report No. BMI-1387  
UC-25 Metallurgy and Ceramics  
(TID-4500, 15th Ed.)

A VISUAL STUDY OF THE CORROSION OF DEFECTED  
ZIRCALOY-2-CLAD FUEL SPECIMENS BY HOT WATER

Elmer F. Stephan  
Paul D. Miller  
Frederick W. Fink

BATTELLE MEMORIAL INSTITUTE  
505 King Avenue  
Columbus 1, Ohio

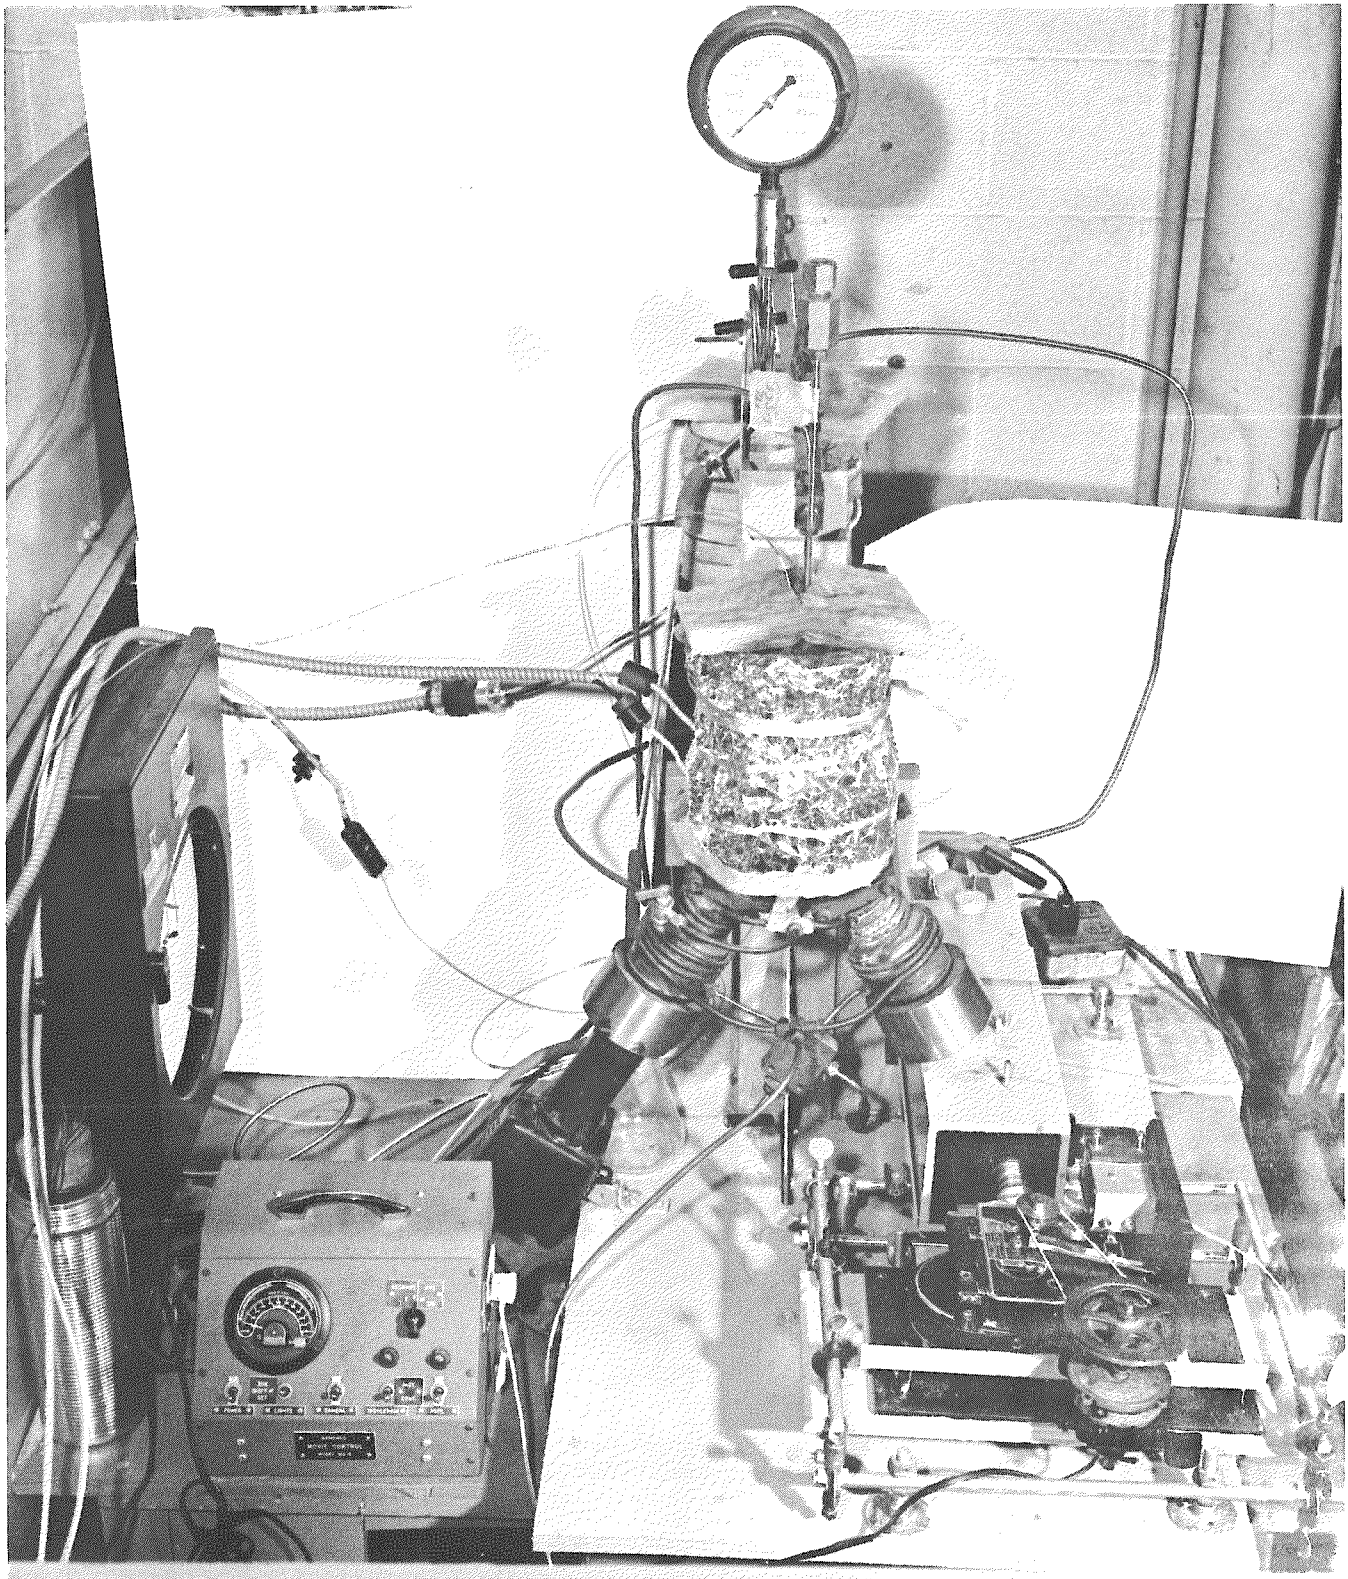
FIGURE 1. PHOTOGRAPH OF APPARATUS FOR OBSERVING THE CORROSIVE ACTION OF HOT WATER ON DEFECTED FUEL ELEMENTS

The autoclave and associated apparatus used for studying the failure of clad fuel specimens are shown in Figure 1. The procedures used for obtaining the time-lapse motion pictures were developed previously and are described in detail in BMI-998.

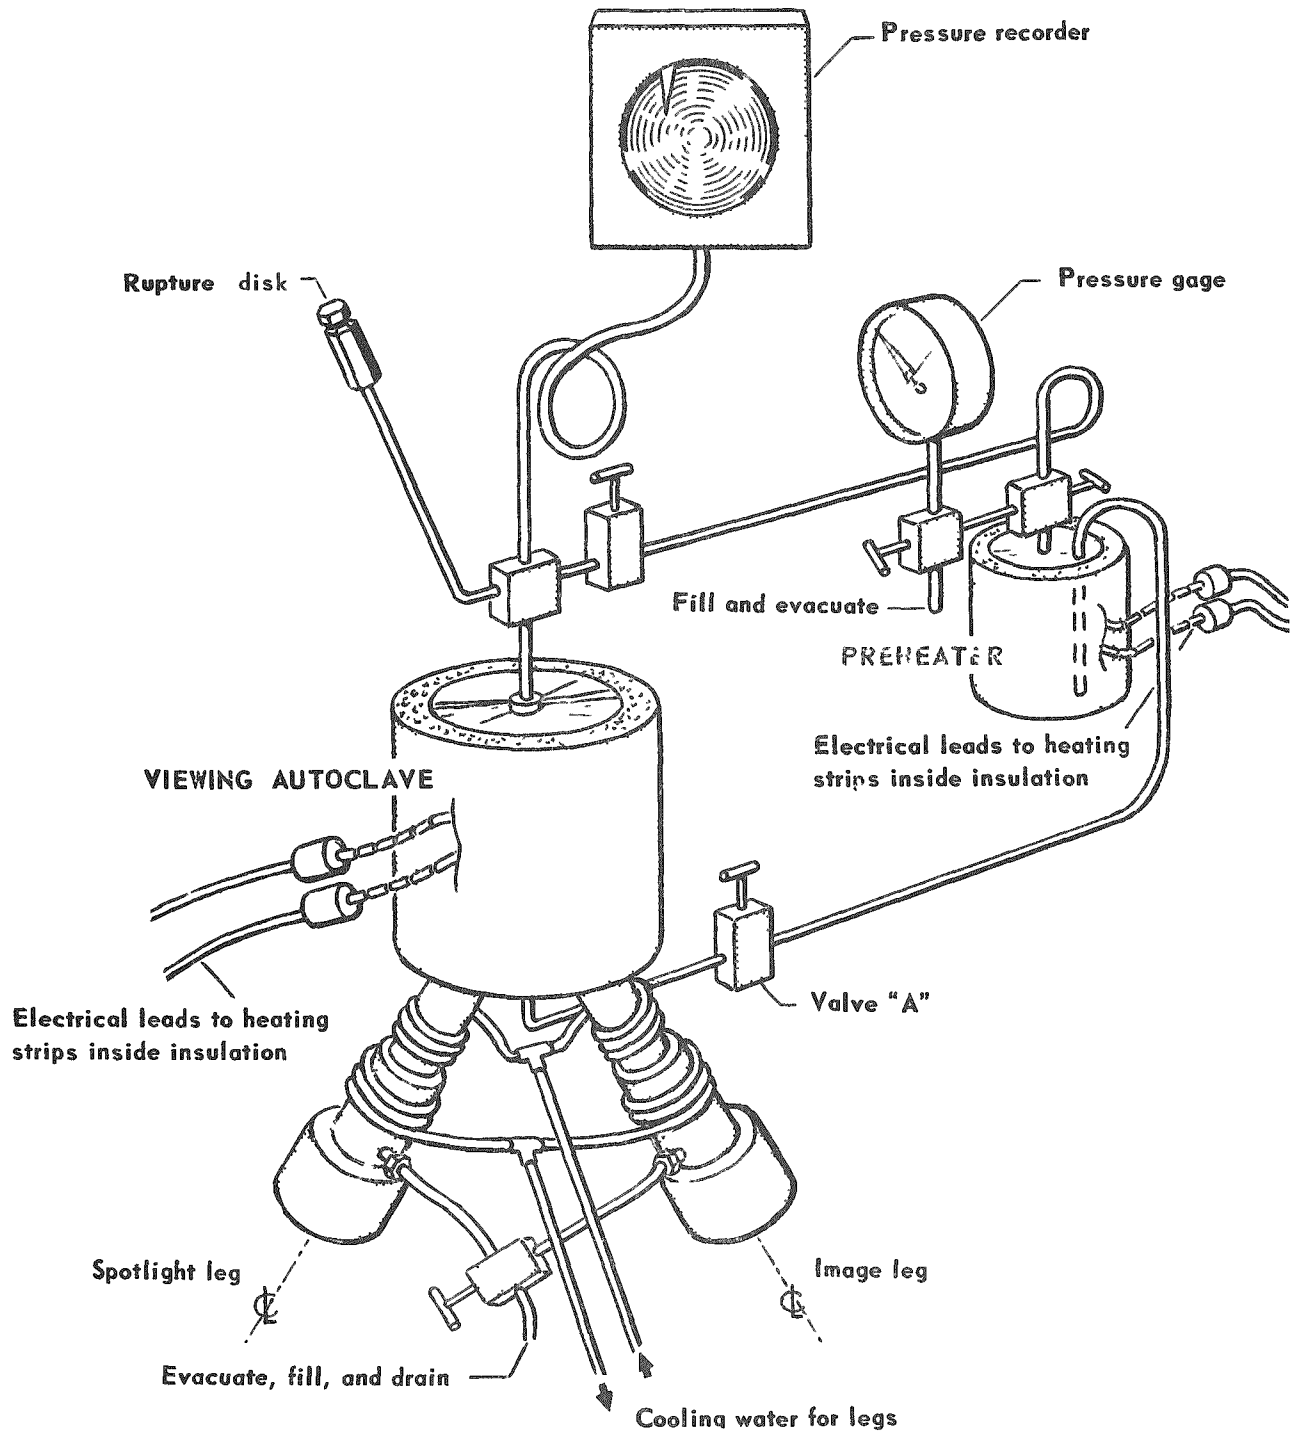
FIGURE 2. WINDOWED-AUTOCCLAVE SYSTEM

Essentially, the apparatus consists of a windowed-autoclave system, shown in Figure 2, and an optical system for photographing and viewing the reaction as pictured in Figure 3. A cross-sectional sketch of the windowed autoclave showing the position and mounting of the specimen is presented in Figure 4. Illumination was furnished by a Bunton spotlight equipped with a General Electric 100G 16-1/2/29SC bulb. The time-lapse motion pictures were taken with a 16-mm Paillard Bolex H-16 movie camera having a 63-mm Ektanon Kodak lens and an external electric motor with a spring drive. A Semenco movie control, Model MC-5, was used to actuate the spotlight, motor, and solenoid tripper for exposing the picture frames at the desired intervals.

Although the equipment was designed for a maximum pressure of 3000 psi, it was necessary in some experiments to bleed off some of the evolved hydrogen because excessive pressures were reached. In this case, the preheater (Figure 2) was used as additional head space for confining the hydrogen. No pressure-time data were obtained for Experiments 7 and 9B because of a high-temperature leak which allowed some hydrogen to escape. In Experiment 2, a slight leak in a valve allowed some of the water from the reaction vessel to leak into the preheater, creating a variable head space. However, sufficient water remained in the reaction vessel to cover the specimens at all times.

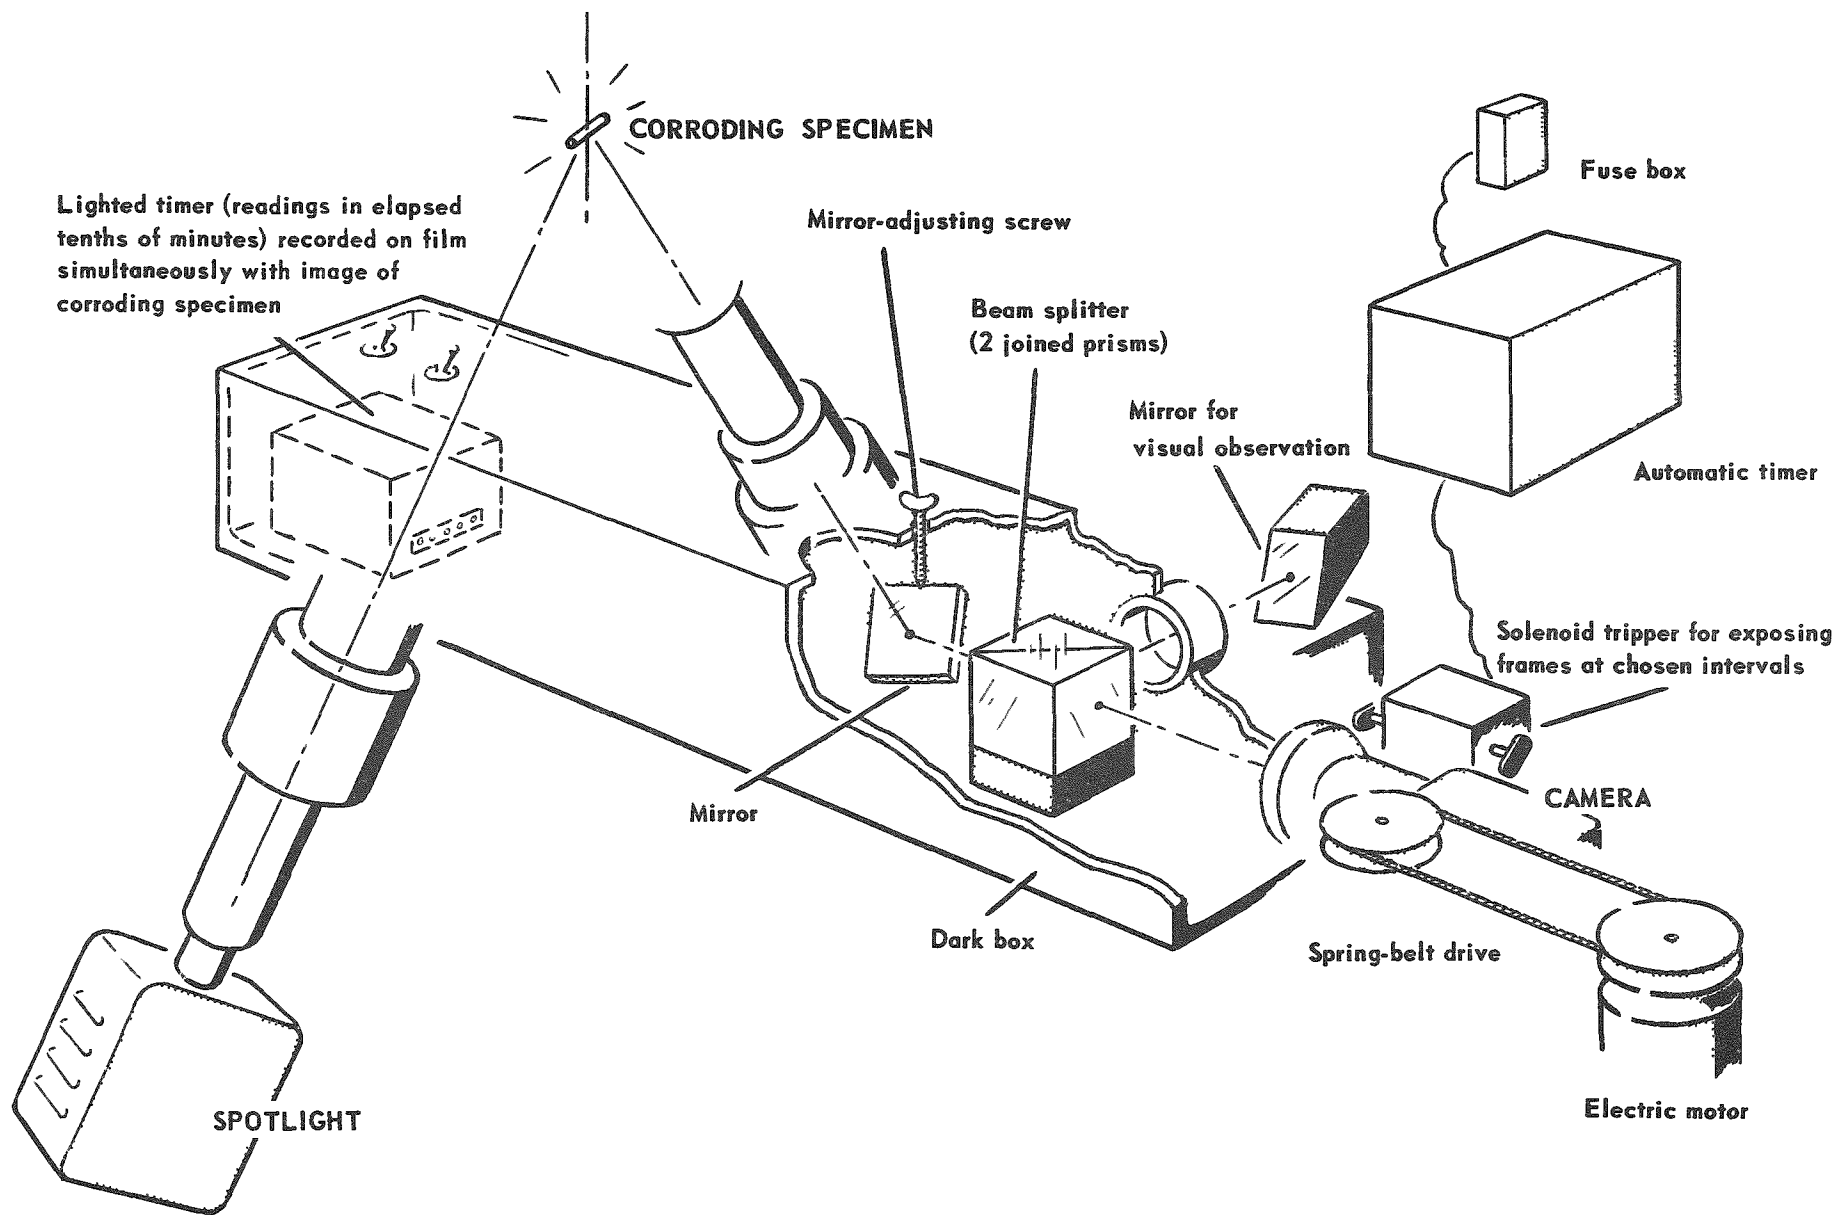
FIGURE 3. PHOTOGRAPHING AND OBSERVATION SYSTEM

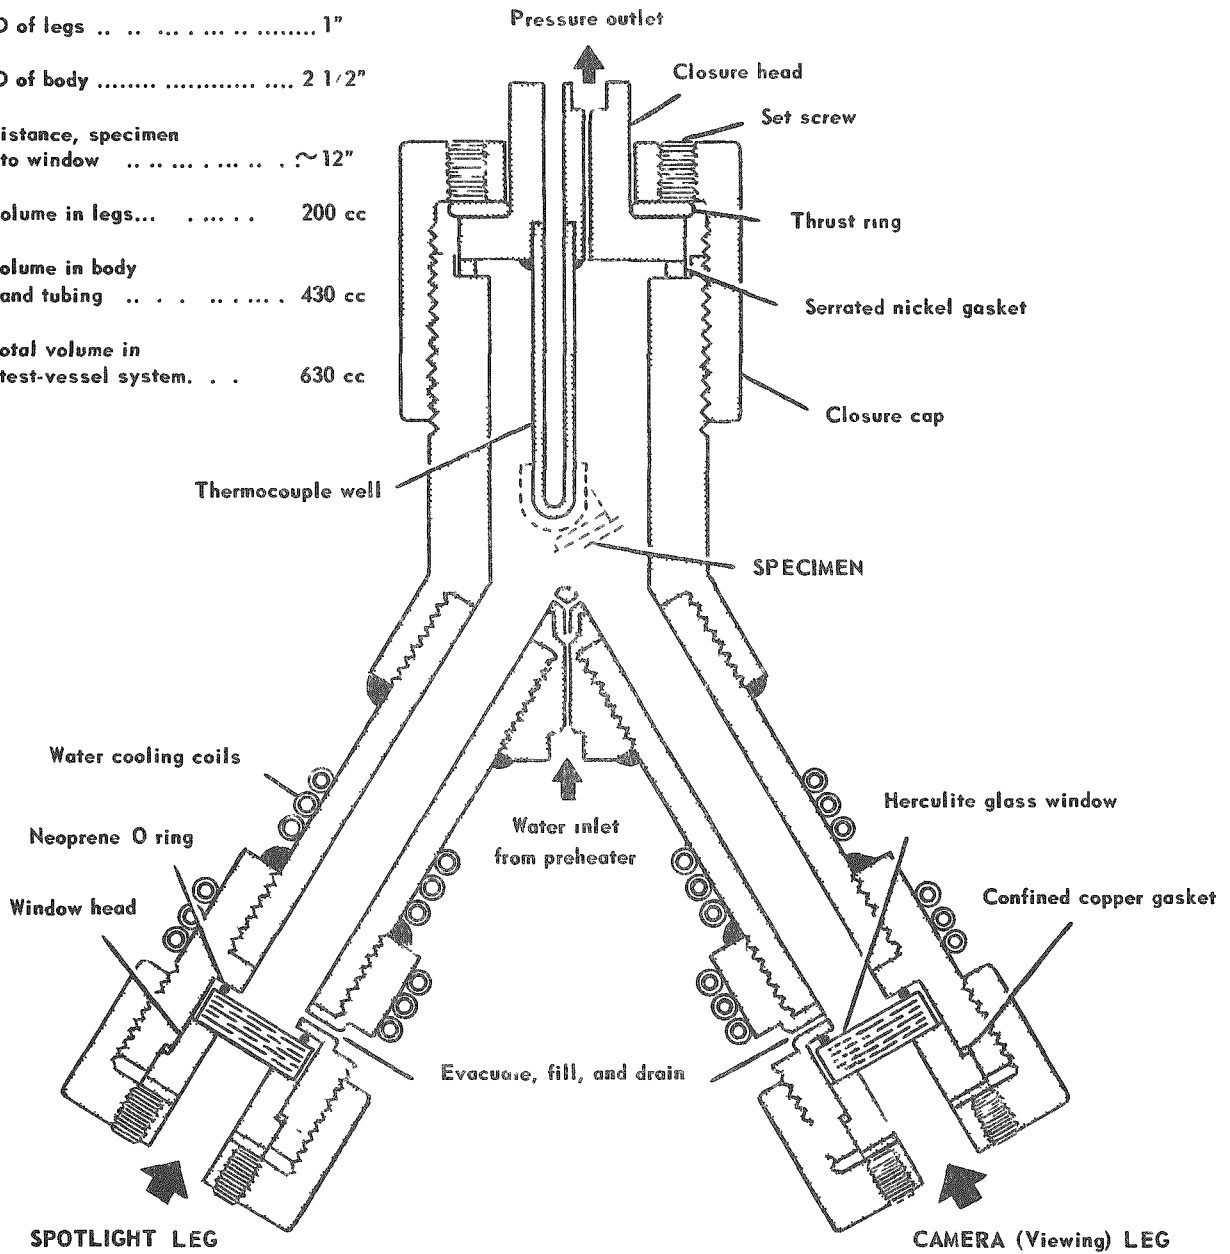
ID of legs .. . . . . .	1"
ID of body .. . . . . .	2 1/2"
Distance, specimen to window .. . . . . .	~ 12"
Volume in legs... .. .	200 cc
Volume in body and tubing .. . . . . .	430 cc
Total volume in test-vessel system. . . .	630 cc

FIGURE 4. CROSS SECTION OF WINDOWED AUTOCLAVE

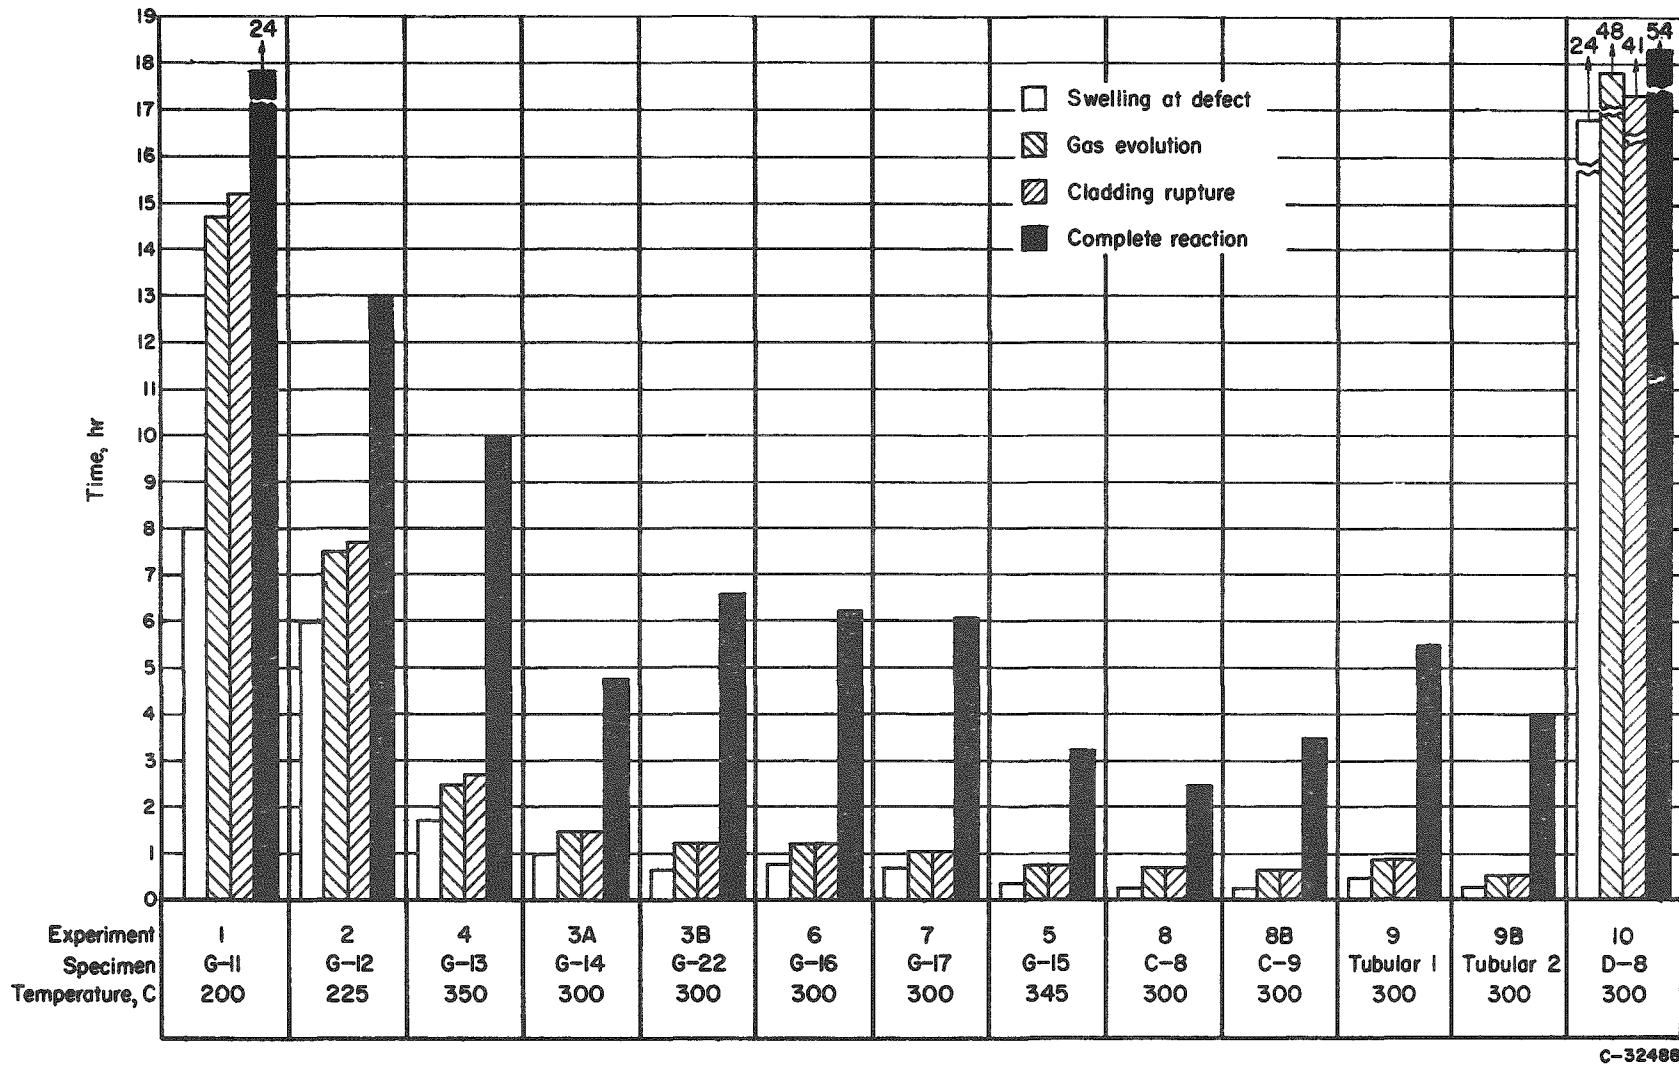
FIGURE 5. SUMMARY OF OBSERVED ACTION VERSUS TIME FOR THE VARIOUS SPECIMENS AND EXPERIMENTAL CONDITIONS

The photographic record and the visual observation of the nature of the attack of the hot water at the defect showed that the corrosive action was similar for all the specimens examined. Wide variations were noted, however, in the times at which the various stages of failure occurred. The first evidence of attack was a slight dimpling of the cladding around the hole. As the action continued, this swelling expanded until a well-defined blister could be seen. The times at which the first detectable swelling could be seen with the various specimens are presented in Table 2, and are shown graphically in Figure 5.

The completion of the reaction was taken to be the time at which no increase in pressure in the autoclave could be detected. It can be seen in Figure 5 that the reaction continued for fairly long times after cracking had occurred.

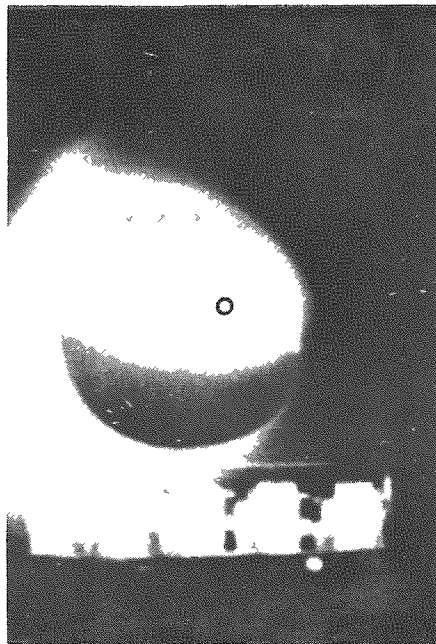
a. After 1.4 Min

Defect is encircled.

Typical examples of the action at various stages are shown in Figure 6. These photographs were reproduced from the film of Experiment 9B.

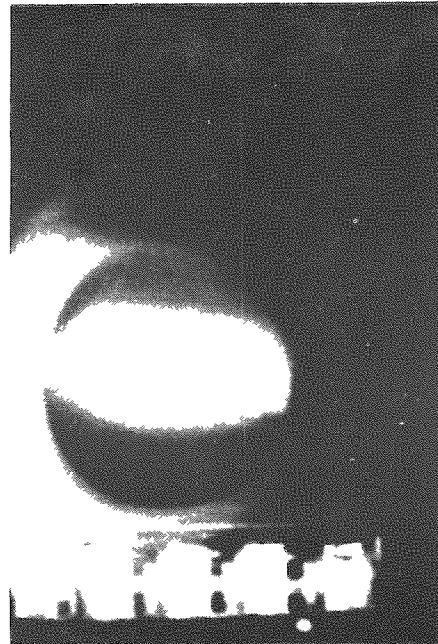
b. After 28.3 Min

Swelling of the cladding surrounding the defect may be seen.

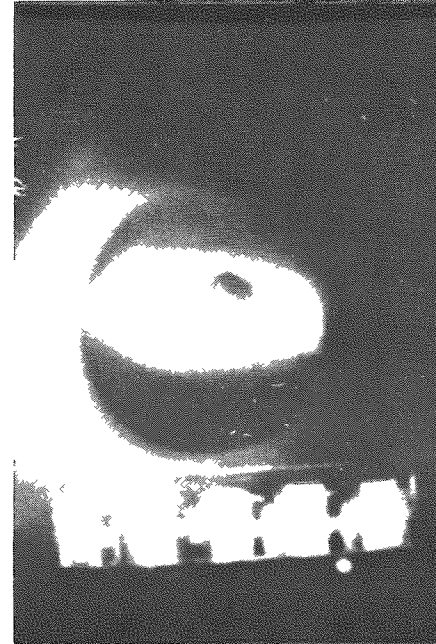
c. After 36.6 Min

The cladding has ruptured at the base of the swelling. Hydrogen bubbles can be seen escaping from the rupture.

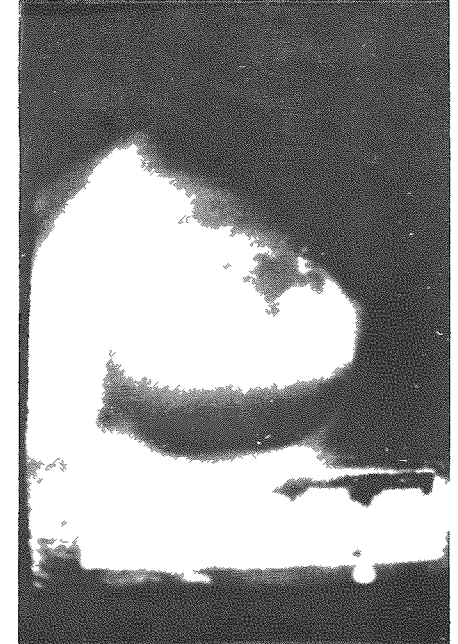
d. After 56.0 Min

The cladding surrounding the defect has been lifted back, exposing the core. Secondary swelling areas are occurring around the initial ruptured area. At this point the water is very dark due to suspended corrosion product. The exposure time was lengthened in order to view the specimen, which overexposed the running-time meter.

FIGURE 6. PROGRESS OF CORROSION IN A ZIRCALOY-2-CLAD ELEMENT EXPOSED TO 300 F WATER

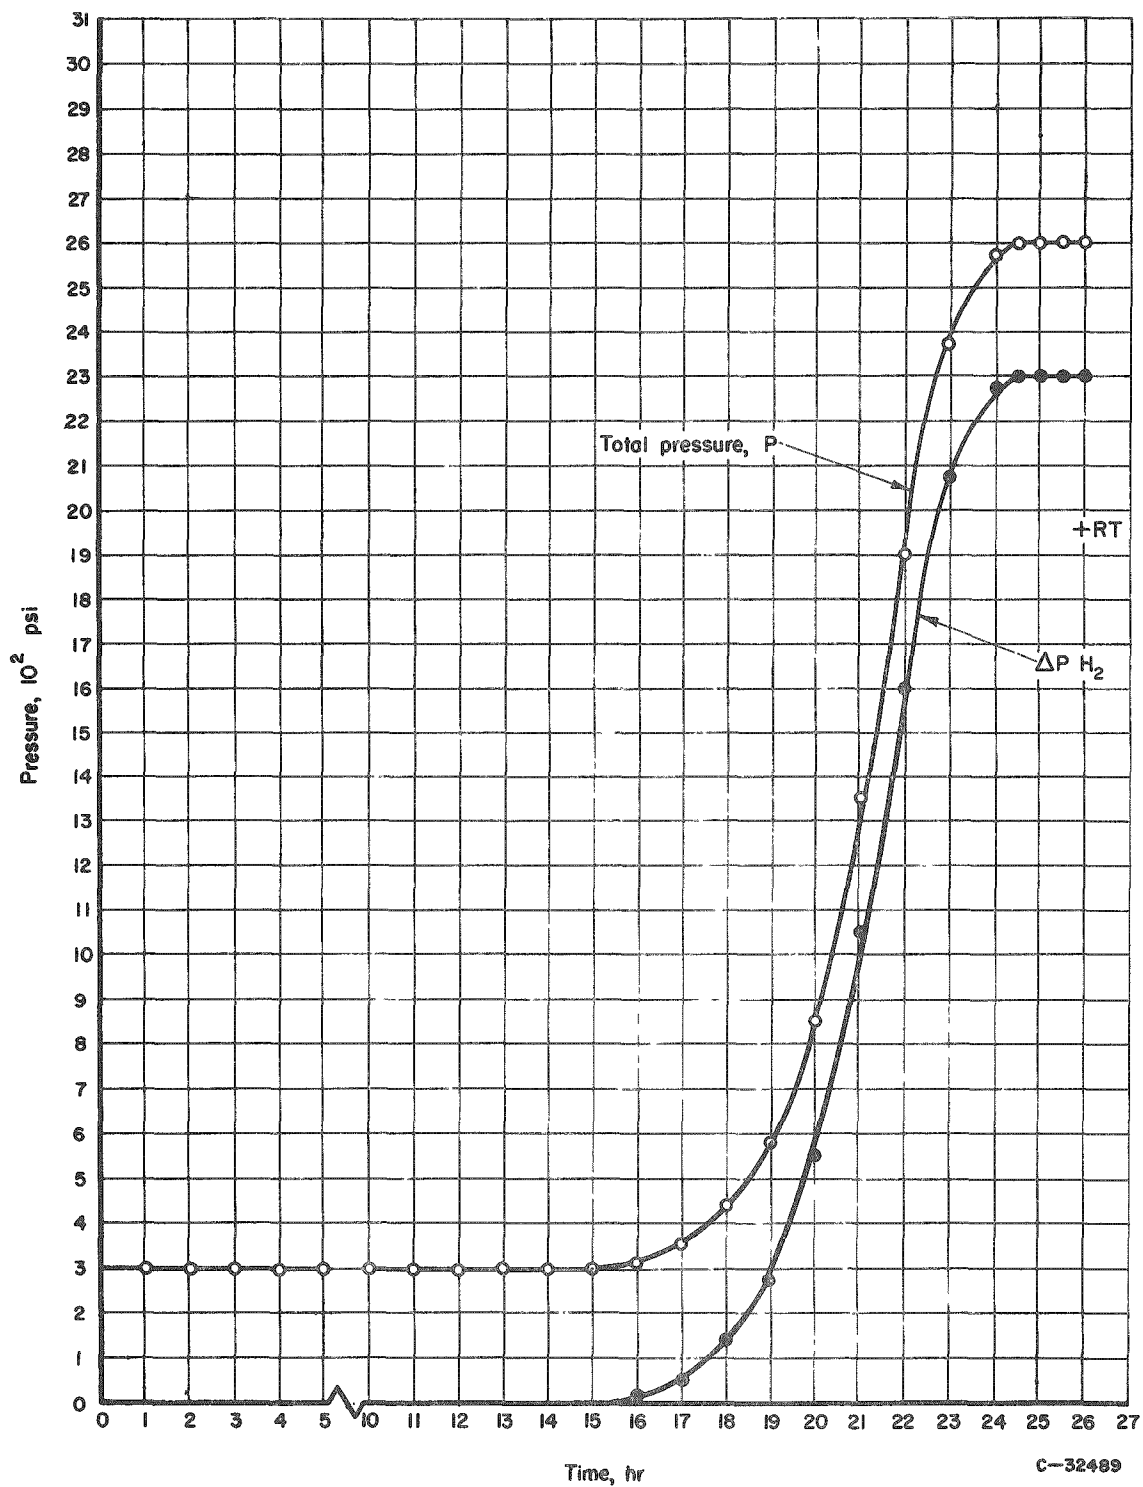
FIGURE 8. PRESSURE-TIME CURVES FOR EXPERIMENT 1

RT is the residual pressure at room temperature after complete reaction.

The pressure-time records for the different experiments are plotted in Figures 8 through 17. Table 2 summarizes the data for each experiment. The curves show the total pressure of the system during the run and the pressure due to evolved hydrogen. The hydrogen pressure is the difference between the total pressure and the vapor pressure of the water for that particular experiment. The residual pressures also are given for the systems after the reactions were completed and the vessel had cooled to room temperature. The volume of the head space is shown so that reaction rates can be calculated. The intervals at which hydrogen was bled from the reaction vessel are indicated by the dotted lines in the curves.

The data in Figures 8 through 17 show that the reaction of the core material with the water accelerates rapidly following rupture of the cladding. Although corrosive action is taking place from the time the water covers the specimen, this is not evidenced by gas evolution. It is only after the cladding has ruptured and a considerable area of the core is exposed that the pressure begins to rise. A direct comparison of the different curves should not be made because of variations in head space, hydrogen solubility, temperature, and mode of cracking.

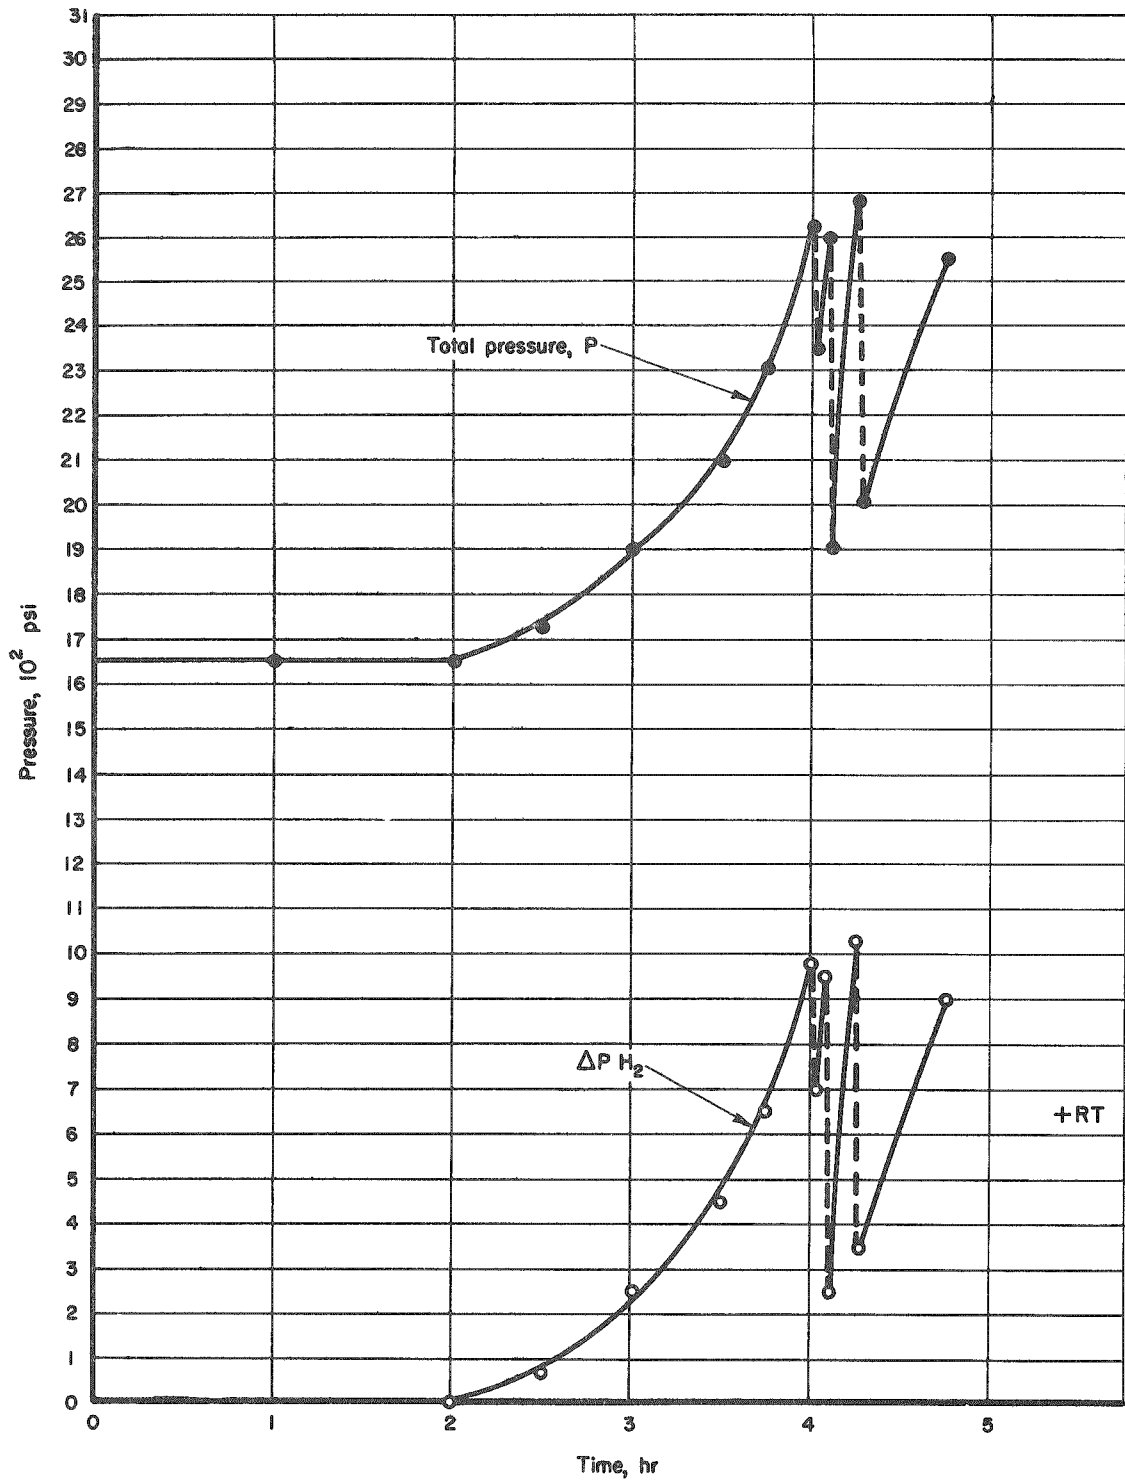
FIGURE 9. PRESSURE-TIME CURVES FOR EXPERIMENT 3A

RT is the residual pressure at room temperature after complete reaction.

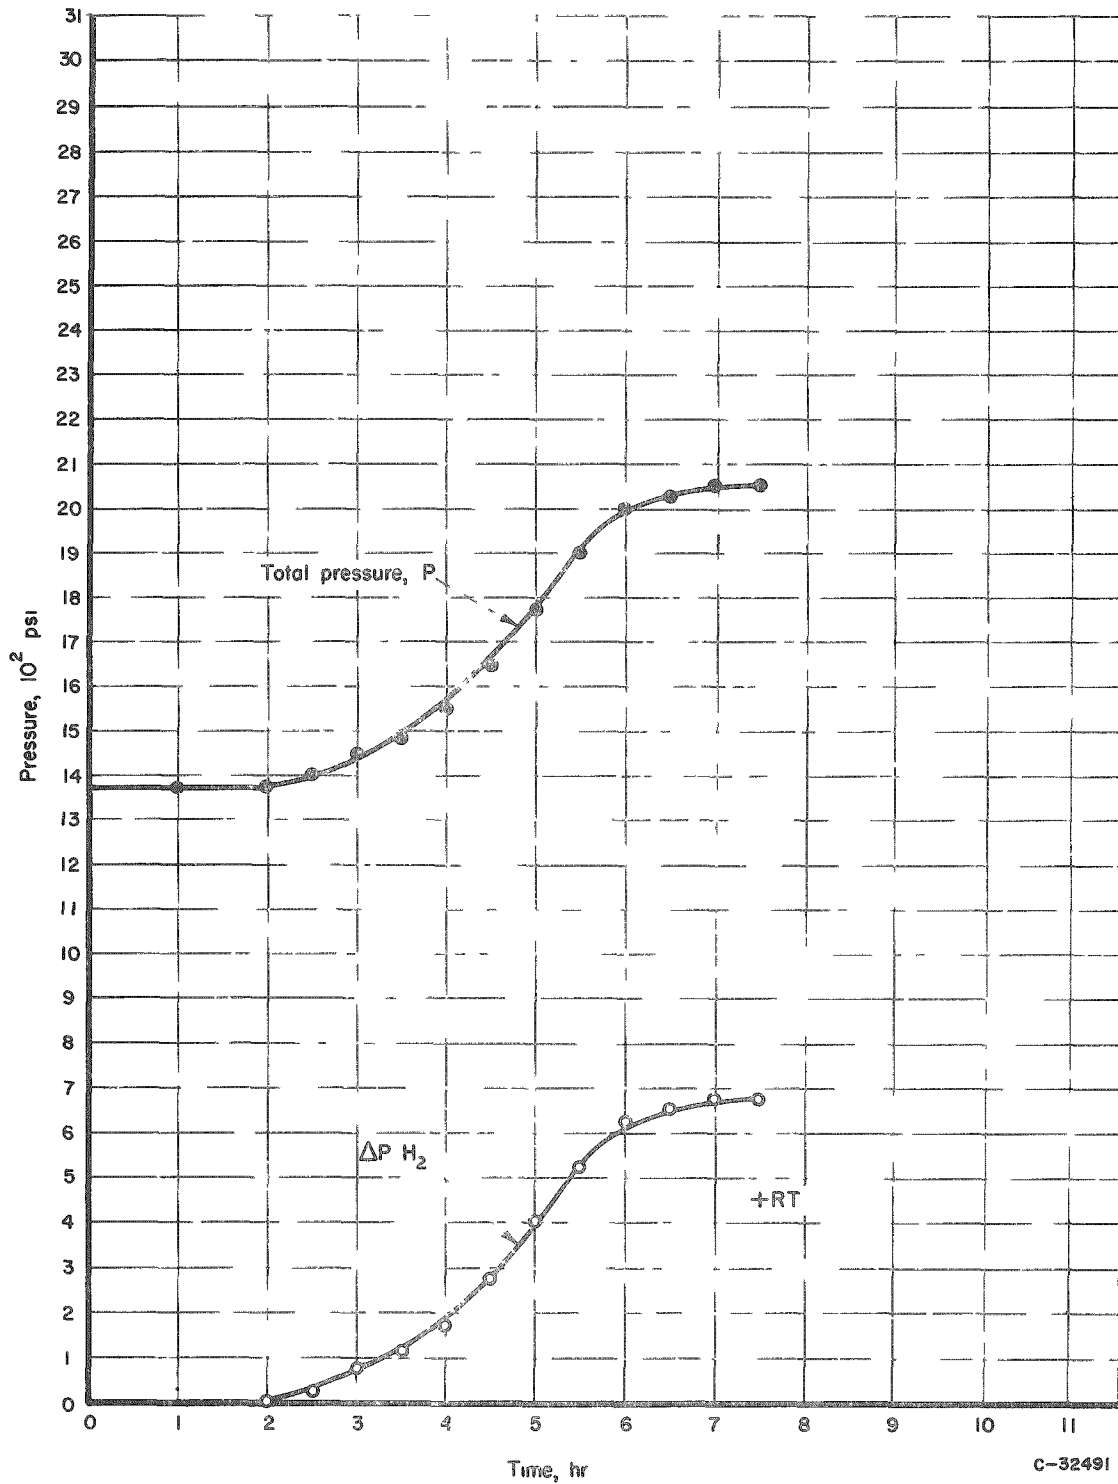
FIGURE 10. PRESSURE-TIME CURVES FOR EXPERIMENT 3B  
 Temperature 500 C  
 Specimen G-22  
 Head space 1140 ml  
 PT is the residual pressure at room temperature  
 after complete reaction.

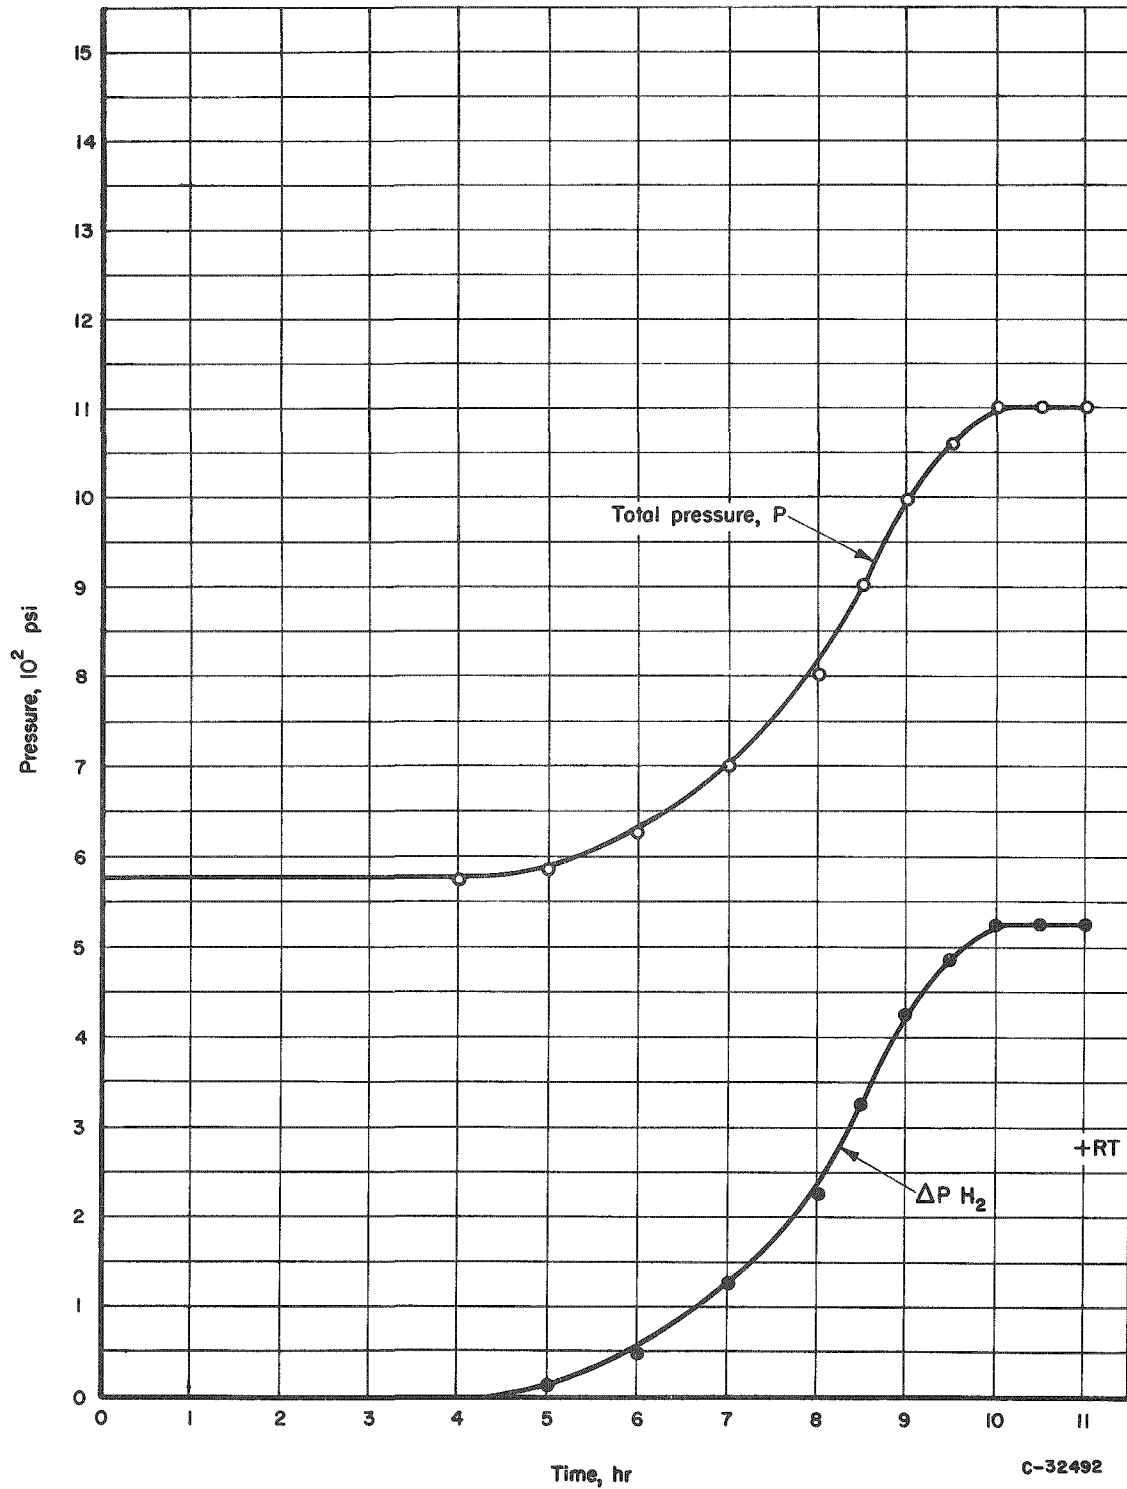
FIGURE 11. PRESSURE-TIME CURVES FOR EXPERIMENT 4

RT is the residual pressure at room temperature after complete reaction.

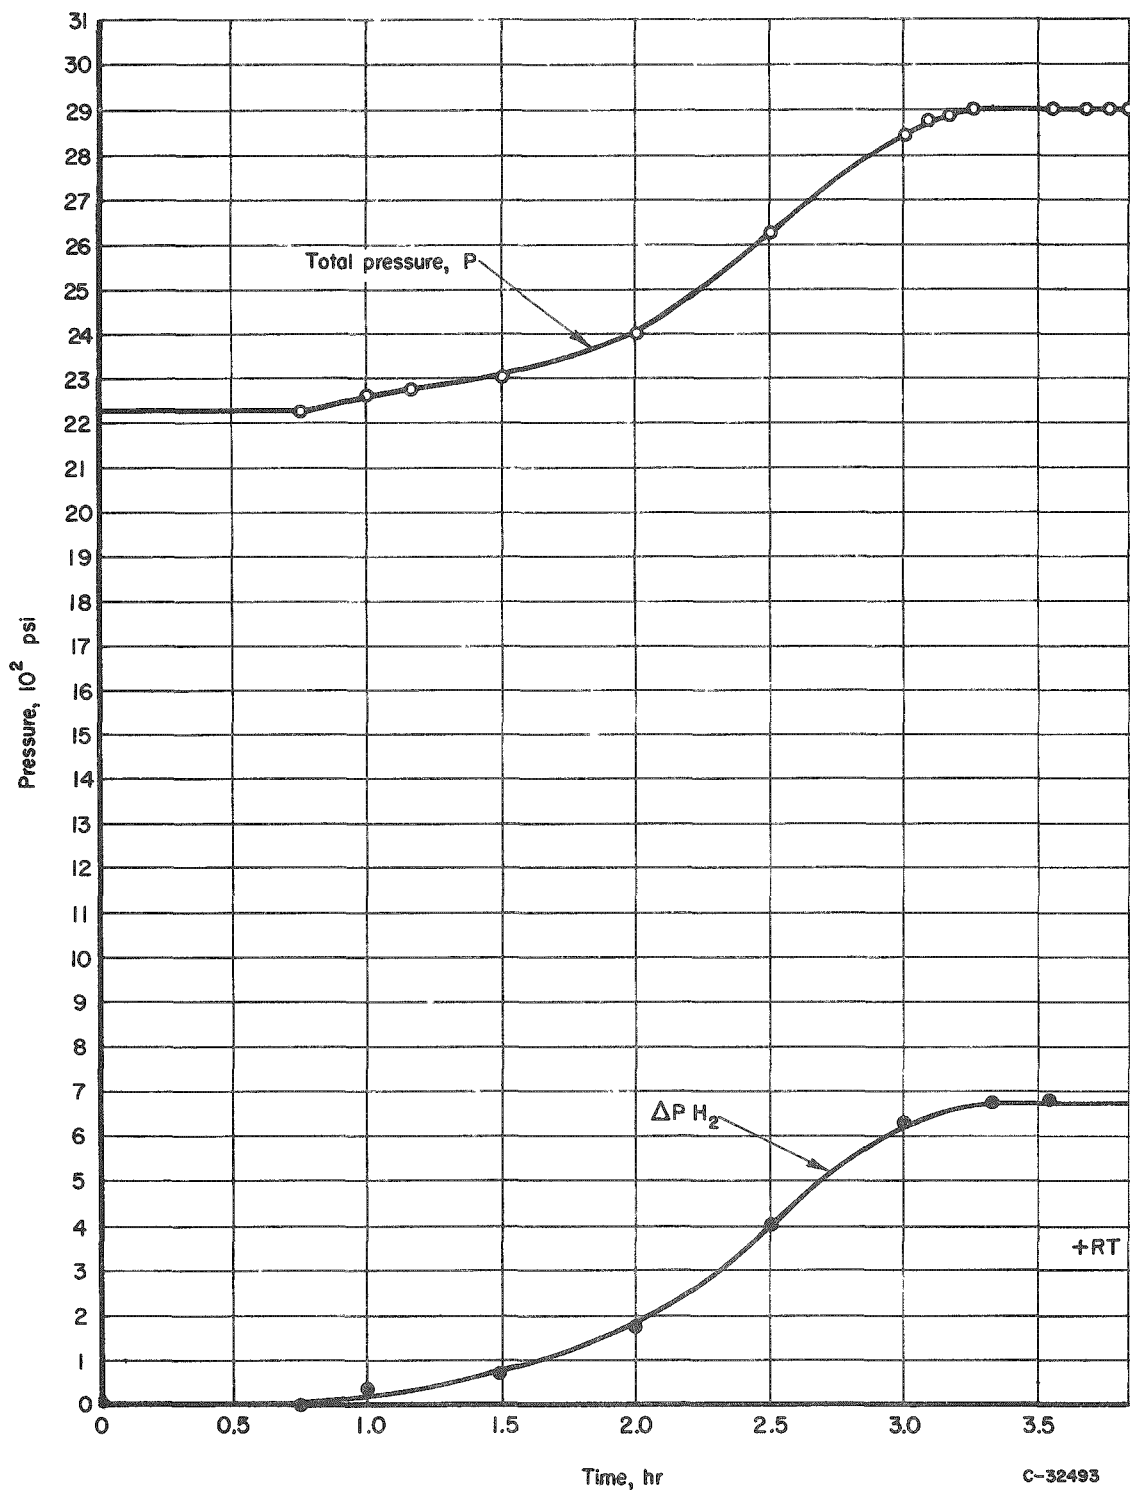
FIGURE 12. PRESSURE-TIME CURVES FOR EXPERIMENT 5

Temperature	345 C
Specimen	G-15
Head space	1200 ml
RT is the residual pressure at room temperature after complete reaction.

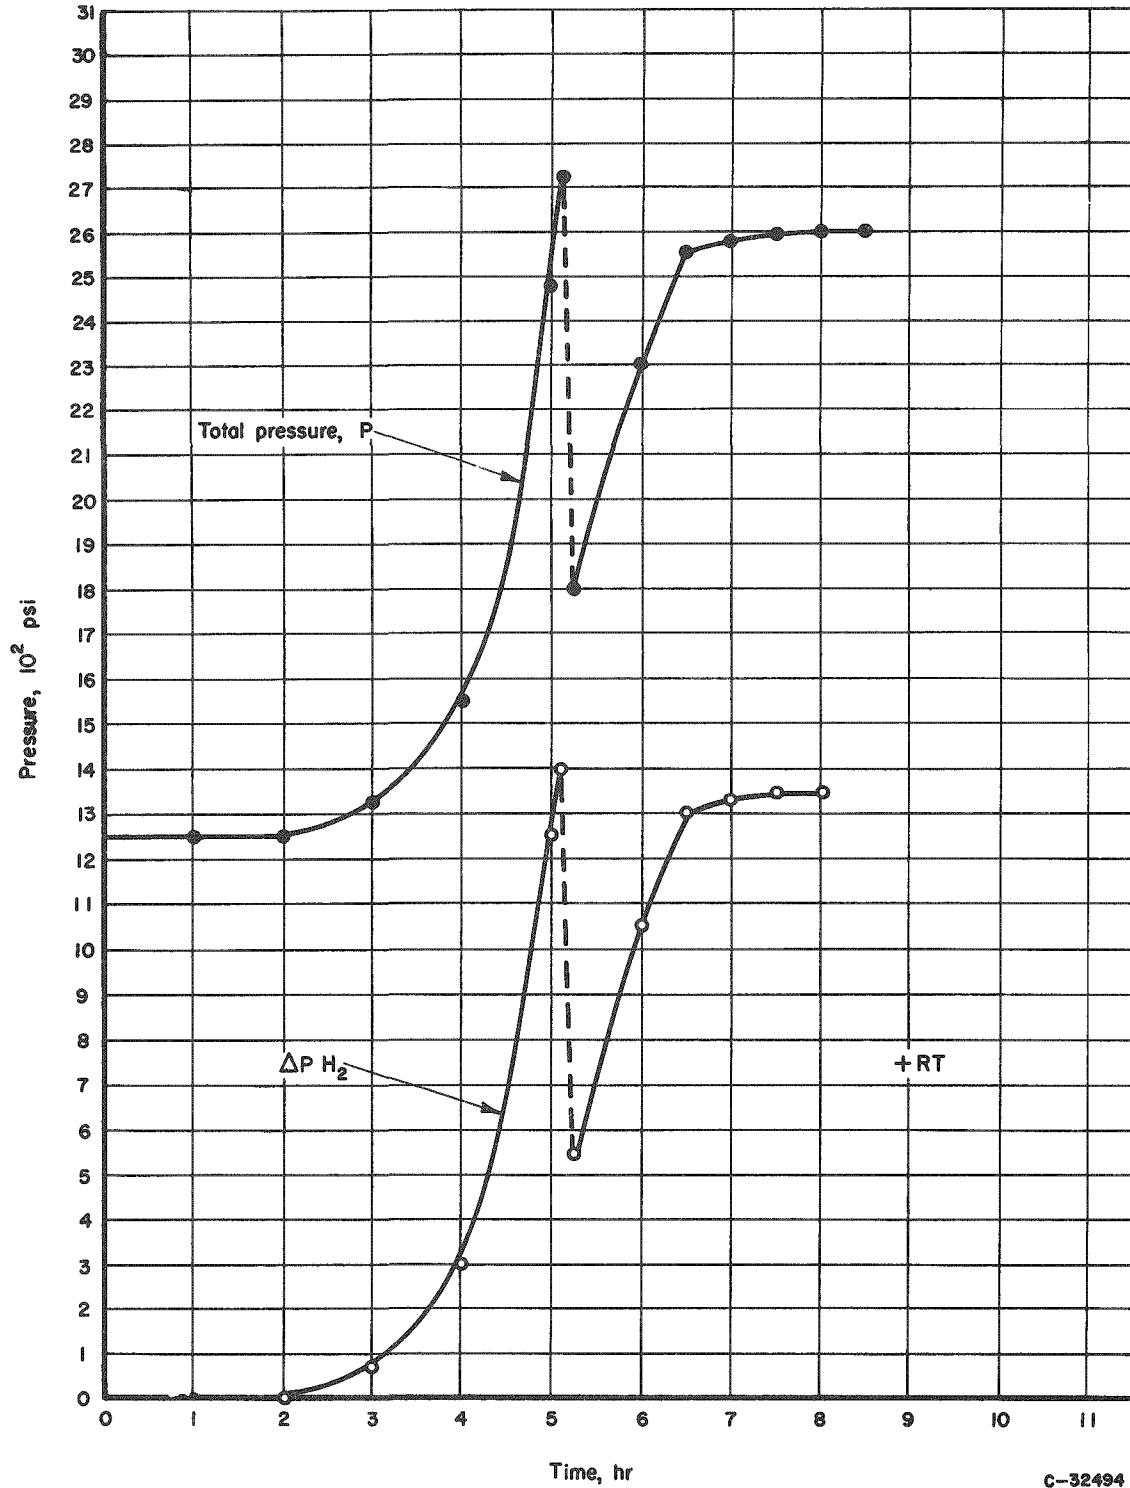
FIGURE 13. PRESSURE-TIME CURVES FOR EXPERIMENT 6

Temperature      300 C  
 Specimen         G-16  
 Head space       150 ml for first segment  
                      1100 ml for last segment  
 RT is the residual pressure at room temperature  
 after complete reaction.
