Report No. BMI-1387  
UC-25 Metallurgy and Ceramics  
(TID-4500, 15th Ed.)

A VISUAL STUDY OF THE CORROSION OF DEFECTED  
ZIRCALOY-2-CLAD FUEL SPECIMENS BY HOT WATER

Elmer F. Stephan  
Paul D. Miller  
Frederick W. Fink

BATTELLE MEMORIAL INSTITUTE  
505 King Avenue  
Columbus 1, Ohio

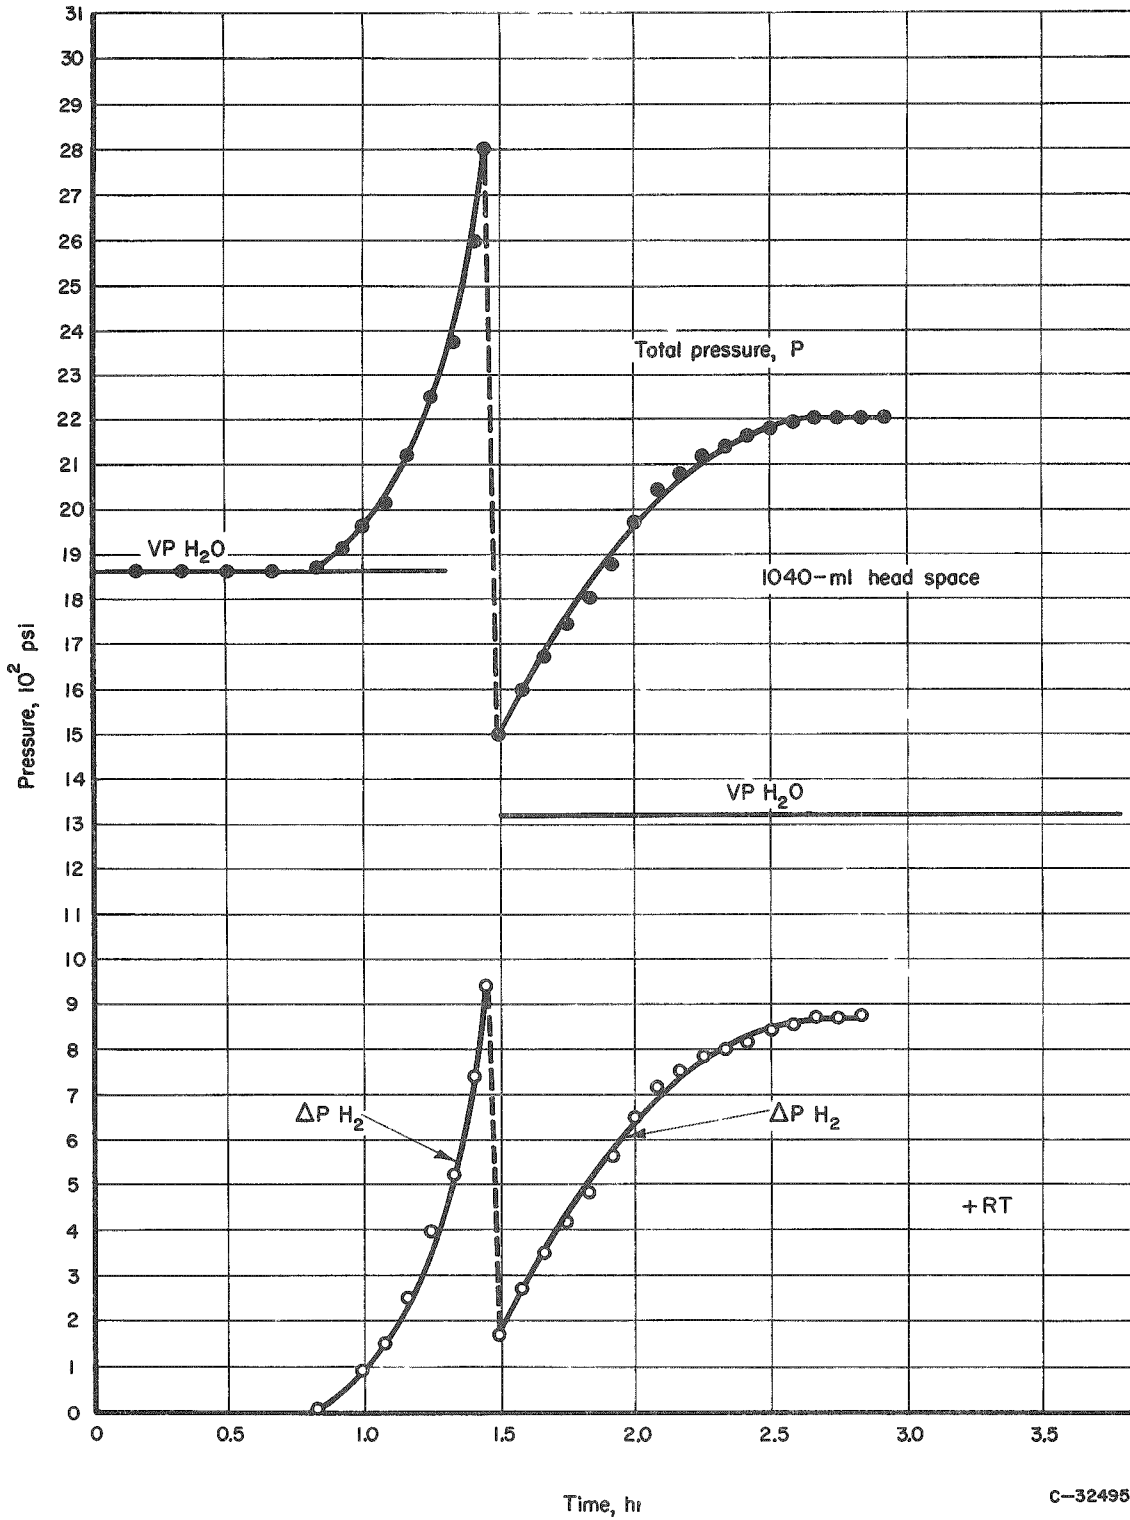
FIGURE 14. PRESSURE-TIME CURVES FOR EXPERIMENT 8

Temperature	300 C
Specimen	C-8
Head space	200 ml for first segment 1140 ml for last segment

The pressure-time records for the different experiments are plotted in Figures 8 through 17. Table 2 summarizes the data for each experiment. The curves show the total pressure of the system during the run and the pressure due to evolved hydrogen. The hydrogen pressure is the difference between the total pressure and the vapor pressure of the water for that particular experiment. The residual pressures also are given for the systems after the reactions were completed and the vessel had cooled to room temperature. The volume of the head space is shown so that reaction rates can be calculated. The intervals at which hydrogen was bled from the reaction vessel are indicated by the dotted lines in the curves.

The data in Figures 8 through 17 show that the reaction of the core material with the water accelerates rapidly following rupture of the cladding. Although corrosive action is taking place from the time the water covers the specimen, this is not evidenced by gas evolution. It is only after the cladding has ruptured and a considerable area of the core is exposed that the pressure begins to rise. A direct comparison of the different curves should not be made because of variations in head space, hydrogen solubility, temperature, and mode of cracking.

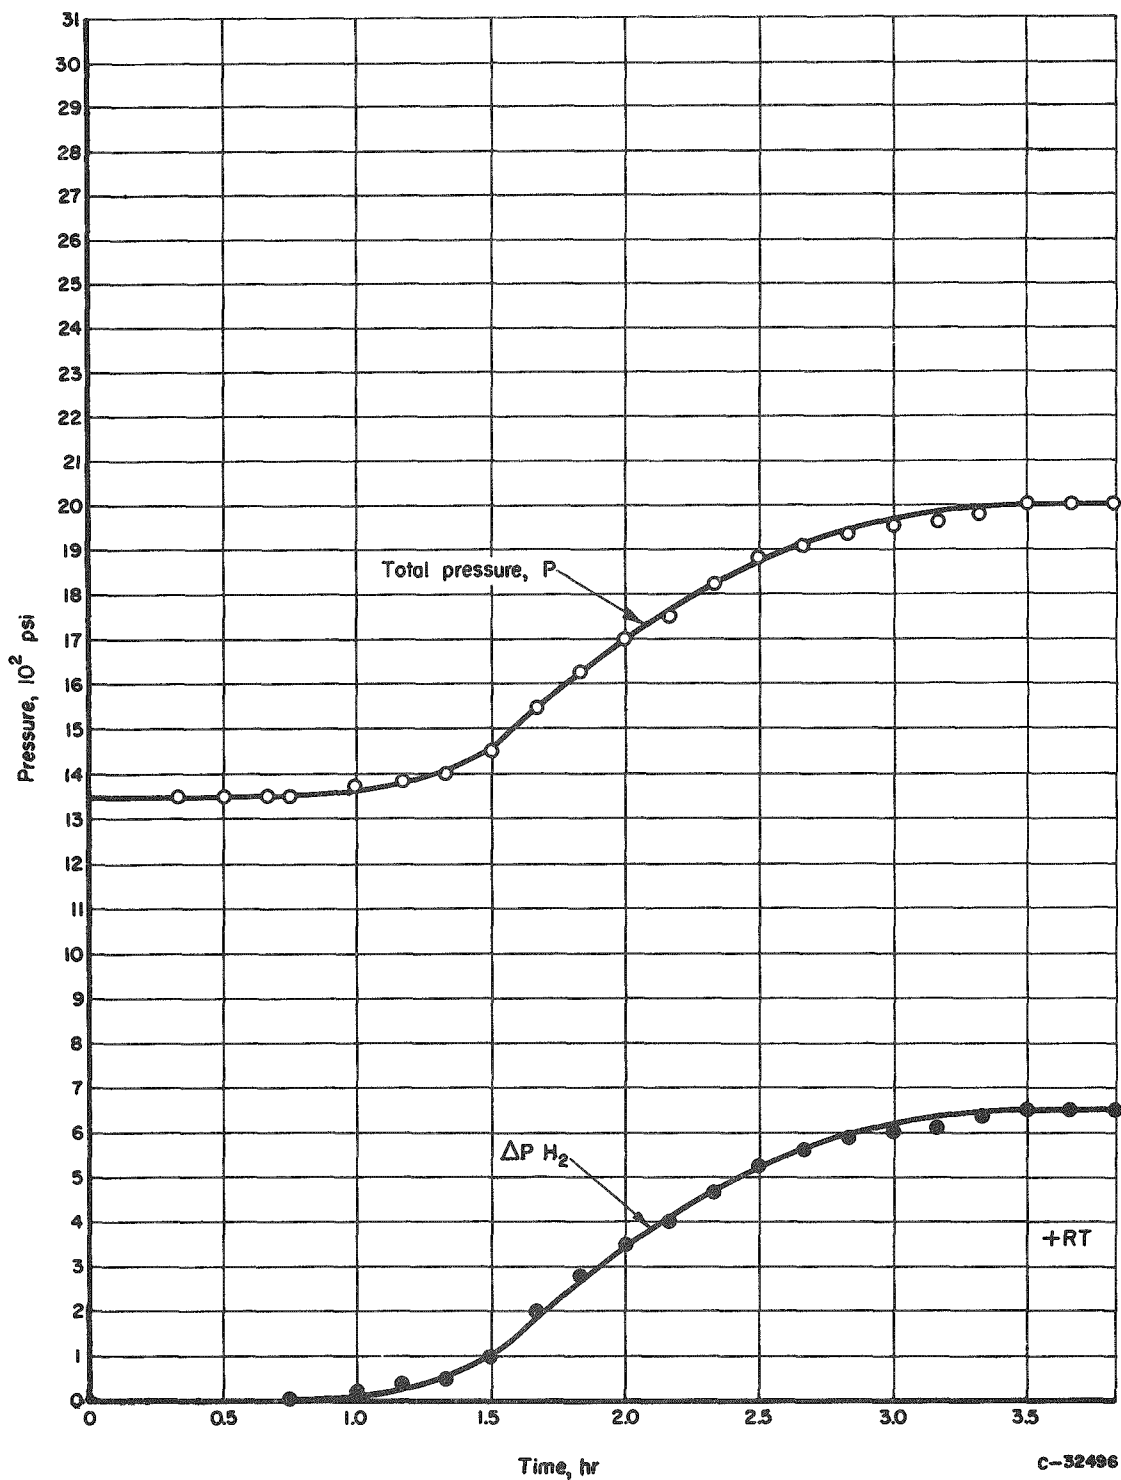
FIGURE 15. PRESSURE-TIME CURVES FOR EXPERIMENT 8B

Temperature	300 C
Specimen	C-9
Head space	1100 ml

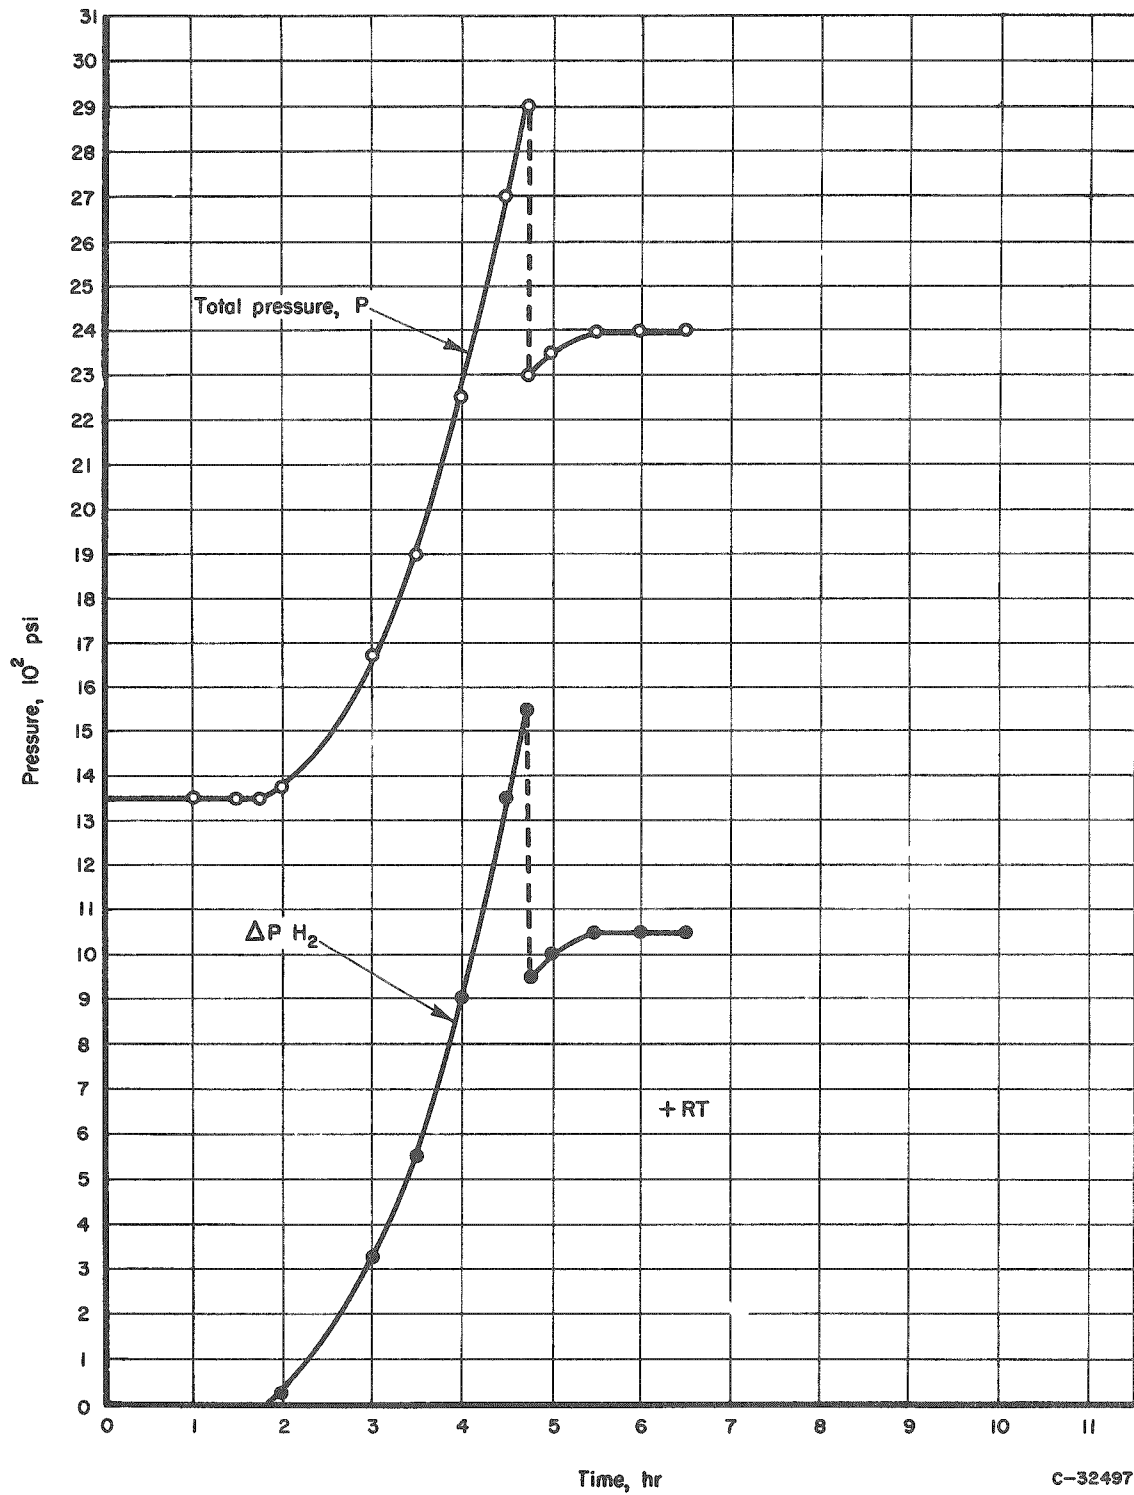
FIGURE 16. PRESSURE-TIME CURVES FOR EXPERIMENT 9

Temperature 300 C  
 Specimen Tubular  
 Head space 1200 ml  
 RT is the residual pressure at room temperature  
 after complete reaction.
