**Pacific Northwest
National Laboratory**

Bulk Vitrification Castable Refractory Block Protection Study

April 2005

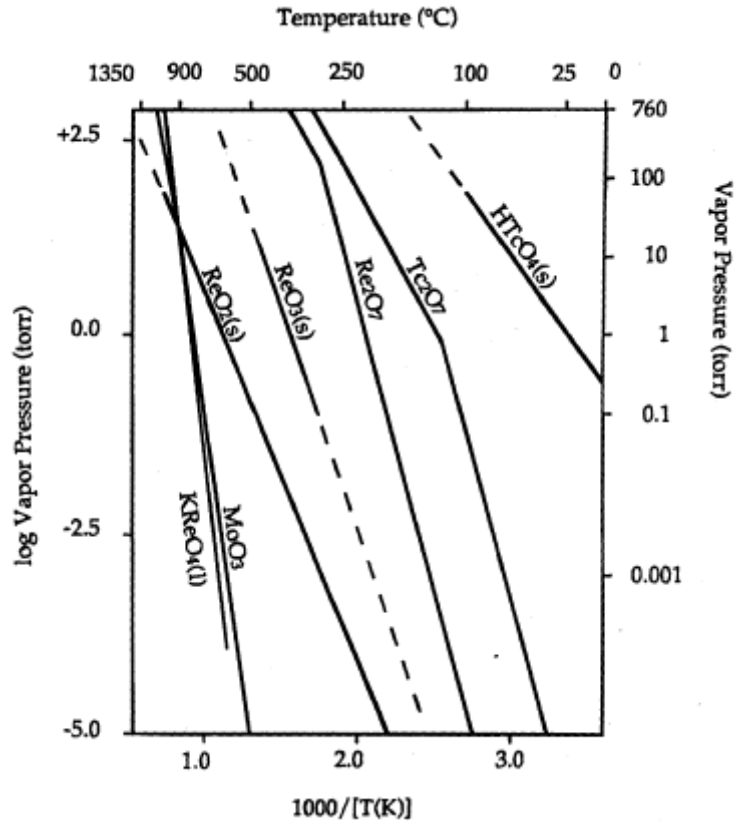
Figure 3.6. Vapor Pressure Versus Temperature for Tc and Re Compounds (Darab and Smith 1996)

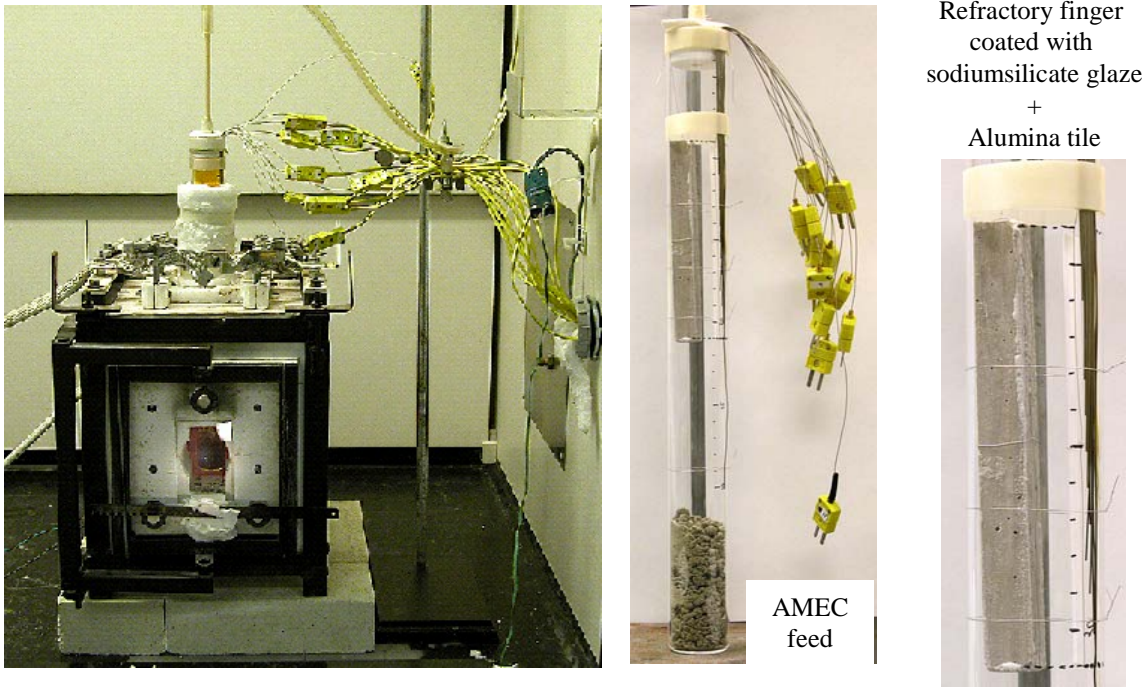
Figure 4.1. Test Assembly for Rhenium Evaporation-Condensation Study

The feed at the bottom of the tube was gradually heated up at a controlled rate of 5°C/min. The top portion of the tube could be visually observed to monitor the progress of condensation. Vapors condensed on the tube wall or on a rod of a refractory material suspended in the tube. The tube surface, or the suspended refractory rod, was then analyzed with optical microscopy and scanning electron microscopy-energy dispersive spectroscopy (SEM-EDS). In the case of a rod, both the exposed surface and a fracture surface perpendicular to the exposed surface were examined.

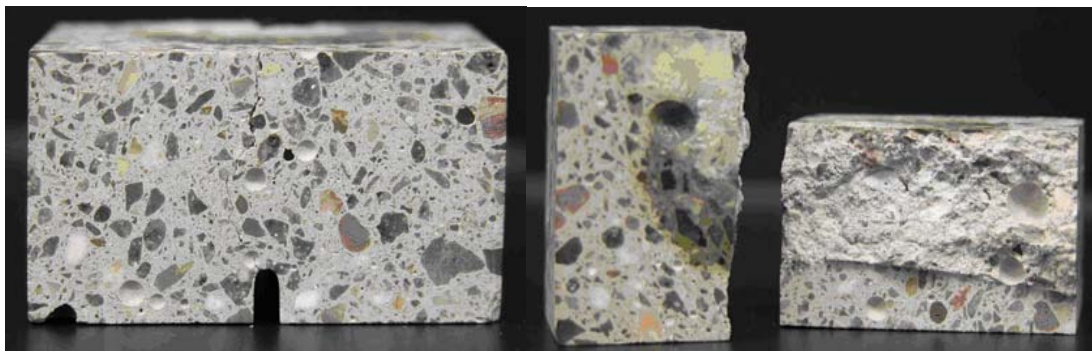
Figure 4.3. Refractory Coupon with a Groove at Bottom Surface (before and after fracturing)

A 100-g batch of simulated condensate was mixed as a dry powder and milled. An ~10-g portion of this powder simulant was spread on a refractory coupon (~25×25×20 mm) to cover a circle of ~16 mm in diameter (using a small alumina crucible). Coupons with simulated condensate were placed into a furnace at various temperatures for 30 min. The top surfaces of the samples were examined with optical microscopy. Samples were then fractured through the center of the circular simulated deposit (a groove was made on the bottom of the coupon before the experiment to facilitate the fracture location (see Figure 4.3), and examined to determine the depth of salt penetration.

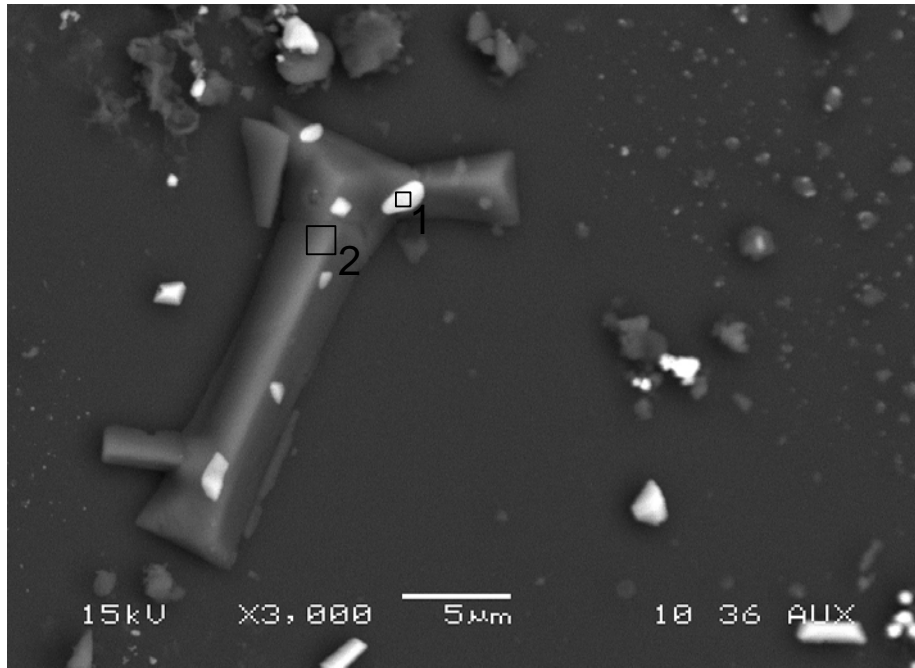
Figure 5.1. Grey NaCl Crystal (2) and White KReO₄ Deposits (1) on Fused Silica Glass Tube at 235°C (SEM micrograph, feed heated to 1000°C with 2-h hold)

Appendix A displays selected SEM and optical images of the deposits and compositions of individual phases. The main deposits detected on the fused silica-glass tube were NaCl and Na_2SO_4 ; NaNO_3 deposits were found when the feed was heated to 800°C. Rhenium-rich salt (KReO_4) appeared in SEM photomicrographs in samples taken from portions of the fused silica glass tube that were at temperatures below 530°C. The Re-rich salt was usually attached to larger deposits of NaCl (Figure 5.1), less often Na_2SO_4 (Figure 5.2) or NaNO_3 (Figure 5.3); Figure 5.4 shows a larger agglomeration of KReO_4 crystals. The amount of deposit on the tube wall increased with increasing feed test termination temperatures. Figure 5.5 displays the condensate composition on the fused silica-glass tube determined through EDS as a function of temperature. Note that Re is still present above 200°C but is not seen in the EDS analysis because it is at a lower relative concentration compared to the S and Na that are present in higher amounts at these higher temperatures.

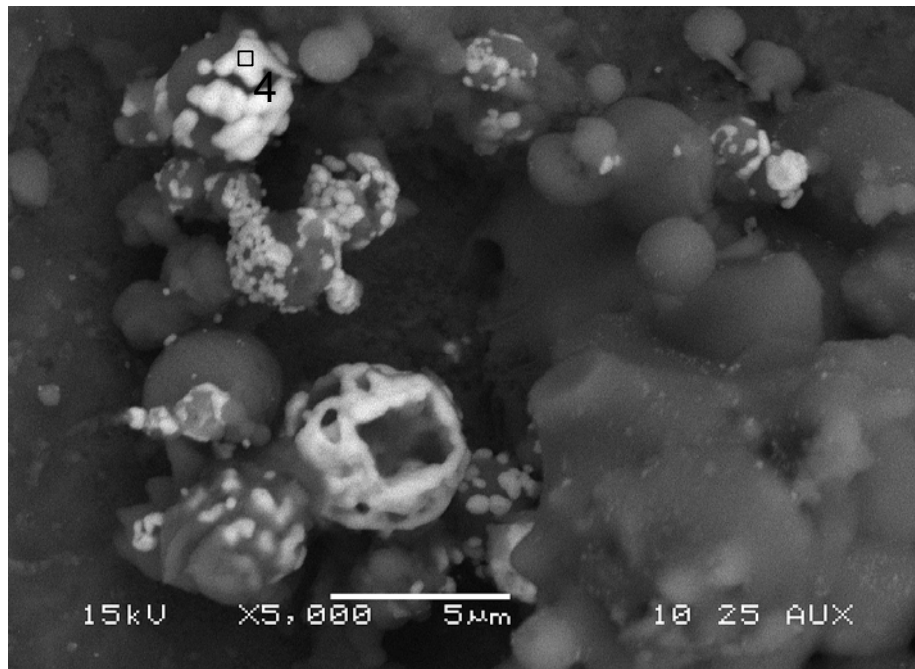
Figure 5.2. White KReO₄ Deposits (4) on Spherical Na₂SO₄ on Fused Silica Glass Tube at 423°C that Appears Corroded by Fluoride Vapors (SEM micrograph, feed heated to 1350°C with 2-h dwell)

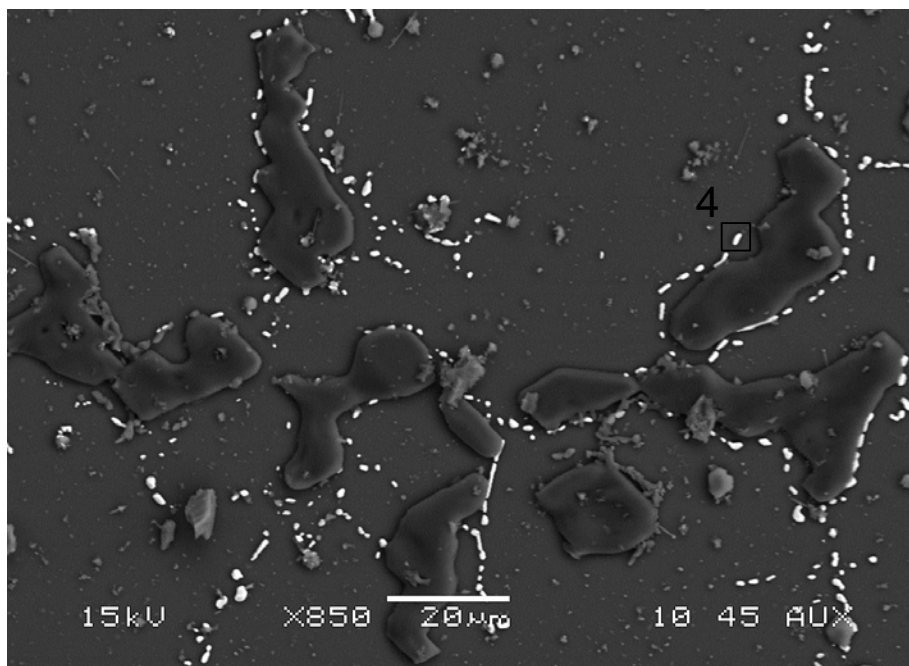
Figure 5.3. White KReO_4 Deposits (4) Around Patches of NaNO_3 on Fused Silica Glass Tube at 432°C (SEM micrograph, feed heated to 800°C with 2-h hold)

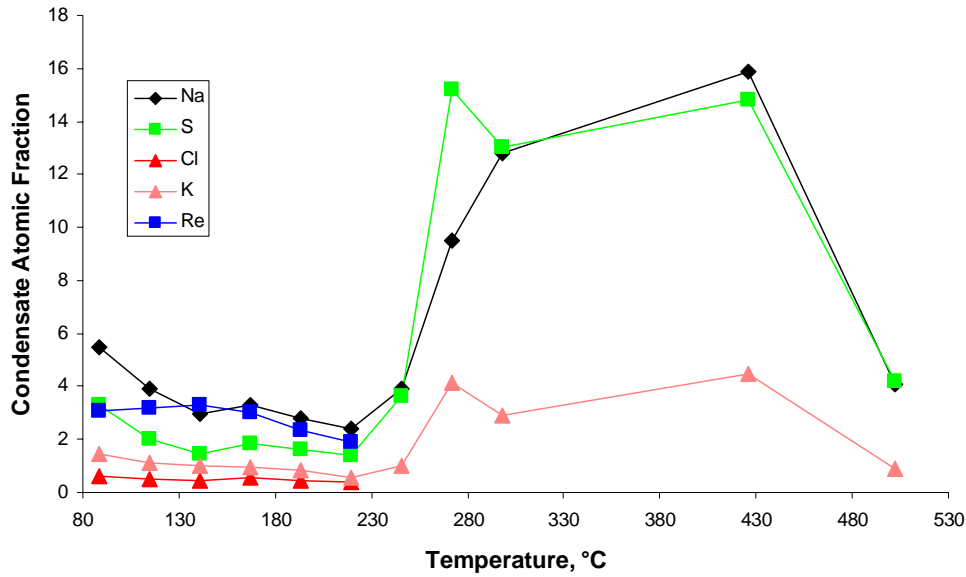
Figure 5.5. Concentration Distribution of Condensate in Fused Silica Glass Tube (feed heated to 1350°C with 2-h hold)

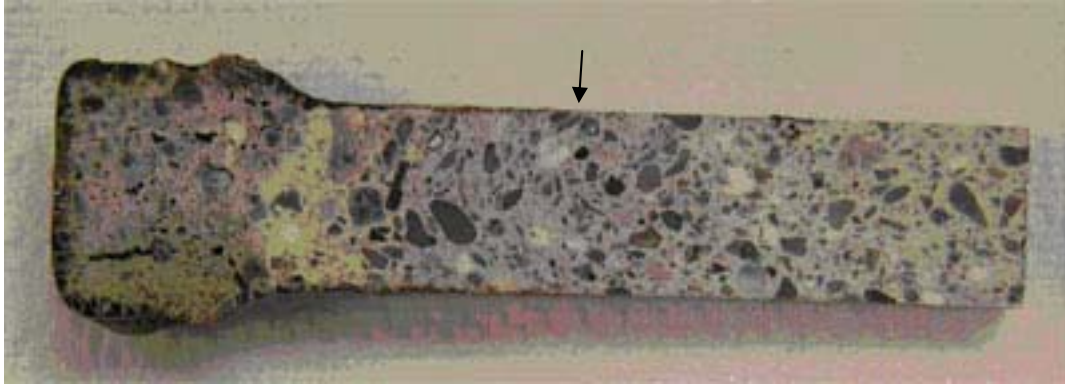
Figure 5.7. Longitudinal Cross-Section of a Partially Immersed Rod (1350°C; note the swelling of the immersed portion of rod; the arrow indicates the approximate position of the line to which the dynamic meniscus extended on the rod surface)

A rod heated up to 1350°C (Figure 5.7 and Figure 5.8, left) was severely corroded by the melt, exhibiting both material loss through dissolution and a substantial swelling caused by salt penetration and subsequent decomposition. The rod surface above the melt line and below the Pt lid was glazed by glass with islands of crystallized sulfate. Cross-sectioning revealed that the interior area below the melt line was turned almost entirely into sponge-like swollen refractory.

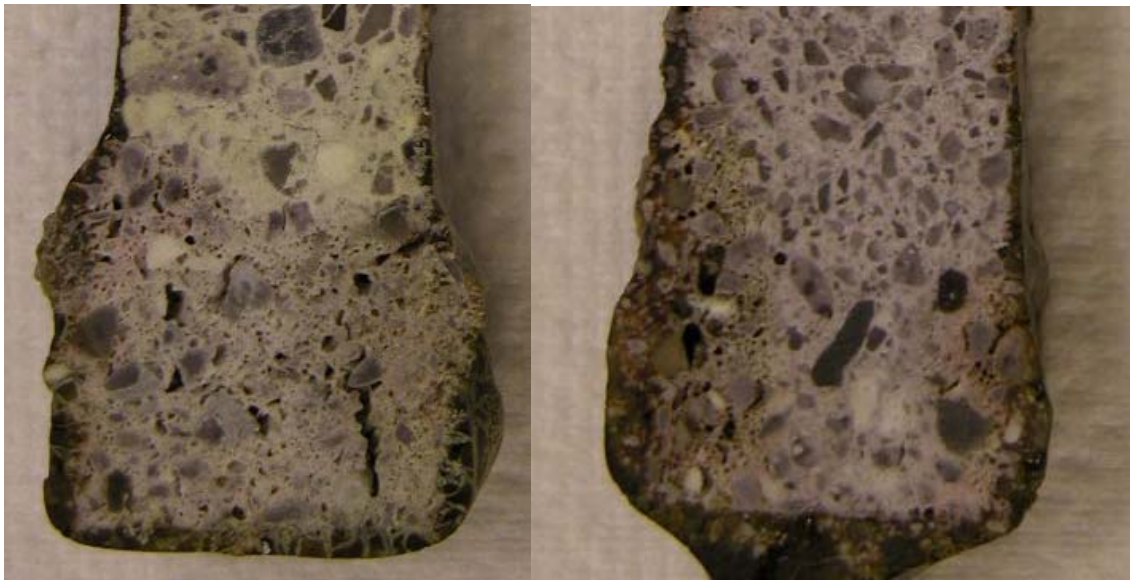
Figure 5.8. The Immersed Part of the Vibrocast Rods with Sulfate Enriched Feed (left, a detail of Figure 5.7), and with normal feed (right).

The experiment was repeated with the standard feed composition. The corrosion and swelling were still substantial, but less extensive than with the sulfate-enriched feed (Figure 5.8, right). As Figure 5.8 shows, excess sulfate increased the thickness of the refractory affected by the swelling, indicating that the sulfate melt penetration into the refractory continued even after the nitrates were decomposed; the penetration depth of sulfate increased with increasing sulfate fraction.

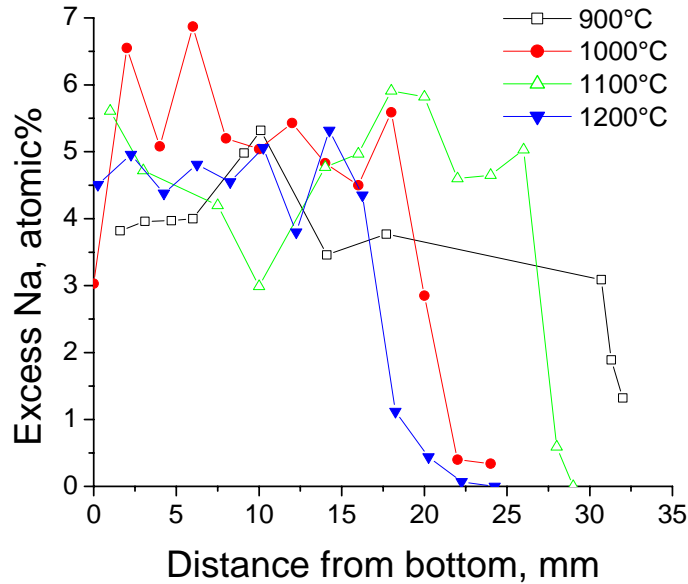
Figure 5.11. Excess of Na over Sulfate and Chloride in Immersed Refractory Rod Heat-Treated at Various Temperatures (2.4 cm from bottom)

Note a large excess of Na over the fractions of chloride and sulfate (Figure 5.11), indicating that the nitrate was initially the main component of the penetrating melt. The Na atomic fraction in the center of the rod (~10 mm from the surface) was 4–5 at% (Figure 5.9) and increased at the interface to 5–12 at% (Figure 5.10).

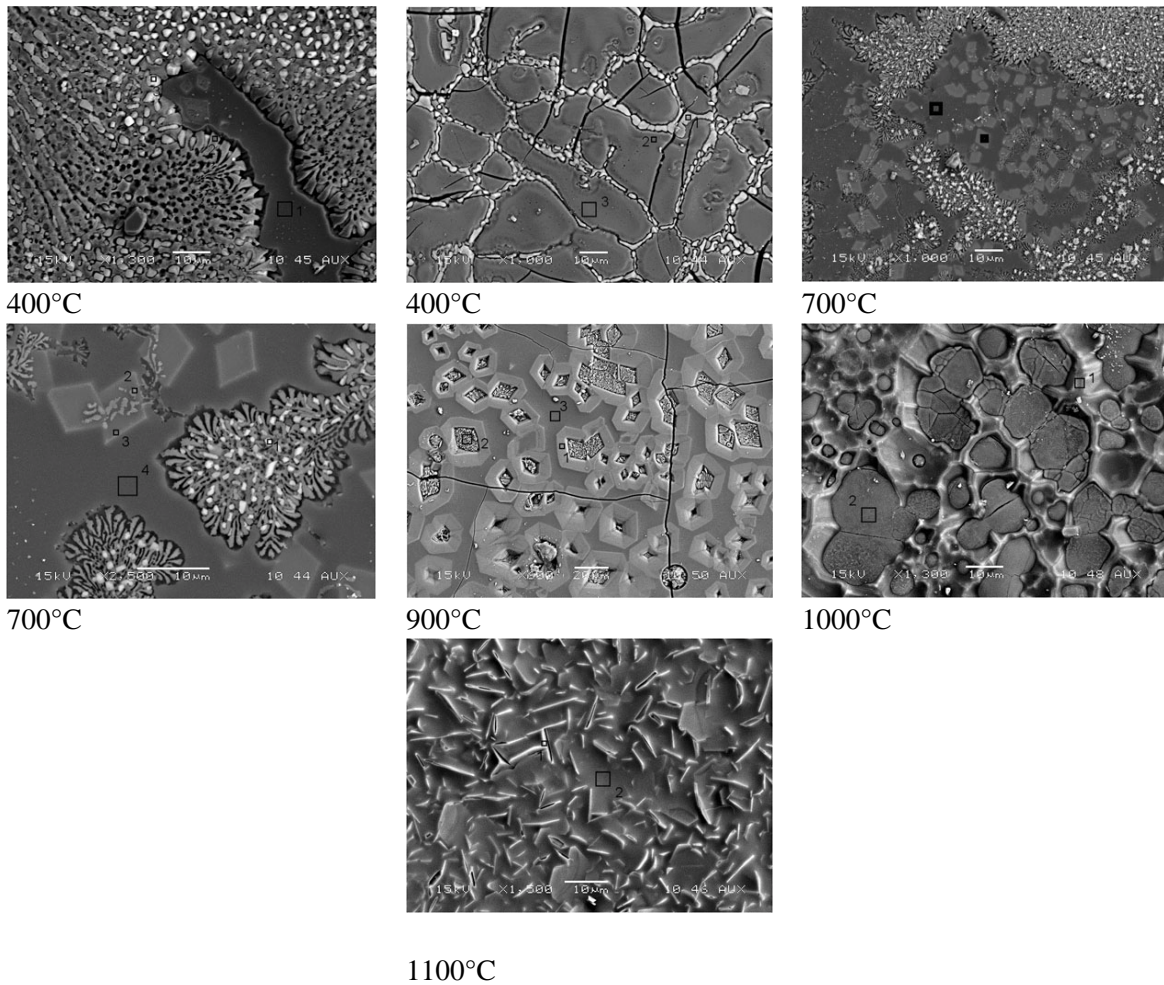
Figure 5.12. Surface Morphology of Vibrocast 60PC Treated with Condensate Simulant at Various Temperatures

Examination of fracture surfaces conducted with SEM-EDS (see Appendix B) showed that, starting from 700°C, the penetration depth of simulated condensate placed on coupons of untreated Vibrocast 60PC decreased as the temperature of isothermal heat-treatment increased. In the coupon heat-treated at 400°C, S, Cl, and F were detected up to 10 mm below the surface. In the coupon heat-treated at 700°C, salt containing S, Cl, and F was detected 15 mm below the surface. At 900°C, the penetration depth was only 7 mm, and only S and Cl were detected; F was most likely evaporated. At temperatures of 1000°C and 1100°C, no salts were found below the coupon surface. These results are summarized in Table 5.3. Electrofused AZS Unikor 501 exhibited a 1-mm penetration depth after heat-treatment with simulated condensate at 1000°C.

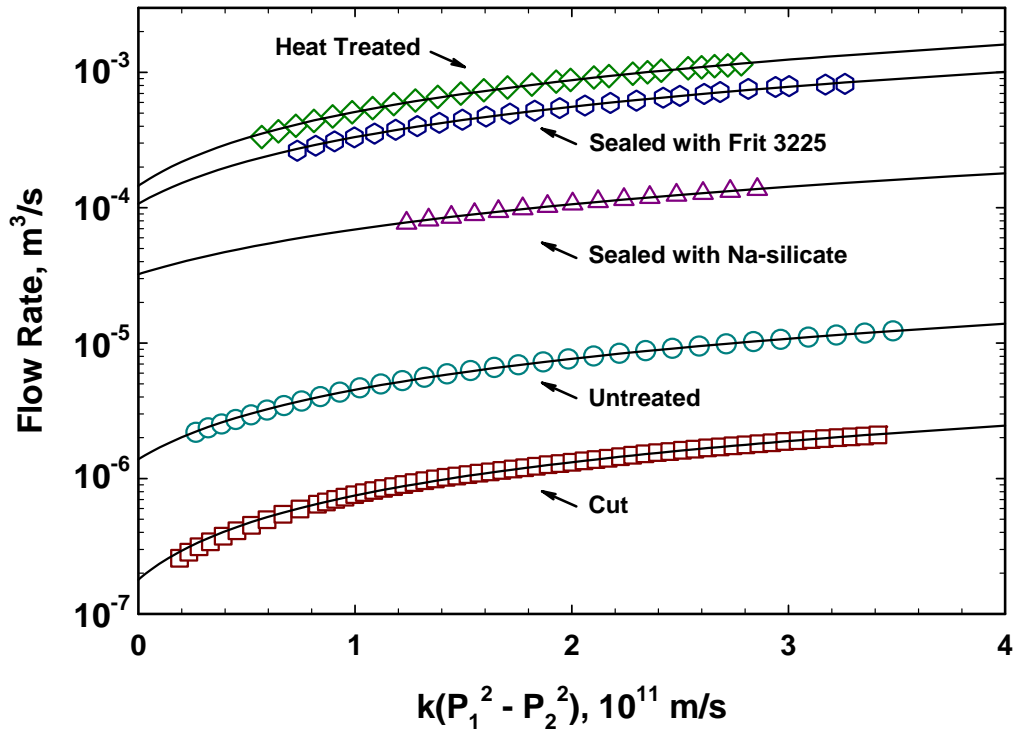
Figure 5.13. Results of Gas Permeability Measurement for Vibrocast 60PC [by Equation (3.1), $k = KA/(2\mu LP_2)$]

Figure 5.13 shows the results of gas permeability testing performed on several samples of the baseline Vibrocast 60PC refractory. The untreated sample was cut with a diamond saw on both sides and showed a lower flow rate than the untreated sample with one original cast surface. This difference is contrary to expectation but may have been caused by the presence of residual humidity in a sample that was cut on both ends (no attempt was made to repeat the measurement). The plot also shows that the flow rate through Vibrocast 60PC increased by nearly three orders of magnitude when the sample was heat-treated at 1050°C. The results of Vibrocast 60PC permeability measurements are summarized in Table 5.4; the last column shows the impact of treatment relative to the untreated material. The results of the glaze tests are discussed in a subsequent section.

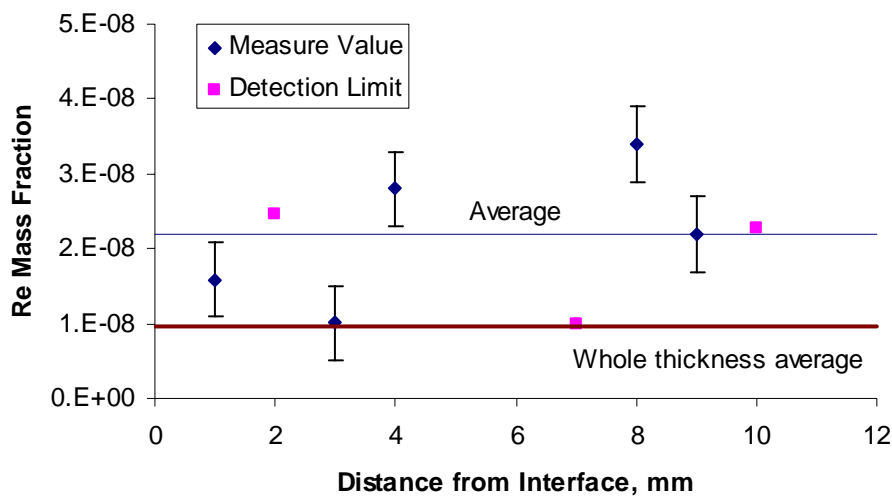
Figure 5.14. Concentration Distribution of Water Soluble Re (at 90°C) in the ES-31B Refractory Wall

The leached solids were analyzed to determine the amount of non-leachable Re that was present in the sample. The average mass fraction of Re in these samples was $(6.4 \pm 1.4) \times 10^{-7}$. The samples contained residual solution, the content of which was not measured before drying. To estimate its content, a CRB piece was crushed and mixed with water that was subsequently removed in the same fashion as from the original samples. The water mass fraction, determined on eleven ~ 1 -g samples, was 0.282 ± 0.021 . The Re mass fraction in the leachate from the original samples was $(7.9 \pm 2.7) \times 10^{-9}$; this is $\sim 1\%$ of Re in the analyzed solid CRB. Thus, the mass fraction of insoluble Re in this portion of the CRB was $\sim 6.4 \times 10^{-7}$, i.e., 96% of total Re (see Figure 5.15, where the results are plotted on a logarithmic scale).

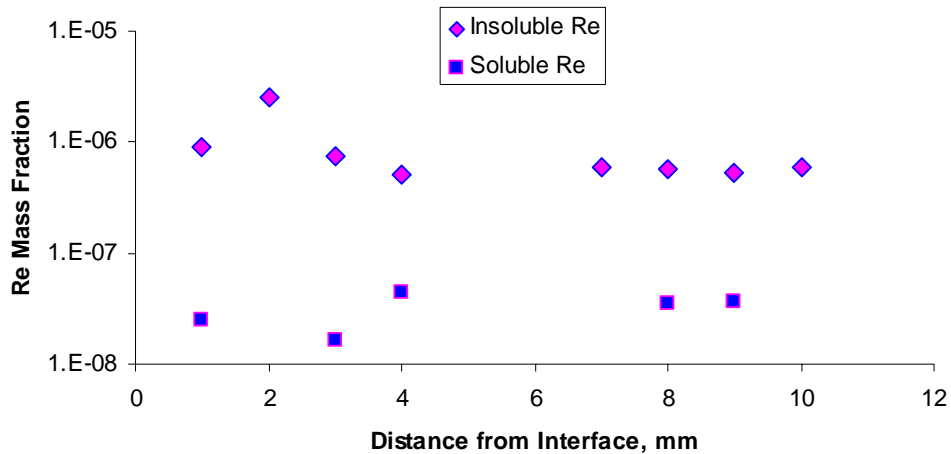
Figure 5.15. Concentration Distribution of Re (leachable and non-leachable) in the ES-31B Refractory Wall

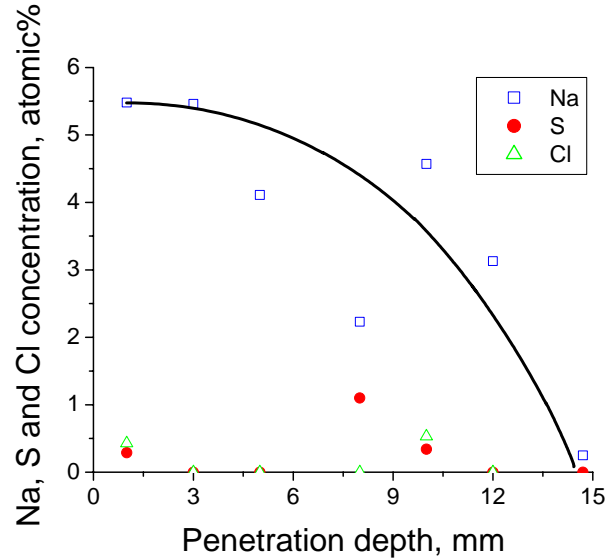
Figure 5.16. Atomic Fractions of Na, S, and Cl in CRB (in ES-31B Test) as Functions of Distance from the Interface with Molten Glass

Alternatively, we can estimate that the SIM present in the first 10 mm of the sample was 7 mass%. This estimation takes the mass fraction of 6.6×10^{-7} Re in the CRB as the starting point, uses the Re/Na mass ratio in MIS from above (3.3×10^{-5}), and assumes that the Na mass fraction in MIS is 30% (a value slightly higher than the 27.5 mass% of Na in the dry simulant because of the release of all crystalline water and organic carbon). Compare this result with the case of the reverse calculation in Section 2.4 (there we took 5 mass% of LAW in the CRB and obtained for the Re mass fraction the value of 5.5×10^{-7} (0.55 ppm)). These calculations show that the measured Re content in the CRB, though based on very limited data from a single sample, agrees reasonably well with the estimate based on the mass balance.

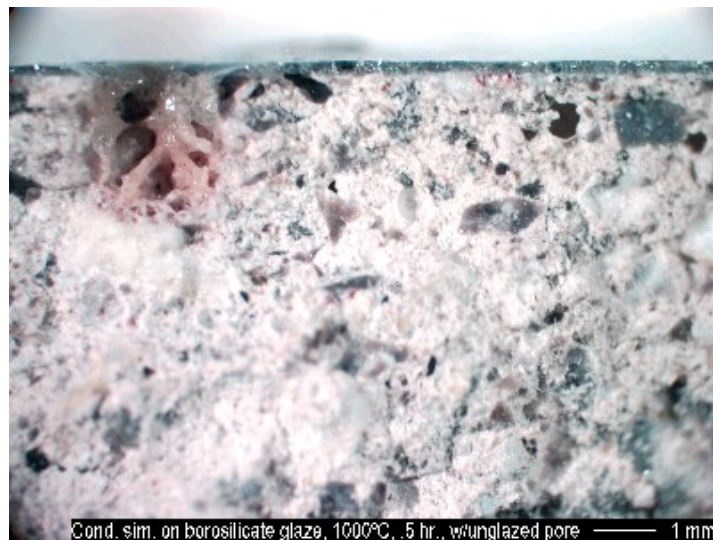
Figure 6.3. Vibrocast 60PC Coated with Borosilicate Glaze and Heat-Treated with Simulated Condensate at 1000°C for 5 hours. The glassy glaze coating is apparent at the top right hand side of the photograph. Large pores like those shown in the left center portion of the photograph are not expected in the manufactured surface of the block.

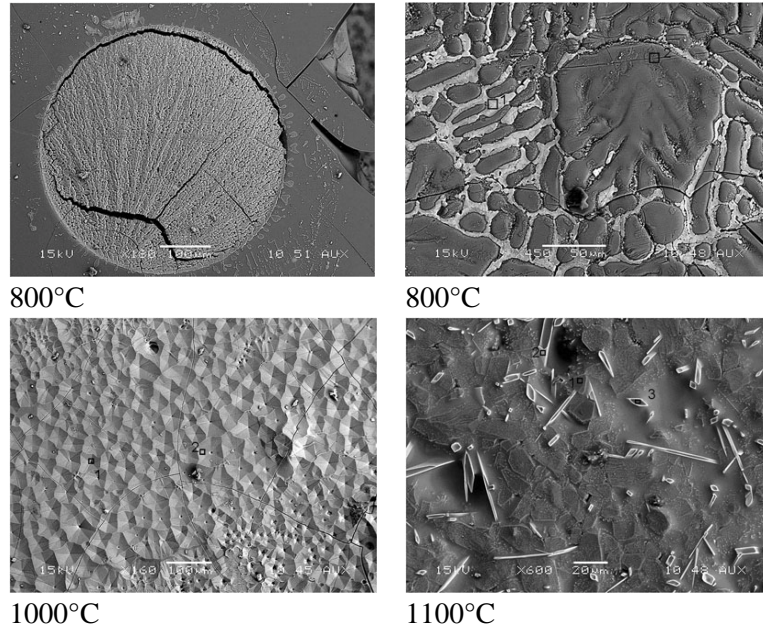
Figure 6.4. Surface Morphology of Vibrocast 60PC Coated with Sodium Silicate Glaze and Treated with Condensate Simulant at Various Temperatures

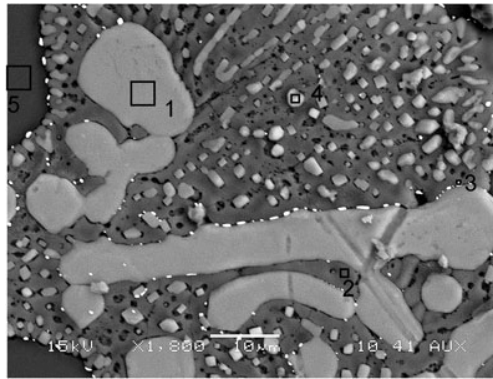
Figure 6.5. Surface Morphology of Vibrocast 60PC Coated with Borosilicate Glaze and Treated with Condensate Simulant at 800°C

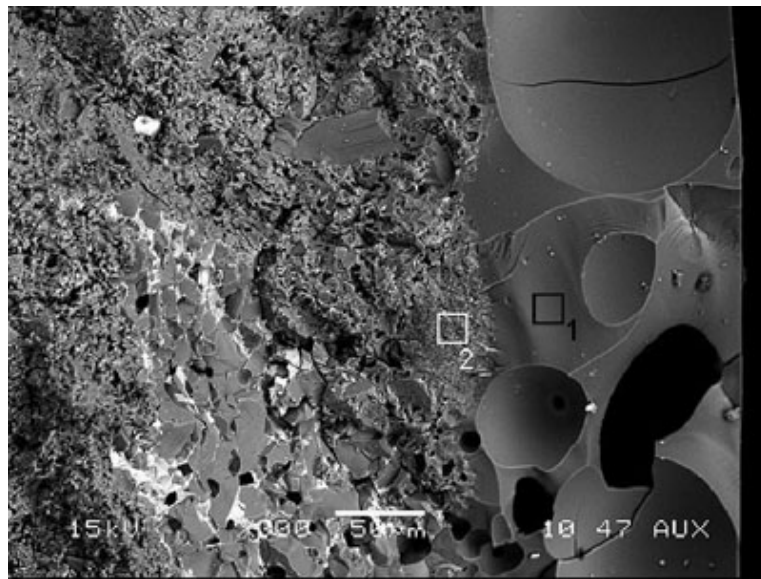
Figure 6.6. Vibrocast 60PC Coated with Sodium Silicate Glaze and Treated with Simulated Condensate at 800°C

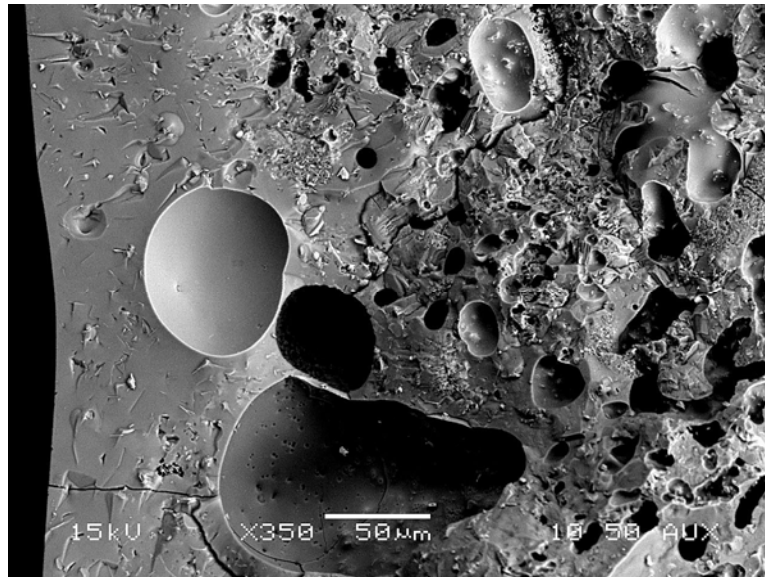
Figure 6.7. Vibrocast 60PC Coated with Sodium Silicate Glaze and Treated with Simulated Condensate at 1100°C (there is no distinct interface between glaze, salts, and the refractory)

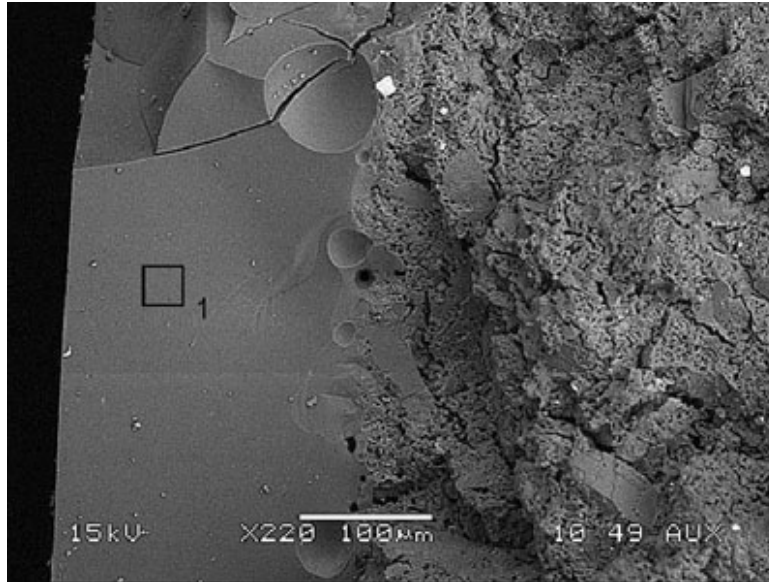
Figure 6.8. Vibrocast 60PC Coated with Borosilicate Glaze and Treated with Simulated Condensate at 800°C (note the sharp interface between glaze and the refractory; the glaze protects medium-sized pores and does not penetrate into small pores)

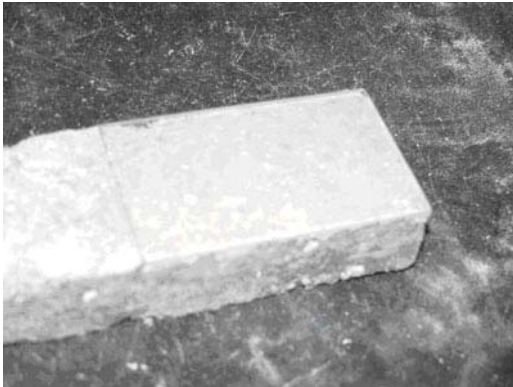
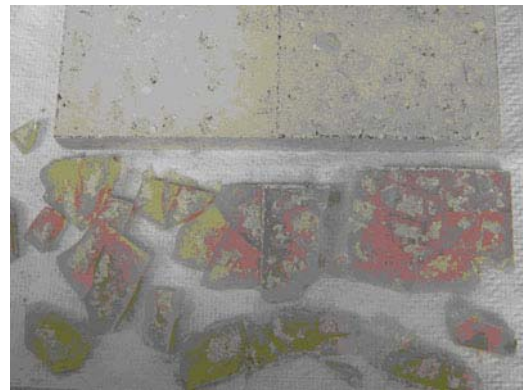
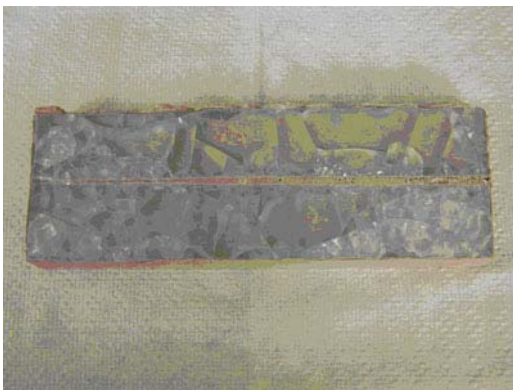
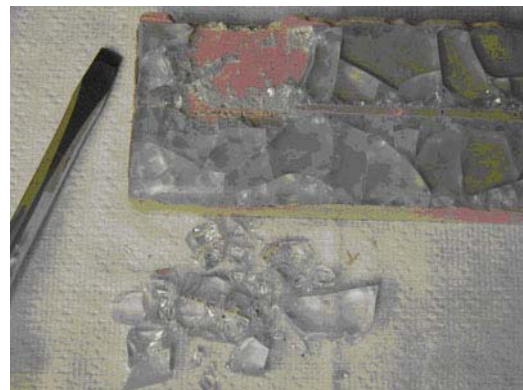
Figure 7.1. Tiles on Vibrocast 60PC as Cast (left) and after Firing to 1000°C (right)

As shown in Table 7.1, bonding to the Vibrocast 60 PC CRB is one of the criteria used to judge the usefulness of tiles for the BV technology. The manufacturing demonstration testing was used as the first gate in the screening process for the candidate tiles. Figure 7.1 shows the results of testing. Only two materials, greystone and AZS, remained intact and well bonded after firing to 1000°C at 5°C/min.

All other tiles failed after firing to 1000°C at 5°C/min:

- The alumina silicate tile spalled off and showed very few signs of adhesion.
- The glass ceramic tile spalled off and showed only a slight sign of adhesion.
- The pyroceram tile spalled off and showed very little, if any, signs of adhesion.
- The alumina tile was visibly separated around the edges from the castable. Minimal manual force separated the alumina tile from the castable.
- The monofrax tile was separated around the perimeter and could be removed with a small manual force.
- The neoceram tile showed serious cracking and slight adherence of some portions of tile while some had spalled off. The shards were easily removed by hand.
- The plate glass cracked and slumped; it showed fairly good adherence to the castable, yet could be easily removed with a screwdriver and a small applied force.

All attempts to separate the greystone tile from the castable failed; the bonding between the greystone tile and castable was as strong as the materials themselves. A significant arching of the greystone tile on the castable upon heating to 1000°C resulted from a large thermal expansion mismatch (Figure 7.2) between greystone and the CRB. The tile expanded by 2.67% on heating to 1000°C (by ~2% between 600°C and

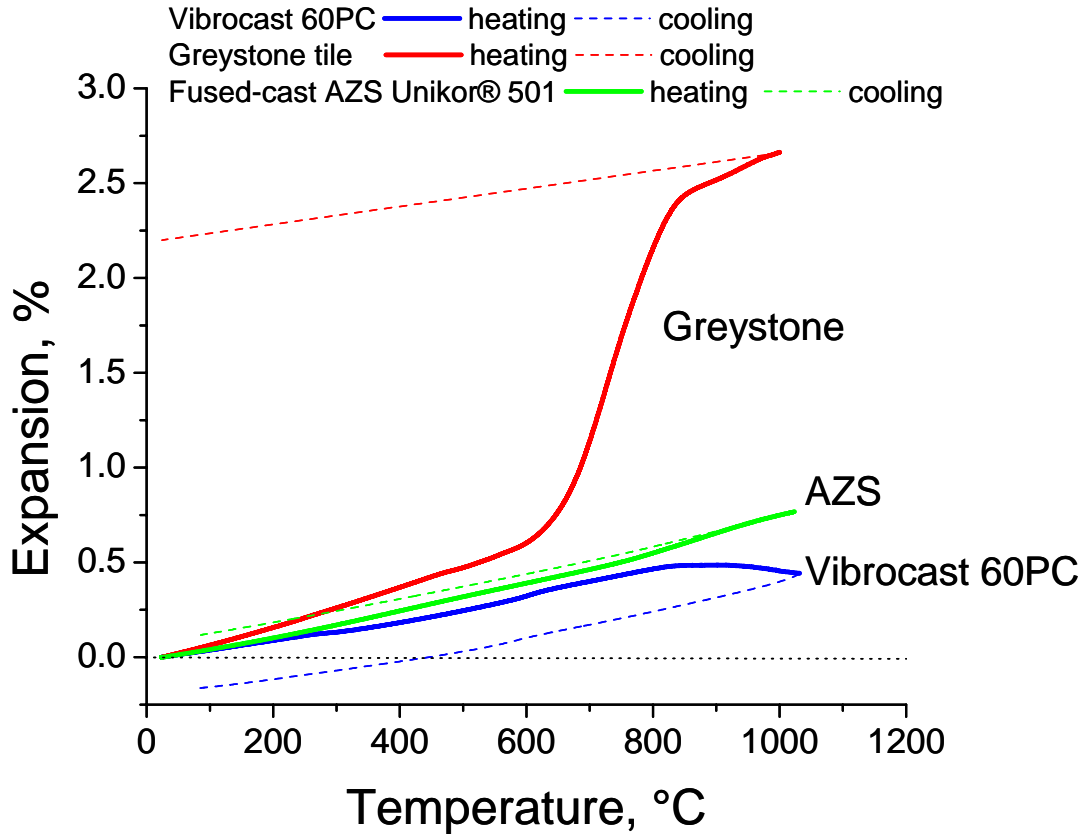
Figure 7.2. Thermal Expansion of Greystone Tile, AZS, and Vibrocast 60PC Specimen (specimens heated and cooled down at 2°C/min)

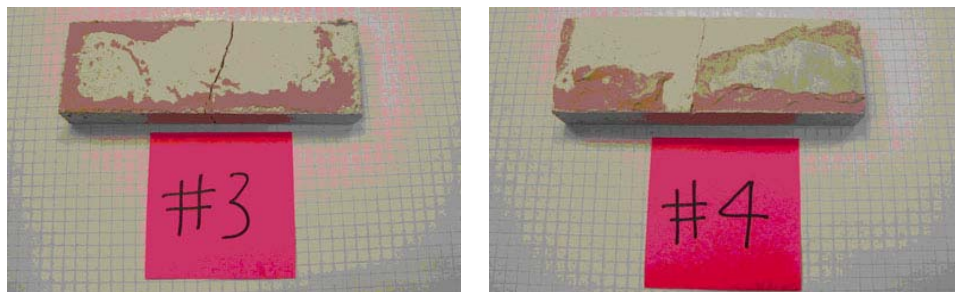
Figure 7.4. Greystone Tile Bonded to CRB after Ramp Heating to 1200°C, Holding for 8 hours, and Attempting to Remove the Tile with Hammer and Chisel (tiles were prefired 800°C, #3 was for 8 hours and #4 for 1 hour)

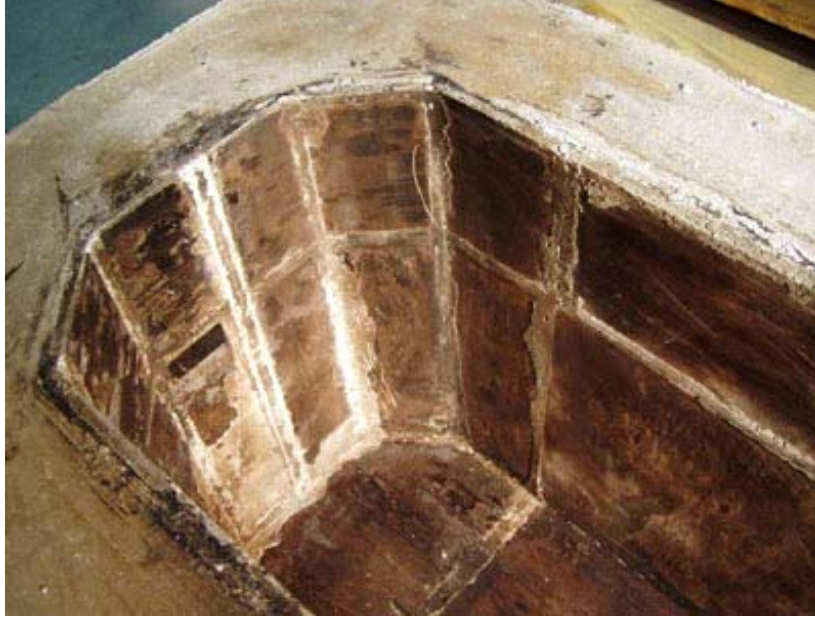
Figure 7.5. Greystone Tile Preparation (tiles were heated in air to 860°C to reduce thermal expansion mismatch and were applied to mold with open joints to allow for expansion)

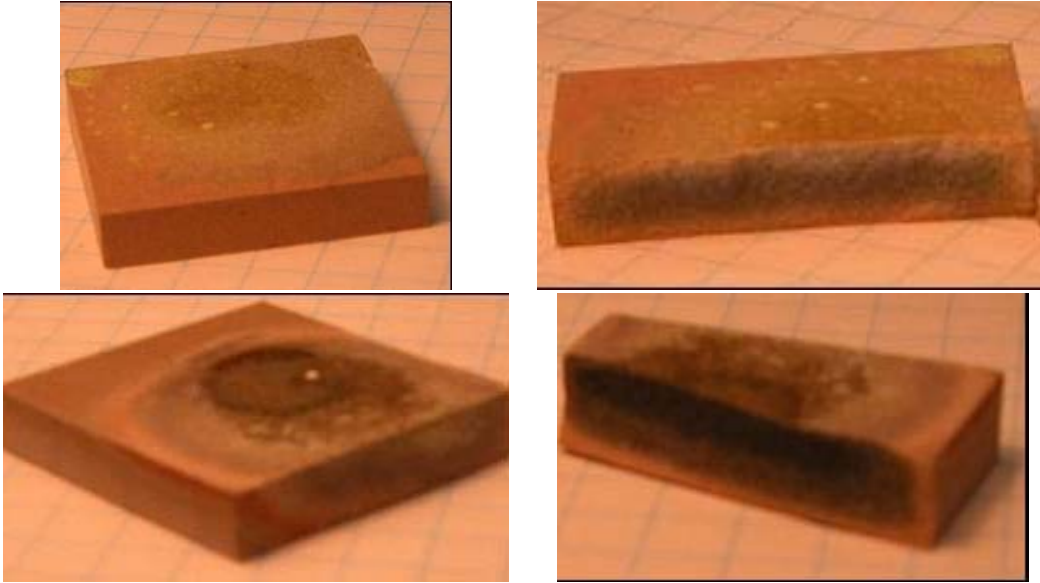
Figure 7.6. Prefired (top) and Unfired (bottom) Greystone Tiles Heat-Treated with Simulated Condensate at 1000°C

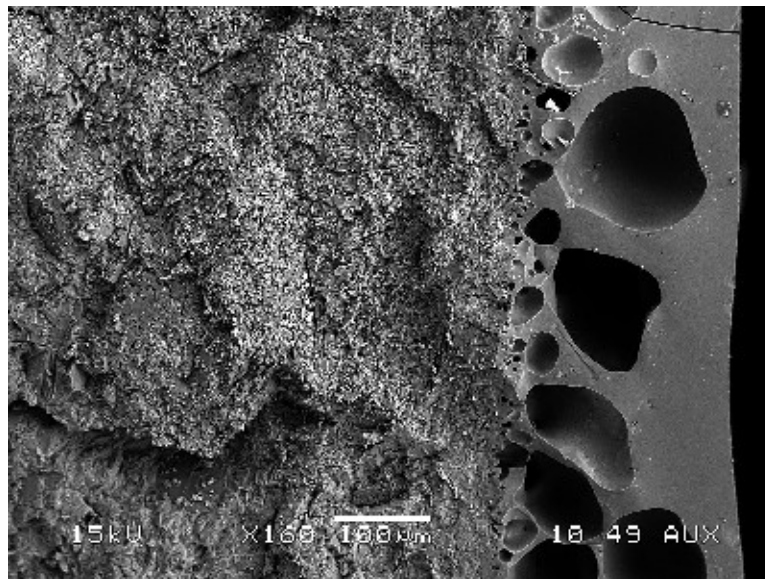
Figure 7.7. Simulated Condensate on Unfired Greystone Tile Heated at 1000°C

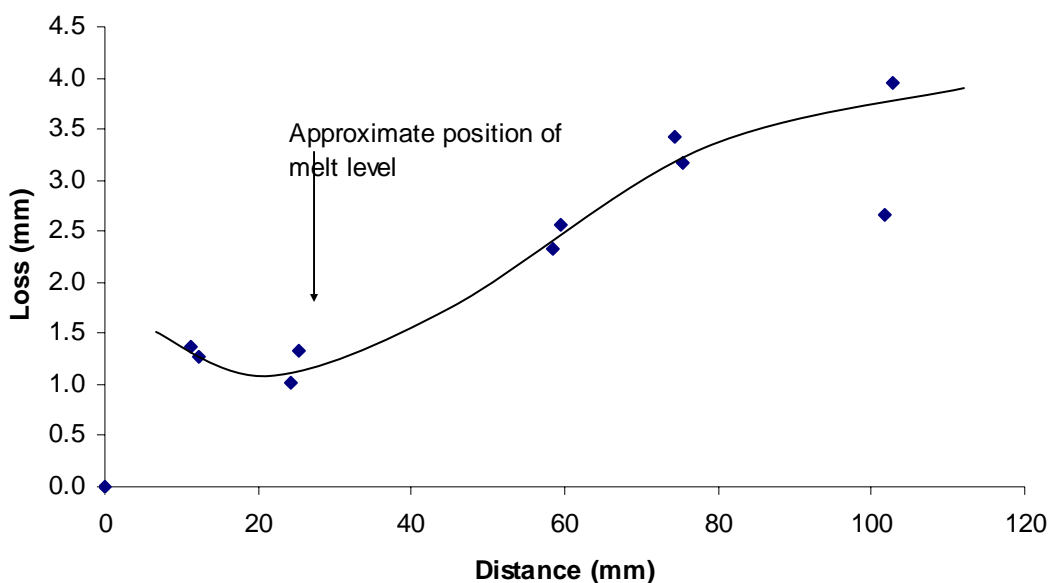
Figure 7.9. Linear Loss of Greystone Tile During 22-h Exposure to Melt at 1350°C as a Function of Distance Measured from the Top of the Tile Downward. Starting Thickness of the Tile Was 6.425 mm.

This test was performed on greystone tile only since the corrosion resistance of the other refractories had been previously established. A strip of greystone tile with a thickness of 6.425 mm was placed in a Pt crucible with pieces of glass, heated at a rate of 10°C/min to 1350°C, and held for 22 hours. The glass used in the corrosion test was collected from a previous ES test and had been pre-melted to 1360°C to remove any gases and prevent reboil during the corrosion test. After the 22-hour corrosion heat-treatment, the strip was removed and sectioned, and its profile was measured with a caliper. For each cut, the width was measured in four or five places to obtain an average corrosion depth. See Appendix D for additional methods of corrosion testing than were used for the CRB.

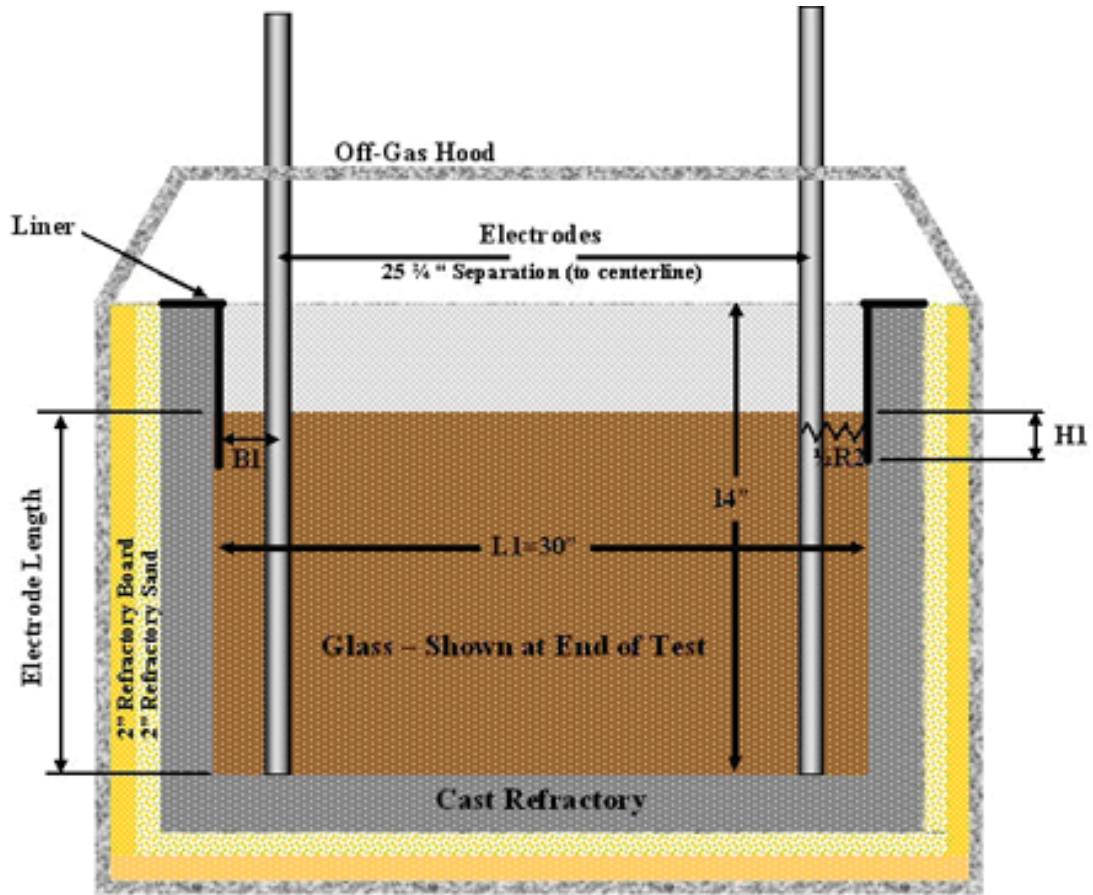
Figure 8.2. Elevation View of ICV™ with Resistor Schematic

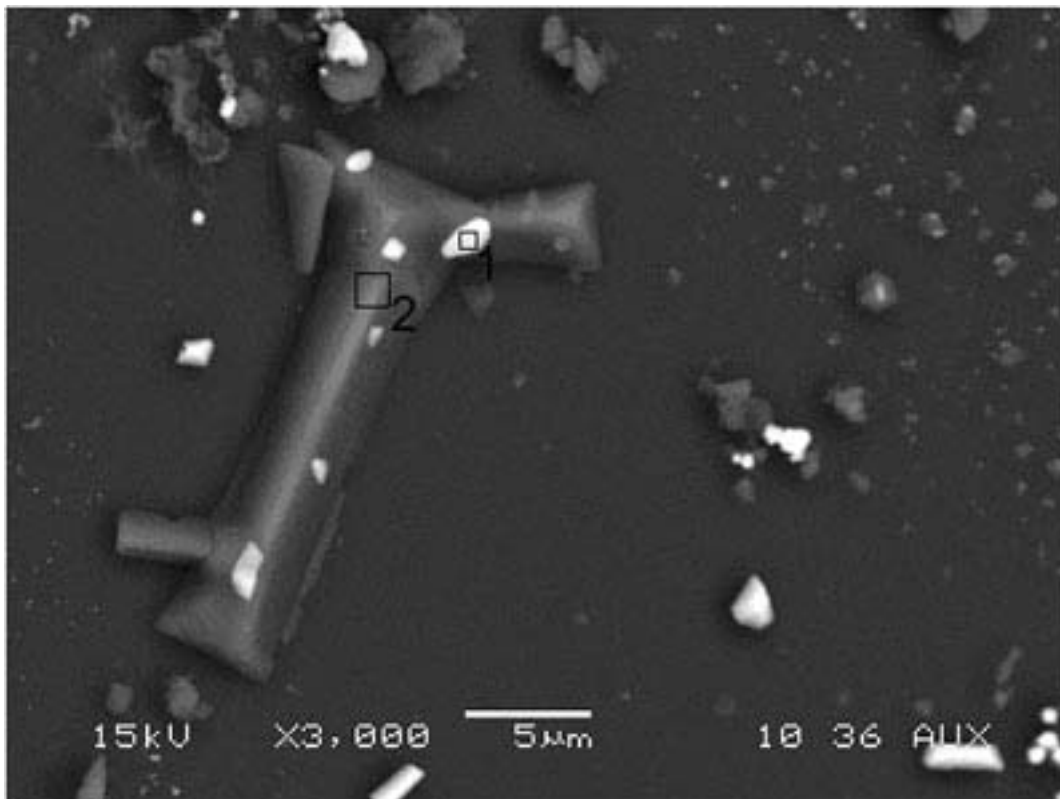
Figure A.4. SEM Micrograph of Condensate Deposit on Fused Silica Glass Wall Tube at 235°C (AMEC feed heat-treated at 5°C/min and held at 1000°C for 2 hours)

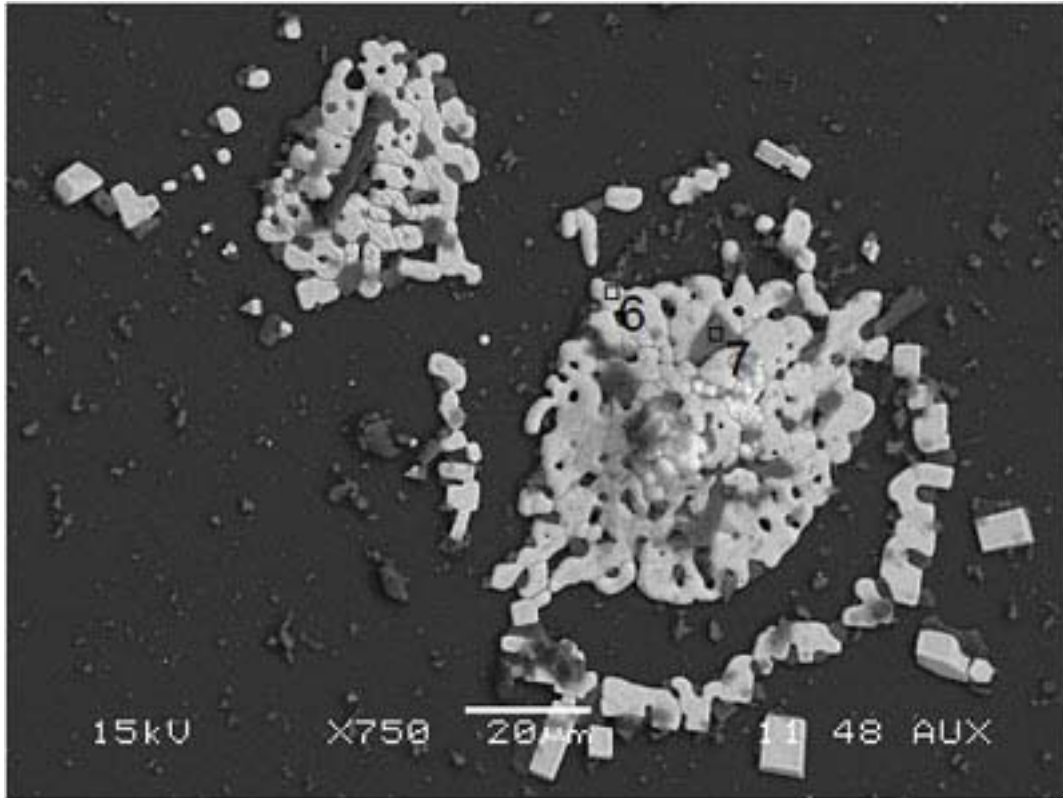
Figure A.7. SEM Micrograph of Condensate Deposit on Fused Silica Glass Wall Tube at 467°C (AMEC feed heat-treated at 5°C/min and held at 1000°C for 2 hours)

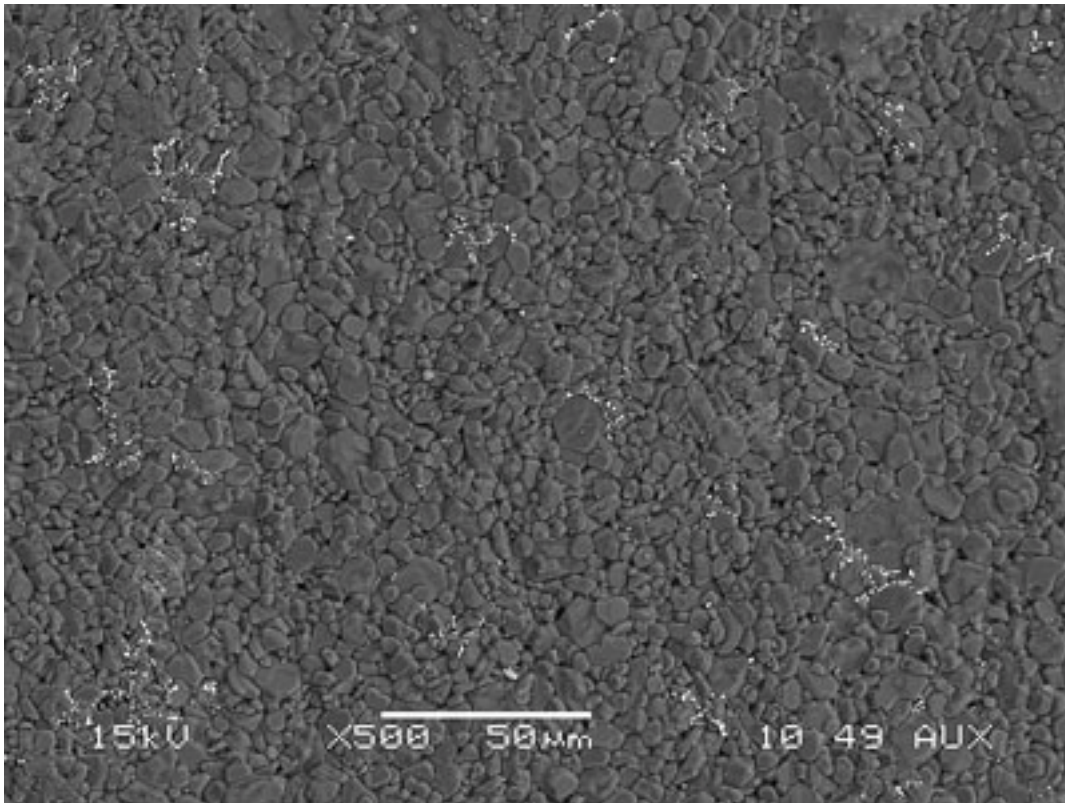
Figure A.10. SEM Micrograph of Condensate Deposit on Alumina Tile Surface at 329°C (AMEC feed heat-treated at 5°C/min and held at 1000°C for 2 hours)
