**Pacific Northwest
National Laboratory**

Bulk Vitrification Castable Refractory Block Protection Study

April 2005

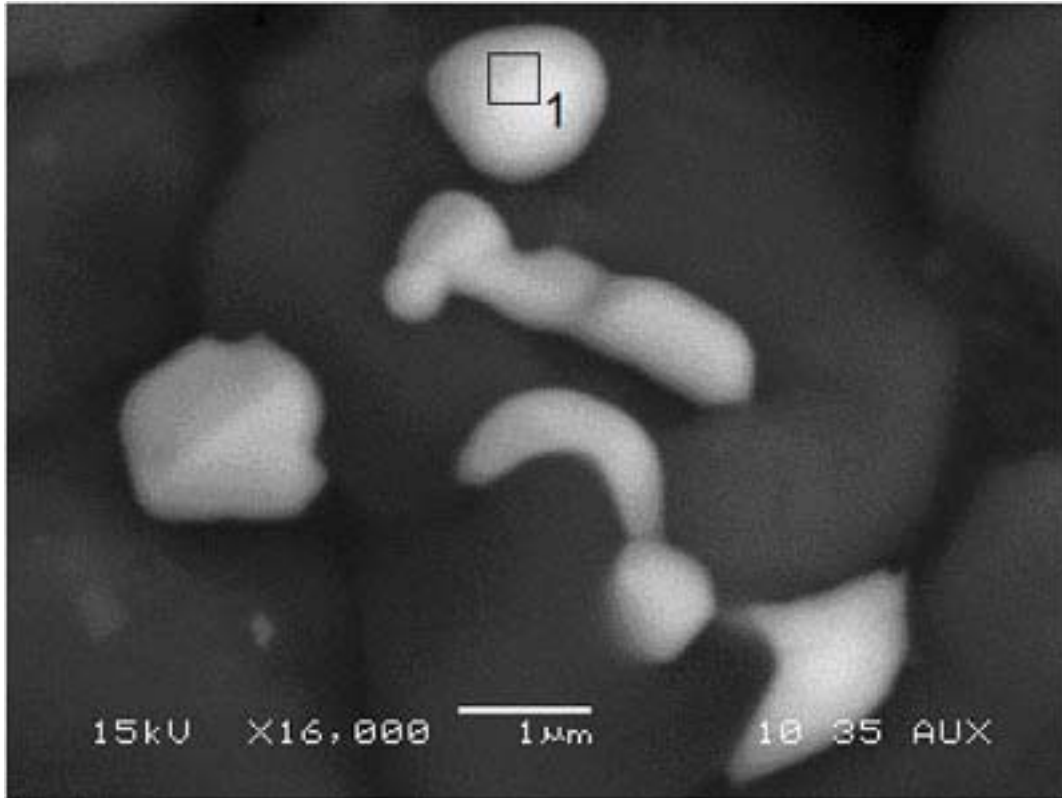
Figure A.11. SEM Micrograph of Condensate Deposit on Alumina Tile Surface at 354°C (AMEC feed heat-treated at 5°C/min and held at 1000°C for 2 hours)

Element	1
	Atomic%
O	39.43
Al	26.63
K	12.30
Re	21.64

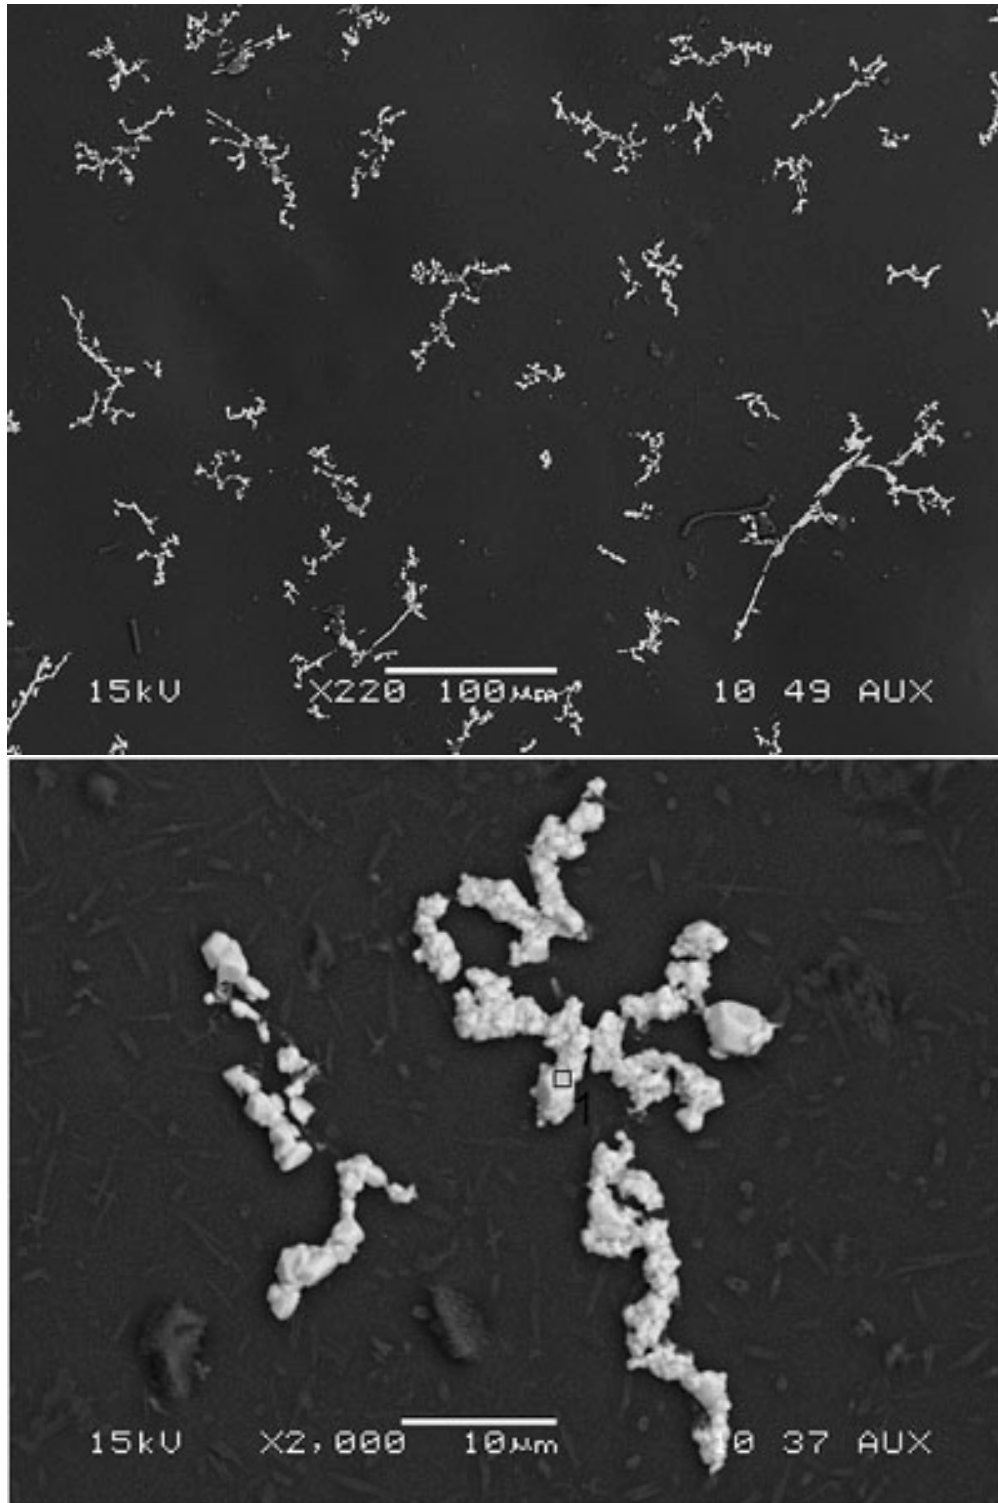
Figure A.12. SEM Micrograph of Condensate Deposit on Borosilicate Glaze Surface at 523°C (AMEC feed heat-treated at 5°C/min and held at 1000°C for 2 hours)

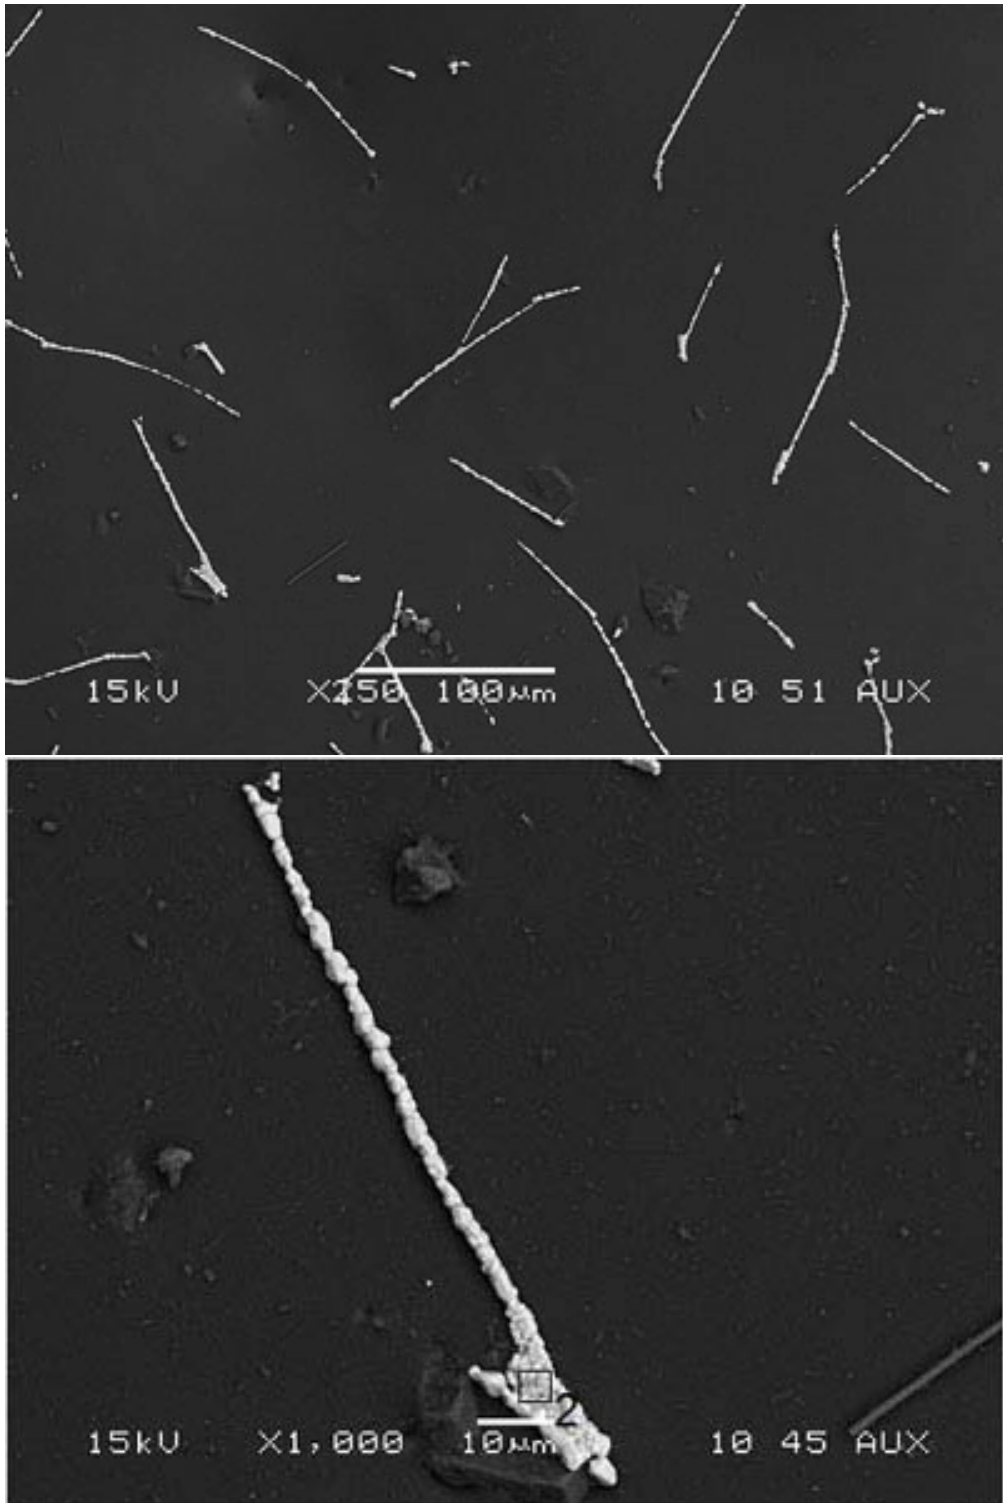
Figure A.13. SEM Micrograph of Condensate Deposit on Borosilicate Glaze Surface at 523°C (AMEC feed heat-treated at 5°C/min and held at 1000°C for 2 hours)

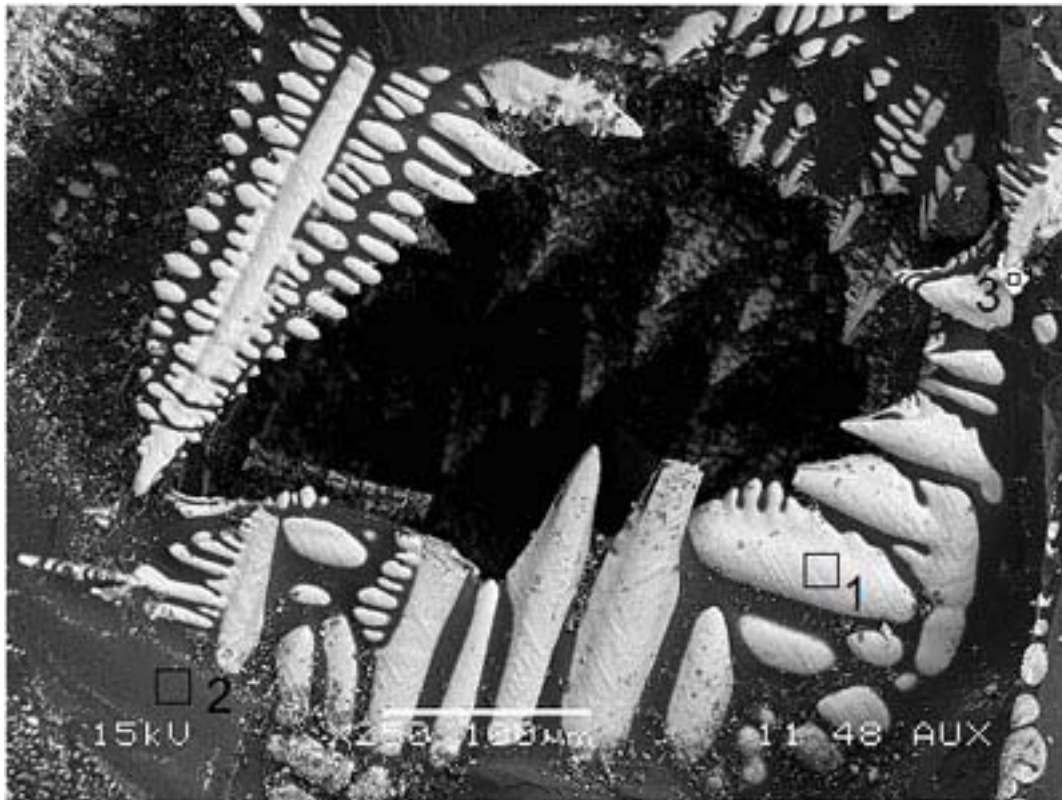
Figure A.16. SEM Micrograph of ELECTROFUSED CAST AZS UNICOR® 501 at 441°C (AMEC feed heat-treated at 5°C/min and held at 1000°C for 2 hours)

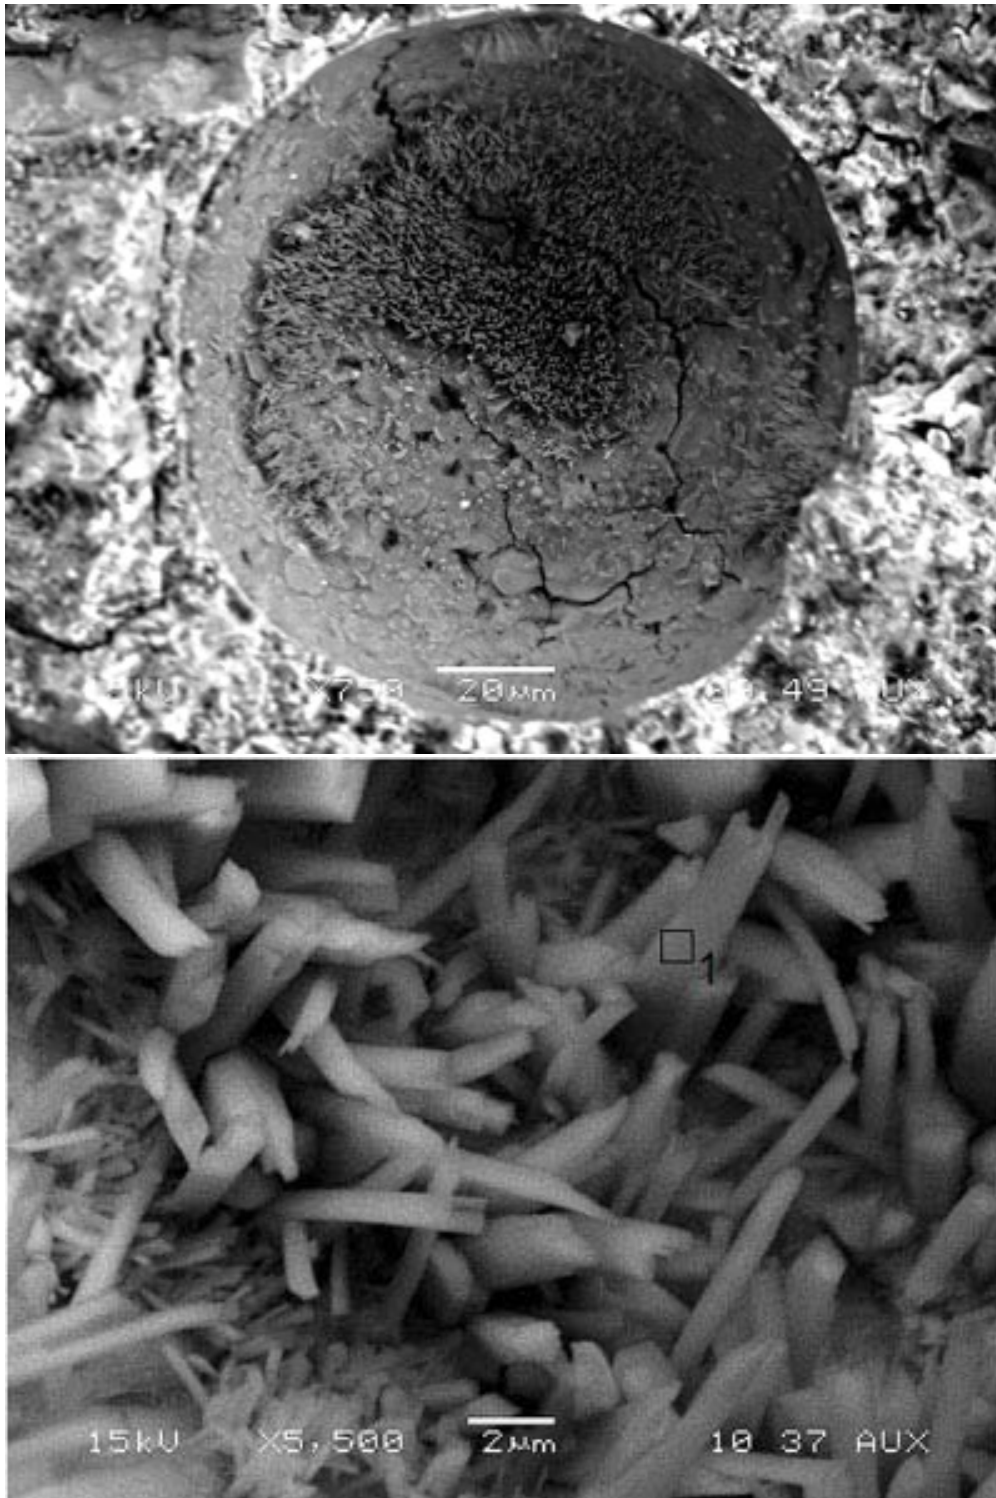
Figure A.18. SEM Micrograph of Untreated VIBROCAST 60PC Side Surface Fractured at 442°C (AMEC feed heat-treated at 5°C/min and held at 1000°C for 2 hours)

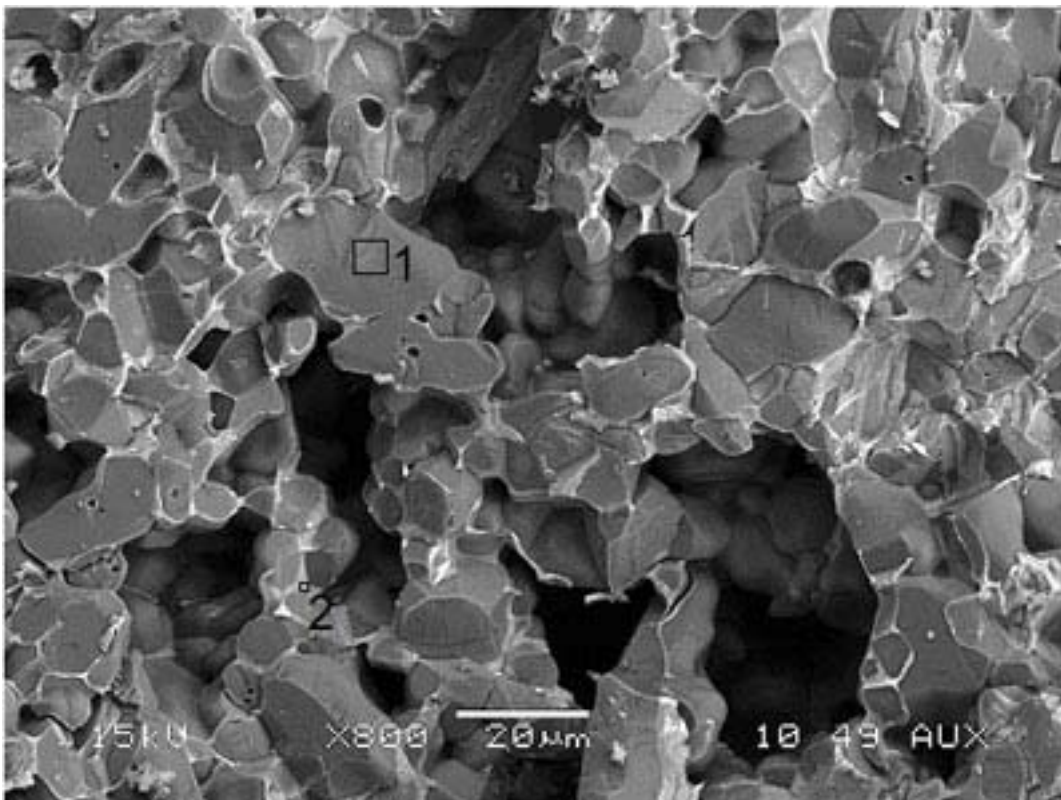
Figure A.19. SEM Micrograph of VIBROCAST 60PC Coated with Sodium Silicate Glaze Side Surface Fractured at 442°C (AMEC feed heat-treated at 5°C/min and held at 1000°C for 2 hours)

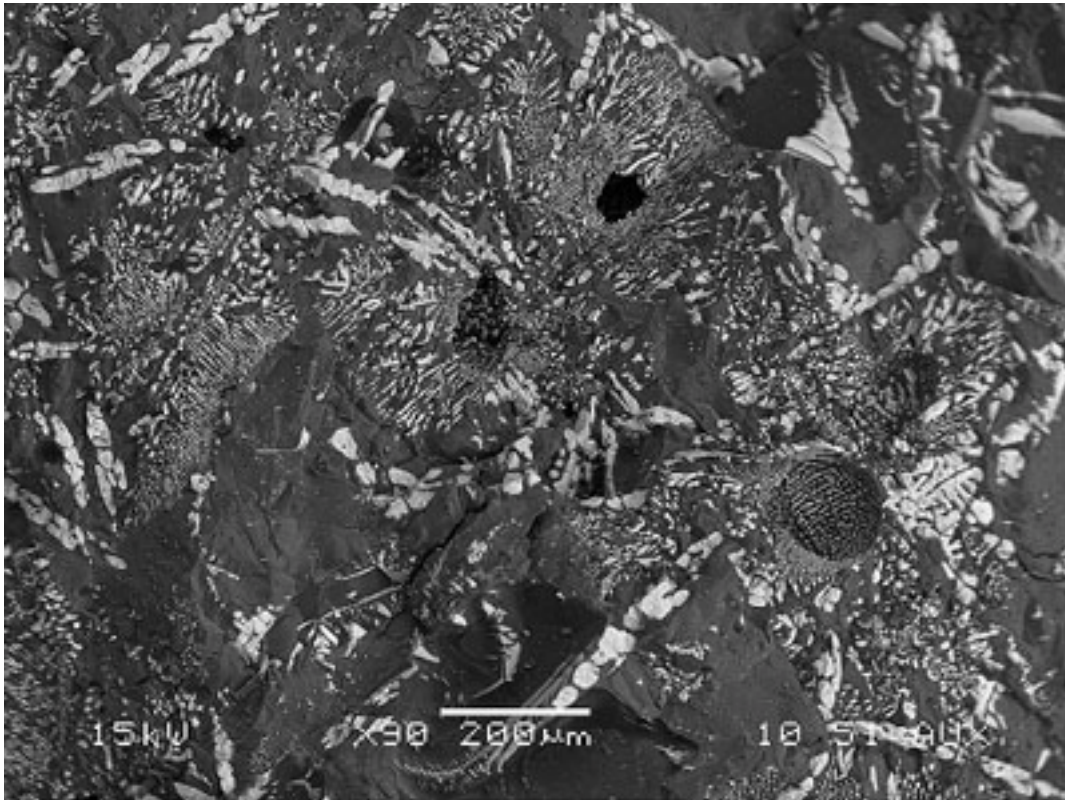
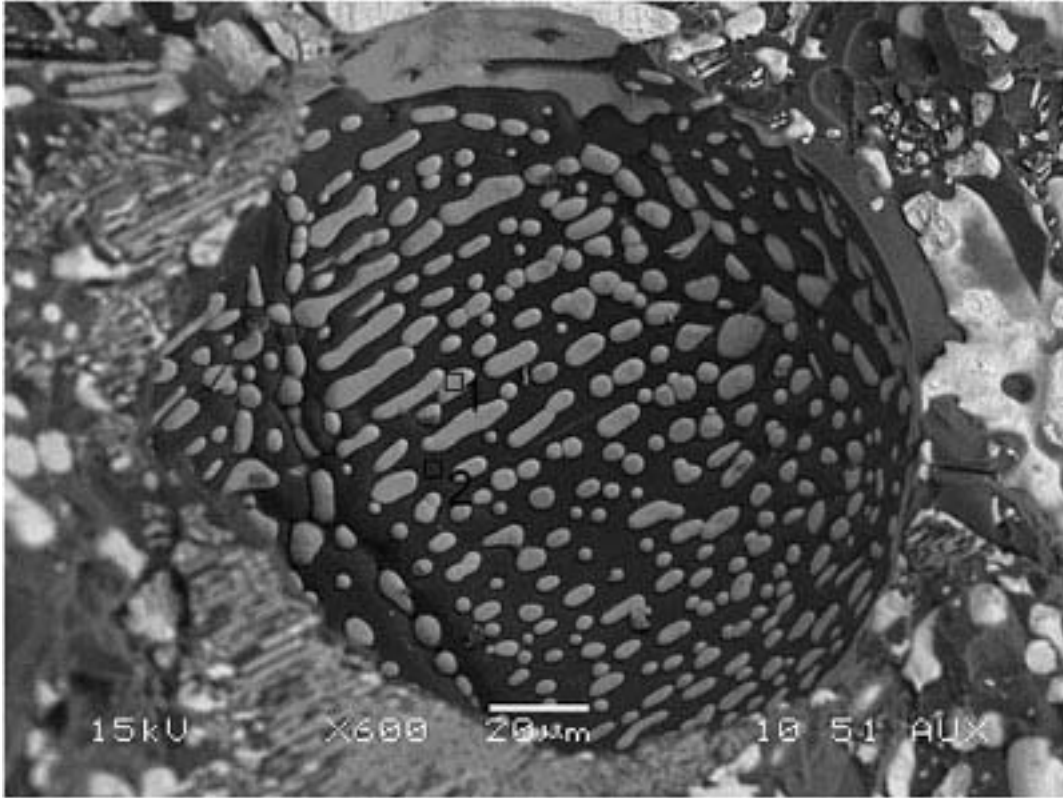
Figure A.20. SEM Micrograph of ELECTROFUSED CAST AZS UNICOR® 501 Side Surface Fractured at 441°C (AMEC feed heat-treated at 5°C/min and held at 1000°C for 2 hours; see below the round object located in the center right)

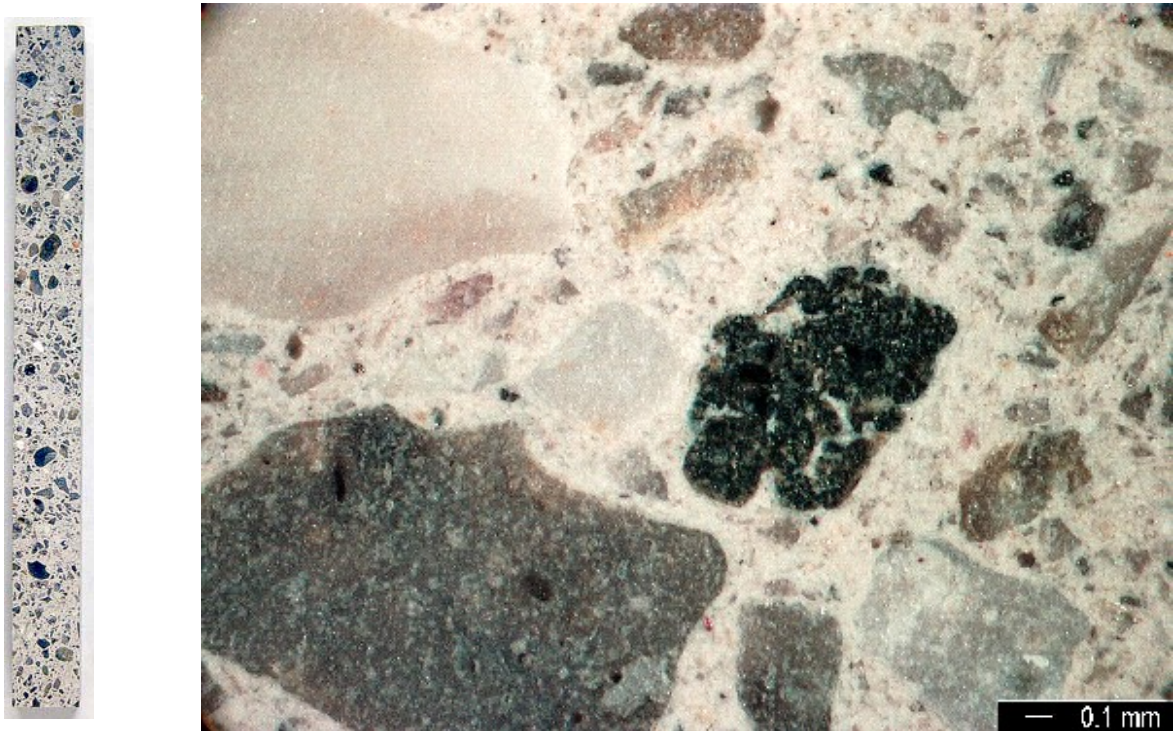
Figure A.21. Optical Micrograph of Untreated VIBROCAST 60PC (AMEC feed heat-treated at 5°C/min and held at 1000°C for 2 hours)

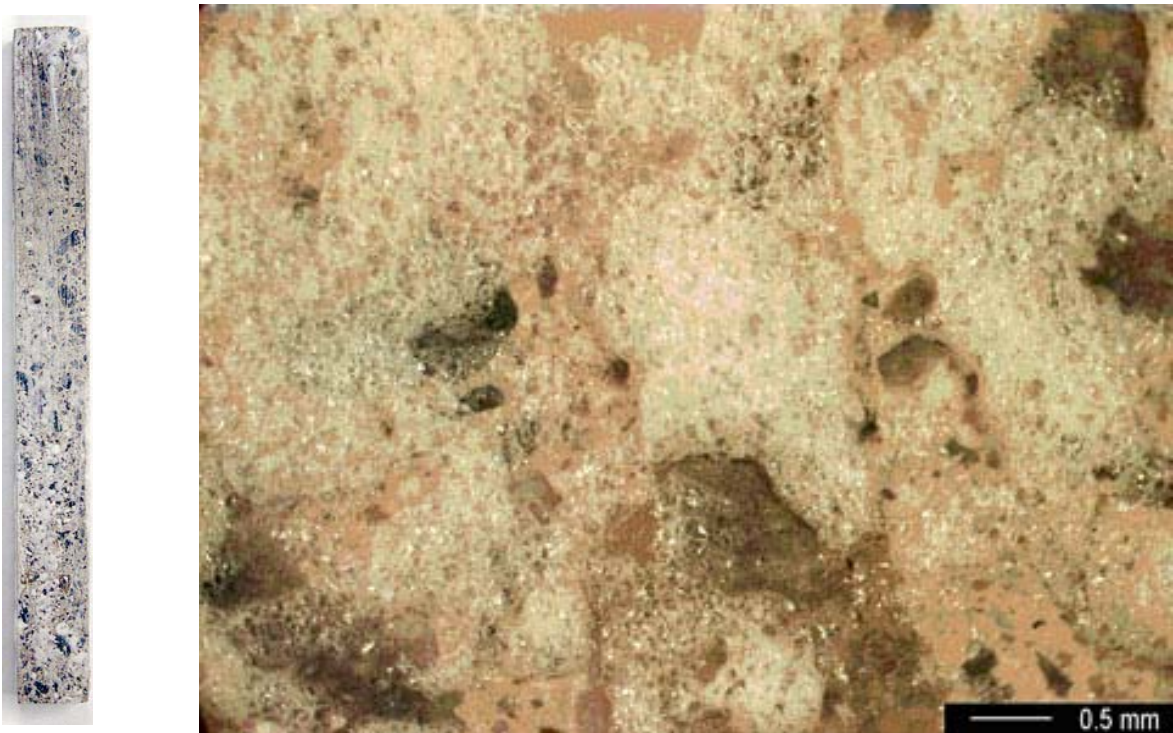
Figure A.22. Optical Micrograph of VIBROCAST 60PC Coated with Sodium Silicate Glaze (AMEC feed heat-treated at 5°C/min and held at 1000°C for 2 hours)

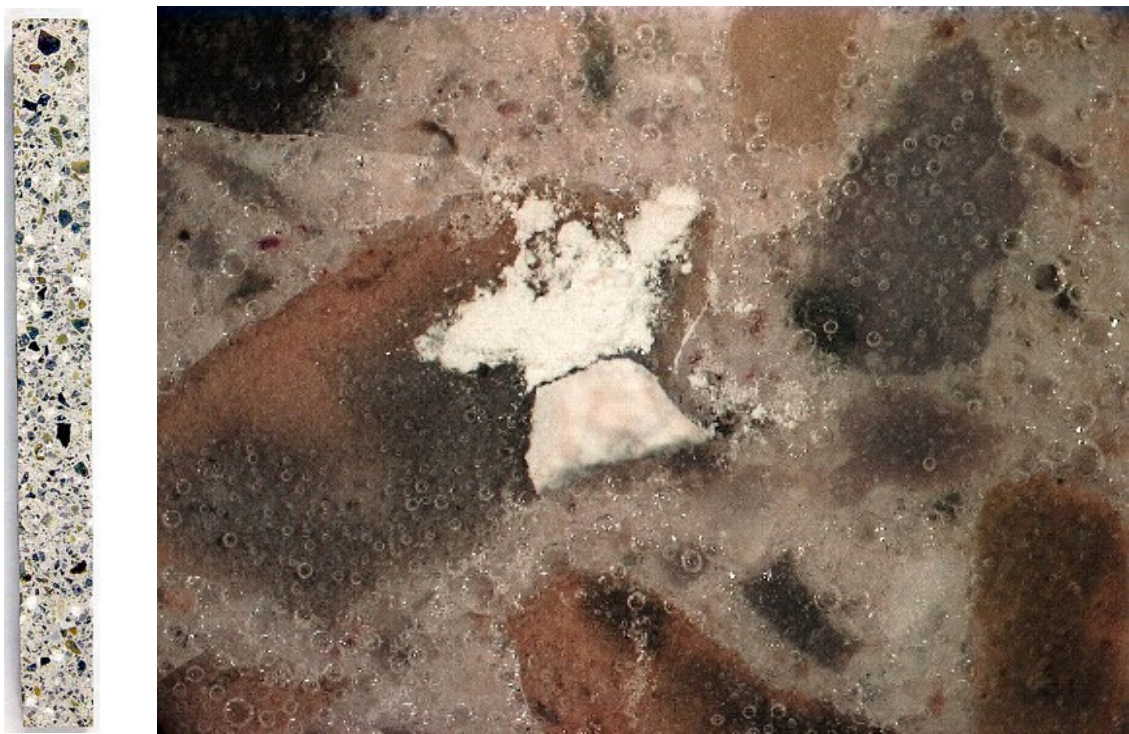
Figure A.23. Optical Micrograph of VIBROCAST 60PC Coated with Borosilicate Glaze (AMEC feed heat-treated at 5°C/min and held at 1000°C for 2 hours)

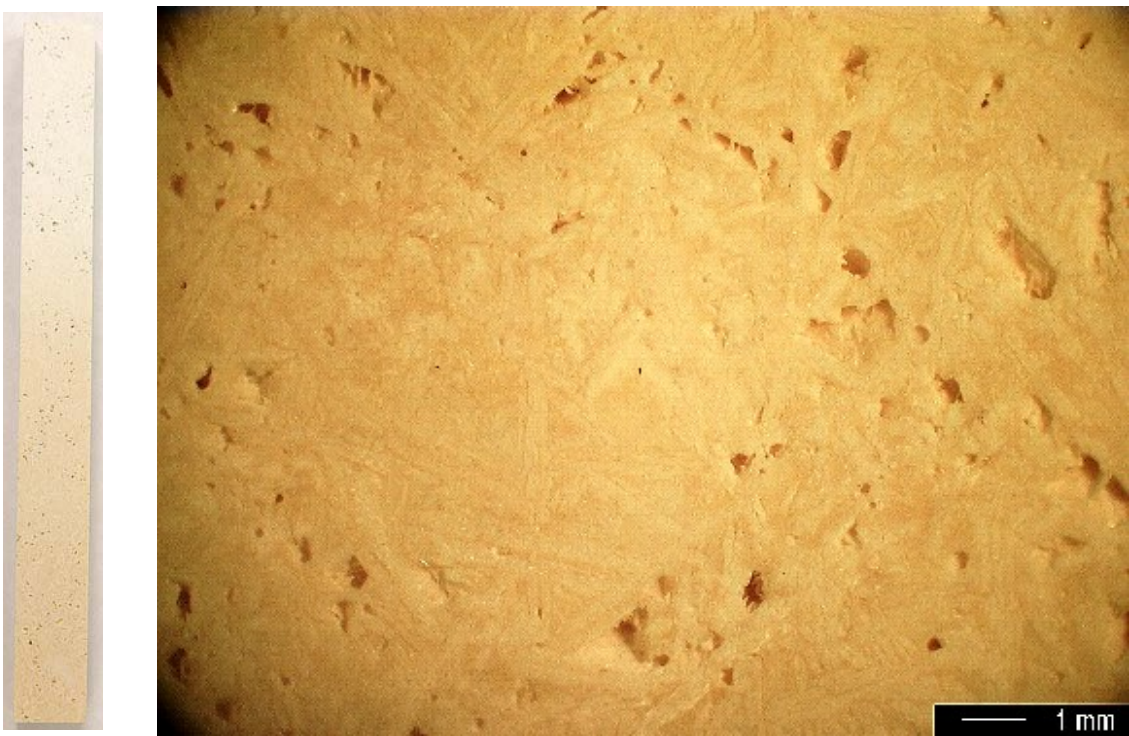
Figure A.24. Optical Micrograph of untreated ELECTROFUSED CAST AZS UNICOR[®] 501 (AMEC feed heat-treated at 5°C/min and held at 1000°C for 2 hours)

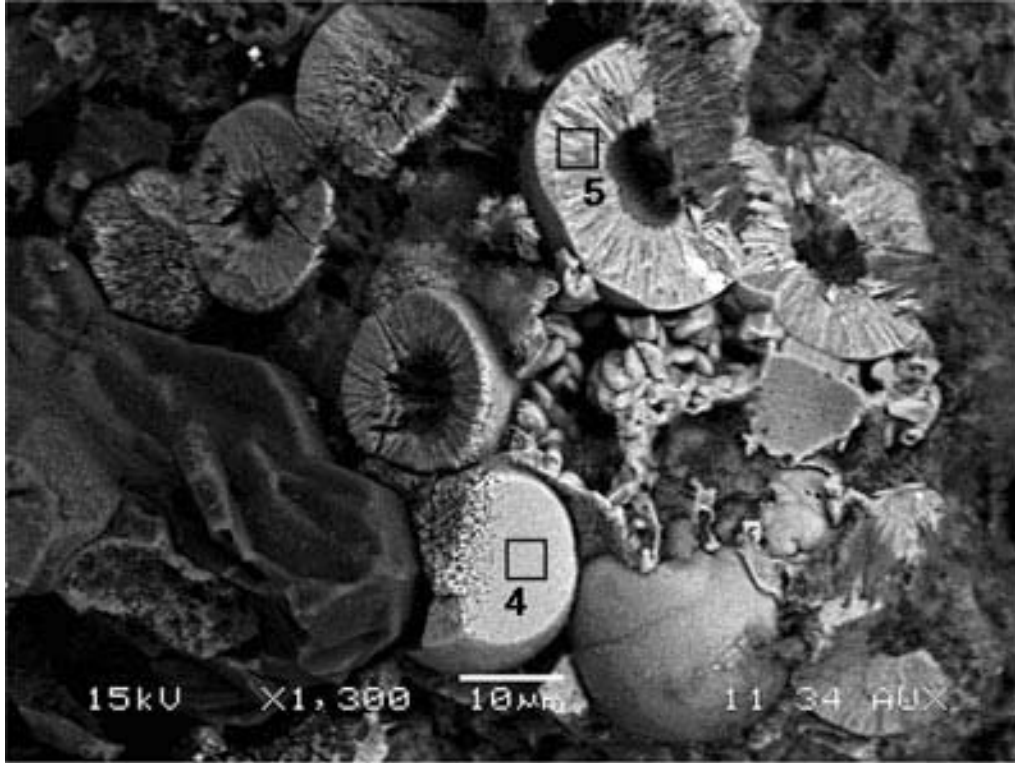
Figure B.8. SEM Micrograph of Cross-Sectioned Untreated Vibrocast 60PC at 700°C

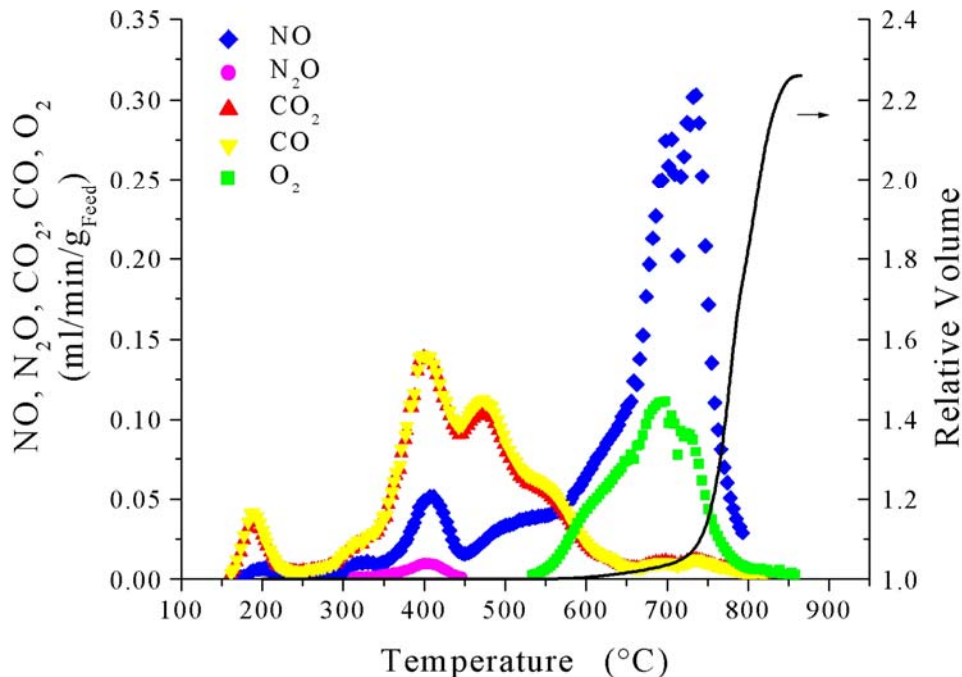
Figure D.4. Evolved Gases from and Relative Volume of BV Feed

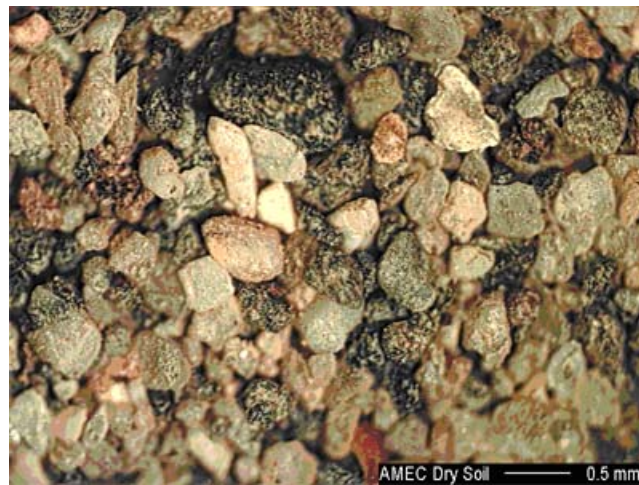
Figure D.5. AMEC Soil, Optical Micrograph

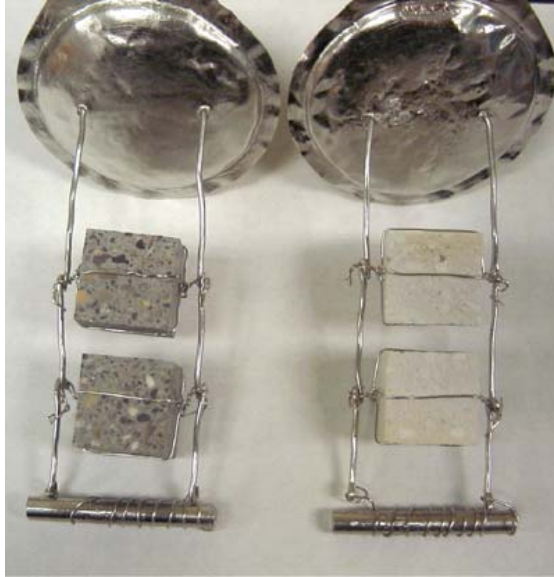
The molten salt penetration tests were conducted on the Alfrax and Vibrocast PC60 materials. The test assembly for refractory coupons is shown in Figure D.8. Two 2×2×2-cm cubic coupons cut from the refractory material are attached to the Pt lid with a Pt wire to be submerged into the MIS in a tall Pt crucible.

Figure D.8. Refractory-Melt Interaction Test Assembly

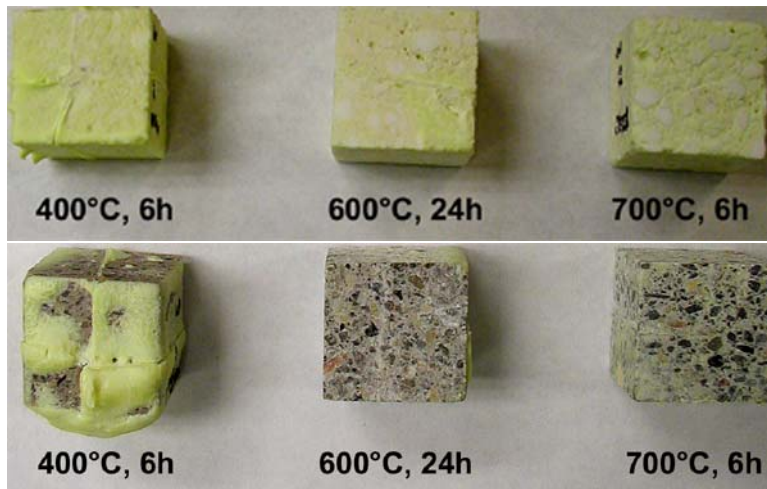
Figure D.9. Alfrax (above) and Vibrocast 60PC (below) Refractory Coupons after Exposure to MIS

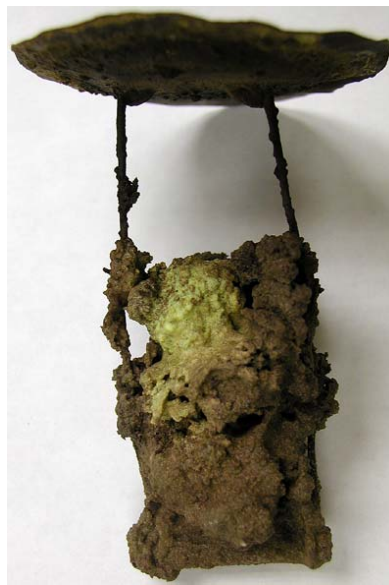
Figure D.10. Coupons of Vibrocast 60PC Exposed to MIS at 800°C for 24 Hours

Coupons of Vibrocast 60PC and Alfrax were exposed to MIS at 400°C for 6 hours, 600°C for 24 hours, 700°C for 6 h (Figure D.9), and at 800°C for 6 hours where the coupons swelled and partly disintegrated (Figure D.10).

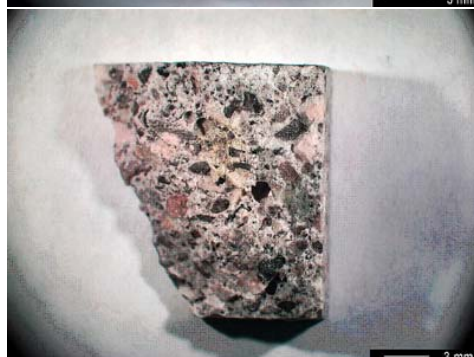
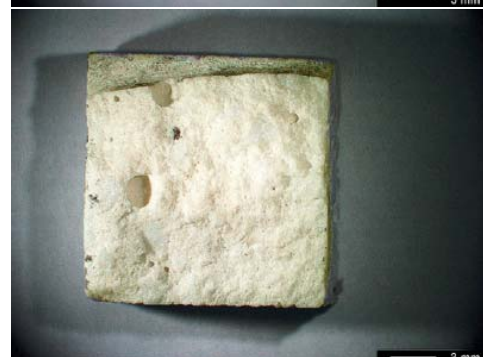
Figure D.11. Fracture Surface of Refractory Coupons Exposed to MIS

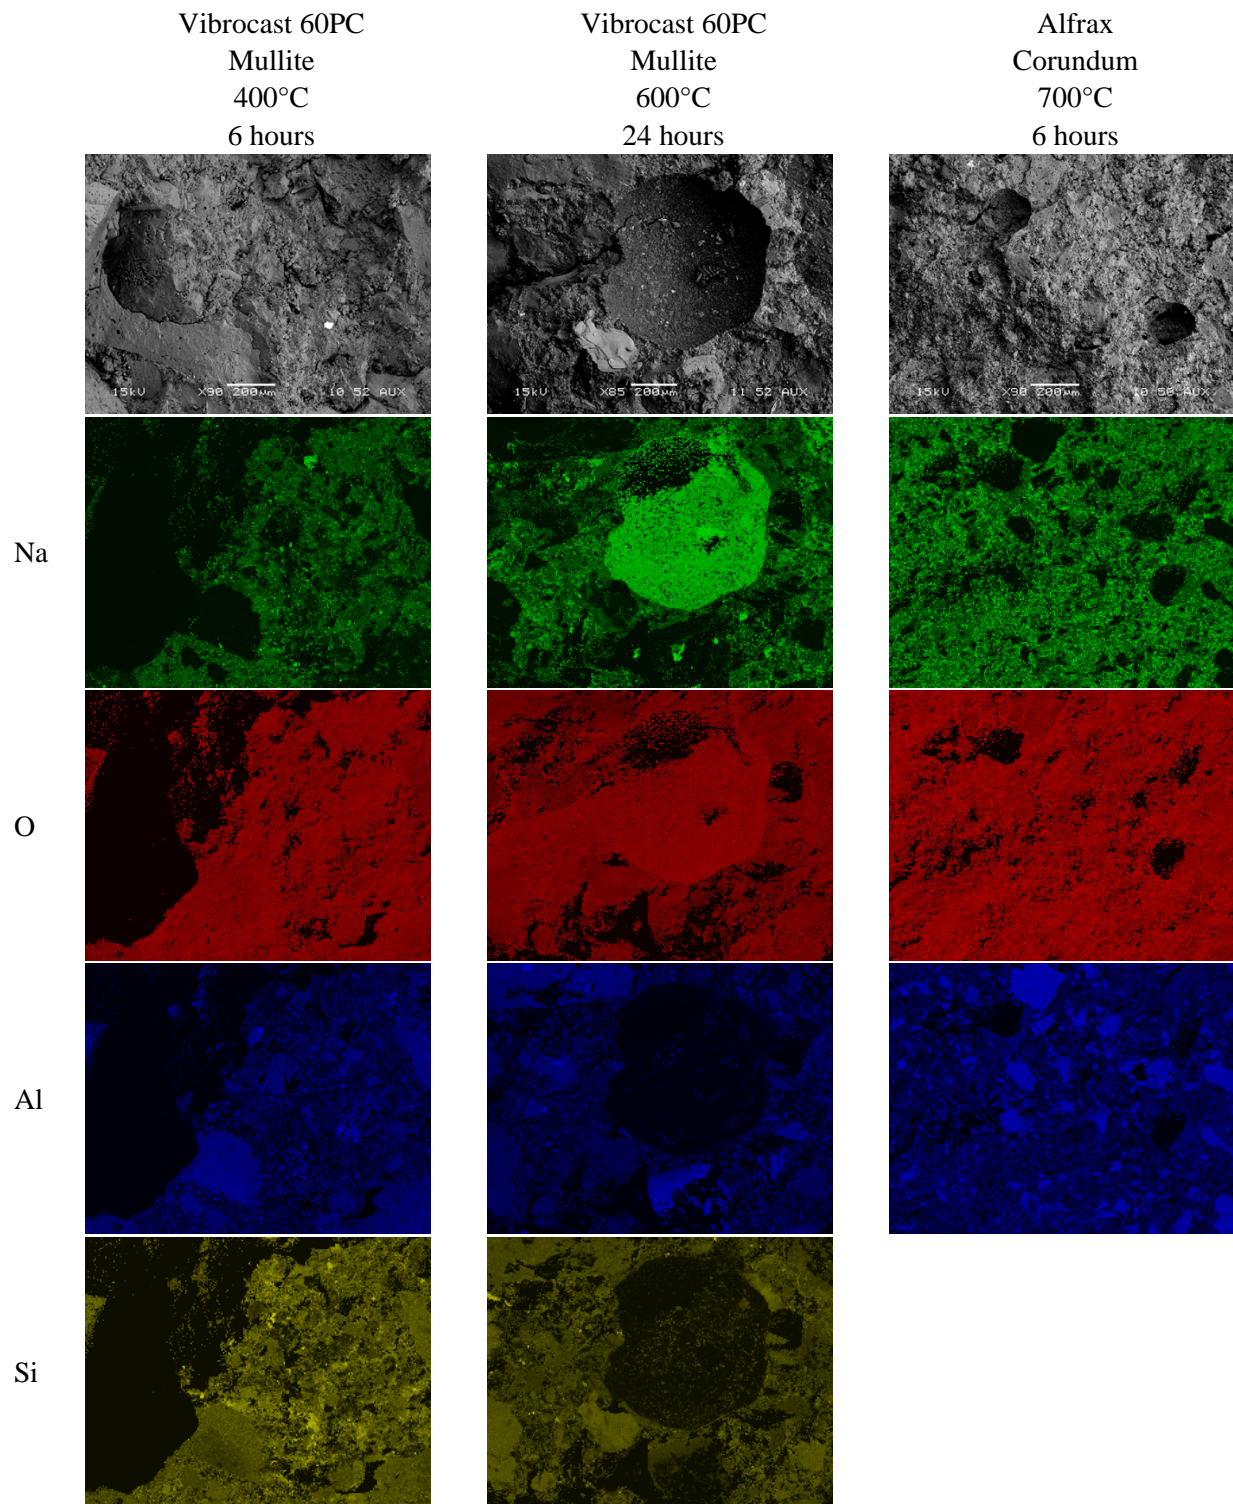
Figure D.12. EDS Dot Maps of Fracture Surfaces of Refractory Coupons Exposed to MIS

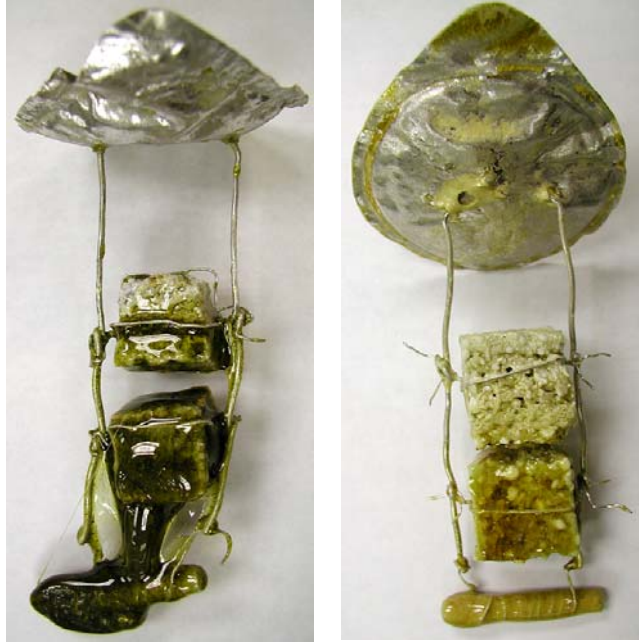
Figure D.13. Coupons of Vibrocast 60PC (left) and Alfrax (right) Exposed to Molten Glass at 1300°C for 10 Hours

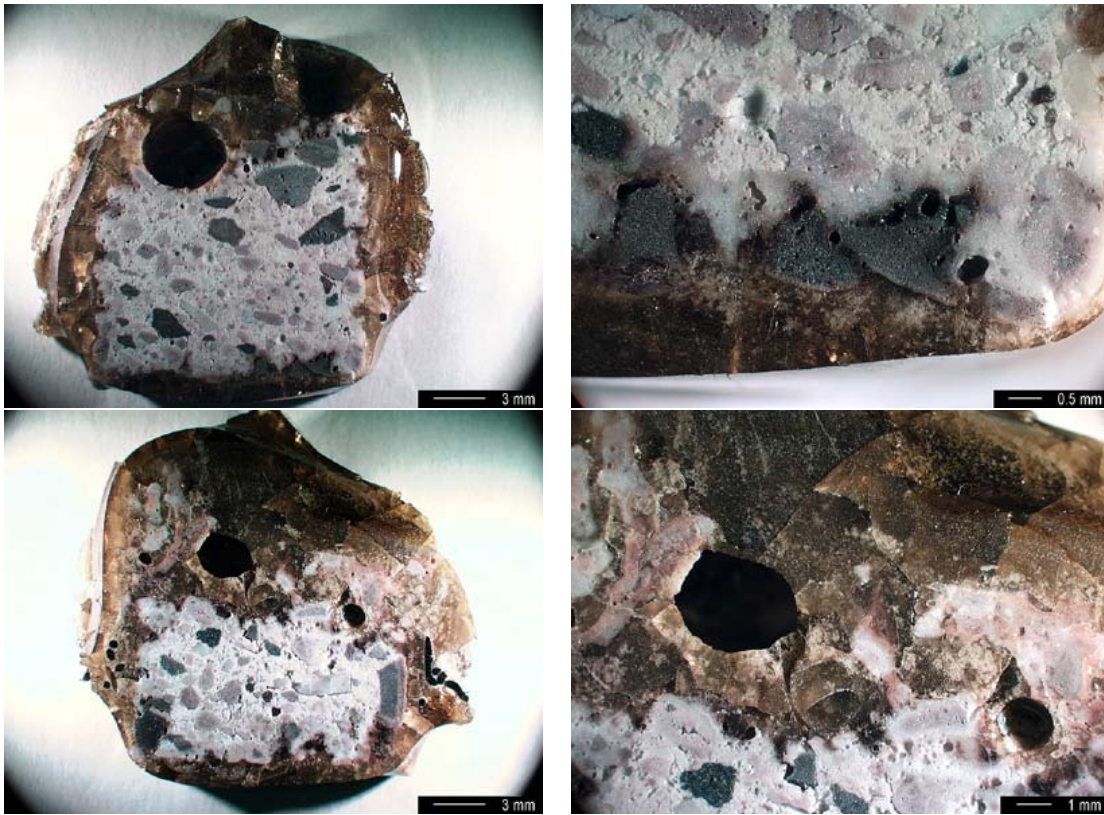
Figure D.14. Vibrocast 60PC (Mullite) Refractory Submerged in Molten Glass at 1300°C for 10 Hours

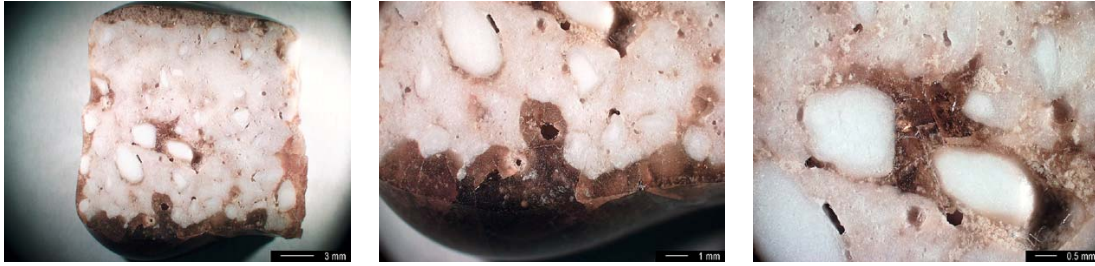
Figure D.15. Alfrax (Alumina) Refractory Submerged in Molten Glass at 1300°C for 10 Hours

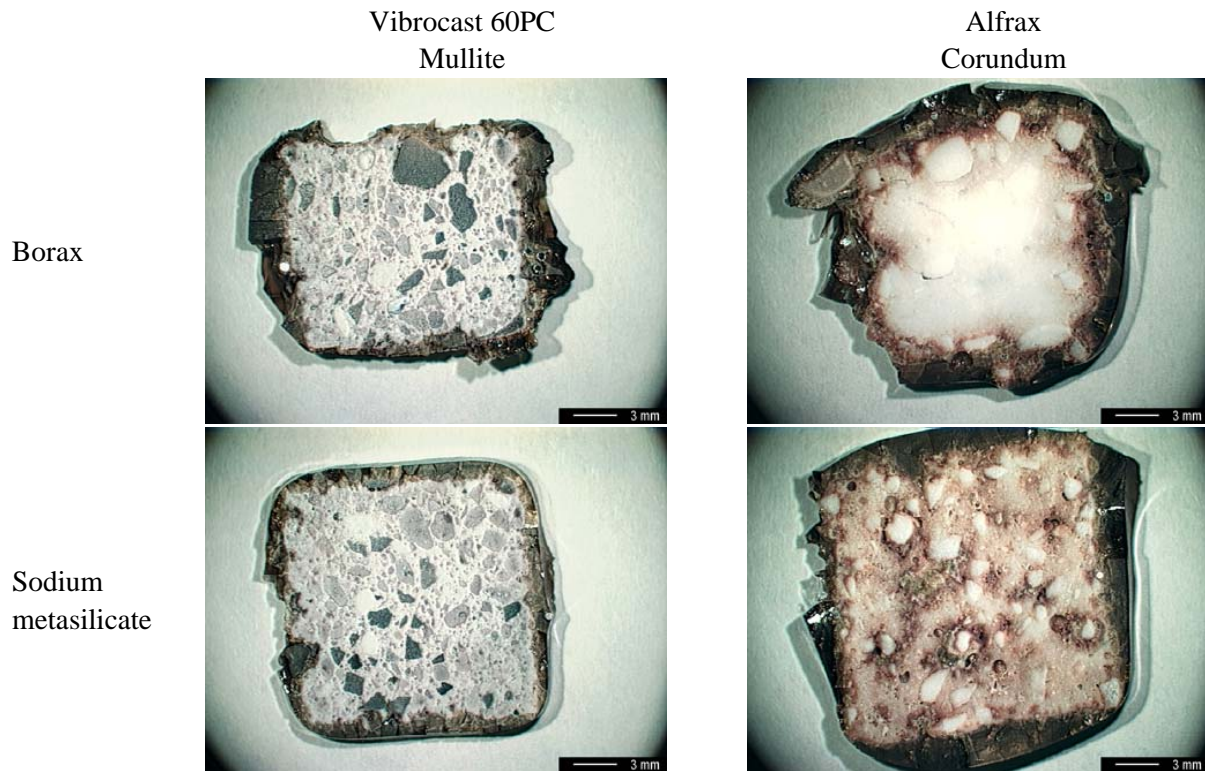
Figure D.16. Sections of Coated Coupons of Refractory Materials After Their 9-h Exposure to Molten Feed at 1300°C

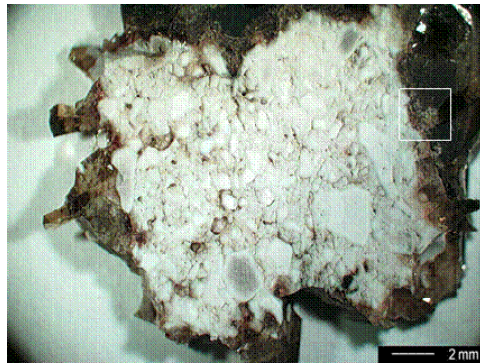
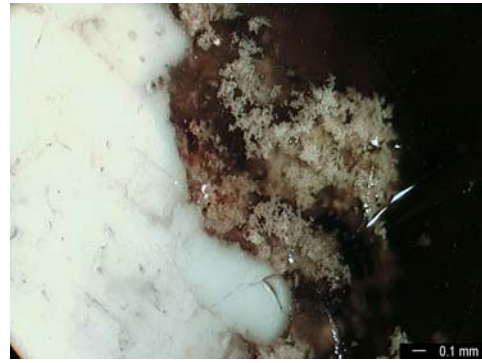
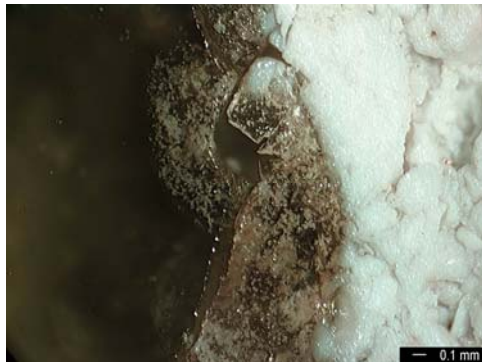
Figure D.17. Sections of Coated Coupons of Fire Brick Yukon After 10-h Exposure to Molten Feed at 1300°C

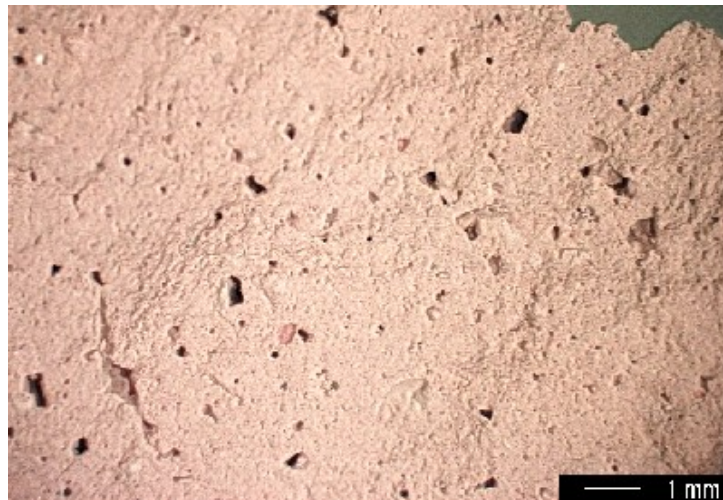
Figure D.19. Section through Fireclay Material (with 50 mass% silica flour)

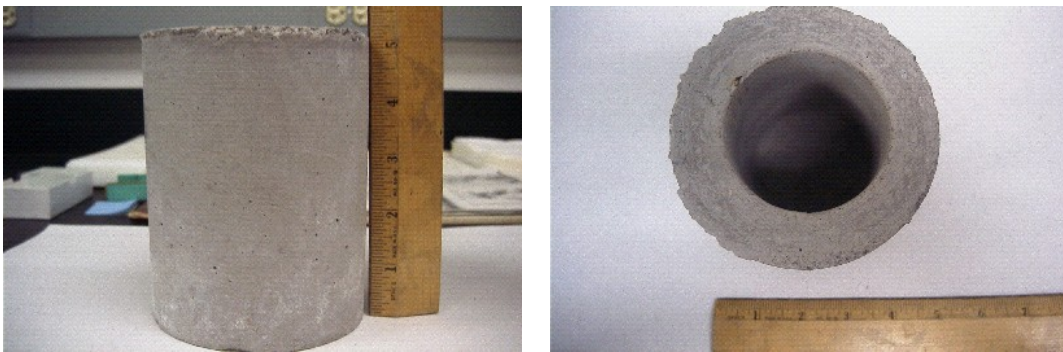
Figure D.20. Vibrocast 60PC Test Crucible

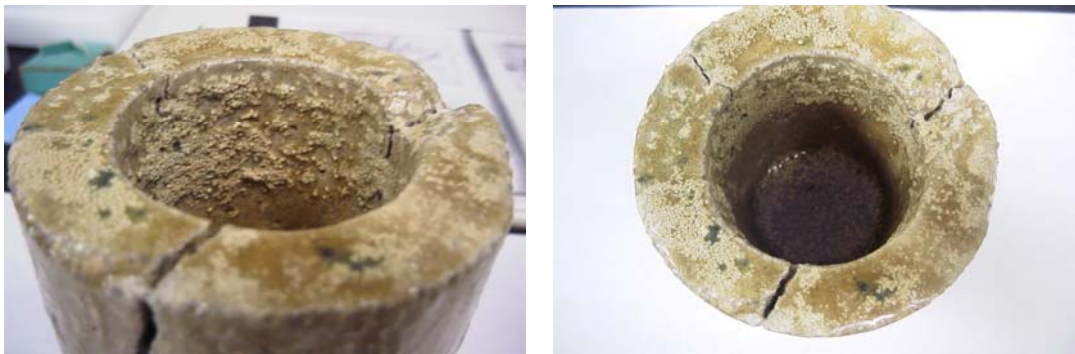
Figure D.21. Cracks in Vibrocast 60PC Test Crucible Heated with BV Feed to 1150°C

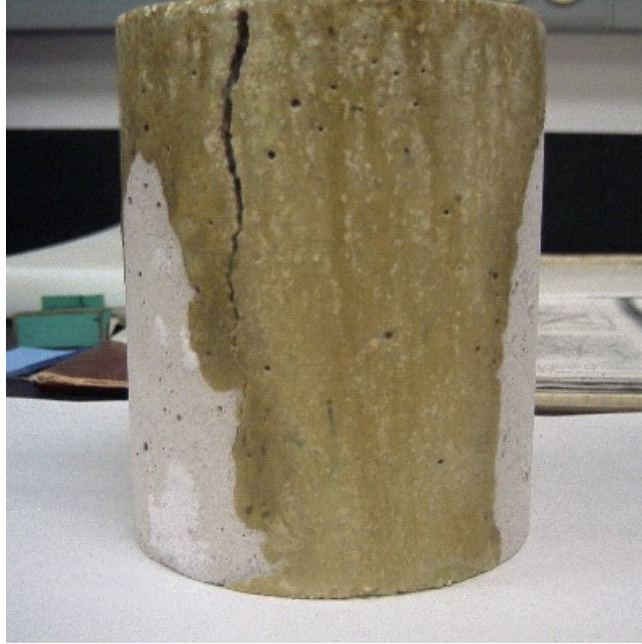
Figure D.22. Side View of Vibrocast 60PC Test Crucible as in Figure D.21

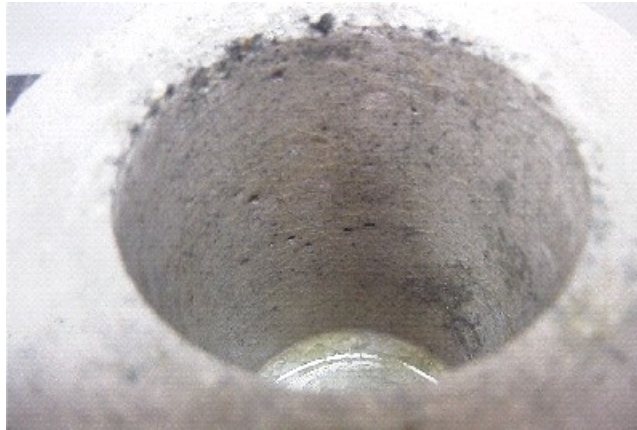
Figure D.23. View of Inner Coating on Vibrocast 60PC Crucible

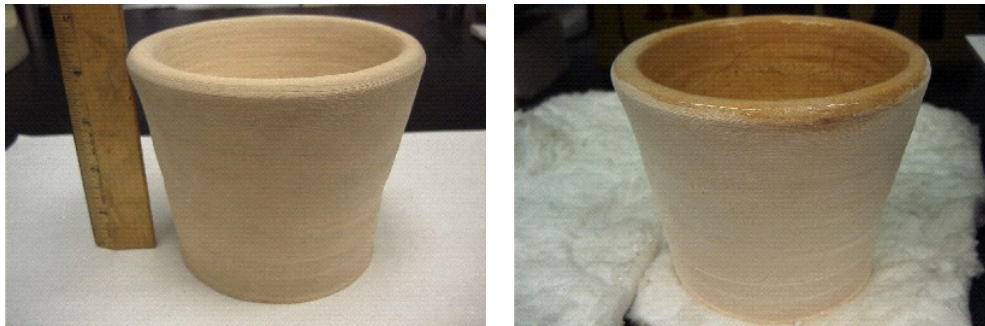
Figure D.24. Fireclay Crucible Before and After Coating
