**Pacific Northwest
National Laboratory**

Bulk Vitrification Castable Refractory Block Protection Study

April 2005

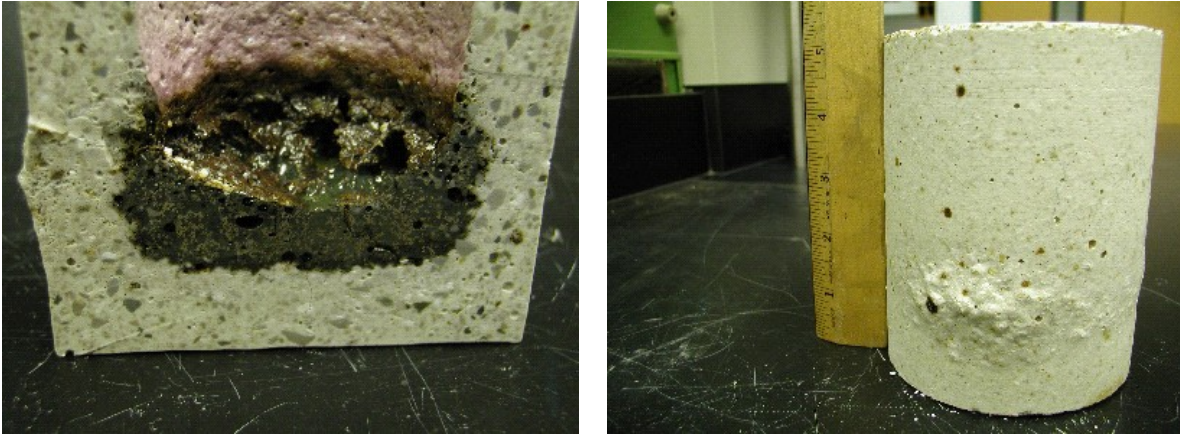
Figure D.25. Vibrocast 60PC Crucible Corroded with BV Feed at 1400°C for 24 Hours

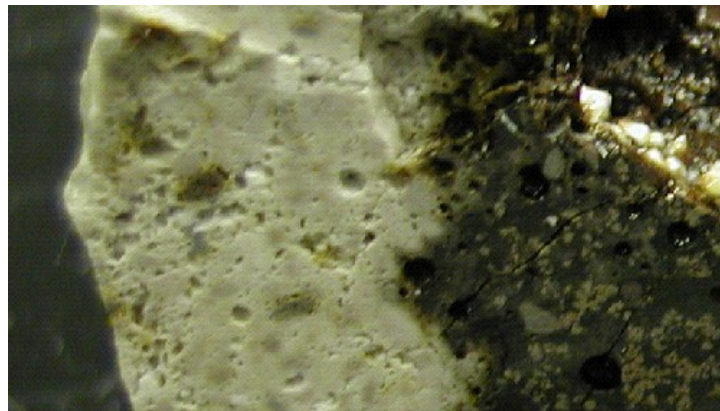
Figure D.26. Detail of Vibrocast 60PC Crucible in Figure D.25

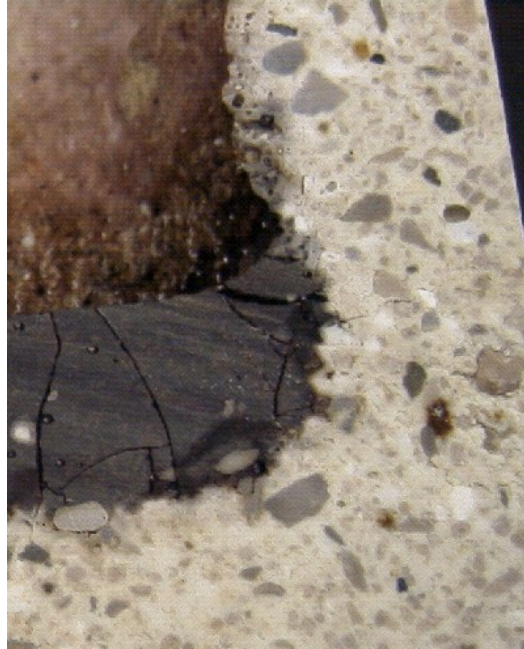
Figure D.27. Detail of Corrosion Damage of Coated Vibrocast 60PC Crucible

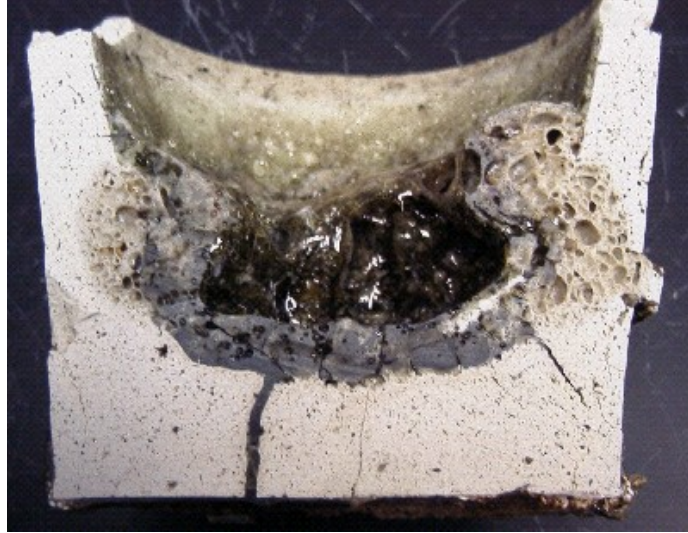
Figure D.28. Fireclay-Silica Crucible Corroded with BV Feed at 1400°C for 100 min

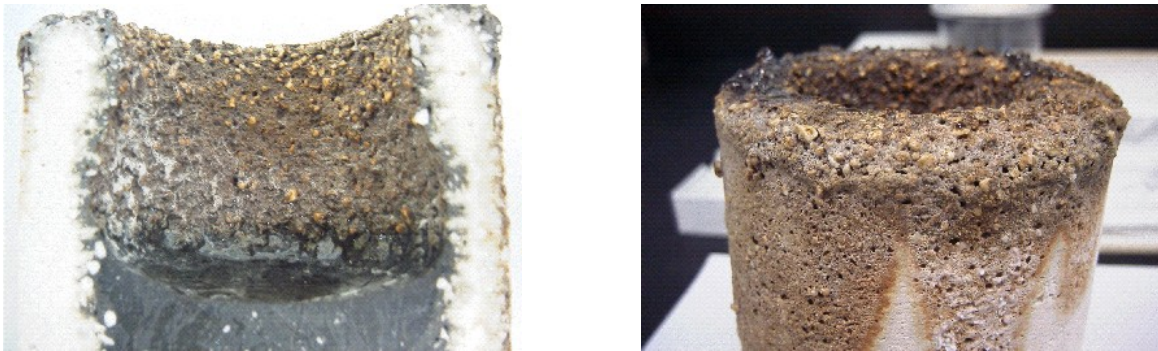
Figure D.29. Corroded Alfrax Test Crucible

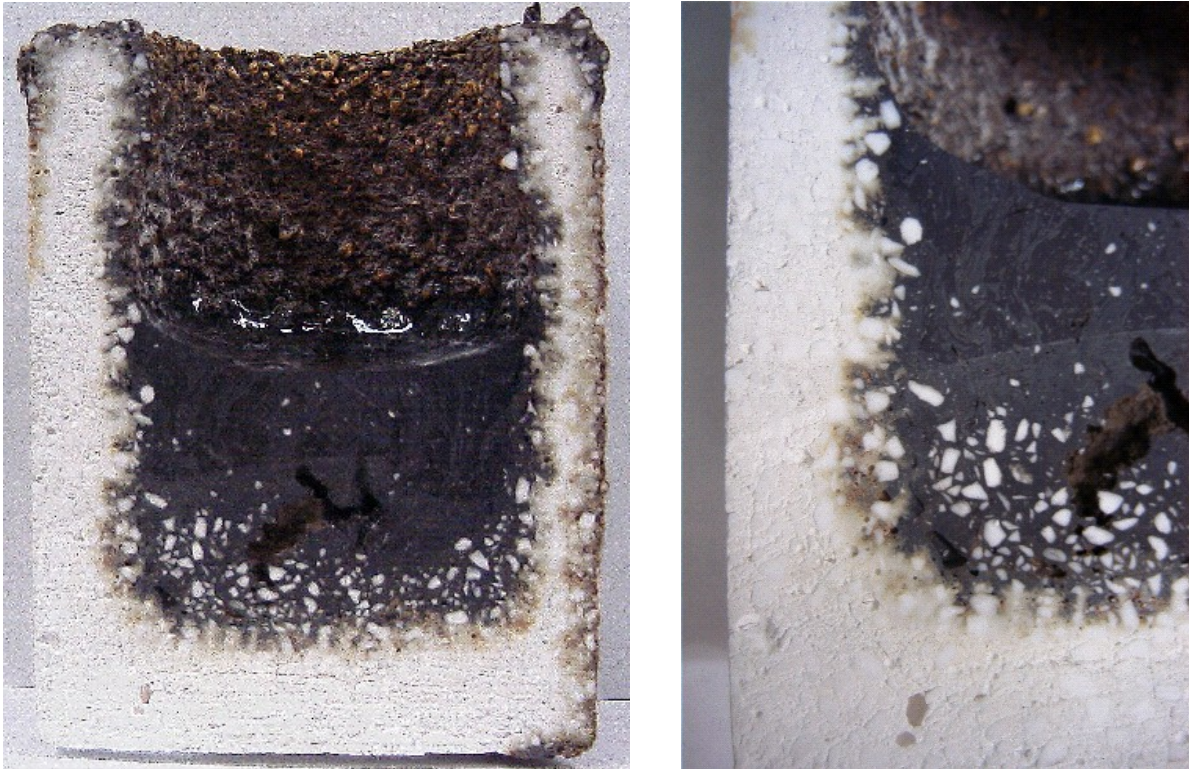
Figure D.30. View of Corroded and Sectioned Alfrax Test Crucible

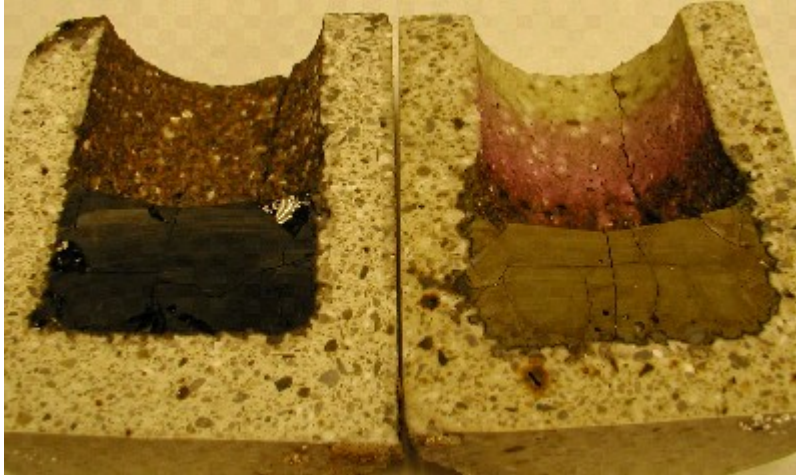
Figure D.31. Corroded Vibrocast 60PC Test Crucibles: 3 Hours at 1500°C (left) and 24 Hours at 1500°C (right)

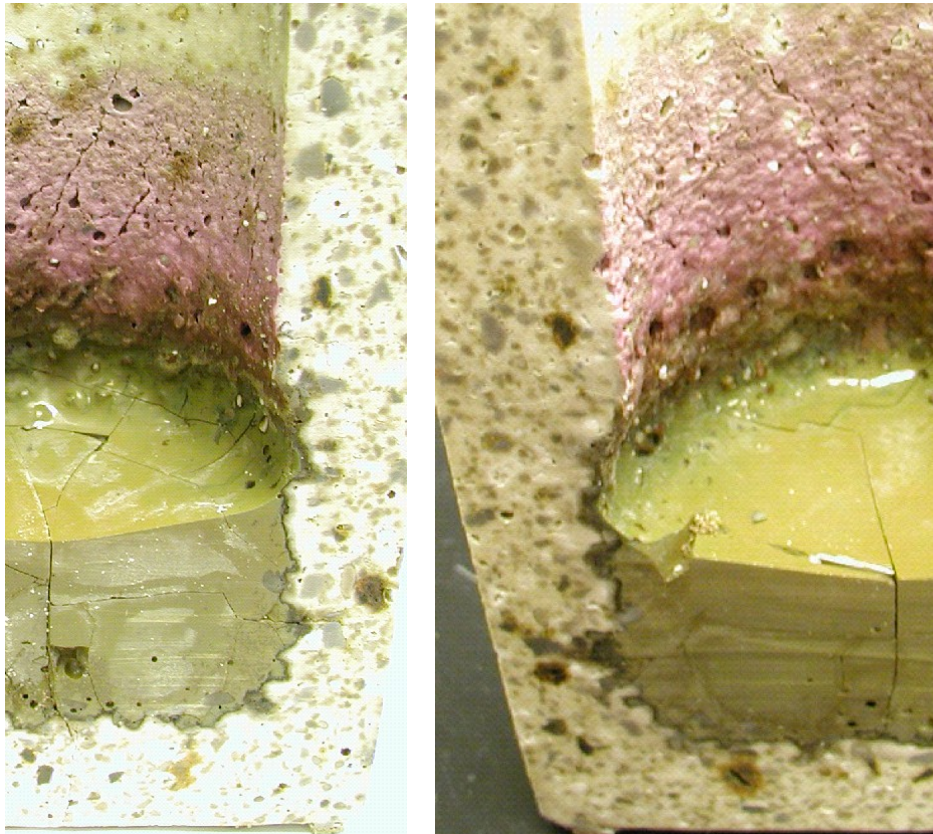
Figure D.32. Corroded Vibrocast 60PC Crucible Cross-Section, 24 Hours at 1500°C

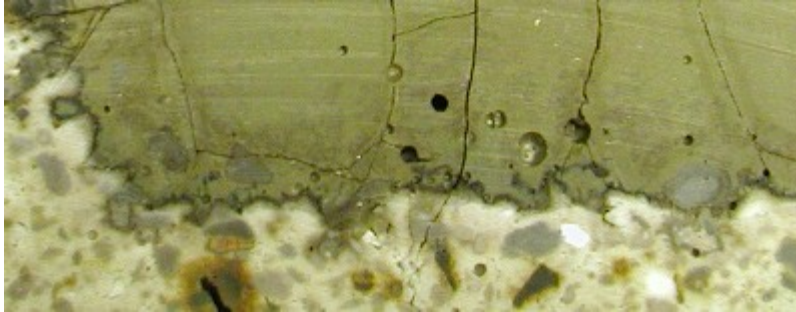
Figure D.33. Vibrocast 60PC, 24 Hours at 1500°C; Melt-Refractory Interface
