SANDIA REPORT

SAND2003-8800

LIGA Microsystems Aging: Evaluation and Mitigation

N. Y. C. Yang, C. San Marchi, C. Cadden

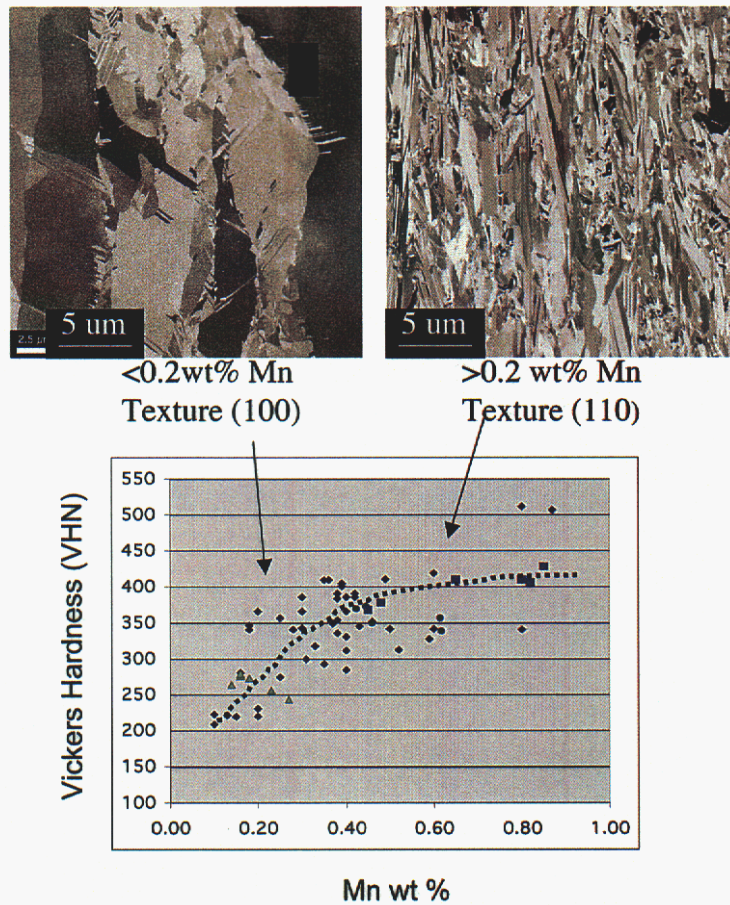
Figure 9. Correlation of Mn concentration, grain size and Vickers hardness for Ni-Mn structures.

The measured Vickers hardness for the Ni-Mn (~0.5wt%Mn) was about 350-400 VHN. However, depending on the Mn concentration and grain size, the hardness could vary from ~220 to 400VHN. Generally, for deposits containing less than 0.2wt% Mn, the microstructure is coarse (>1.0micron) and soft (<300VHN). On the other hand, for deposit containing greater than 0.3wt%Mn, the microstructure is fine (<<1.0micron) and hard (>300VHN) as shown in Figure 9.

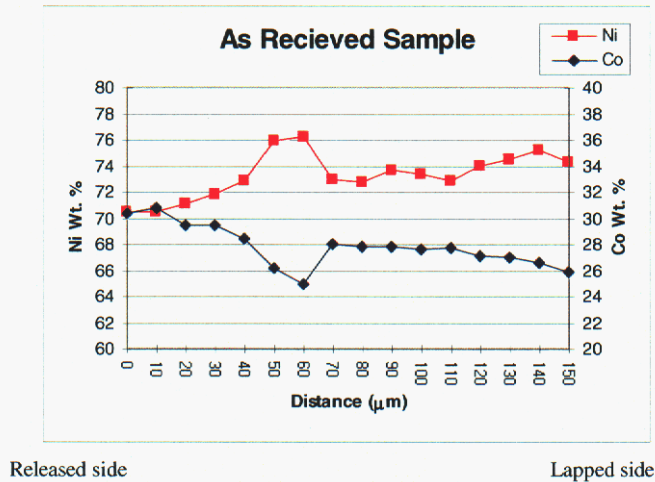
Figure 11. Alloy composition profile through the thickness of the Ni-Co deposit.

EMPA/WDS measurements show that the overall composition among the Ni-Co deposits can vary about $\pm 10-15\%$ from the nominal composition (30wt% Co). In addition, composition variations through the thickness were observed. For the low aspect ratio mold-free deposit, Co concentration tended to deplete gradually toward the plating surface (Lapping side) as shown in Figure 11. The Co concentration near the lapped surface is about $\sim 15\%$ below the nominal concentration.

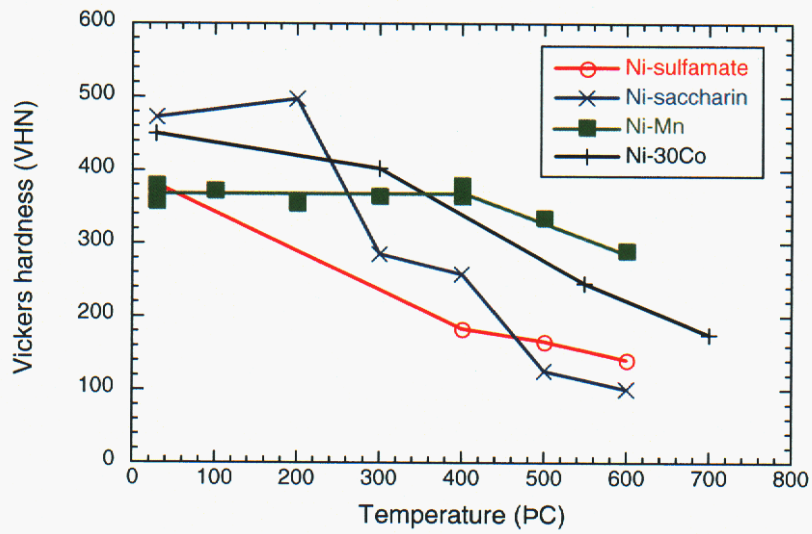
Figure 17. Effect of heat treatment on the Vickers hardness of electrodeposited materials

The plot of hardness vs. temperature in Figure 17 implies that the grain structure of Ni-30 Co and Ni-0.5Mn undergo little microstructural change when annealing at temperatures up to 300C for one hour. Figure 18 shows that the grain size of the Ni-0.5Mn electrodeposit is quite stable up to 600C. For Ni-30Co annealed at 600C, it is noticed that the grains began to coarsen from columnar to equiaxed (Fig 19). SEM/BEI images and knoop hardness measurements show a gradual increase in grain size and decrease in hardness toward the plating surface. As described previously the grain size and hardness gradient are the results of Co depletion through the thickness (Figure 11) and these gradients are amplified when subjected to annealing without significant modification of the compositional gradient, Figure 19. This means that the thermal stability of the Ni-Co deposit is greatly dependent on the alloy composition and existing gradients.

The Ni-saccharin and Ni-sulfamate, on the other hand, are much less stable at these elevated temperatures. The nanoscale grains began to coarsen at temperatures as low as 250-300C (Figure 18) and the hardness drops dramatically, particularly for the Ni-saccharin, to levels similar to those of wrought Ni, i.e. ~100-120 VHN.

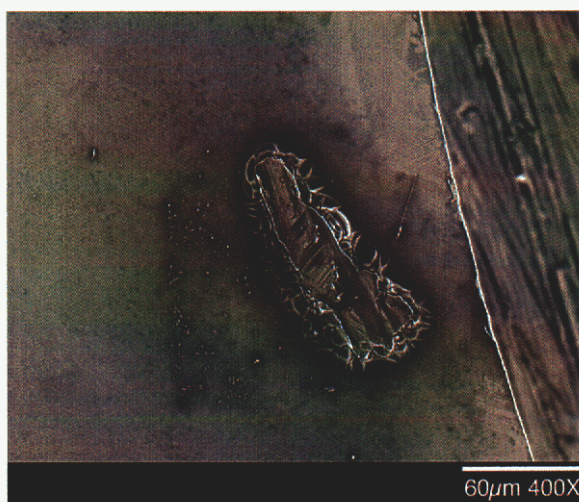
Figure 37. Flakes of material embedded in the release side of tensile bar 1041; these flakes are thought to be steel since EDS reveals that they are rich in Fe and Cr.

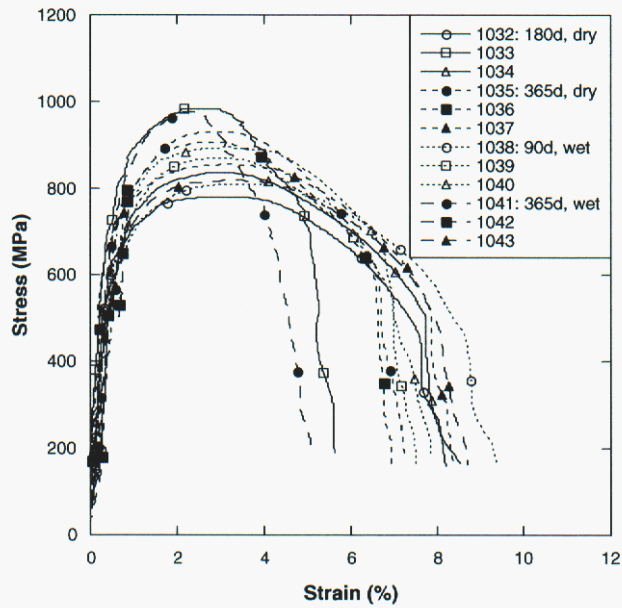
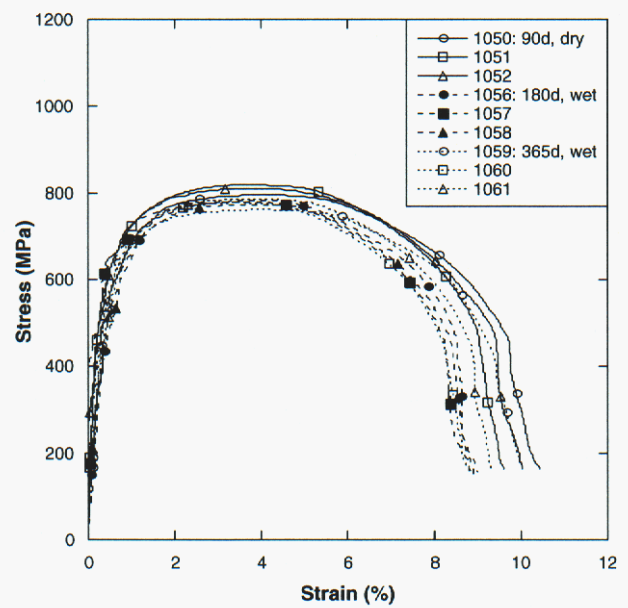
Figure 40. Stress-strain curves plotted by lot of material: (a) 14/31-306; (b) 13/31-307; (c) 13/36-351; and (d) 13/36-352.
