**SAND 2006-6203**

# **Contamination and Solid State Welds**

Bernice E. Mills

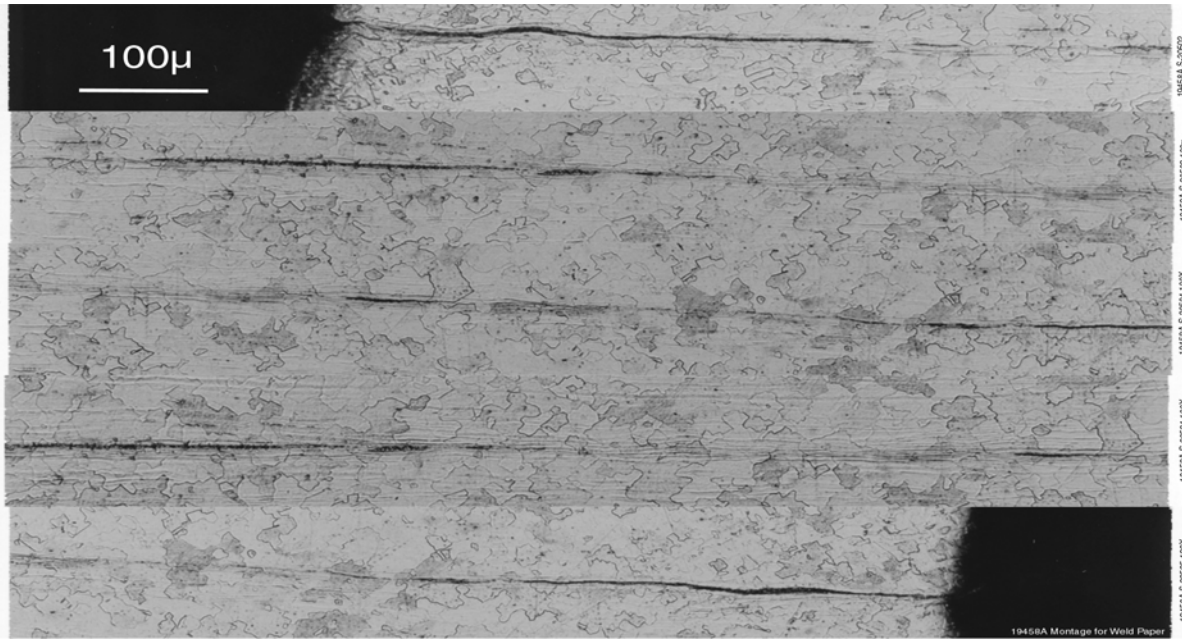
Historically there have been observations of contamination likely introduced during stem drilling at Rocky Flats. After close examination of gun drilled stems and pinch welds produced during qualification of new pinch welding stations in the 1990s, it was observed that some of the stems had significant amounts of contamination that was incorporated into the weld, Figure 1.

**Figure 1. Examples of pinch welds made using contaminated stems.**

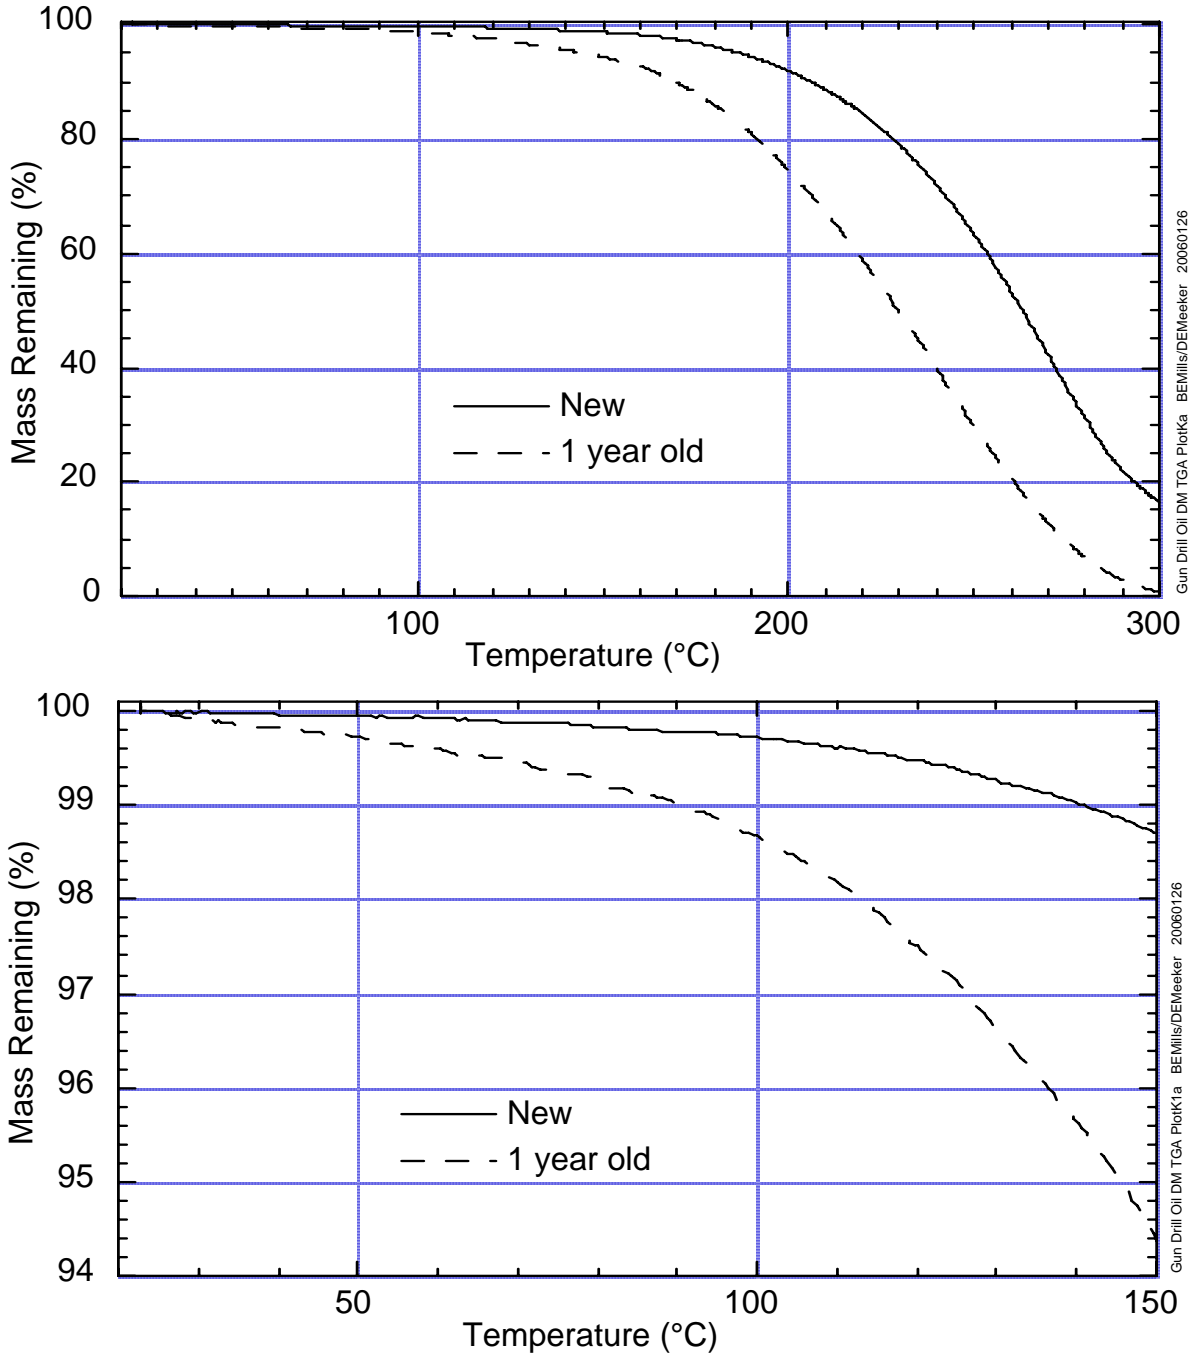
New and aged cutting oil was also compared using thermogravimetric analysis (TGA) (Figure 7). The old oil begins to volatilize well below 100°C and well below that of the new oil. As the oil vaporizes, its heat capacity decreases by up to two orders of magnitude, decreasing the effectiveness of the cooling.

**Figure 7. Thermogravimetric analysis (TGA) of new gun drill oil compared to one year old oil. The bottom shows a blow-up of the first few percent of vaporization. Note that the onset of vaporization begins at very low temperature and continues at up to 50 K lower temperature for the old oil compared to the new oil.**

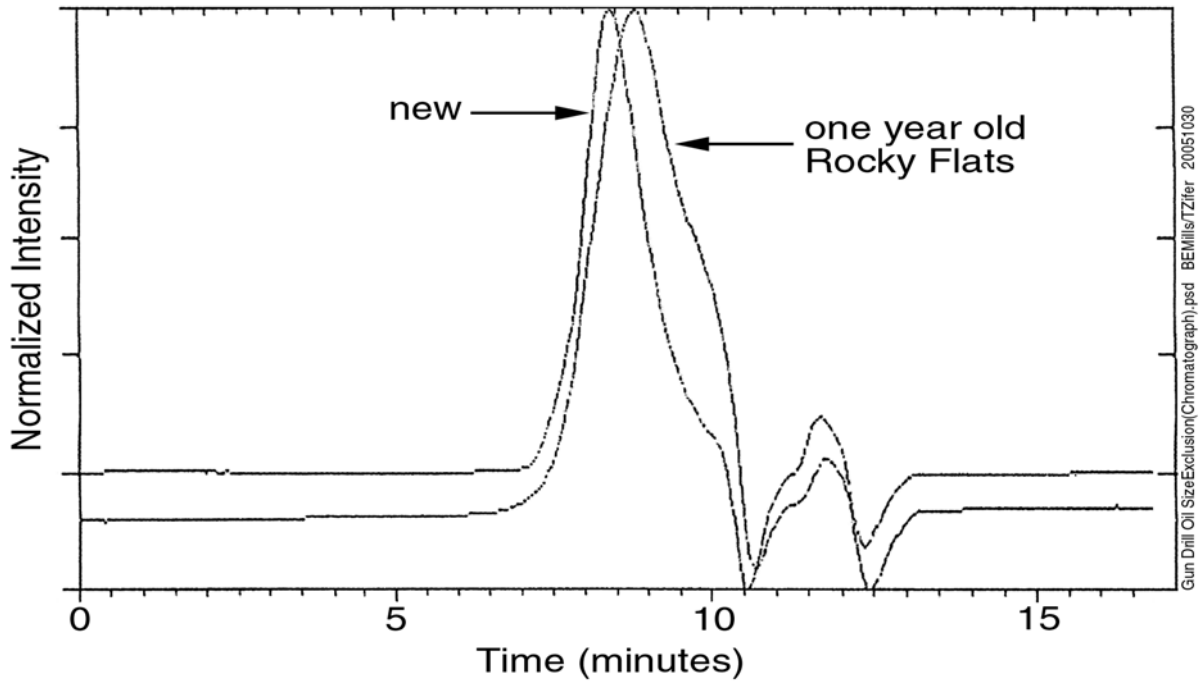
New and old cutting oil was also compared using size exclusion chromatography (SEC) (Figure 8) [3]. As the average molecular weight of a sample decreases, the retention time in SEC increases. The average retention time for new oil increased from 8.48 to 8.81 for the sample of old oil, indicating a decrease in average molecular weight. The shoulder on the right side of the old oil peak suggests chain breakage.

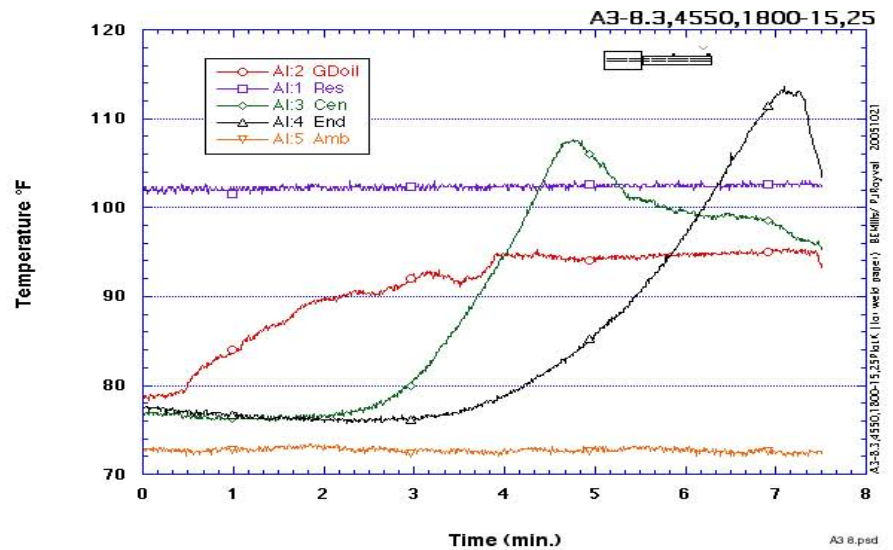
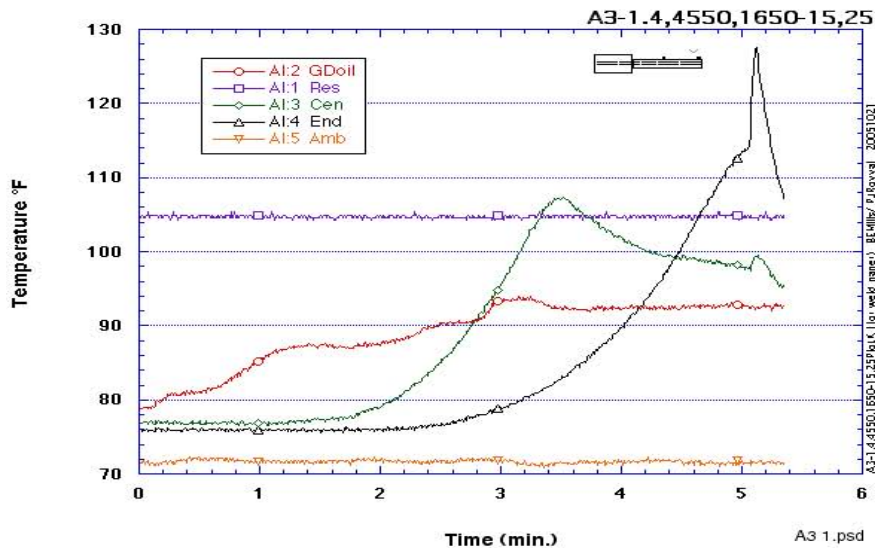
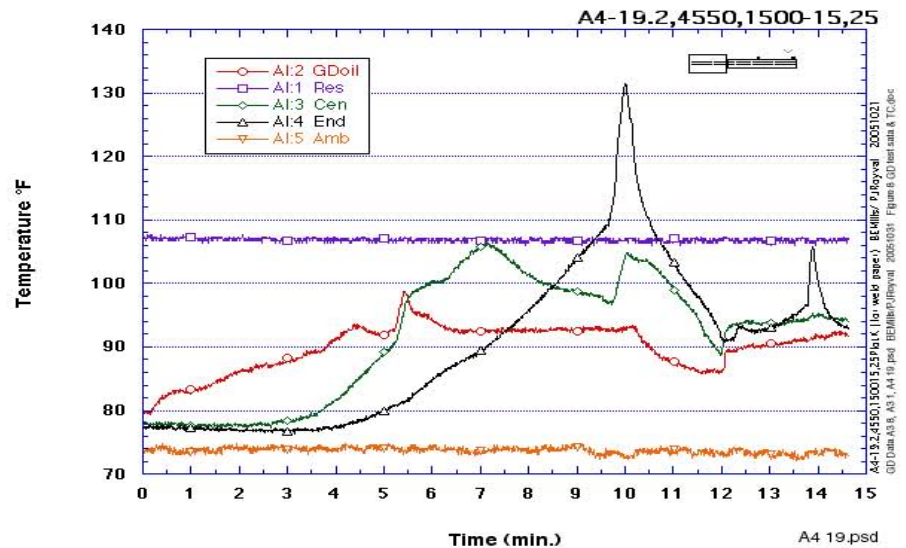
**Figure 9.** An example of one of the attempts to determine the cause of contaminated stems with some examples of temperatures of the outside of the stem and of the oil. See text for detailed discussion.

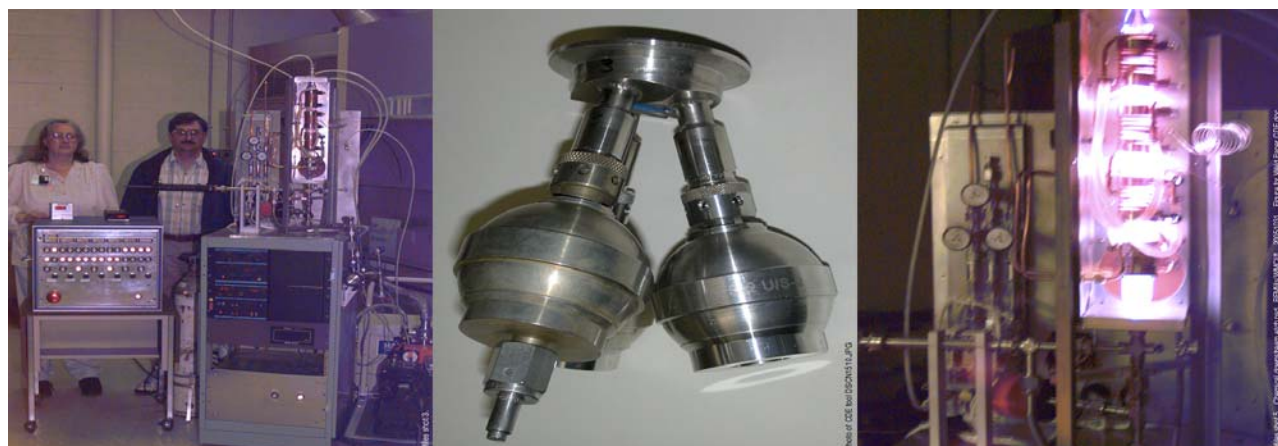
A tool was constructed specifically to clean stems (Figure 13) operating at 360 millitorr using a 13.56 MHz radio frequency plasma generator operating at 400 W. A 2" quartz tube contains, transports, and neutralizes the plasma while mass flow controllers meter in the oxygen at 160 and  $\text{CF}_4$  at 60 sccm. Cleaning the parts takes 8 to 12 hours depending on the configuration and the material.

**Figure 13.** Custom chemical downstream etching (CDE) tool built to clean carbon-contaminated stems. Left: Tool, including control and pumping. Center: fixture to allow three bottles to be cleaned simultaneously. These bottles can be fitted with instrumentation to measure pressures and temperatures during development. Right: Tool with the power on showing the plasma.

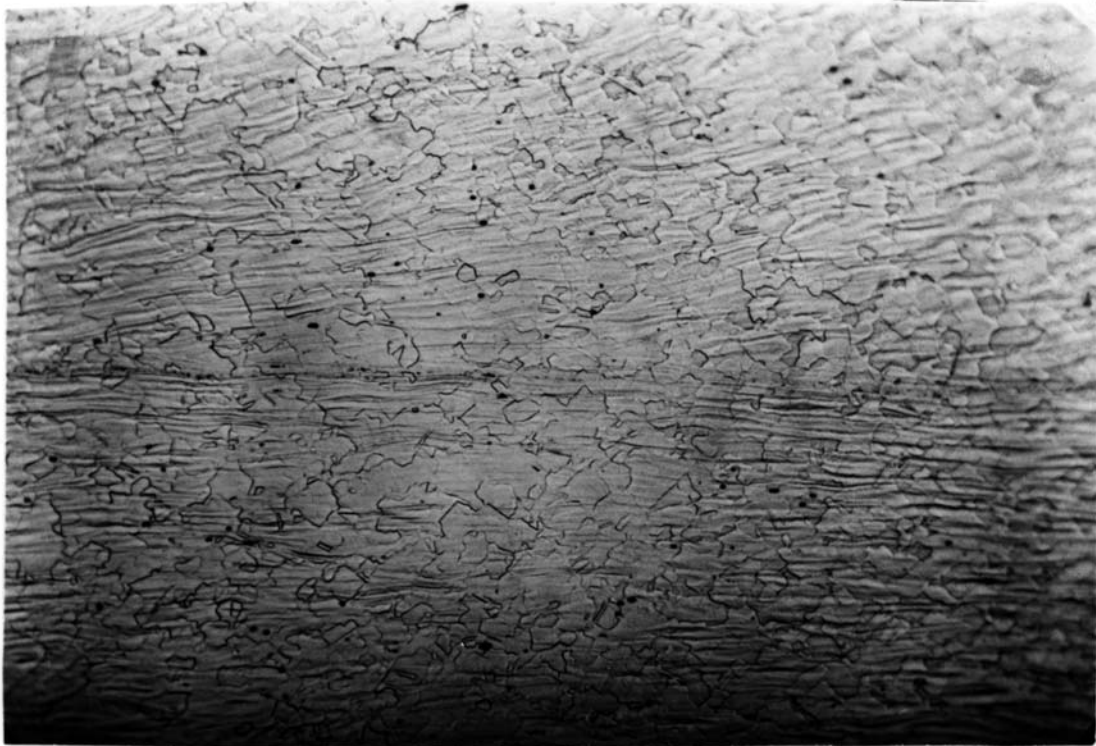
**Class 1.** Interface not visible in etched condition.  
Good grain growth across entire length of  
interface.

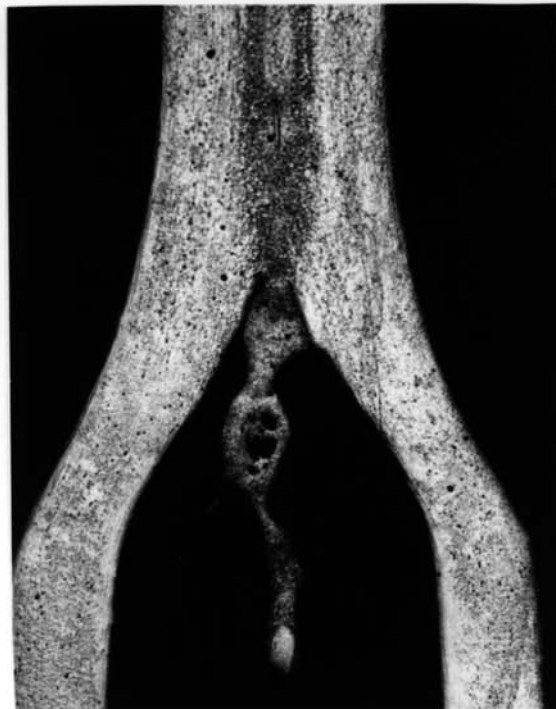
Spitting - Detached resolidified metal.

FIGURE 4 - TYPICAL DEFECTS OCCASIONALLY OBSERVED IN LONGITUDINAL SECTIONS OF PINCH WELDS (BOTH CONFINED AND UNCONFINED).

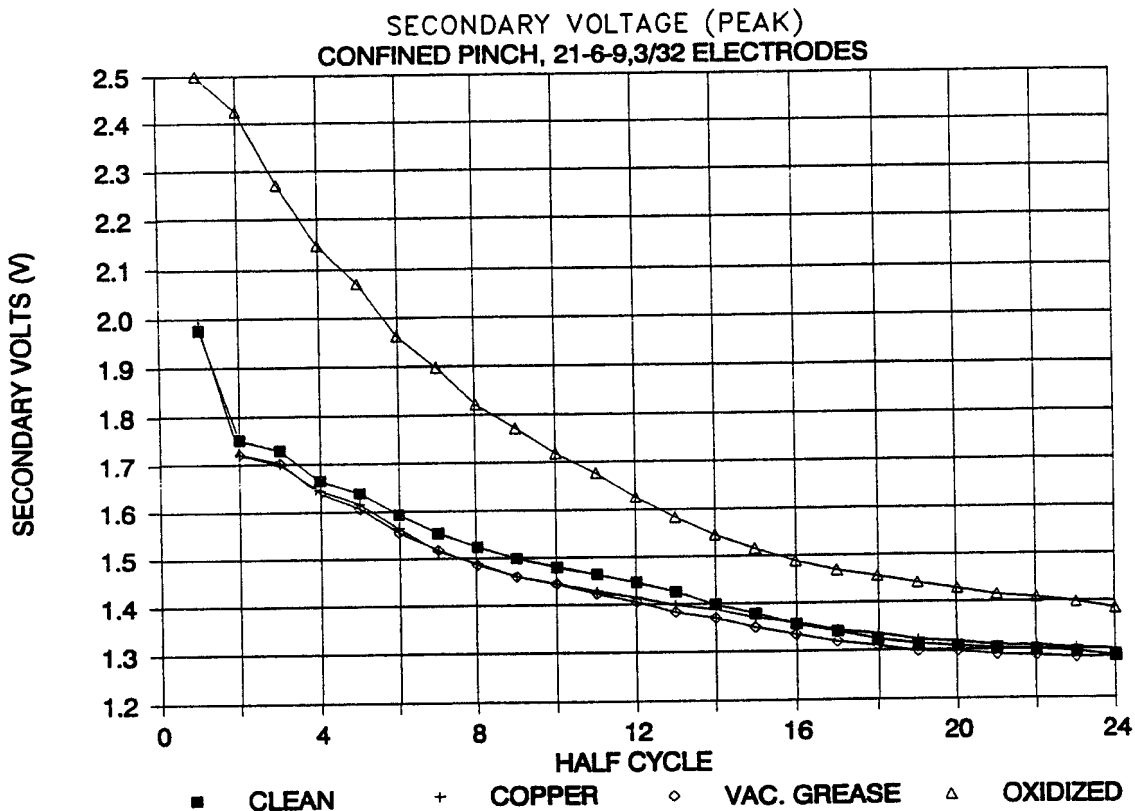
Evaluation of the secondary weld voltage indicated that only the oxidized stems showed significant variations. The increase in voltage drop through the weld can be explained by the increased resistance at the weld interface. Figure 1 shows the peak weld voltage as a function of weld cycle for a cleaned stem and several contaminated stems.

Figure 1 - Secondary weld voltage as a function of weld time.

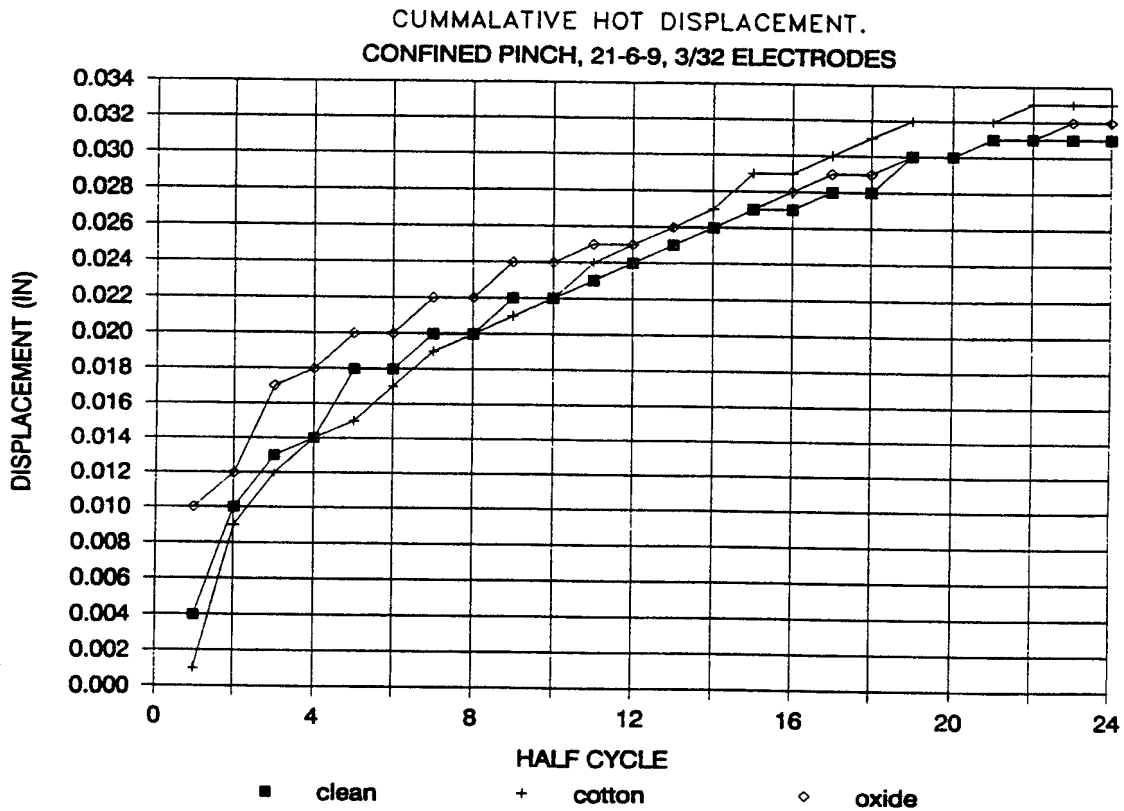
Figure 2 shows the cumulative displacement as it takes place during a weld for a clean stem and stems contaminated with cotton fiber and heavy oxide. Note that there is little difference between the shape of the displacement curves. The oxide trace consistently remains above the other curves because the oxidized tube became thinner during welding.

Figure 2 - Weld displacement as a function of weld time.

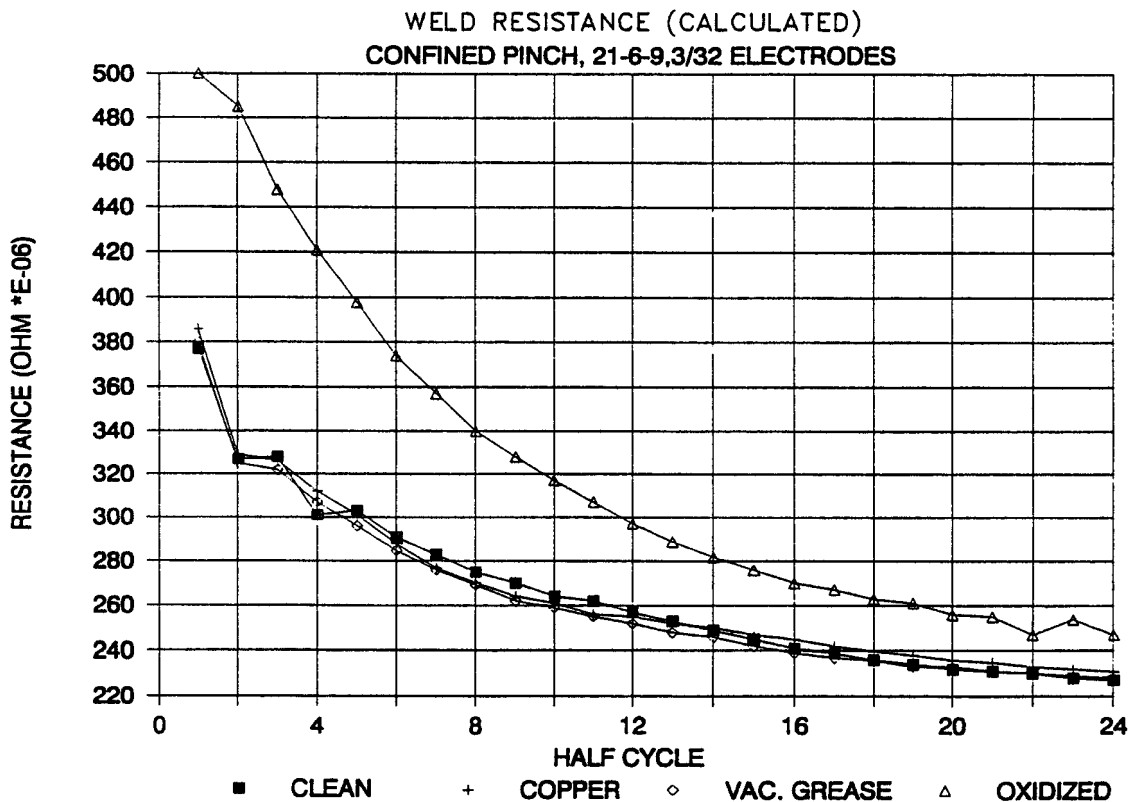
Weld resistance during the weld was obtained by calculating a value using the peak current and voltage for each half cycle. Figure 3 displays the values

Figure 3 - Weld resistance as a function of weld time.

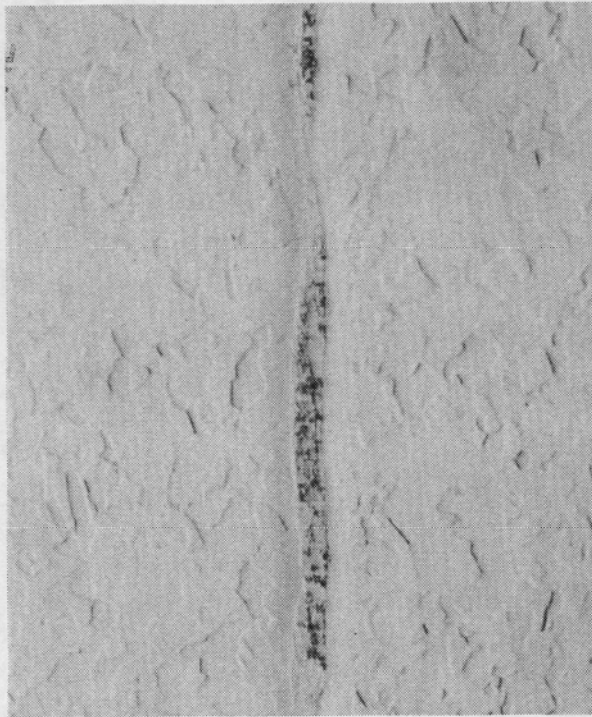
Stems produced by EDM received the most extensive analysis of any contaminant. Figures 33-36 show the resulting poor bond quality. The electrode used during the EDM operation to produce the stem was copper. At first look the bond quality is a generous class 4. A deep valley is produced on etching. Evaluation prior to etching indicated a fairly good bond would exist with areas of defects as shown in Figures 35 and 36. As it turned out, the stems were coated with a copper layer from the EDM operation. Because the etchant used was electrolytic nitric acid, it is understandable that a large valley was formed. Evaluation of the contaminants in Figure 35 showed increased concentrations of chromium, oxygen, carbon, and copper.

Figure 33 - SN 06001, standard pinch 304L, EDM. (22X)

Figure 34 - SN 06001, standard pinch 304L, EDM. (500X)

Figure 35 - SN 020002, standard pinch 304L, EDM. (460X)

Figure 36 - SN 020002, standard pinch 304L, EDM. (460X)

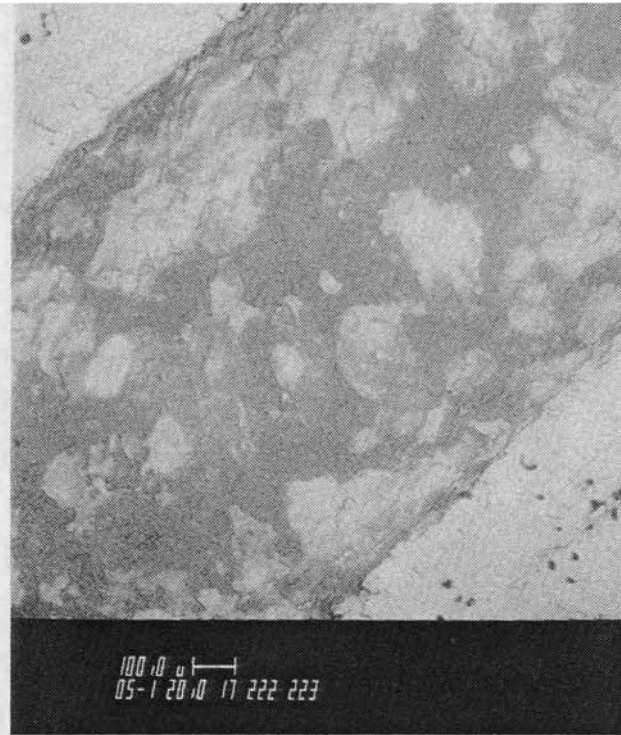
Figures 37 and 38 show the inside surfaces of the stems. A very rough melted surface is evident. Figure 38 is a backscatter image with the darker areas being copper contamination.

Figure 37 - SN 130001, standard pinch 304L, EDM. (50X)

Figure 38 - SN 130001, standard pinch 304L, EDM. (50X)
