Final Report for the Arroyo Las Positas Maintenance Impact Study, Lawrence Livermore National Laboratory

M. van Hattem, L. Paterson

January 2006

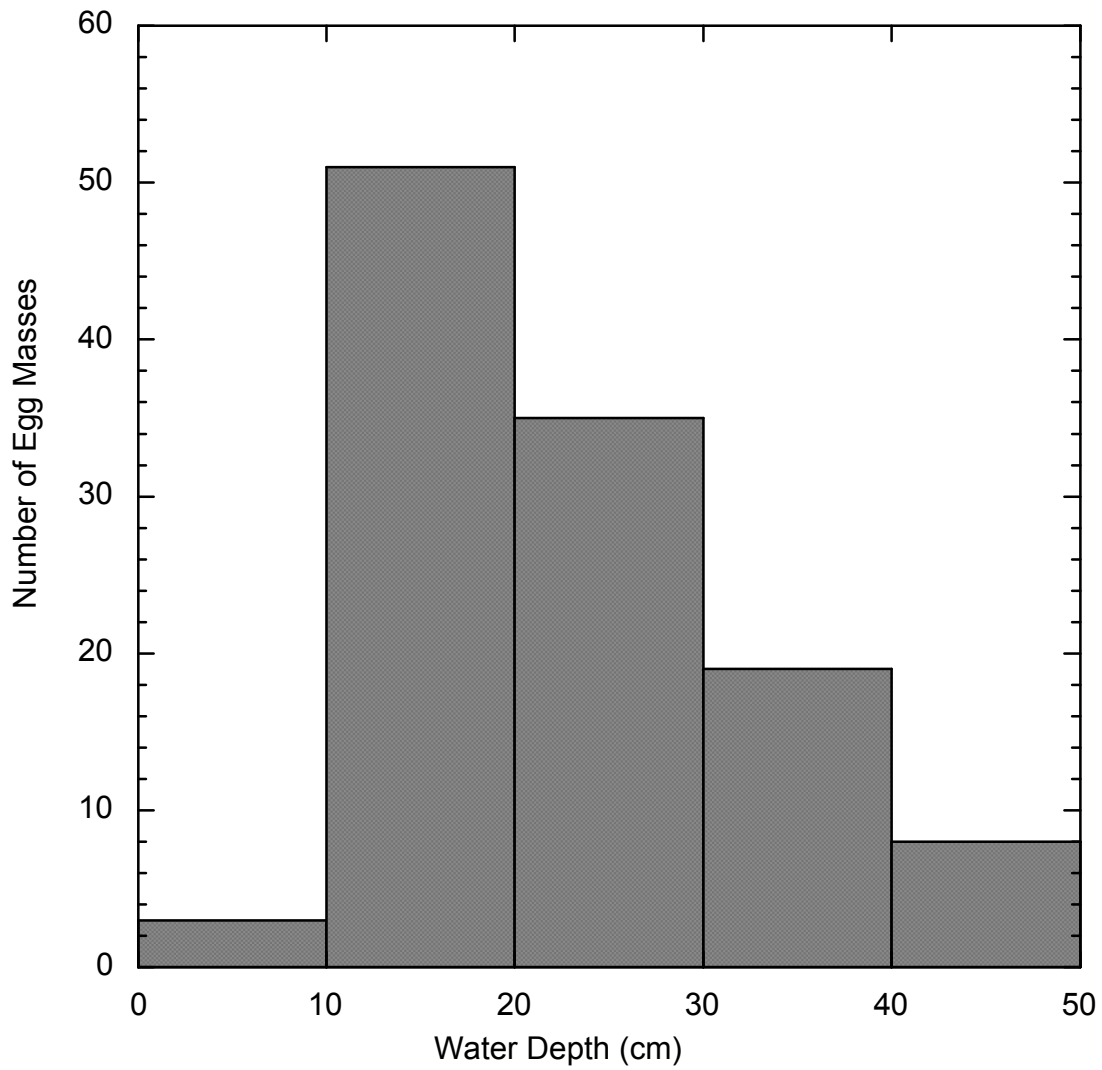
Figure 4. Histogram showing the depth of water at the location of egg mass attachment for egg masses observed from 2001 through 2004. N = 109 (number of egg masses)

Oviposition sites tended to be shallow ($22.86 \text{ cm} \pm 9.40 \text{ cm}$), and all egg masses were located in water shallower than 50 cm (Figure 4). Most egg masses were within one meter of the shore ($65.29 \text{ cm} \pm 40.75$) and near the surface ($3.90 \text{ cm} \pm 6.25 \text{ cm}$). Egg masses were usually deposited on vegetation that provided structure and to a lesser extent rigidity, such as attached inflorescence (*Cyperus* and *Rumex*), but unattached debris such as downed branches and decomposing vegetations were also used for oviposition (Figure 5).

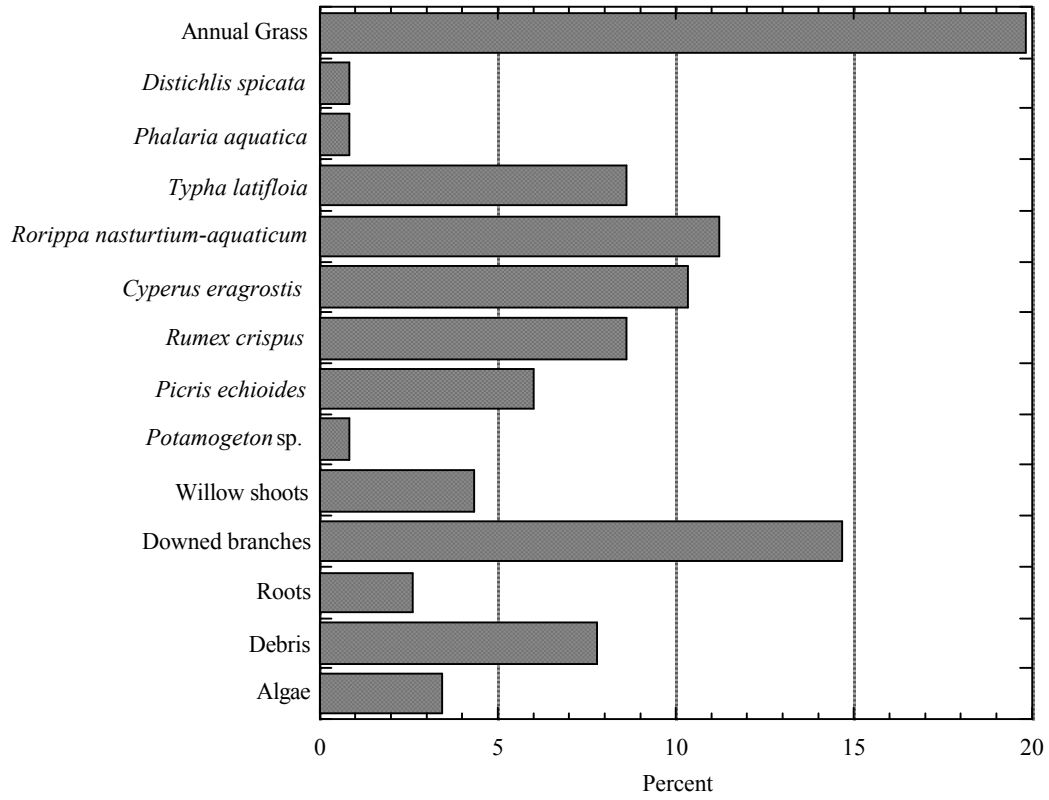
Figure 5. Attachment point for CRLF egg masses 2001-2004. N = 109 (number of egg masses).

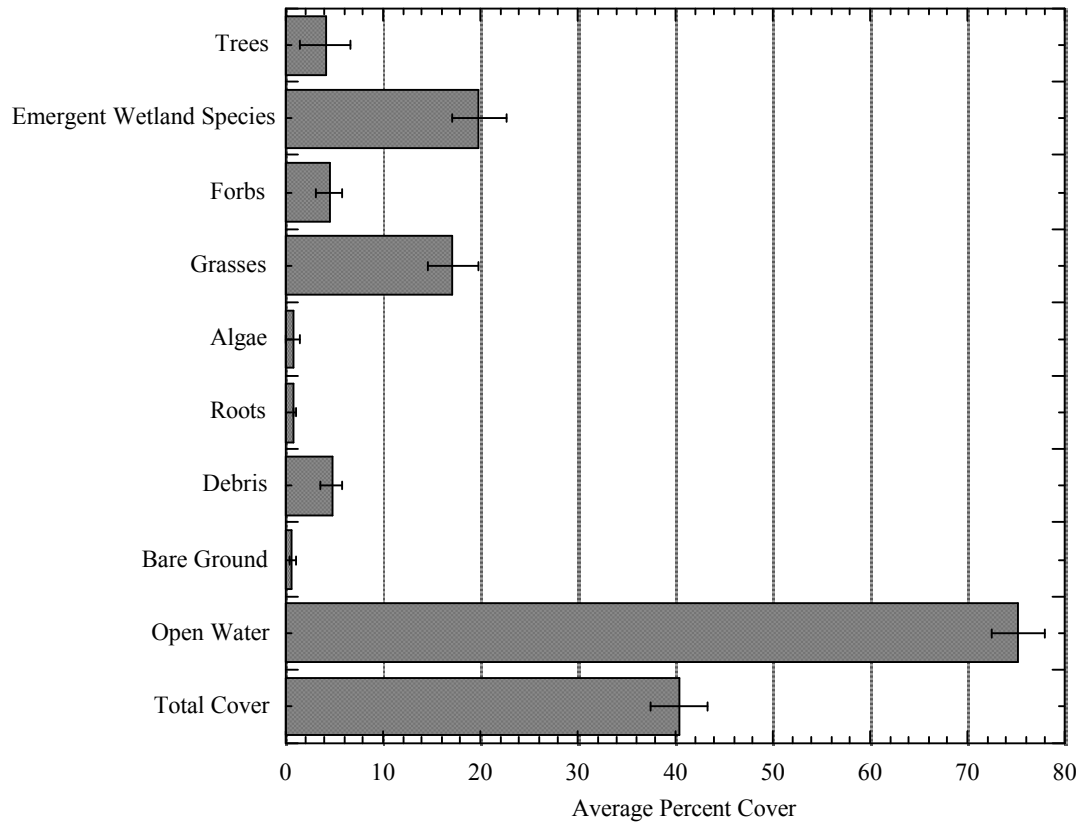
Figure 6. Average percent cover of vegetation types for 1-m² quadrats centered on CRLF egg masses for egg masses observed in 2003 through 2004. N = 46 (number of quadrats). Values are averages \pm 1 SE.

Most 1-m² quadrats centered on egg masses included a portion of the stream bank and a portion of the hydrated stream channel, as a result cover estimates include emergent wetland species that occur in the stream channel, and upland and facultative wetland species that occur on the banks of the stream just above the water level (Figure 6). Egg masses were located in areas with $64.0\% \pm 17.9\%$ cover of open water. Grasses and emergent wetland species covered similar percentage of the quadrats (Table 1). The most common species were the exotic grass *Echinochloa crus-galli* ($6.0 \pm 13.3\%$ cover) and two emergent wetland species *Cyperus eragrostis* ($5.6 \pm 10.7\%$ cover) and *Rorippa nasturtium-aquaticum* ($6.6 \pm 12.1\%$ cover). One tree species, *Salix exigua*, was found in the vegetation quadrats. *S. exigua* was only found near three of the 39 egg masses located in Arroyo Las Positas in 2003 and 2004.

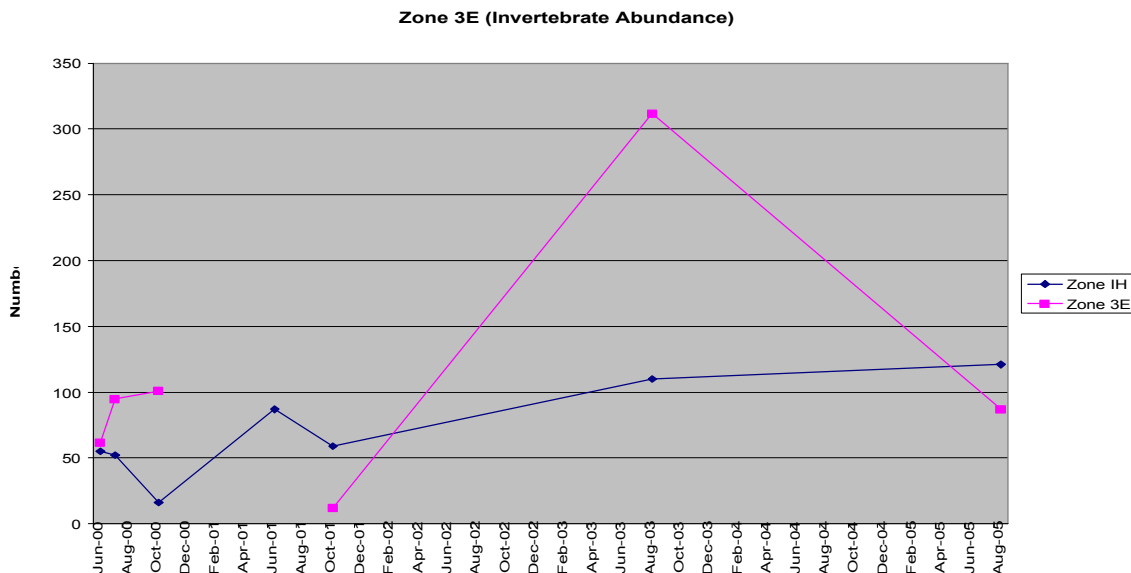
Figure 7. Macro-invertebrate abundance in Zone 3E between June 2000 and August 2005.

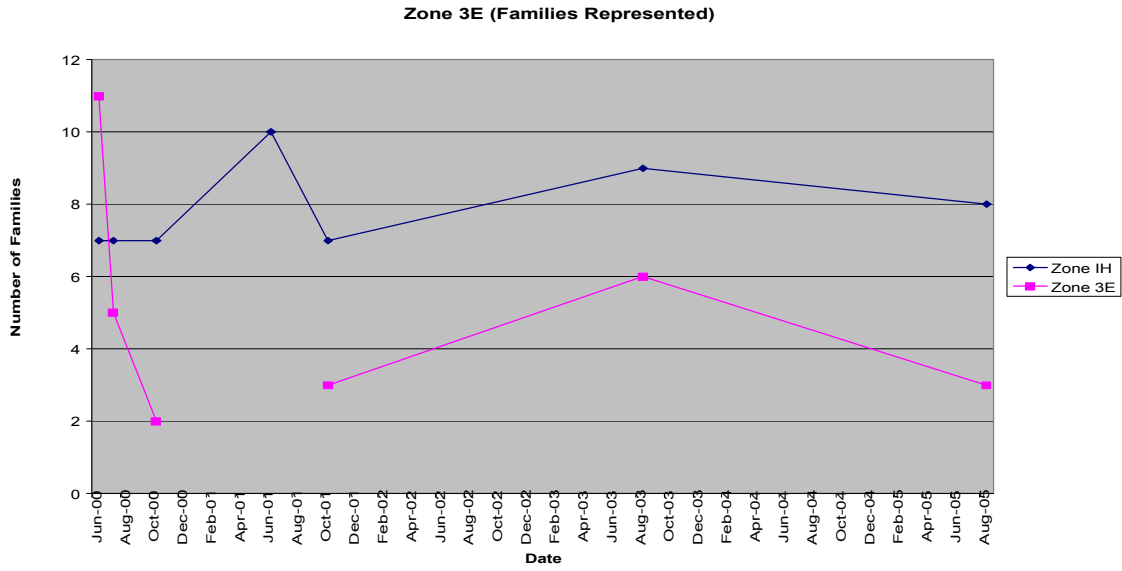
Figure 8. Number of macro-invertebrate families in Zone 3E between June 2000 and August 2005.

Seven invertebrate families were collected during both baseline surveys in the control site 1H in 2000. Families collected in 3E ranged from 11 to 6 in June 2000 and July 2000 respectively. The number of families represented in 3E showed a steep drop relative to the control and to the baseline numbers following dredging activities in the summer of 2000 and remained low through October 2001. Families increased to near pre-project levels in 2003, but fell again in 2005. The most significant change occurred between the two pre-project samples when family numbers dropped by 55% (Figure 8).

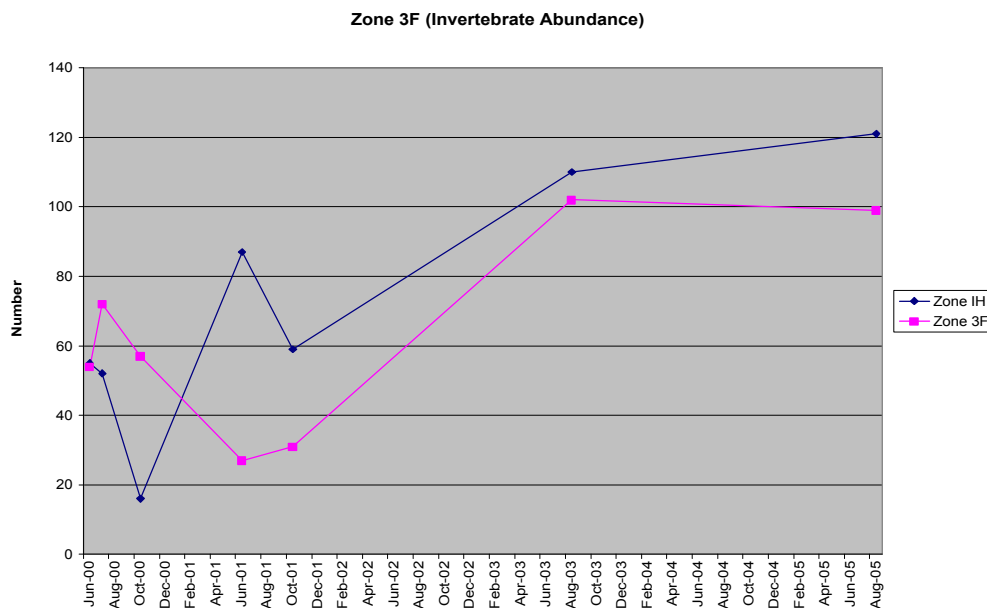
Figure 9. Macro-invertebrate abundance in Zone 3F between June 2000 and August 2005.

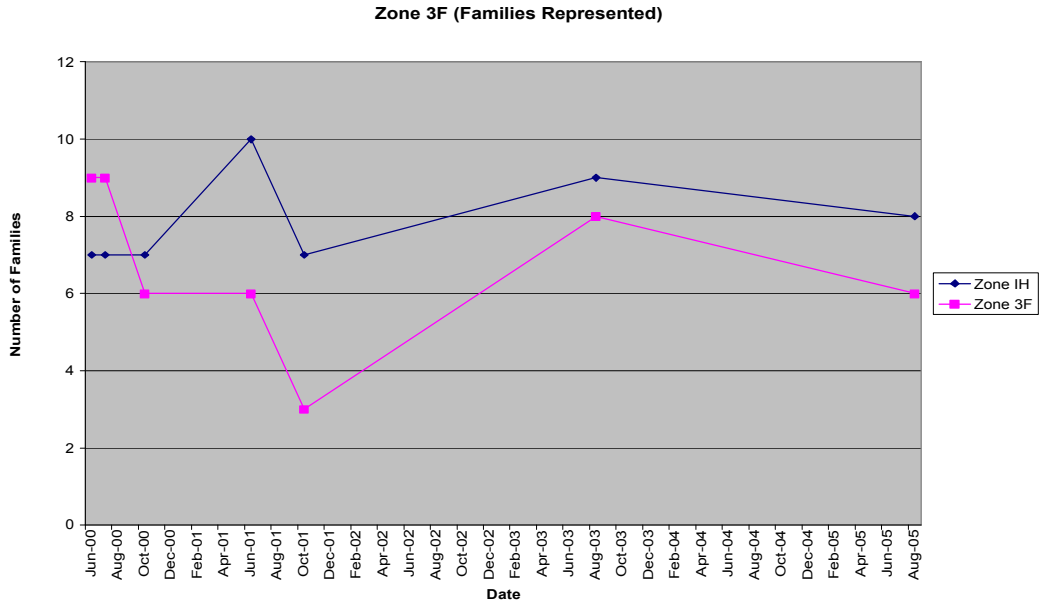
Figure 10. Number of macro-invertebrate families in Zone 3F between June 2000 and August 2005.

Seven invertebrate families were collected during both baseline surveys in the control site 1H in 2000. Nine families were represented in site 3F during the same time period. After dredging in the summer of 2000, family numbers in site 3F dropped by 66% to three through 2001 and increased to 8 in 2003. The final survey yielded 6 families, 33% below baseline numbers. Families represented in the control site were more abundant in all post dredging samples except in 2001 when they remained the same (Figure 10).

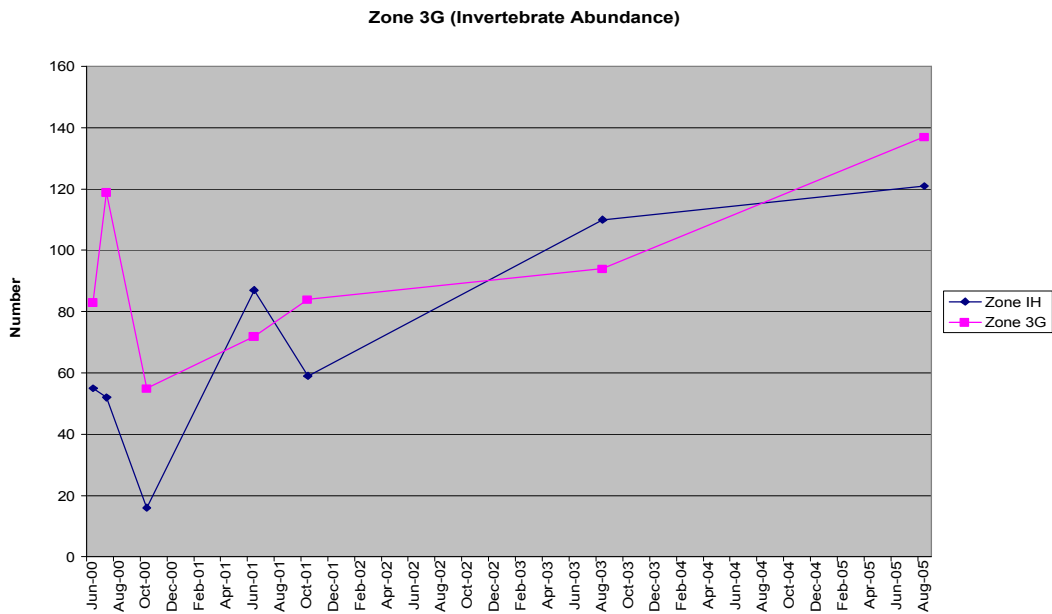
Figure 11. Macro-invertebrate abundance in Zone 3G between June 2000 and August 2005.

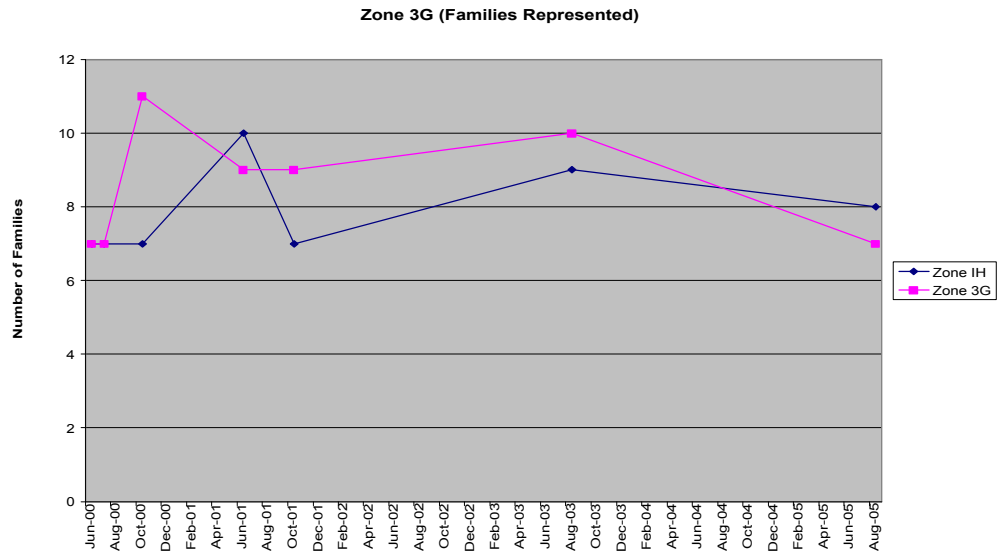
Figure 12. Number of macro-invertebrate families in Zone 3G between June 2000 and August 2005.

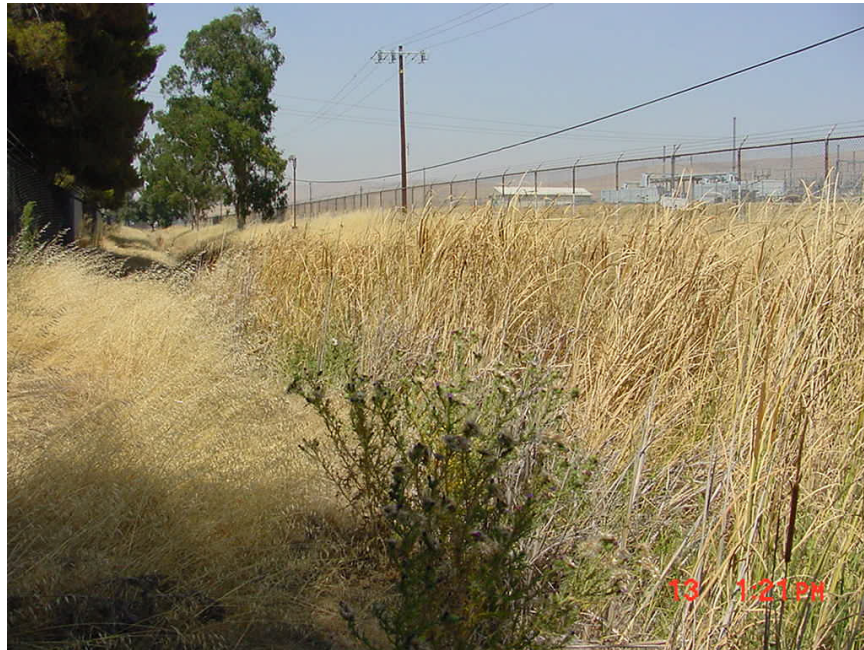
Figure 13. Zone 3C was uniformly cattail dominated in 2000. The above photograph was actually taken from Zone 3B, adjacent to 3C. As shown in this Figure and Figure 14, cattails dominated Reach 1 from the ALP infall to the northeast corner and the start of Reach 2.

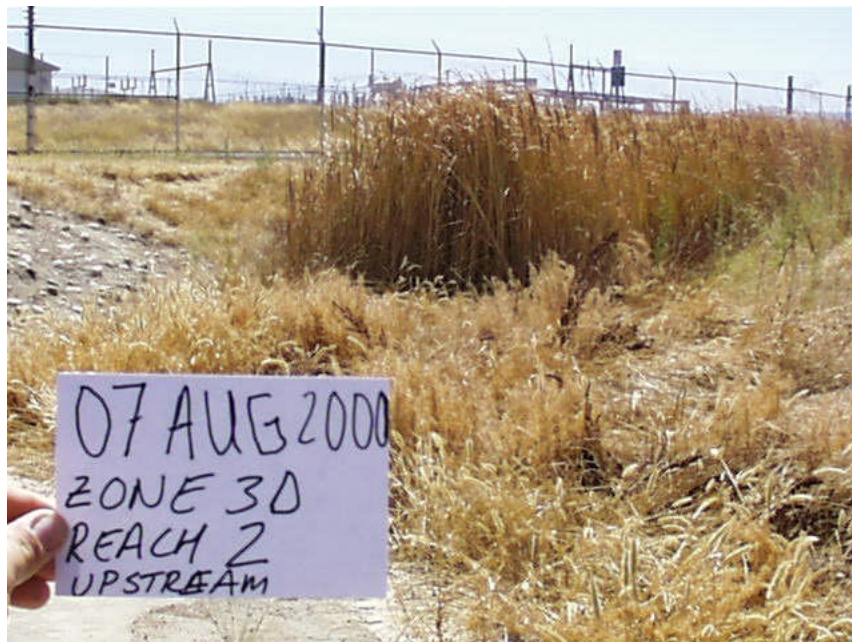
Figure 14. Zone 3D is uniformly cattails as described in Figure 13, from the ALP infall to the transition to Reach 2. Although this figure is not of Zone 3C, it shows the uniformity of cattail through the Reach 1.

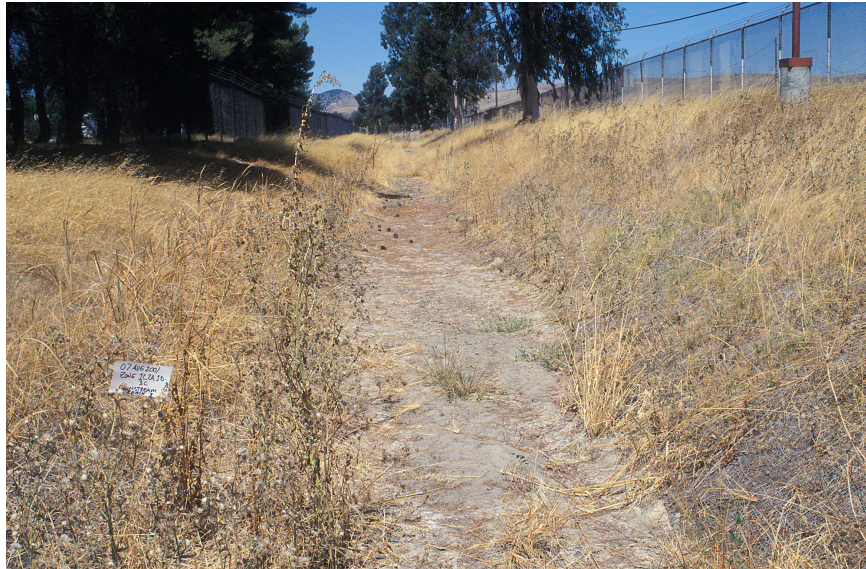
Figure 15. In 2001, Zone 3C (downstream view) contained no water by summer so vegetation re-growth was limited to exotic annual grasses.

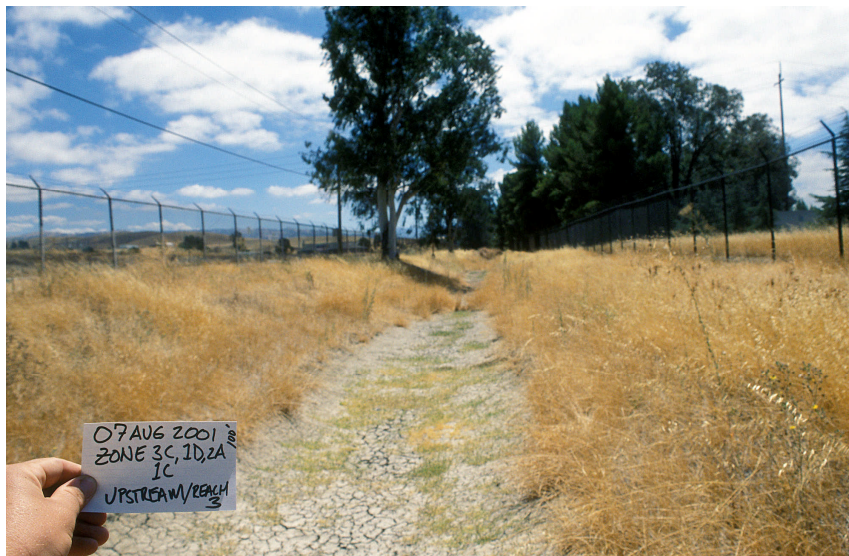
Figure 16. Re-growth in the lower portion of Zone 3C was limited to exotic annual grasses.

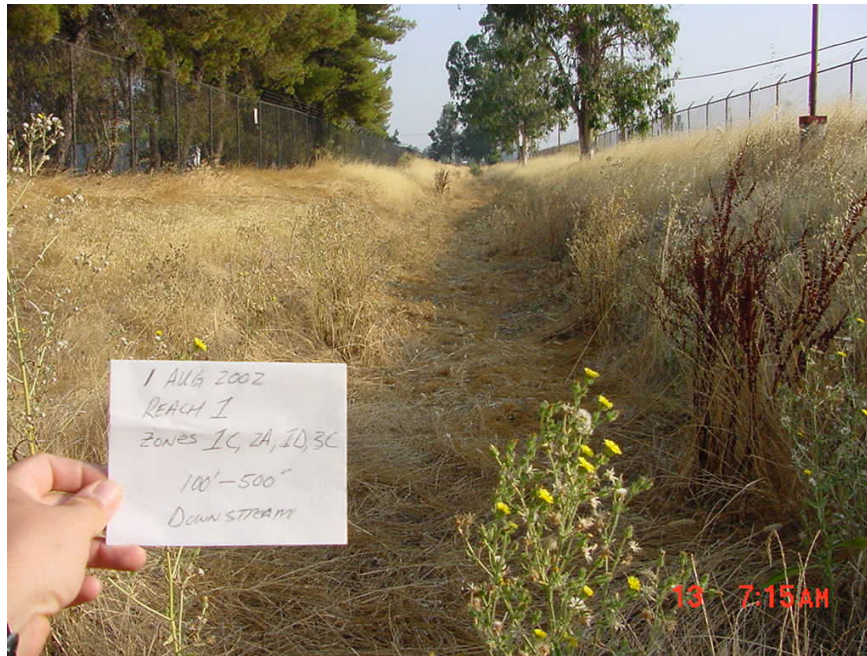
Figure 17. In 2002, Zone 3C showed uniform coverage by annual grasses and limited growth of clustered dock and spiny sowthistle.

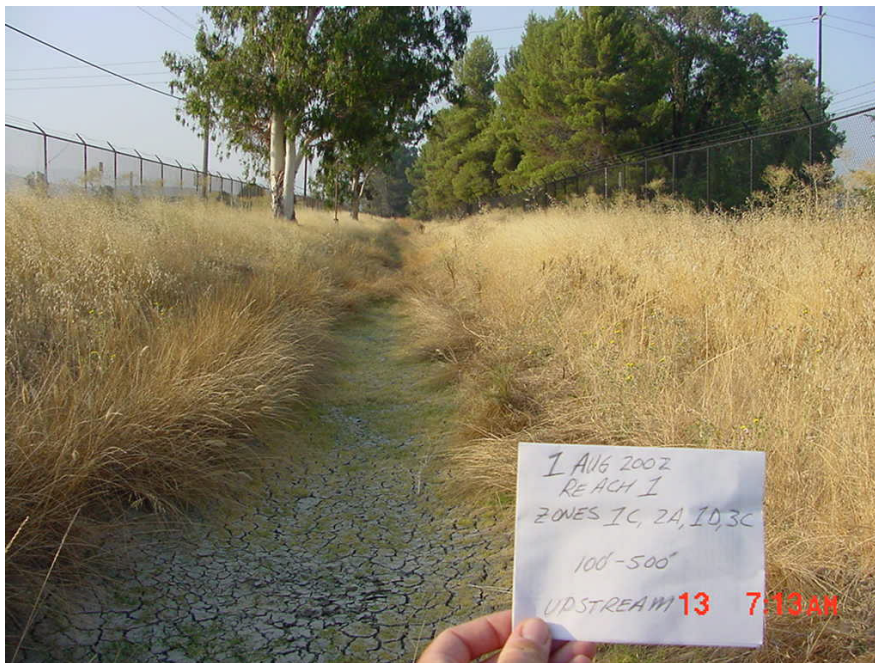
Figure 18. Re-growth in the lower portion of Zone 3C remained unchanged from 2001.

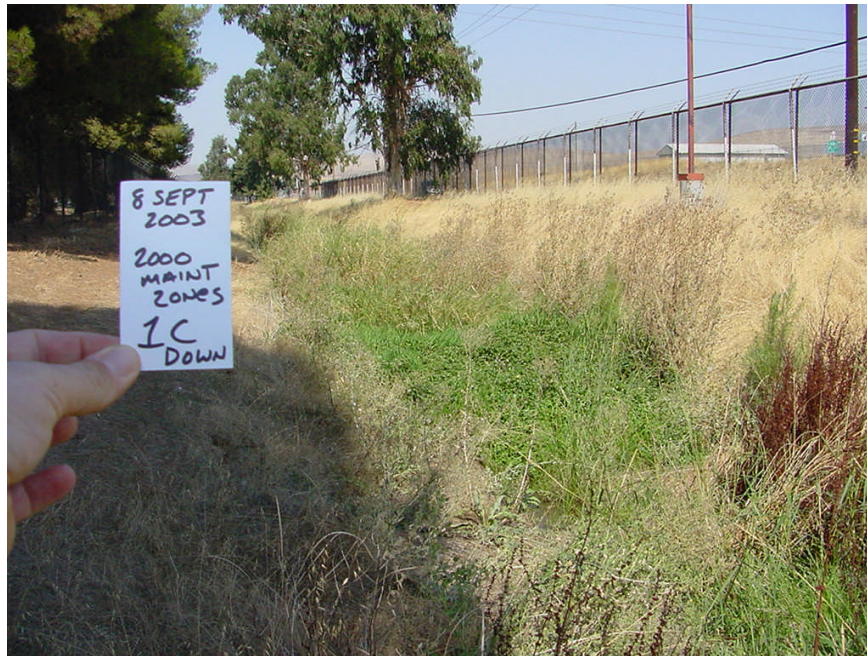
Figure 19. In 2003, Zone 3C showed substantial growth due to unseasonal hydration associated with offsite water management. Species diversity was similar to previous years.

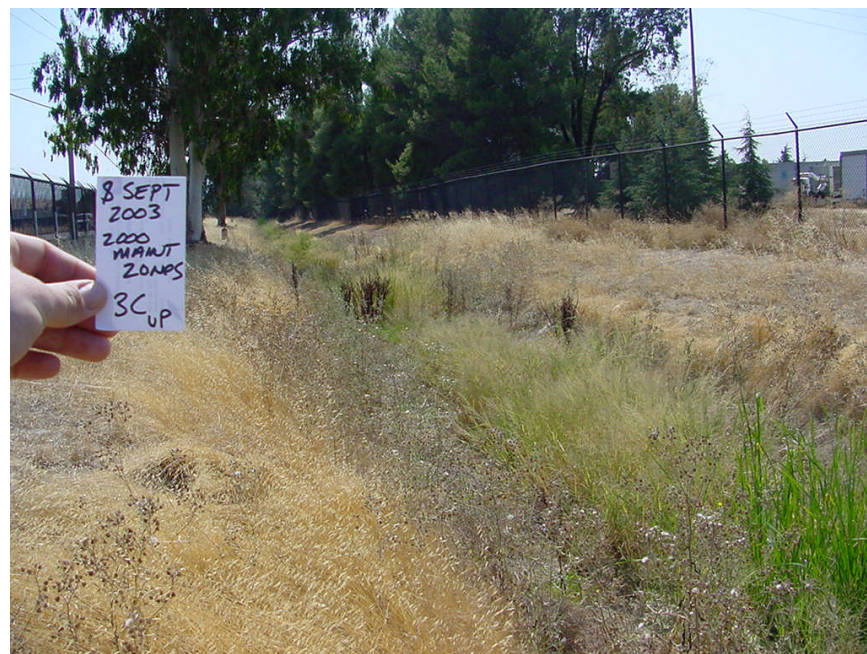
Figure 20. Similar to the upper portion of Zone 3C, substantial growth occurred in 2003 due to hydration from offsite water management, however, most of the growth was Italian ryegrass (*Lolium multiflorum*).

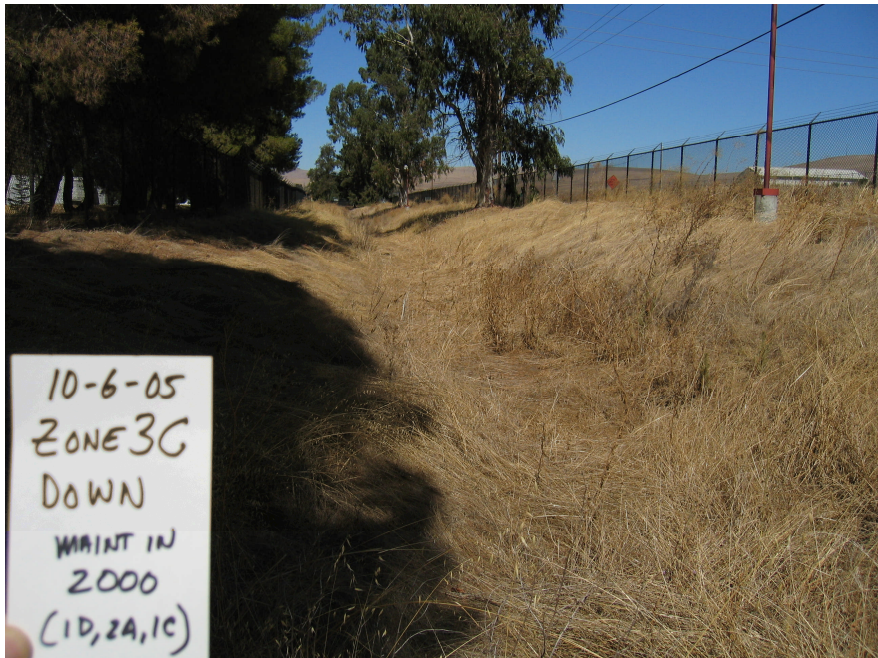
Figure 21. By 2005, the water that was entering the ALP in Reach 1 (2003) was gone and dry conditions prevailed. Vegetation was mostly wild oats, Italian ryegrass, and spiny sowthistle.

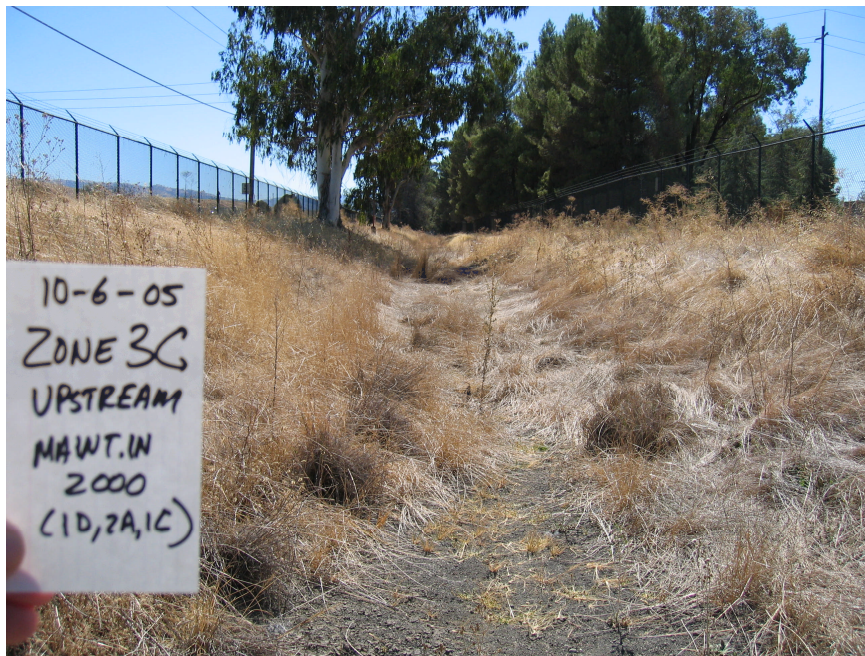
Figure 22. Similarly to the upper portions of 3C, the lower sections were dry and lacked wetland vegetation.

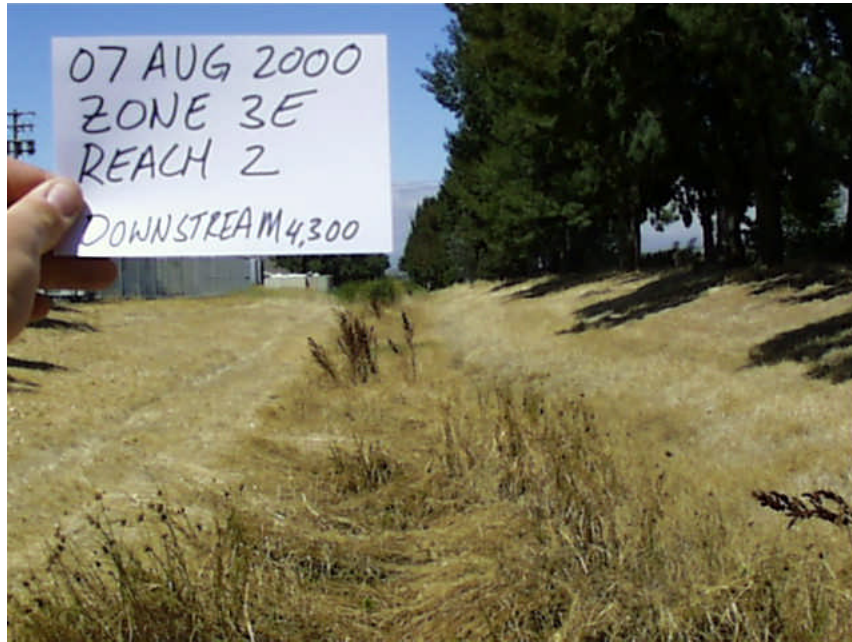
Figure 23. The upper 60% of Zone 3E is hydrated naturally through rainfall and not CERCLA effluent, therefore, the upper portion of 3E (downstream view) is dry during most summers. Species like rabbitfoot polypogon, clustered dock, and alkali bulrush were most common in this portion of the zone.

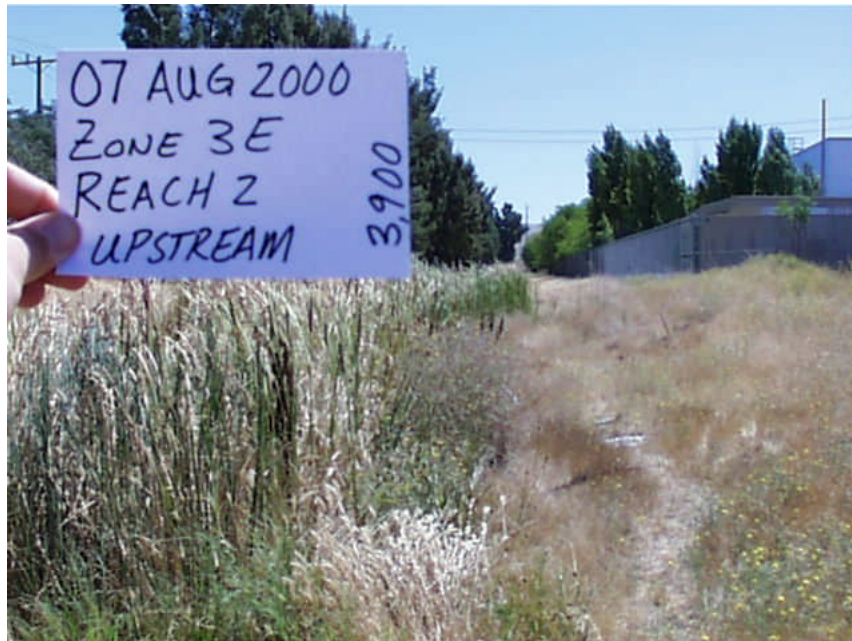
Figure 24. The lower 40% of Zone 3E (upstream view) is hydrated by both natural rainfall and runoff from site landscaping. The resulting cattail growth (shown in the photograph) is a function of the artificial flow (note the perpendicular growth of cattails at the bottom right of the identification card).

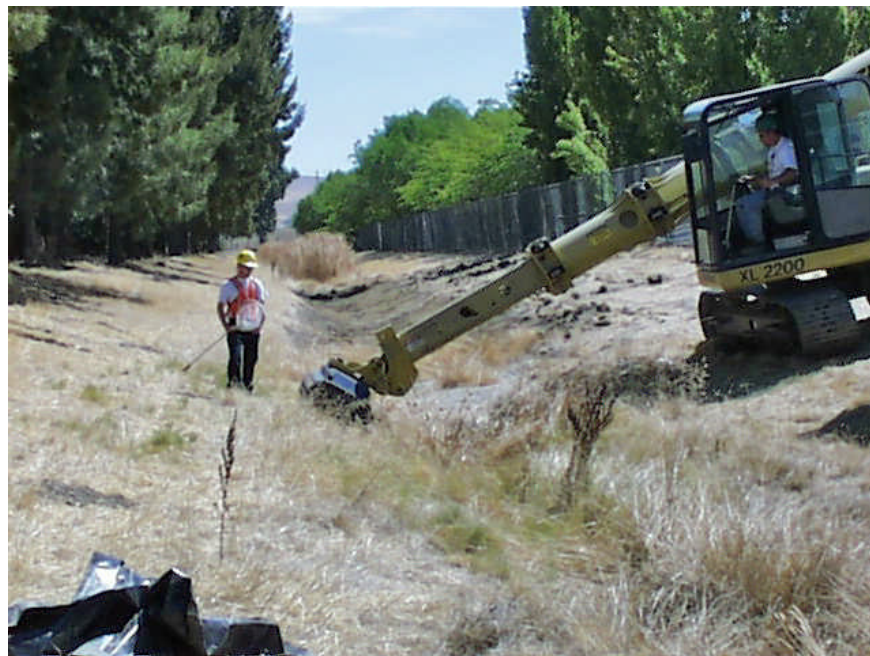
Figure 25. A biologist closely monitored all dredging activities to reduce the potential of California red-legged frog mortality.

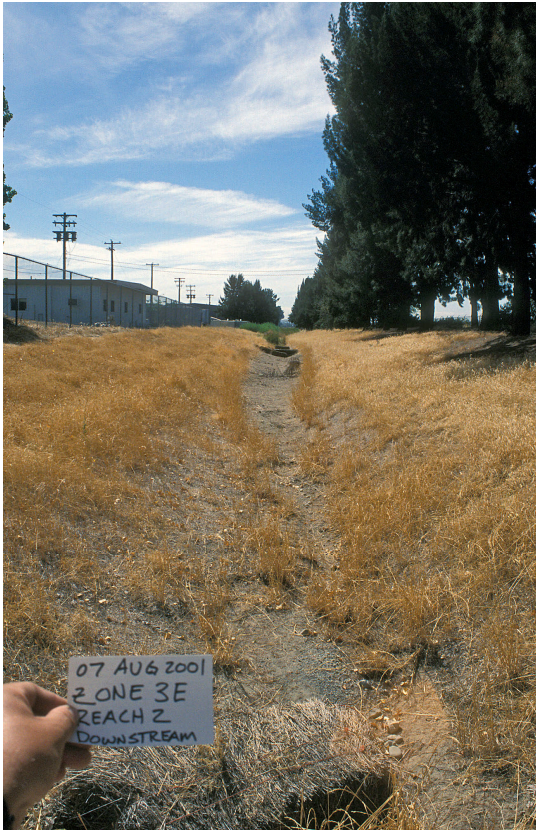
Figure 26. The upper portion of Zone 3E showed no natural wetland recovery in 2001.

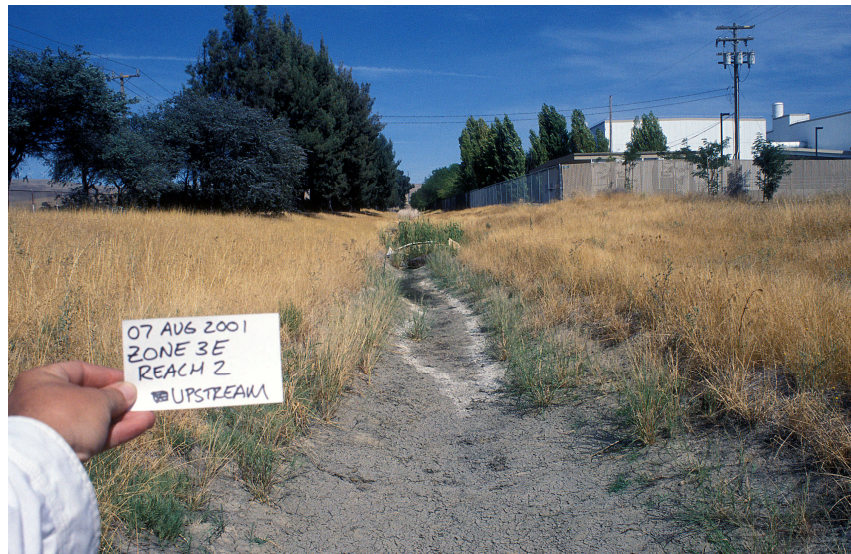
Figure 27. Zone 3E remained dry and wetland vegetation remained un-established except where cattails developed near the center of the zone where site landscaping runoff enters the zone from a storm drain.

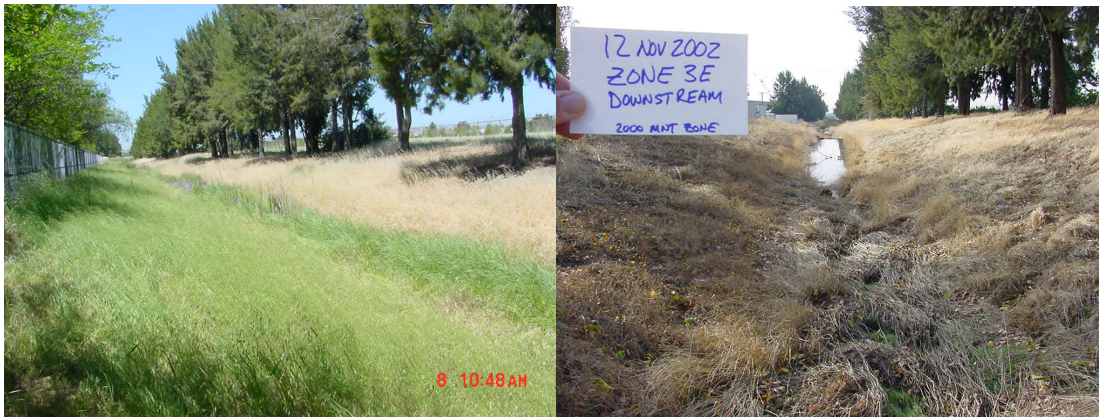
Figure 28. Zone 3E with summer annual grass growth (left) consisting mostly of wild oats (*Avena fatua*) and then again in fall (right) with pool formation up the storm drain outfall.

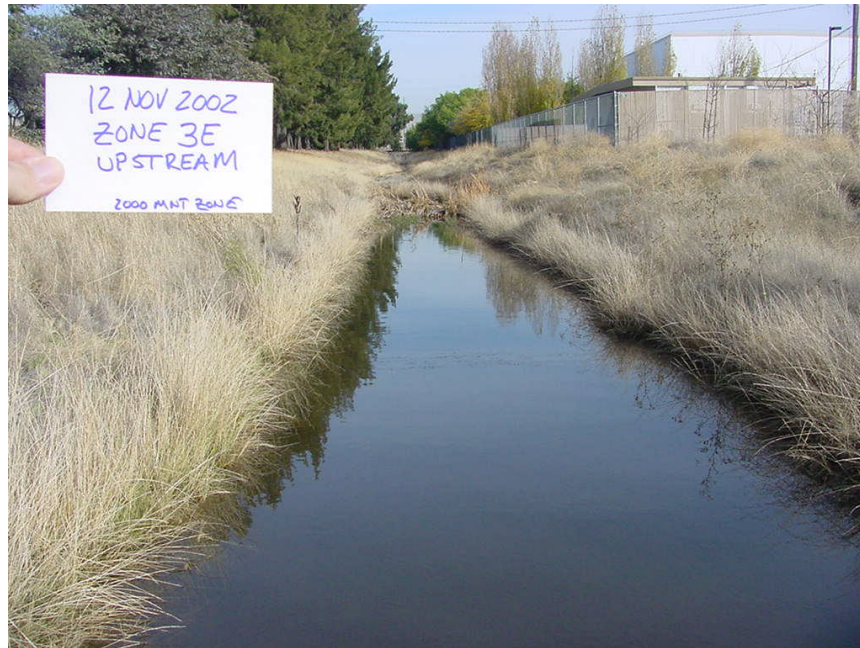
Figure 29. Zone 3E hydrated with storm drain effluent.

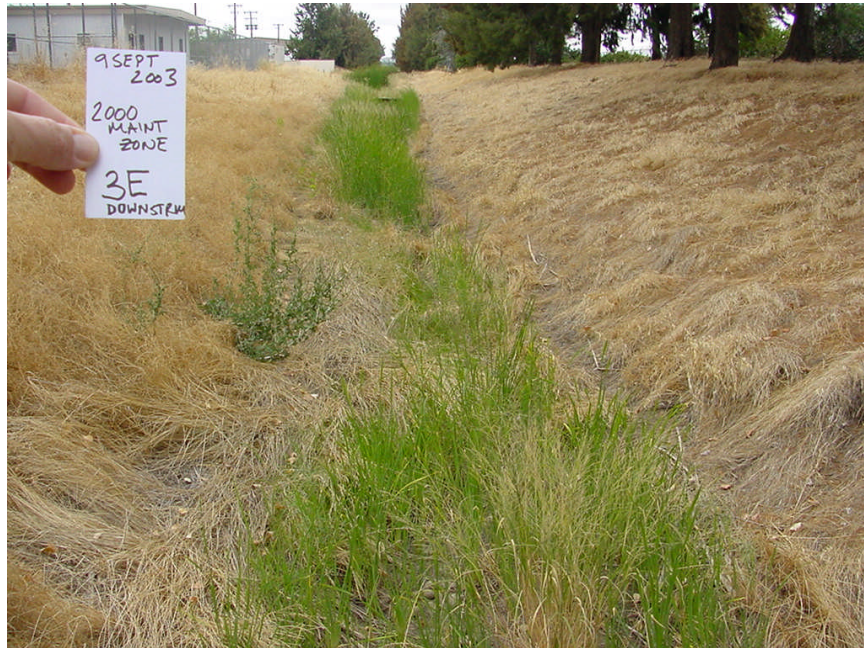
Figure 30. Zone 3E with annual grass growth consisting mostly of wild oats.

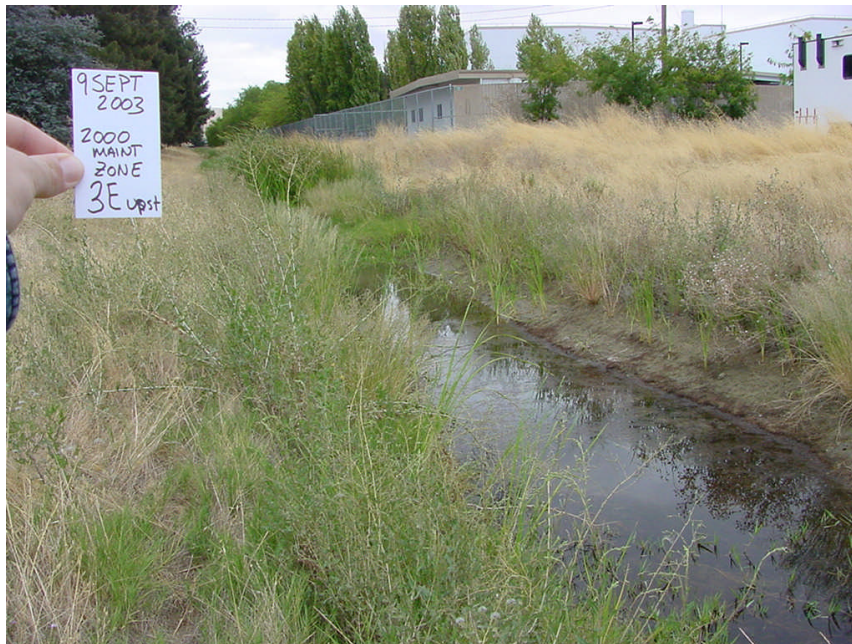
Figure 31. Zone 3E continued to be hydrated, but with little formation of hydrophytes except at the outfall of the storm drain near the middle of the zone.

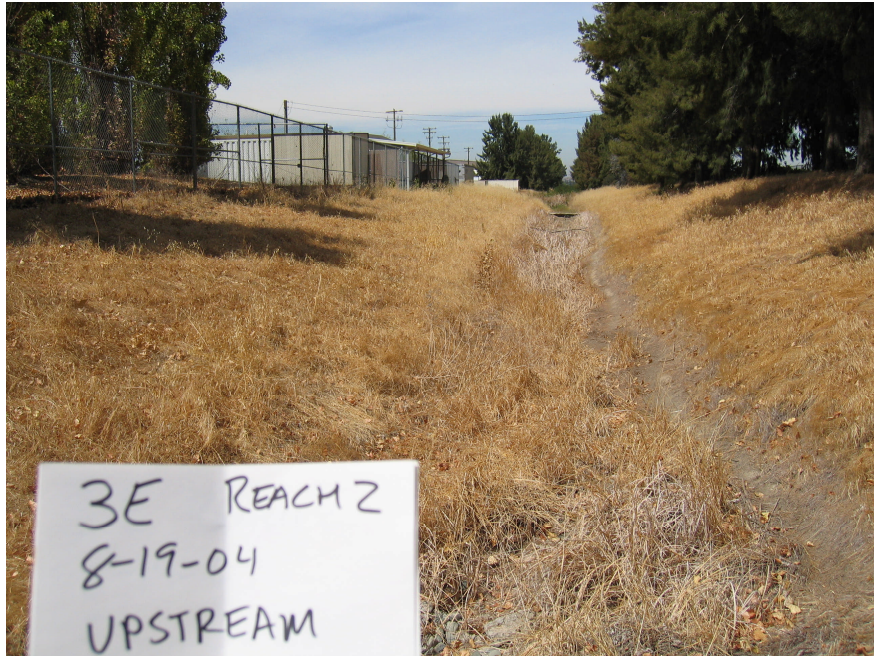
Figure 32. Zone 3E with annual grass growth consisting mostly of wild oats. Note the identification card is mislabeled as “upstream view,” but is actually the downstream view.

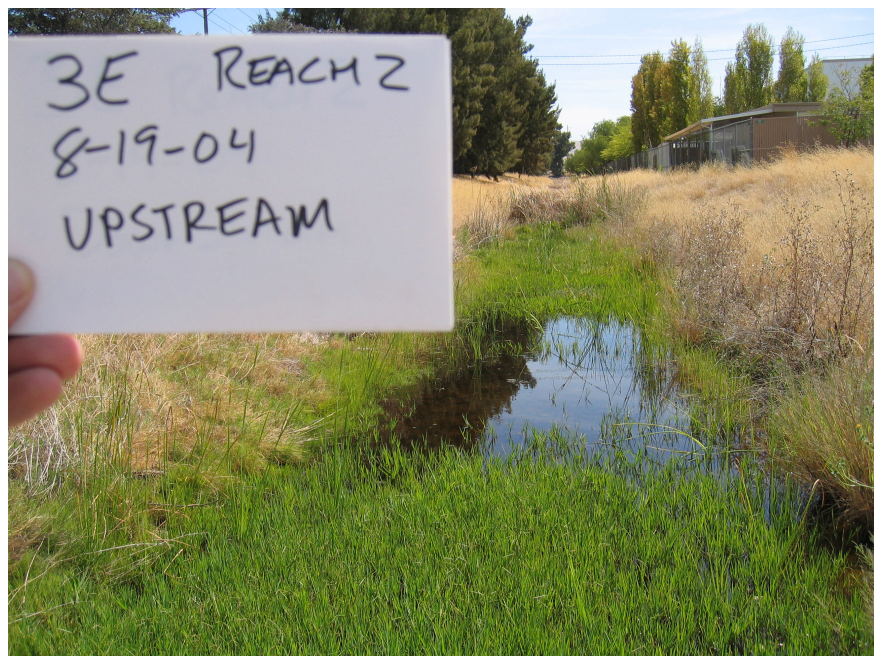
Figure 33. Zone 3E continued to be hydrated into 2004 and began to form patches of Bermuda grass (*Cynodon dactylon*) with cattail growth.

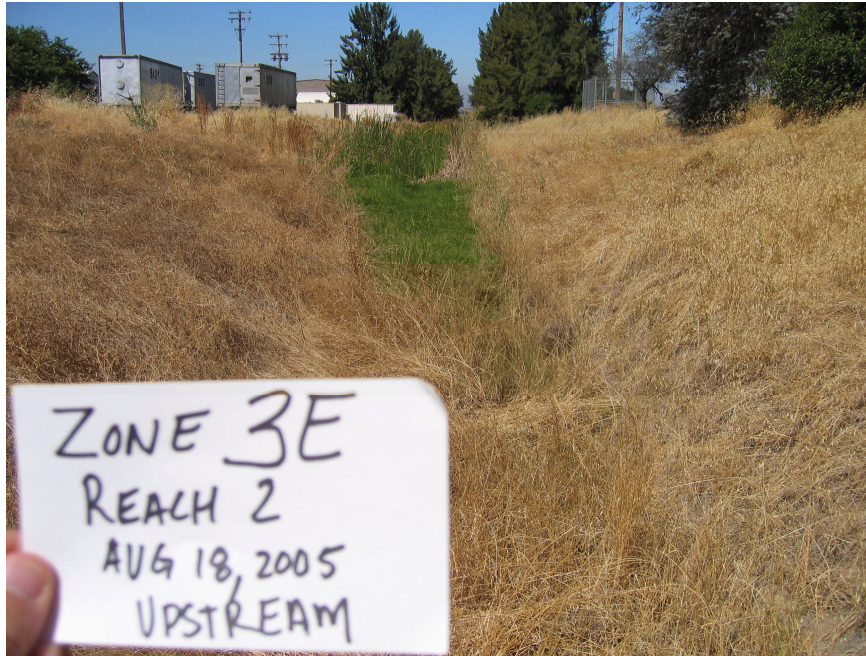
Figure 34. Zone 3E with annual grass growth consisting mostly of wild oats. Note the identification card is mislabeled as “upstream view,” but is actually the downstream view.

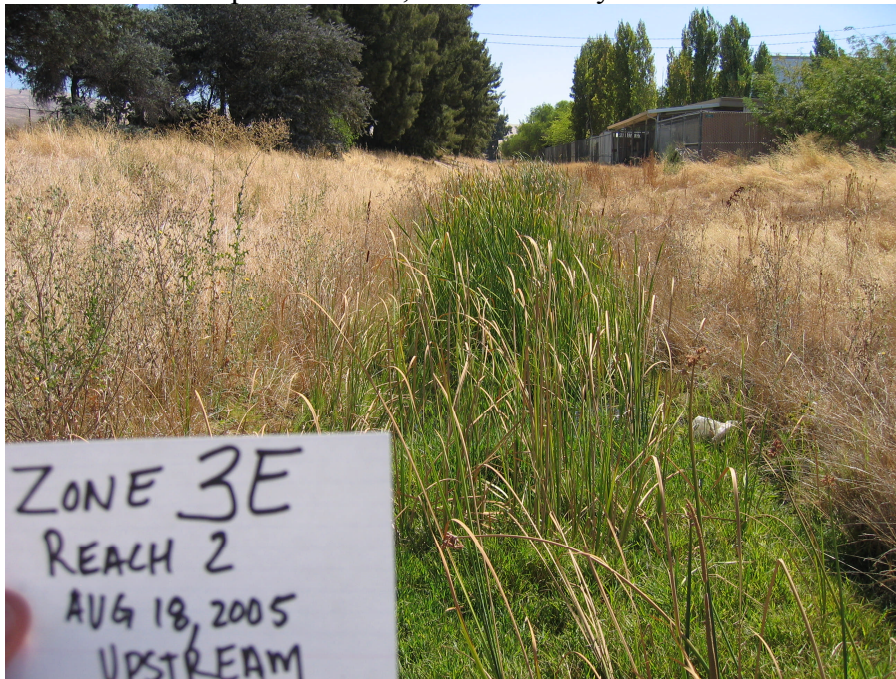
Figure 35. Zone 3E showed substantial cattail growth from previous years.

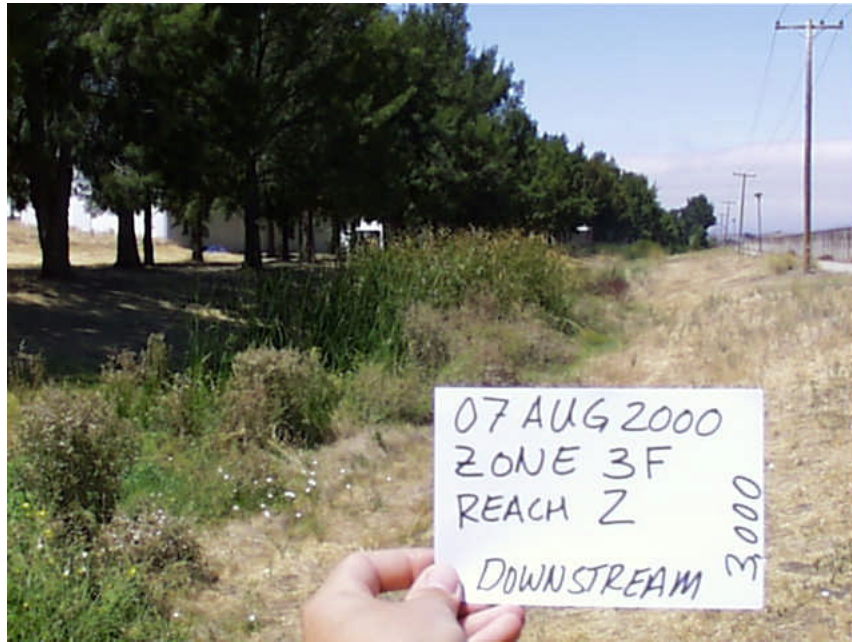
Figure 36. Photograph showing the top of Zone 3F with mature wetland vegetation (downstream view) prior to dredging in 2000. Note large defined patches of cattails and robust herbaceous growth, including spiny sowthistle and tall flatsedge in the foreground. No open water habitat existed in this zone prior to dredging activities.

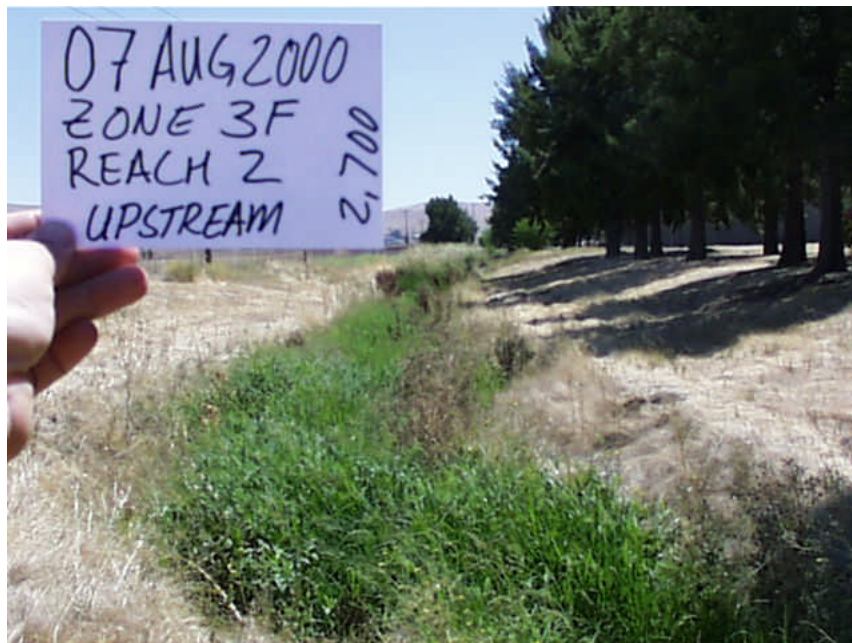
Figure 37. Photograph showing the lower end of Zone 3F with mature wetland vegetation (upstream view) prior to dredging in 2000. Pale smartweed, perennial grasses, and tall flatsedge dominated the lower portion of Zone 3F. No open water habitat occurred in this zone prior to dredging.

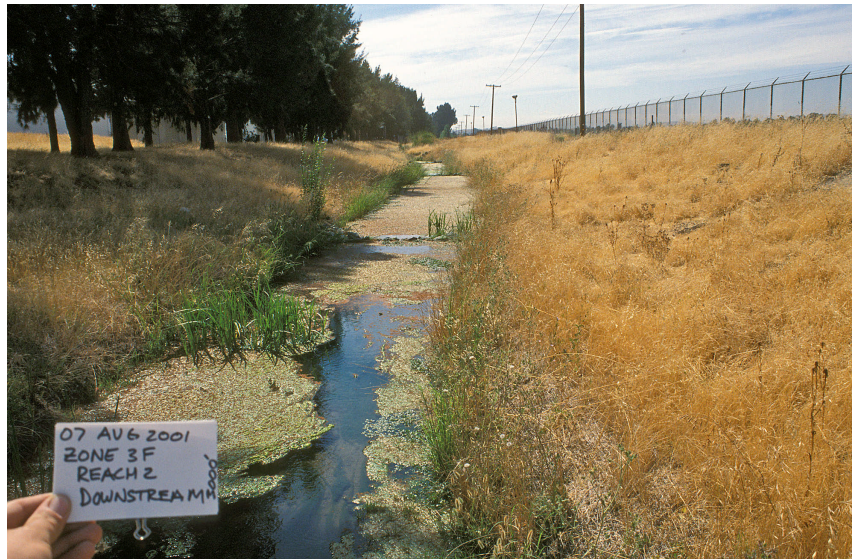
Figure 38. Photograph showing the top of Zone 3F with mature wetland vegetation (downstream view) prior to dredging in 2000. Note large defined patches of cattails and robust herbaceous growth, including spiny sowthistle and tall flatsedge in the foreground. No open water habitat existed in this zone prior to dredging activities.
