Final Report for the Arroyo Las Positas Maintenance Impact Study, Lawrence Livermore National Laboratory

M. van Hattem, L. Paterson

January 2006

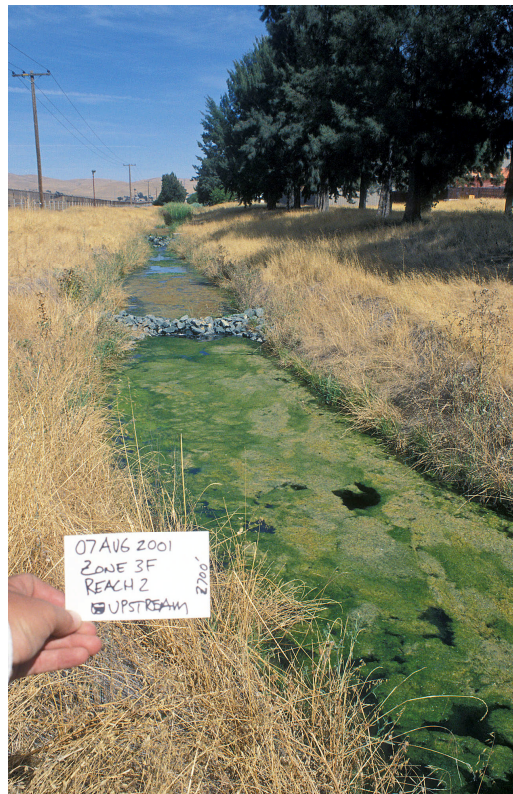
Figure 39. Photograph showing the lower end of Zone 3F (upstream view) with early succession annual and perennial grasses (upstream view). Open water habitat with significant algal growth was the dominant feature in 2001. Note rock weirs used for grade adjustment.

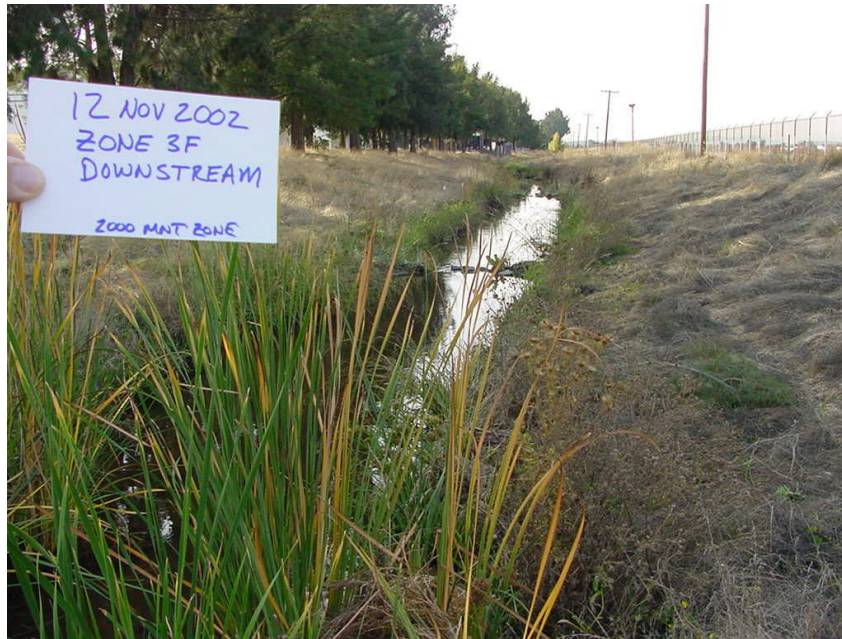
Figure 40. Photograph showing the top of Zone 3F (downstream view) with wetland vegetation reestablishing throughout the littoral zone.

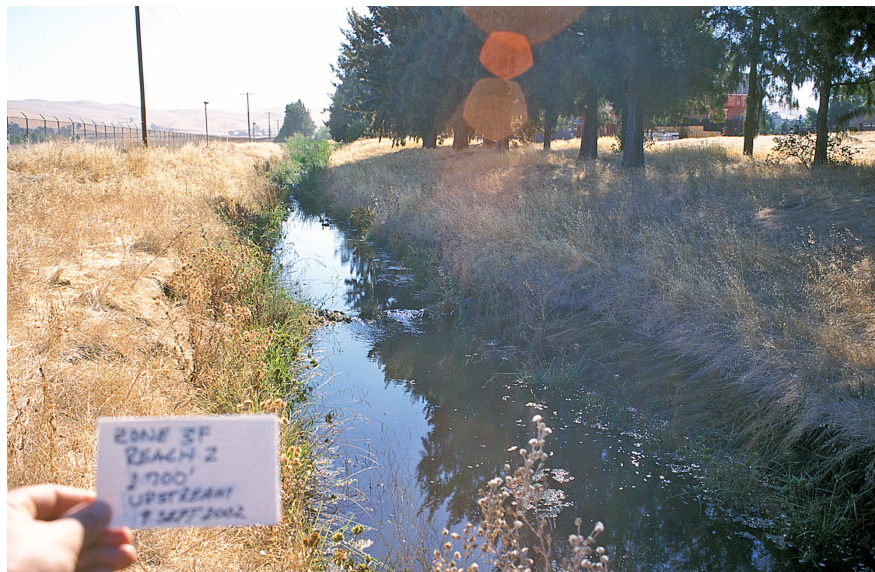
Figure 41. Wetland plants such as tall flatsedge increased in 2002, but remained in a mosaic of annual grasses and spiny sowthistle in the lower portion of 3F. Open water habitat remained prevalent in this portion of the zone.

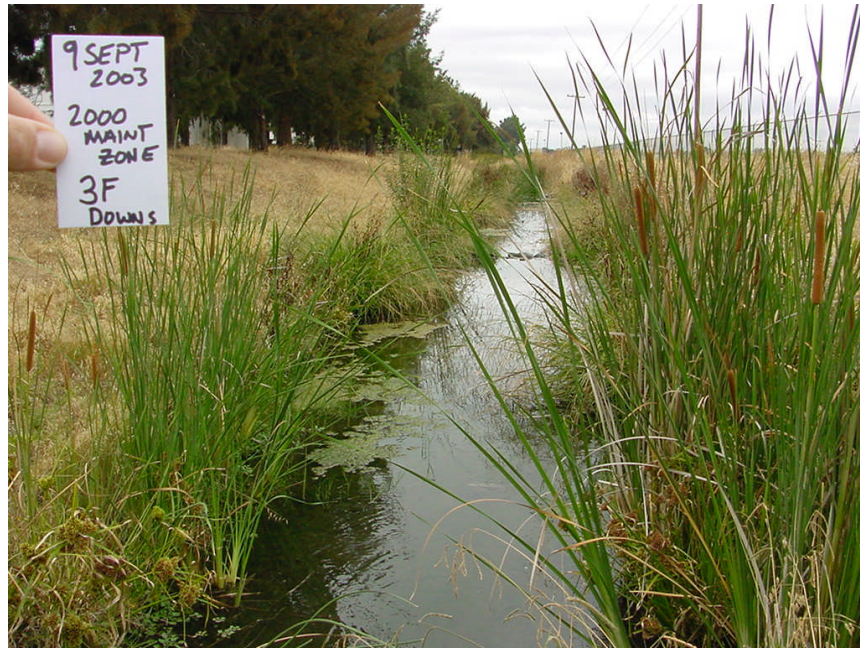
Figure 42. Photograph showing the top of Zone 3F (downstream view) with wetland vegetation established. Important wetland plants such as tall flatsedge were dominant by 2003.

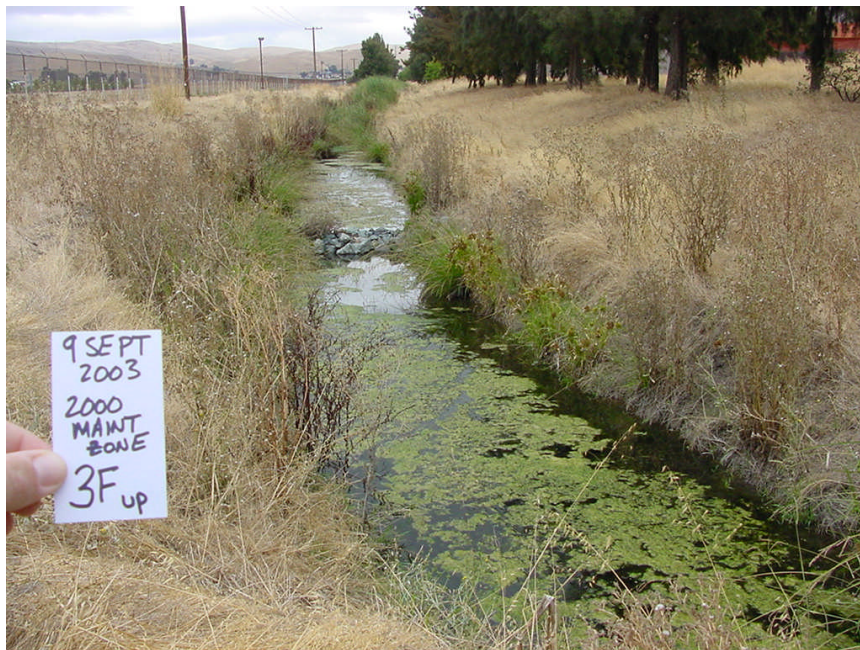
Figure 43. Wetland plants such as tall flatsedge increased by 2003, but still remained patchy as annual grasses and spiny sowthistle were dominant in the lower portion of 3F. Open water habitat remained prevalent in this portion of the zone.

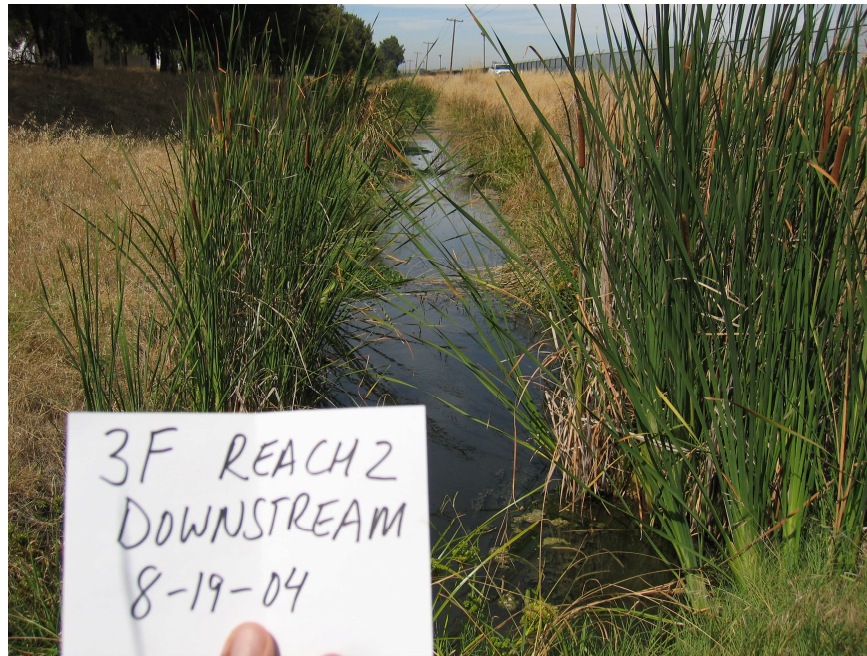
Figure 44. Photograph showing the top of Zone 3F (downstream view) with wetland vegetation established and mature. Important wetland plants such as tall flatsedge were dominant by 2003. Cattails increased in density through this period.

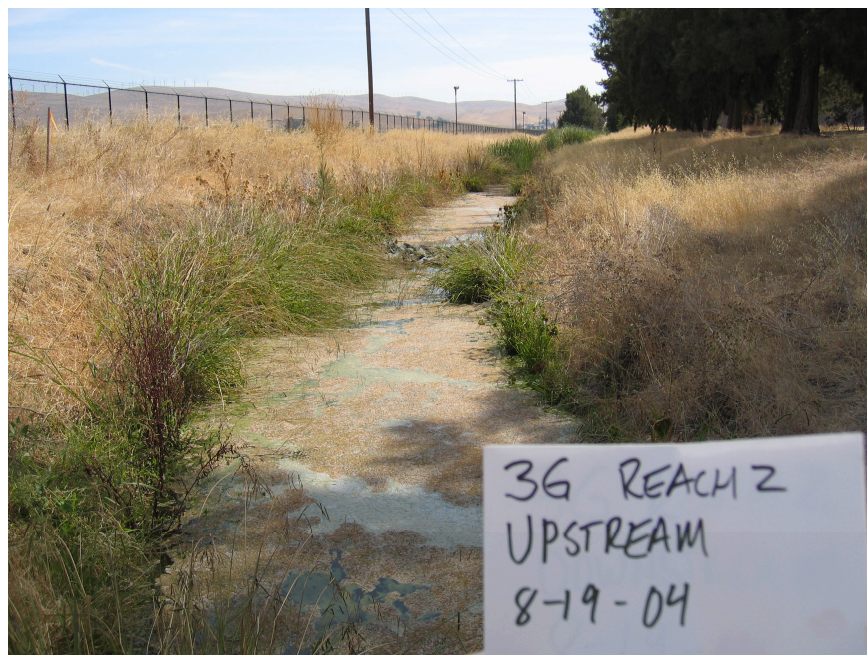
Figure 45. Wetland plants such as tall flatsedge increased by 2004 from 2003, although annual grasses were still prevalent. (Note: Note card is mislabeled as 3G).

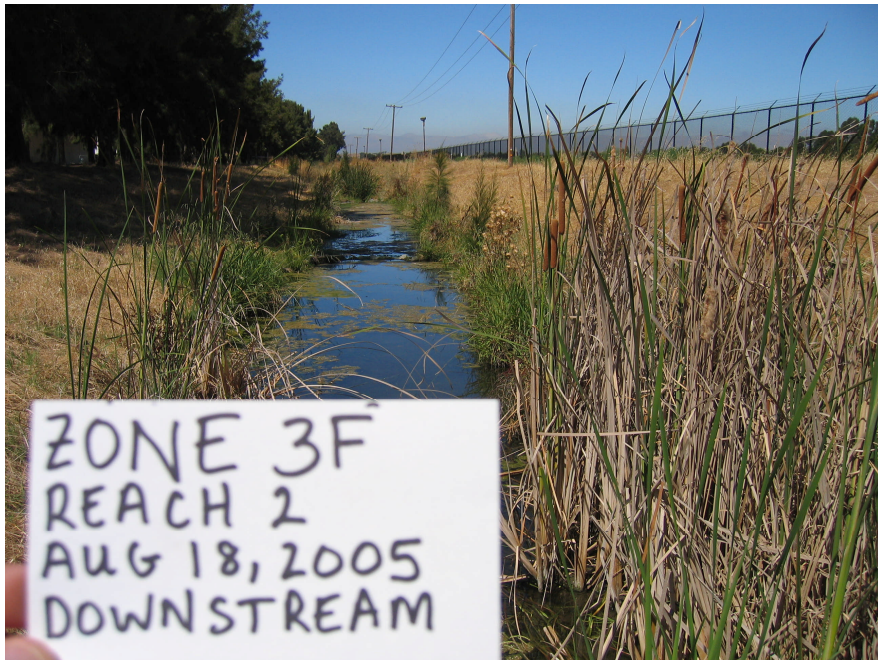
Figure 46. Photograph showing the top of Zone 3F (downstream view) with wetland vegetation established and mature. Wetland features remain essentially unchanged since 2004, with significant open water habitat.

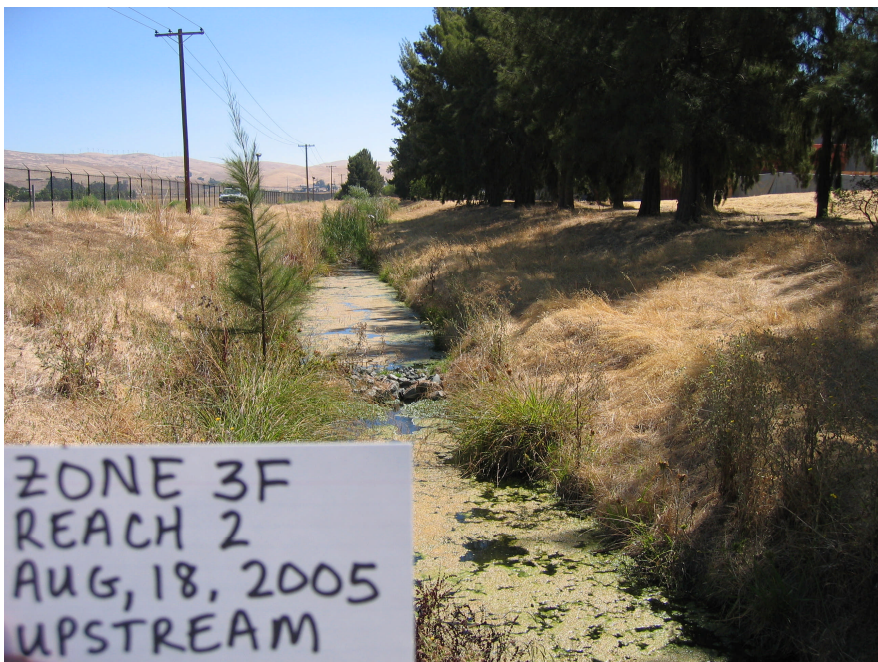
Figure 47. Photograph showing the lower portion of 3F (upstream view), essentially unchanged from previous years.

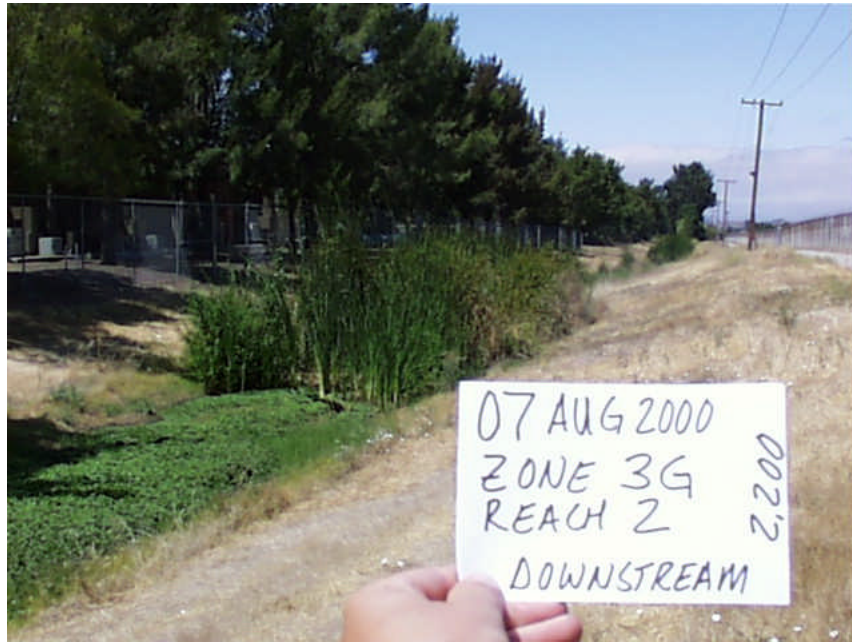
Figure 48. Photograph showing the top of Zone 3G with mature wetland vegetation (downstream view) prior to dredging in 2000. Note large defined patches of watercress and cattails, and mowed upper banks with no open water habitat.

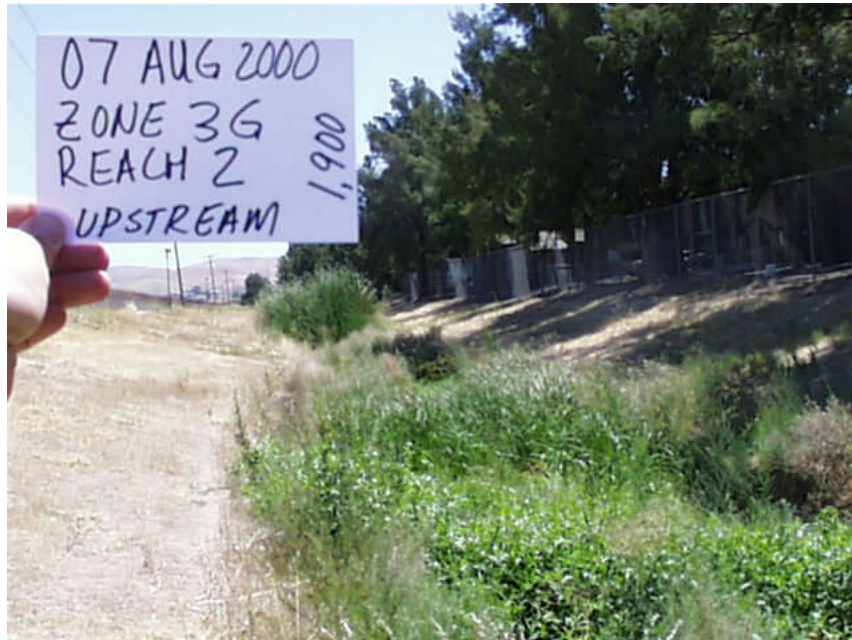
Figure 49. Photograph showing the lower end of Zone 3G with mature wetland vegetation (downstream view) prior to dredging in 2000. Pale smartweed and watercress in addition to perennial grasses and tall flatsedge (Table 5) dominated the lower portion of Zone 3G. No open water habitat occurred in this zone prior to dredging.

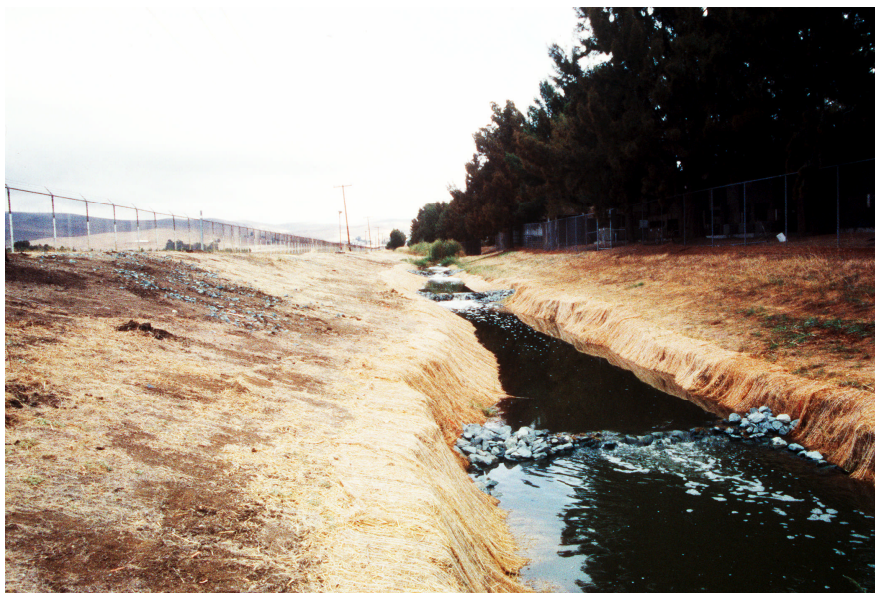
Figure 50. Photograph of 3G after dredging activity during initial precipitation of the year. Note erosion control blankets used for bank stabilization and rock weirs used for grade adjustment.

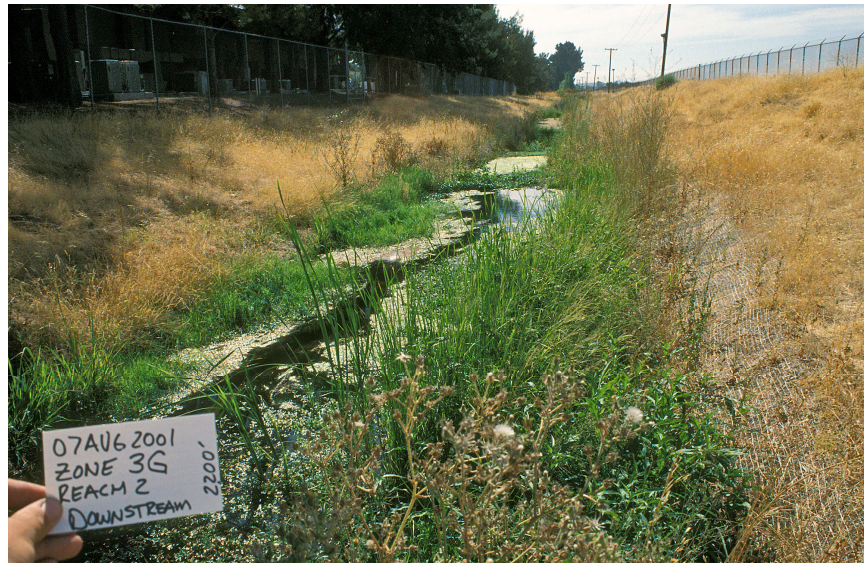
Figure 51. Photograph showing the upper end of Zone 3G (downstream view) a year after dredging with hydrophytes re-colonizing and well established. As expected, hydrophyte diversity was similar, but less robust post dredging (early succession stage), and open water habitat was created.

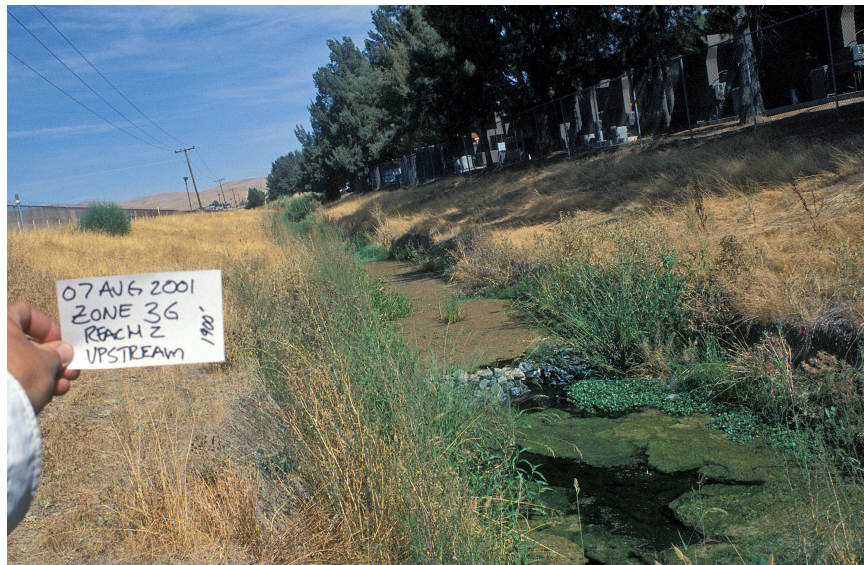
Figure 52. Photograph showing the lower end of Zone 3G (upstream view) a year after dredging with hydrophytes re-colonizing and well established. As expected, hydrophyte diversity was similar, but less robust post dredging (early succession stage), and open water habitat was created.

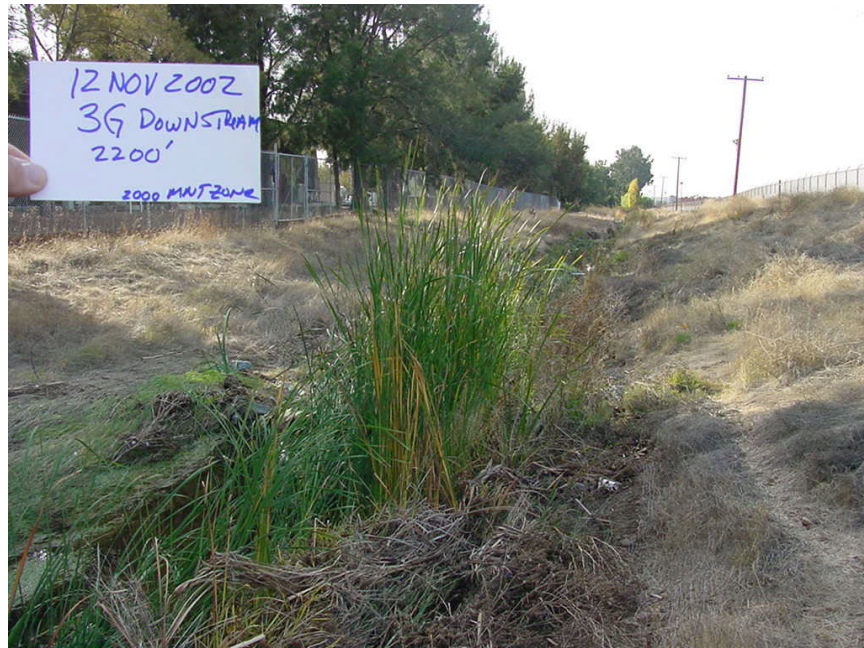
Figure 53. Photograph showing the upper end of Zone 3G (downstream view) two years after dredging with hydrophytes re-colonizing and well established. The only visible vegetative change during this period was the re-establishment of cattails.

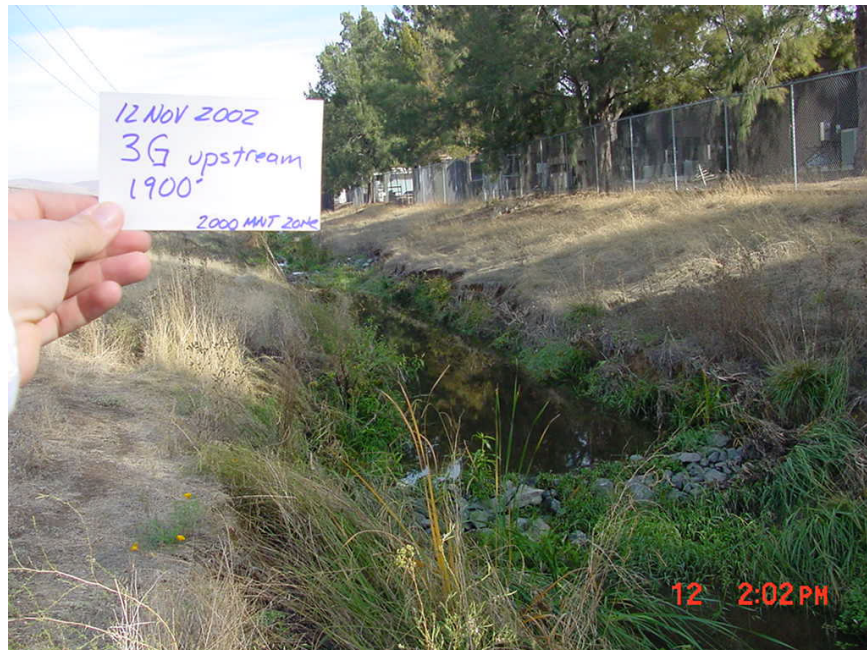
Figure 54. Photograph showing the lower end of Zone 3G (upstream view) two years after dredging with hydrophytes re-colonizing and well established. As expected, hydrophyte diversity was similar, but less robust post dredging (early succession stage), and open water habitat was created.

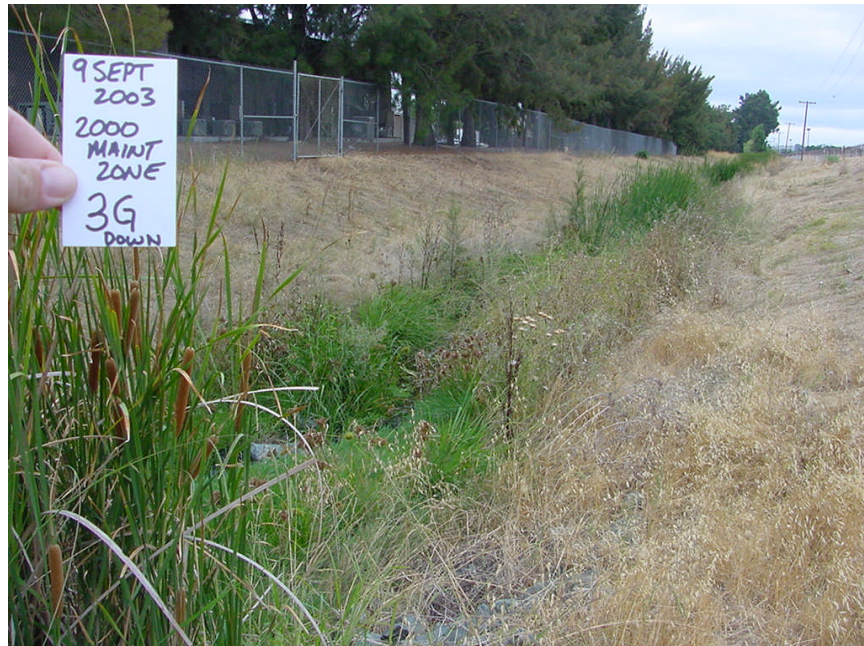
Figure 55. Photograph showing the upper end of Zone 3G (downstream view) three years after dredging with hydrophytes well established. Cattail establishment continued during this period.

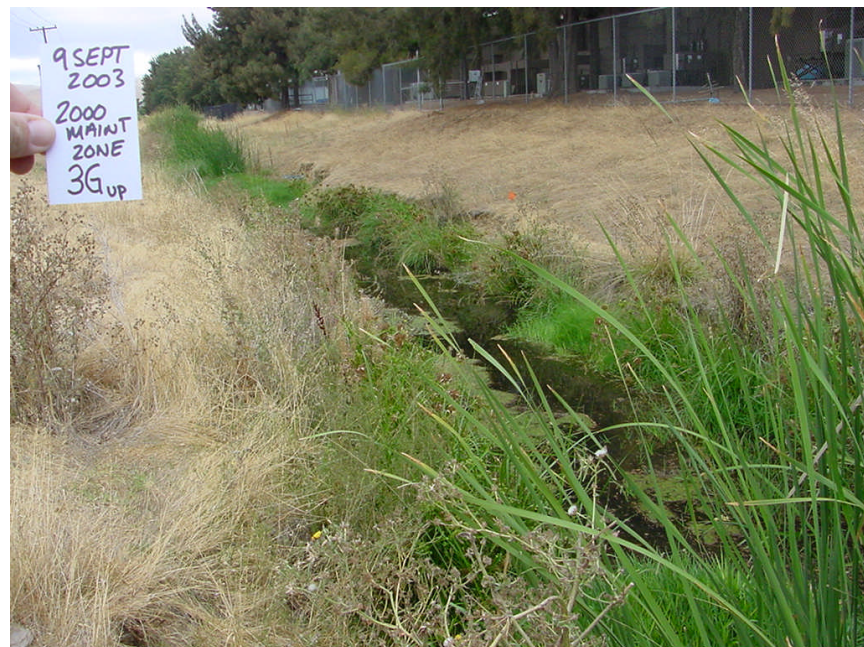
Figure 56. Photograph showing the lower end of Zone 3G (upstream view) three years after dredging with hydrophytes established and closing in on open water habitat.

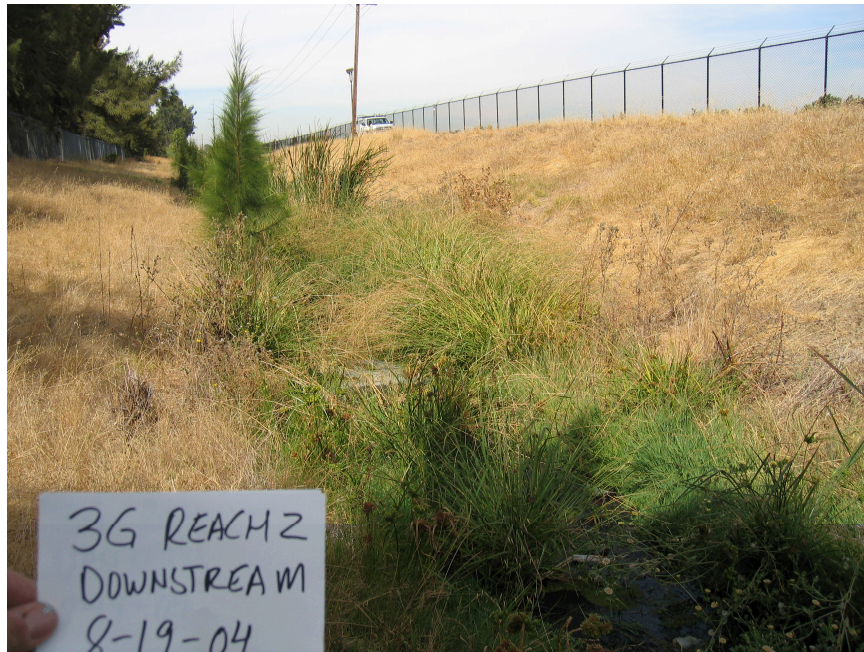
Figure 57. Photograph showing the upper end of Zone 3G (downstream view) four years after dredging with hydrophytes well established with less open water habitat. Note the establishment of volunteer Australian pines (*Cassaurina sp.*) from the adjacent tree line.

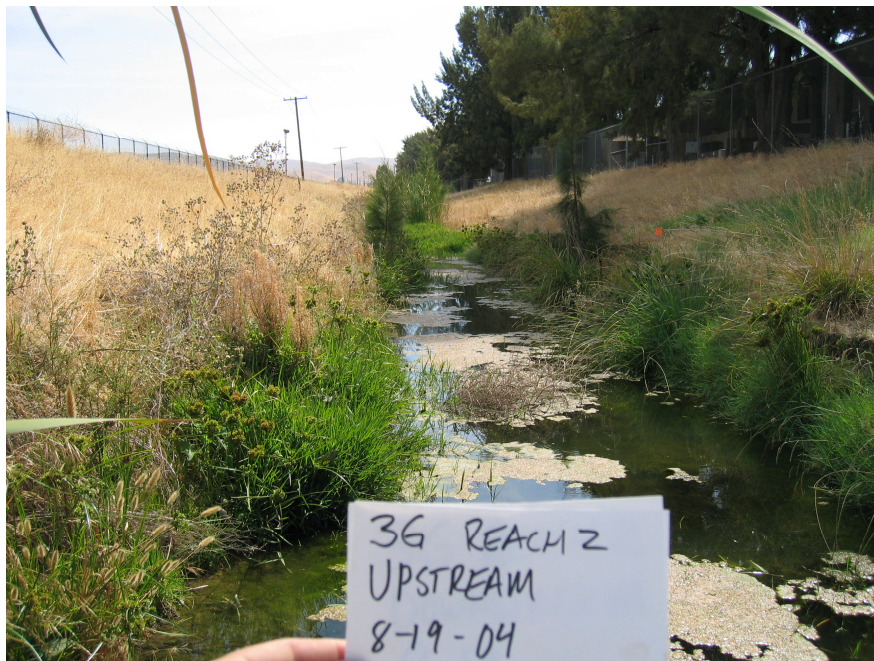
Figure 58. Photograph showing the lower end of Zone 3G (upstream view) three years after dredging with hydrophytes established. Important plants such as tall flatsedge dominate the open water littoral zone of the lower reach. Additionally, red swamp crayfish (*Procambarus clarkii*) became established in the ALP during 2004 and now may be a contributing factor to the openness of Zone 3G.

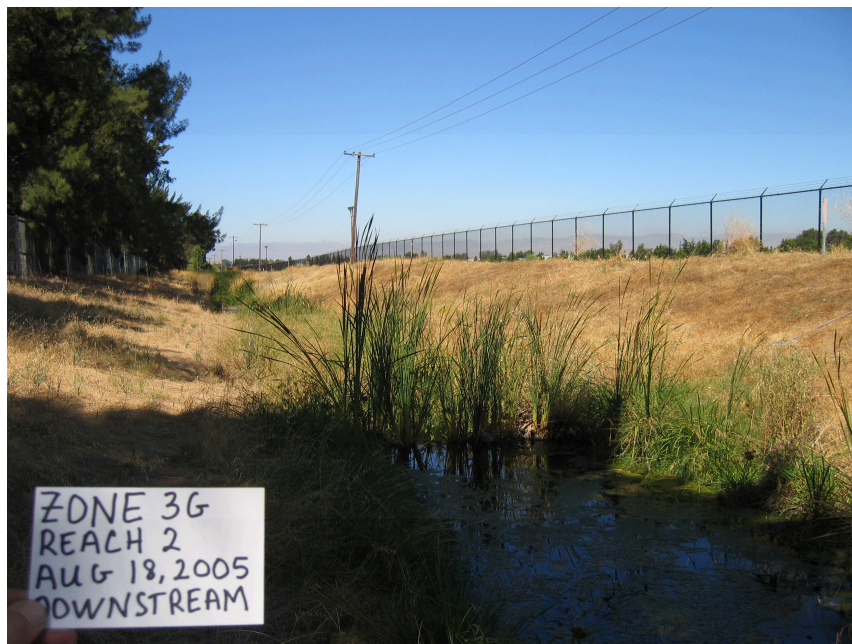
Figure 59. Photograph showing the upper end of Zone 3G (downstream view) five years after dredging with hydrophytes well established.

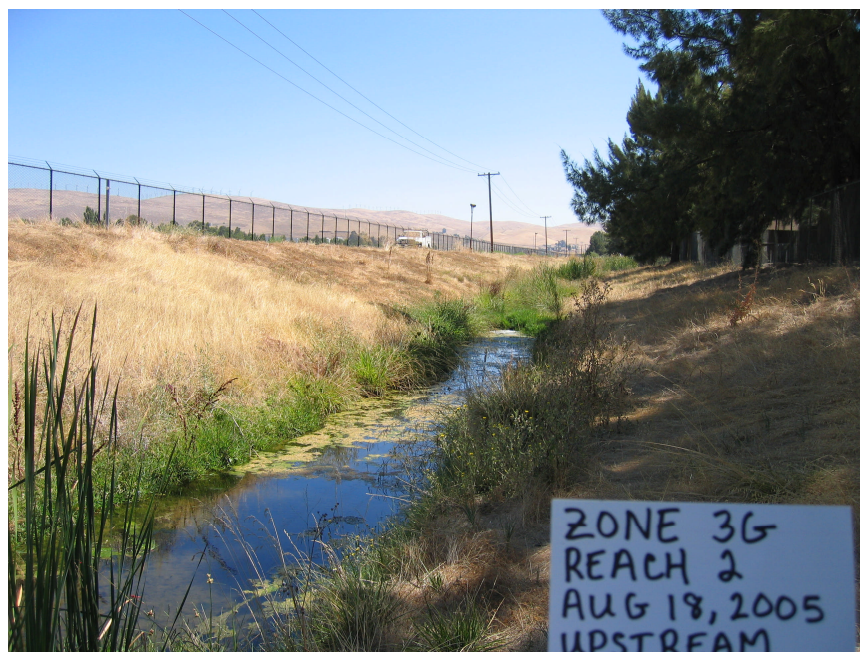
Figure 60. Photograph showing the lower end of Zone 3G (upstream view) five years after dredging with hydrophytes established.
