# Partial Closure Report for the Area 514 Treatment and Storage Facility

Mohammad Abri

May 2, 2005

**PARTIAL CLOSURE REPORT FOR THE AREA 514  
TREATMENT AND STORAGE FACILITY**

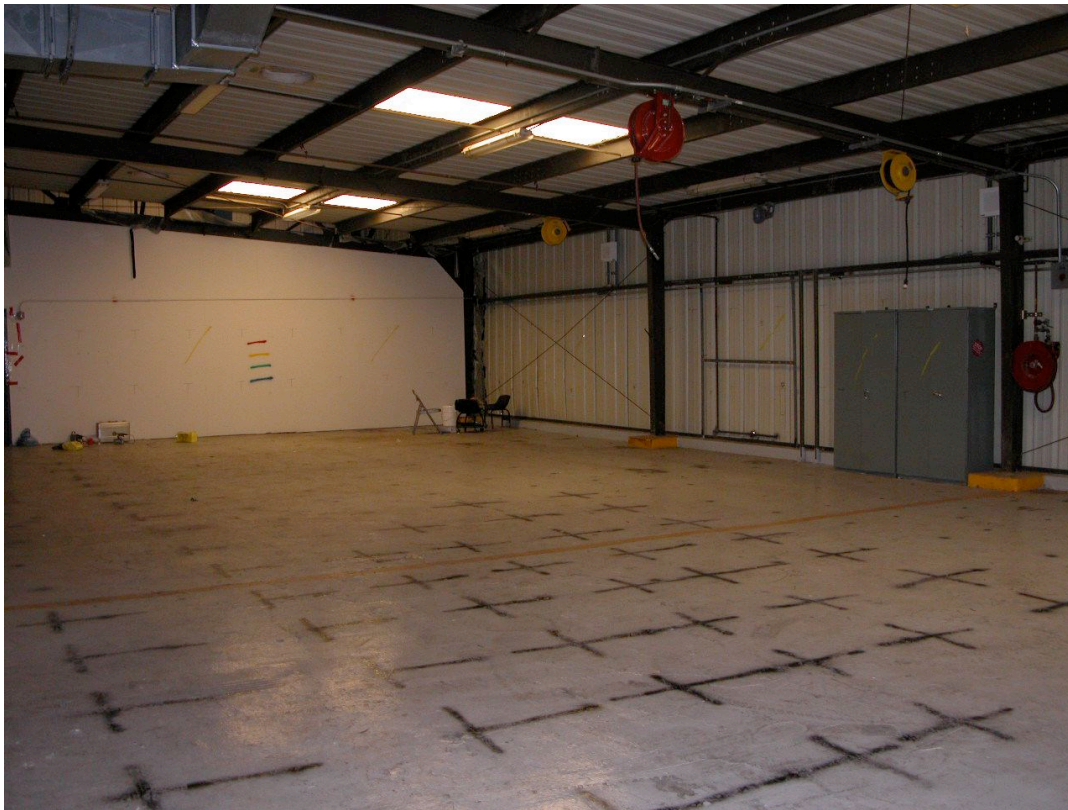
**Figure 3-2. Building 513**

Building 513 was a pre-engineered, one-story building that covered an area 35 ft by 100 ft (**Figure 3-2**). It was located on the south end of A514. The building was constructed of steel columns, beams, girts, purlins, and bracing. The structure was totally enclosed and had sheet metal roof and walls. The inside floor was a concrete slab that sloped to the south; and it was surrounded by an 8-in.-wide, concrete curb on the south, east, and west sides.

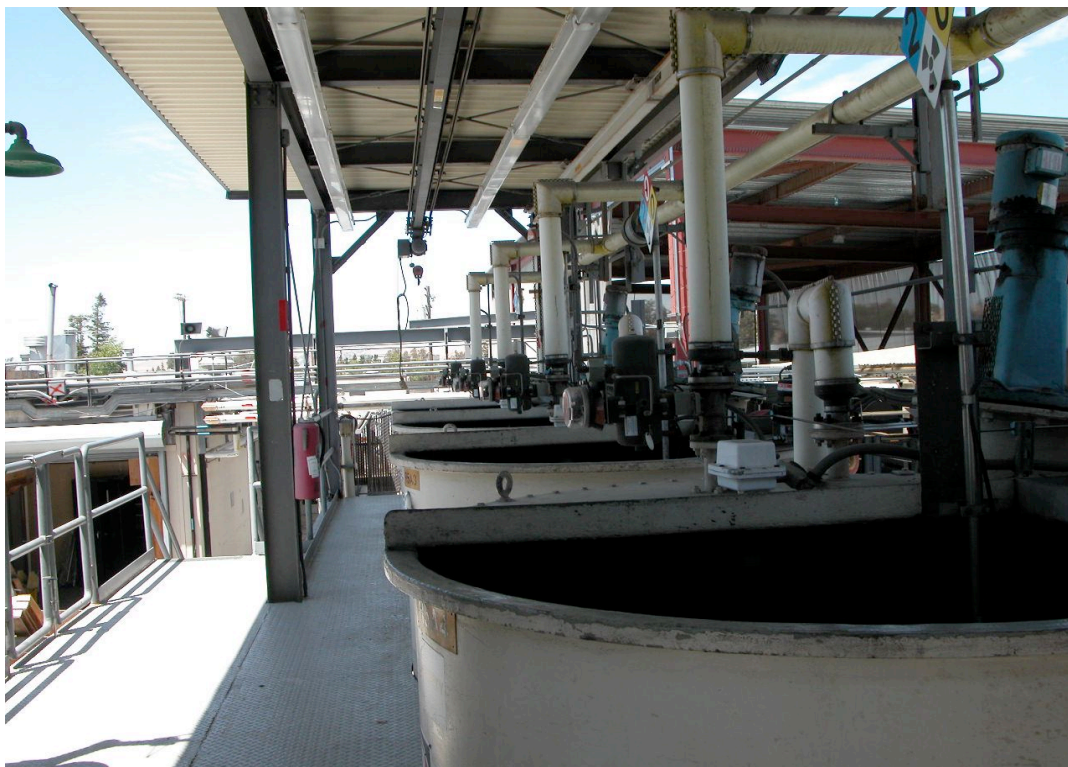
**Figure 3-3. Wastewater Treatment Tank Farm**

The WTTF unit consisted of six 1850-gal treatment tanks (514-RA-1, -2, -3, -4, -5, and -6), a covered bulking/rinsing area, and associated ancillary equipment and piping. See **Figure 3-3**.

Six open-top treatment tanks were located in a bermed concrete area that was covered with sheet metal roofing. An elevated walkway allowed access to the top of the tanks and the controls.

The WTF Unit consisted of six treatment tanks, a canopy, a metal walkway, concrete berm, and a concrete floor. After the waste-conveying pipes and other ancillary equipment were removed, the steel canopy, supports, and the elevated walkway were dismantled mechanically on July 10. The demolition is shown in **Figure 4-6**.

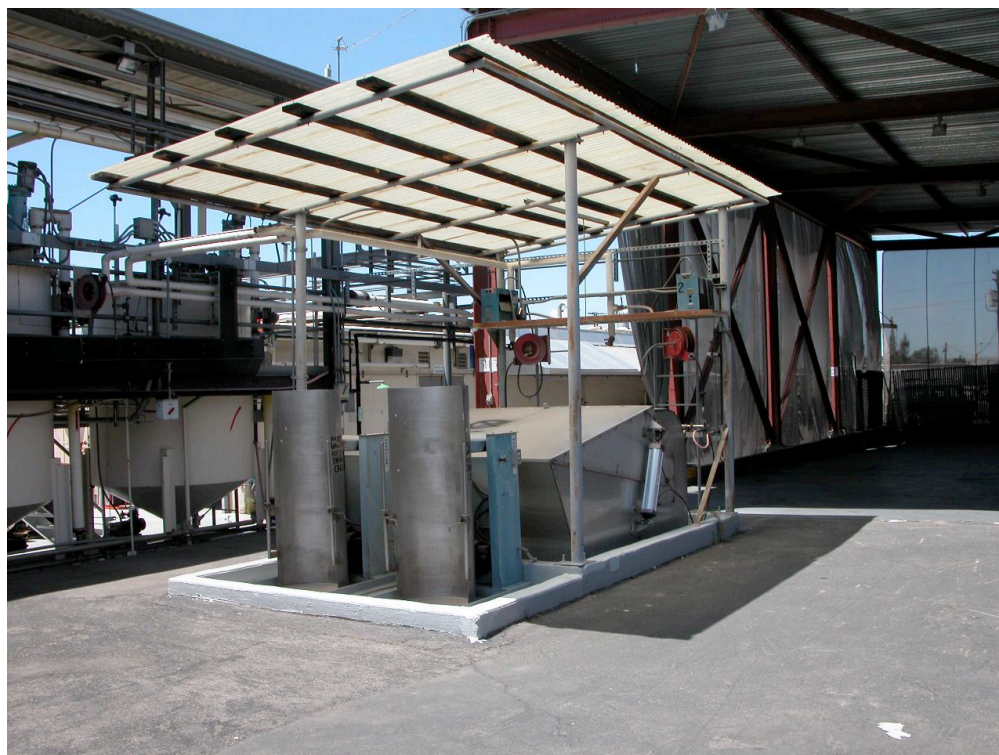
**Figure 3-4. Bulking/Rinsing Station**

The bulking/rinsing station consisted of a covered, stainless steel “trough” and two drum-dumper devices. The trough had a cover that was operated hydraulically and was located within a concrete floor that measured approximately 11 ft by 14 ft and was bermed on four sides (**Figure 3-4**). The bulking/rinsing station was used to bulk and transfer wastes into the treatment tanks and to triple-rinse waste containers. No wastes remained in the tanks or in the bulking/rinsing station when closure activities began.

The bulking / rinsing station included a stainless steel “trough” to receive the waste and drum rinsate. According to LLNL staff, the stainless steel trough was never used; however, confirmatory samples were taken.

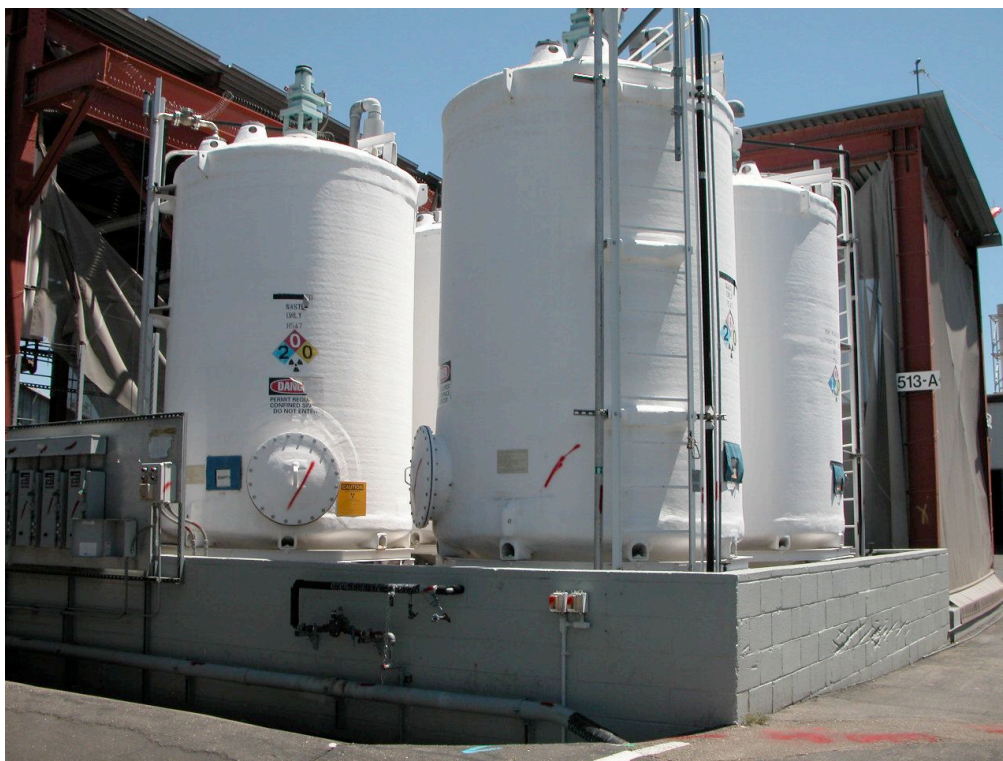
**Figure 3-5. Quadruple Tank Unit**

The A514 Quadruple Tank Unit consisted of four closed-top, fiber-reinforced, vinyl ester storage tanks and ancillary equipment. The tanks were located on a concrete floor that measured approximately 21 ft by 21 ft and surrounded by masonry block walls (**Figure 3-5**). Two of the storage tanks, 514-R5A7 and 514-R5A9, had been used to process regulated waste; and the other two tanks, 514-R5A8 and 514-R5AA, had contained non-DTSC-regulated wastes. These tanks had been used to store and transfer wastes into the treatment tanks. The tanks were marked “empty” when closure activities began.

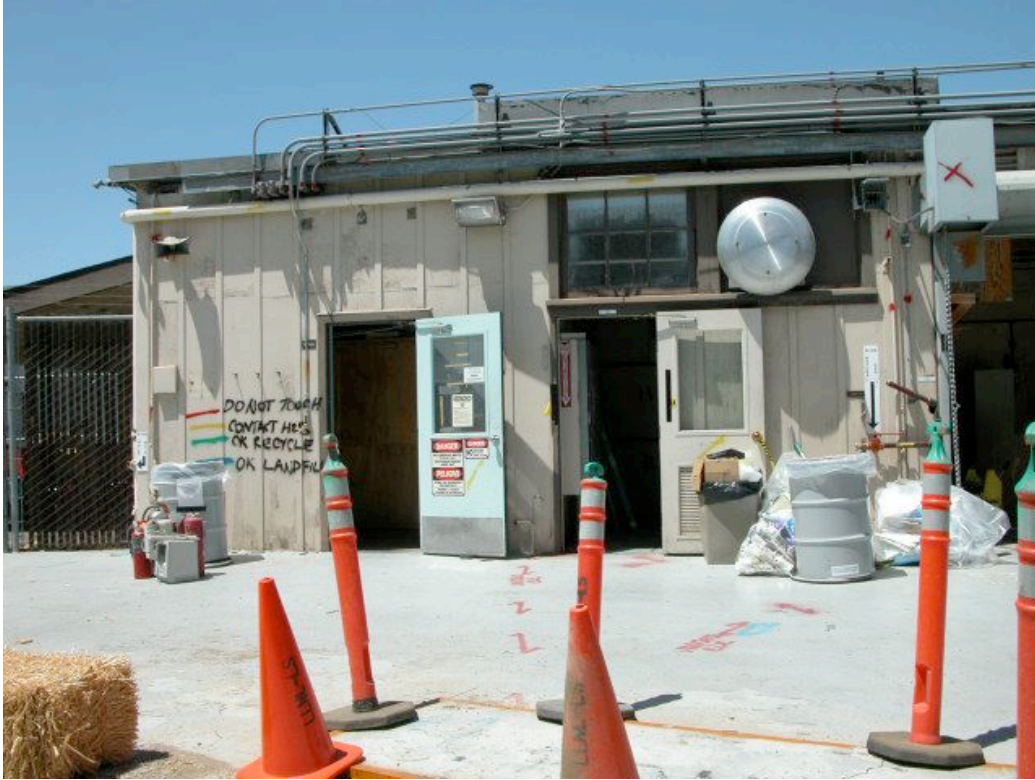
**Figure 3-6. Building 514**

Building 514 (B514) was located in the northwest quadrant of A514 and measured approximately 35 ft by 69 ft (**Figure 3-6**). B514 had been used as an office area, equipment rooms, and a shop; the wastewater filtration unit had been housed in Room 108. B514 also housed a silver recovery unit that was closed under a partial closure in 1997, see appendix C-2 of the approved final closure plan (LLNL 2004). (Note: the closure of the silver recovery unit was certified by an independent engineer and is not a part of this certification.) Lead-contaminated soil was discovered during the silver recovery unit closure process, but further action was deferred until this final closure of the facilities.

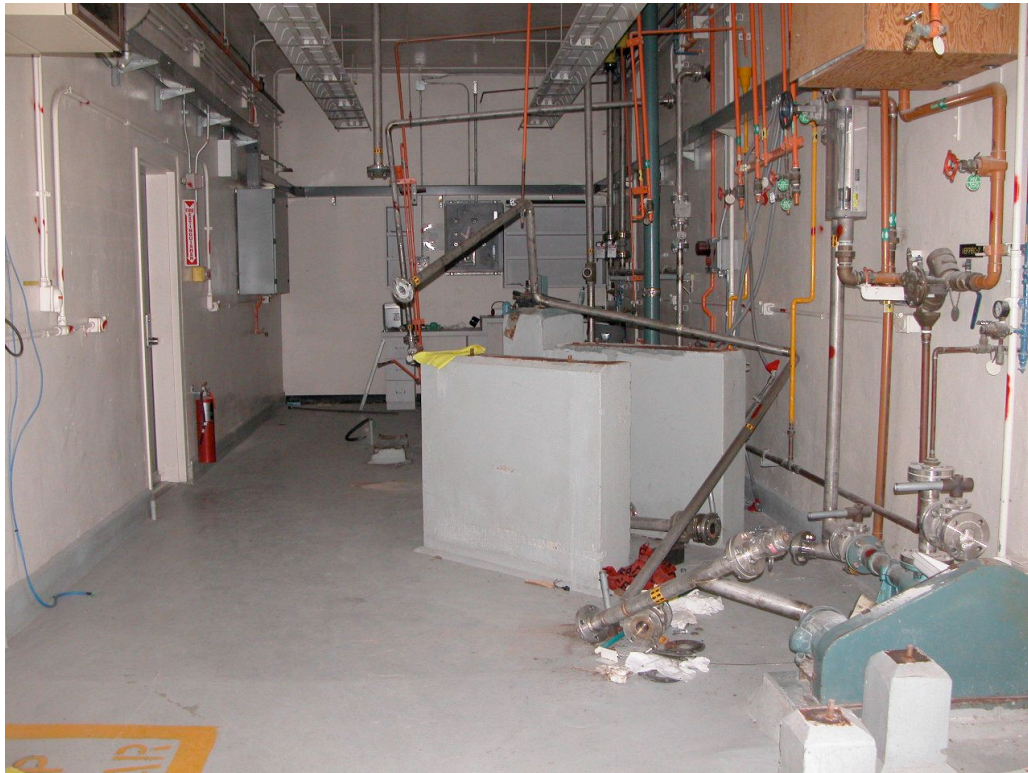
**Figure 3-7. Wastewater Filtration Unit**

The wastewater filtration unit was a rotary drum filter that had received treated wastewaters from the WTTF before the wastewater was released to the sewer (**Figure 3-7**). According to LLNL staff, the rotary drum filter had been removed for maintenance purposes before the closure activities began. There were no wastes remaining in the building to be filtered. The closure of the waste filtration equipment is not a part of this report.

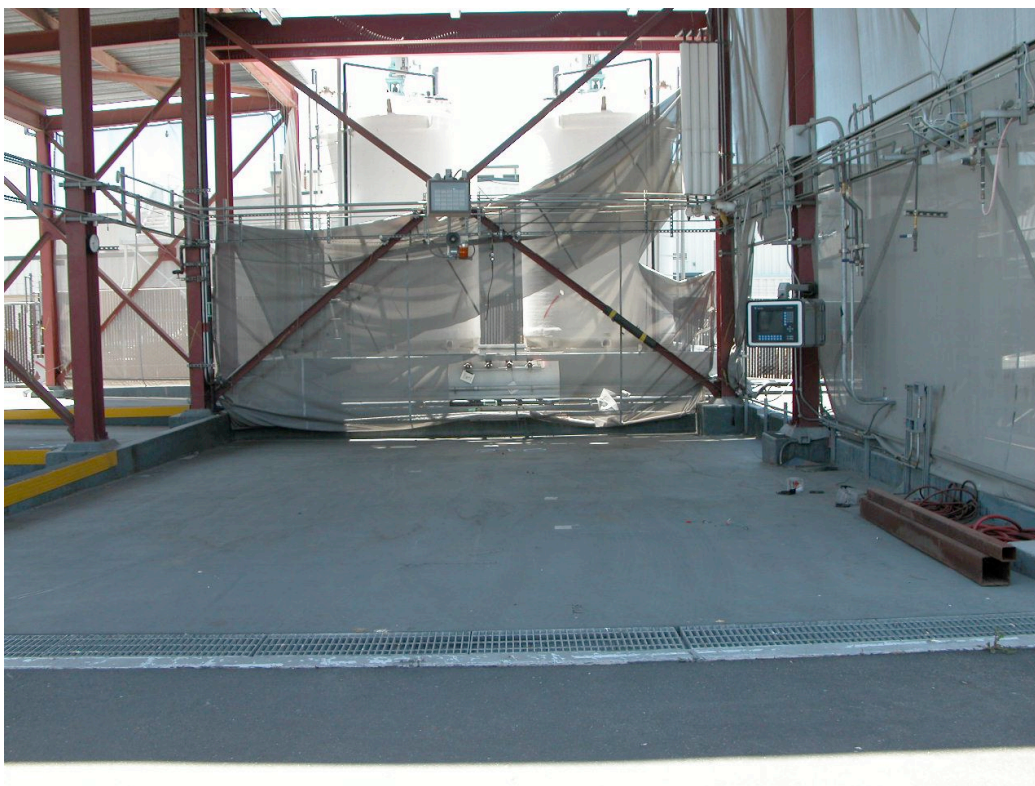
**Figure 3-8. Area 514-1 Container Storage and Treatment Unit**

The Area 514-1 CSTU was located near the center of A514. It had a 36-ft-by-24-ft concrete floor that sloped in an east-west direction; and the unit was surrounded by a berm on the north, south, and west sides (**Figure 3-8**). The unit had housed a centrifuge, a cold vapor evaporator, a tank blending unit, a portable tank blending unit, and a carbon adsorption unit. According to LLNL staff, the treatment units had been removed in accordance with a transition plan (LLNL, 2004) as part of the LLNL hazardous waste permit issued by the DTSC. The area had also been used to store waste containers. No wastes remained in the unit at the beginning of closure activities.

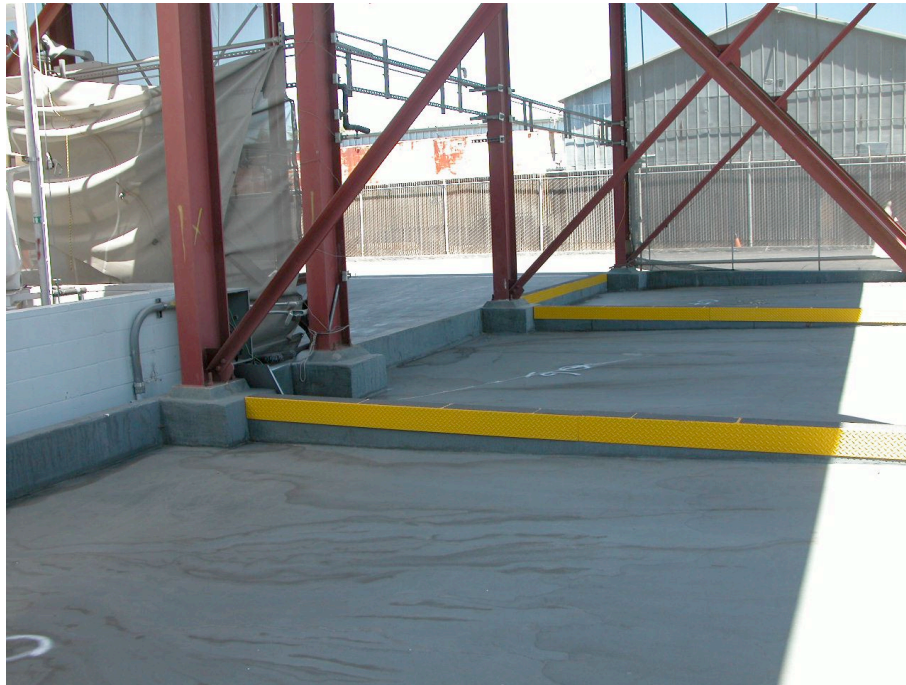
**Figure 3-9. Area 514-2 Container Storage Unit**

The Area 514-2 CSU consisted of three separate, covered, concrete-floored cells that measured 19.5 ft by 18.5 ft. The floors of the cells sloped toward the north; and the unit was surrounded by concrete berms on the north, east, and west sides (**Figure 3-9**). No wastes remained in the unit at the beginning of closure activities.

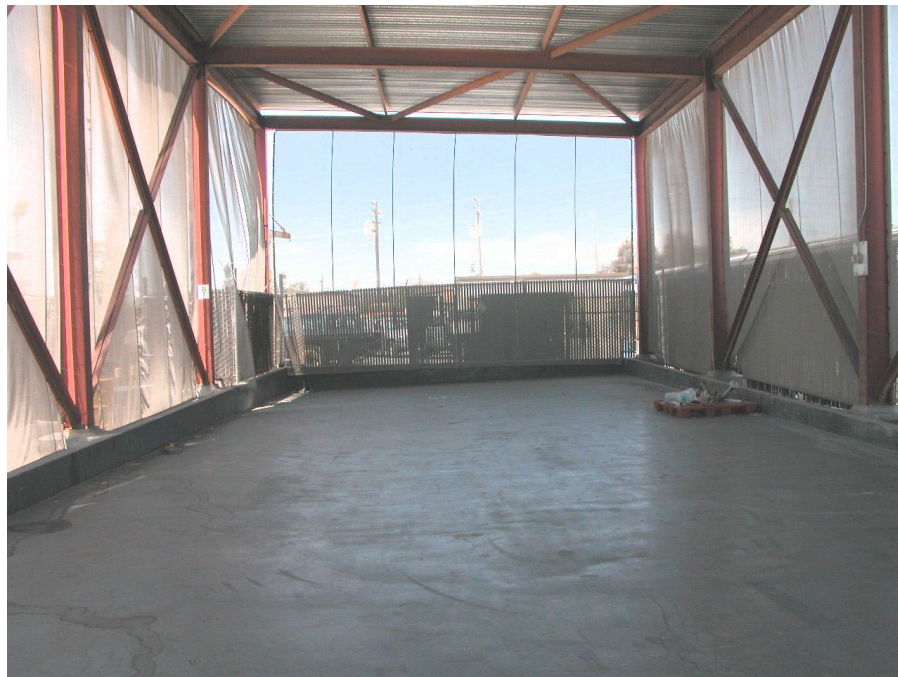
**Figure 3-10. Area 514-3 Container Storage Unit**

The Area 514-3 CSU consisted of a covered, concrete floor that measured 83 ft by 28 ft (**Figure 3-10**). The concrete floor sloped in a northwest direction to a small sump. Concrete berms

surrounded the area on the north, east, and west sides. No wastes remained in the unit at the beginning of closure activities.

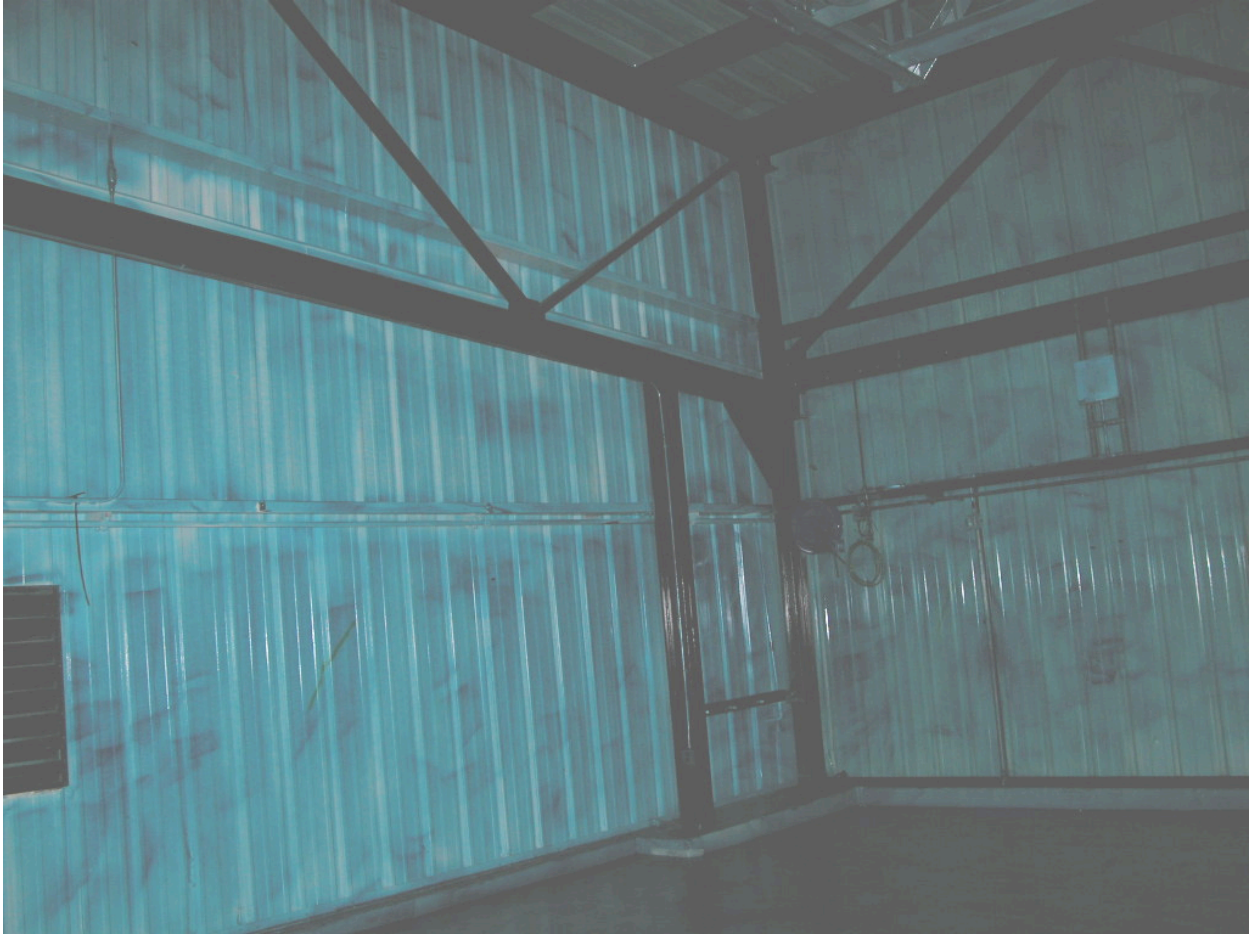
**Figure 4-1. Building 513 Room 1002 (Shredder Room)**

After sampling was completed, the floor, walls and ceiling of Building 513 Room 1002, where the shredder had been located, were sprayed with "CC Fixative Media" to immobilize any possible residual radioactive contamination (**Figure 4-1**). See **Appendix E** for a copy of material safety data sheets (MSDS) for CC Fixative Media.

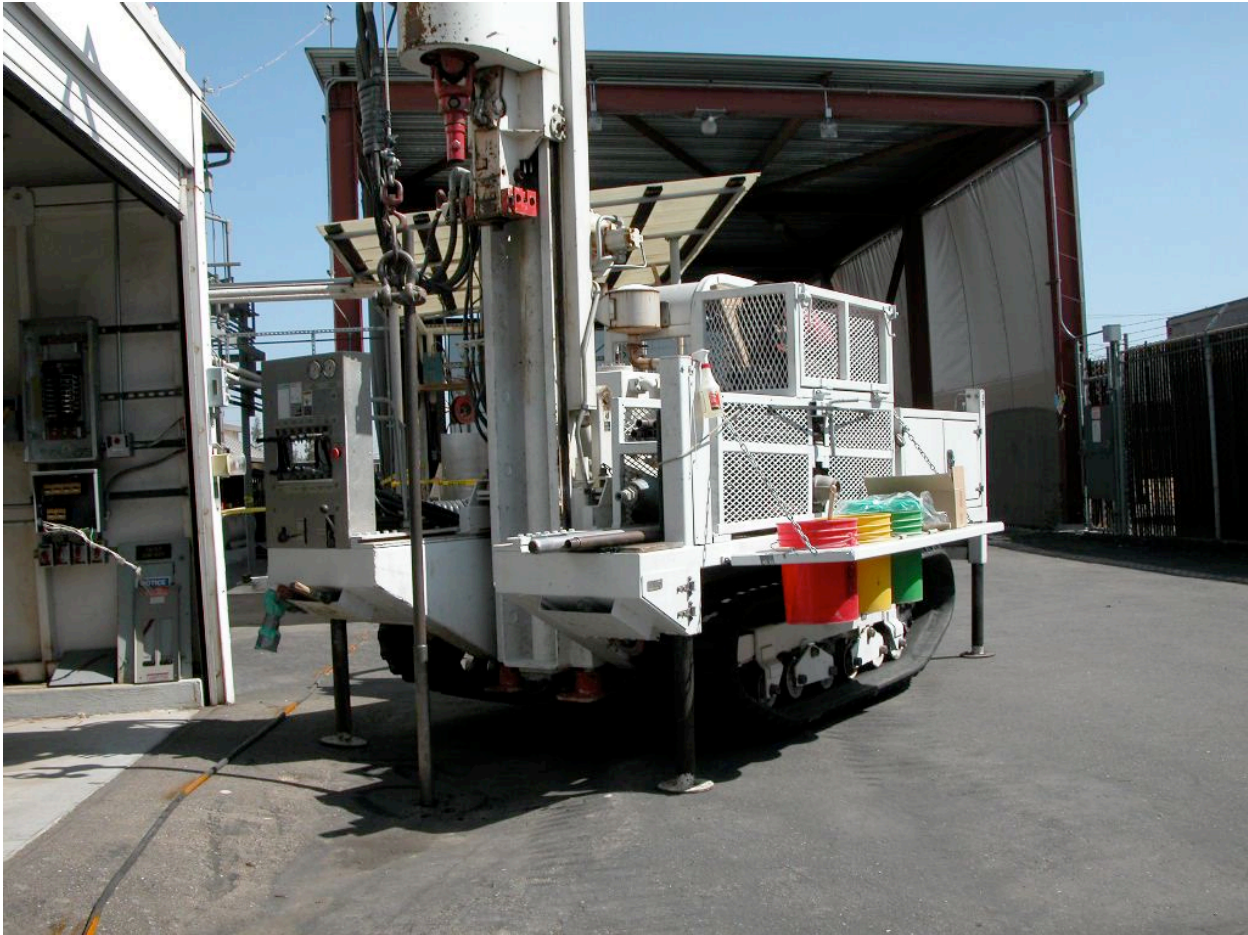
**Figure 4-2. Direct Push Sampling Rig**

The concrete core samples were collected using a drill; soil samples were collected using the direct push method (**Figure 4-2**). The direct push method to obtain soil samples is preferable because it minimizes waste generation of excess soil cuttings.

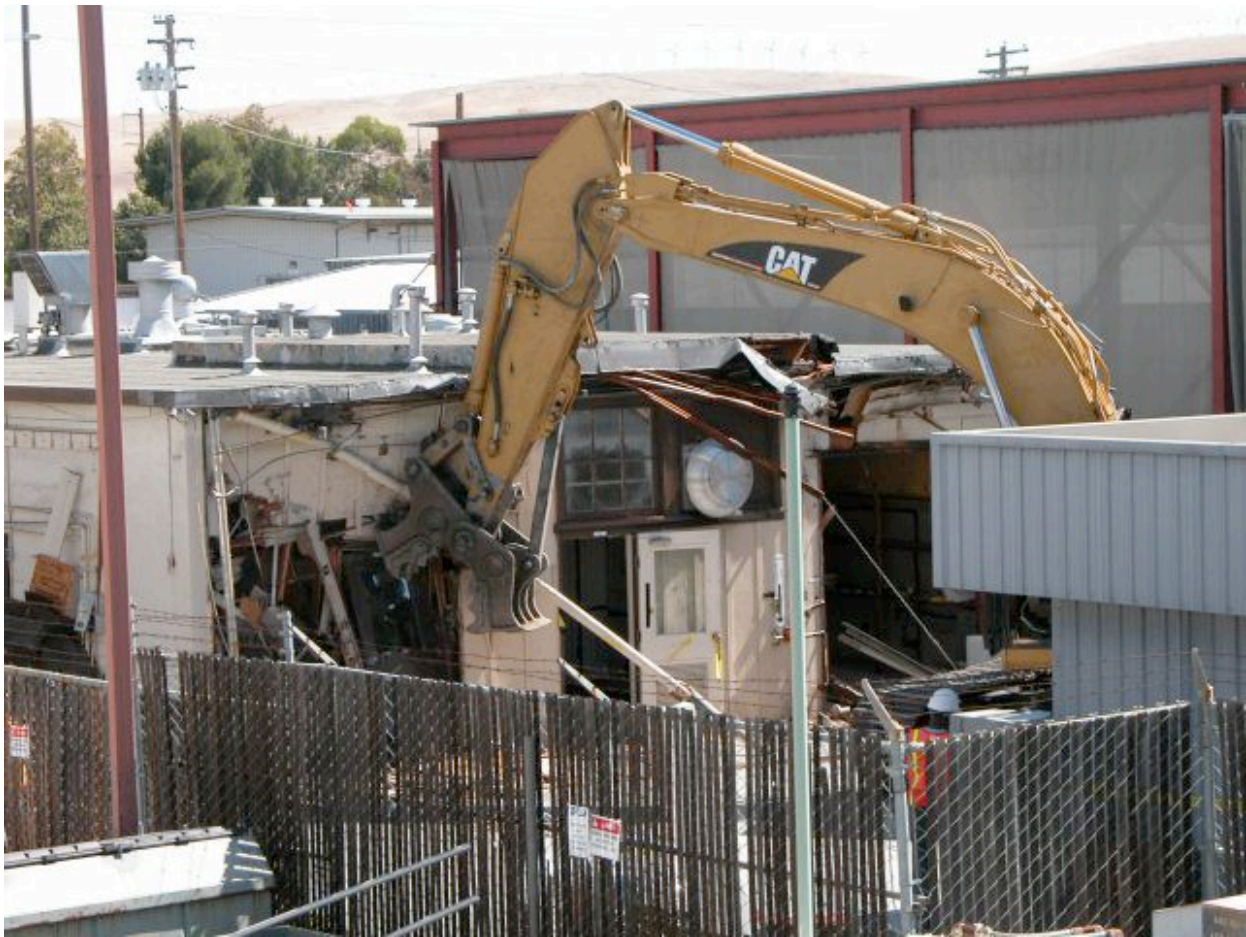
**Figure 4-3. Building 514 Demolition**

The filtration unit room and a support room north of B514 were demolished on June 29. The demolition debris piles were kept separate because the filtration room had been used to handle hazardous, mixed, and radioactive waste. The roofing material for the support room was kept separate as well because the room was constructed during a period when arsenic was used in roofing material as a rodent control method. The demolition for this area followed the same procedures as the office area except that there was no wood to be removed. The demolition debris for the filtration room was loaded into lined bins and stored at the T6498 WAA.

The concrete floor of the entire B514 area was removed using an excavator. The concrete floor from the filtration room was kept separate from the rest of building pending further characterization. A lined, cylindrical sump measuring approximately 3 ft in diameter and 4 ft deep was uncovered during the floor removal operations in the filtration room. The sump was located approximately 15 ft from the north wall and 10 in. from the west wall of the room. The stainless steel liner was removed from the sump and placed in a roll-off bin. The concrete wall of the sump was penetrated by underground piping in three locations (**Figure 4-4**). The soil beneath the sump was sampled (CAS #32), See **Section 5.0** for sample results.

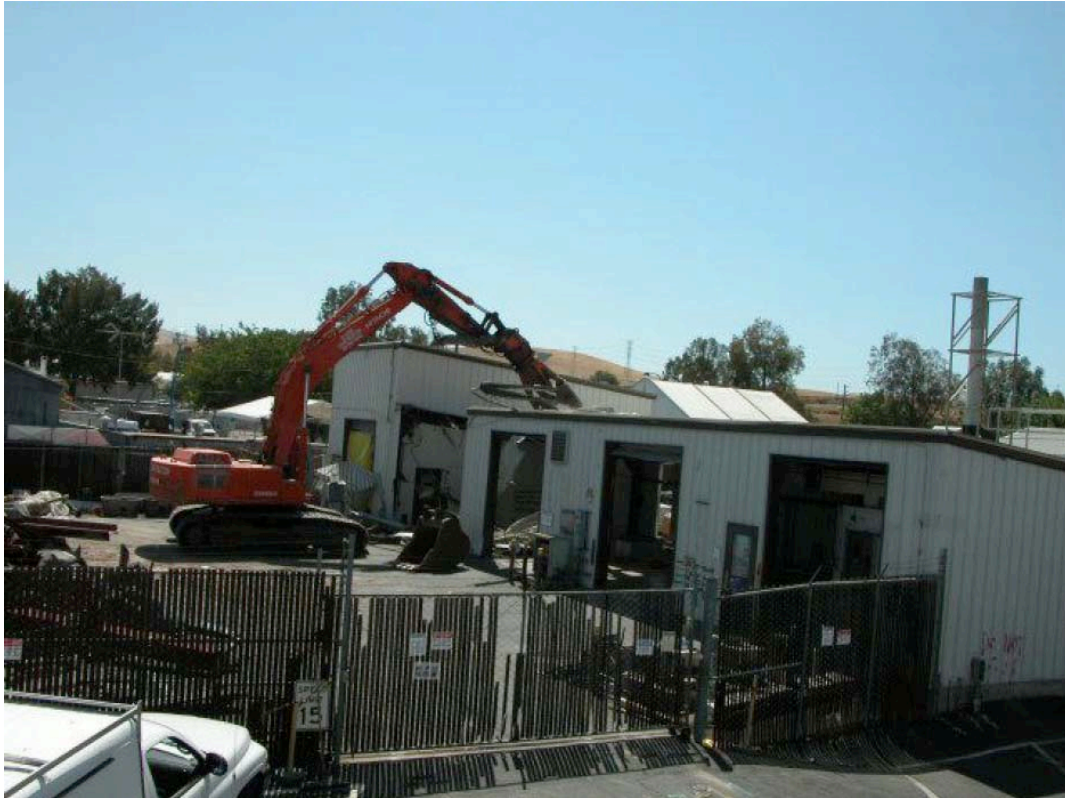
**Figure 4-5. Building 513 Demolition**

On July 19, the B513 CSU and the solidification unit areas were mechanically demolished with a shearing device used to cut the supports and beams (**Figure 4-5**). The treatability laboratory was demolished separately on July 20.

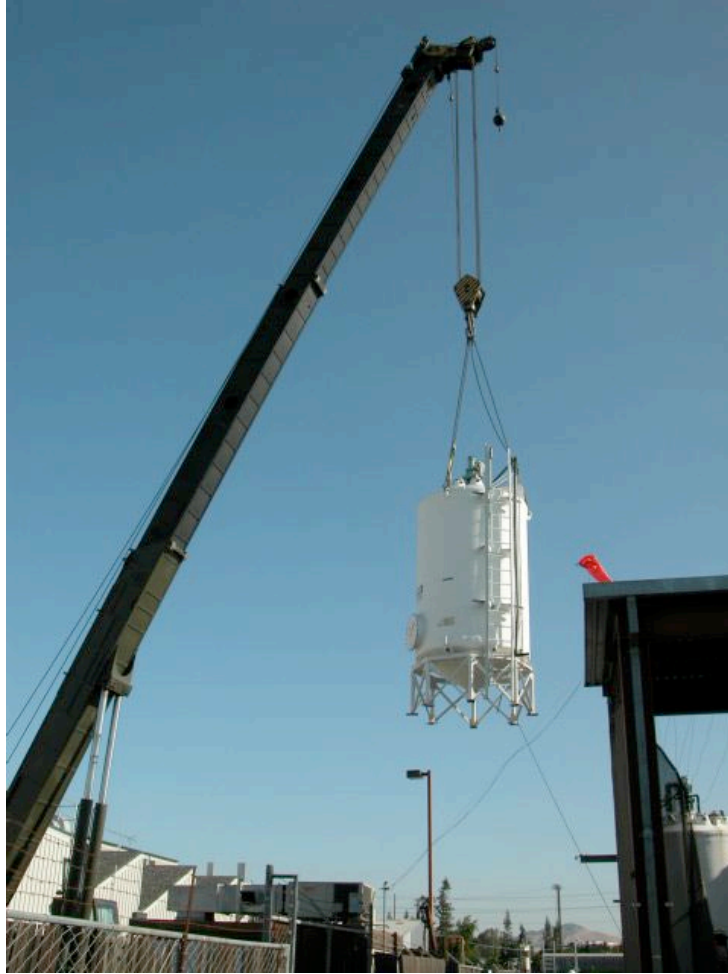
**Figure 4-7. Quadruple Tank Unit Removal**

The Quadruple Tank Unit consisted of four storage tanks, (514-R5-A7, -A8, -A9, and 514-R5AA), cinderblock secondary containment walls, and a concrete floor. The tanks were removed intact (**Figure 4-7**) using a crane and stored in T6498 WAA for further processing. The tanks were stored at the WAA for longer than 90 days. LLNL submitted an extension request to the DTSC for the two hazardous waste tanks, 514-R5-A7 and 514-R5-A9; however, the DTSC denied the requests (see **Appendix I**). The tanks were later brought back to the project site and size-reduced. For more information, see **Sections 6.2** and **6.3**.

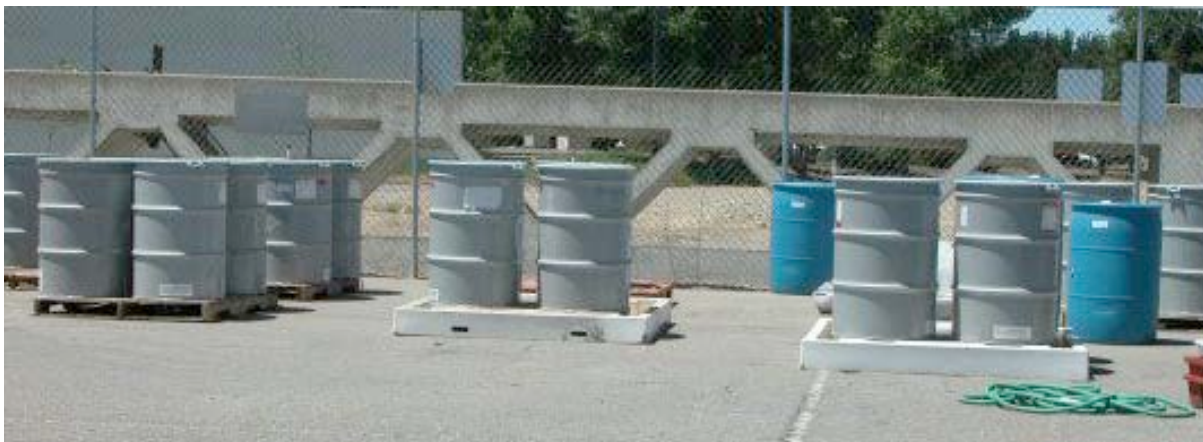
**Figure 6-1. T4798 Waste Accumulation Area**

The Area 514-3 CSU and the A514 yard areas were used as satellite accumulation areas for closure-generated wastes. The wastes were moved into a WAA at T6498 that was set up for this purpose. The T6498 WAA is shown in **Figure 6-1**. LLNL established an additional WAA at Building 412 as waste accumulated awaiting further characterization and handling.

In the WAAs, liquid hazardous, mixed and low-level wastes were stored in drums on secondary containment pallets. Solid mixed wastes were stored in closed drums or bins with lids lined with plastic sheeting. Solid low-level wastes were stored in bins with either lids or covered with tarps. Nonhazardous construction debris was stored in open and closed bins.

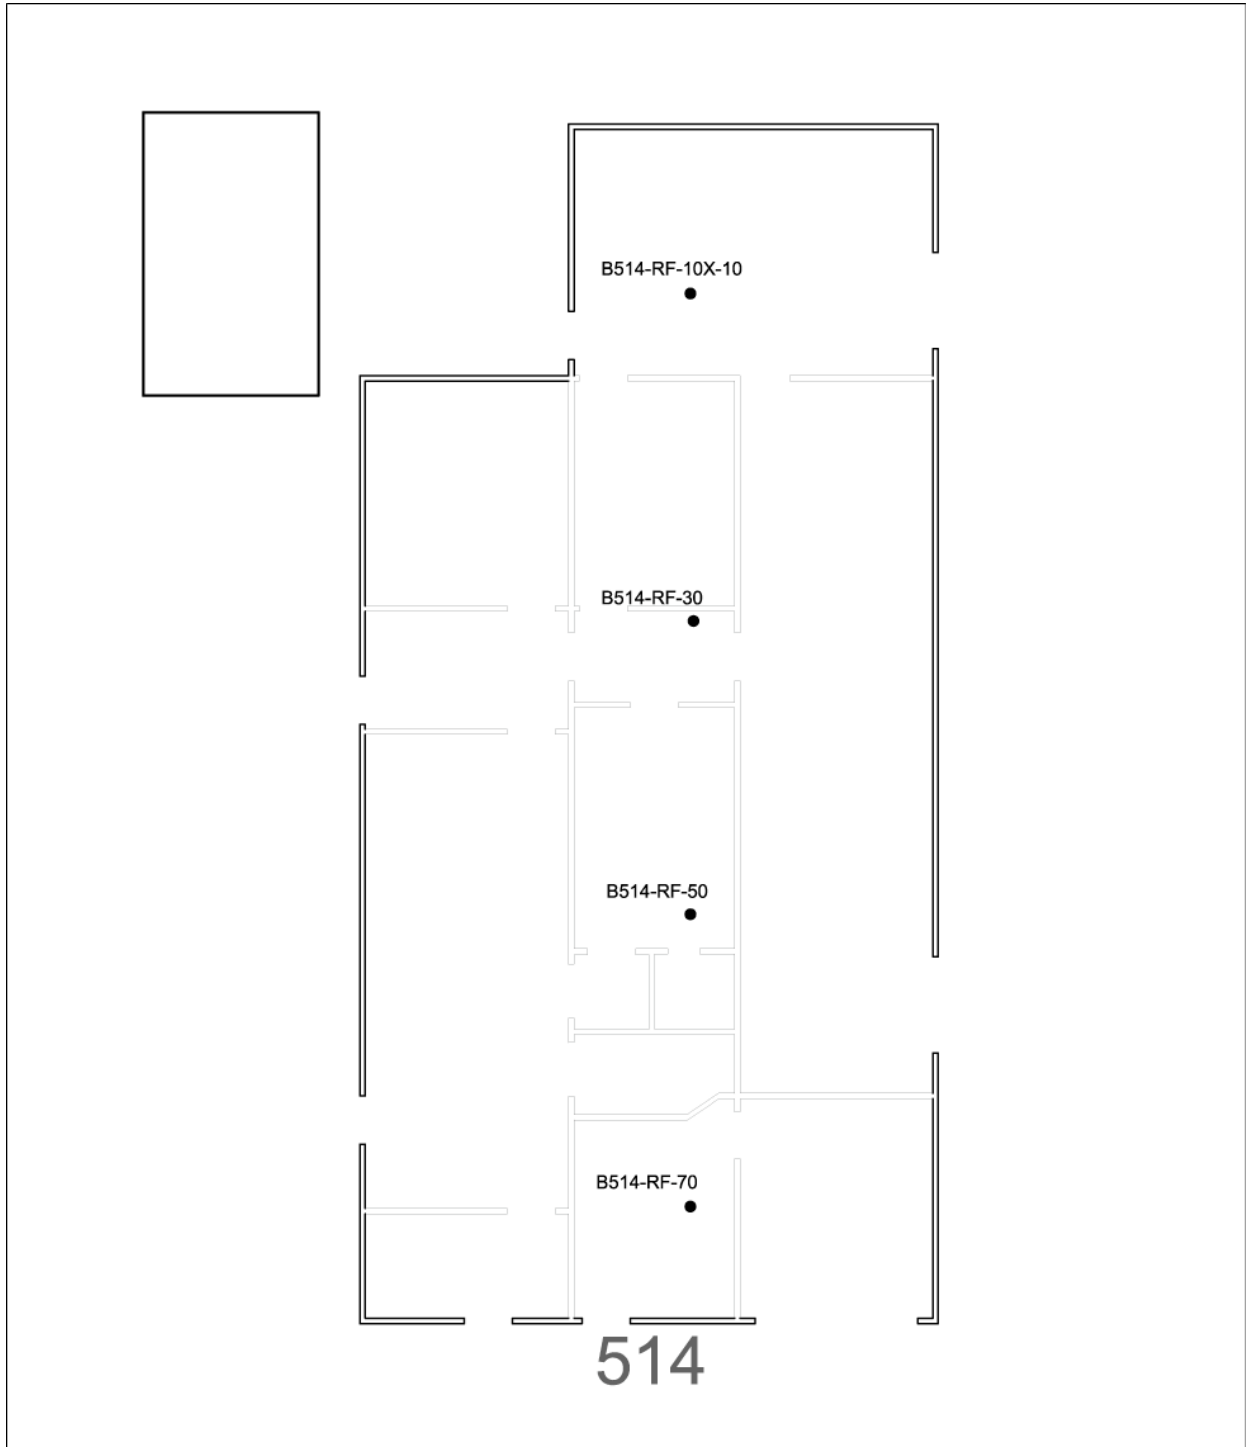
The B514 sampling area included the B514 office area, rotary drum filtration unit, Room 108, former silver recovery unit, Room 105, and the support areas, Rooms 110 and 124. For locations of the samples, see **Figures F-1, F-2, and F-3** in **Appendix F**.

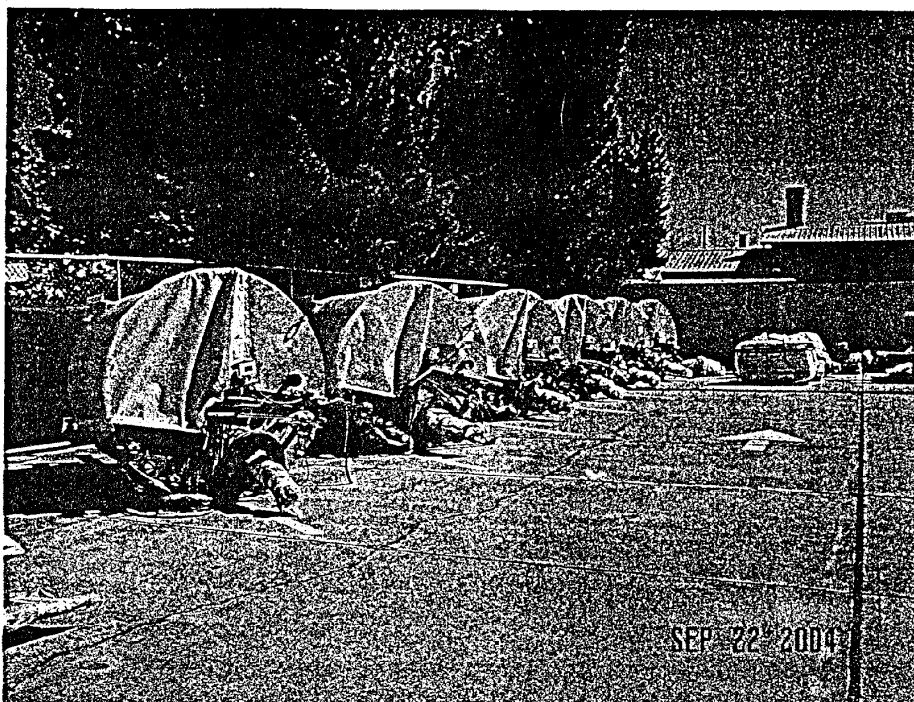
**Six Steel Tanks Contaminated by Depleted Uranium and Mercury Wastes**

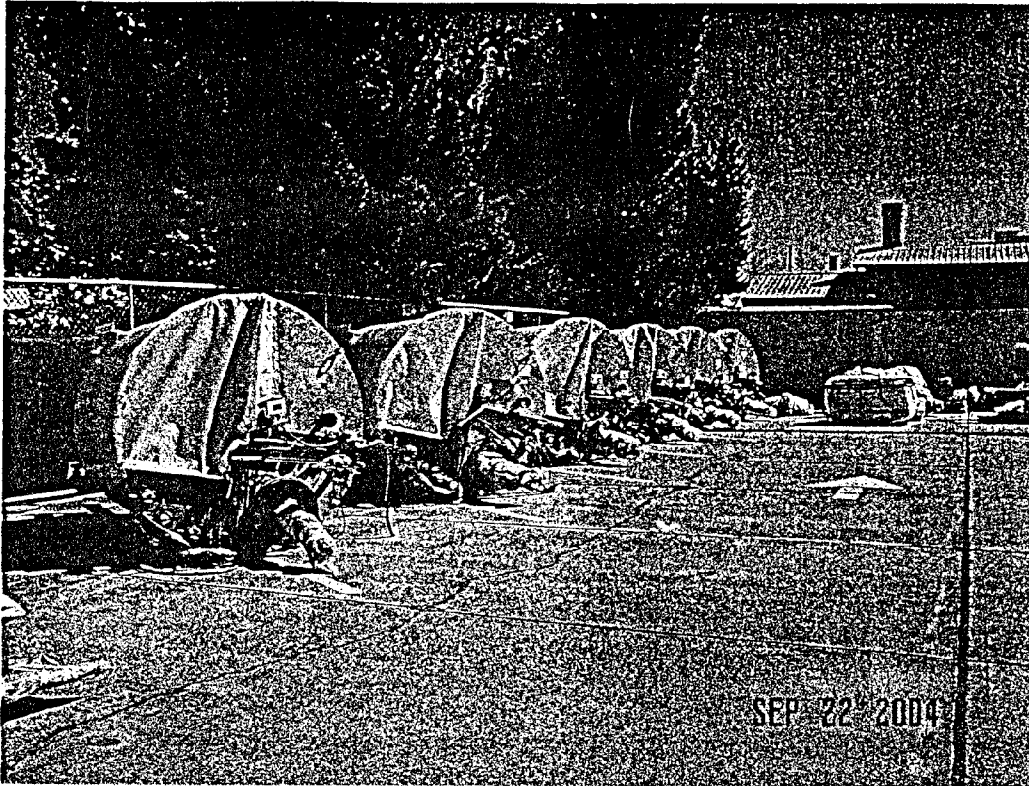
**Six Steel Tanks Contaminated by Depleted Uranium and Mercury Wastes**

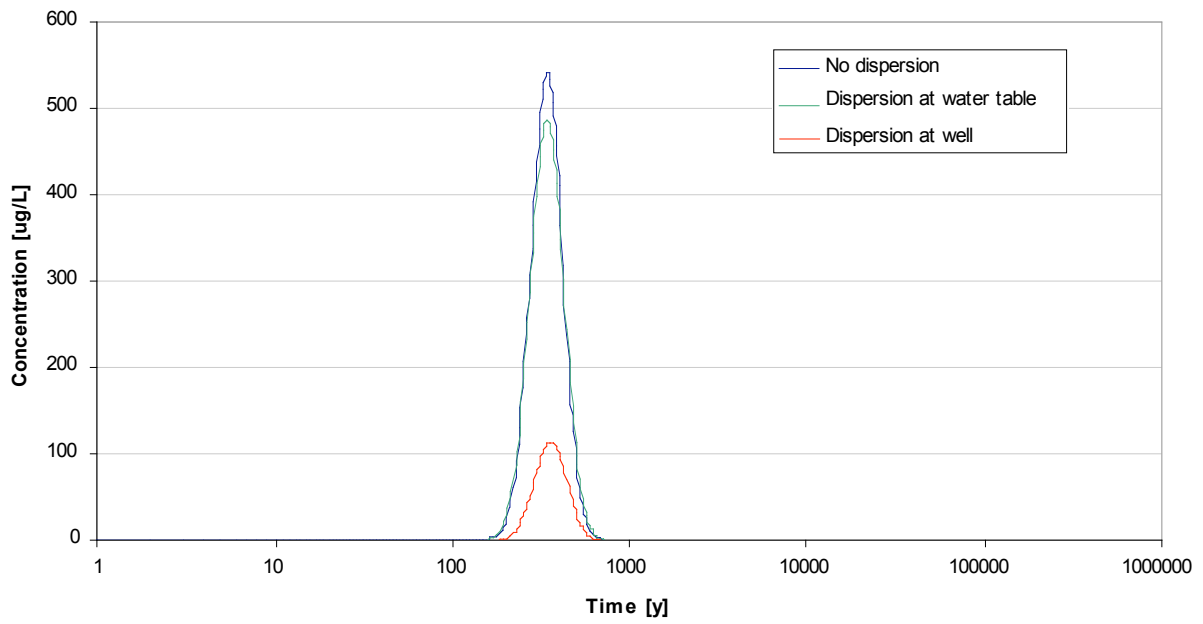
**Figure 6. Sensitivity analysis results for assumptions used in the model.**
