Structural Testing of 9 m Carbon Fiber Wind Turbine Research Blades

Conference Paper
NREL/CP-500-40985
January 2007

Three 9 m carbon fiber wind turbine blades have been designed through a research program initiated by Sandia National Laboratories. The individual designs feature such innovations as carbon spar caps, material-induced twist-bend coupling, and flatback airfoils, among others. All blades were constructed with conventional dry lay-up and VARTM infusion processes. Static tests of these blades were conducted at the National Wind Technology Center. The blades were subjected to flapwise loading to simulate the extreme wind loads expected for each design in a Class 2b wind site. The blades were loaded with a three-point whiffle-tree arrangement. Upon obtaining the predetermined test load, the blades were subsequently loaded to failure. Load, deflection, strain, and acoustic emissions were monitored throughout the experiments. All blades survived the specified test loads, with two designs exceeding it significantly. In addition, carbon strains of over 0.8% in both tension and compression were recorded in one of the tests. Finally, acoustic microphones were able to detect are

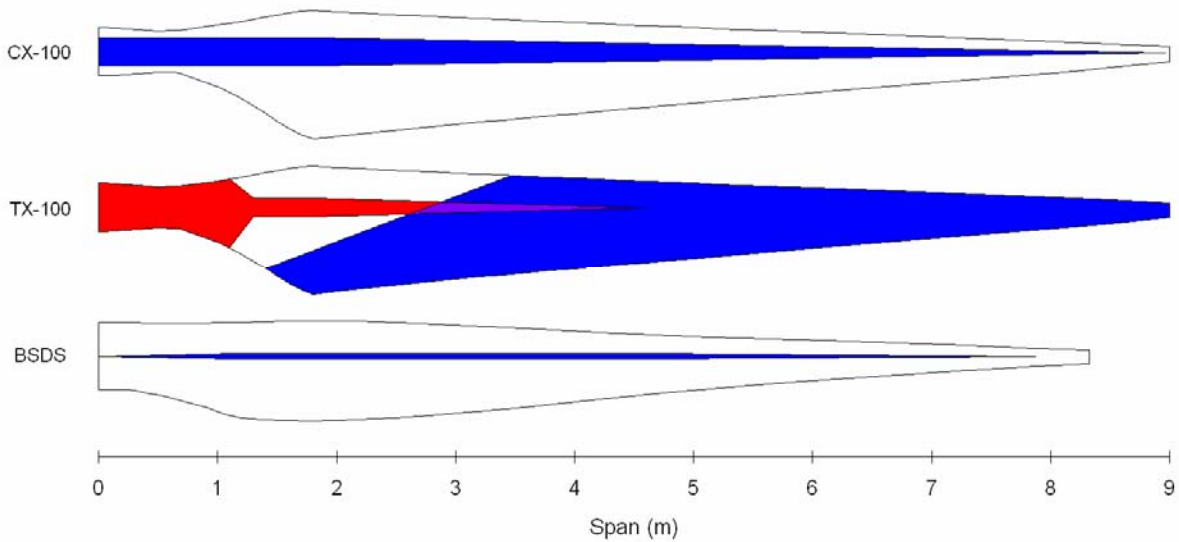
Figure 1: 9 m blade plan forms and major material regions.

design. The blade was designed to have passive aerodynamic load reduction by orienting unidirectional carbon 20° off of the pitch axis in the skins from approximately 3.50 m outward. Studies^{7,8,9,10,11,12} had indicated the possibility of such a method of passive aerodynamic load alleviation through material induced twist-bend coupling, with 20° being determined as the optimum angle. Other methods of twist-bend coupling have also been suggested^{13,14,15,16}. The TX-100 also contained a fiberglass spar cap which terminated at the mid-span of the blade. The final blade design was named the BSDS, owing its name to the research program under which it was created. The BSDS had a length of 8.325 m rather than the 9.000 m length of the CX-100 and TX-100. This blade design exhibited a highly efficient structure which included such features as a thin, large-diameter root; flatback airfoils; integrated root studs; and a full-length, constant-thickness, carbon spar cap. A drawing of the plan form of these blades is shown in Figure 1, with the carbon-containing areas shown in blue. Note the carbon spar caps of the CX-100 and the BSDS blades, and the carbon outboard skins of the TX-100. The unidirectional fiberglass spar cap of the TX-100 is shown in red in the figure and extends only to the mid-span of the blade. It was determined that the large amount of carbon contained in the skin was adequate to carry loads outboard in this design, making a full length spar cap unnecessary. The narrow, constant thickness spar cap of the BSDS blade alludes to the inherent structural stiffness of this design. In addition, the BSDS design features a gradual transition between the root and max-chord areas as compared to the CX and TX plan form. Figure 2 provides a view of the two different blade geometries as seen from the trailing edge. Note the flat back on the inboard portion of the BSDS blade, as well as the larger root and smoother chord thickness transition.

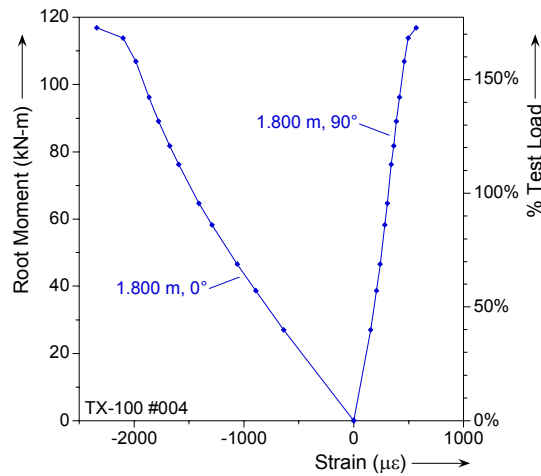
Figure 16: TX-100 aft panel strains parallel and perpendicular to blade axis.

Figure 15, Figure 16, and Figure 17 show the strains measured in the panel regions aft of the spar cap for the CX-100, TX-100, and BSDS blades respectively. These are regions that are susceptible for buckling in extreme loading situations. The CX-100 and TX-100 blades showed indications of buckling in the 1.800 m region near a root moment of about 117 kN-m. These blades were of identical geometry and had similar construction in this area. Thus, this result is not unexpected. The BSDS blade showed slight signs of buckling at the 1.575 m station at around a 150 kN-m root moment. However, it is important to note that the blade continued to withstand load well beyond this point.

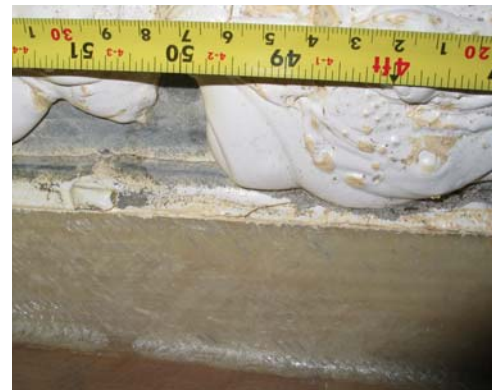
Figure 23: Crack in shear web to LP skin bond joint at 1.20-1.30 m on the CX-100 blade.

During the CX-100 test, several high-energy events were located between 1.20 m and 1.30 m along the spar cap. The CX-100 blade was observed during failure to experience a catastrophic buckling of the low-pressure skin near the 1.2-m station. A post mortem inspection of the blade in this region showed a large crack in the bond joint between the low pressure skin and the shear web. A photograph of the crack is shown in Figure 23.

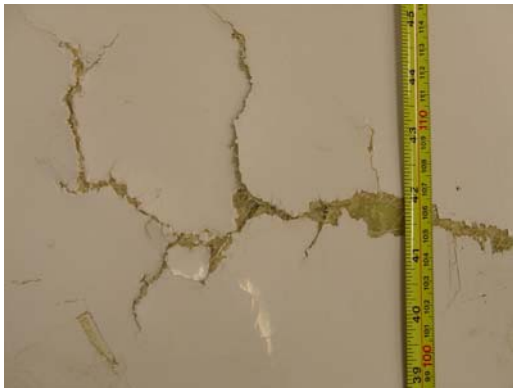
Figure 24: Crack near blade centerline on TX-100 blade.

The TX-100 blade test produced high-energy events just beyond the 1.00 m station. The blade eventually failed at the 1.0-m station, with a failure described as a buckling of the compressive skin, initiated towards the leading edge. A photograph of the fracture is shown in Figure 24.

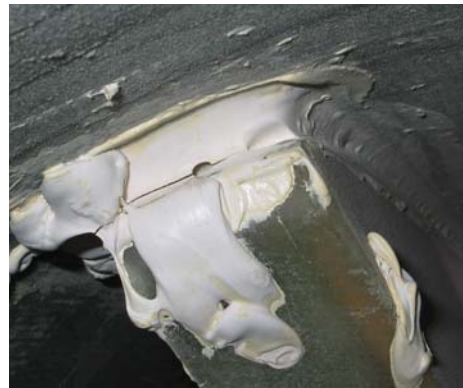
Figure 25: Crack at shear web termination on the LP surface of the BSDS blade.

During the BSDS test, the only high-energy events were located around 0.350 m, which is the station where the shear web terminates on the root end. A closer examination of this area after the test showed that a large crack had developed between the low-pressure skin and the shear web in the bonding joint. A photograph of the crack is shown in Figure 25.
