WSRC-STI-2007-00189

TESTING OF TMR SAND MANTIS FINAL REPORT

Robotics, Remote & Specialty Equipment Section
Engineered Equipment and Systems Directorate
Savannah River National Laboratory
Aiken, SC 29808

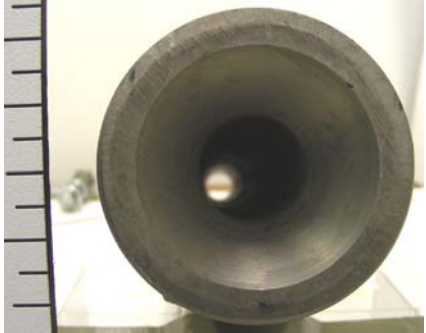
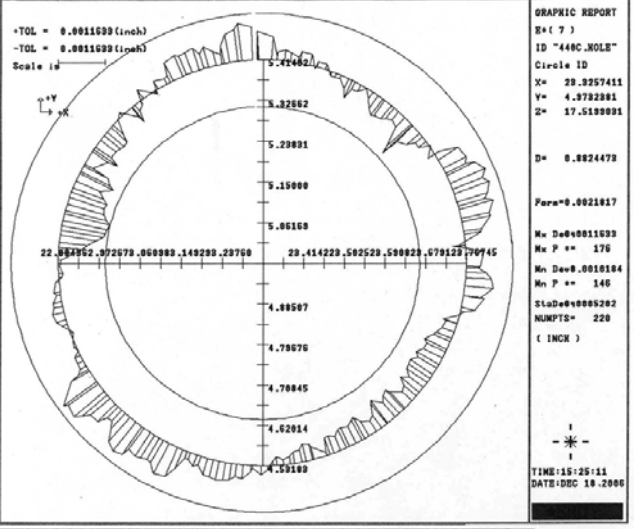
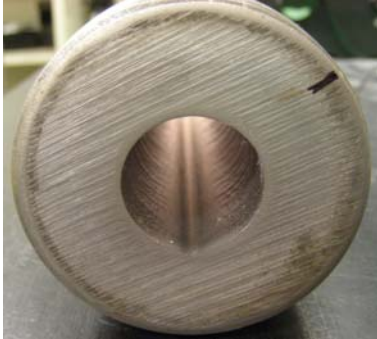
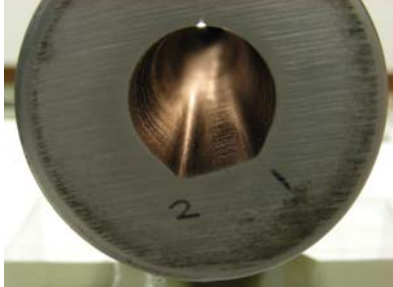
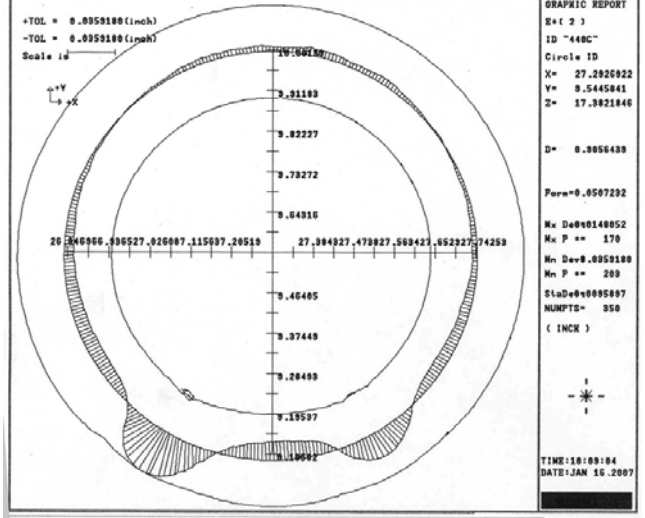
Table 1. Notes and measurements for erosion tests on 440C zoom tube

Hardness	HRC 53		
			Inlet profile (total out-of-roundness) = 0.002 inch
After 1st Batch			
Batch size	1000 lbs sand

Max. wear depth	0.032 inch		
Wear location	Disch. end, ~5:00, ~6 inches long		
Final weight	9127.3 grams		
Weight change	4.6 grams loss		
After 2nd Batch			
Batch size	800 lbs sand

Max. wear depth	0.051 inch		
Wear location	Disch. end, ~7:00, ~6 inches long		
Final weight	9124.9 grams		
Weight change	2.4 grams loss		
			Outlet profile (total out-of-roundness) = 0.051 inch

After the first batch of simulant, wear was evident on each zoom tube. A groove was worn into the last several inches of the 440C and Goodyear hose zoom tubes. In addition, the adapter at the end of the Goodyear hose also contained a worn groove. A groove was worn near the entrance of the A2 zoom tube, extending several inches in length, and a second smaller groove was worn further downstream. The position of the grooves in the A2 zoom tube is attributed to a small metal chip that was found behind the high pressure orifice and disrupted the flow pattern for this run only.

After the second batch of simulant, additional wear was evident on the 440C and A2 zoom tubes. Due to a slight change in the nozzle orientation, a second groove was worn into the last several inches of the 440C zoom tube. Grooves of noticeable depth were also worn into the last several inches of the A2 zoom tube. A minor region of wear was also noted on the adapter at the end of the Goodyear hose zoom tube (away from the previous groove), but it was not obvious that additional wear occurred on the hose. The Goodyear hose is slightly ovalized, as shown in the profiles in Table 3. This effect was taken into account in identifying the depth of material loss after the tests.

For both the 440C and A2 zoom tubes, more zoom tube material was removed during the first batch than during the second batch. The weight loss for the A2 zoom tube during the first batch was more than triple that of the second batch. The magnitude of this difference suggests that material removal rates are increased if the stream is interrupted (in this case due to debris lodged in the orifice) to move the impact point of the stream closer to the nozzle.

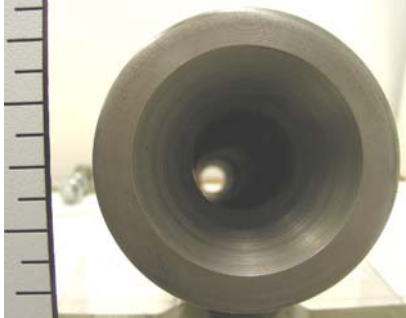
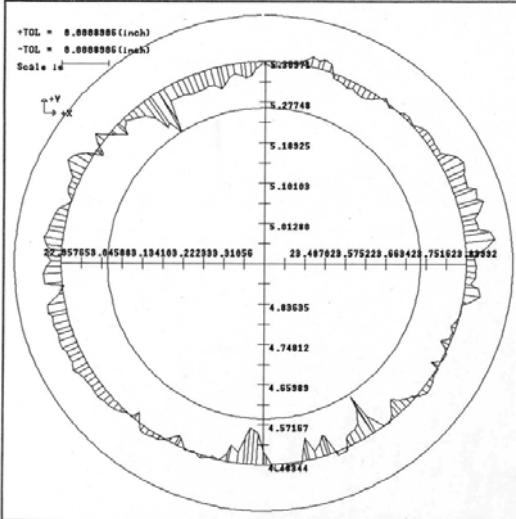
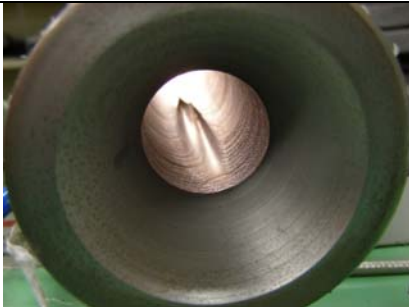
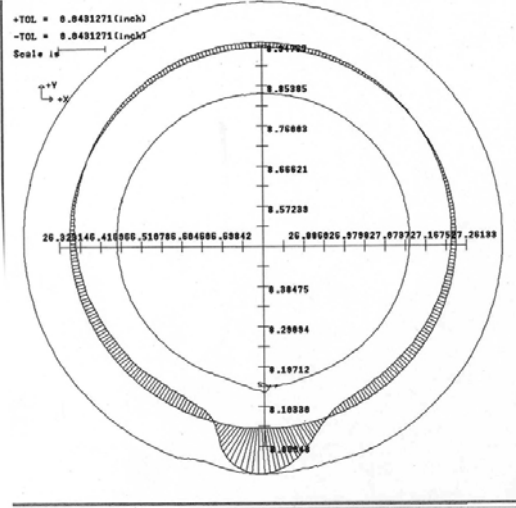
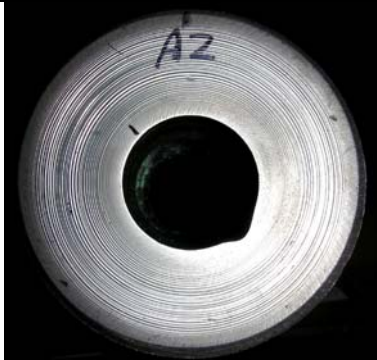
Table 2. Notes and measurements for erosion tests on A2 zoom tube

GRAPHIC REPORT E= (5) ID "A2_MOLLS" Circle ID X= 28.2880139 Y= 4.9244748 Z= 17.5632898 D= 0.8818828 Para=0.0014575 Mx Dev=0.0008886 Mx P = 201 Mn Dev=0.0005568 Mn P = 53 StdDev=0.002552 NUMPTS= 228 (INCH) TIME:15:10:08 DATE:DEC 18 .2006
		Inlet profile (total out-of-roundness) = 0.001 inch
After 1st Batch		
Batch size	1000 lbs sand

Max. wear depth	0.063 inch	
Wear location	Inlet from just past cone, ~6:00, ~4 inches long, a second groove farther downstream	
Final weight	9459.4 grams	
Weight change	13.2 grams loss	
After 2nd Batch		
Batch size	1000 lbs sand

Max. wear depth	0.056 inch	
Wear location	Disch. end, ~5:00, ~4 inches long	
Final weight	9455.2 grams	
Weight change	4.2 grams loss

GRAPHIC REPORT E= (1) ID "A2" Circle ID X= 26.7821891 Y= 8.4877524 Z= 17.4282898 D= 0.8886582 Para=0.0562614 Mx Dev=0.0131343 Mx P = 286 Mn Dev=0.0481271 Mn P = 176 StdDev=0.0188888 NUMPTS= 338 (INCH) TIME:08:37:48 DATE:JAN 16 .2007

Outlet profile (total out-of-roundness) = 0.056 inch

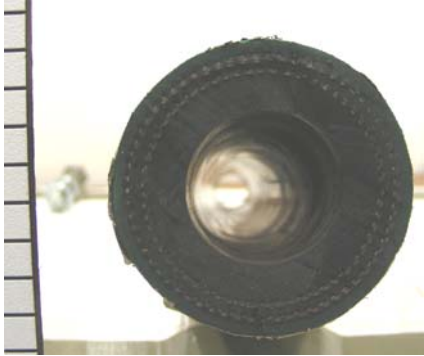
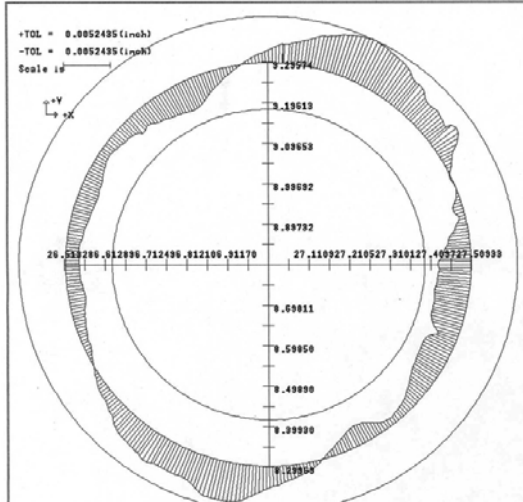
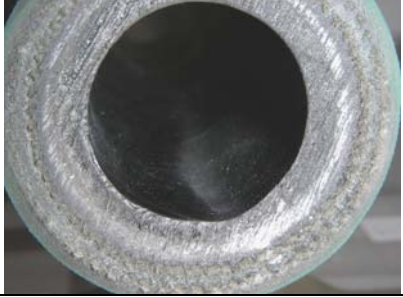
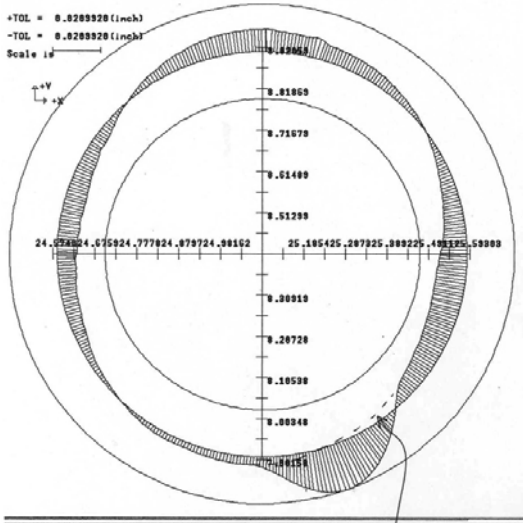
Table 3. Notes and measurements for erosion tests on Goodyear hose zoom tube

<p>GRAPHIC REPORT E= (5) ID "MOSE2.BASE" Circle ID X= 27.8129296 Y= 8.7982106 Z= 17.2199591 D= 0.9920136 Para=0.0081909 Mx Dev=0.0038994 Mx P = 102 Mn Dev=0.0052495 Mn P = 25 StatDev=0.0026027 NUMPTS= 383 (INCR) + * - + * - TIME:08:48:12 DATE:JAN 16 2007 17</p>
Zoom tube weight	723.8 g			
Hardness	40 Durometer A			
			Inlet profile (total out-of-roundness) = 0.009 inch (from spare hose section cut from outlet end of tested hose)	
After 1st Batch

Batch size	1000 lbs sand			
Max. wear depth	Not measured			
Wear location	Disch. end, ~2:00, ~3 inches long			
Final weight	724.3 grams			
Weight change	0.5 gram gain			
After 2nd Batch

<p>GRAPHIC REPORT E= (9) ID "MOSE" Circle ID X= 25.8852551 Y= 8.4896652 Z= 18.0419617 D= 1.0020888 Para=0.0342882 Mx Dev=0.030662 Mx P = 187 Mn Dev=0.0289928 Mn P = 178 StatDev=0.0089352 NUMPTS= 387 (INCR) + * - + * - TIME:10:00:08 DATE:JAN 16 2007</p>

Batch size	800 lbs sand			
Max. wear depth	0.021 inch			
Wear location	Additional wear not obvious			
Final weight	724.6 grams			
Weight change	0.3 gram gain			
			Outlet profile (total out-of-roundness) = 0.034 inch (corrected for ovalization)

The hose used in the erosion test was contained within a pipe section, and held securely with an adapter on the downstream end. The adapter ID is nominally the same as the hose ID, which extends the transition to the 1-1/2 inch ID tube an additional 3 inches. To the extent the adapter influences the flow pattern within the hose, the wear of the hose cannot be compared directly to the wear of the other zoom tubes. The minimal wear in both the zoom tube and the adapter during the second batch indicates that the impact zone may have been downstream of the zoom tube and adapter. The nozzle and nozzle holder were removed and retorqued to ensure the correct angular orientation of the nozzle and to inspect the nozzle for wear. This reinstallation process may have moved the zone of direct impingement downstream past the zoom tube.

The hose has a larger ID than the other zoom tubes (1 inch vs. 7/8 inch). This is expected to have the effect of moving any damage zones further downstream. The high pressure water stream expands as it moves downstream, and the point where it impacts the wall will be further downstream for a larger ID.

The maximum depth of penetration after the second batch was 0.021 inch. Comparing the photographs after each batch, it appears that most if not all of this wear occurred during the first batch. The wear rate for the hose is therefore bounded by 0.021 inch / 1000 lb simulant. The inner wear layer of the hose is 5/16 inches thick (nominal). Approximately 7% of this thickness was penetrated with the transfer of 1000 pounds of simulant.
