**Spectrally Enhanced Lighting Program
Implementation for Energy Savings:**

Field Evaluation

Prepared by
Pacific Northwest National Laboratory

August 2006

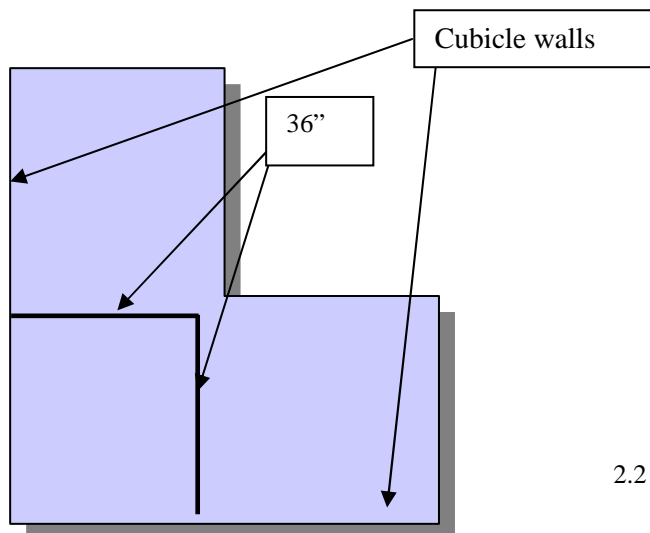
Figure 2.1. Illuminance measurements were taken at 36" from the cubicle wall at 30" above the floor for horizontal measurements and at 46" above the floor for vertical measurements.

Pre-retrofit and post-retrofit illuminance measurements were taken at representative spaces in each building to assess the lighted characteristics of the test areas before and after retrofit. Repeatable measurements were taken at a point 36" from one cubicle or office wall and 36" from the adjoining perpendicular wall as shown in Figure 2.1. Horizontal measurements were taken on a horizontal plane (the desktop) at 30" above the floor (approximately desk height) and vertical measurements were taken in the vertical plane (with the illuminance meter head facing the office or cubicle wall) at 46" above the floor (approximately eye height when seated) to represent a typical occupant's viewing level (see Figure 2.2). The direction of the vertical measurement was chosen to represent what was considered to be the most common viewing direction of the occupant during their work day, based on location of work and reference materials in the workspace.

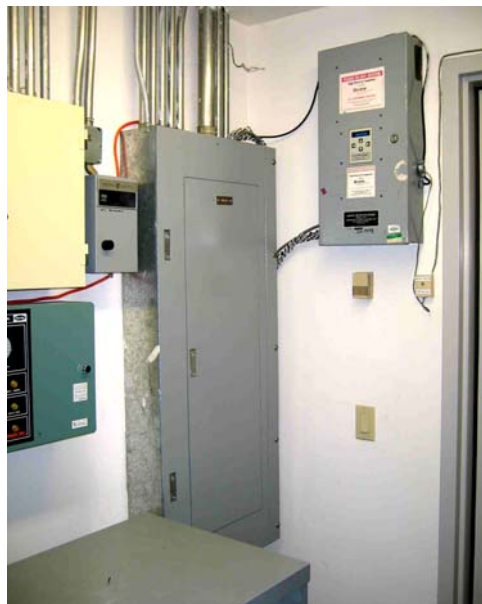
Figure 3.1. End Use Metering Logger. The box to the right of the control panel is one of two end use metering loggers used to measure current, power, and apparent power in Building A.

The fixtures affected by the retrofit are powered from eighteen 277-volt dedicated lighting circuits. Two end-use metering loggers were installed to monitor these circuits. One of the loggers is shown in Figure 3.1; the other logger installation is essentially identical. The pre-retrofit study period was August 10 to September 2, 2005, and the post-retrofit period was September 12 to October 15, 2005.

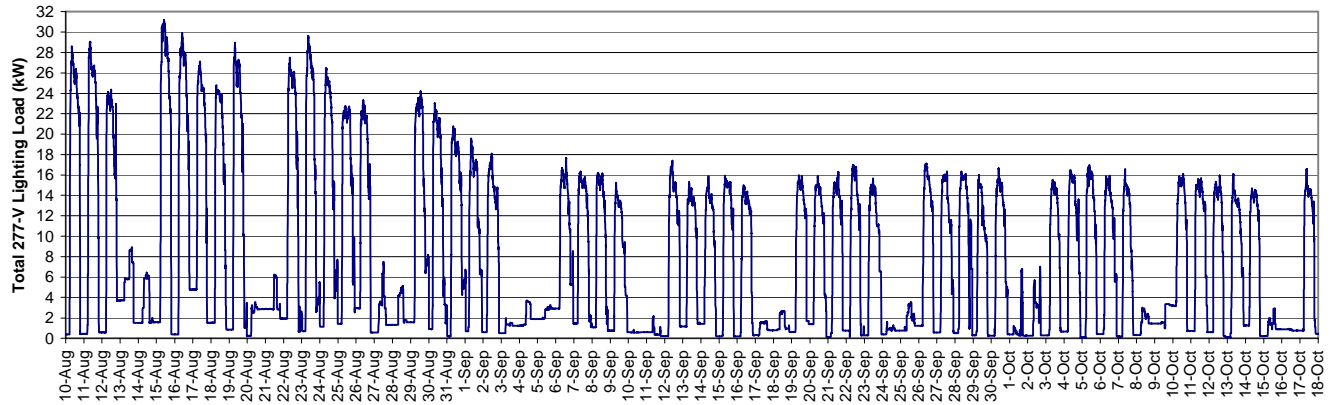
Figure 3.2. Building A total lighting load from Aug. 10 to Oct. 15. Retrofit activity took place Sept. 2-11, 2005

The time series data streams from the two loggers were merged into a single time series of total lighting power (sum of all circuits) shown in Figure 3.2.

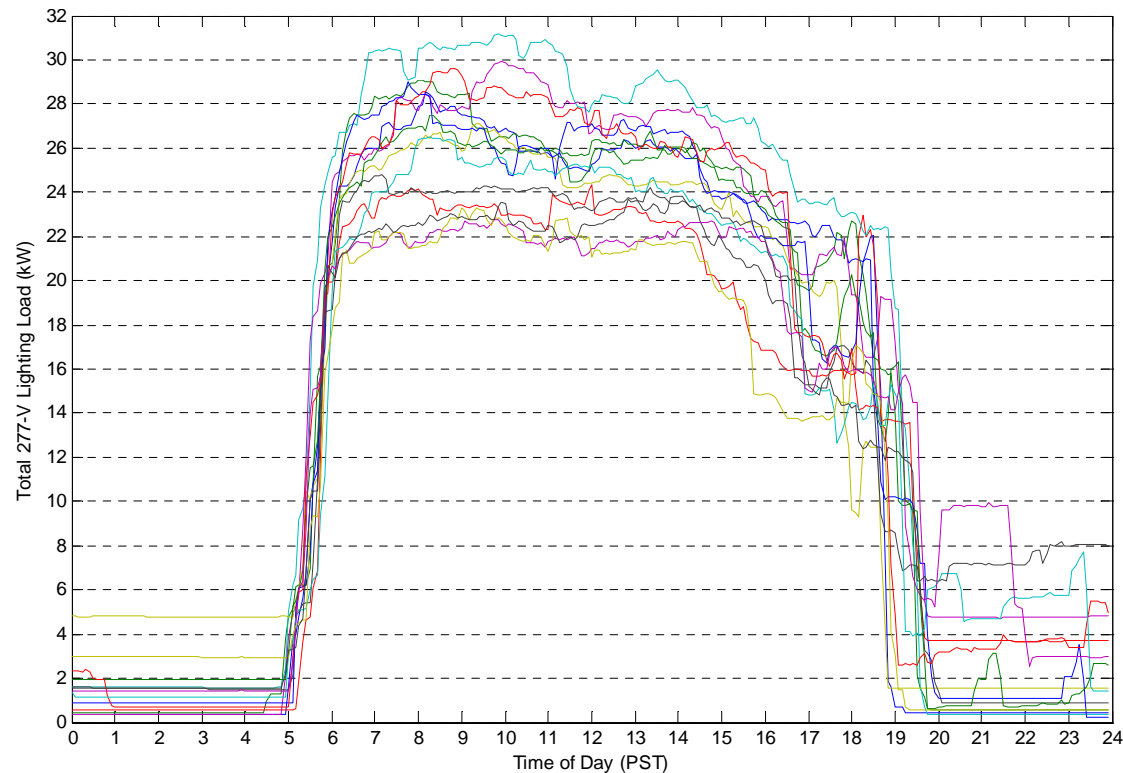
Figure 3.3. Building A Pre-Retrofit Weekday Load Profiles for Aug. 10 – Aug. 29, 2005

Daily lighting load profiles for pre-retrofit weekdays (Aug. 10-29) are shown in Figure 3.3 and daily lighting load profiles for post-retrofit weekdays (Sept. 12-Oct. 7) are shown in Figure 3.4. Each line represents a different day's profile in Figures 3.3 and 3.4.

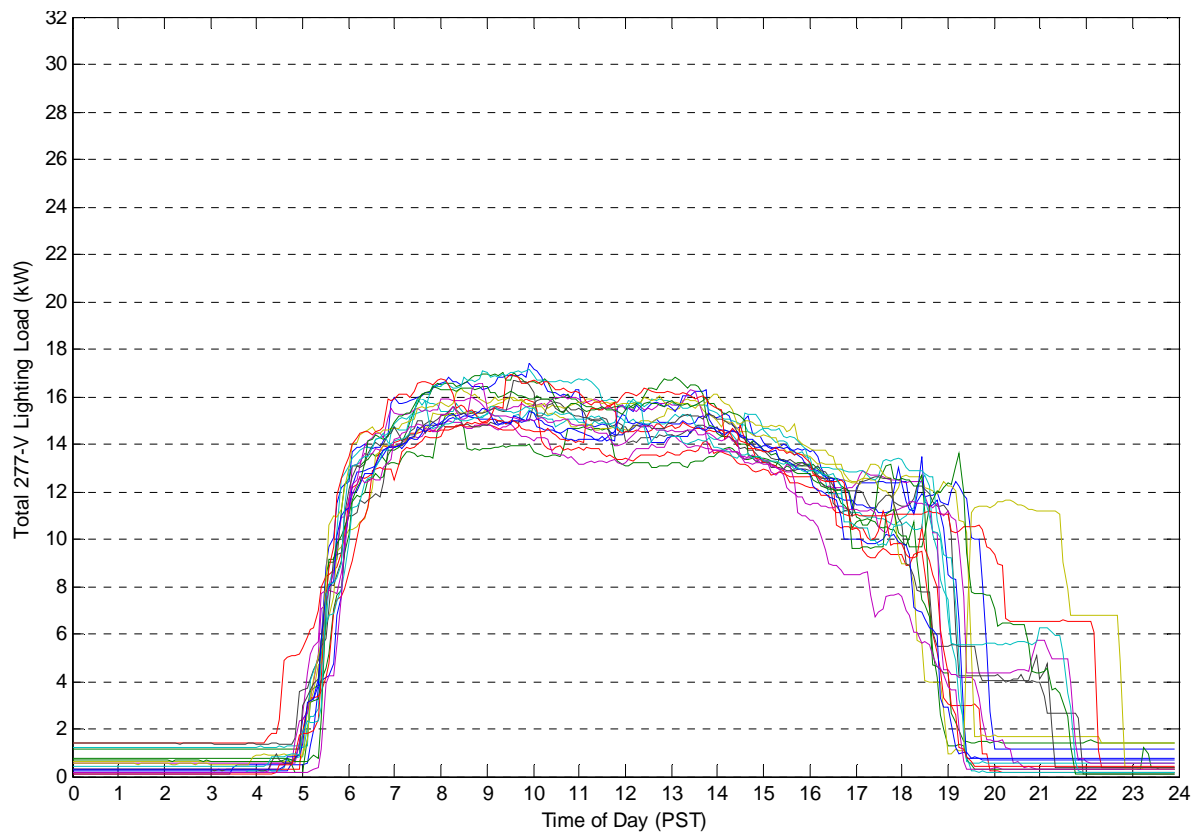
Figure 3.4. Building A Post-Retrofit Weekday Load Profiles for Sept. 12 – Oct. 7, 2005

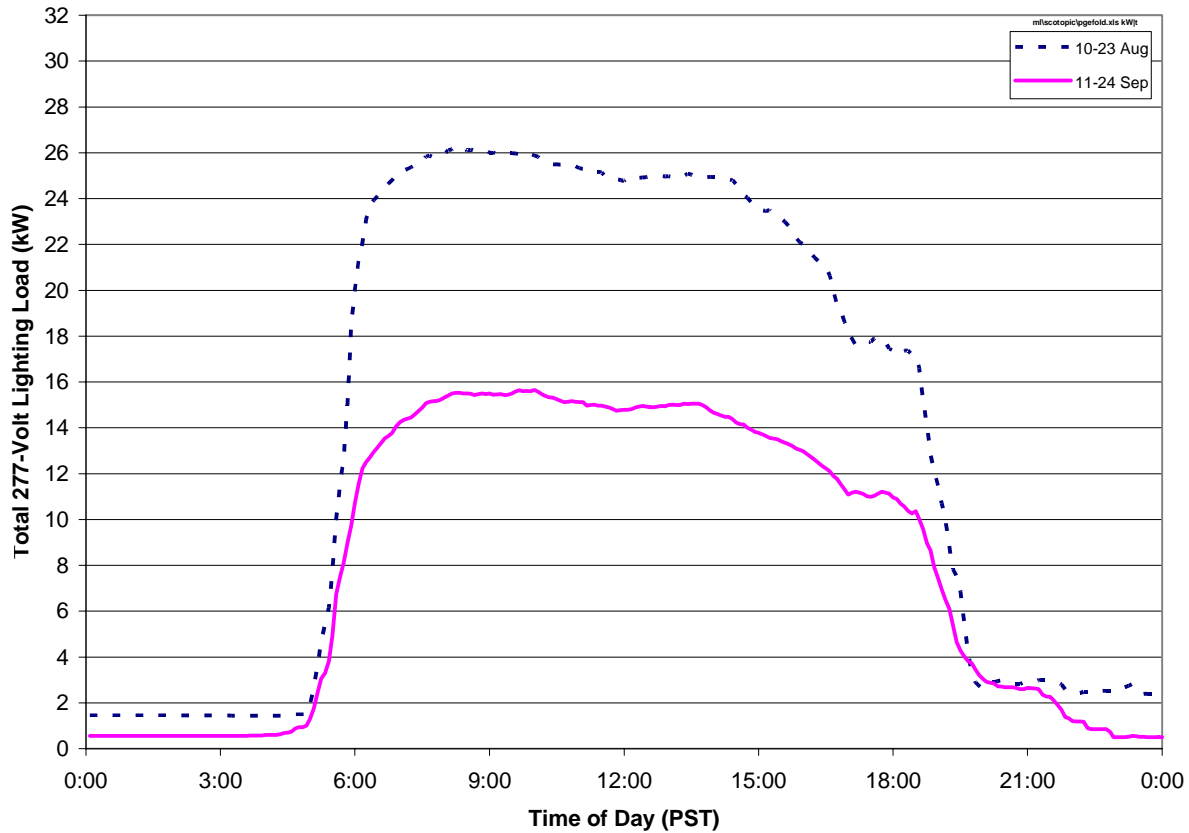
Figure 3.5. Building A Mean Pre- and Post-Retrofit Workday Load Profiles

Figure 3.5 shows a comparison of the average pre-retrofit load to average post-retrofit load for the periods measured. This graph indicates a 40.9% drop in average daily lighting load after the retrofit.

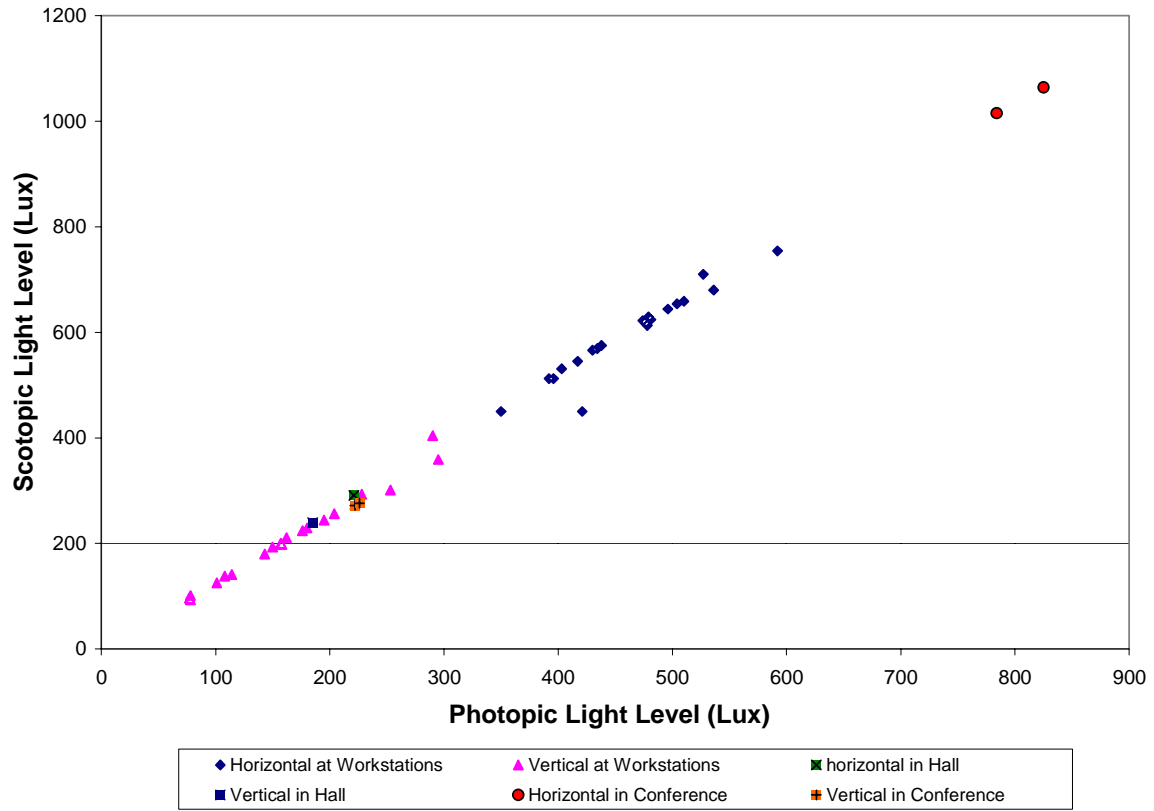
Figure 3.6. Building A - Pre-Retrofit Scotopic/Photopic Ratio Comparison

As expected, the slope represented by the lines in the plots is steeper for the post-retrofit ratios, confirming the increased scotopic content of the post-retrofit lamps. Both charts show fairly uniform slopes for the plotted data, indicating consistent data with few outliers. The data for any outliers in the dataset were carefully considered to determine if they could be specifically identified as bad data points. In these cases the values that were considered outside of the expected values were either considered within the realm of possible data recording or effects from retrofit differences. Because they are so few in number and so small in magnitude, they have a negligible effect on the results.

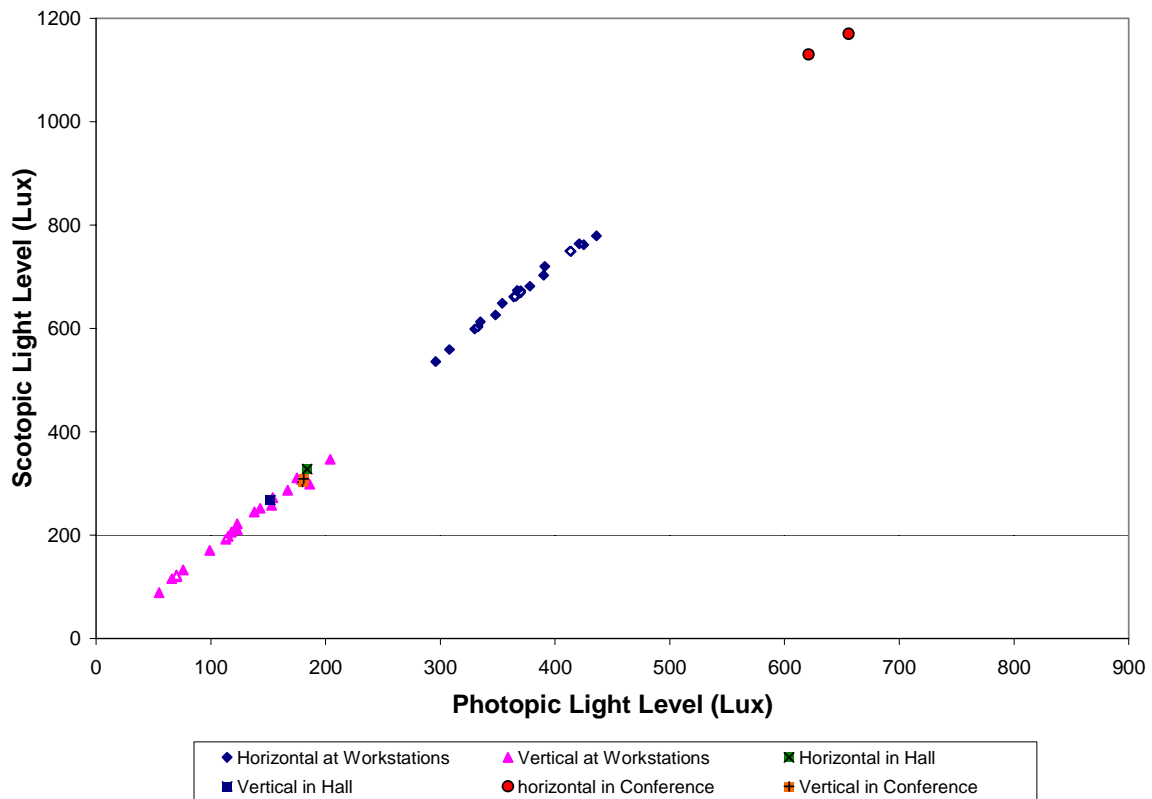
Figure 3.7. Building A - Post-Retrofit Scotopic/Photopic Ratio Comparison

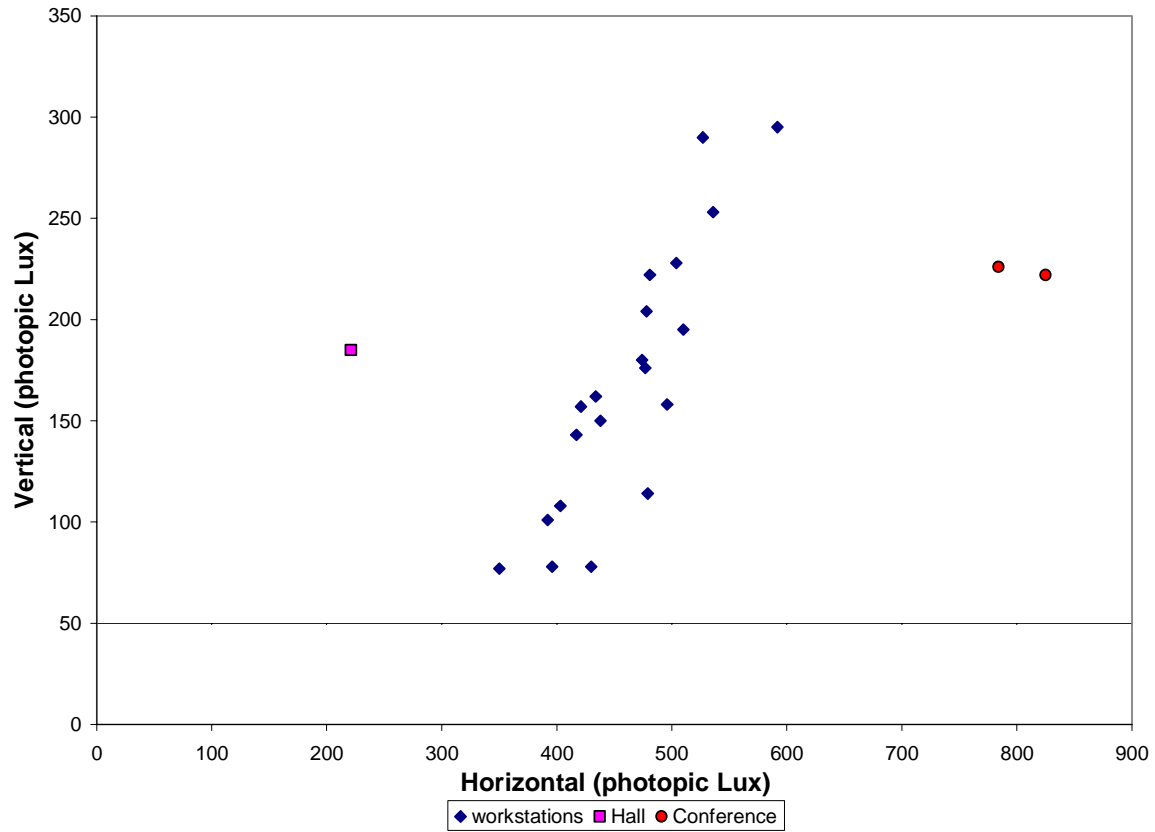
Figure 3.8. Building A - Pre-Retrofit Vertical vs. Horizontal Comparison (Photopic)

One of the major variables affecting the light level measurements is the varied workspace environment and changing character of the occupied spaces. Workspaces are oriented in different ways in relation to overhead lighting fixtures and partition walls. Materials surrounding desk spaces and posted on walls (personal and business related) are also varied and can have an effect on the horizontal and vertical illuminance readings between spaces and in particular between time periods. This tends to reduce the consistency of the comparison between illuminance values within a specific set of measurements and between pre- and post-retrofit sets. As averaged data, these effects are less noticeable but it is useful to understand this variability. Figures 3.8 and 3.9 present ratios of horizontal to vertical measurements for each location. The cloud of data points shows the extent of the variability.

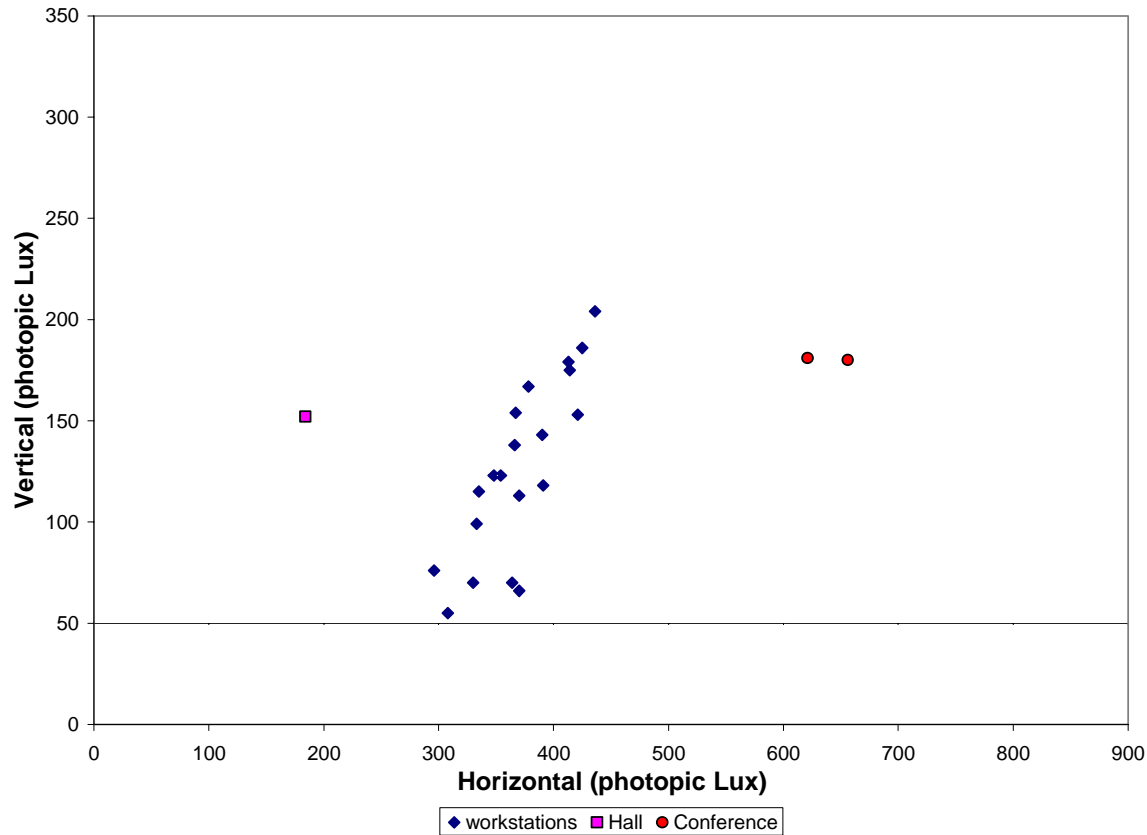
Figure 3.9. Building A - Post-Retrofit Vertical vs. Horizontal Comparison (Photopic)

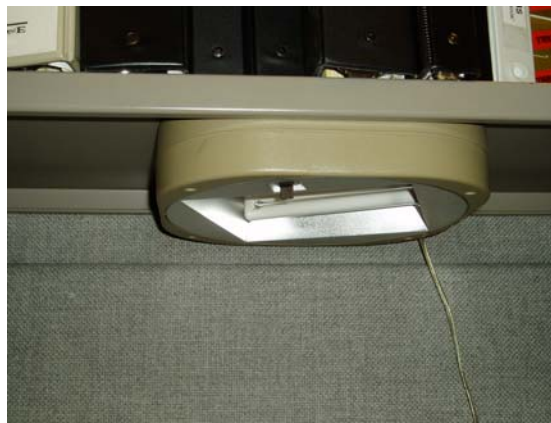
Figure 3.11. Building A Workstation Task Light

To assess pre- and post-retrofit task lighting use, individual data loggers were deployed at a sample of the building's workstations. Figure 3.10 and 3.11 show one style of task light and workstation/cubicle present in Building A. The lighting data loggers used were Onset Computer Hobo® H-8 models (see Appendix D for specifications). These were installed on or near 45 workstation task lights. The loggers were set to sense whether the task light was on or off by measuring the light intensity coming from the fixture at 10-minute intervals. Data were collected for more than two weeks in both the pre- and post-retrofit periods. The post-retrofit data were collected after the three-week adaptation period to allow for occupant adjustment to the new overhead lighting.

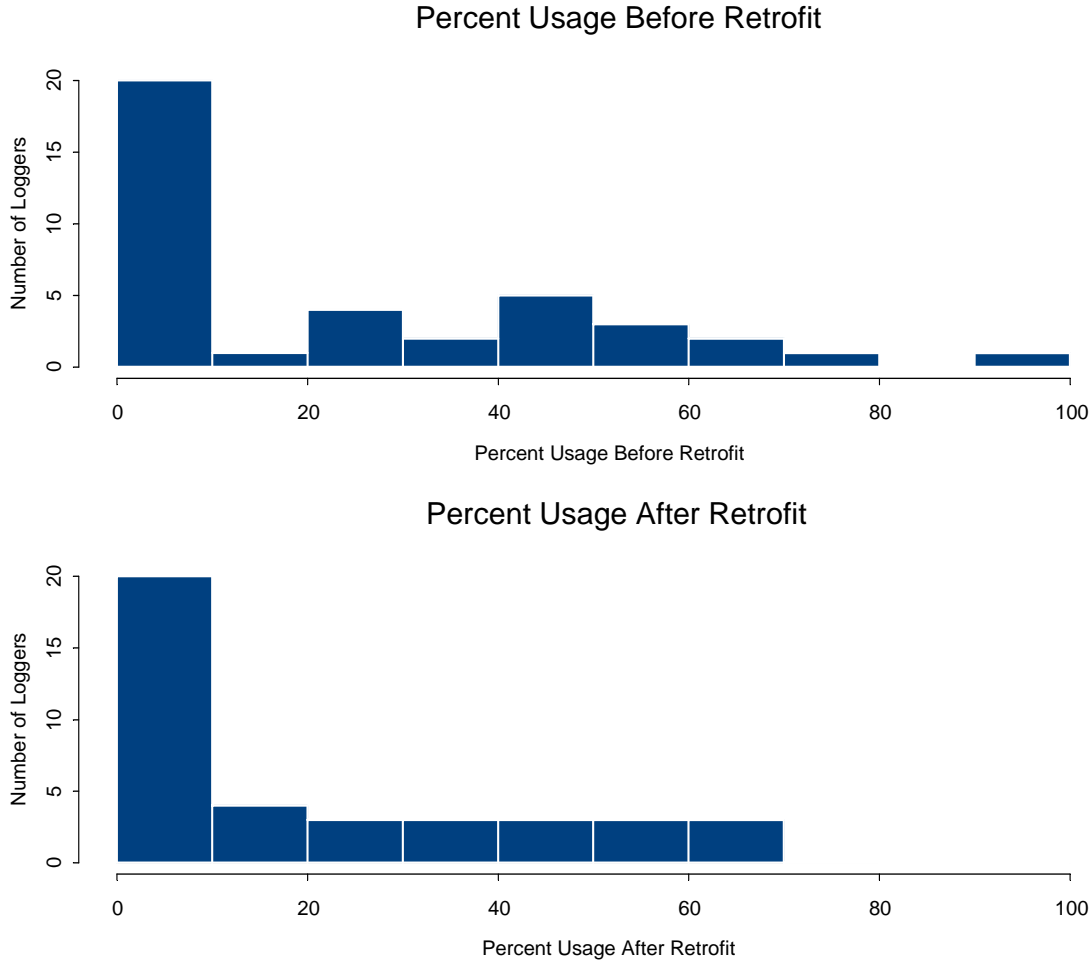
Figure 3.12. Building A - Task Light Usage as a Percentage of Business Hours Before and After Retrofit

Figure 3.12 shows the percentage of hours of the business day that each of the 39 task lights logged were used before and after retrofit. As can be seen, 20 of the task lights were almost never used before or after the retrofit. The plotted differences (post-retrofit – pre-retrofit) are shown in Figure 3.13, which indicate the data has an approximate normal distribution – with a small tail to the left.

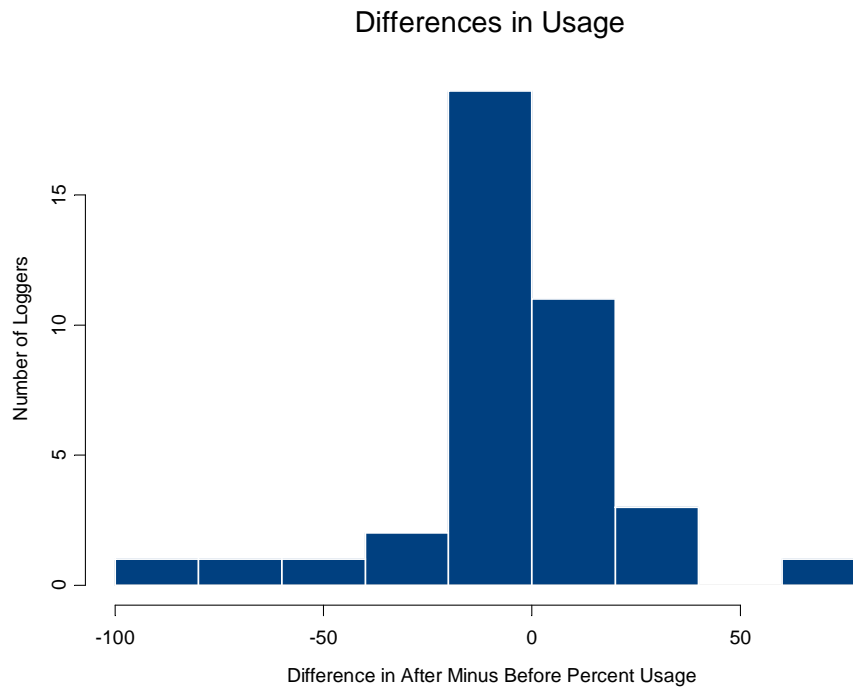
Figure 3.13. Building A - Task Lighting Logger Difference in Usage Before and After Retrofit

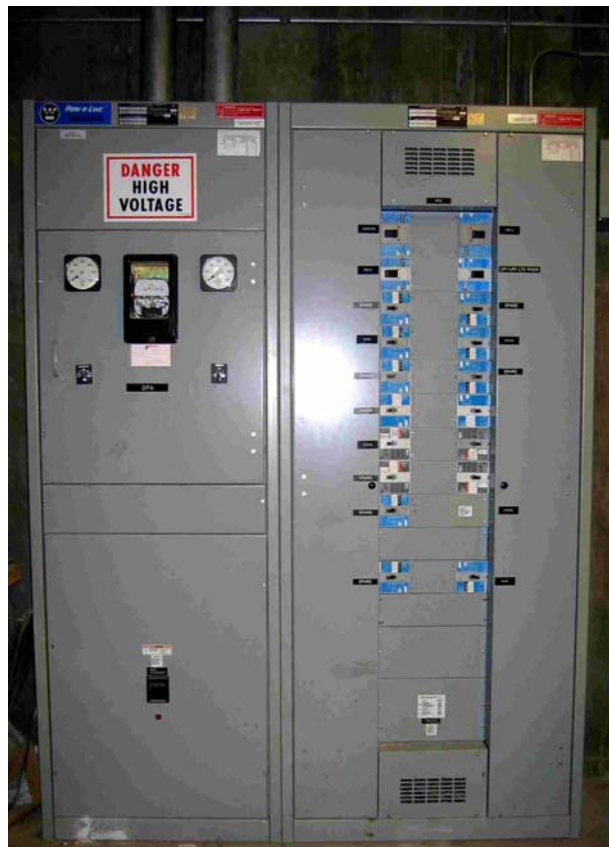
Figure 4.2. Building B - Distribution Panel with Three-Phase Lighting Riser Logger Installed in Right-Hand Compartment

The fixtures affected by the retrofit are powered from three 277-volt dedicated interior lighting panels on the second through fourth floors (one panel per floor) and a mixed lighting panel on the first floor. The first floor panel serves exterior and stairwell lighting as well as the overhead office lighting. Two loggers were installed to monitor lighting power. An end-use metering logger was installed at the first-floor lighting panel similar to the installation shown in Figure 3.1 for Building A. A four-wire three-phase power logger was installed on the lighting riser circuit of the distribution panel in the main electrical room as shown in Figure 4.2. The total overhead lighting load is taken to be the riser load minus the exterior and stairwell loads. The pre-retrofit study period was October 13 - November 4, and the post-retrofit period was November 7 – December 6, 2005.

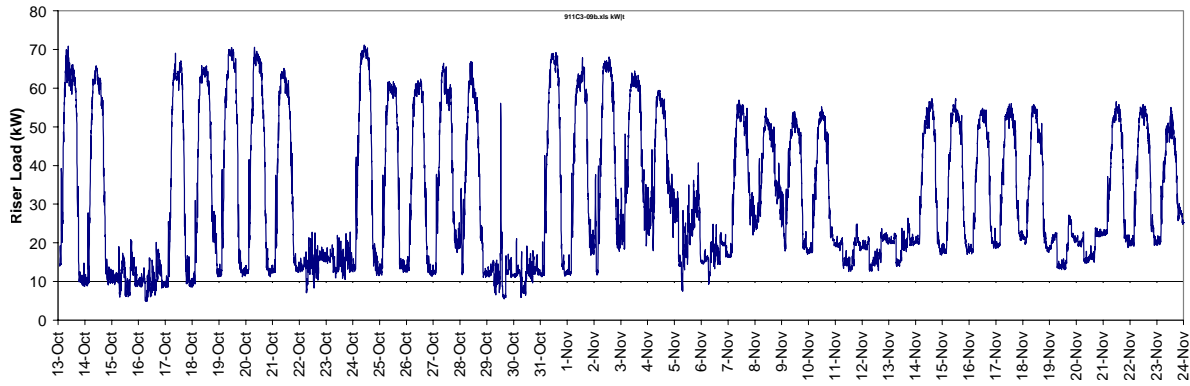
Figure 4.3. Building B Lighting Riser Load Oct. 13 to Nov. 23. Retrofit activity took place Nov. 3-6.

The time series data from the riser logger indicates total lighting power over the pre- and post-retrofit periods of the study as shown in Figure 4.3.

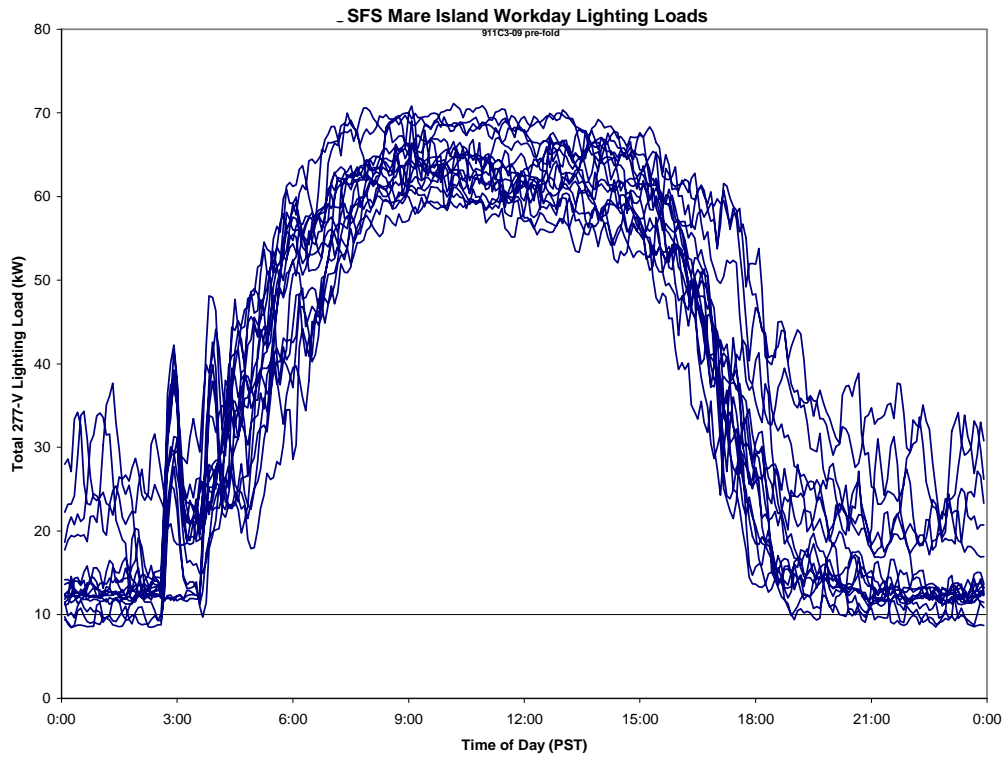
Figure 4.4. Building B Pre-Retrofit Weekday Load Profiles for Oct. 13–Nov. 4, 2005

To better see the effects of varying building operations, the daily total lighting power profiles are shown for pre-retrofit weekdays in Figure 4.4 and for post-retrofit weekdays in Figure 4.5. Each daily load profile is a separate line in Figures 4.4 and 4.5.

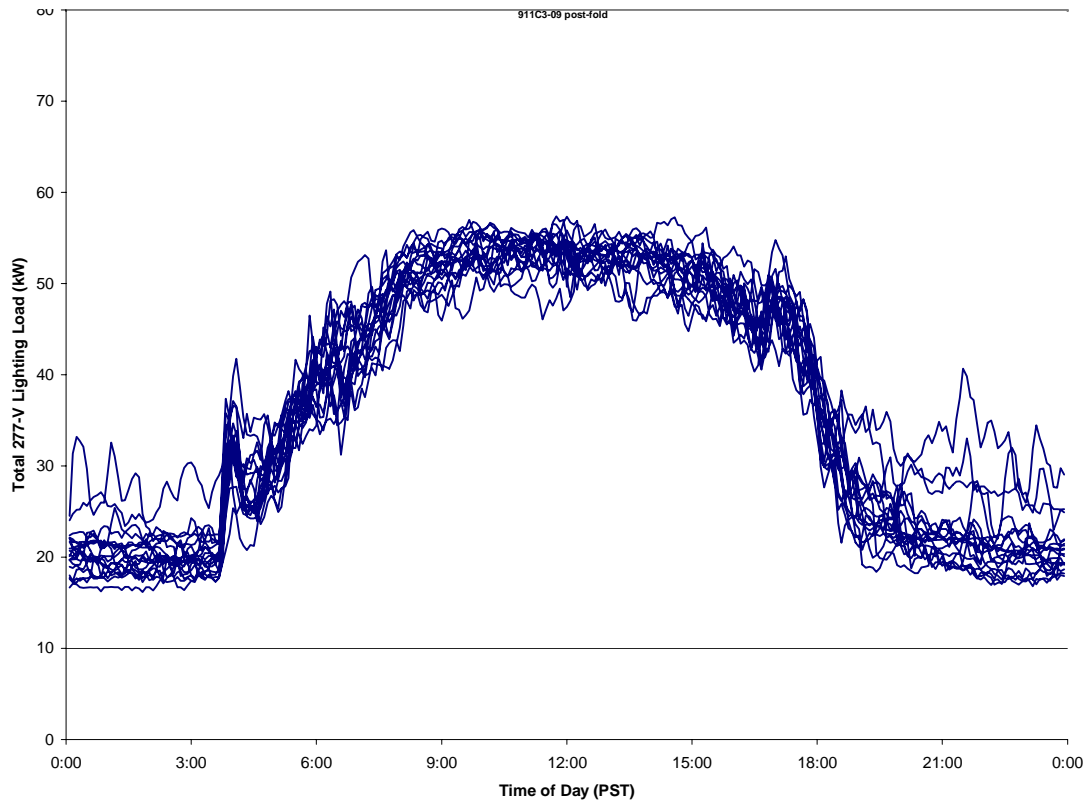
Figure 4.5. Building B Post-Retrofit Weekday Load Profiles for Nov. 7–Dec. 6, 2005

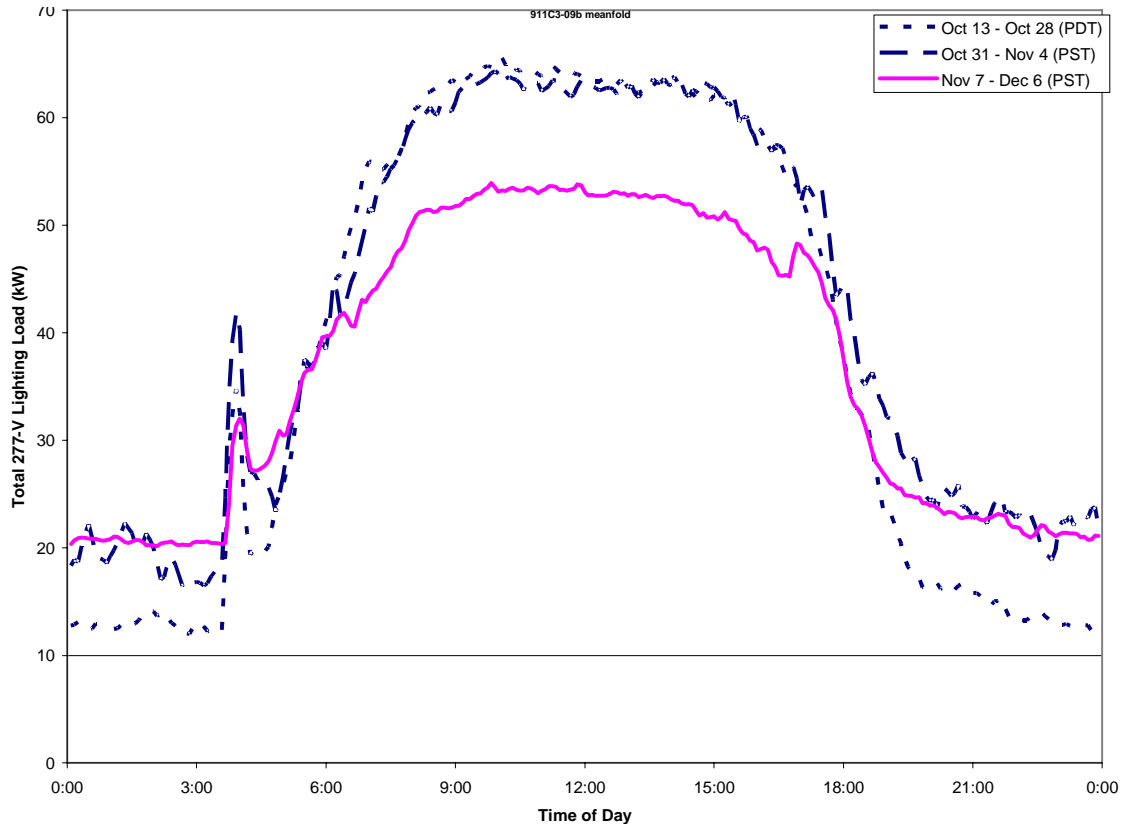
Figure 4.6. Building B Mean Pre- and Post-Retrofit Workday Load Profiles

The mean daily profiles, after removing exterior lighting loads, are shown together in Figure 4.6. The two pre-retrofit profiles (Figures 4.3 and 4.4) show that a significant change in nighttime lighting use occurred with the change from daylight-savings to standard time on October 30. We postulate that the seasonal onset of afternoon darkness results in more lights being left on.

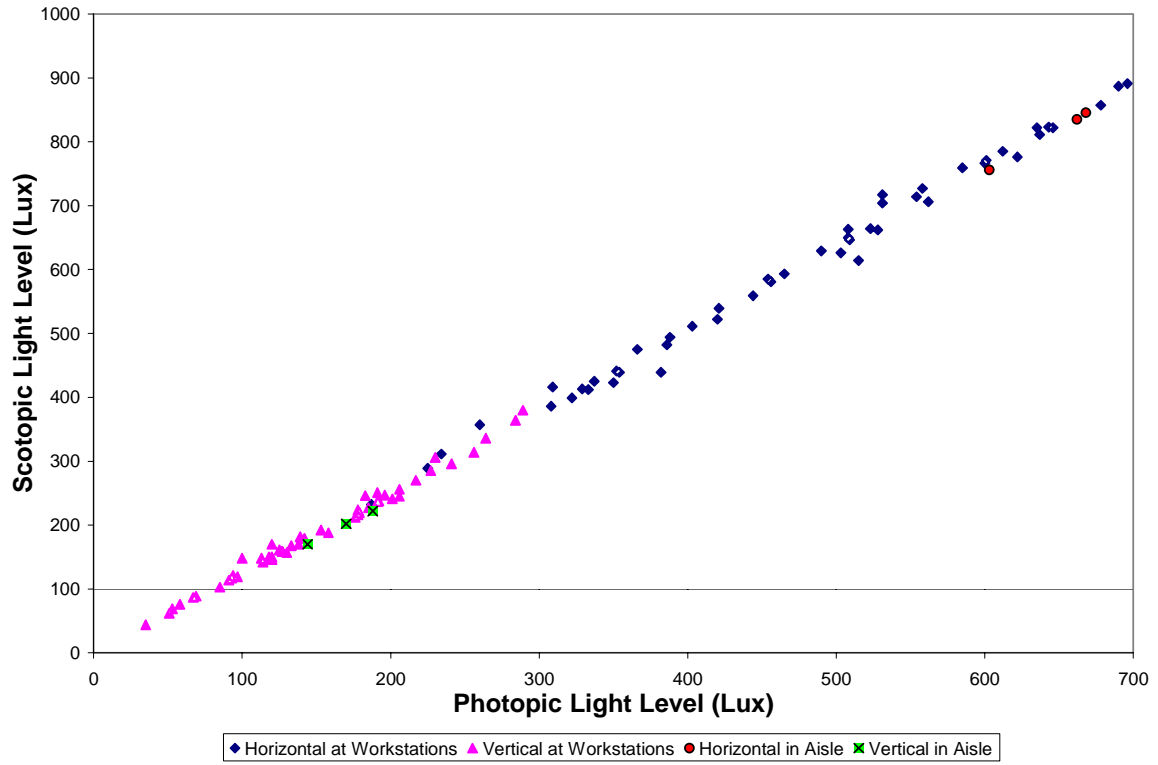
Figure 4.7. Building B - Pre-Retrofit Scotopic/Photopic Ratio Comparison

As expected, the slope represented by the lines in the plots is steeper for the post-retrofit ratios, confirming the increased scotopic content of the post-retrofit lamps. Both charts show fairly uniform slopes for the plotted data, indicating consistent data with few outliers. The data for any outliers in the dataset were carefully considered to determine if they could be specifically identified as bad data points. In these cases, the values that were outside of the expected values were either considered within the realm of possible data recording or effects from retrofit differences. Because they are so few in number and so small in magnitude, they have a negligible effect on the results.

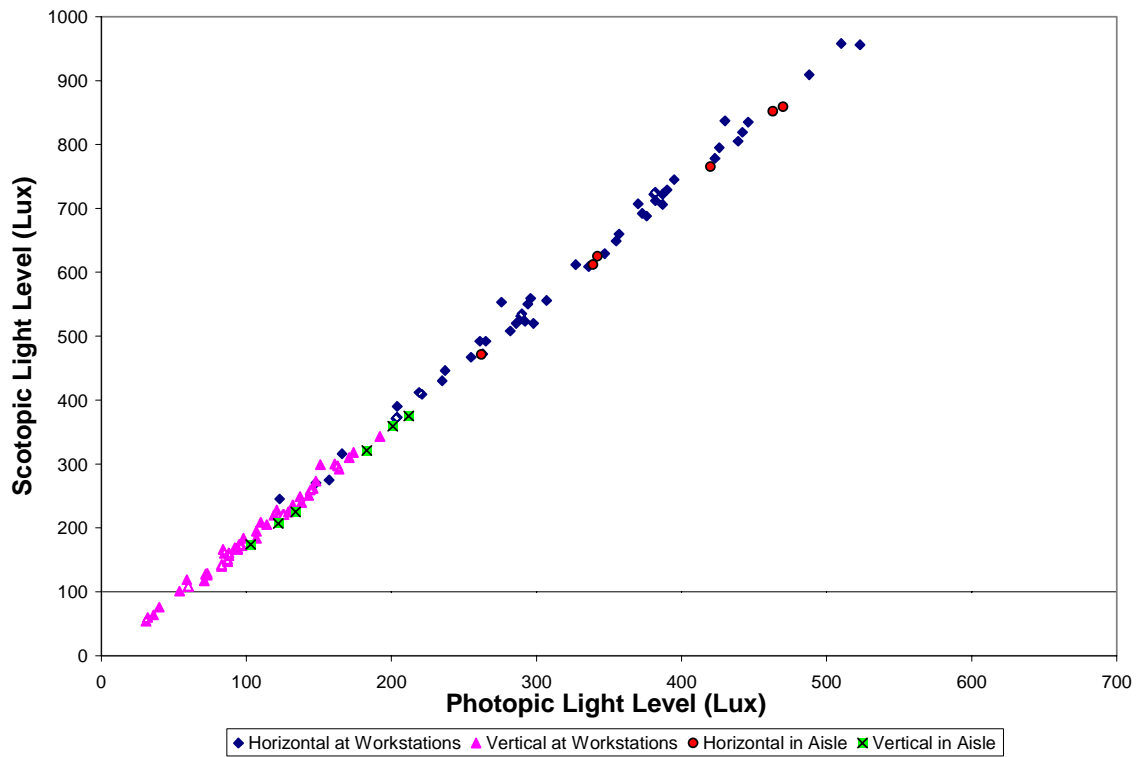
Figure 4.8. Building B - Post-Retrofit Scotopic/Photopic Ratio Comparison

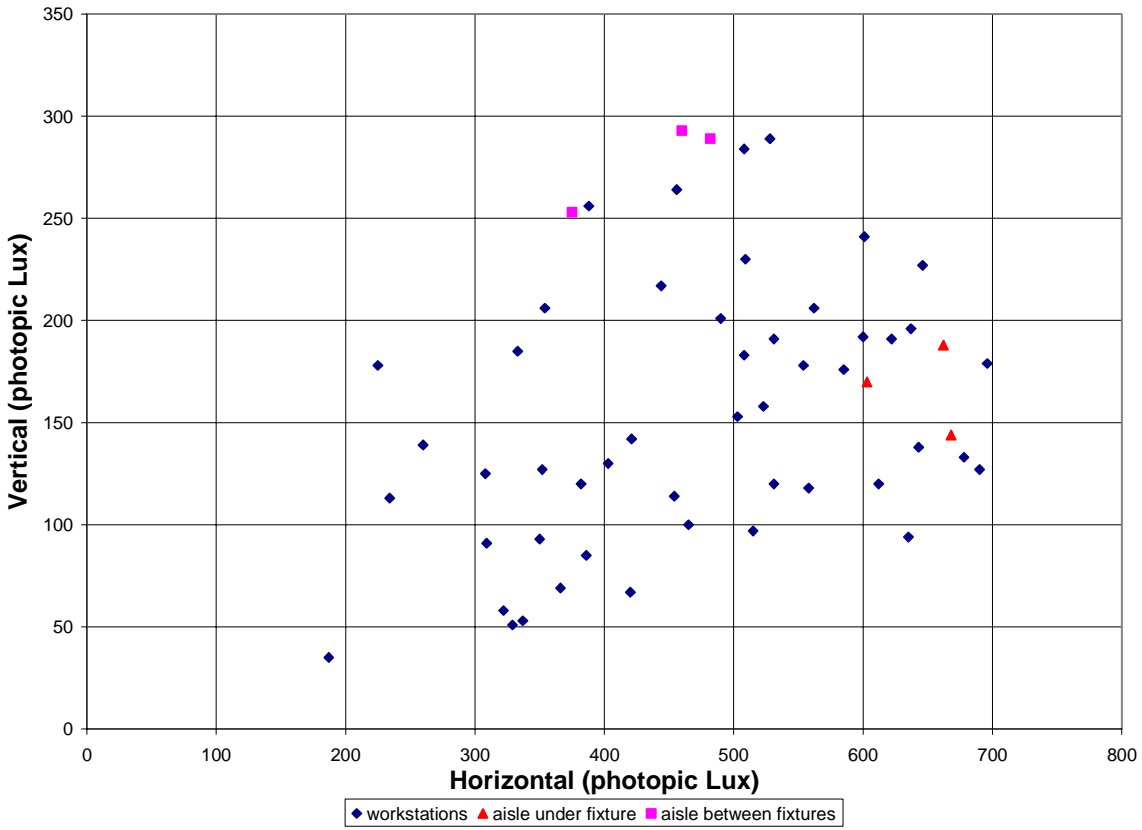
Figure 4.9. Building B - Pre-Retrofit Vertical vs. Horizontal Comparison (Photopic)

One of the major variables affecting the light level measurements is the varied workspace environment and changing character of the occupied spaces. Workspaces are oriented in different ways in relation to overhead lighting fixtures and partition walls. Materials surrounding desk spaces and posted on walls (personal and business related) are also varied and can have an effect on the horizontal light level readings between spaces and in particular between time periods. This tends to reduce the consistency of the comparison between horizontal values within a specific set of measurements and between pre- and post-retrofit sets. As averaged data, these effects are less noticeable but it is useful to understand this variability. Figures 4.9 and 4.10 present ratios of horizontal to vertical measurements for each location. The cloud of data points shows the extent of the variability.

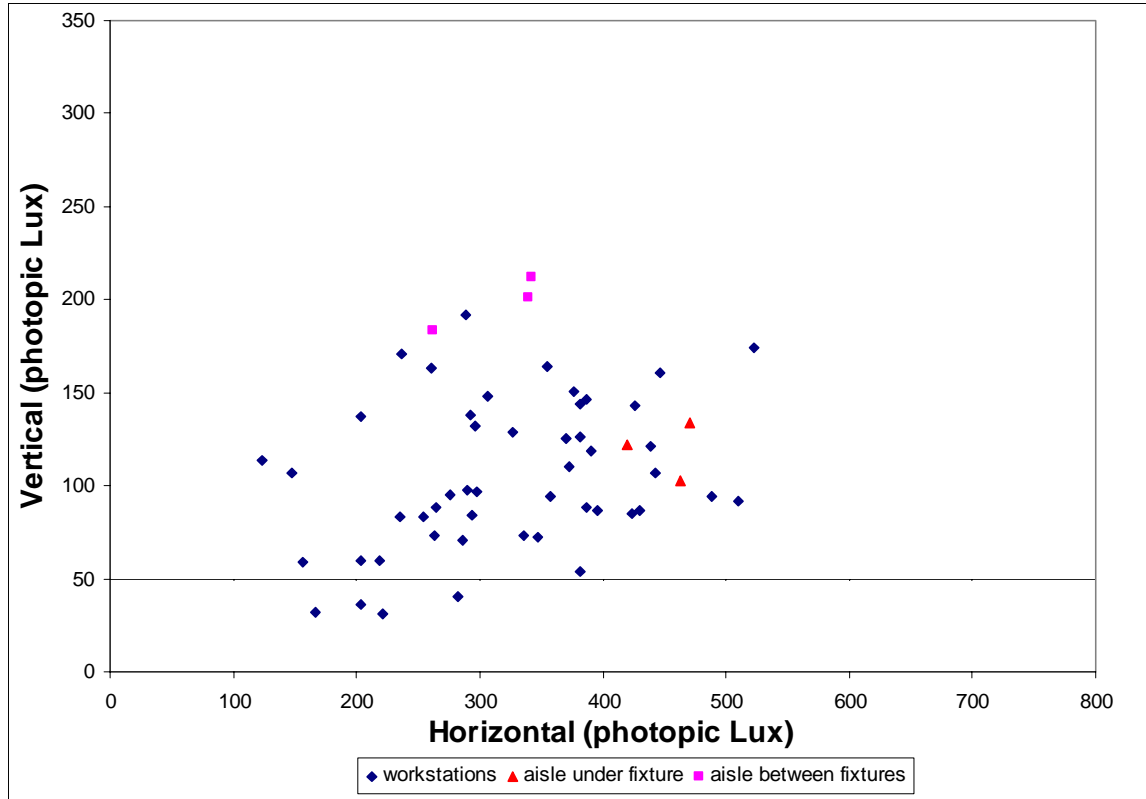
Figure 4.10. Building B - Post-Retrofit Vertical vs. Horizontal Comparison (Photopic)

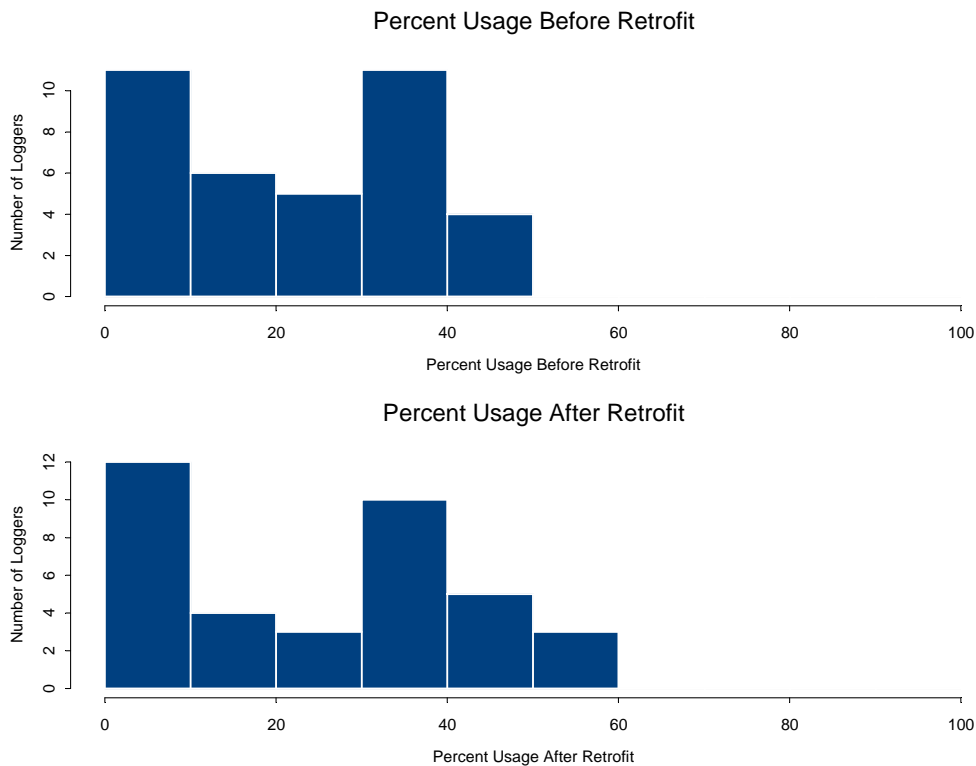
Figure 4.13. Building B - Task Light Usage as a Percent of Business Hours Before and After Retrofit

Figure 4.13 below shows the percentage of work hours during which the monitored task lights were in use before and after the retrofit.

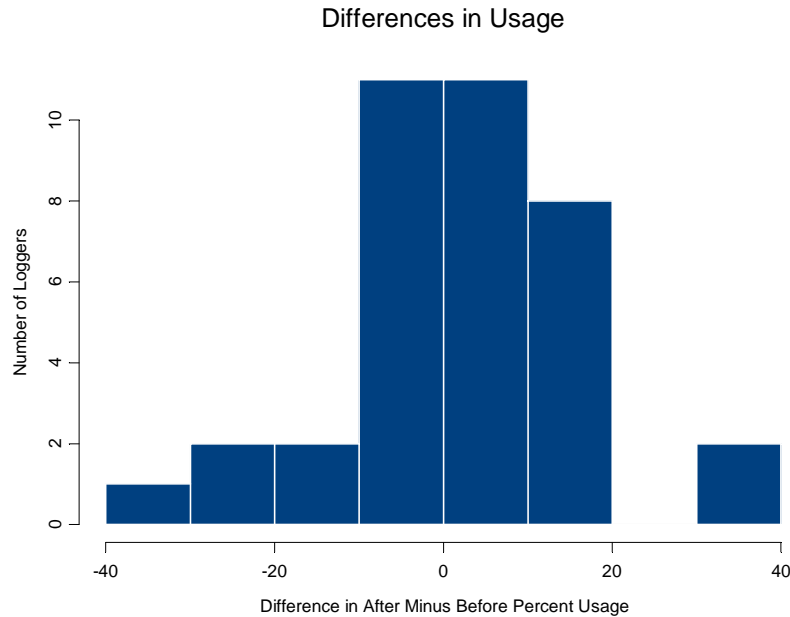
Figure 4.14. Building B - Task Lighting Logger Differences in Usage Before and After Retrofit

Figure 4.14 is a difference usage chart representing the percentage usage for each logger before and after retrofit. The plotted differences show the data has an approximate normal distribution – with a small tail to the left.

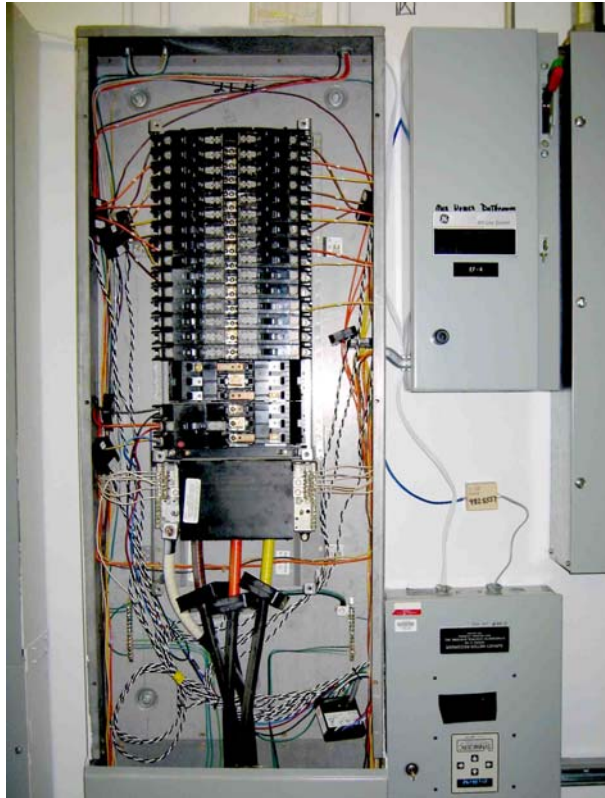
Figure 5.3. Building C - One of Two End-Use Logger Installations, Second Floor, Panel L2A.

A problem with the data collected via the logger installation on the first floor was discovered which made this data unusable. Please see Appendix A, Section A.7 for a full explanation of the issue. The data presented in this section were collected from the data logger installed on the second floor.

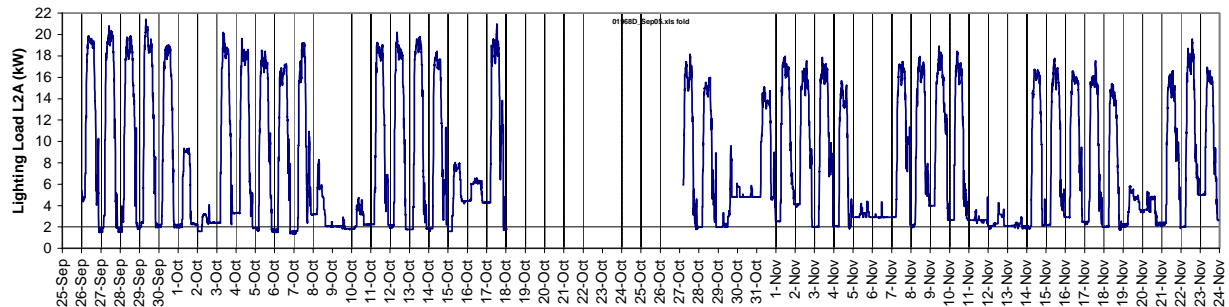
Figure 5.4. Building C Second-Floor Lighting Load, Sept. 26 - Nov. 23, 2005. Retrofit activity took place October 21-29, 2005.

The time series data of total lighting power monitored by the second-floor logger is shown in Figure 5.4.

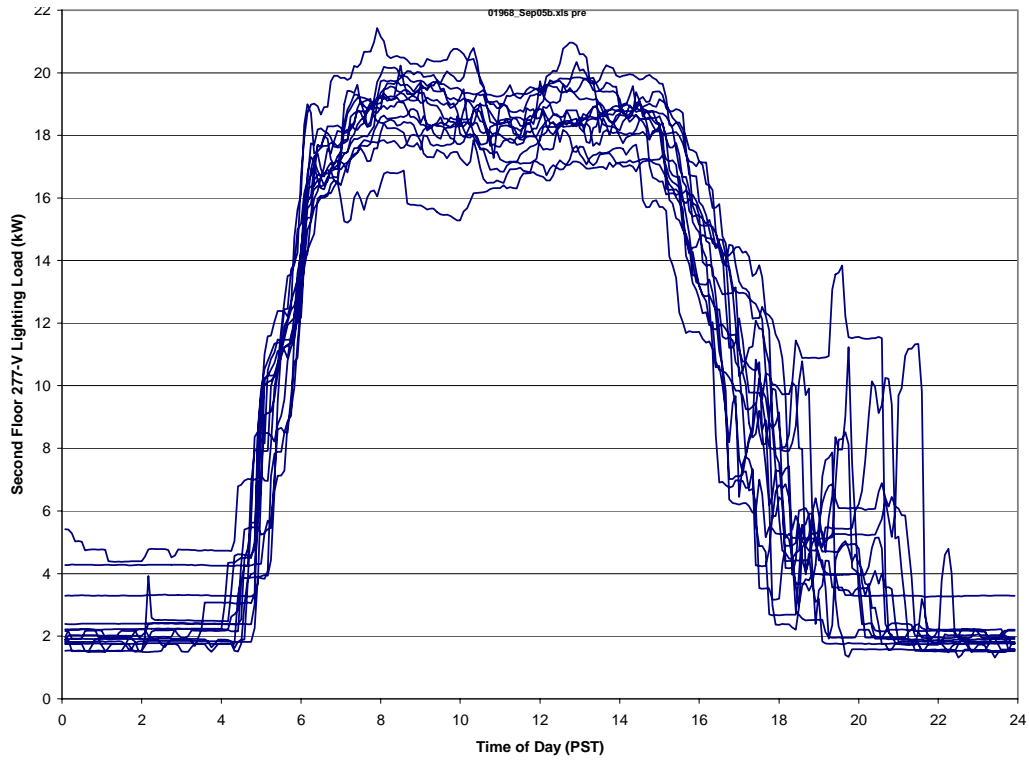
Figure 5.5. Building C Second Floor Pre-Retrofit Weekday Load Profiles, Sept. 26 – Oct. 17, 2005

Daily lighting load profiles are shown for pre-retrofit weekdays (Sept. 26-Oct. 17) in Figure 5.5 and for post-retrofit weekdays (Oct. 31 - Nov. 22) in Figure 5.6. Each daily load profile is a separate line in Figures 5.5 and 5.6.
