**Spectrally Enhanced Lighting Program
Implementation for Energy Savings:**

Field Evaluation

Prepared by
Pacific Northwest National Laboratory

August 2006

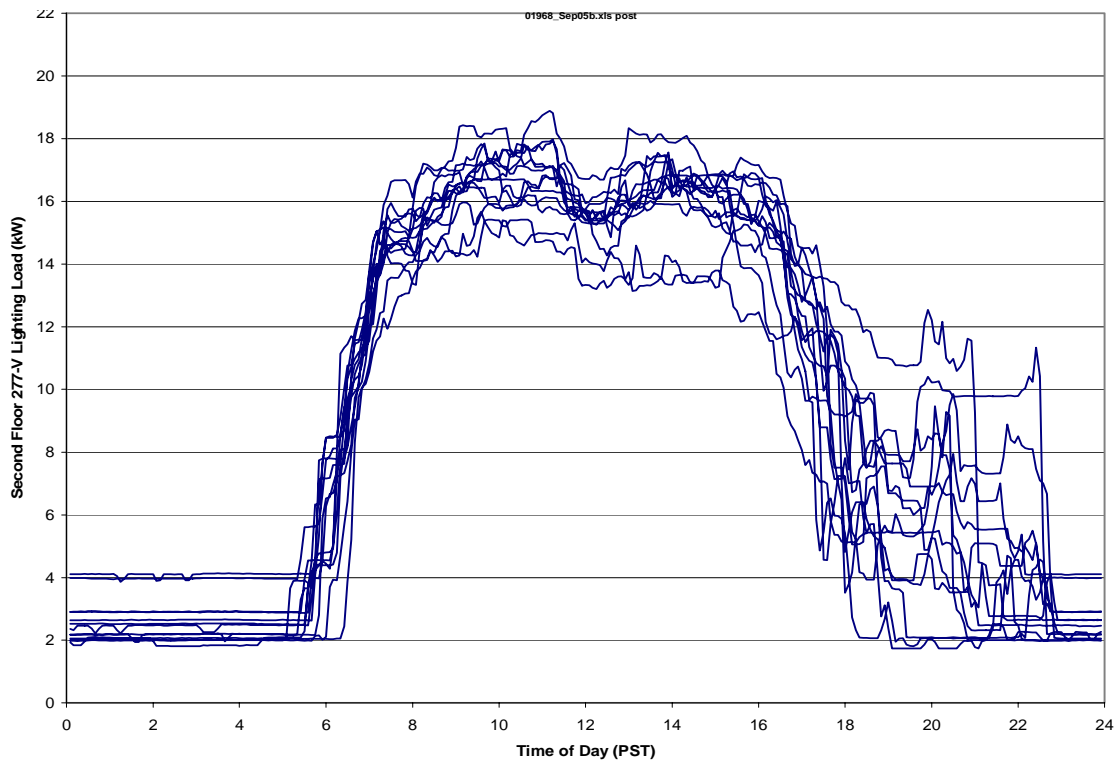
Figure 5.6. Building C Second-Floor Post-Retrofit Weekday Load Profiles, Oct. 31 –Nov. 22, 2005

Daily lighting load profiles are shown for pre-retrofit weekdays (Sept. 26-Oct. 17) in Figure 5.5 and for post-retrofit weekdays (Oct. 31 - Nov. 22) in Figure 5.6. Each daily load profile is a separate line in Figures 5.5 and 5.6.

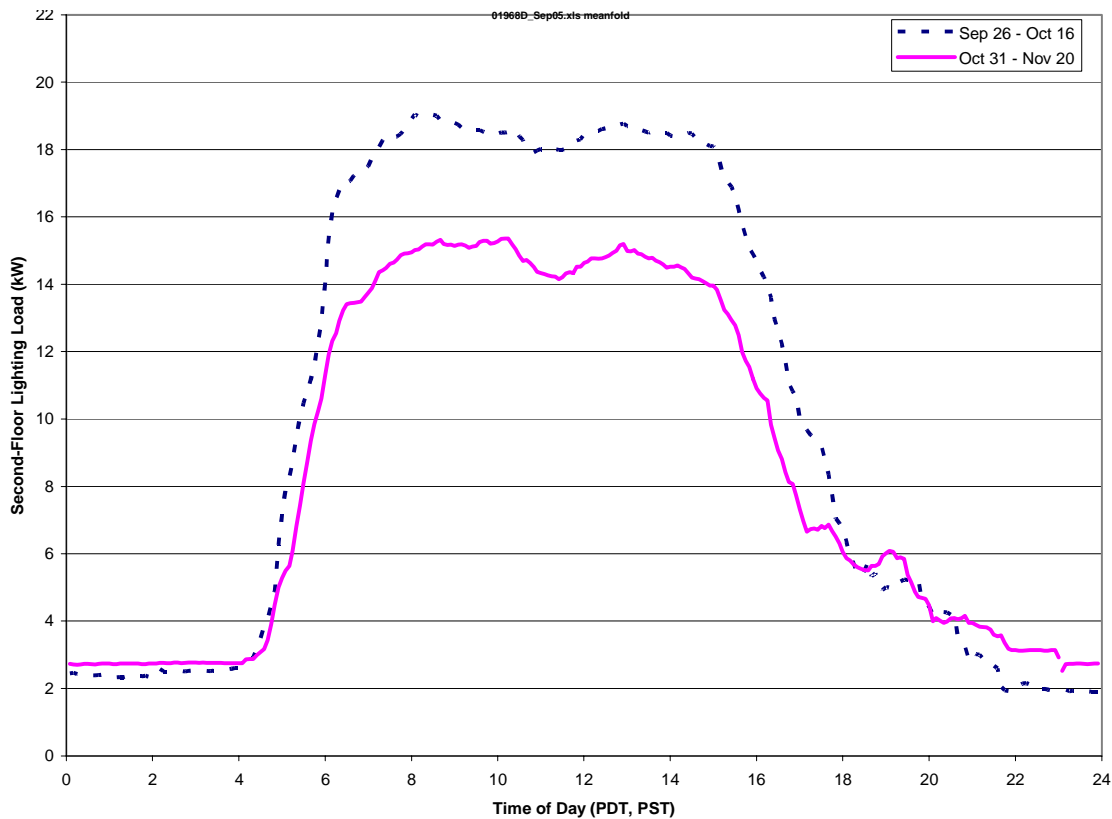
Figure 5.7. Building C Second Floor Mean Pre- and Post-Retrofit Weekday Load Profiles

Figure 5.7 shows a comparison of the average pre-retrofit load to average post-retrofit load for the periods measured. This graph shows the small increase in average nighttime load in spite of the expected significant uniform decrease in work-hours load.

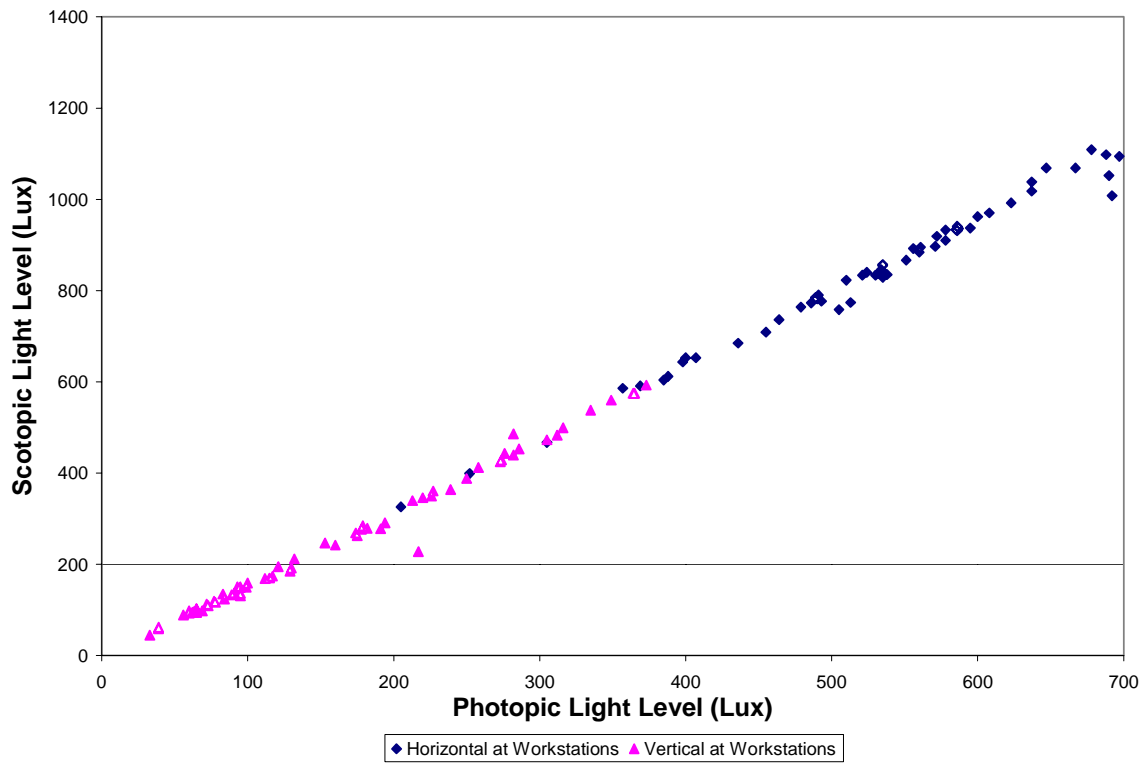
Figure 5.8. Building C - Pre-Retrofit Scotopic/Photopic Ratio Comparison

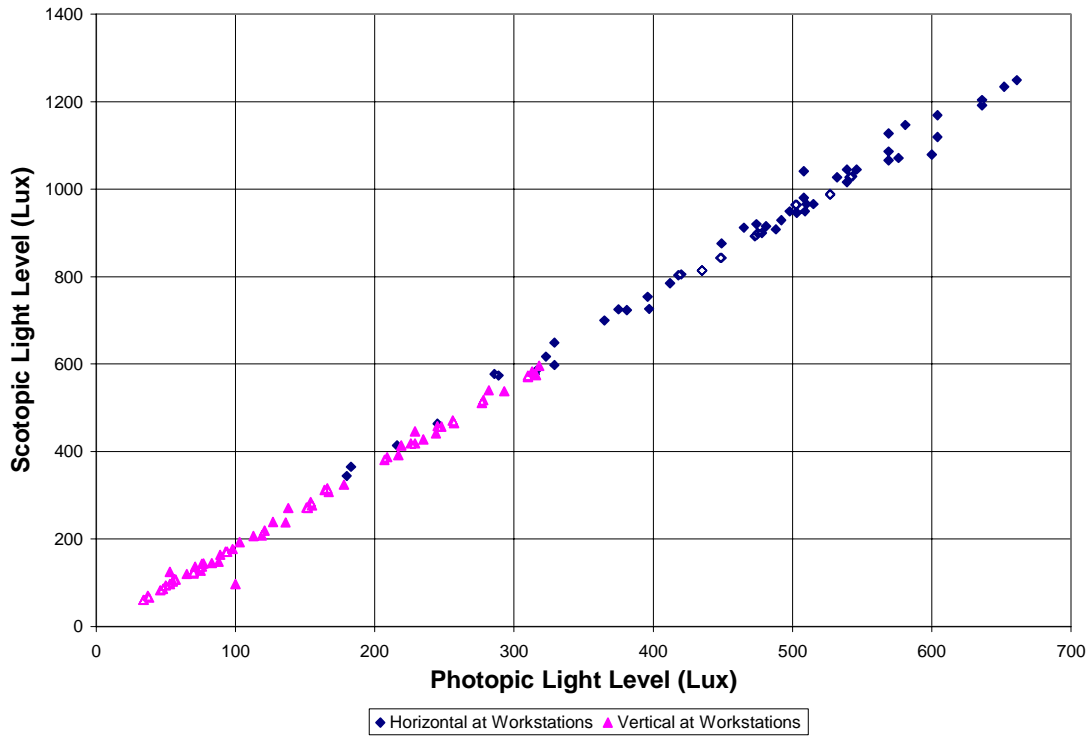
Figure 5.9. Building C - Post-Retrofit Scotopic/Photopic Ratio Comparison

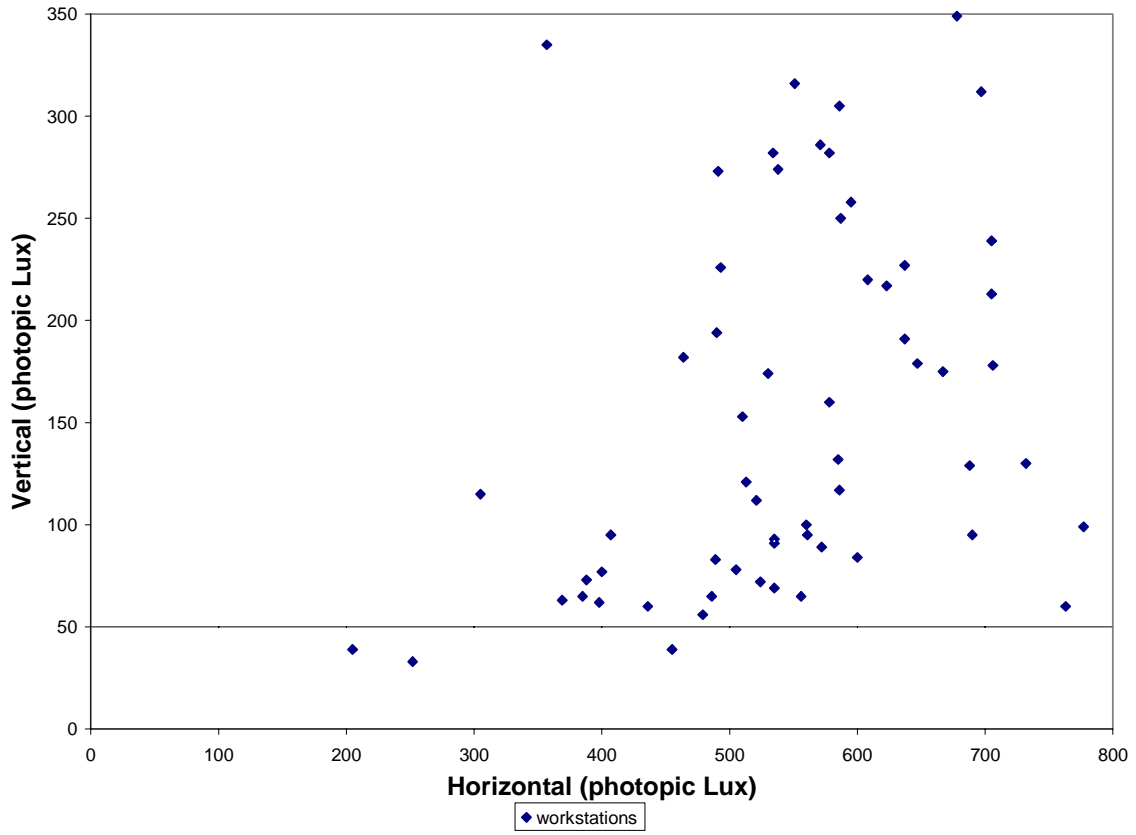
Figure 5.10. Building C - Pre-Retrofit Vertical vs. Horizontal Comparison (Photopic)

One of the major variables affecting the light level measurements is the varied workspace environment and changing character of the occupied spaces. Workspaces are oriented in different ways in relation to overhead lighting fixtures and partition walls. Materials surrounding desk spaces and posted on walls (personal and business related) are also varied and can have an effect on the horizontal light level readings between spaces and in particular between time periods. This tends to reduce the consistency of the comparison between horizontal values within a specific set of measurements and between pre- and post-retrofit sets. As averaged data, these effects are less noticeable but it is useful to understand this variability. Figures 5.10 and 5.11 present ratios of horizontal to vertical measurements for each location. The cloud of data points shows the extent of the variability. Both of these charts show a subtle slope trend indicating some consistency between vertical and horizontal reading changes but still a fairly wide variation.

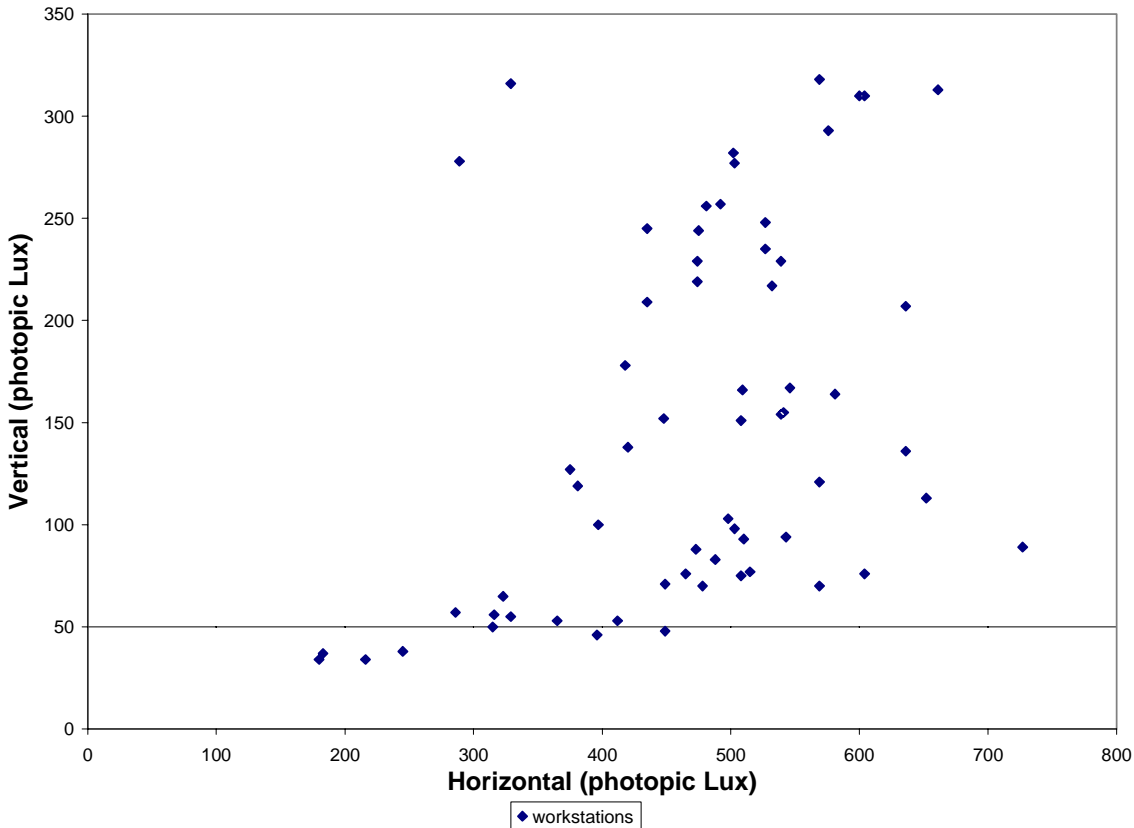
Figure 5.11. Building C - Post-Retrofit Vertical vs. Horizontal Comparison (Photopic)

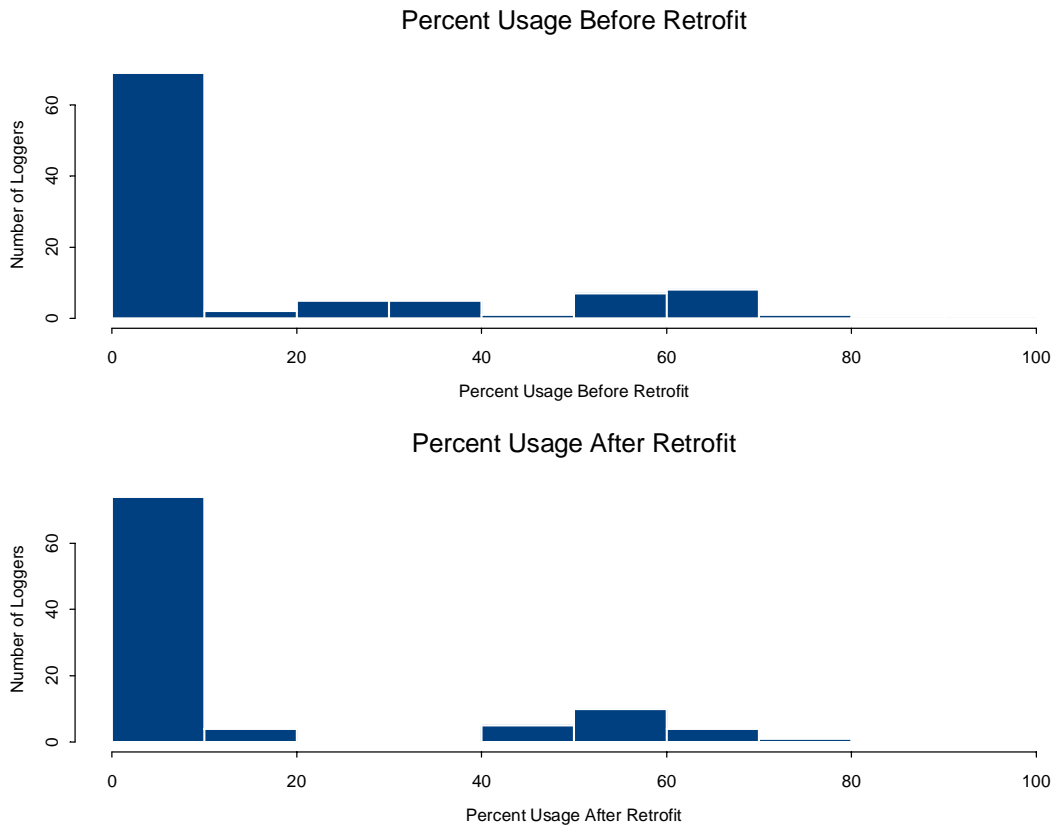
Figure 5.14. Building C - Task Light Usage as a Percent of Business Hours Before and After Retrofit

While the mean on-time decreased in nominal terms for Building C, there is no statistically significant evidence of task lighting usage change after the retrofit. Figure 5.14 below shows the percentage of work hours during which the monitored task lights were in use before and after the retrofit.

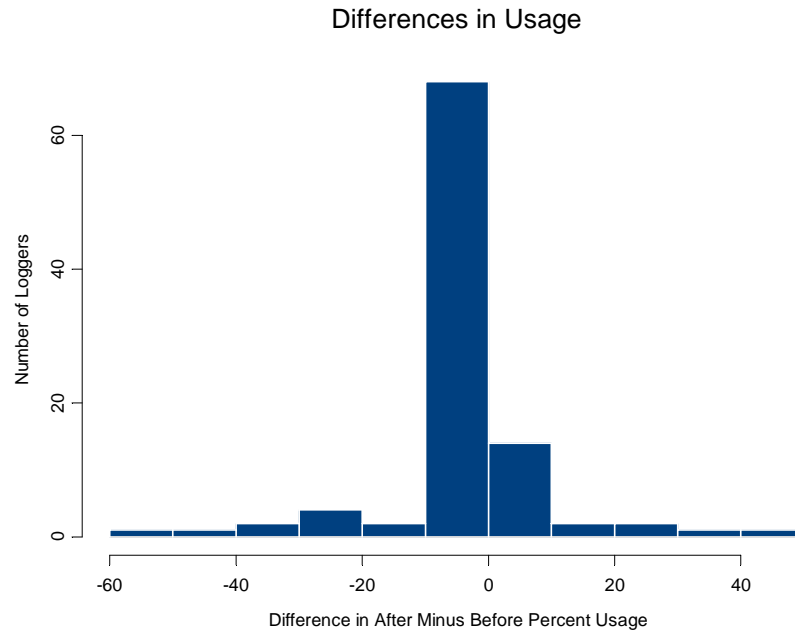
Figure 5.15. Building C - Task Lighting Logger Differences in Usage Before and After Retrofit

Percent usage was calculated for each logger before and after retrofit. The difference of After minus Before was calculated. The plotted differences are shown in Figure 5.15, which shows that most loggers had a small change, but several had very large changes. Non-parametric tests will be reported in addition to tests assuming a normal distribution. Non-parametric tests are more valid in this case.

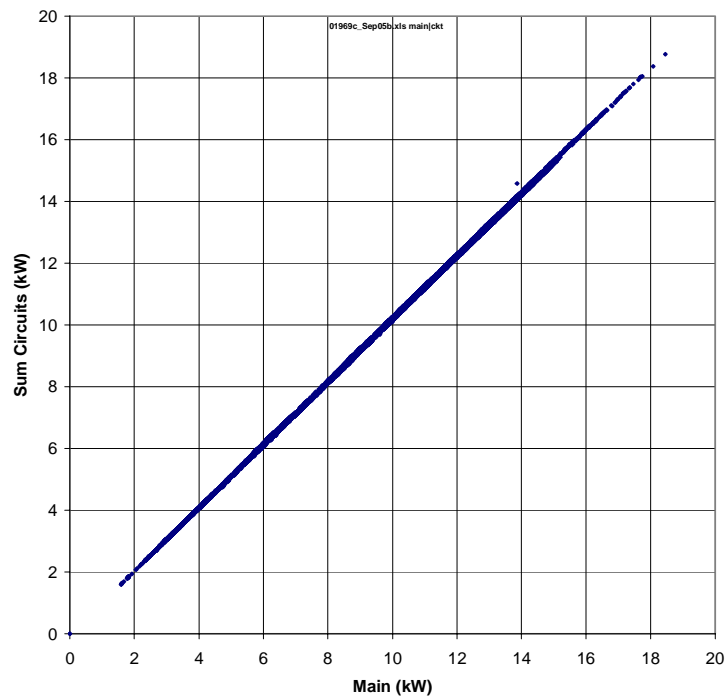
Figure A.1. Panel L1A Checksum Plot

The checksum analysis performed on both loggers installed at Building C initially indicated that there were no installation errors. Figure A.1 shows the standard checksum plot for lighting panel L1A.

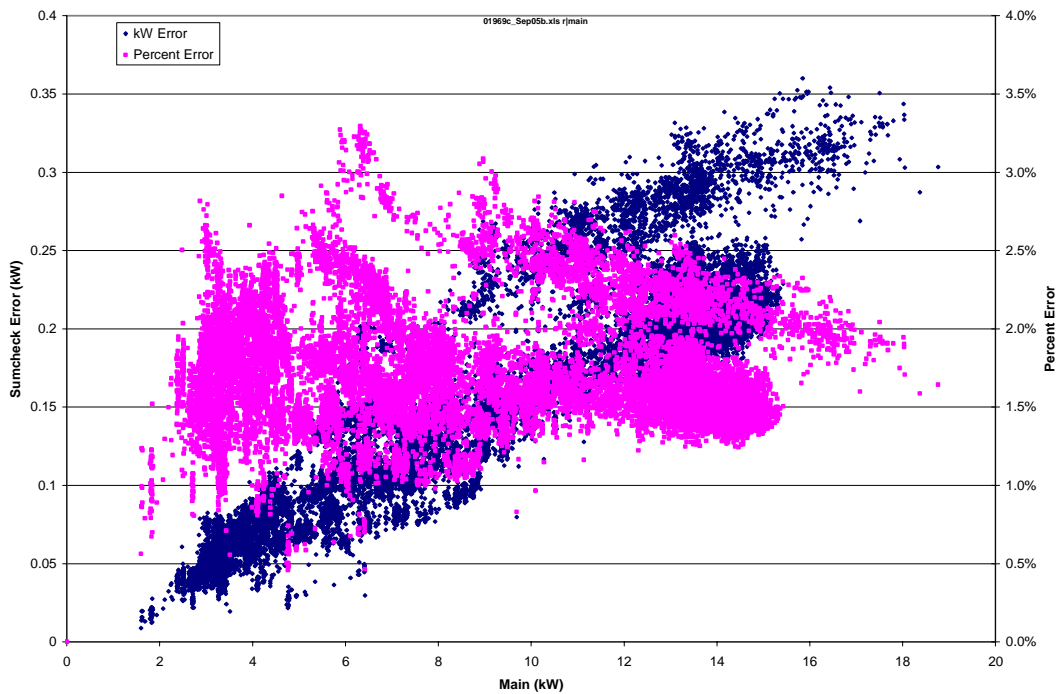
Figure A.2. Panel L1A Checksum Residuals

Further analysis performed after the retrofit indicated larger, possibly significant errors for the first-floor end-use metering logger. Further checksum analysis was performed. The checksum residuals for panel L1A are shown in Figure A.2 and the residual for panel L2A are shown in Figure A.3. The residual for panel L2A behave as expected: the absolute error increases with panel total power but with diminishing slope. The same information is represented a different way by the percent error, which decreases with panel total power. The residuals from panel L1A do not exhibit this expected behavior. The absolute error increases more or less linearly with panel total power.

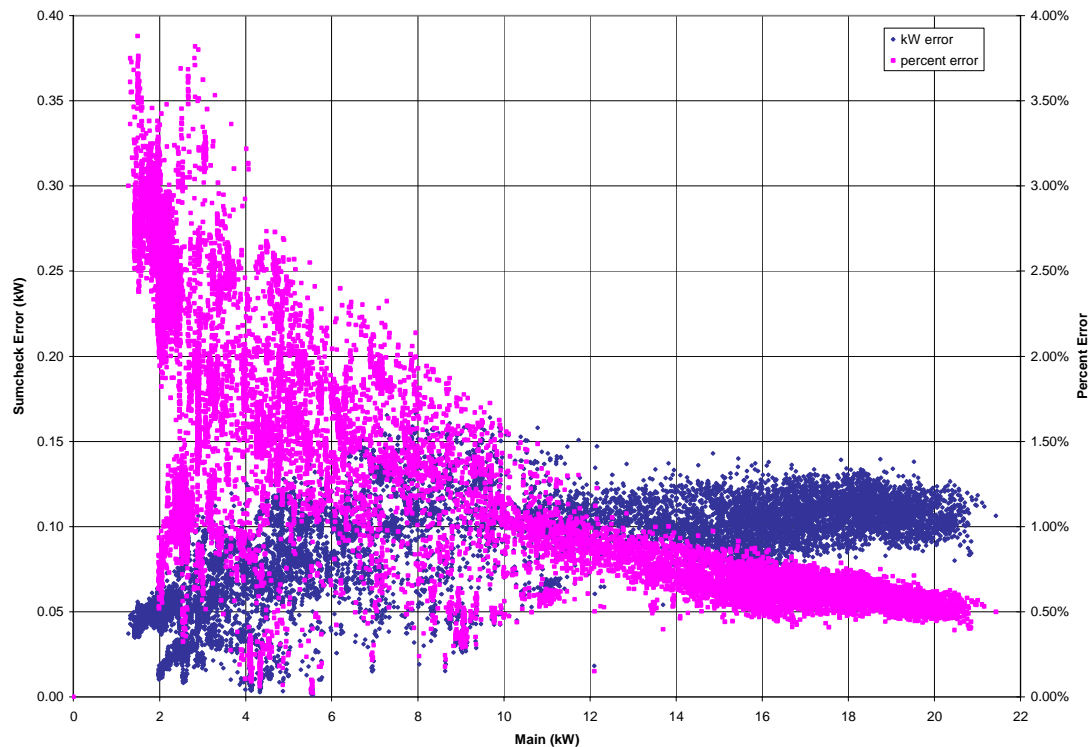
Figure A.3. Panel L2A Checksum Residuals

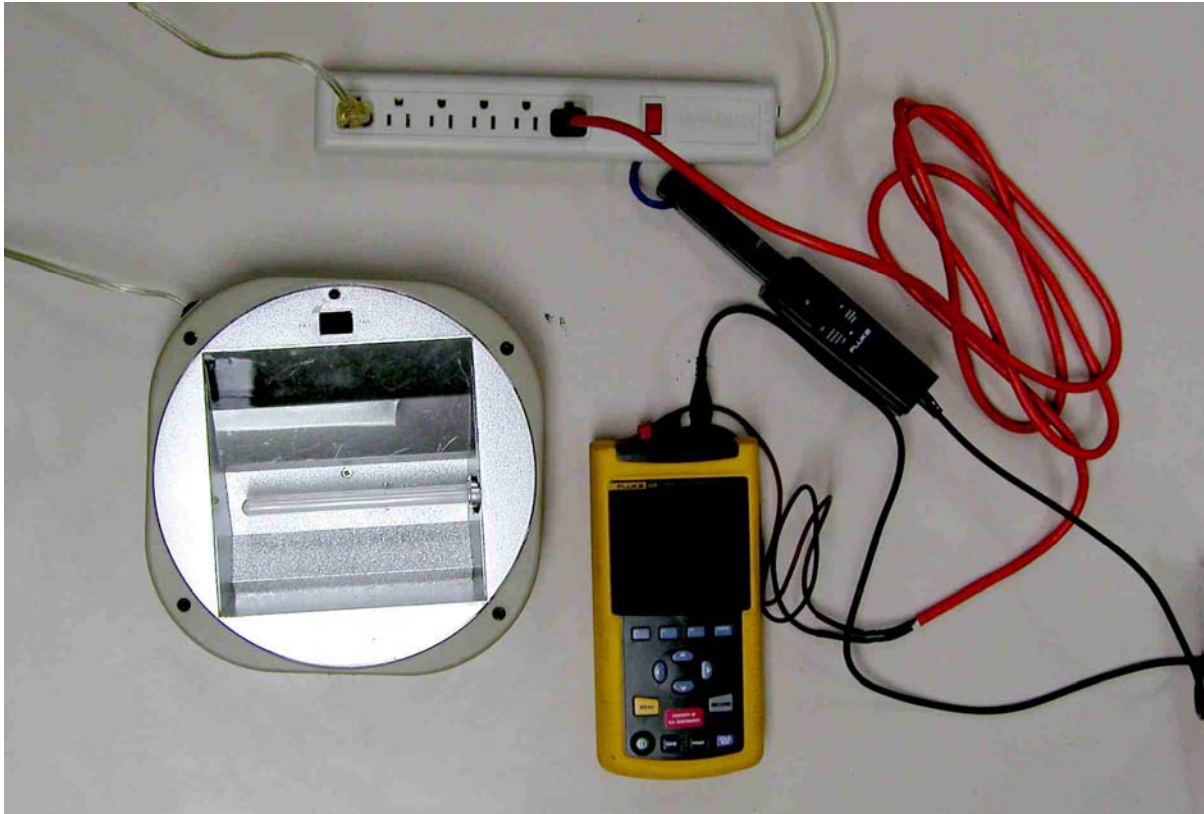
Figure A.4. One-Time Task Light Power Measurement Using 100A Current Probe and 10-Turn “Amplifier”

The Fluke 43B Power Quality Analyzer is intended to measure signals associated with 50- and 60-Hz power systems. It can measure true rms voltage and current and calculates real and reactive power at fundamental (60Hz) and harmonic (120, 180, 240, ...Hz) frequencies with sufficient bandwidth to measure up to the 51st harmonic as well as the ability to measure any dc components of voltage and current. Figure A.4 is a photo of the meter in use. The meter's performance specifications are provided below. For complete description see <http://us.fluke.com/usen/products/Fluke+43B.htm>.
