FINAL REPORT

Aluminum Bronze Alloys to Improve the System Life of Basic Oxygen and Electric Arc Furnace Hoods, Roofs and Side Vents.

DOE Award Number: DE-FC36-02ID14345

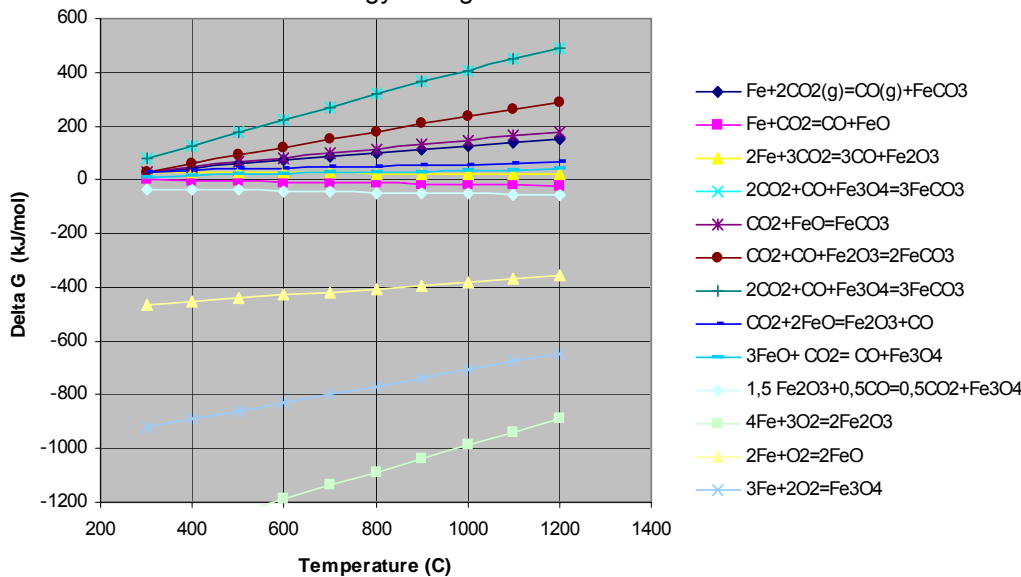
The reactions were developed by examining the phase stability diagrams for the system Fe-C-O. Calculated Gibbs energy changes for these reactions are shown below.

Figure 11. Gibbs Free Energy Changes; Fe – C – O System

The probability for each of these reactions to occur is function of Gibbs energy change for the case considered. Figure 11 suggests that, in the temperature interval considered, only the interactions between Fe and O₂ are likely to occur (see lowest 3 lines on the above plot). The stability areas of Fe containing species in this gas environment as a function of CO₂ and CO partial pressure and temperature are shown on Figure 12. While the positions of the phase boundaries change with temperature, thermodynamically, the FeO phase remains stable throughout the entire temperature interval. It is well recognized that FeO possesses extremely low protective properties for the base metal and does not hinder subsequent corrosion processes.

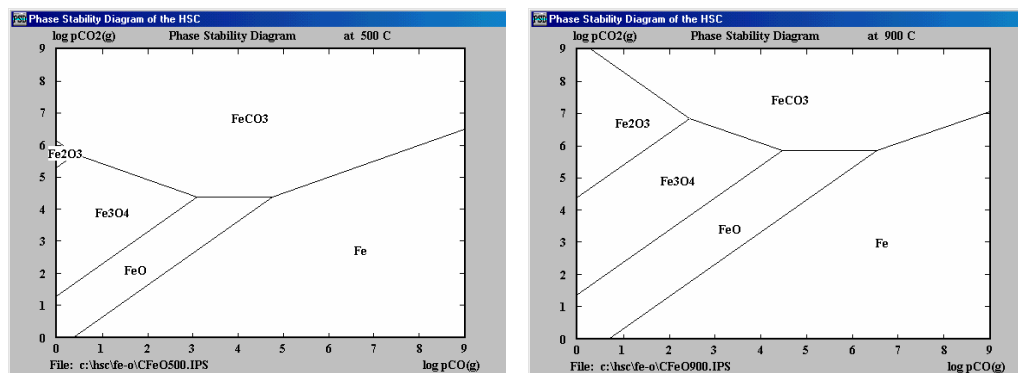
Figure 12. Phase Stability Diagram; Fe – C – O System; at 500°C (left) and 900°C (right)

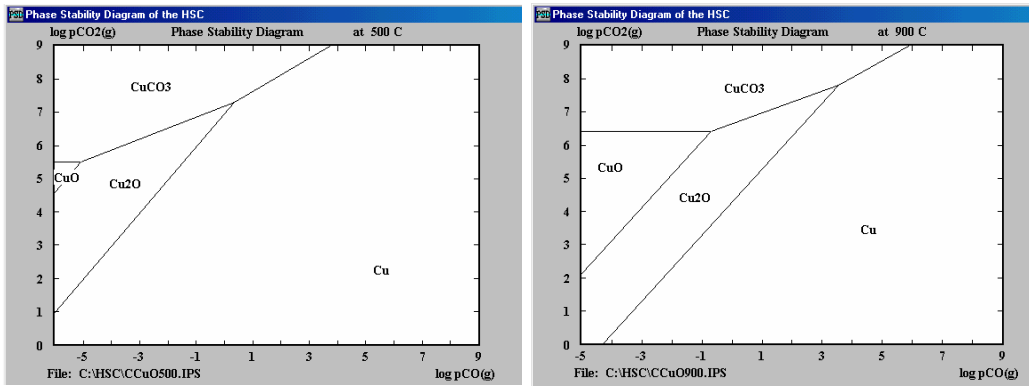
The areas of Cu-containing compounds stability as function of partial pressures of CO₂ and CO are shown in Figure 14. Generally, the areas of stability for copper oxides enlarge with temperature growth but under BOF hood conditions (relatively low partial pressures) the Cu phase is the only phase present.

Figure 14. Phase Stability Diagram; Cu – C – O System; at 500°C (right) and 900°C (left) (Note: x-axis represents significantly lower CO levels than Fe system diagrams)

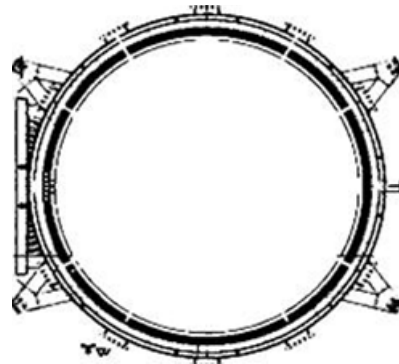
Design and fabrication of the skirt and trough proceeded throughout the summer of 2004 with the equipment delivered to REP in late August 2004. The skirt that was produced had a water cooled section 40 5/16" tall with an upper diameter of 14'8" and a lower diameter of 17'4". The skirt was fabricated from 2.75" diameter extruded Al-Bronze tubing with a nominal wall thickness of 0.275" (+/- 0.03"). While the design required some minor changes in installation techniques and required ~ 250 gpm more cooling water, installation was fairly straightforward and the modifications to the cooling system minimal. Installation of the skirt and attendant water seal

Figure 17. Top view. Al-Bronze Skirt

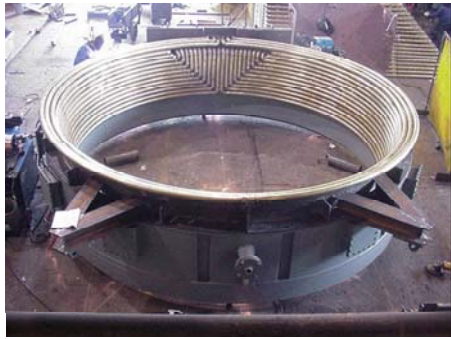
Figure 18. Al-Bronze Skirt before Installation

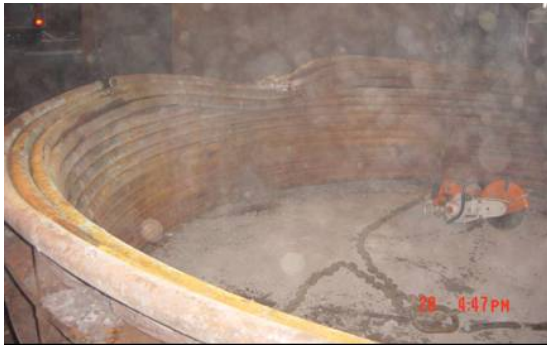
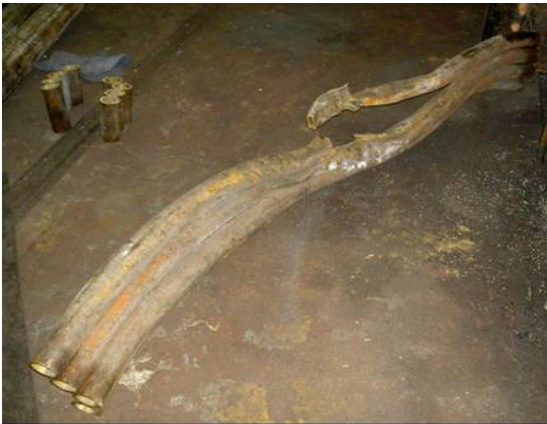
the completed heat. On this occasion, a failure in the furnace control system allowed the skirt to descend while the heat was being tapped and, as the furnace was rotated into operating position, it crashed into the lower portion of the skirt. The damage was extensive, necessitating the replacement of approximately 15 lineal feet of the lowest four courses of tubing (Figure 20.) AmeriFab was called in and repaired the damage in less than one week.

Figure 20. Skirt Damage, Collision with BOF Vessel.

This was the first of several unintended benefits from the use of Al-Bronze in BOF applications. Discussions with REP personnel after the collision with the furnace indicated that, in their opinion, had the same thing occurred with a carbon steel skirt after 2000 heats, the skirt would have had to have been replaced entirely. This opinion was based on two factors. First, a steel skirt would have suffered more damage than the Al-Bronze as a result of the higher yield strength and ultimate tensile strength of carbon steel. Secondly, the amount of metal loss generally experienced on the process side of carbon steel tubes would have made it questionable whether the skirt repair could have been accomplished in a manner that would have extended the life of the skirt. Thermal stresses normally experienced by a carbon steel skirt during operation would have been magnified by the extensive welding needed to repair the skirt. Aside from the stresses induced in the metal during welding, the wall thicknesses of the new tubing would have been significantly greater on the process side than those on the remaining skirt as a result of corrosion and metal removal during cleaning to achieve a weldable surface. This thickness variation would have provided significant stress points for rapid failures in the future. As it was, the damage was fairly localized in the Al-Bronze skirt and very little wall loss noted. This made a thorough repair relatively easy as evidenced by the more than 2600 heats subsequently processed without thermal or corrosion induced cracking.

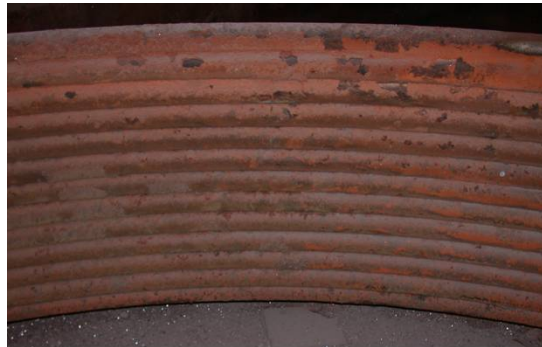
General Observations – The general condition of the tubes in the process side of the skirt was very good (Figure 21). The tubes were generally covered uniformly by a thin, non-adherent coating typically less ~ 1/16" thick. This coating was easily removed, by hand with a wire brush. Several locations around the skirt did have a tightly adherent coating that was considerably thinner than the loose coating but these locations were localized and not extensive. Several other locations exhibited heavy coatings, 1/4" in and thicker (See Figure 22. These areas were predominantly located around header portion of the skirt (See Figure 18) and are assumed to be the result of slag splashing and the physical arrangement of the piping in that area providing resistance to the free release of the coating. In all cases, these heavy coatings were not physically bound to the tubing and were easily removed with the bare hand revealing a surface with the thin coatings previously described.

Figure 21. Al-Bronze Skirt (Process-side looking south) after 4653 Heats.

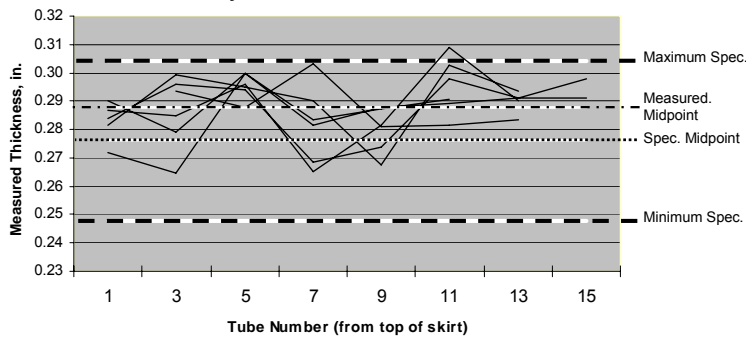
the tubes. All thickness measurements remain within standard manufacturing specifications as established by AmeriFab.

Figure 25. Ultrasonic Thickness Measurement, Al-Bronze

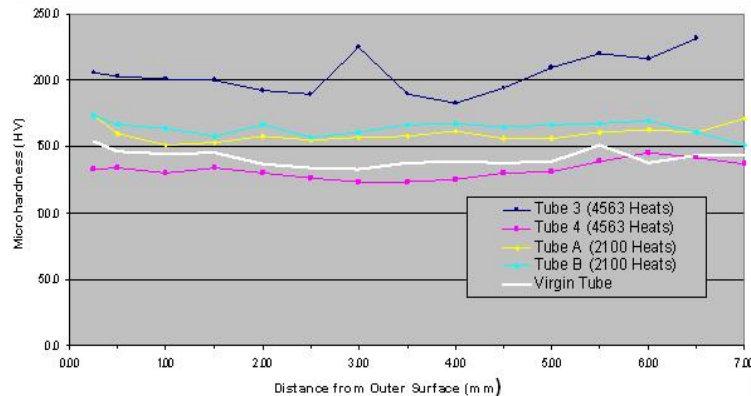
The cause of the cracking exhibited in Tube 3 is of concern since experience has shown that physical cracking is a major cause of failures in tubing is BOF/EAF service. Figure 28 is a plot of micro hardness measurements across the tube wall of various samples of Al-Bronze taken from samples that had seen service

Figure 28. Aluminum Bronze Micro Hardness
