Concrete Shield Performance of the VSC-17 Spent Nuclear Fuel Cask

**2006 International High Level
Radioactive Waste Management
Conference**

April 2006

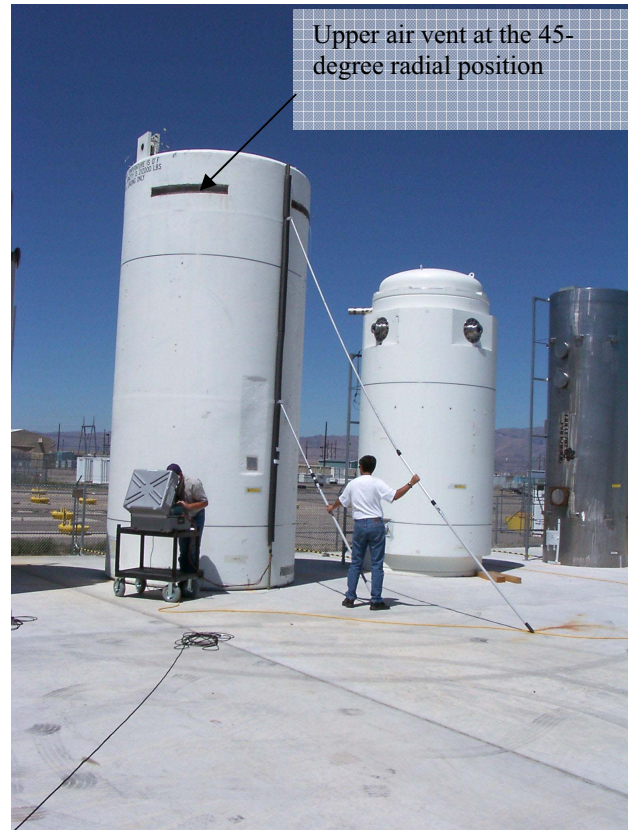
8.8-degree intervals. The zero point corresponds to the south lifting lug, and 90 degrees corresponds to the nameplate position on the cask. The data acquisition system recorded values every second and reported the maximum and minimum value for that period. Data were taken as three sets of 30-second periods for each radial position. The test was performed operationally as shown in Figure 3. This image shows the thermocouple rake being supported against the cask surface by extension poles.

Fig. 3. Thermocouple measurements were taken using a thermocouple ladder.

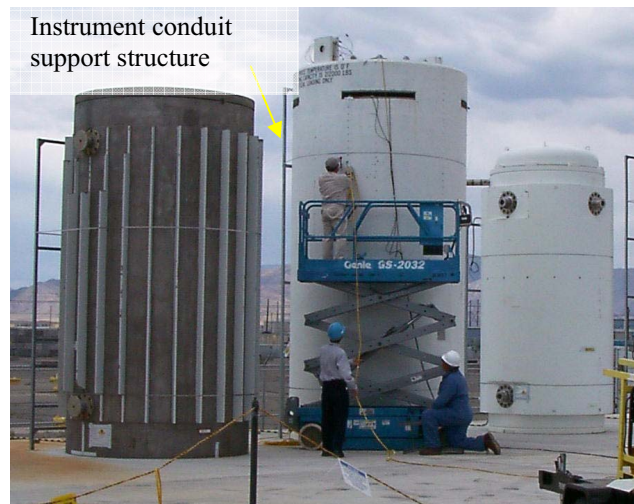
Since performing nondestructive examination in 2003, the cask was fitted with a conduit support structure that extended out sufficiently to interfere with making thermocouple contact readings between 210 degrees to 340 degrees. See Figure 4. Therefore, only 27 of the planned 41 radial positions were accessible. The test indicated limited variation in temperature on the cask surface.

Fig. 4. Electrical conduit is visible from behind the VSC-17 cask.

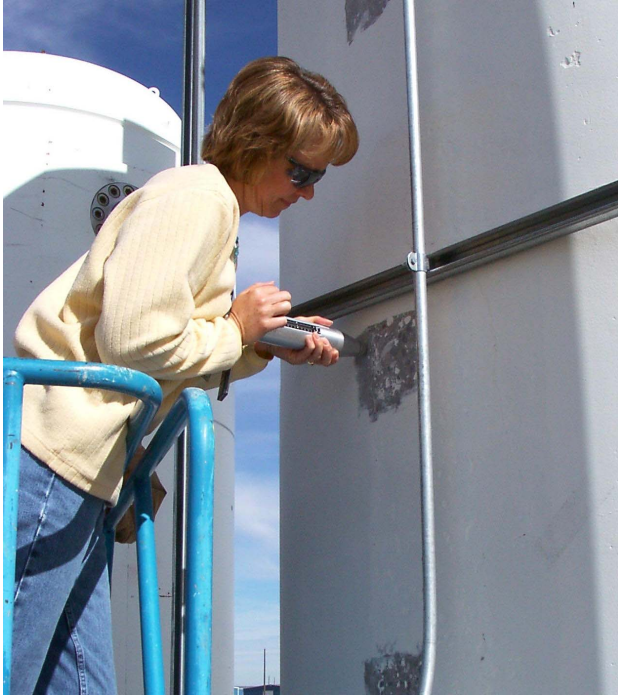
locations. Figure 7 shows testing being performed at the 270-degree position. What may appear to be residual paint in the work areas is actually exposed aggregate. The 90 and 270-degree radial locations have flat areas that were ground off to provide space for nameplate installation. Grinding the 30-cm (1-ft)-wide × 90-cm (3-ft)-high flats exposed the larger gravel aggregate.

Schmidt rebound hammer testing was performed at 70 locations on the concrete exterior surface of the VSC-17 VCC. Test interval spacing was at 20 cm (8 in.) for 10 positions below the 45-degree upper air vent where greater porosity was expected to be found. A test interval of 20 cm (8 in.) was also used at 90 degrees for 12 positions below the top of the cask because this portion of the cask was expected to have good porosity. The smaller test intervals used at the 45 and 90-degree positions provided a set of values to compare to the ultrasonic testing performed in these same locations. Twenty hammer impacts were performed at each location (twice the minimum required by the ASTM C805-02 method).

Fig. 7. Schmidt rebound hammer testing on the VSC-17 cask.

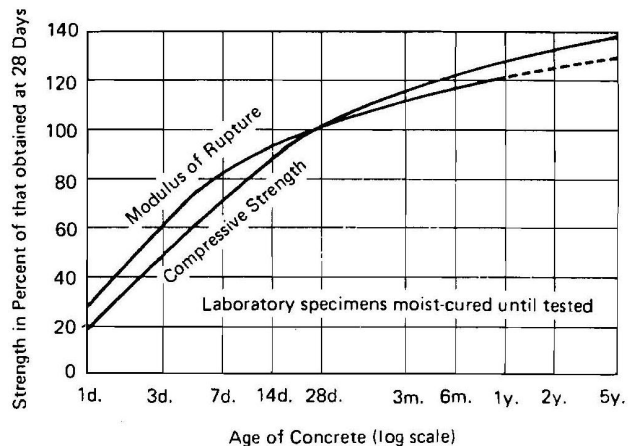
To gauge the readings received by hammer testing, a standard concrete test specimen was rebound tested and then broken at the INL Materials Testing Laboratory. The adjusted average rebound value for the first specimen was 37.1, while the second was 35.3. These specimens broke at 4,895 and 4,570 psi, respectively. When extrapolated, the average value indicated for compressive strength of the VSC-17 shield concrete is approximately 6,600 psi. In typical circumstances, concrete gains compressive strength as it ages, but the expected increase is typically about 20%. For the concrete used to construct the VSC-17 shield, that value should be on the order of 5,400 to 5,500 psi. In moist cured concrete, the value may increase by as much as 40%, which would project the 28-day average values from the cask fabrication pour from 4,509 psi to 6,312 psi at 5 years (Figure 9).

Fig. 9. Age-strength relationships for moist-cured concrete.⁴

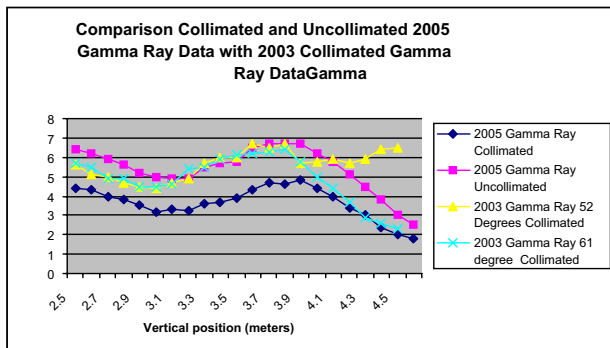
Because of a need to reconcile the 2004 data with the 2003 measurements, collimated and uncollimated gamma ray measurements were made at the 52-degree radial position for vertical positions from 0.9 to 2.4 m (3 to 18 ft). The measurements made in 2005 suggest that the progressive increase of dose rate above 4 m (13.1 ft) is anomalous, the result of either incorrect recording or incorrect positioning of the detector during the 2003 measurements. Inconsistent values are believed to have been recorded due to problems getting all the equipment mounted on the lift platform to function simultaneously. The 2003 values from the 61-degree radial position appear to be consistent with the 2005 data. The comparisons are shown in Figure 10.

Fig. 10. Comparison of 2003 and 2005 collimated measurements.

Review of the 2003 log book for data acquisition indicated that inconsistent positioning of the detector with the value recorded resulted in the apparent increase in values above the 4-m (13.1-ft) position. On a less readily explained note, it appears that the 2005 measurements do not show the same step-change at 2.4-m (7.9 ft) vertical position as seen in all 41 measurements in 2003. Additional gamma reading would be required to further investigate this discrepancy; however, the classic radiation profile of the VSC-17 SNF suggests that there were likely anomalies in the 2003 data.

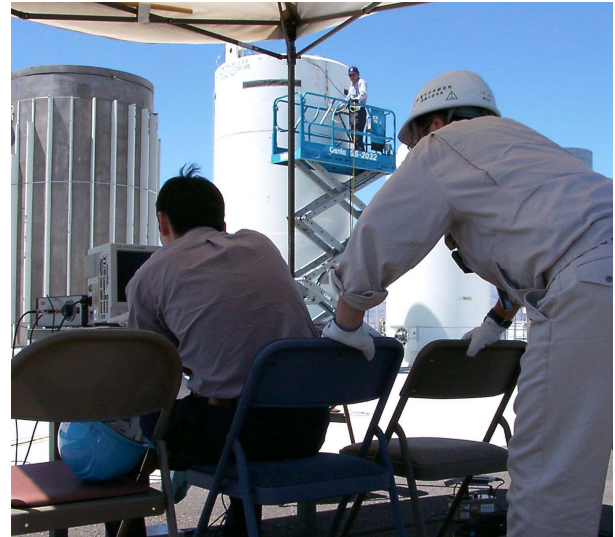
In August 2005 CRIEPI and their subcontract team from LAZOC Sensing Technology joined the INL project team to perform ultrasonic testing on the VSC-17. Figure 11 shows the CRIEPI team applying sensors to the VSC-17 and gathering data.

Fig. 11. CRIEPI and LAZOC Inc. representatives performed ultrasonic testing in August 2005.
