# ***New Waste Calcining Facility Non-Radioactive Process Decontamination***

*September 2001*

*Idaho National Engineering and Environmental Laboratory  
Bechtel BWXT Idaho, LLC*

## ABSTRACT

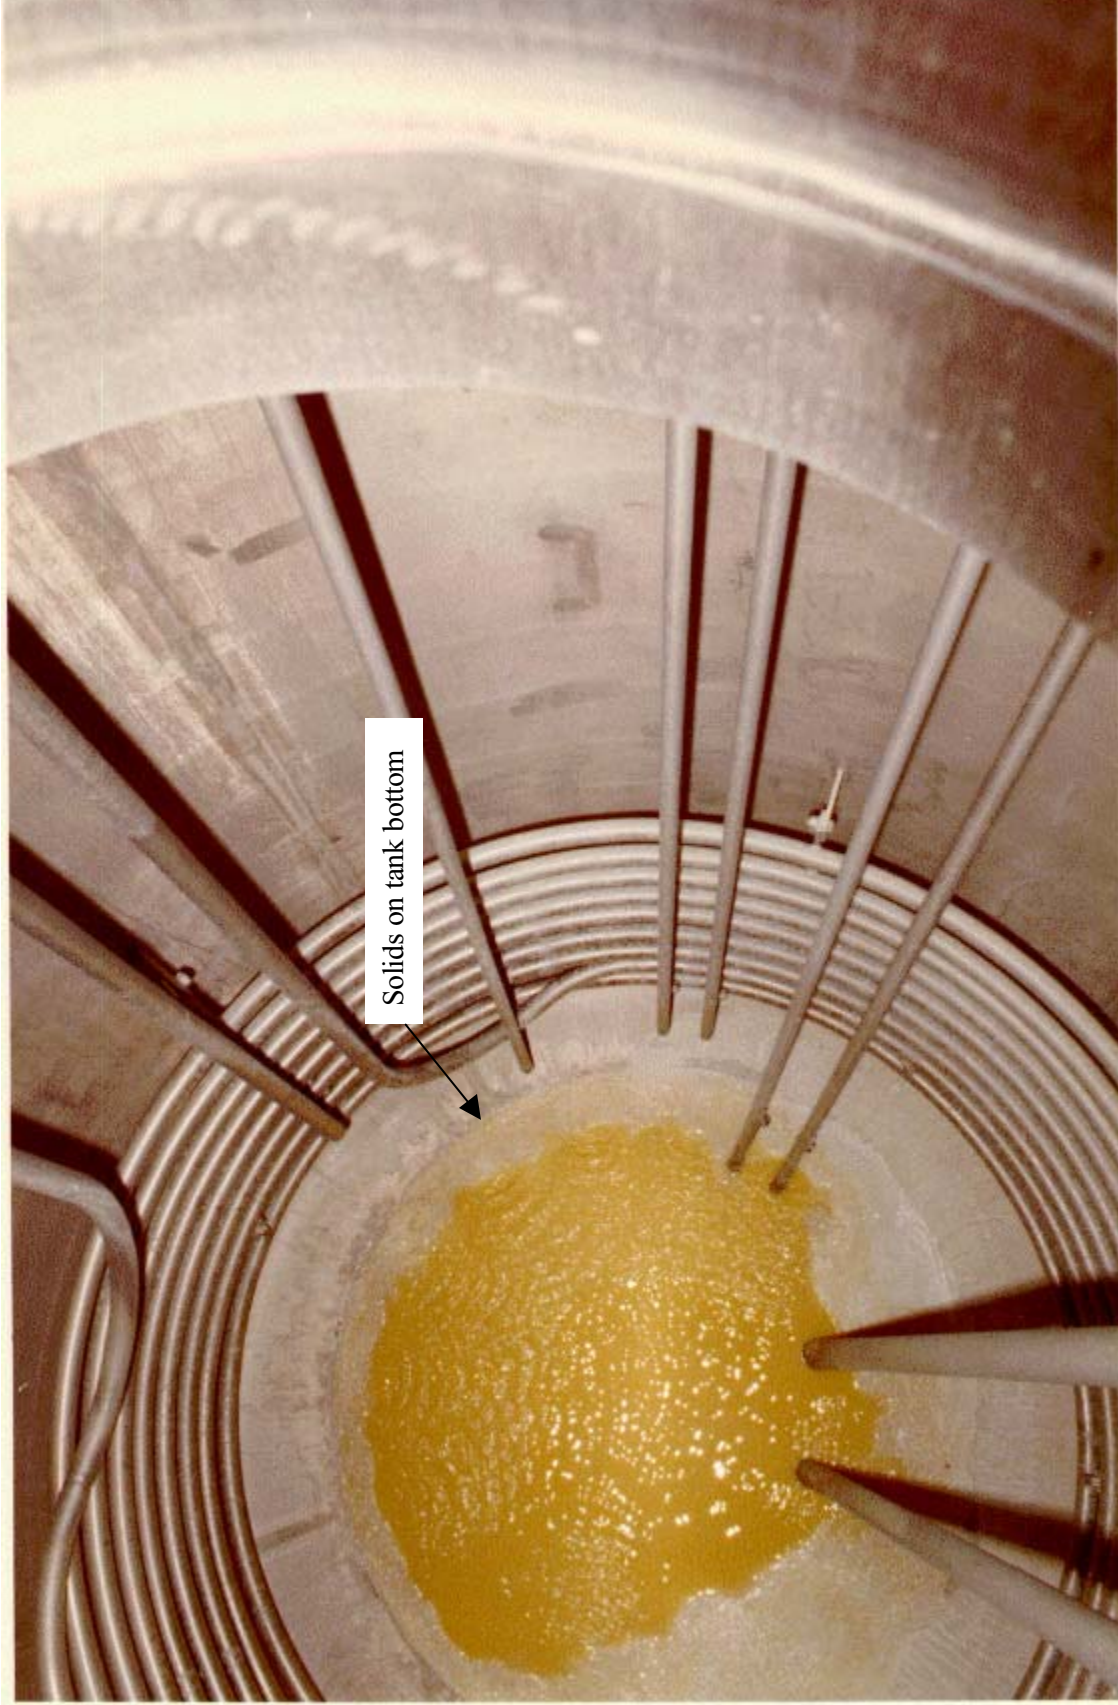
In the blend and hold cell, vessels NCC-102 (hold tank) and NCC-104 (feed tank) were inspected. Vessel NCC-102 is identical to vessel NCC-103 (hold tank), and very similar in configuration and service to vessel NCC-101 (blend tank). Because of the configuration and service similarities, vessel NCC-102 was considered representative of the three blend and hold tanks. It was inspected, but the other blend and hold tanks were not inspected. Vessel NCC-102 is a vertical cylinder (8 feet in diameter) with AMSE flanged and dished heads on both the top and bottom of the tank. Access to the interior of the vessel was via a manway on top of the vessel. The pre-decontamination inspection found the internal walls of NCC-102 were clean, with no visible solids on the vessel walls (see Figure A-1). However, a substantial amount of solids (up to four inches) was present in the nearly flat, dished bottom of the vessel. Analysis of the solids from the bottom of the vessel indicated they were high in alpha alumina.

**Figure A-1.** Interior of hold tank VES-NCC-102 prior to decontamination. There are no solids on vessel wall, but there are solids in the bottom of the vessel (81-5552).

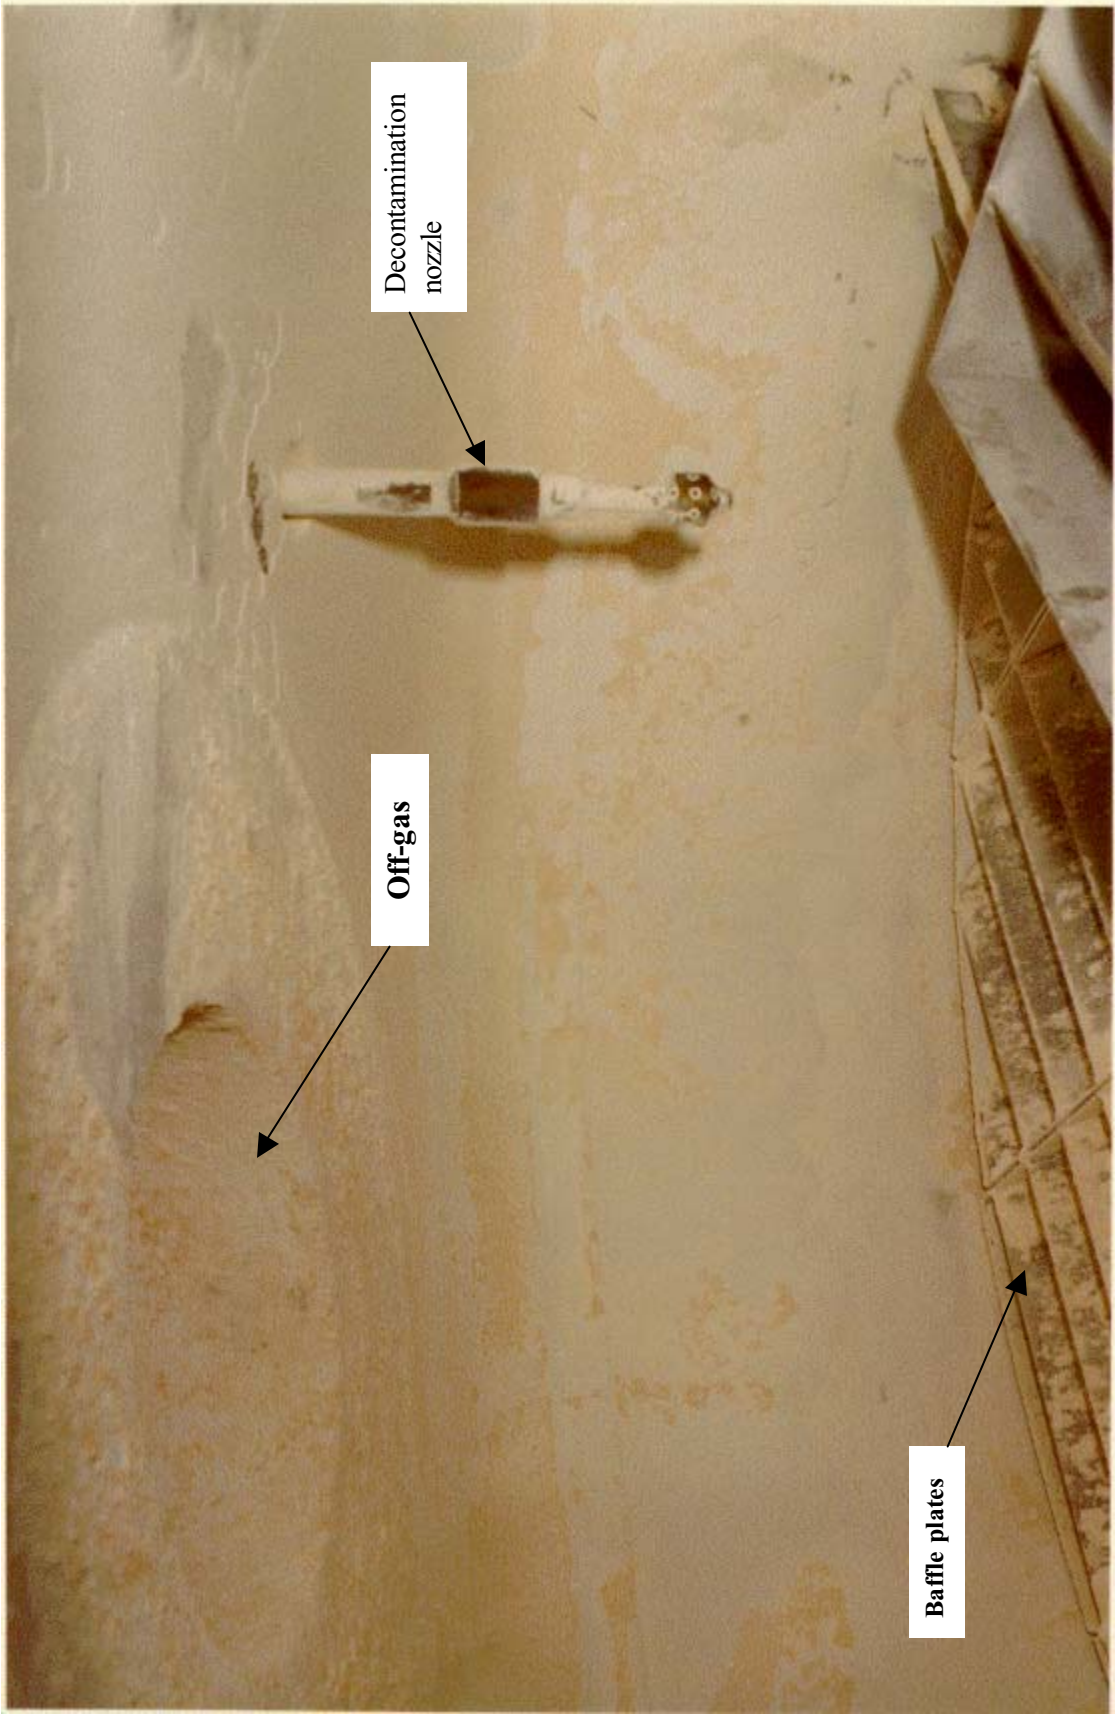
In the top of the Calciner, above the baffle plates, a thin layer of solids (less than 1/2 inch thick) covered the interior surface of the Calciner (see Figures A-2 and A-3). Calcine also collected in the joints between the baffle plate sections, on the upper surface of the baffle plates, and on the baffle support beams (see Figure A-4). Calcine filled the conical plug in the baffle plate inspection port (Figure A-5). There was also a layer of calcine approximately 1 inch deep in the short section of off-gas line between the Calciner and the cyclone.

**Figure A-2.** Calcine-covered interior of the upper portion of the Calcliner (VES-NCC-105), off-gas line, and baffle plates before decontamination (81-5590).

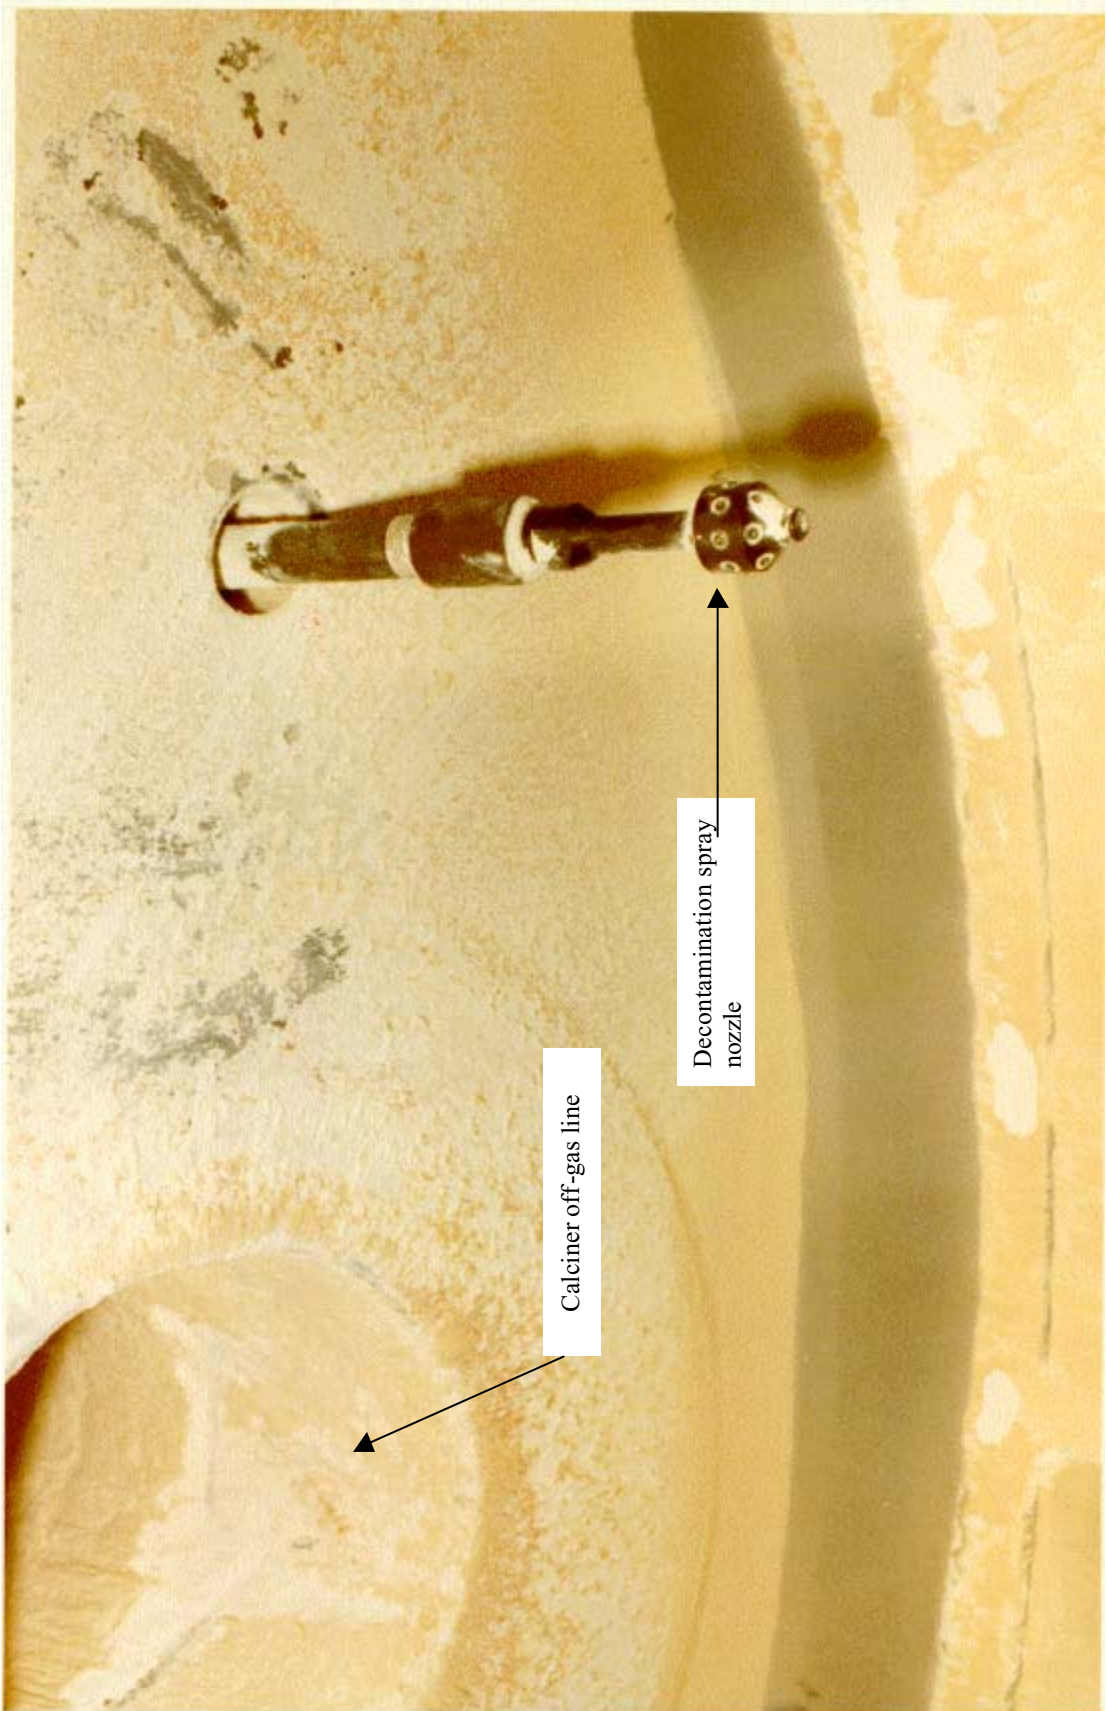
Calciner off-gas line

Decontamination spray nozzle

**Figure A-3.** Calciner-covered interior of the Calciner (VES-NCC-105) and off-gas line before decontamination (82-4812).

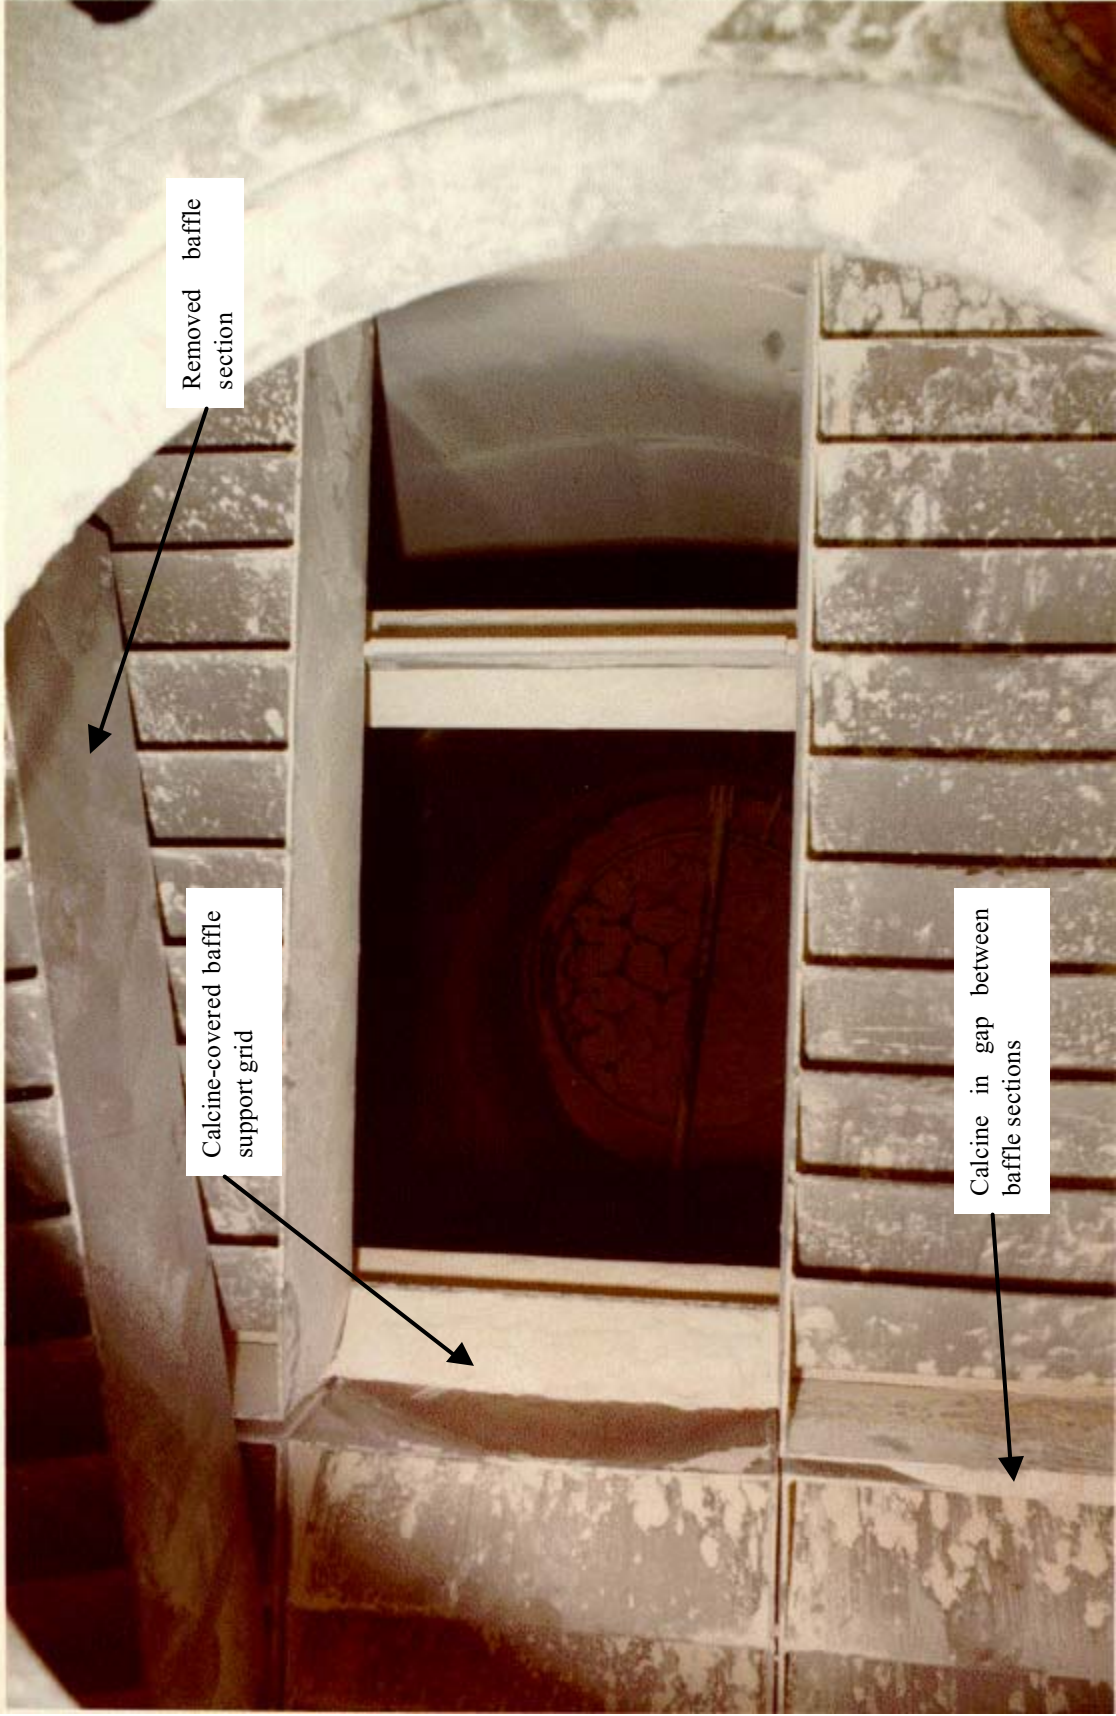
**Figure A-4.** View of the top of the Calciner baffle plates before decontamination. One section of the baffles has been moved, leaving a hole through which the baffle support grid can be seen (81 -5591).

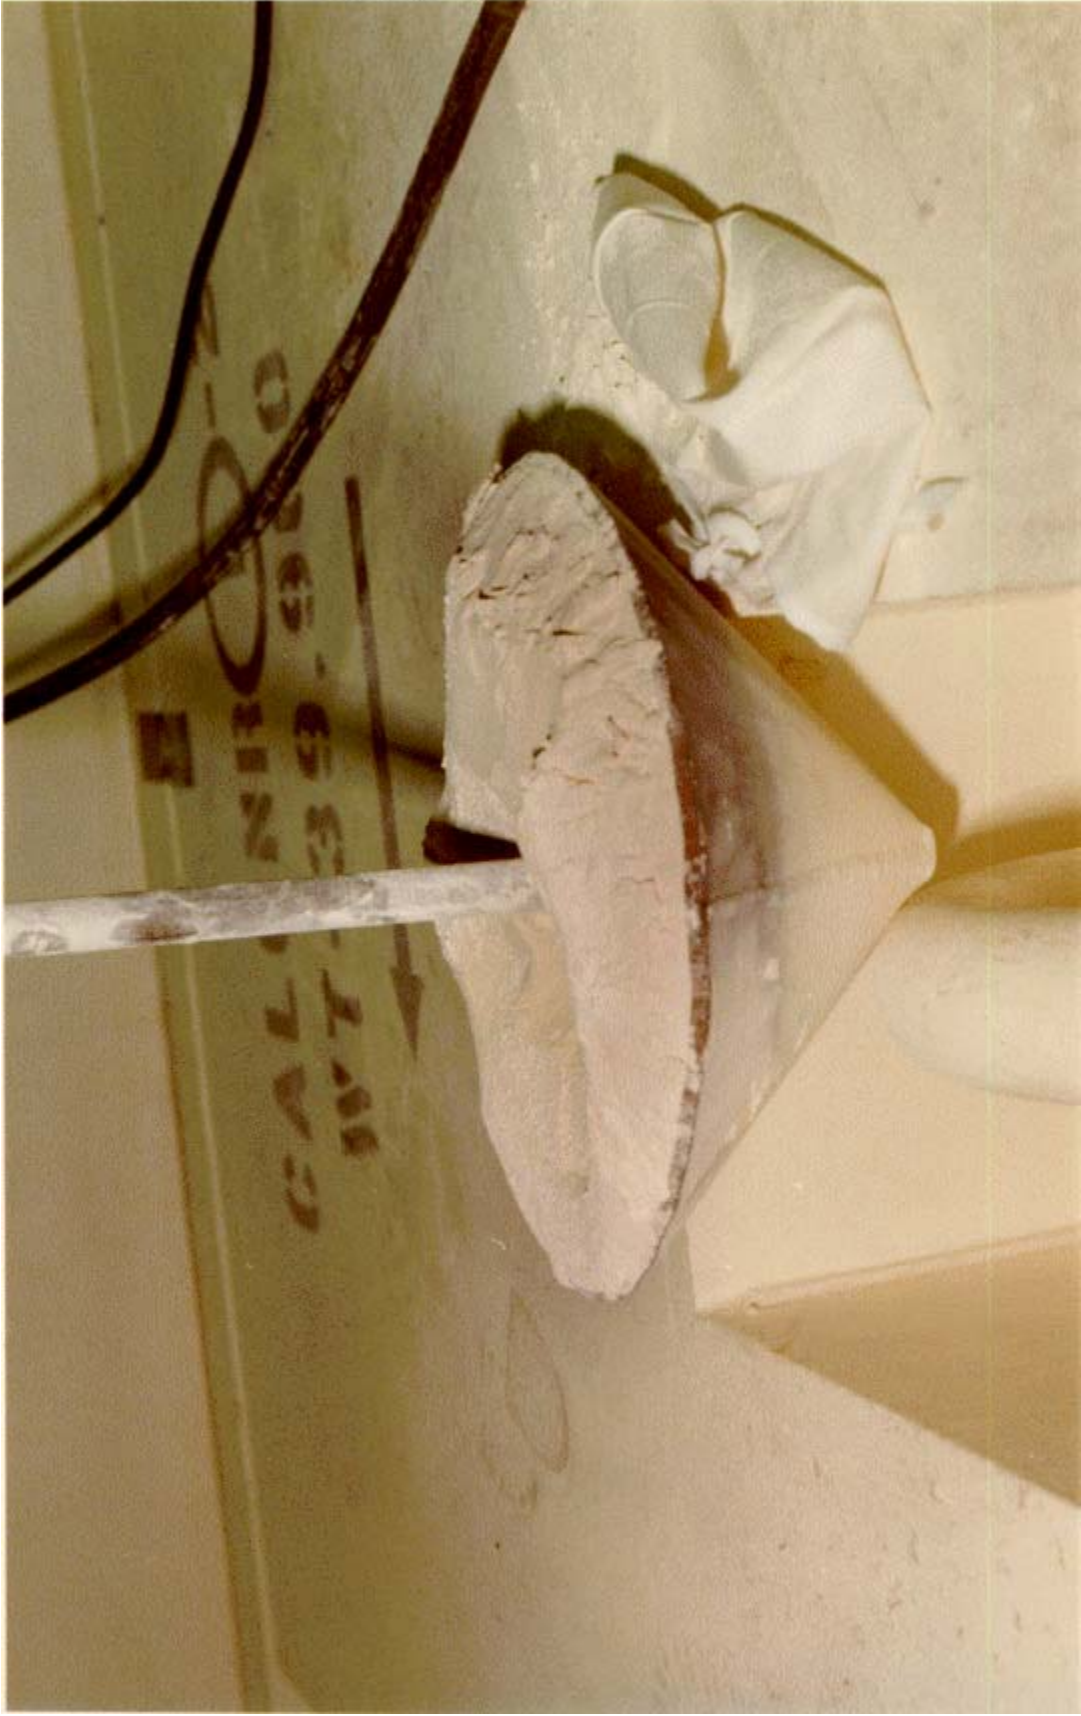
**Figure A-5.** Calciner baffle inspection port plug filled with calcine before decontamination (81-5584).

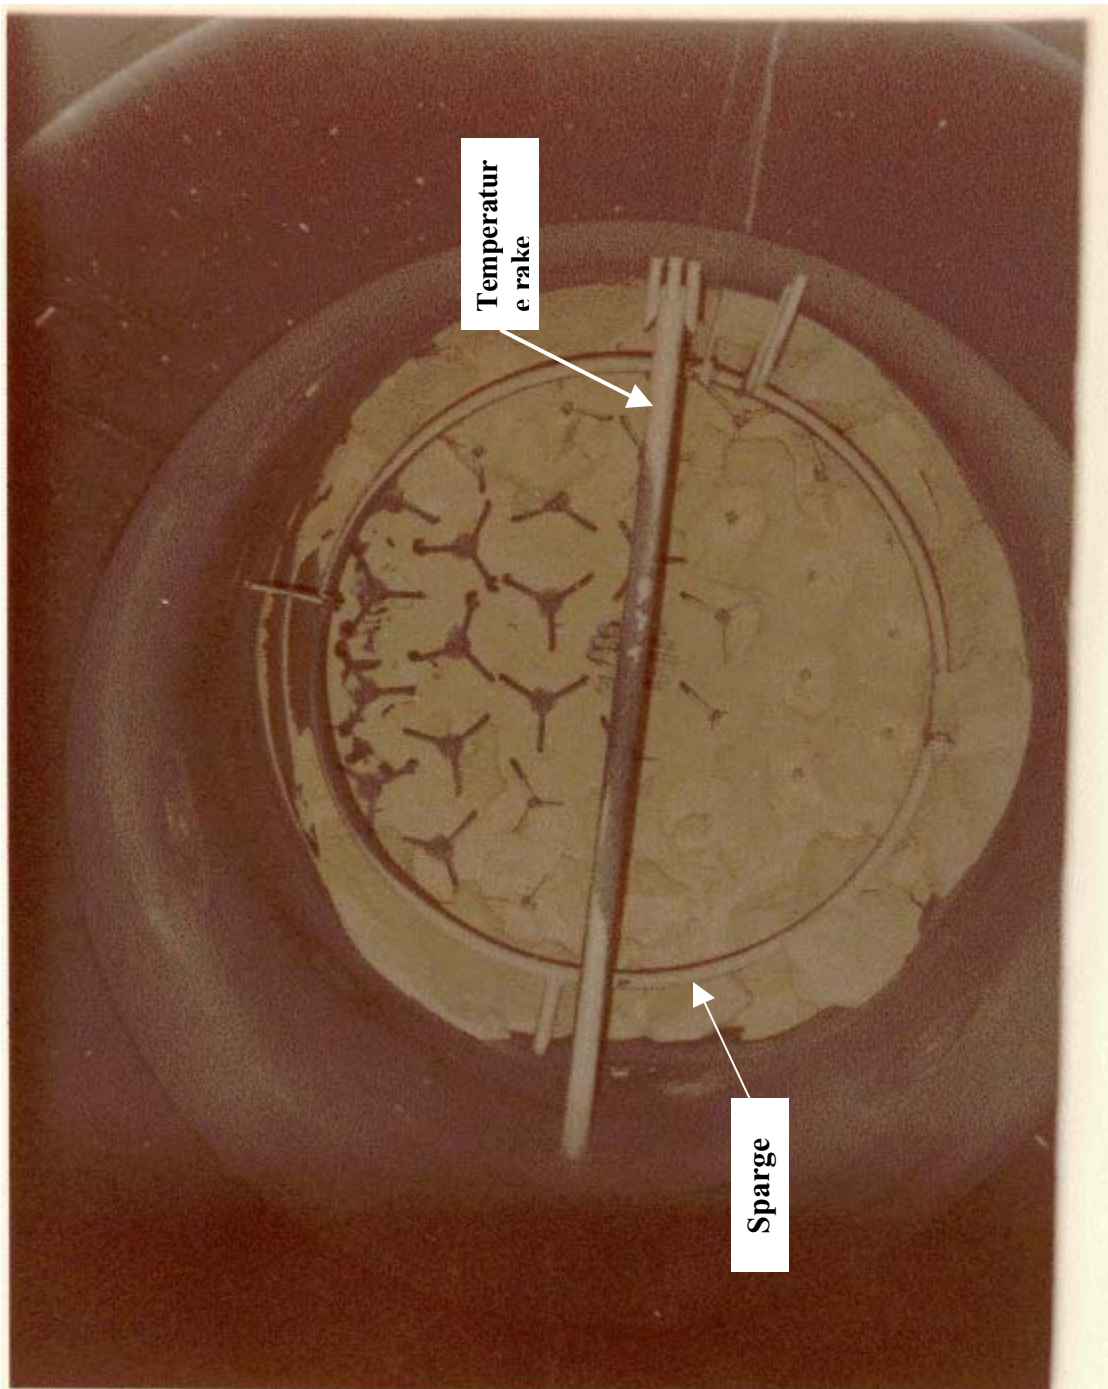
**Figure A-6.** Calcine-covered fluidizing air distributor plate in VES-NCC-105 before decontamination. The circular sparge ring (located 14 inches above the grid) and the horizontal thermowell (temperature rake) extending through the center of the vessel are visible (81-5594).

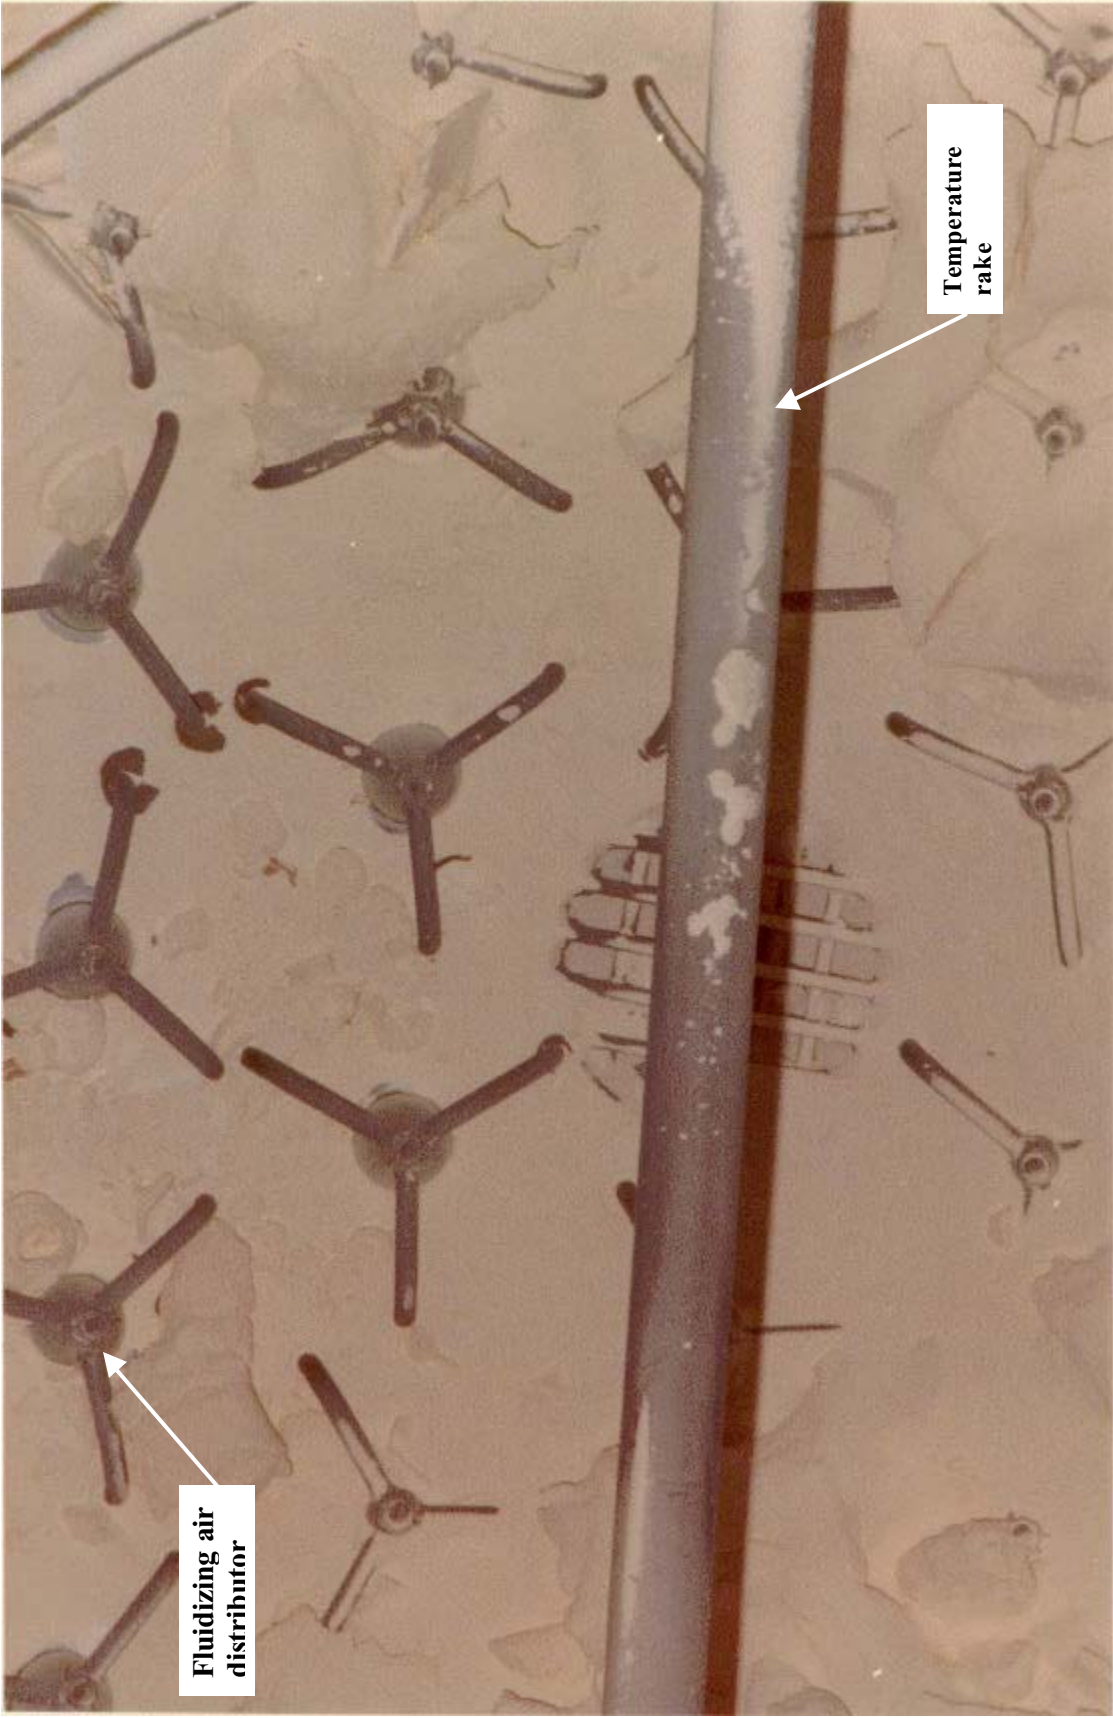
**Figure A-7.** Close-up view of calcine on top of fluidizing air distributor plate prior to decontamination. Several fluidizing air distributor caps with their three support legs are visible and others are covered with calcine. Varying amounts of calcine cover the distributor caps (81-5593).

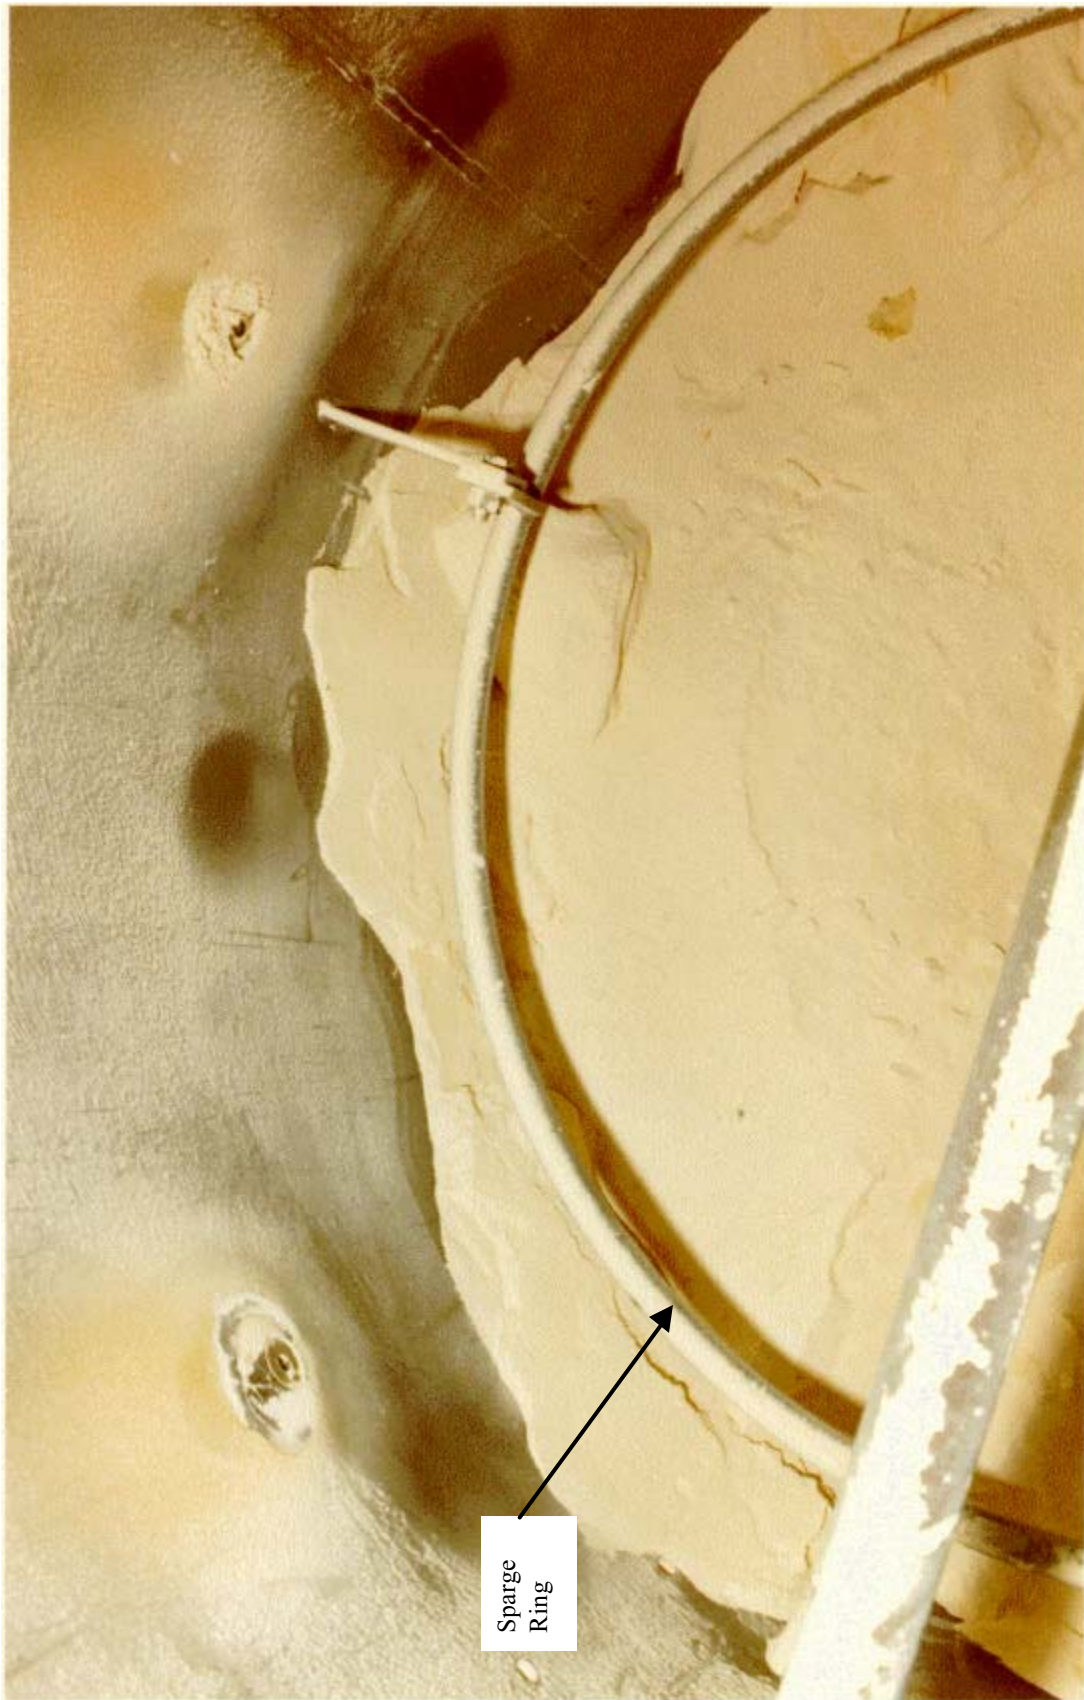
Figure A-8 is a picture of the calcine in the Calciner vessel following the non-radioactive operation of the Calciner in June 1982. Figure A-8 is not associated with the decontamination test of December 1981. It is included to illustrate the amount of calcine remaining on the distributor varies from one shutdown to another. There are no air distributor caps visible in Figure A-8, indicating there was more calcine present in June 1982 than in December 1981. However, the sparge ring is visible in Figure A-8, indicating the calcine is below the 14-inch level. The calcine on the distributor plate had an average depth of 6 inches in June 1982.

**Figure A-8.** View of the calcine remaining on the fluidizing air distributor plate following the June 1982 shutdown and before any decontamination. The calcine remaining on the distributor completely covers the fluidizing air distributor caps, but the sparge ring is visible above the calcine (82-4803).

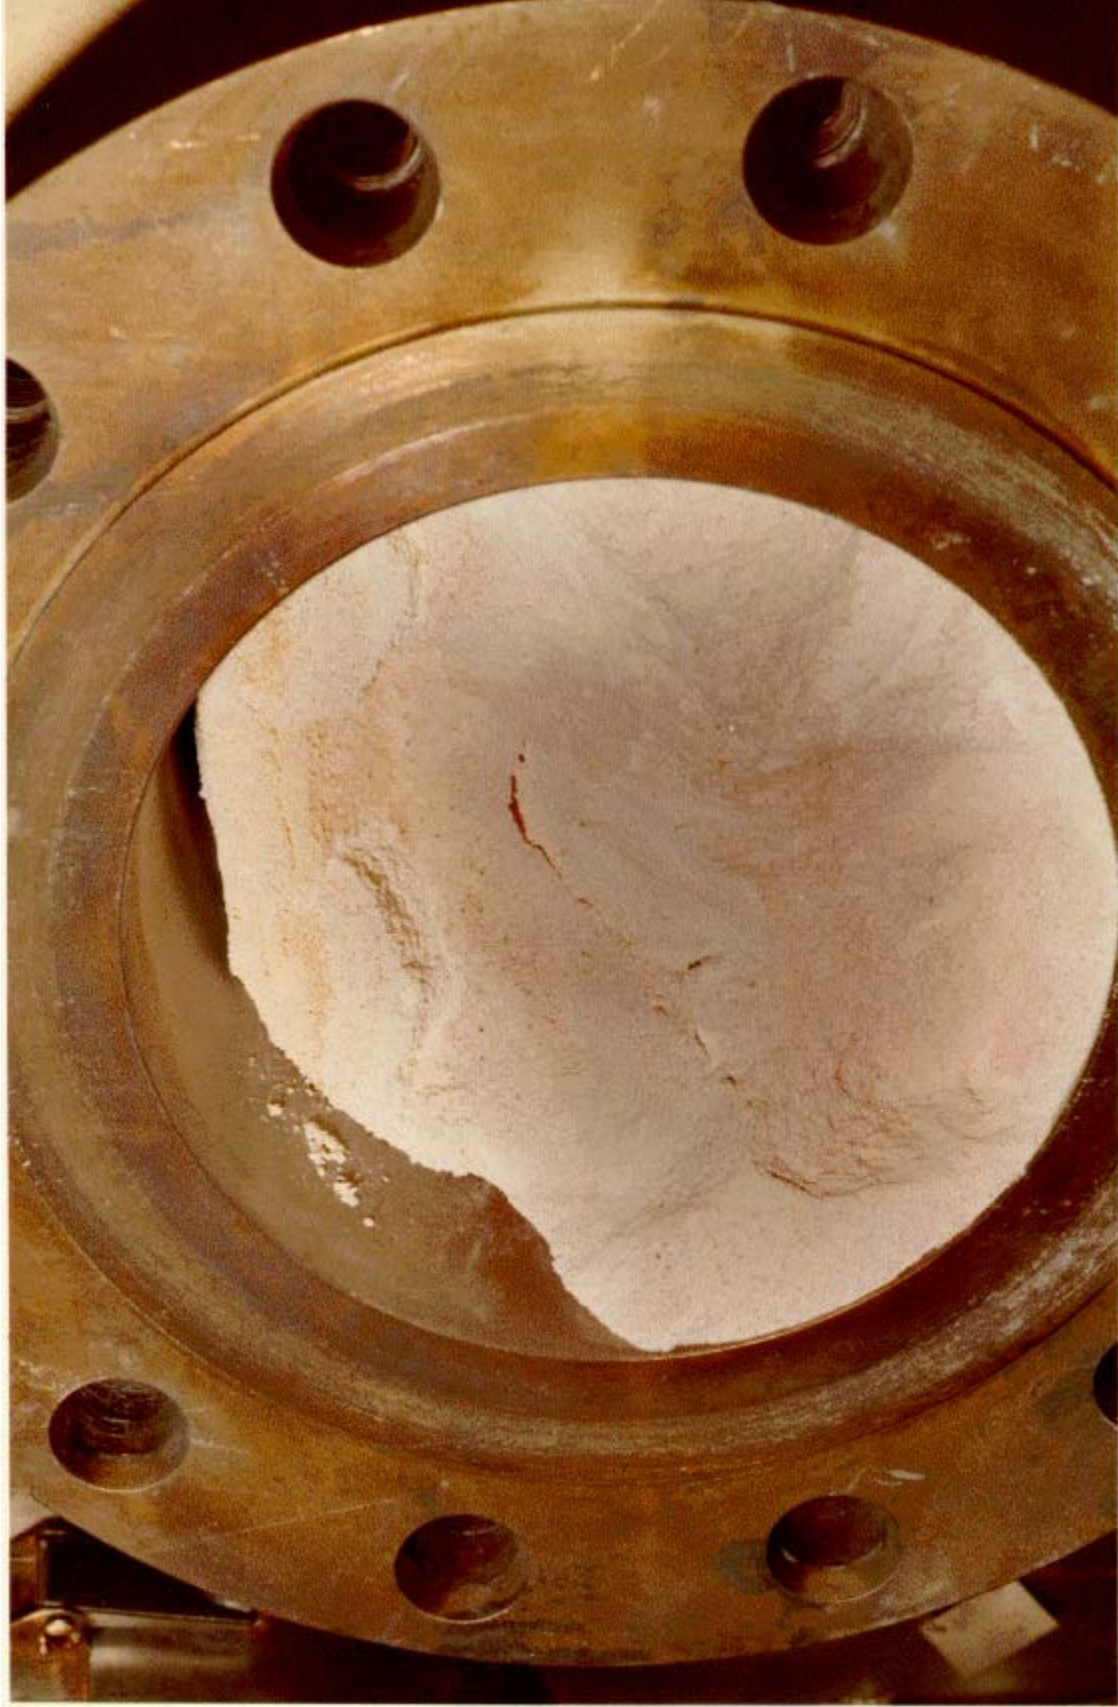
The pre-decontamination inspection found the upper east Calciner handhole (an 8-inch nozzle located just above the fluidizing air distribution grid) completely filled with calcine (see Figure A-9). The handhole is a non-fluidized area that collects calcine during Calciner operation. Normal shutdown procedures can not remove calcine from the handhole. Only vessel decontamination, using acid to dissolve the calcine, can

remove calcine from such locations. The calcine in the east handhole was removed by hand during the pre-decontamination inspection to provide access into the vessel to continue the vessel internal inspection. The inspection found the handhole located on the west side of the vessel also filled with calcine. The calcine in the west handhole was left in place to judge the effectiveness of the subsequent calcine dissolution and decontamination effort.

**Figure A-9.** Calciner east handhole (8-inch nozzle) located just above the fluidizing air distributor plate filled with calcine prior to decontamination (81-5579).

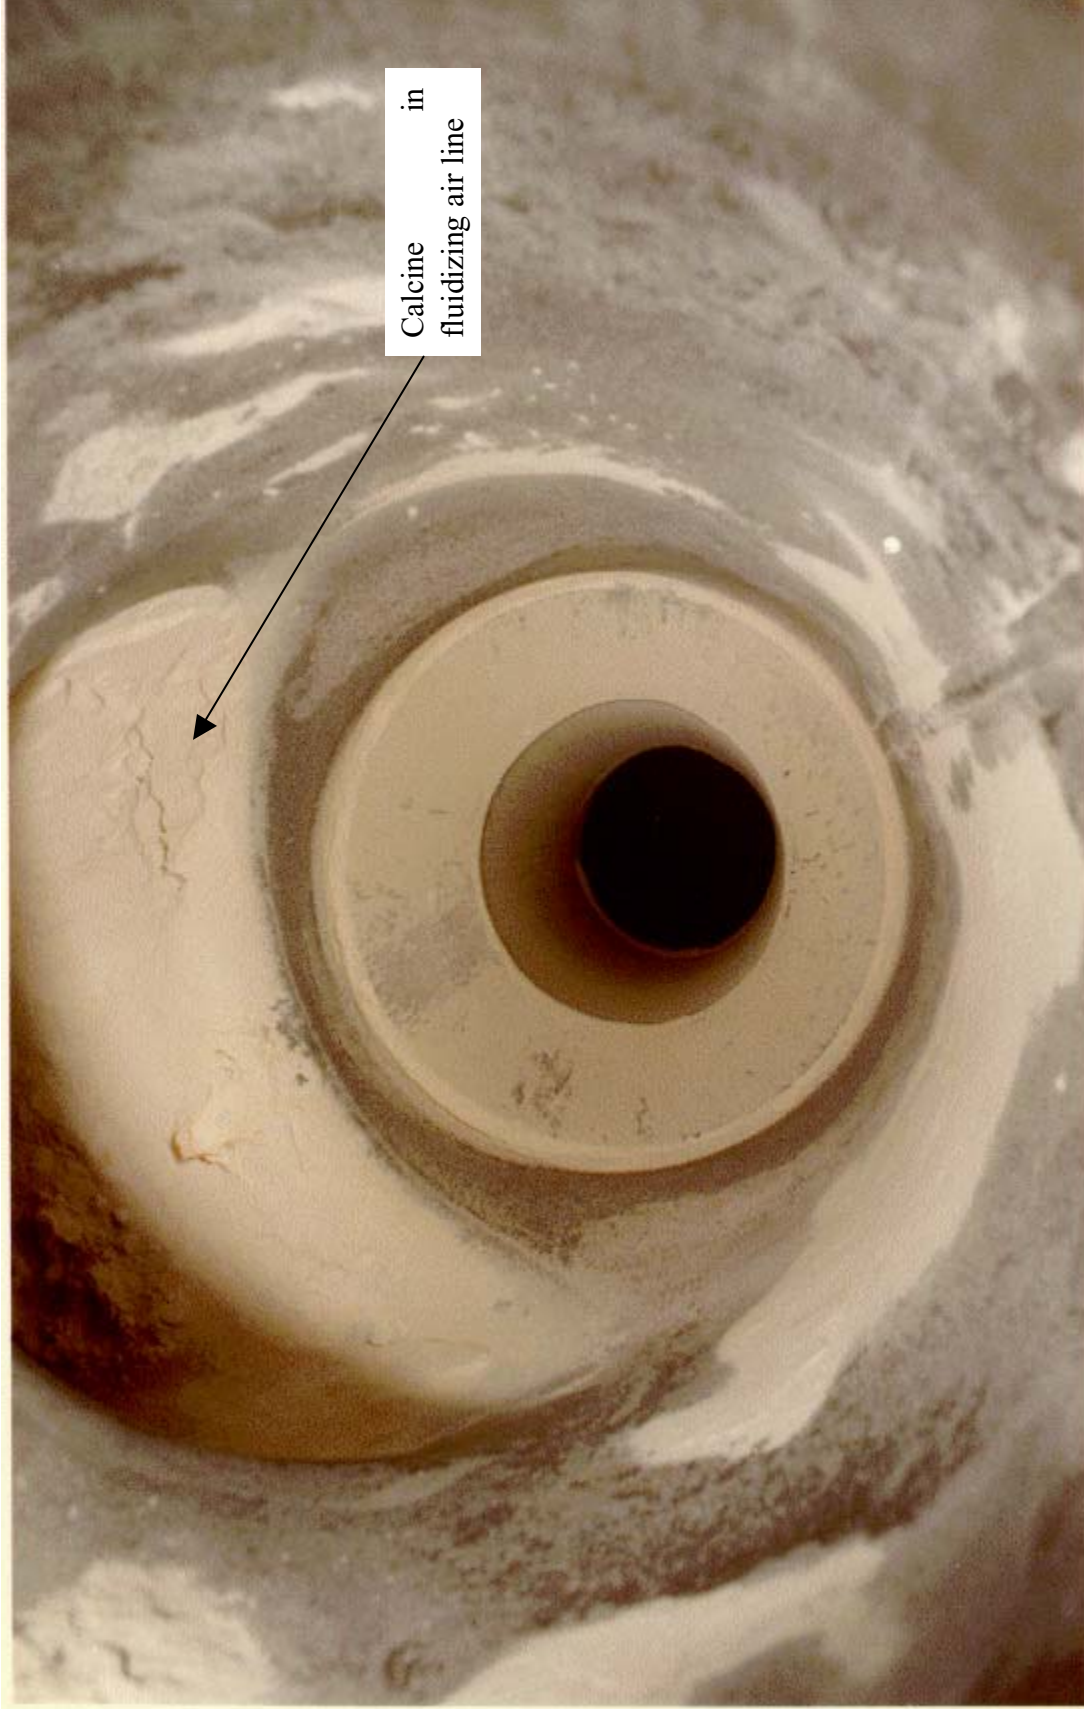
The fluidizing air distribution plenum below the fluidizing air distribution grid had some fine calcine dust on portions of the plenum wall. A significant amount of calcine (1 inch deep) was in the bottom of the 8-inch fluidizing airline where it joins the fluidizing air distribution plenum (see Figure A-10).

**Figure A-10.** Calciner fluidizing air plenum with a significant quantity of calcine in the fluidizing air line prior to decontamination. The 8-inch fluidizing air line joins the plenum in a tee connection in the upper left hand portion of the photo. The dark hole in the center of the picture is the plenum drain line (81-5547).

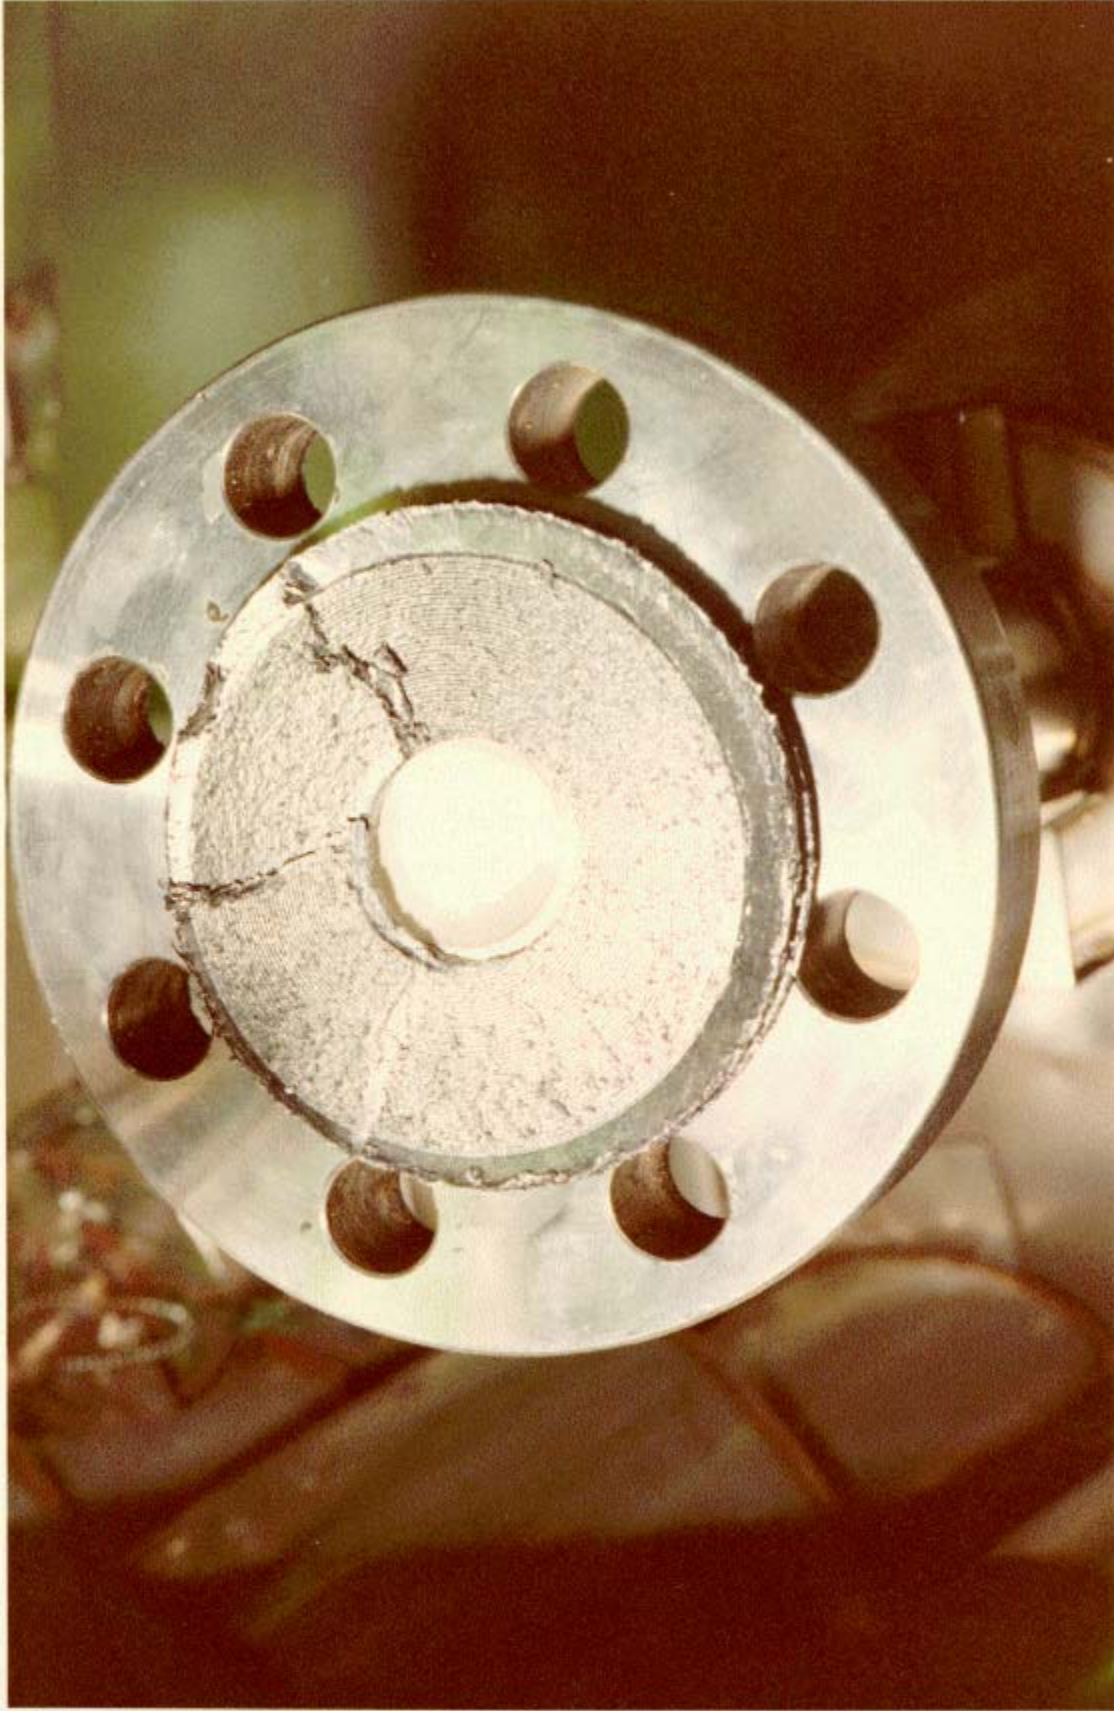
Calcine plugged the west product removal line during the non-radioactive test operation of the Calciner. Inspection of that line showed it to be packed with calcine (see Figure A-11). The calcine was left in the line to determine the effectiveness of the decontamination effort.

**Figure A-11.** The west calcine product removal line plugged with calcine prior to decontamination (81-5542).
