# ***New Waste Calcining Facility Non-Radioactive Process Decontamination***

*September 2001*

*Idaho National Engineering and Environmental Laboratory  
Bechtel BWXT Idaho, LLC*

## ABSTRACT

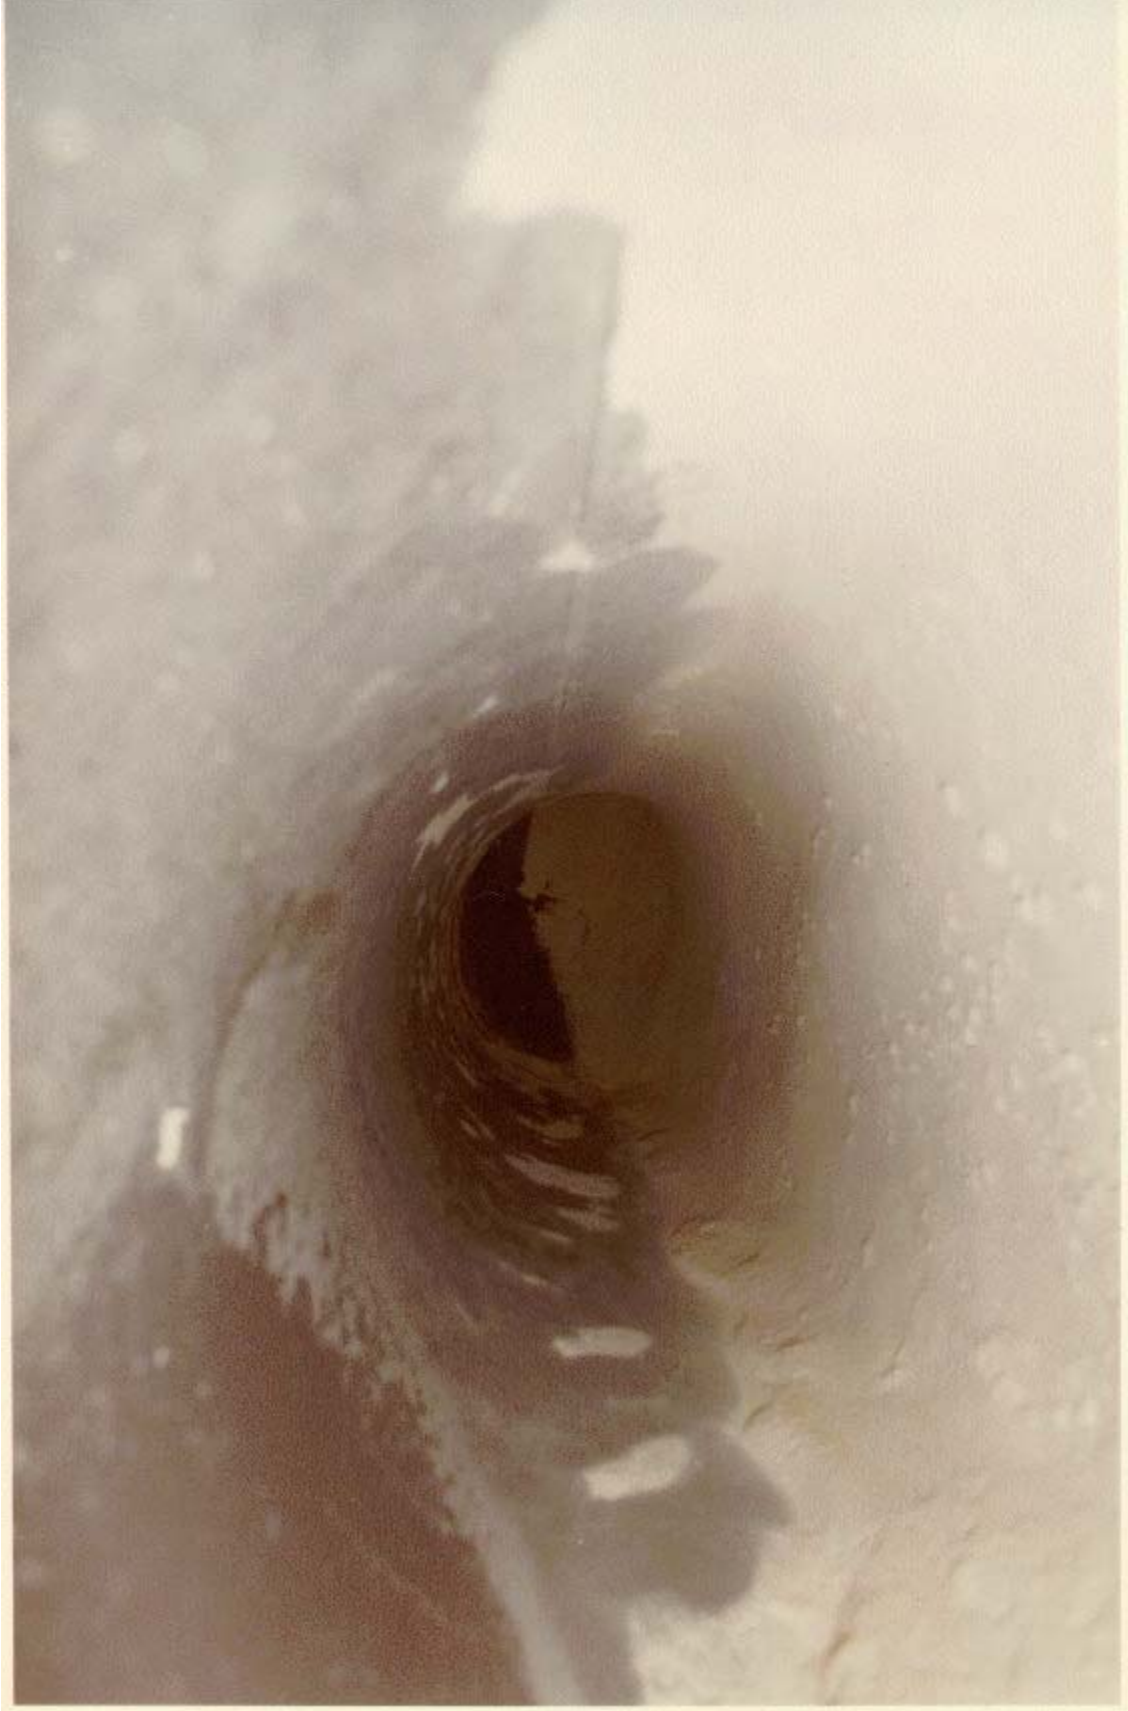
The largest accumulation of solids observed during the entire pre-decontamination inspection was in the horizontal portion of the 16-inch off-gas line between the cyclone and the quench tower. Fine calcine dust covered the bottom of the visible portion of the line. The depth of solids was 3 to 4 inches in the bottom of the pipe (see Figure A-12). The solids depth appeared to be uniform throughout the length of off-gas line. However, only the first 7 feet of the 22-foot horizontal line were inspected. An elbow in the line prevented the inspection of the last 15 feet. The off-gas line contained approximately 200 pounds of calcine dust<sup>1</sup>. Calcine partially filled the off-gas line during normal operation because the line was too large in diameter and the resulting off-gas velocity was too low to prevent solids deposition in the bottom of the pipe<sup>1</sup>.

**Figure A-12.** Off-gas line downstream of cyclone vessel with 3 to 4 inches of calcine in the bottom of the 16-inch pipe (81-5540).

The large accumulation of solids in the cyclone off-gas line was unexpected. Consequently, there was no decontamination method to remove the calcine from the off-gas line during the test. Instead, as much calcine as possible was removed by hand from the off-gas line during the pre-decontamination inspection. Modifications to the off-gas line were later made to the off-gas line to provide decontamination capability (see Post-Decontamination Modification section of this report).

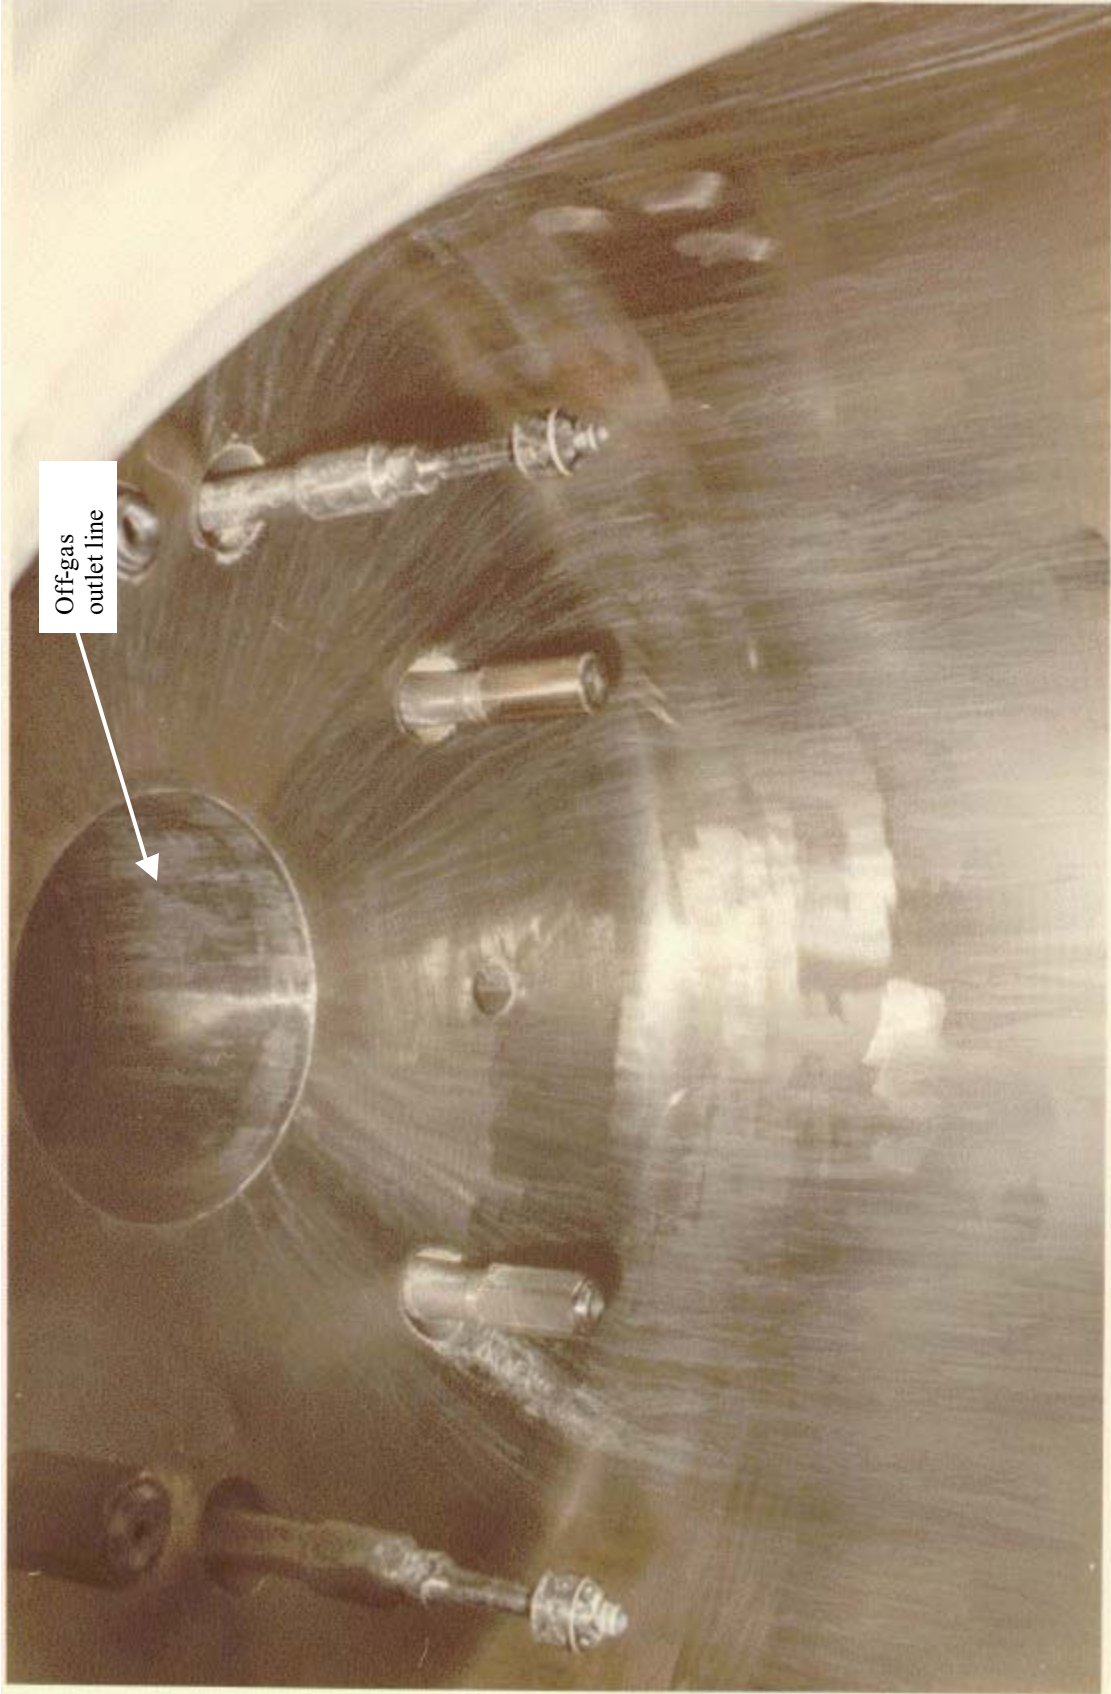
Figures A-13 through A-18 show the interiors of vessels in the quench and scrubbing systems before decontamination. Figures A-13 and A-14 show the interior of the quench tower (VES-NCC-109). Figure A-13 shows the liquid spray nozzles and off-gas outlet in the upper portion of the vessel. Figure A-14 shows the off-gas distributor plate in the lower portion of the vessel. Both photographs show light streaks of residue on the vessel walls from evaporated quench solution. There is no accumulation of calcine in the vessel.

**Figure A-13.** Upper portion of the quench tower (VES-NCC-109) before decontamination. The vessel interior walls were relatively clean before decontamination. The off-gas outlet and the quench and decontamination nozzles are visible in the photograph (81-5572).

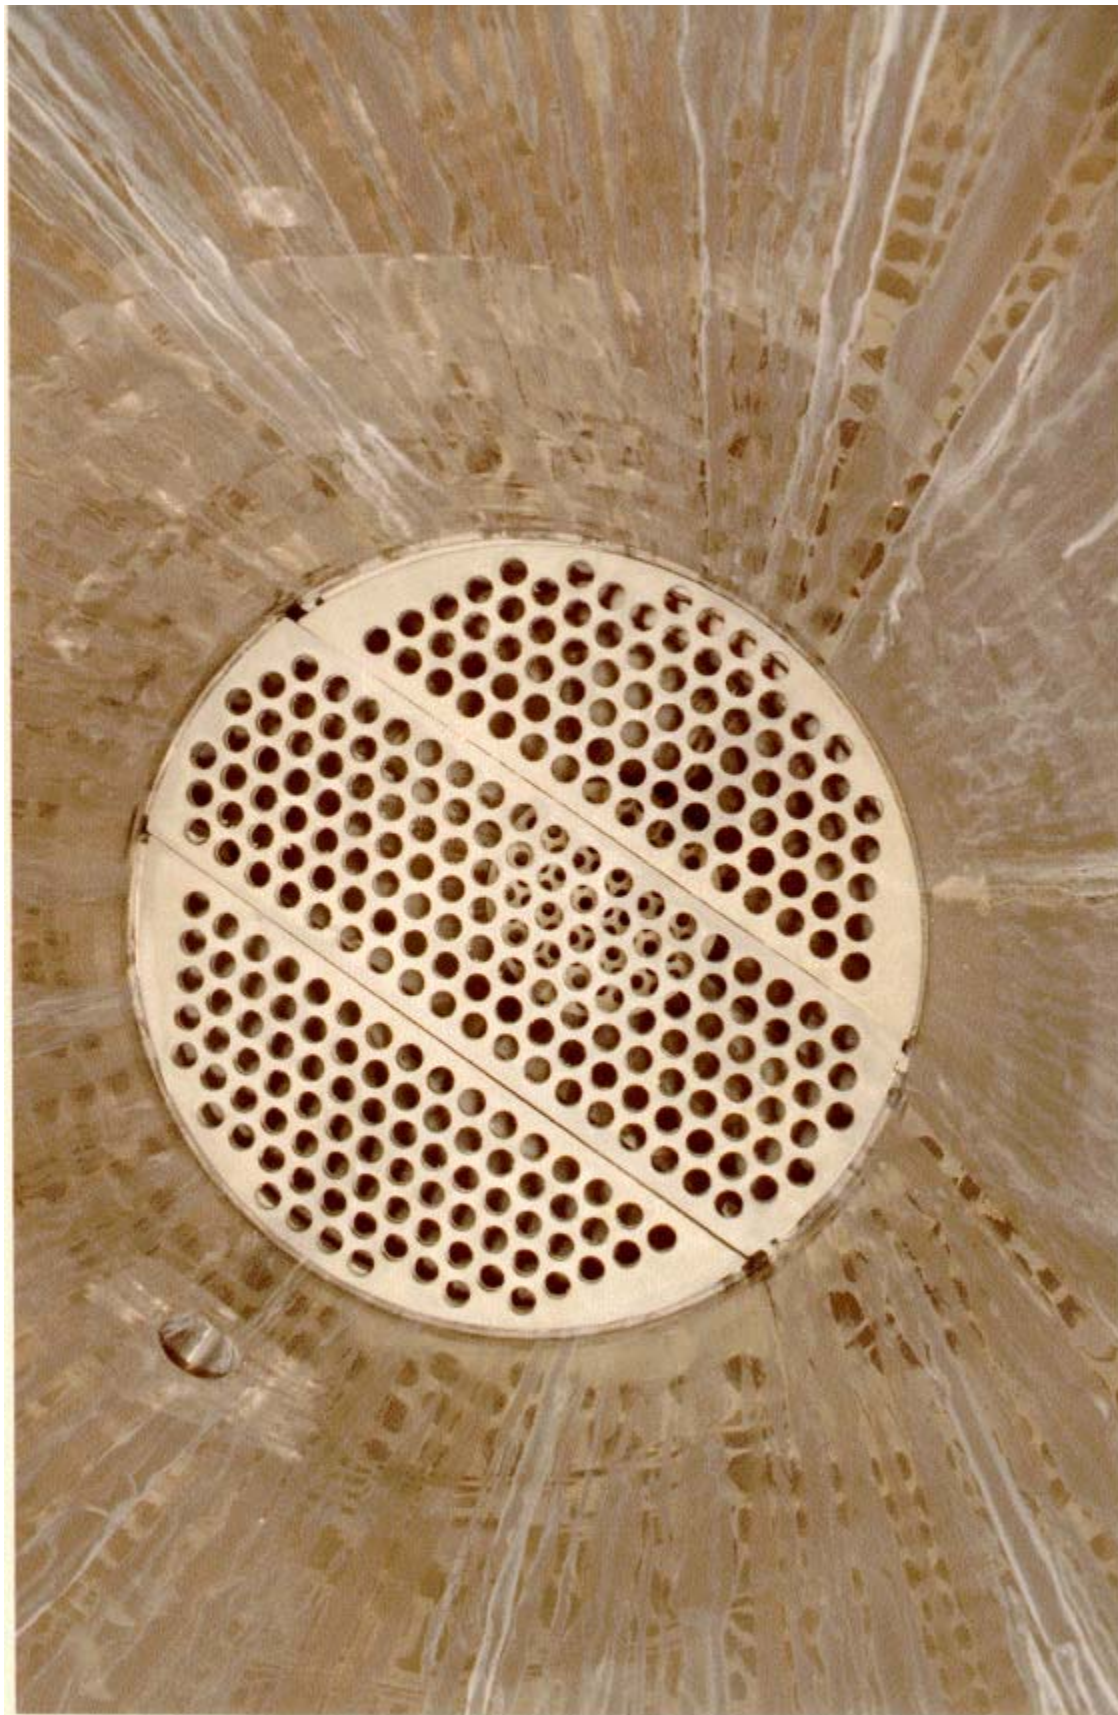
**Figure A-14.** Lower portion of the quench tower. The vessel was relatively clean prior to decontamination. Some streaks of dried quench solution residue are visible on the walls (81-5564). The Calcliner off-gas distribution plate is visible in the bottom of the vessel.

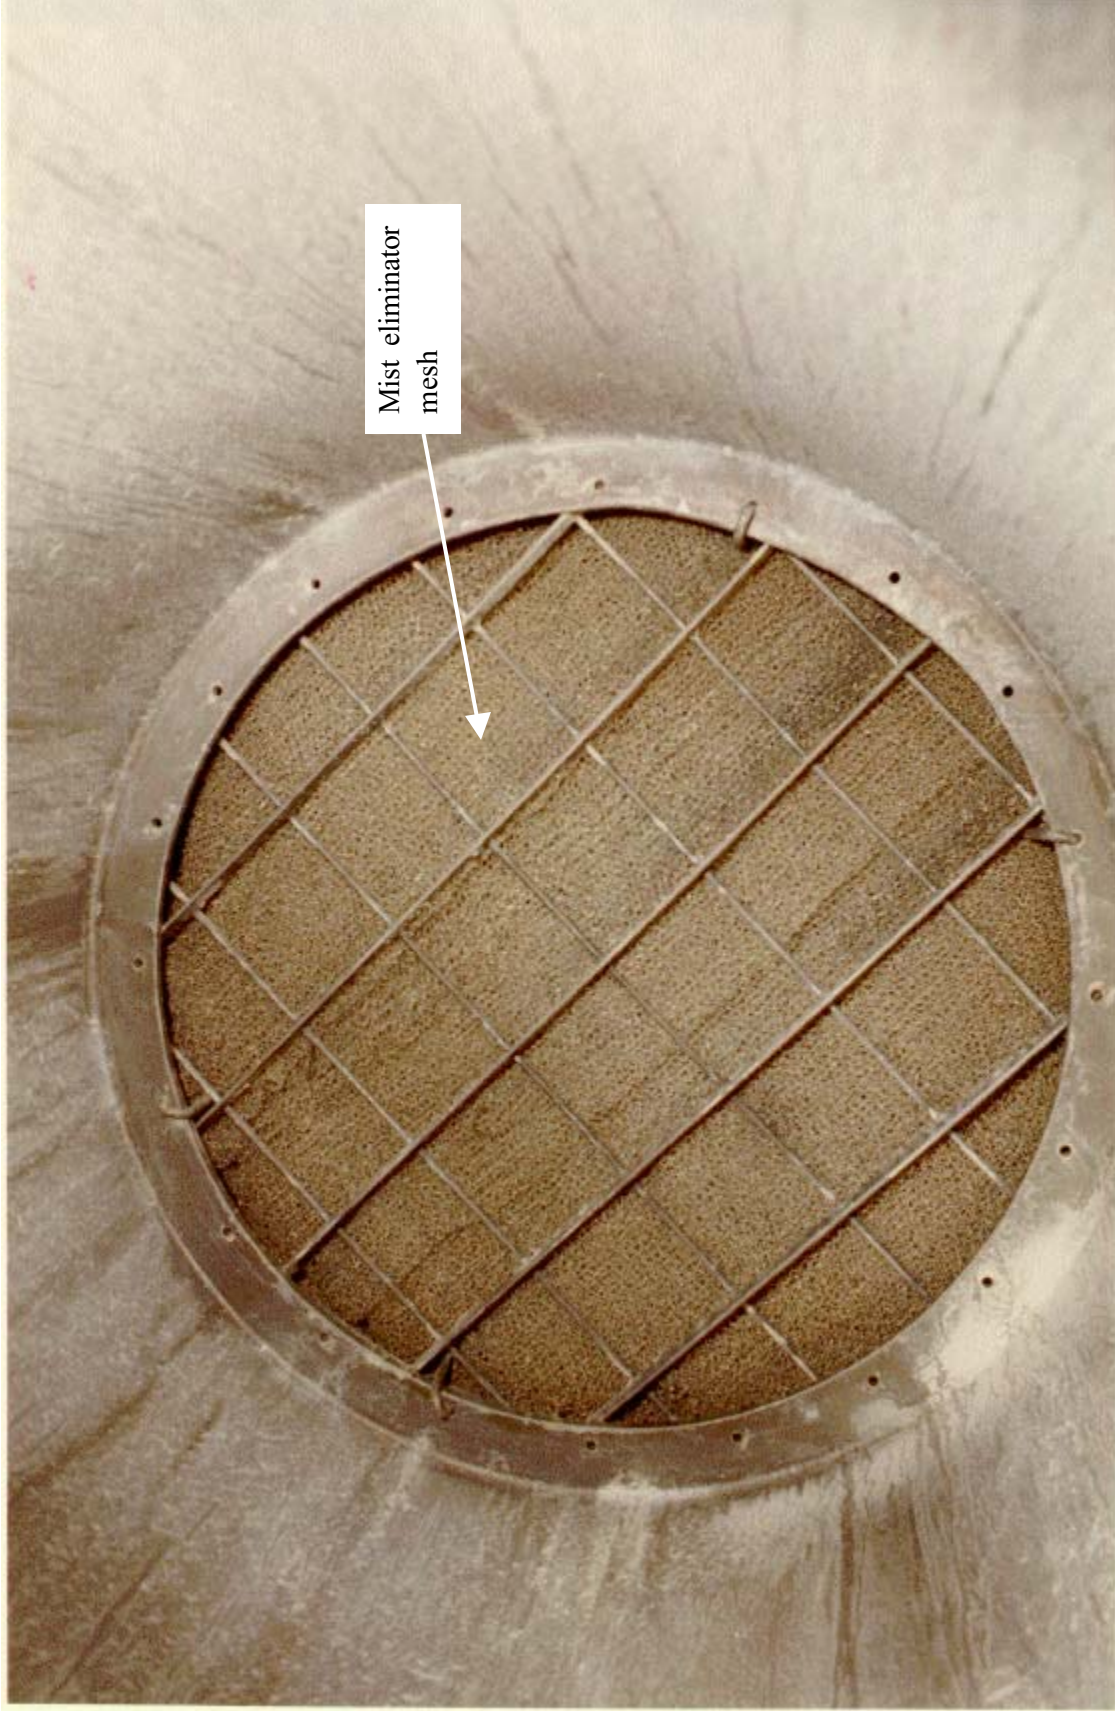
Figures A-15 and A-16 show the interior of the venturi scrubber knockout drum (VES-NCC-111) before decontamination. Figure A-15 shows the upper portion of the knockout drum and its stainless steel mesh. Figure A-16 shows the lower portion of the knockout drum with its baffles and catch plate over the liquid drain line. The knockout drum is clean except for some streaks remaining from evaporated quench solution. The vessel walls and the mesh are free of accumulated calcine.

**Figure A-15.** Upper portion of knockout drum (VES-NCC-111) before decontamination. Some white streaks are visible on the vessel walls from dried quench solution prior to decontamination (81-5560).

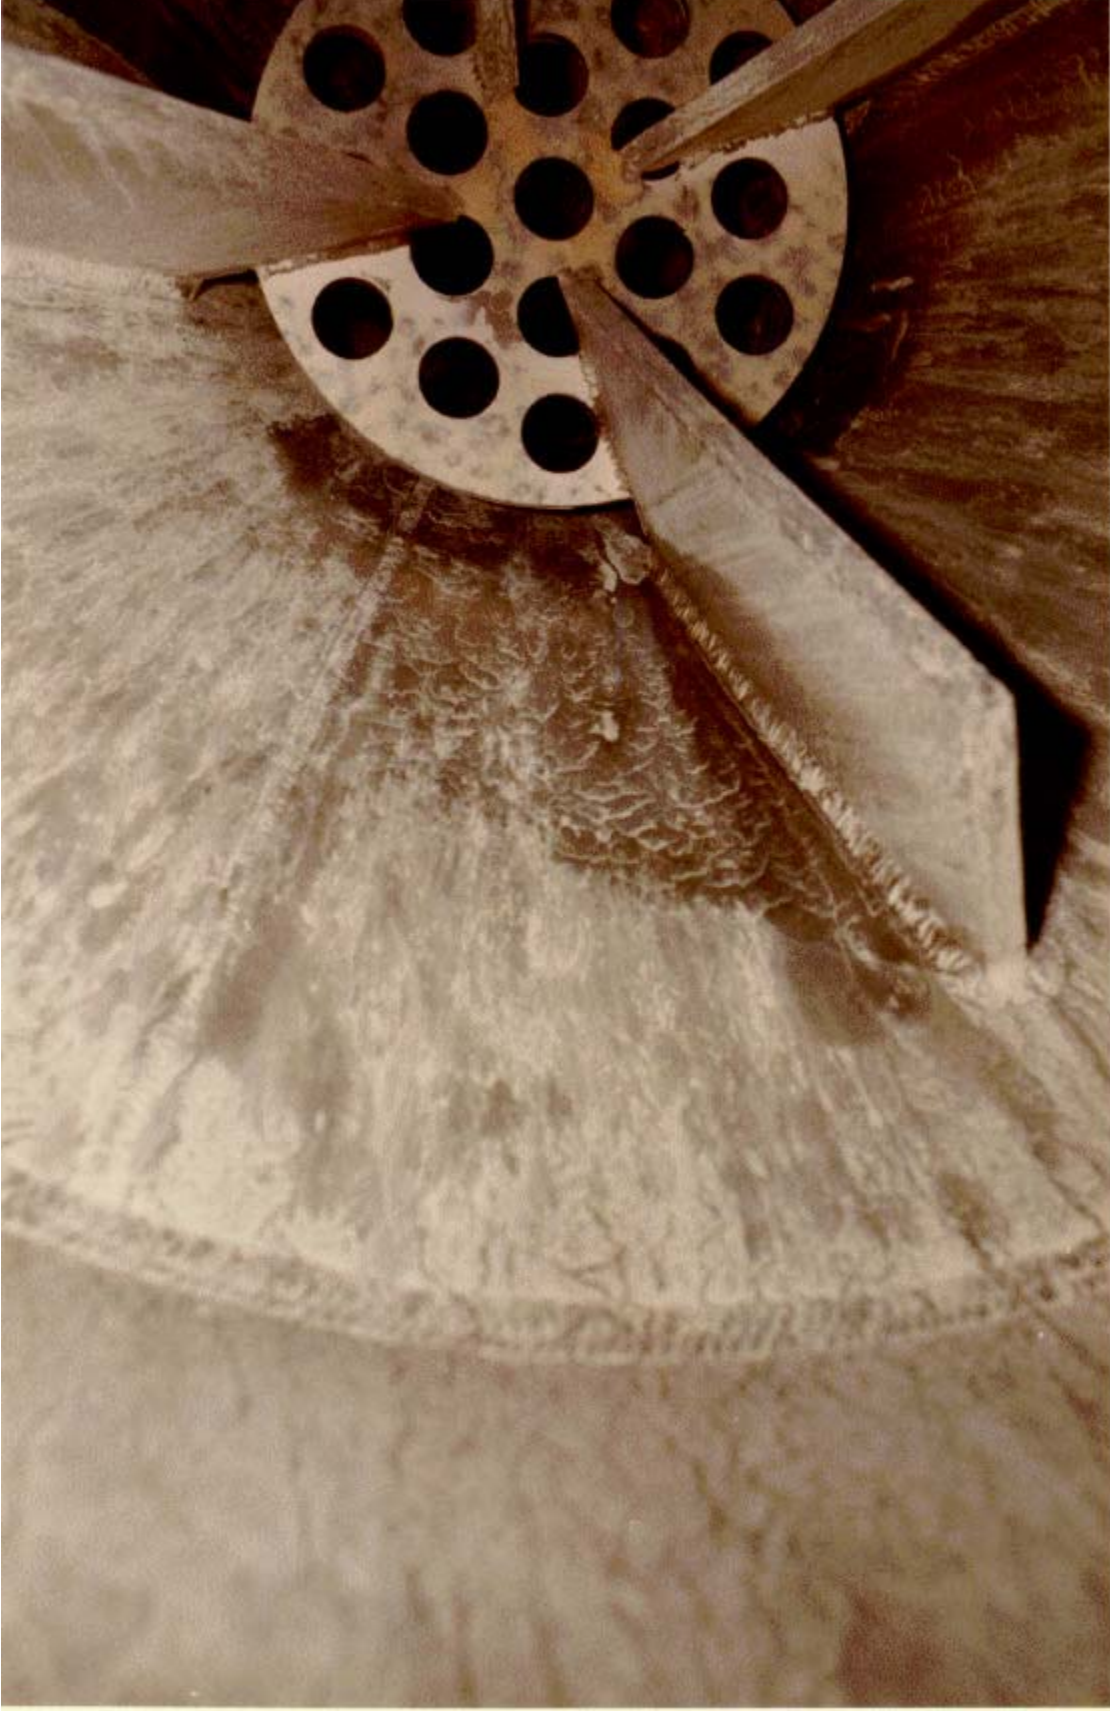
**Figure A-16.** Lower portion of knockout drum (VES-NCC-111) prior to decontamination. There was no calcine accumulation on the baffles or catch plate in the bottom of the vessel (81-5570).

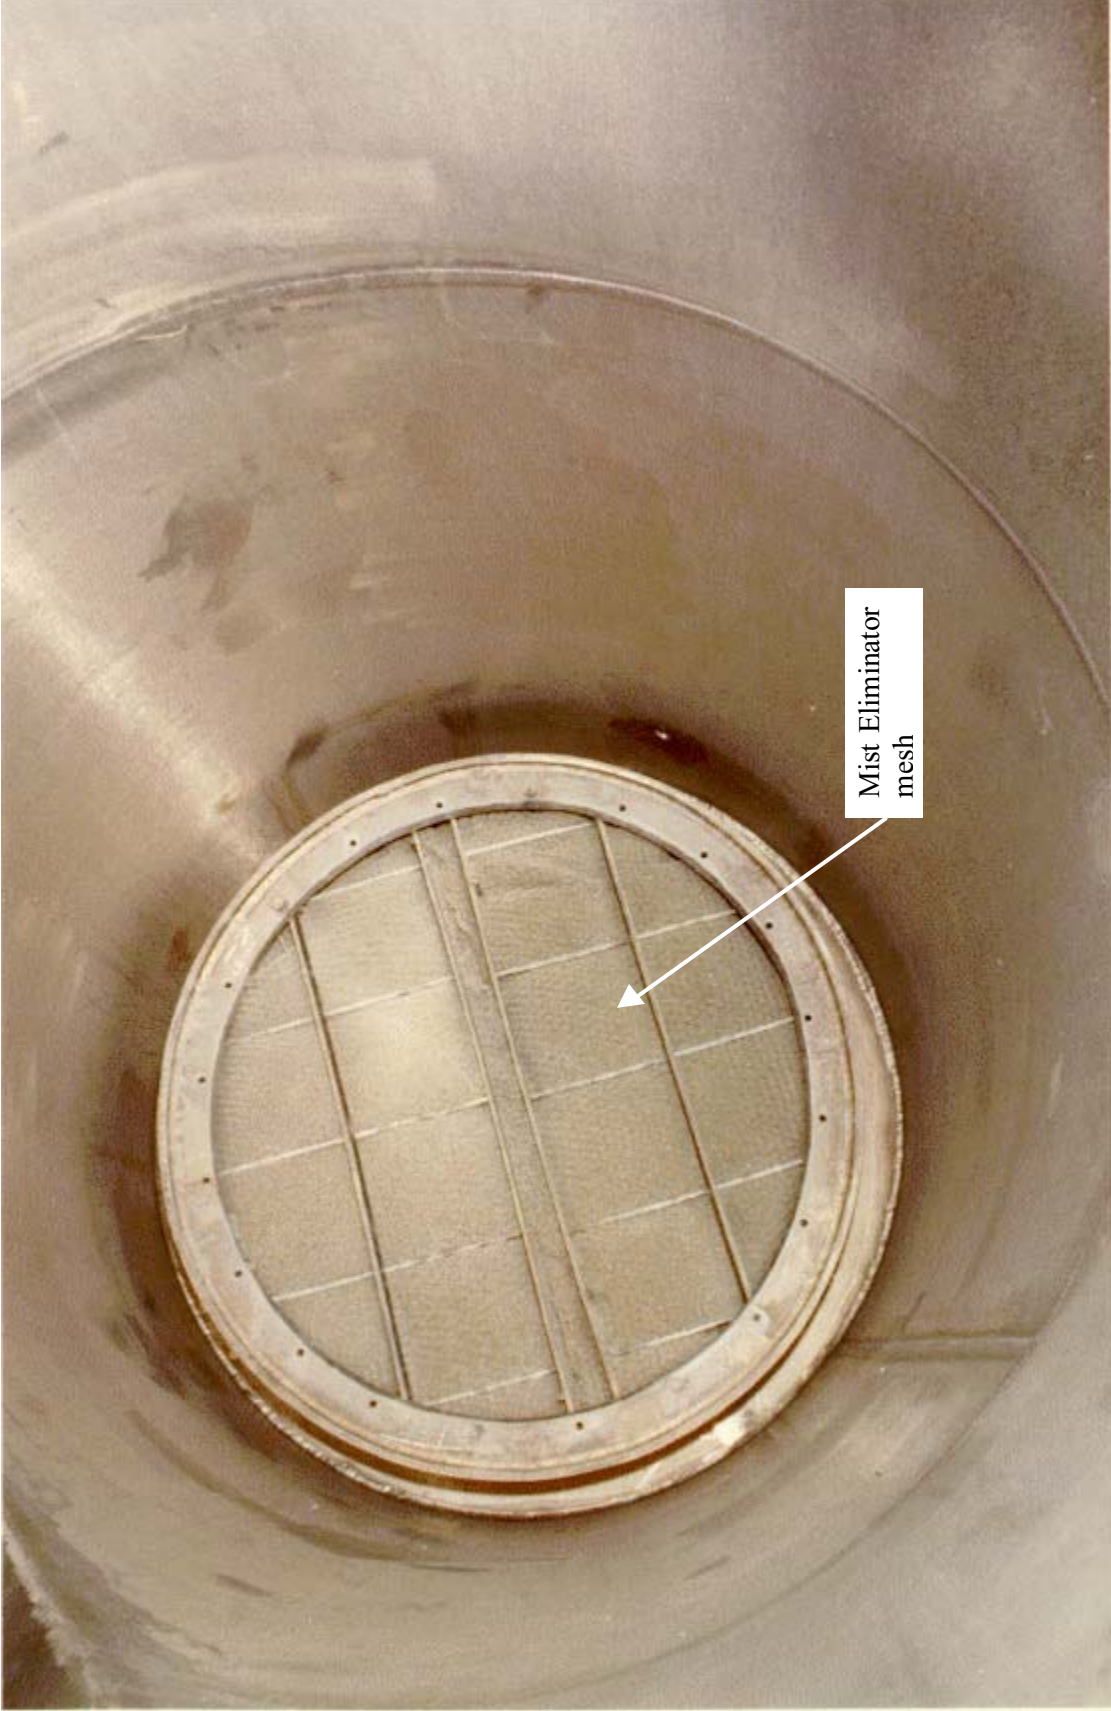
Figures A-17 and A-18 show the interior of the mist eliminator (VES-NCC-110) before decontamination. Figure A-17 shows the upper portion of the vessel and its outlet wire mesh. Figure A-18 shows the lower portion of the vessel and the catch plate over the liquid drain line. The mist eliminator was cleaner than the quench tower or knockout drum. It had less streaking on the vessel walls, and no calcine accumulation.

**Figure A-17.** View of the upper portion of mist eliminator VES-NCC-110 and its outlet (second of two) mesh prior to decontamination. The mesh and vessel walls are clean with no indication of calcine accumulation (81-5565).

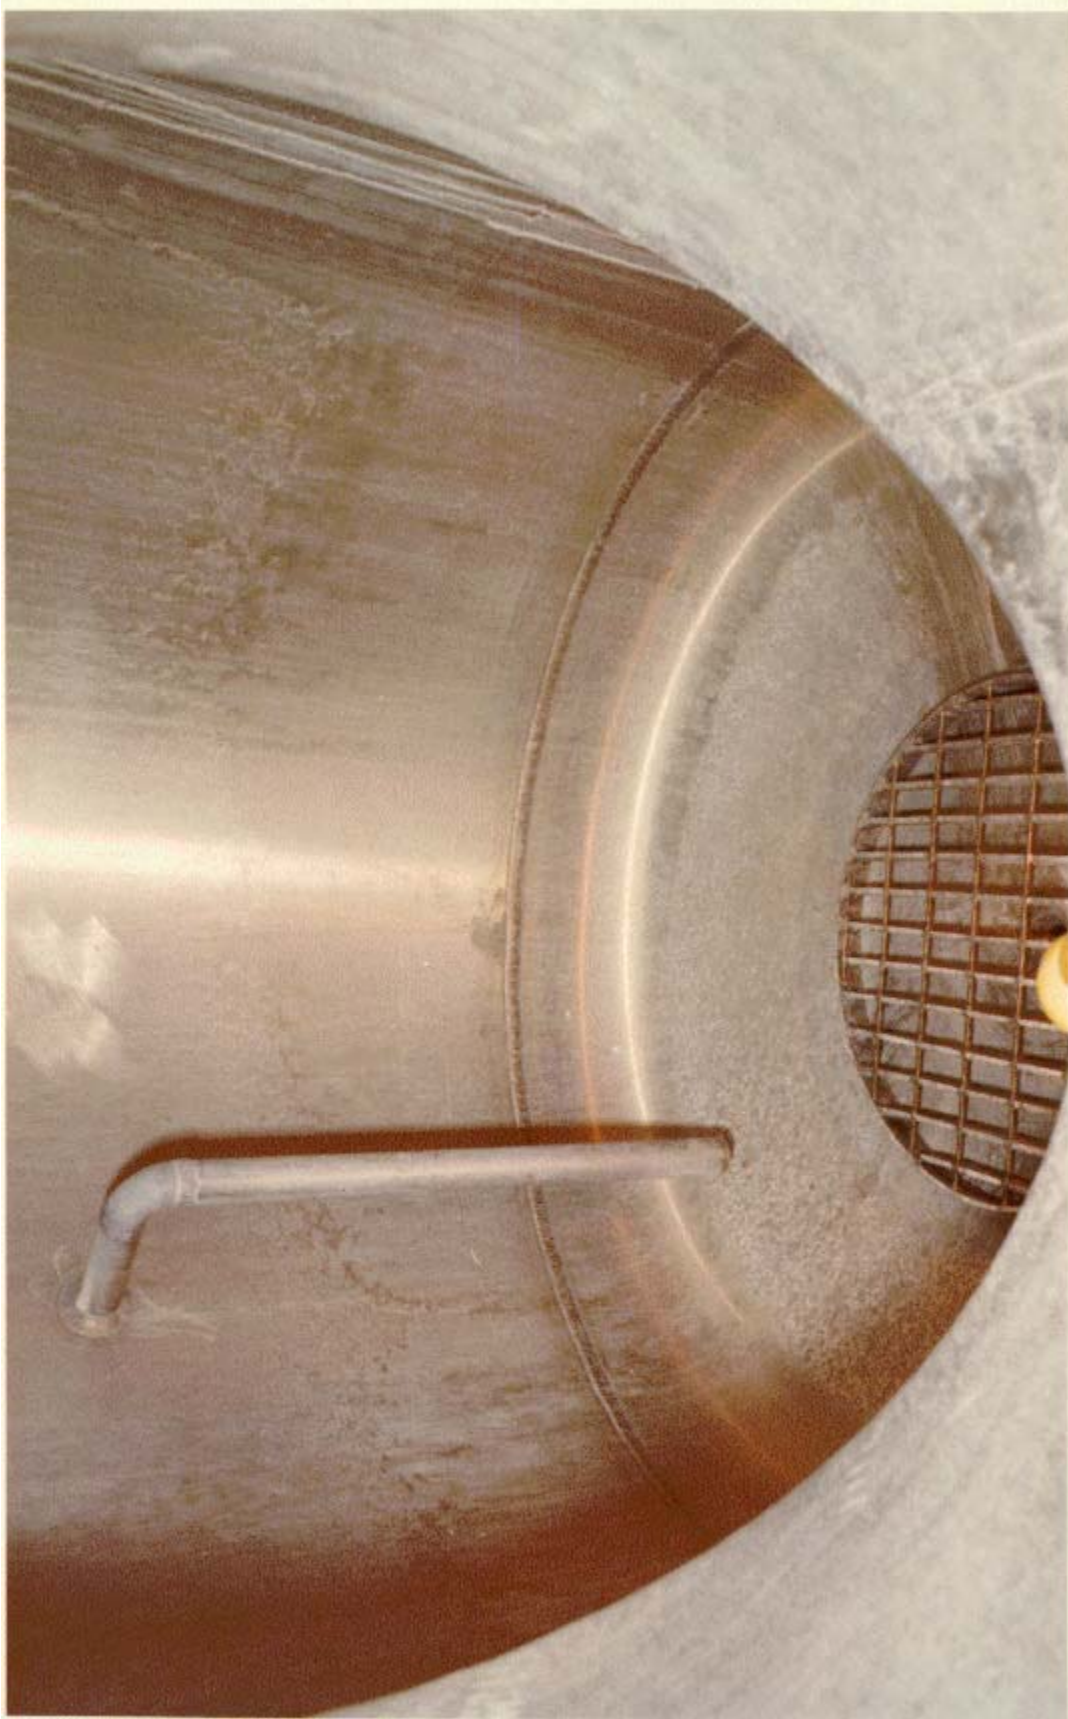
**Figure A-18.** View of the lower portion of mist eliminator (VES-NCC-110) before decontamination showing no calcine accumulation. The catch plate over the liquid drain line is in the lower part of the photograph (81-5568).

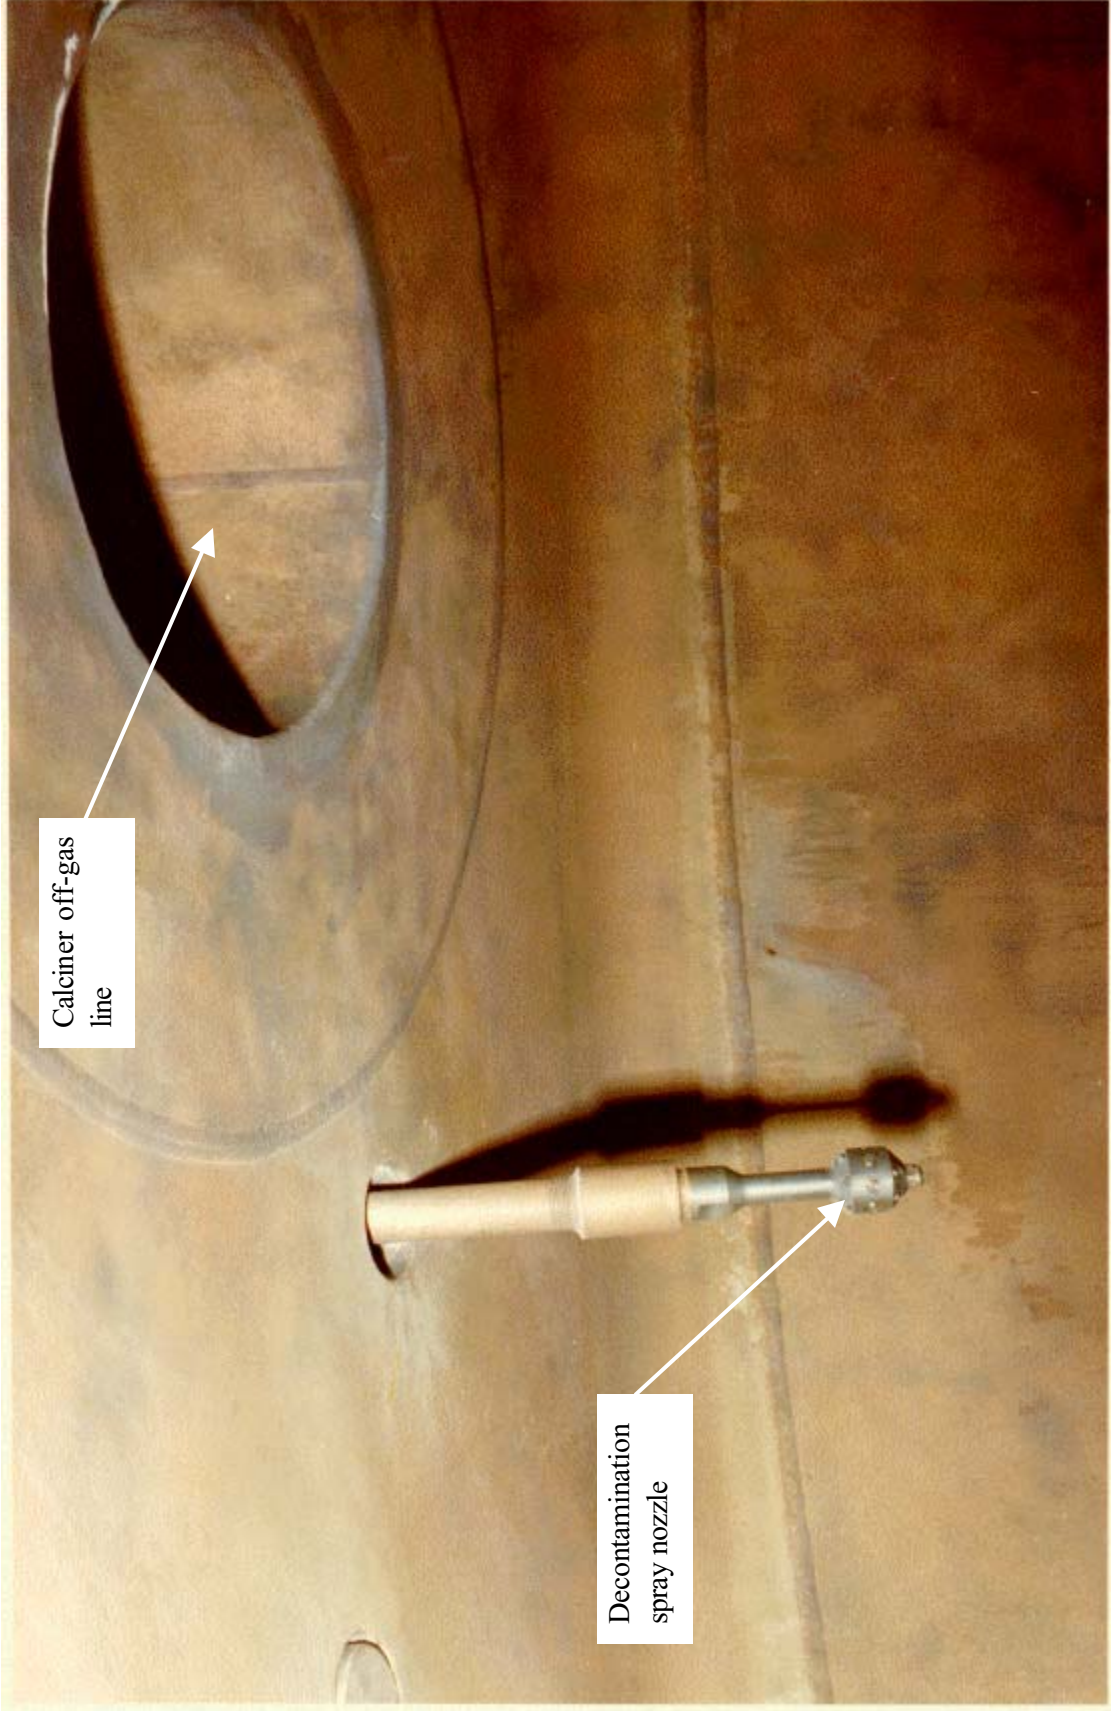
Calcliner off-gas  
line

Decontamination  
spray nozzle

**Figure B-1.** Upper portion of the Calcliner vessel, above the baffle plates, after the decontamination showing a virtually clean vessel. A comparison of this photograph with Figures A-2 and A-3 shows a dramatic reduction in calcine on the interior surfaces resulting from the decontamination (82-254).

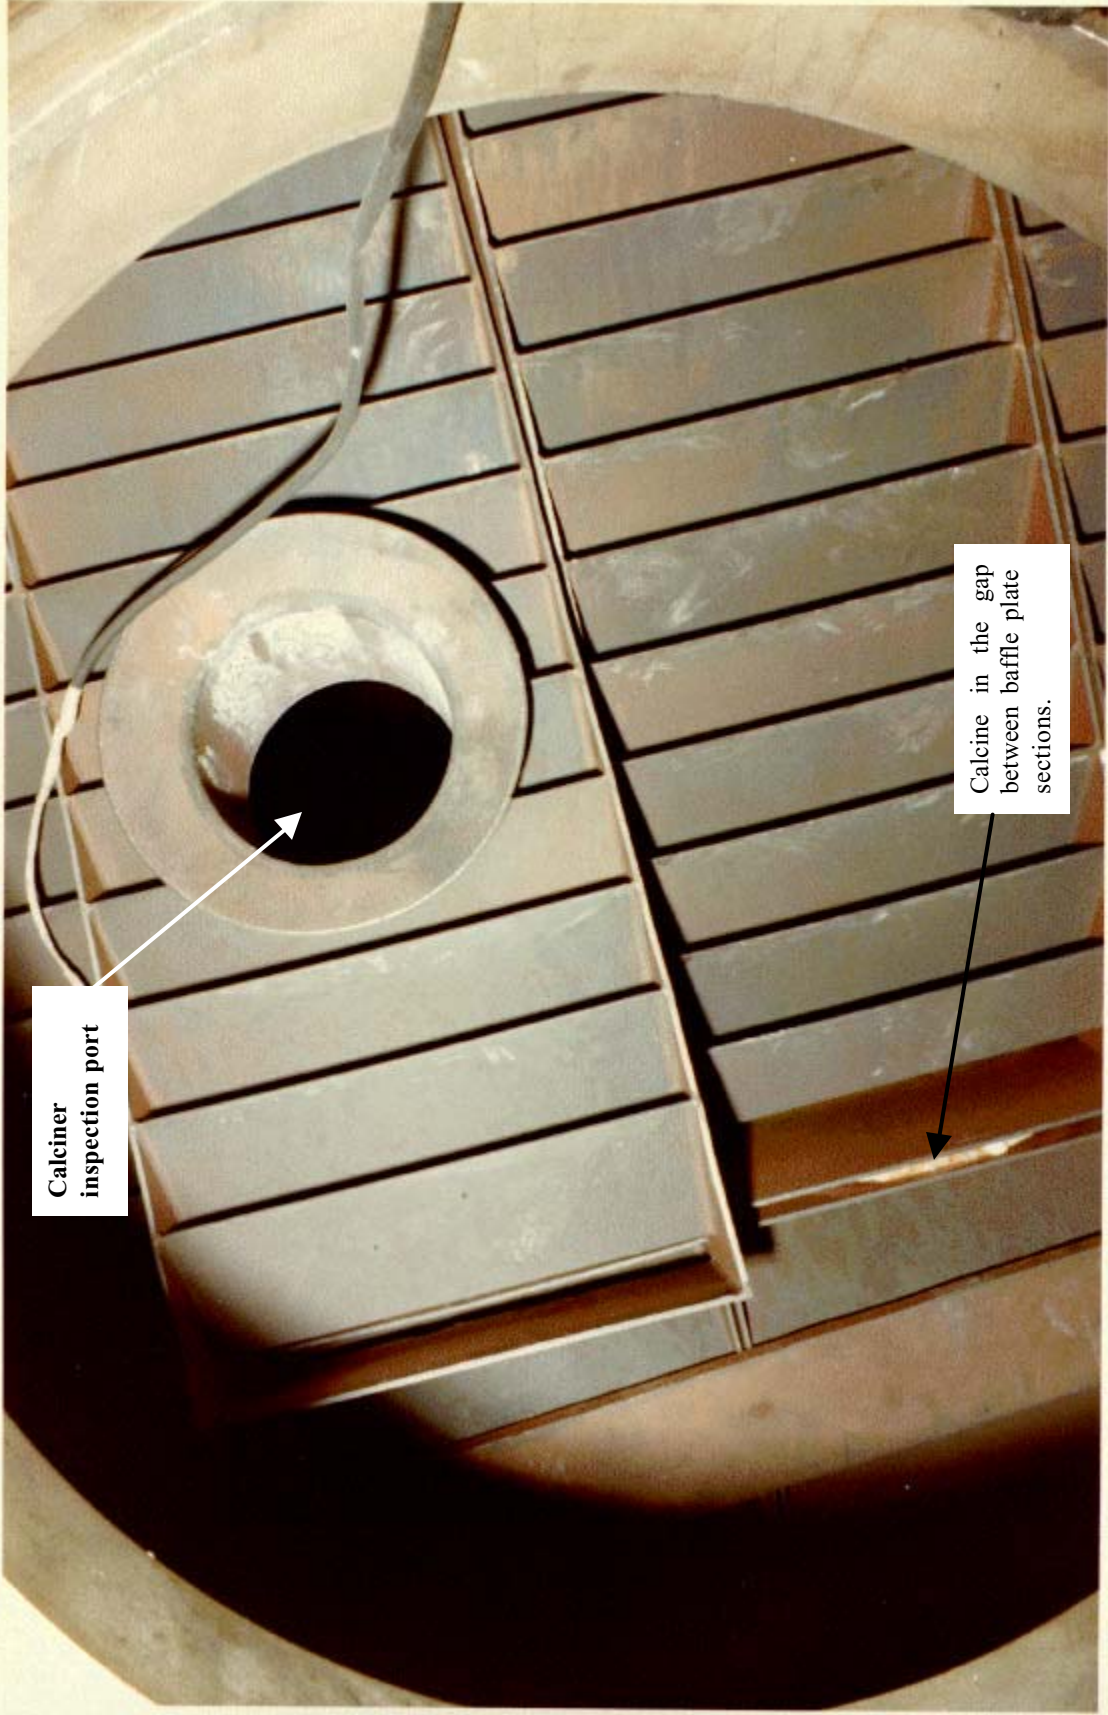
**Figure B-2.** View of the upper surfaces of the Calciner baffle plates after decontamination (82-255). This photograph shows most of the calcine present prior to the decontamination is gone (compare with Figure A-4). However, some calcine remains in the gaps between the baffle plate sections. The hole in the baffle plate is an inspection port and is normally plugged during Calciner operation (see figure B-4 for baffle plug).

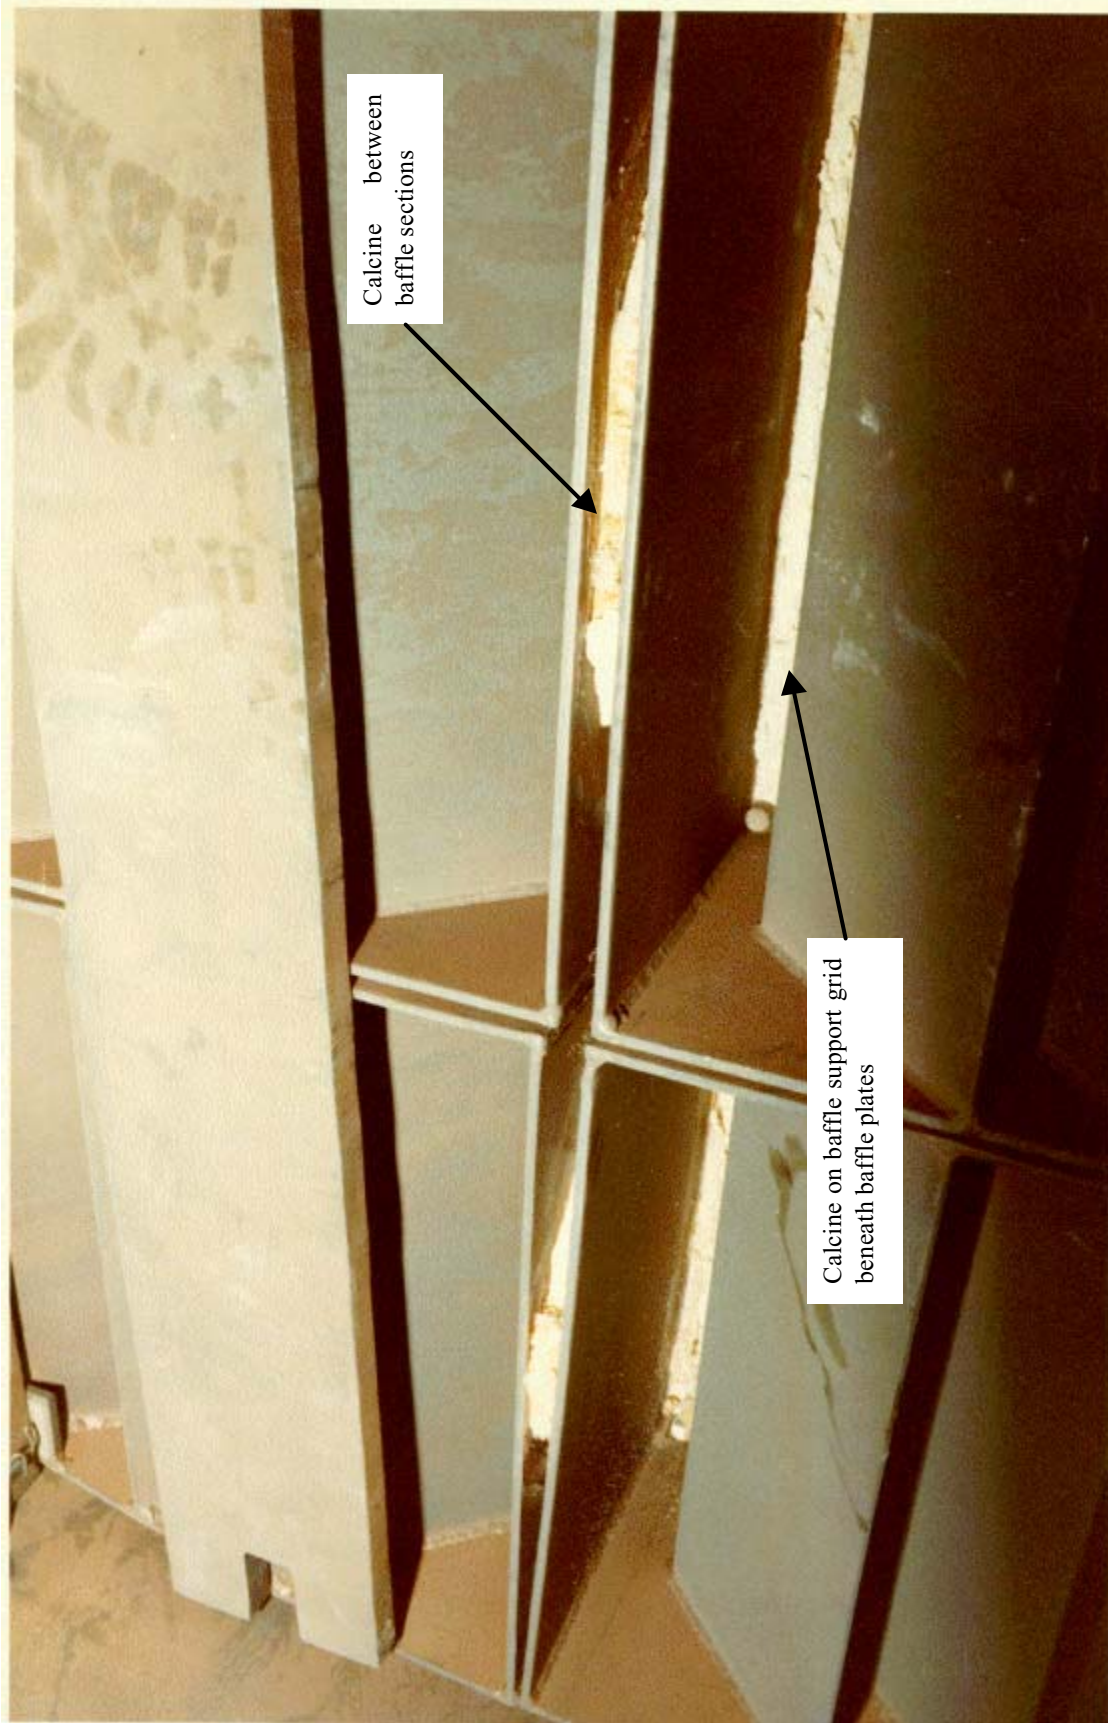
**Figure B-3.** Close-up view of Calciner baffle plates after decontamination showing calcine remaining between the baffle plate sections and on the baffle support grid beneath the section joints. The baffle supports were modified to eliminate the calcine residue seen in this picture (82-258).

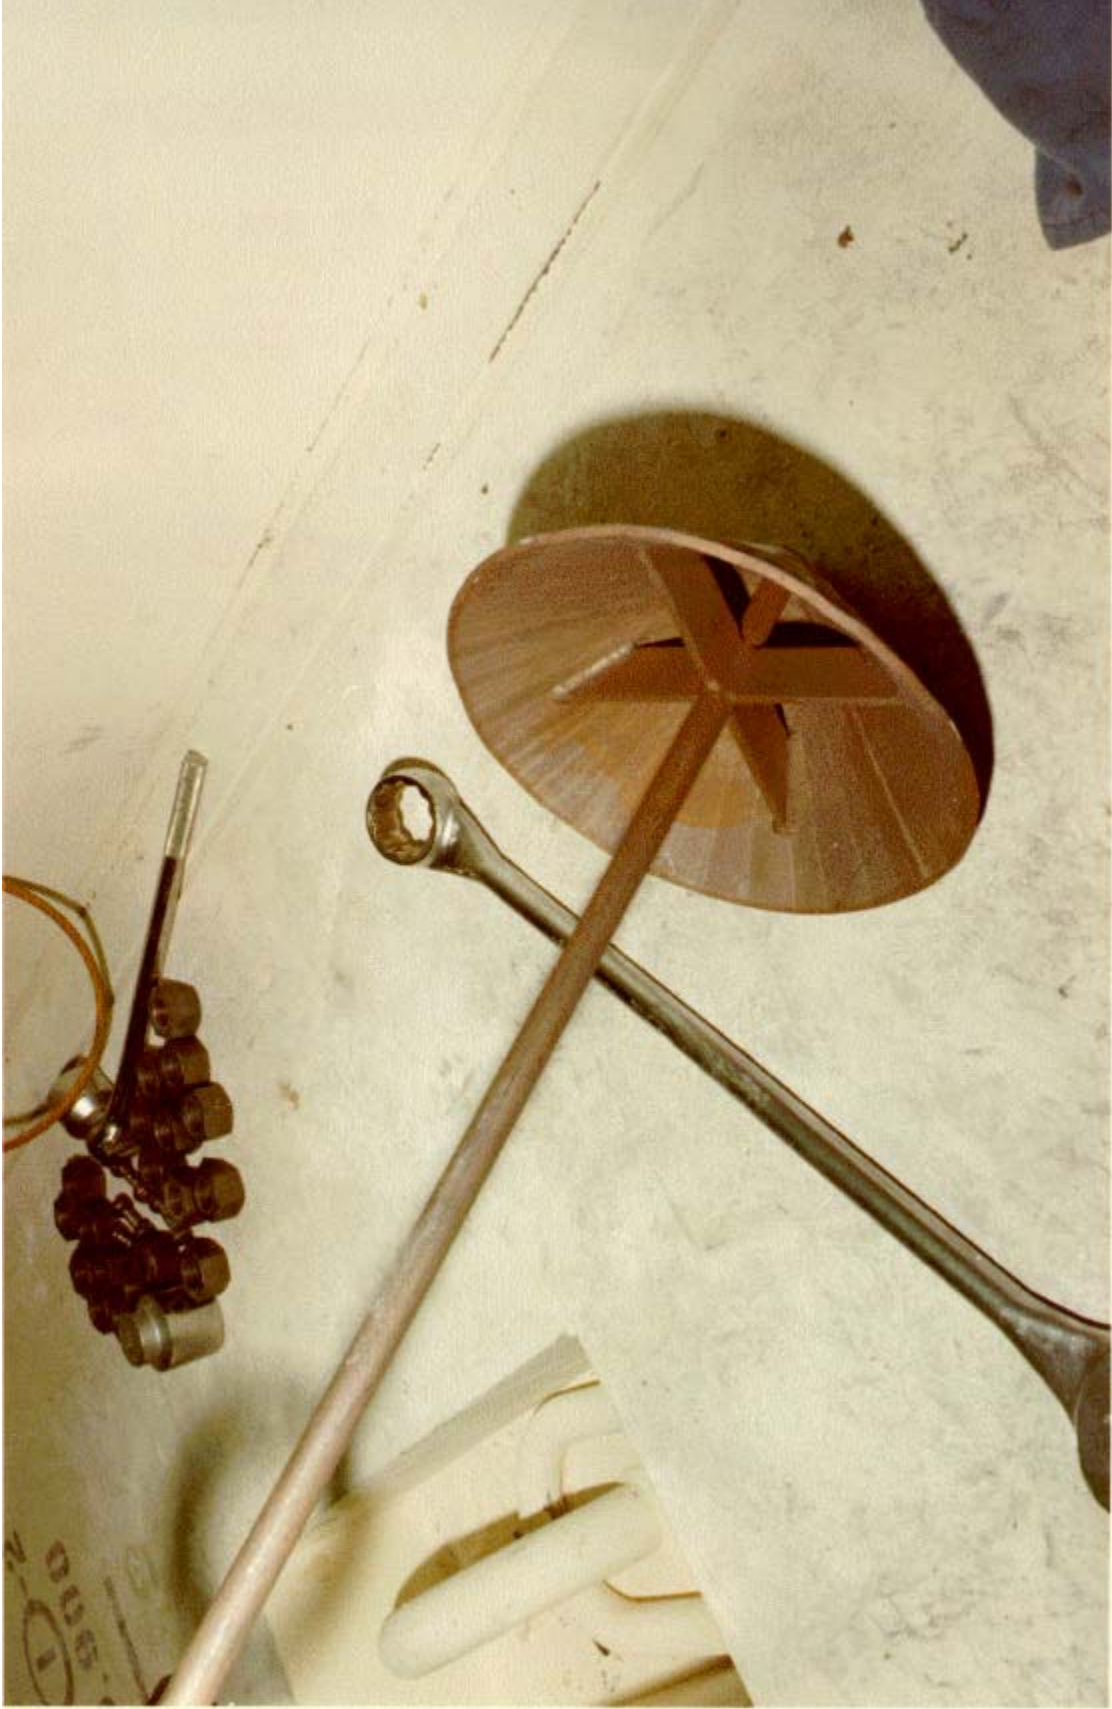
**Figure B-4.** View of the Calciner baffle plate inspection plug following decontamination. The plug is free of calcine. Compare with Figure A-5 for the pre-decontamination condition of plug when it was filled with calcine (82-246).
