# ***New Waste Calcining Facility Non-Radioactive Process Decontamination***

*September 2001*

*Idaho National Engineering and Environmental Laboratory  
Bechtel BWXT Idaho, LLC*

## ABSTRACT

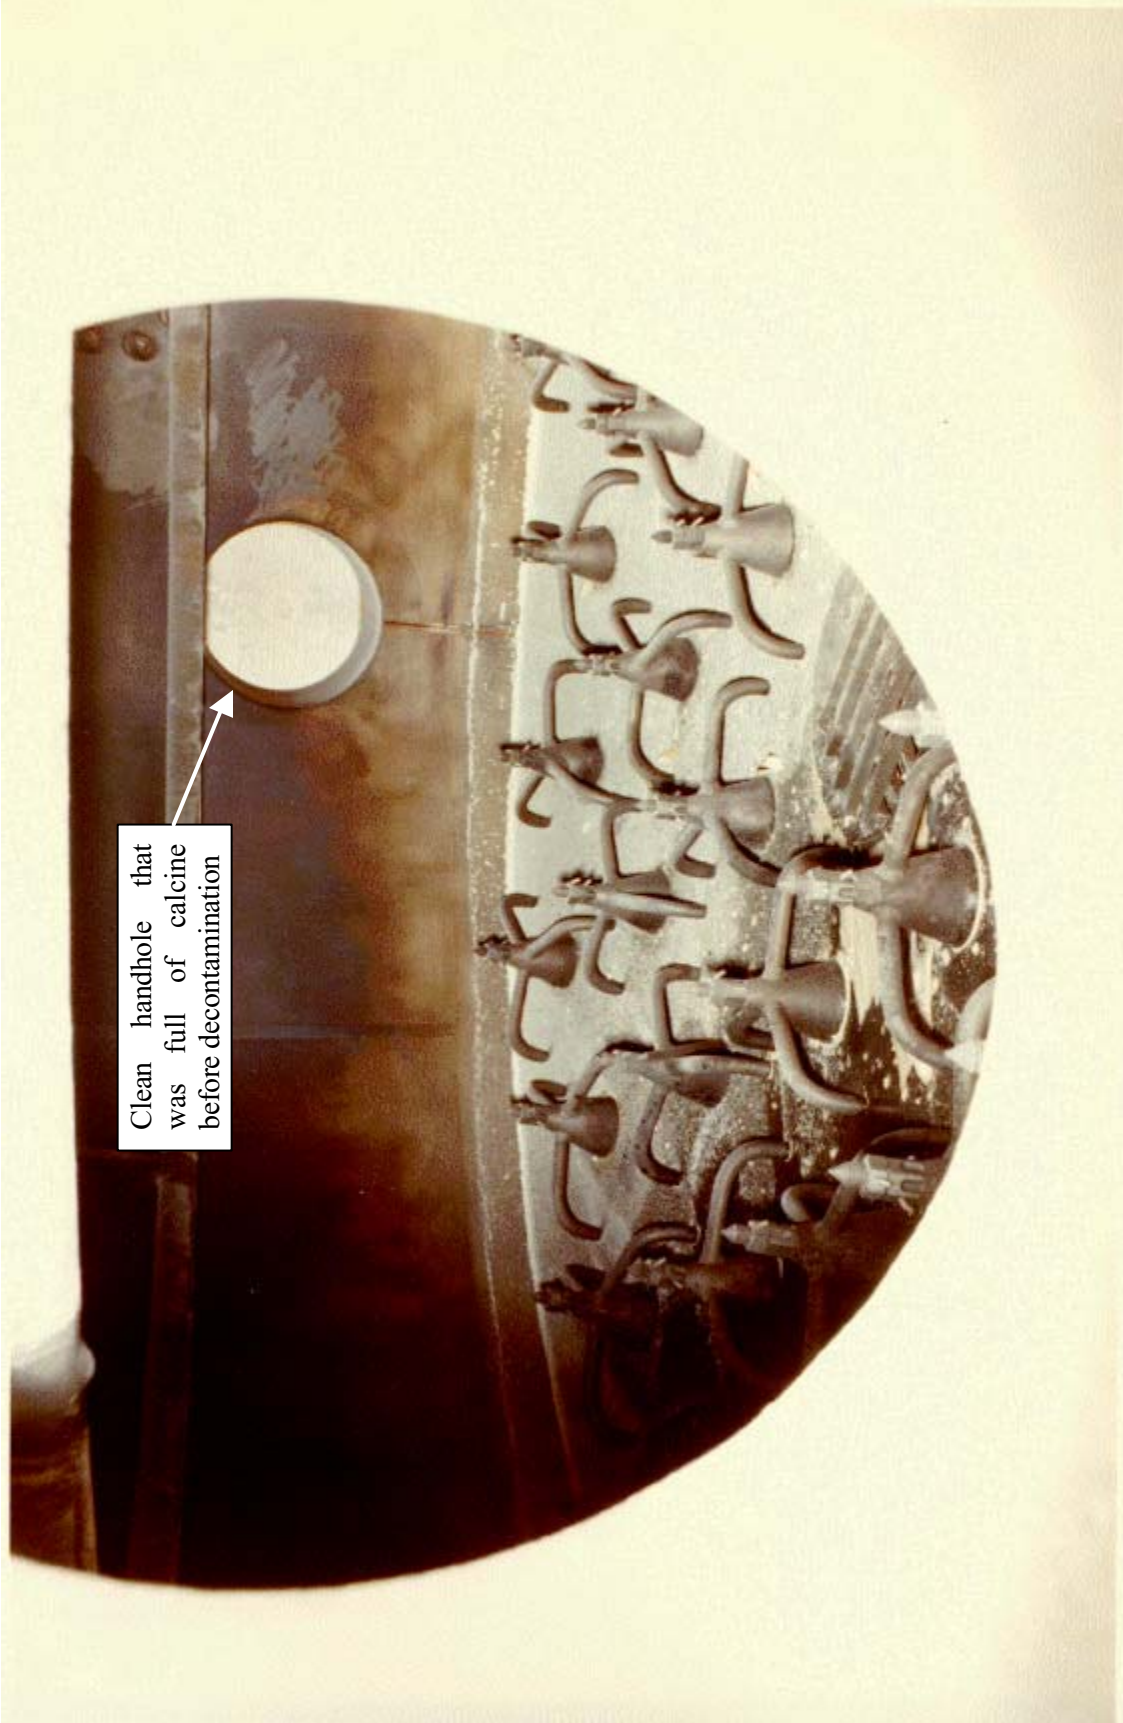
**Figure B-5.** View of the Calciner fluidizing air distributor grid after decontamination. The bulk of the calcine that was present prior to decontamination is gone (compare with Figures A-7 and A-8 for the pre-decontamination view). The distributor is clean with bare metal showing in some areas. A very thin layer (less than 1/8 inch) of calcine residue and a few small chunks remain in other areas (82-263).

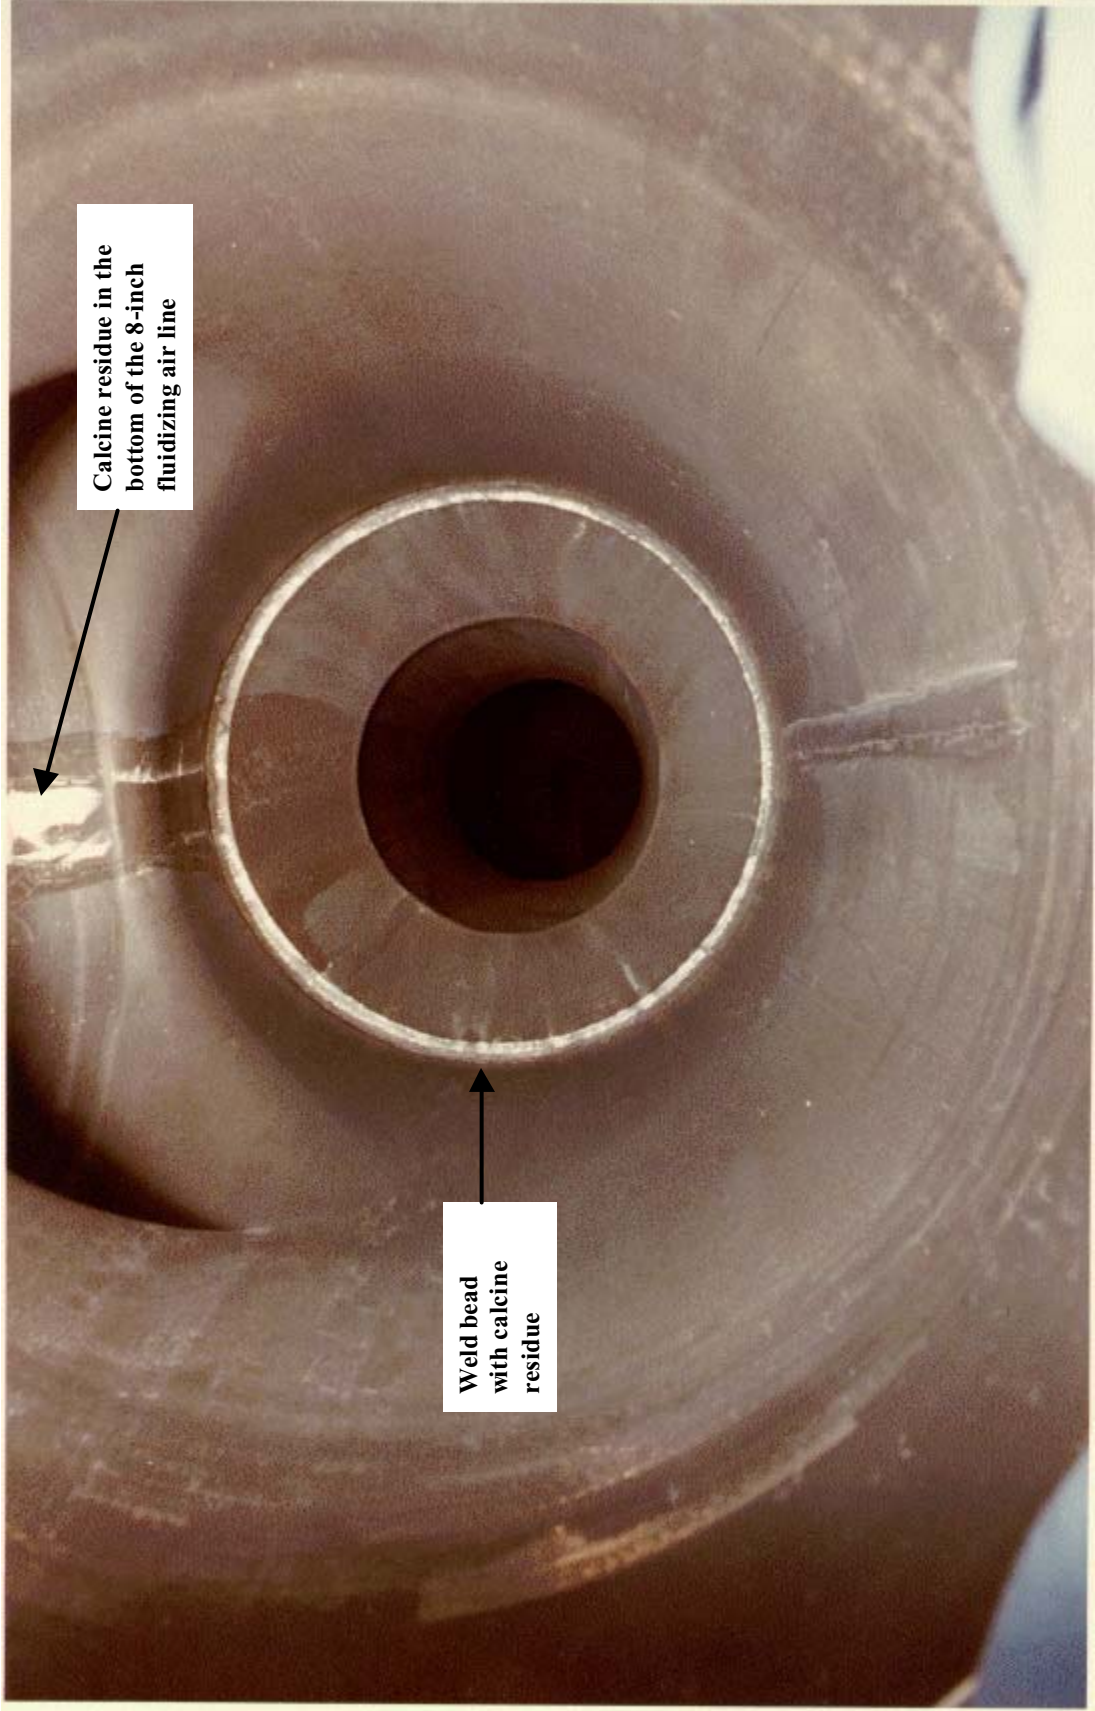
**Figure B-6.** View of the fluidizing air distribution plenum following the decontamination. Most of the calcine that was in the plenum prior to decontamination is gone. There is some calcine residue in the bottom of the fluidizing air line, and a very small amount on a weld bead in the bottom of the plenum. Compare with Figure A -10 for condition of plenum prior to decontamination. Additional decontamination nozzles were added to the fluidizing air line to eliminate the residue shown in this picture (82-267).
