# Clean-in-Place and Reliability Testing of a Commercial 12.5 cm Annular Centrifugal Contactor at the INL

**Global 2007**

**September 2007**

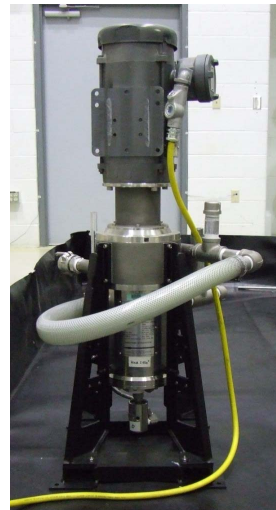
Figure 2. A photo of the CINC V-05 during reliability testing.

Reliability monitoring of an additional 12.5 cm contactor was initiated in April, 2006. This unit operates at 1750 rpm on a continuous basis. It was filled with approximately 4 liters of tap water and the heavy phase discharge hose was connected to one of the housing inlets. Therefore, the contactor is pumping at a full rate of about 20 liters per minute under recirculation. A manometer was installed to monitor the liquid level in the mixing annulus and more water is added as needed to maintain level. During operation, vibration measurements are obtained using a Balmac™ (model 205) hand-held vibration meter. Measurements were obtained from startup and taken daily for one week. Once daily measurements were completed, measurements were then taken weekly. Four locations on the CINC V-05 were chosen to

measure vibration and were appropriately labeled A, B, C and D. Location A is located at the bottom of the motor housing near the motor/contactor coupler housing. Locations B and C are situated at the top and bottom bearing flanges. Location D is located directly on the CIP rotary coupling.

In addition to vibration measurements, temperature readings are also taken. Temperature was measured using a Fluke thermometer (model 52) utilizing a Type-K thermocouple. Locations for temperature readings are nearly identical to those of vibration. However, location C is situated on the contactor housing above the lower bearing flange. Locations A, B and D are identical.

Amperage draw values are also obtained from the frequency drive controller (Allen Bradley Powerflex 4). Following power interruptions, the unit is restarted as soon as discovered and outages logged. A photo of the CINC V-05 during reliability testing is shown in Figure 2.

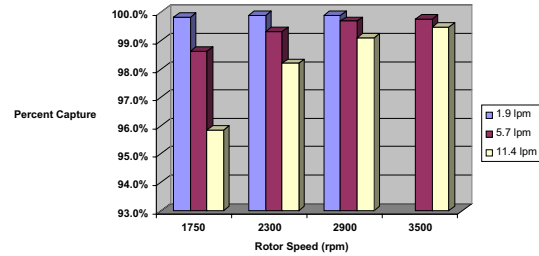
Figure 3. Percent capture as a function of flowrate and rotor speed.

Table 2 provides the percent capture data for the capture evaluation. Figure 2 displays the percent capture as a function of rpm and flowrate. As was expected, data indicate that capture efficiencies increase as rotor speeds increase. This observation is most prevalent in

the series at the 11.4 lpm flowrate. For example, the percent capture at 1750 rpm was 95.9%, but at 2900 rpm the percent capture increased to 98.2%. The percent capture at 2900 and 3500 rpm were 99.1 and 99.4%, respectively.

The data also indicates that as flowrates increase at constant rpm, the percent capture decreases. This is due to the higher residence time associated with lower flowrates. The 1750 rpm series displays the greatest decrease in capture with increasing flowrate followed by the 2300, 2900 and 3500 rpm series. These data demonstrate that percent capture is impacted by both flowrate and rotor speed.

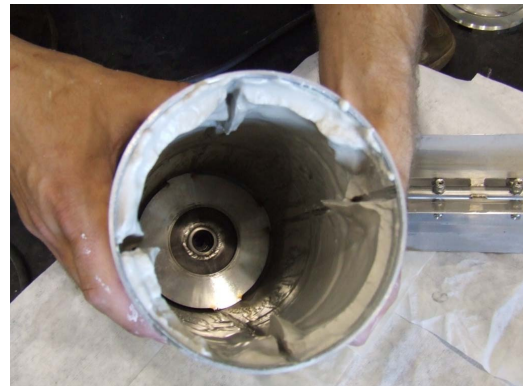
Fig. 4. Solids capture, inside rotor.

Figures 4 through 7 pictorially display the presence and location of solids accumulation within the contactor assembly following loading of 109 L of a 0.1 wt % diatomaceous earth solution. Figure 4 displays a thick cake of diatomaceous earth within the rotor. It should be noted that an evenly distributed cake was most likely present during operation, but during rotor holdup draining, the solids sloughed to the bottom of the rotor assembly. Figure 5 displays solids present in the upper weir assembly. Though difficult to see, minimal solids were present in the upper weir package indicating a sufficient cake had formed allowing solids to pass over the upper weir and exiting the contactor with the effluent. When referring to figure 6, solids can be observed in the bottom of the vane package (top center of photo). Figure 7 displays solids present in the bottom mixing plate.

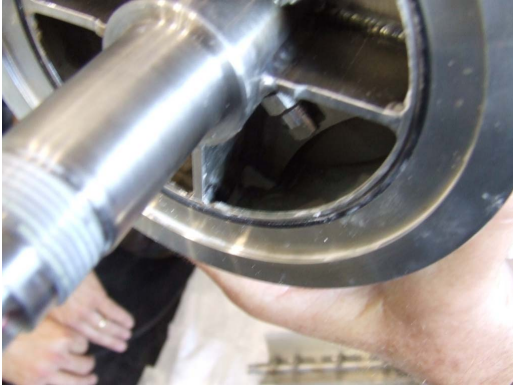
Fig. 5. Solids capture, upper weir.

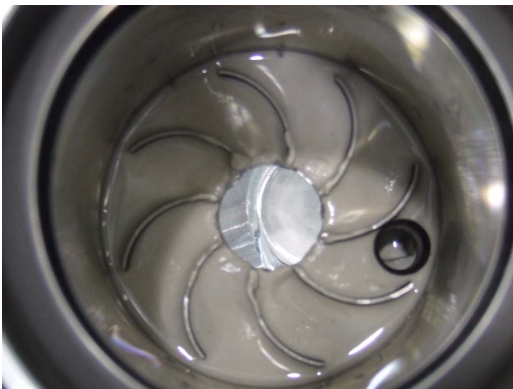
Fig. 7. Solids capture, mixing plate.

CIP processes performed at 40 psig (25.4 lpm) for three 15 or three 10 second cycles were very effective at the removal of solids from internal contactor surfaces. In addition, previous experience has shown some solids holdup within the torturous path of the bottom housing mixing plate. Additional drains could be added to alleviate this potential problem and should be considered in future modifications.

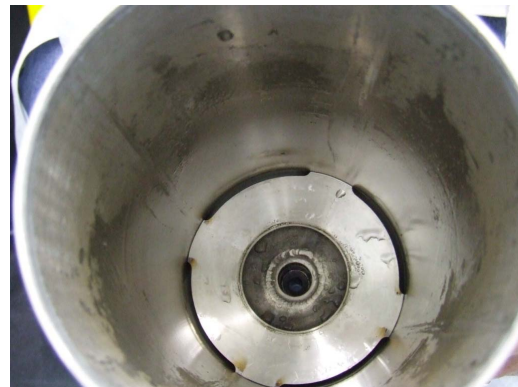
Fig. 8. Following CIP, inside rotor.

Figures 8 through 11 pictorially summarize the complete removal of solids within the contactor assembly following the ten second CIP clean out test. Figures 8 and 10 display the absence of solids within the rotor and vane packages. In addition, no solids were present in the upper weir or bottom mixing plate as shown in figures 9 and 11. Pictures of contactor parts following the second CIP process performed for 15 seconds are not shown. However, comparable results were obtained.

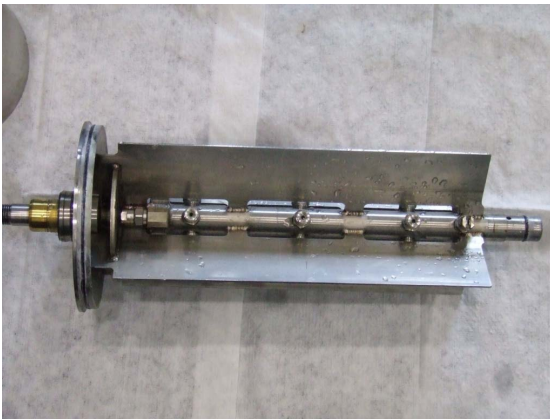
Fig. 10. Following CIP, complete vane package.

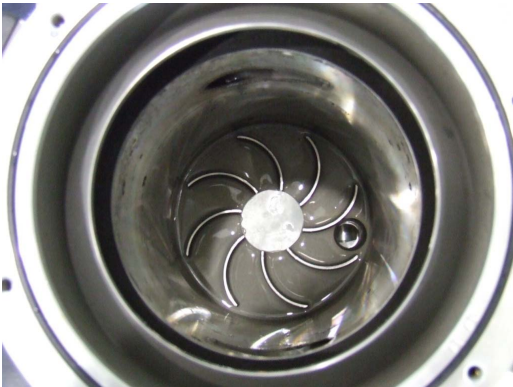
Fig. 11. Following CIP, mixing plate.
