# Developing and Evaluating Candidate Materials for Generation IV Supercritical Water Reactors

Final Technical Report  
INERI 2003-008-K

March 2006

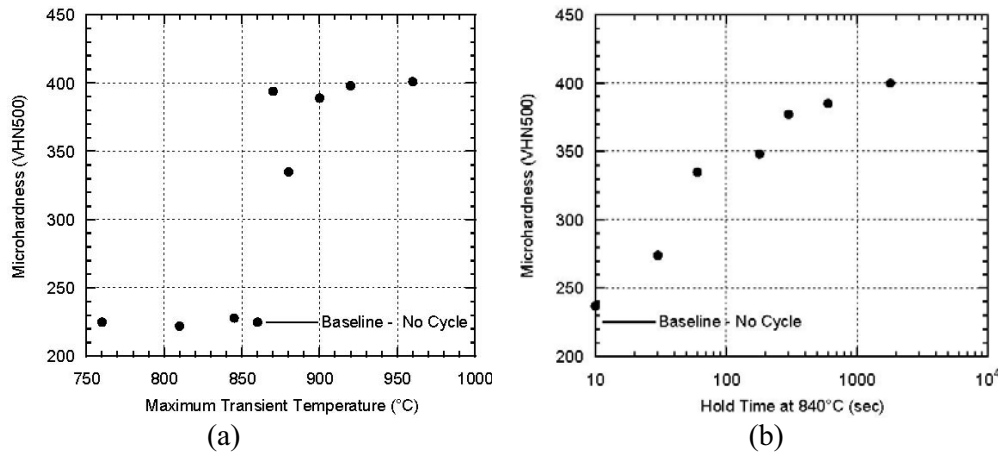
Figure 9 Variation of Grade 91 (heat 2) post-transient microhardness with (a) maximum transient temperature without hold, (b) hold time at 840 °C maximum transient temperature.

The effects of varied maximum transient temperature and hold time at 840°C transient temperature on the microhardness of Grade 91 steel are shown in Figure 9a and Figure 9b,

respectively. Also indicated are the pre-cycling baseline hardness values. No change in microhardness was observed for maximum cycle temperatures of 860°C and below; for transient temperatures above 860°C the microhardness dramatically increased to a plateau level of 400 VHN<sub>500</sub>. Hold periods at 840°C greater than 10 s resulted in microhardness that increased with hold duration; a maximum microhardness of 400 VHN<sub>500</sub> was observed after 1800 s holding at 840°C. Etched optical microstructures observed after cycling reflected the microhardness changes; significant fractions of untempered martensite were observed for maximum transient temperatures of 870°C and above and 840 °C hold periods greater than 10 s. Typical baseline and cycled structures are shown in Figure 10; lightly etched areas in the cycled microstructures are untempered martensite.

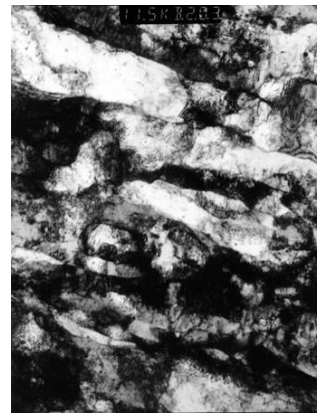
Figure 14 TEM micrograph of (a) MA956 rod and (b) PM2000 plate.

From TEM micrographs shown in Figure 14, the size distributions of oxide particles in MA956 and PM2000 are analyzed as shown in Figure 15. The size distributions of the two different alloys are very similar and average dispersoid size is measured 20nm. Recrystallized MA956 rod shows very low dislocation density within the grains. But, in case

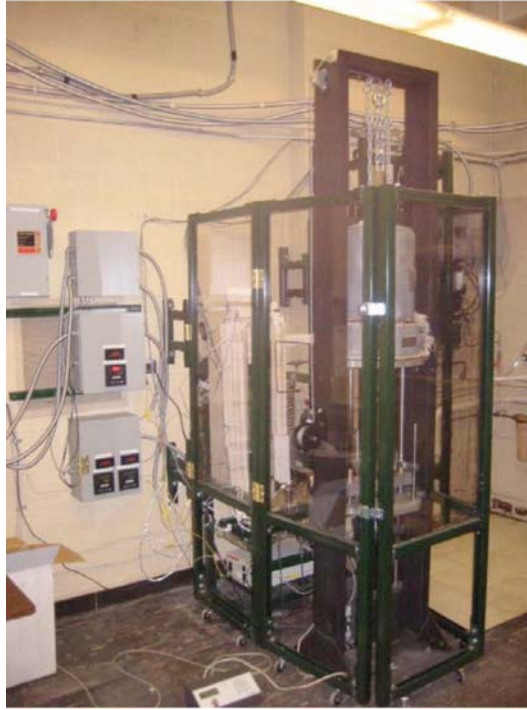
Figure 47 Photograph of the multi-sample SCW-SCC facility in HTCL.

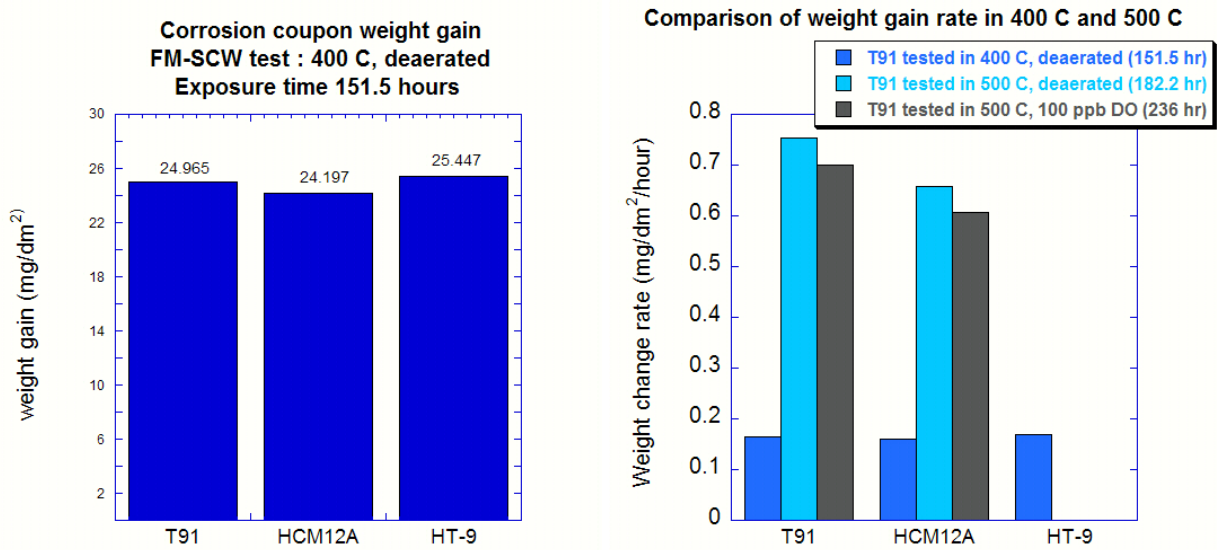
Figure 59 Comparison of weight gain of F-M alloys in supercritical water (a) 3 alloys in deaerated 400°C supercritical water (b) T91 as a function of temperature and oxygen concentration.

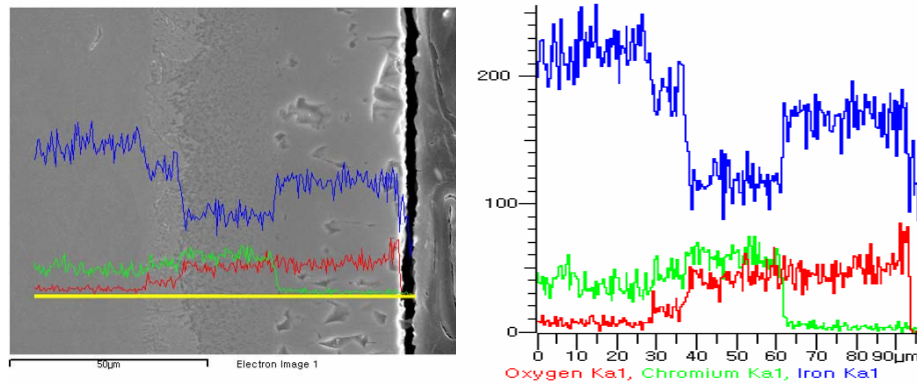
Figure 80 Line profiles of Fe, Cr, and O across the oxide layers on T91 specimen.

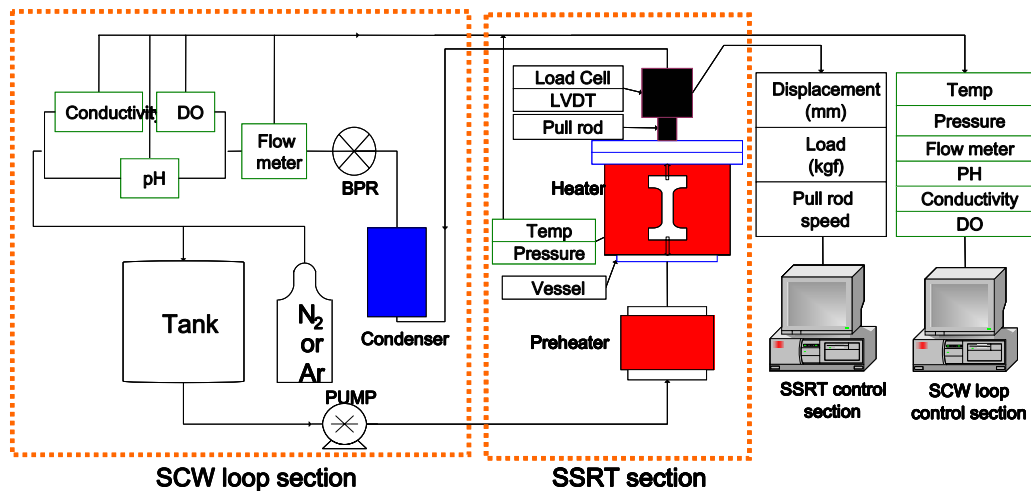
Figure 89 Schematic Diagram of SSRT Facility.

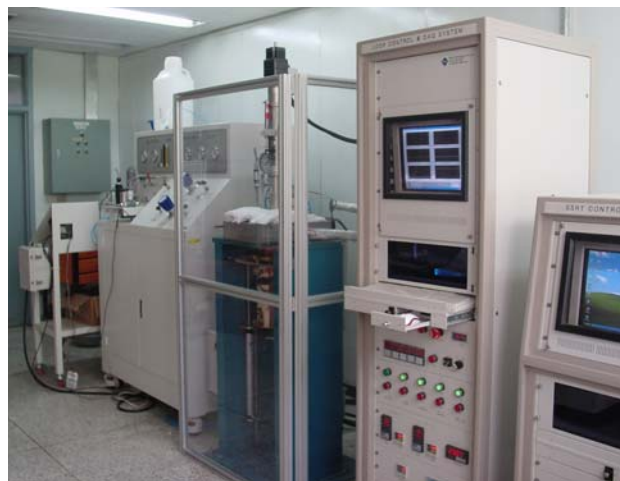
Figure 90 SCW SCC Test Loop at KAERI (1).

One set of SCW SCC test facility was fabricated and installed at KAERI. The SCC test vessel was fabricated from Hastelloy C-276 alloy, and the design temperature and pressure are 650°C and 35 MPa respectively and the maximum flow rate is 70 cc/min. Figure 89 illustrates the schematic diagram of the facility that is composed of four parts; SCW loop, SCC test unit, control and data acquisition unit of SCW loop, and control and data acquisition unit of SCC test. Figure 90 contains photographs of the installed SCW SCC test facility under operation. One SSRT (slow strain rate test) specimen and sixteen U-bend specimens can be simultaneously tested in an experiment. Figure 91 shows an example of T91 steel specimen of which the SSRT test at 600°C was accidentally interrupted after 200 hr. Any evidence of SCC (e.g cracks on the specimen side surface) at the test condition of strain rate:  $3 \times 10^{-7}$ /sec and D.O <5 ppb was not observed.

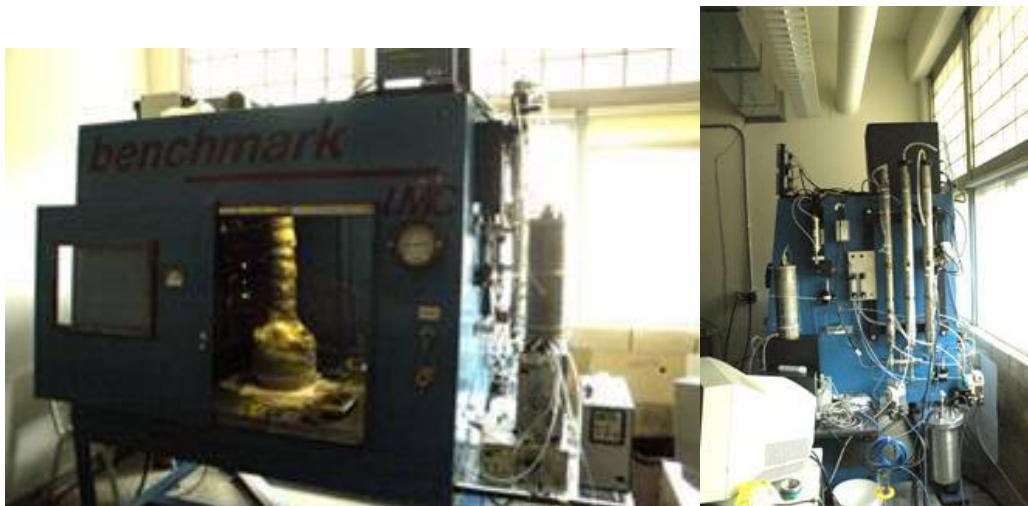
Figure 100 Supercritical water corrosion cell at the University of Wisconsin, used for the 600oC SCW corrosion tests.

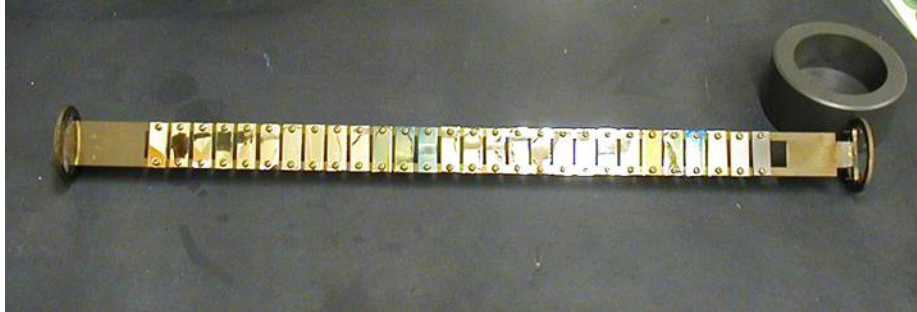
Figure 101 Inconel 625 holder used for fixturing the samples in the SCW corrosion cell. The test samples were 1.25" in length, 0.5" in width, and about 0.02" in thickness.

Supercritical water testing was performed in two facilities at the University of Wisconsin. During the first phase (500°C tests) of this INERI project, tests were performed in the SCW corrosion loop with a supercritical water maximum velocity of about 1m/s. Since this facility was also used for thermal hydraulics and heat transfer research, a separate SCW corrosion test cell dedicated to materials and corrosion research was built. The second phase of testing (600°C tests) was performed in this corrosion cell. Both systems are equipped for continuous on-line monitoring of temperature, pressure, conductivity, and oxygen content during the supercritical water tests. Figure 100 shows a photograph of the SCW corrosion test facility used for the second phase of this project. Figure 101 shows the fixturing of the samples in the Inconel 625 holder with the test steel samples.

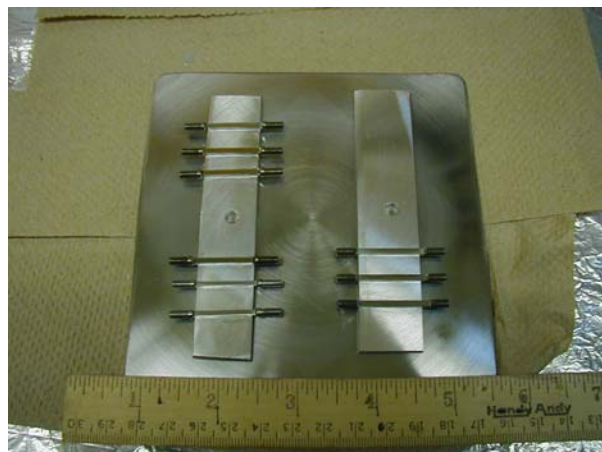
Figure 128 SCC samples of the three steels, HT9, HCM12A and T91 steels just after removing from the plasma immersion ion implantation chamber after oxygen ion implantation.

near surface regions of the steels, (ii) compressive stresses at the surface that may delay crack initiation, and (iii) the ballistics of the ion implantation process may alter the microstructure at the surface through homogenization effects. Figure 128 shows the SCC samples of the three steels just after removing from the plasma immersion ion implantation chamber after oxygen ion implantation. Oxygen ion implantation was performed at an energy of 40kV to a dose of  $3 \times 10^{17}$  ions/cm<sup>2</sup>.
