DOE/SNF/REP-082
Rev. 0

National Spent Nuclear Fuel Program

Fuel Canister Stress Corrosion Cracking Susceptibility Experimental Results

**Idaho National Engineering and Environmental Laboratory
Idaho Falls, Idaho 83415**

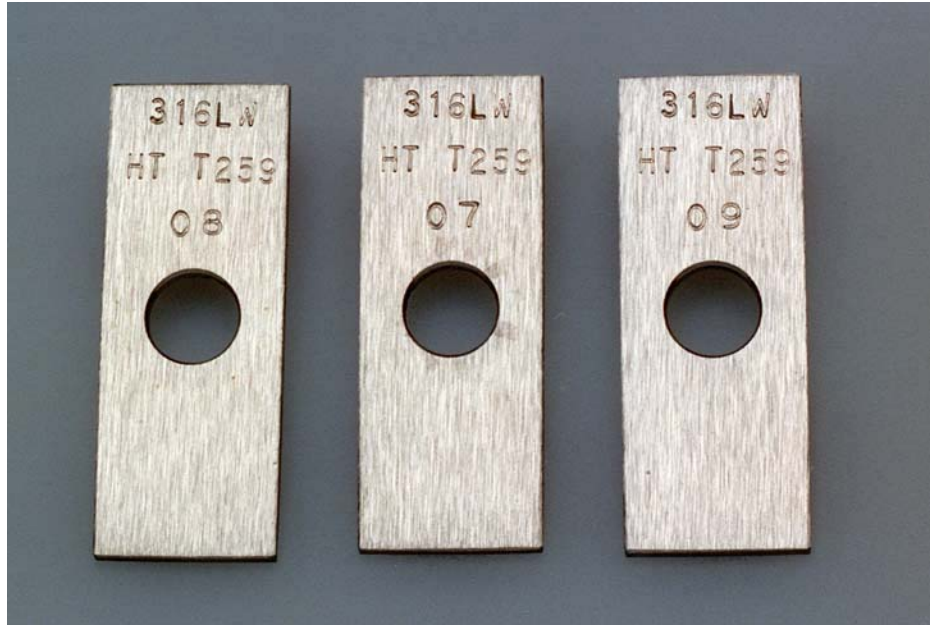
Figure 1. Type 316LW tested in deionized water at 90°C.

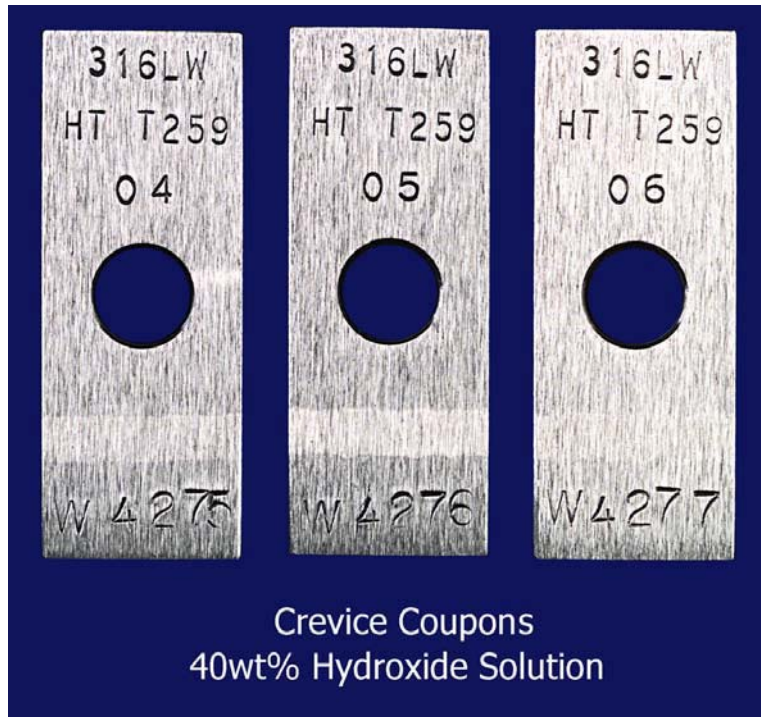
Figure 3. Type 316LW tested in 40-wt% hydroxide solution with halides at 90°C.

Coupons tested in the 40-wt% hydroxide solutions (Figures 3 and 4) are darker than the ones tested in the 20-wt% hydroxide solution (Figure 2). Different photography techniques have made this color contrast less apparent in the pictures. Coupons from the 20-wt% hydroxide solution and 40-wt% hydroxide solution without halides show a tinted “footprint” where the crevice washer had been, but very little localized corrosion has occurred. Interferometry techniques detected no discernible depth to the crevice area. The surface roughness of the corrosion site appeared to be the same magnitude as the rest of the coupon. The welds are etched in all the hydroxide solutions tested. Neither the etched welds nor the minor accelerated crevice corrosion are severe enough to indicate an early failure mechanism.

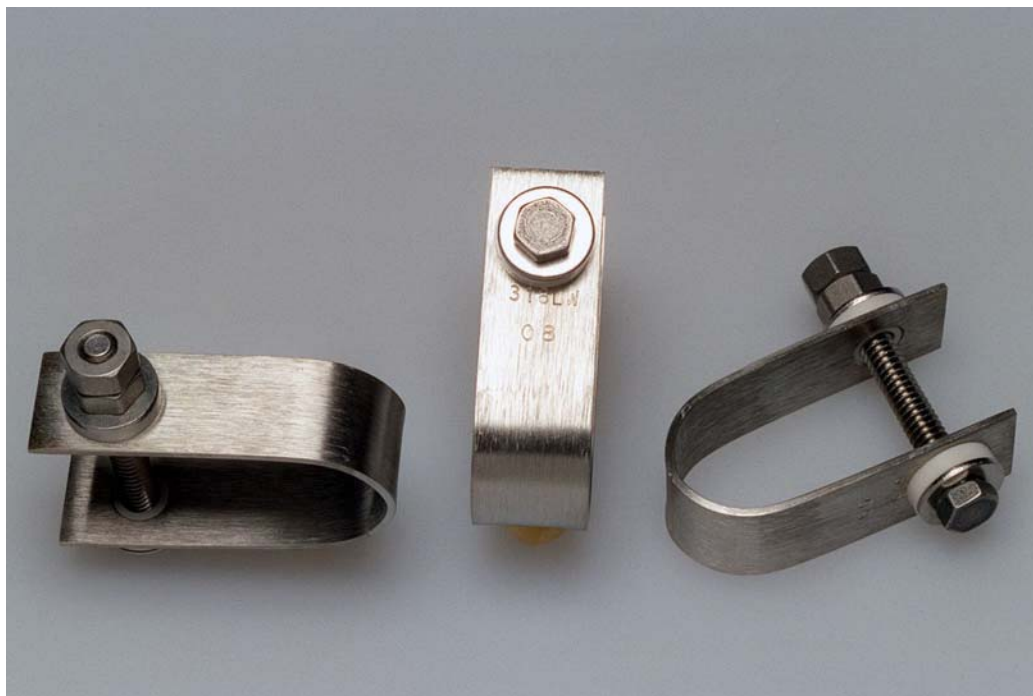
Figure 5. Type 316LW tested in deionized water at 90°C.

Type 316LW U-bend tests in the deionized water were immersed for 6 months at 90°C. None of the three test coupons have shown any clear indication of cracking. A very small weight loss trend indicated a small level of general corrosion was occurring, and this correlates to the results of the crevice tests. The coupons did not darken, but some small rusty spots were visible randomly across the surface. Figure 5 shows the post-test appearance of the coupons.

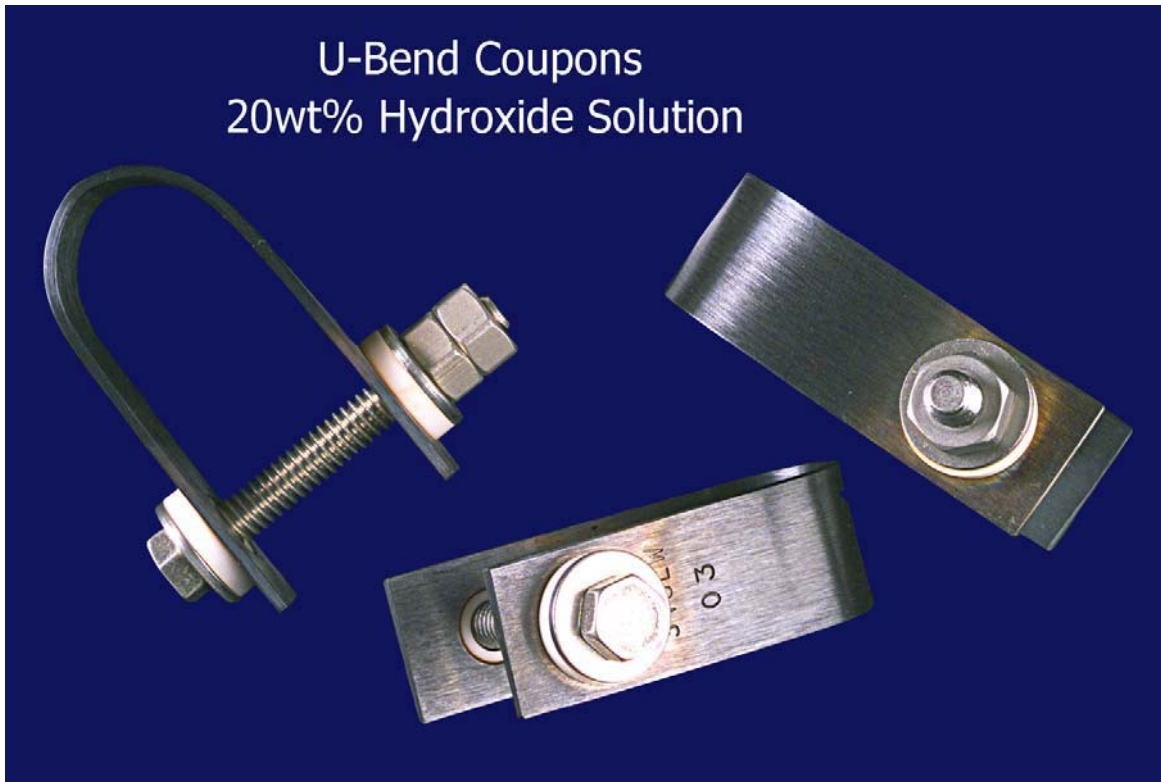
Figure 6. Type 316LW tested in 20-wt% hydroxide solution at 90°C.

None of the 316LW U-bend test coupons had any clear indications of cracking after 6 months exposure to the three hydroxide solutions. Microscopic examination of coupon numbers 2, 5, and 6 during the first week showed an opening that appeared to be deformation damage. No changes were seen throughout the test period, and they were assumed to have occurred during the bending of the coupon. Although the primary analysis method with U-bend tests is visual, some weight measurements were made before and after exposure. Small weight losses (less than 0.1 g) indicate some general corrosion was occurring, which correlates to the results from the crevice tests. Figures 6 through 8 show the condition of the U-bend coupons in 20% and 40% cesium/rubidium/hydroxide with iodine and bromine. The hydroxide solution turned the coupons dark brown as seen in Figures 6 and 8. The general corrosion appears worse in the area exposed to the vapor. Figure 7 details this area showing the discoloration.

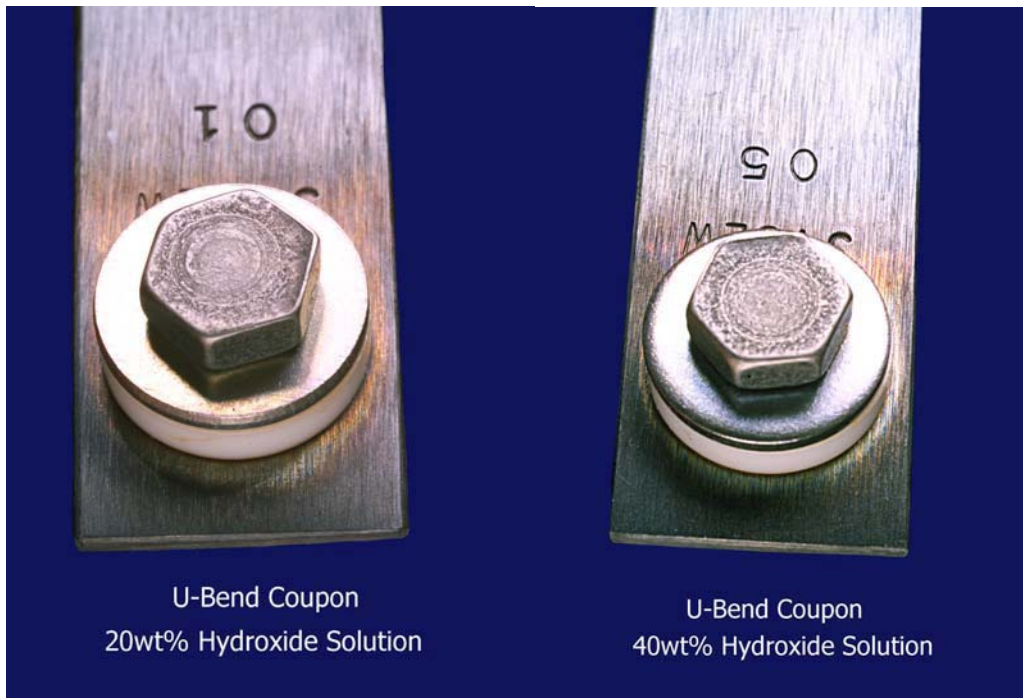
Figure 7. Type 316LW U-bend coupons showing liquid/vapor interface area.

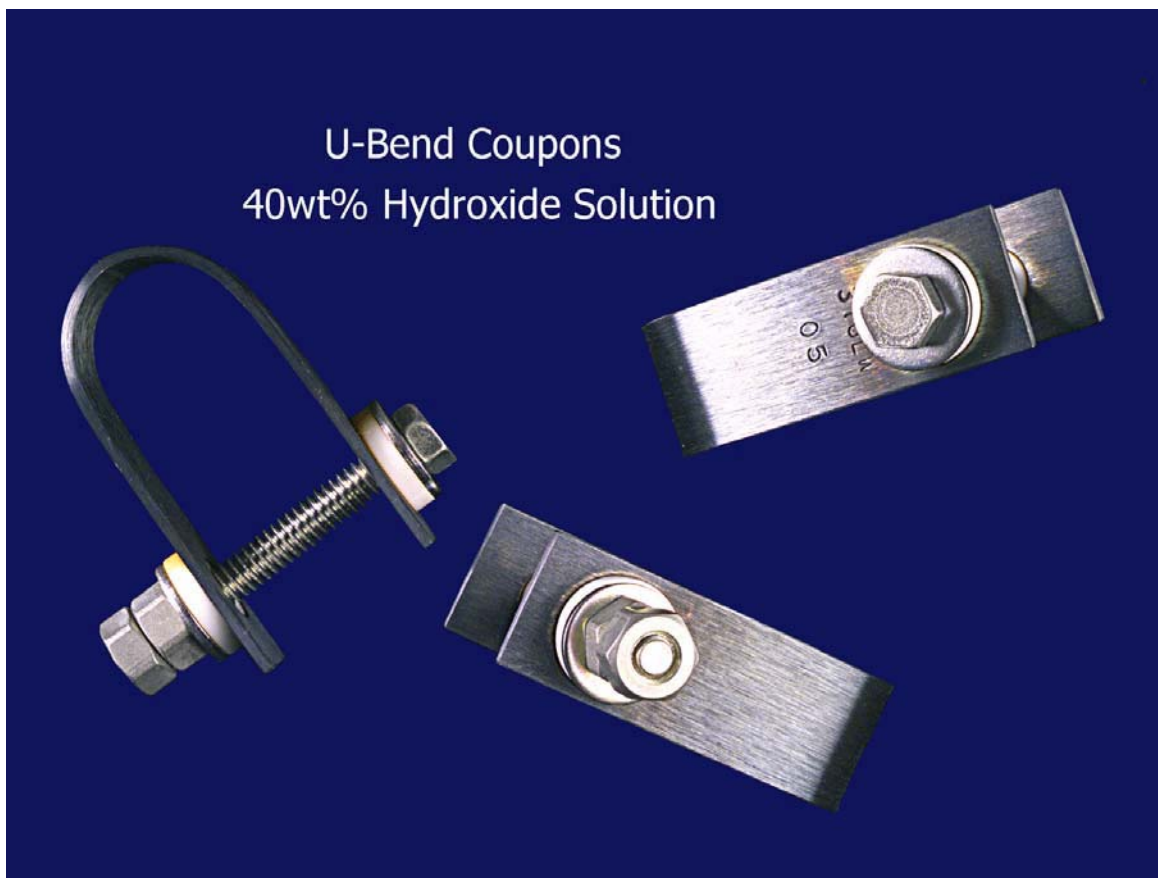
Figure 8. Type 316LW tested in 40-wt% hydroxide solution with halides at 90°C.

Results from the 316LW U-bend tests in the 40-wt% hydroxide solution with halides was similar. After 6 months of exposure, no cracking was identified on the three coupons. Microscopic examination of coupon numbers 5 and 6 revealed openings that also looked like deformation damage caused by the initial bending of the coupon. This damage did not change throughout the test period and is assumed to have occurred during the bending of the coupon. A small weight loss trend indicated a small level of general corrosion was occurring, which correlated to the results of the crevice tests. The solution has turned the coupons a dark brown overall as can be seen in Figure 8. The general corrosion was worse in the vapor space portion of the coupon as opposed to the immersed section in the same fashion as the coupons tested with the 20-wt% solution. Figure 7 also details the interface area of the coupon tested with the 40-wt% hydroxide solution.

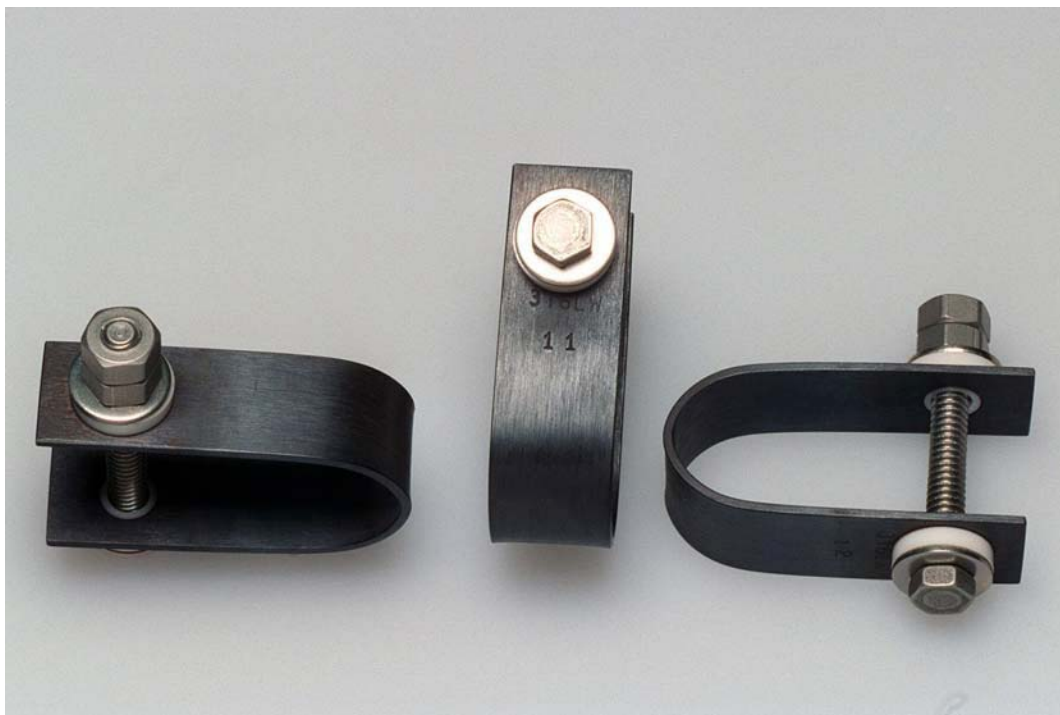
Figure 9. Type 316LW tested in 40-wt% hydroxide solution without halides at 90°C.

The 316LW U-bend tests in the 40-wt% hydroxide solution without halides were immersed for 5 months at 90°C, and no indications of cracking were identified. Discoloration was more pronounced without the iodine and bromine (see Figure 9). However, microscopic examination and weight loss measurements were similar to the tests with halides included in the test solution.

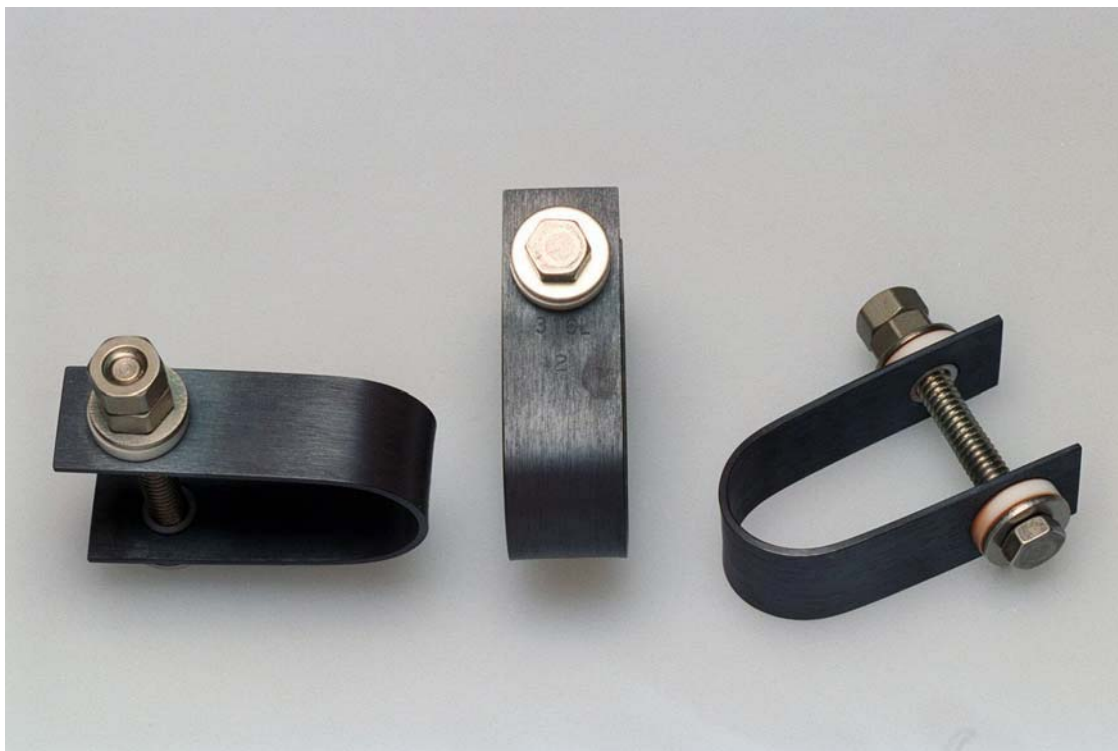
Figure 10. Type 316L (unwelded) tested in 40-wt% hydroxide solution with halides at 90°C.

Similar results were seen with 316L, unwelded coupons in 40-wt% hydroxide solution with halides at 90°C after 5.5 months; shown in Figure 10. General corrosion was worse in the vapor space portion of the coupon as opposed to the immersed section, as seen in the other U-bend tests. No difference was seen in the results compared to the welded coupons. Heat input from welding can cause a region around the weld that is more susceptible to localized and general corrosion than the bulk material. Weld areas were not preferentially attacked in the U-bend experiments, thus no increased susceptibility to cracking due to welding was indicated.

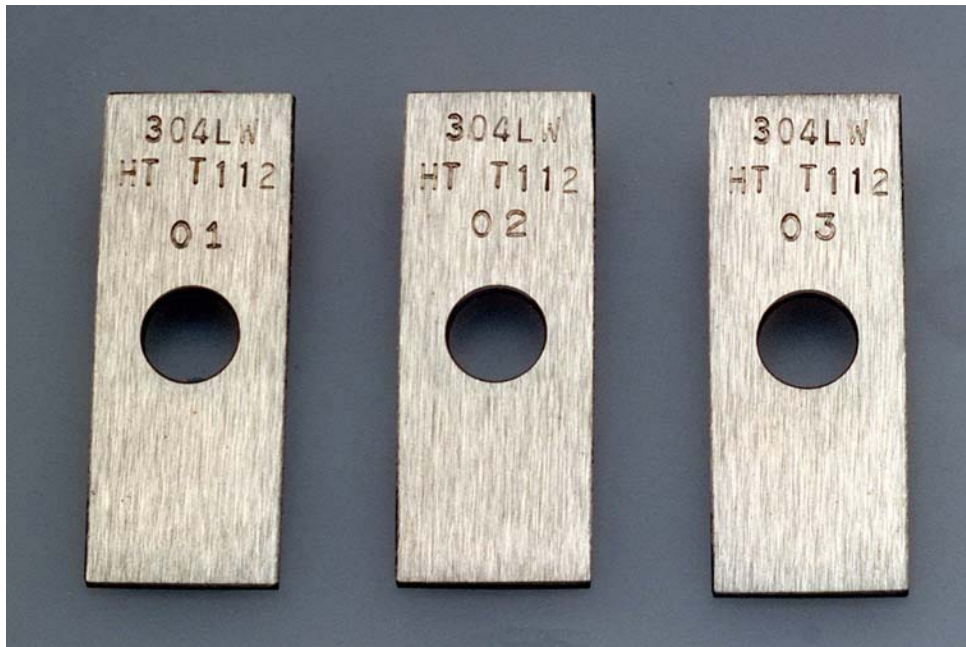
Figure 12. Type 304LW tested in deionized water at 90°C.

not reveal corrosion attack any worse than seen on the other samples. The final weight was repeated, and a review of weights and dimensions compared to the other coupons was performed. No indication of measurement errors was found. Thus, the higher corrosion rate was included in the average rate. No indications of pitting or cracking were seen in any of the tests. Minor crevice corrosion was seen on the coupons tested in both 40-wt% hydroxide solutions. White light interferometer measurements were taken from these corrosion sites, but the surface roughness did not differ from the other parts of the corrosion coupon. Figures 12 through 15 show the final condition of the coupons from all the test solutions. The color of the coupons tested in deionized water remained unchanged except for a few oxide (rust) spots.

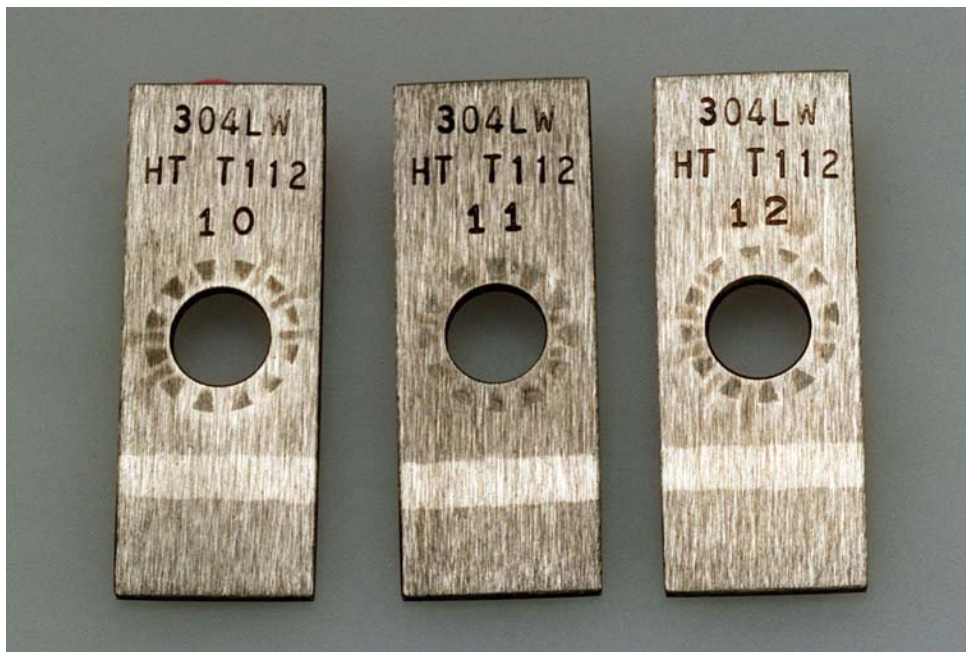
Figure 13. Type 304LW tested in 20-wt% hydroxide with halides at 90°C.

The coupons tested in the hydroxide solutions turned a brown color as a result of the chemical attack. The coupons tested in the 40-wt% solution with halides were darker than the ones tested in the 20-wt% hydroxide solution. The coupons tested in the 40-wt% hydroxide solution without halides were the darkest. As discussed in the Type 316L experimental results, the discoloration is only a few angstroms thick. All coupons from the hydroxide solutions showed a tinted footprint where the crevice washer had been placed, but only minor localized corrosion has occurred on the coupons tested in the 40-wt% hydroxide solutions. All the coupons tested in the hydroxide solutions had the welds etched.

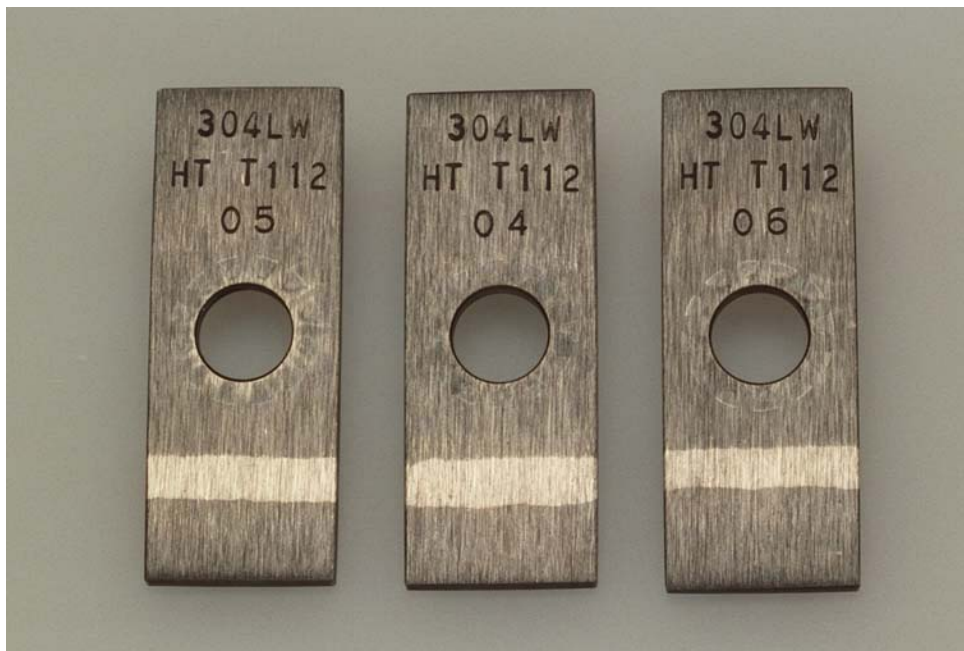
Figure 14. Type 304LW tested in 40-wt% hydroxide solution with halides at 90°C.

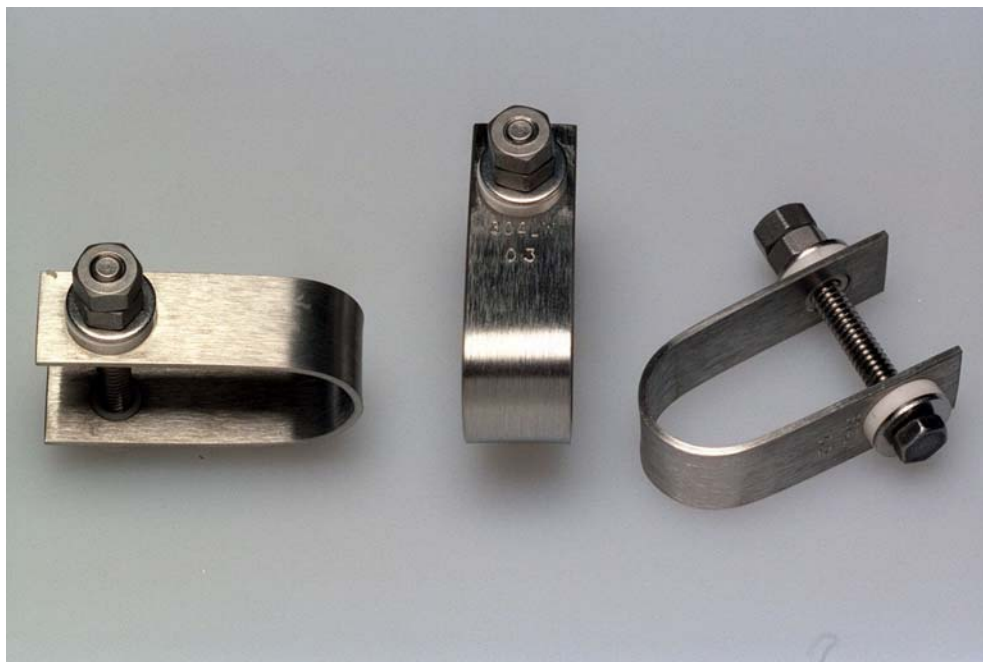
Figure 16. Type 304LW tested in deionized water at 90°C.

None of the three 304LW U-bend test coupons showed any clear indication of cracking after 6 months in deionized water at 90°C. Weight losses of the U-bend coupons were measured as a general indication of corrosion. A very small weight loss trend (<0.1 g) indicated a small level of general corrosion was occurring, and this correlates to the results of the crevice tests. The coupons did not darken, but some small oxide (rust) spots were visible. Figure 16 shows the post-test appearance of the coupons.

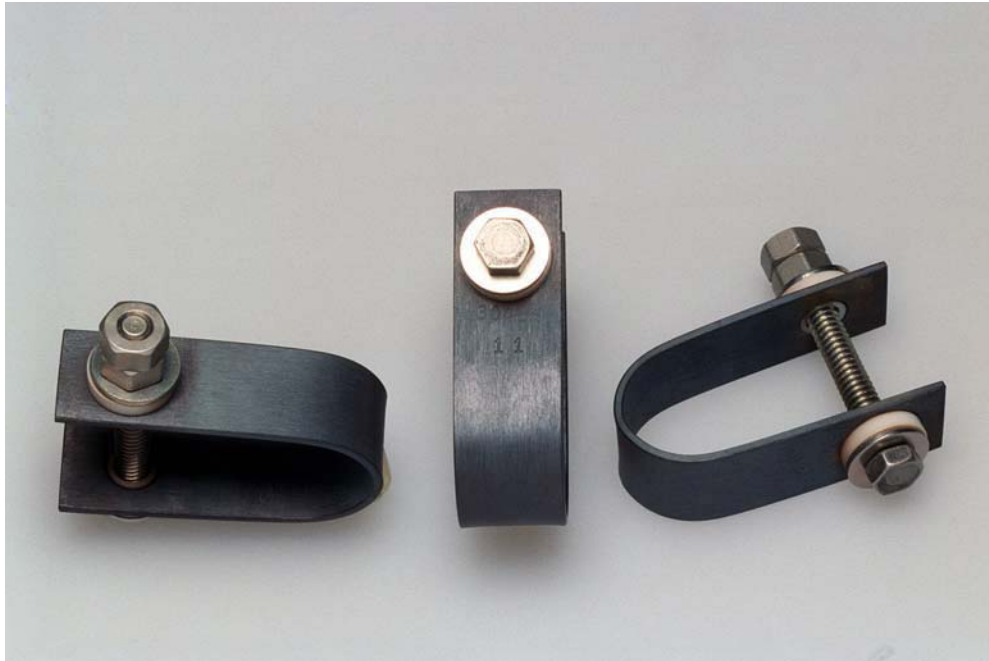
Figure 17. Type 304LW tested in 20-wt% hydroxide solution at 90°C.

The 304LW U-bend tests in the 20-wt% and 40-wt% hydroxide solutions with halides were immersed for 5 months at 90°C. A small weight loss trend indicated a small level of general corrosion was occurring, but did differ from the losses seen in deionized water. The corrosion appears more prevalent in the vapor space areas as was seen on the other U-bend coupons. Microscopic examination of the triplicate coupons revealed no localized corrosion, such as cracking, was occurring. Figure 17 shows the post-test appearance of the coupons exposed to 20-wt% hydroxide solution. Figure 18 shows the coupons from the 40-wt% hydroxide tests.

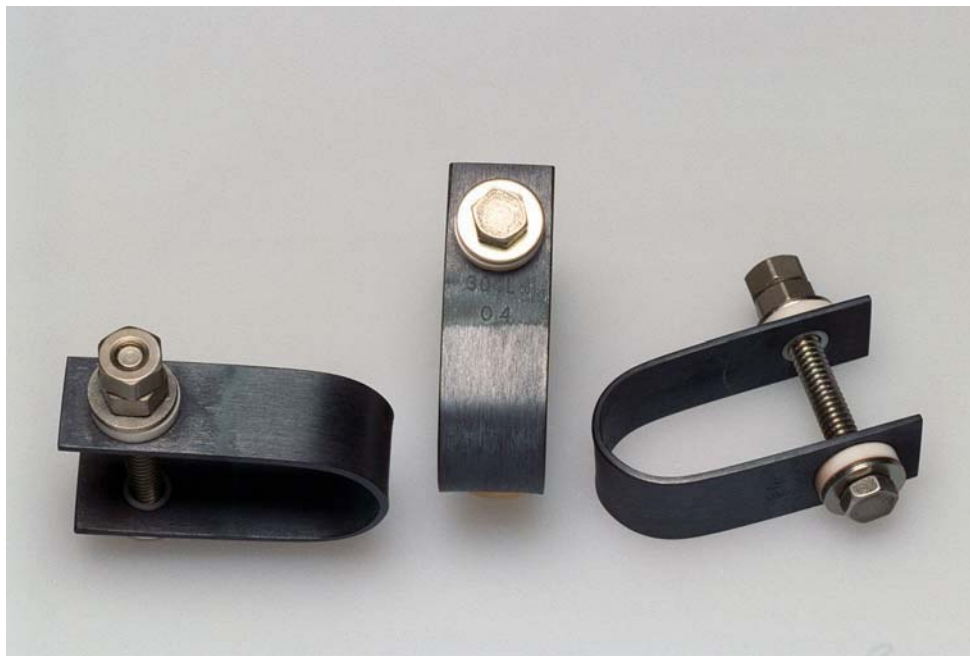
Figure 18. Type 304LW tested in 40-wt% hydroxide solution with halides at 90°C.

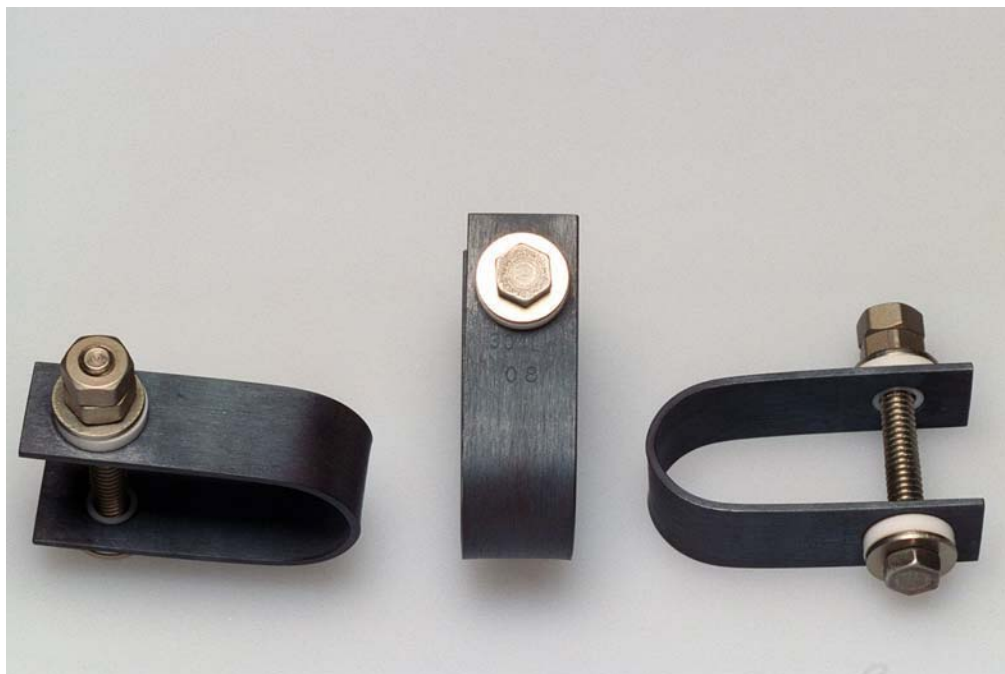
Figure 19. Type 304LW tested in 40-wt% hydroxide solution without halides at 90°C.

Additional experiments were completed to evaluate the effects of halides in the test solution and to assess any increased susceptibility to cracking from the welding operation. Three 304LW U-bend coupons were exposed to 40-wt% hydroxide solution without halides at 90°C for 5 months. Results were very similar to the tests with halides in solution, small weight losses and no visible indications of localized attack such as cracking. Vapor space attack appears to be slightly worse than the areas exposed to solution. Figure 19 is a photograph of the coupons after exposure. Unwelded Type 304L coupons also showed no differences in degradation after 5.5 months in the 40-wt% hydroxide solution with halides at 90°C. Microscopic examination and weight loss measurements were essentially identical between the welded and unwelded coupons. Final conditions are shown in Figure 20.

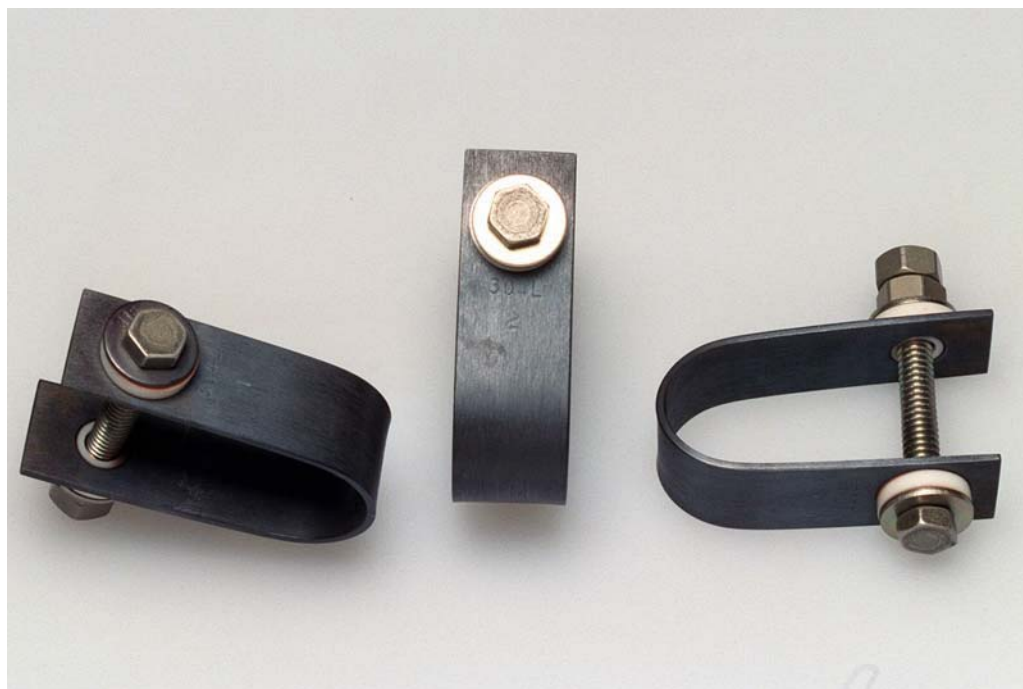
Figure 20. Type 304L (unwelded) tested in 40-wt% hydroxide solution with halides at 90°C.
