INEEL/EXT-02-01548

Structural Integrity Program for the Calcined Solids Storage Facilities at the Idaho Nuclear Technology and Engineering Center

May 2003

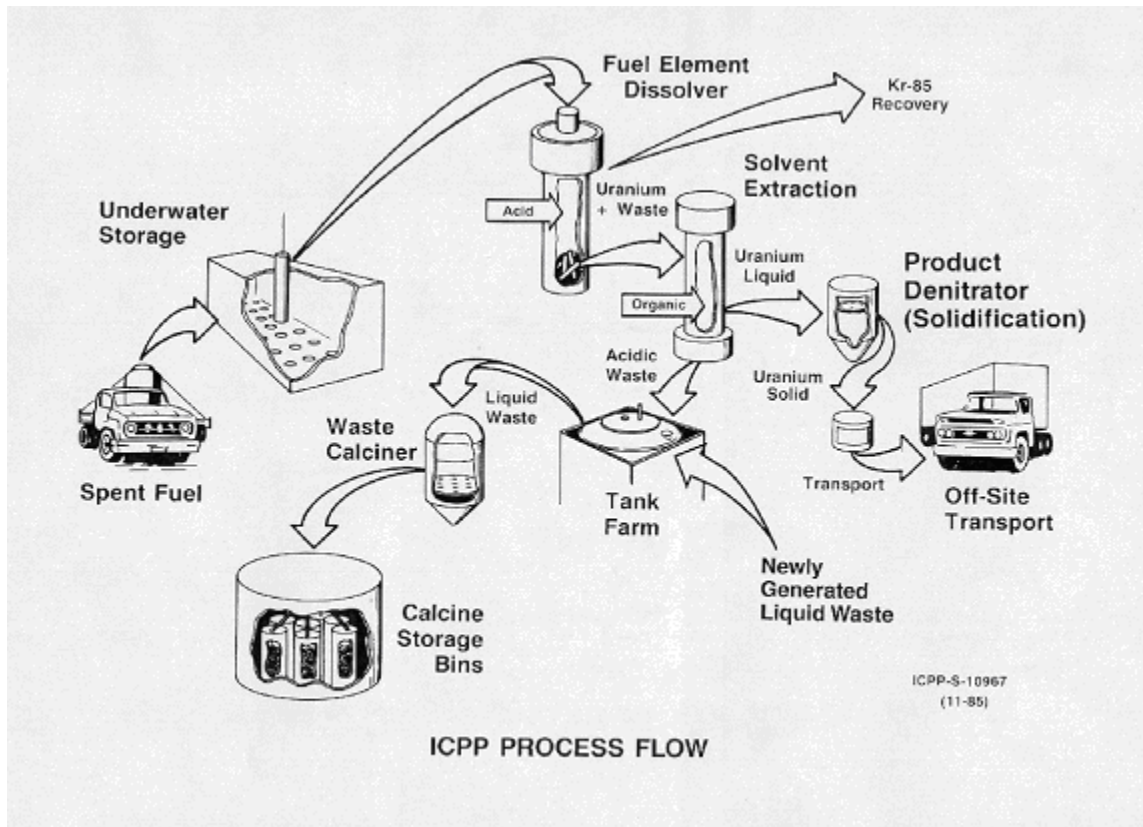
Figure 1. Process flow diagram at the Idaho Nuclear Technology and Engineering Center.

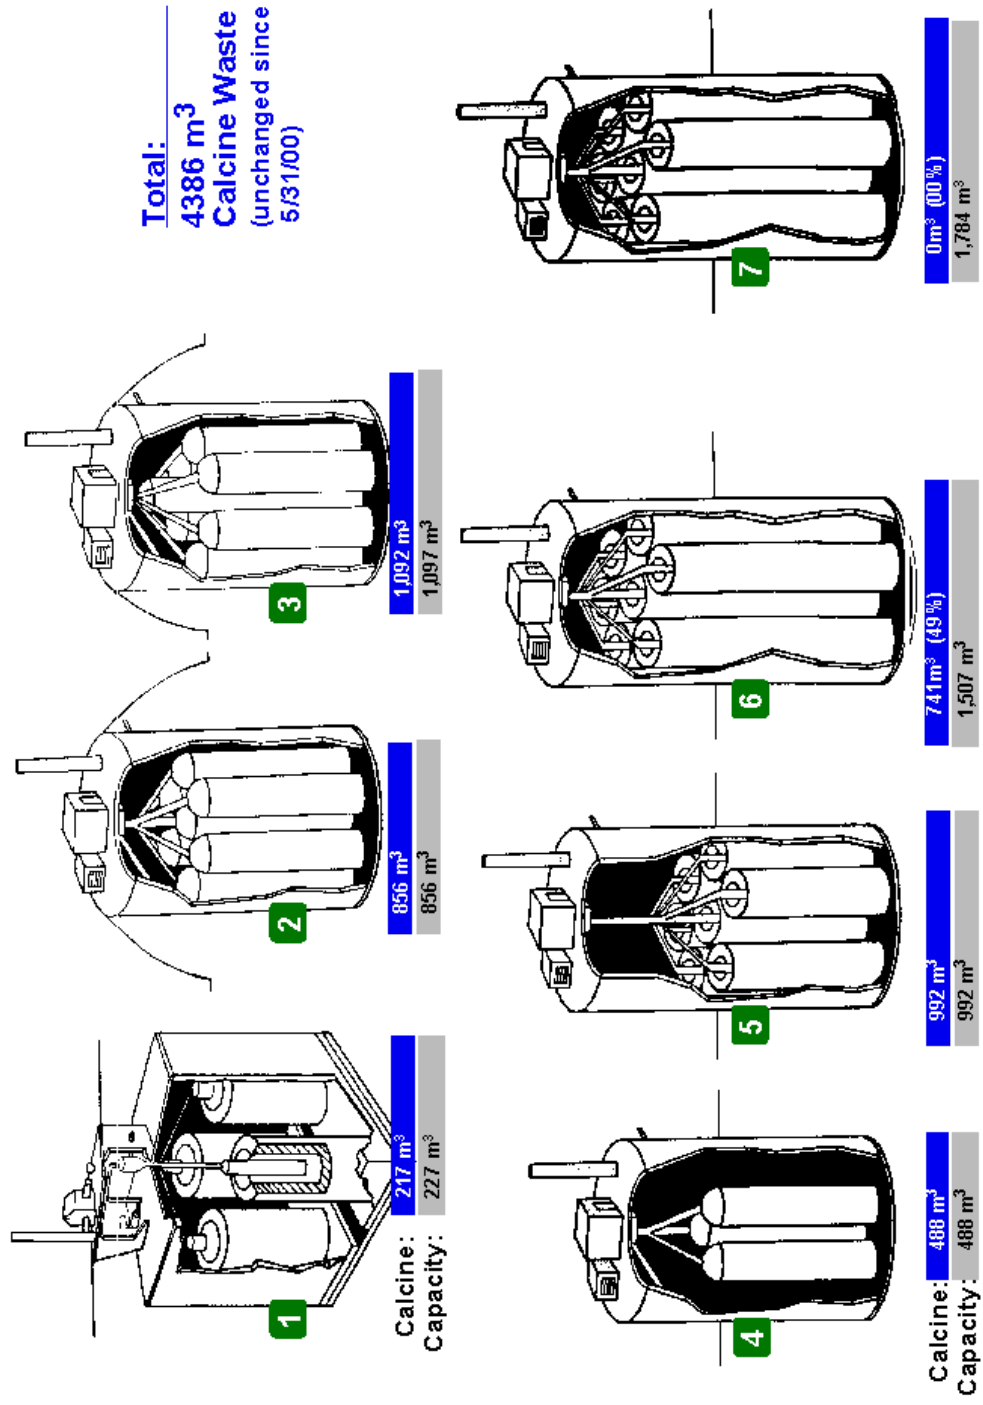
Figure 2. Calcined Solids Storage Facilities.⁹

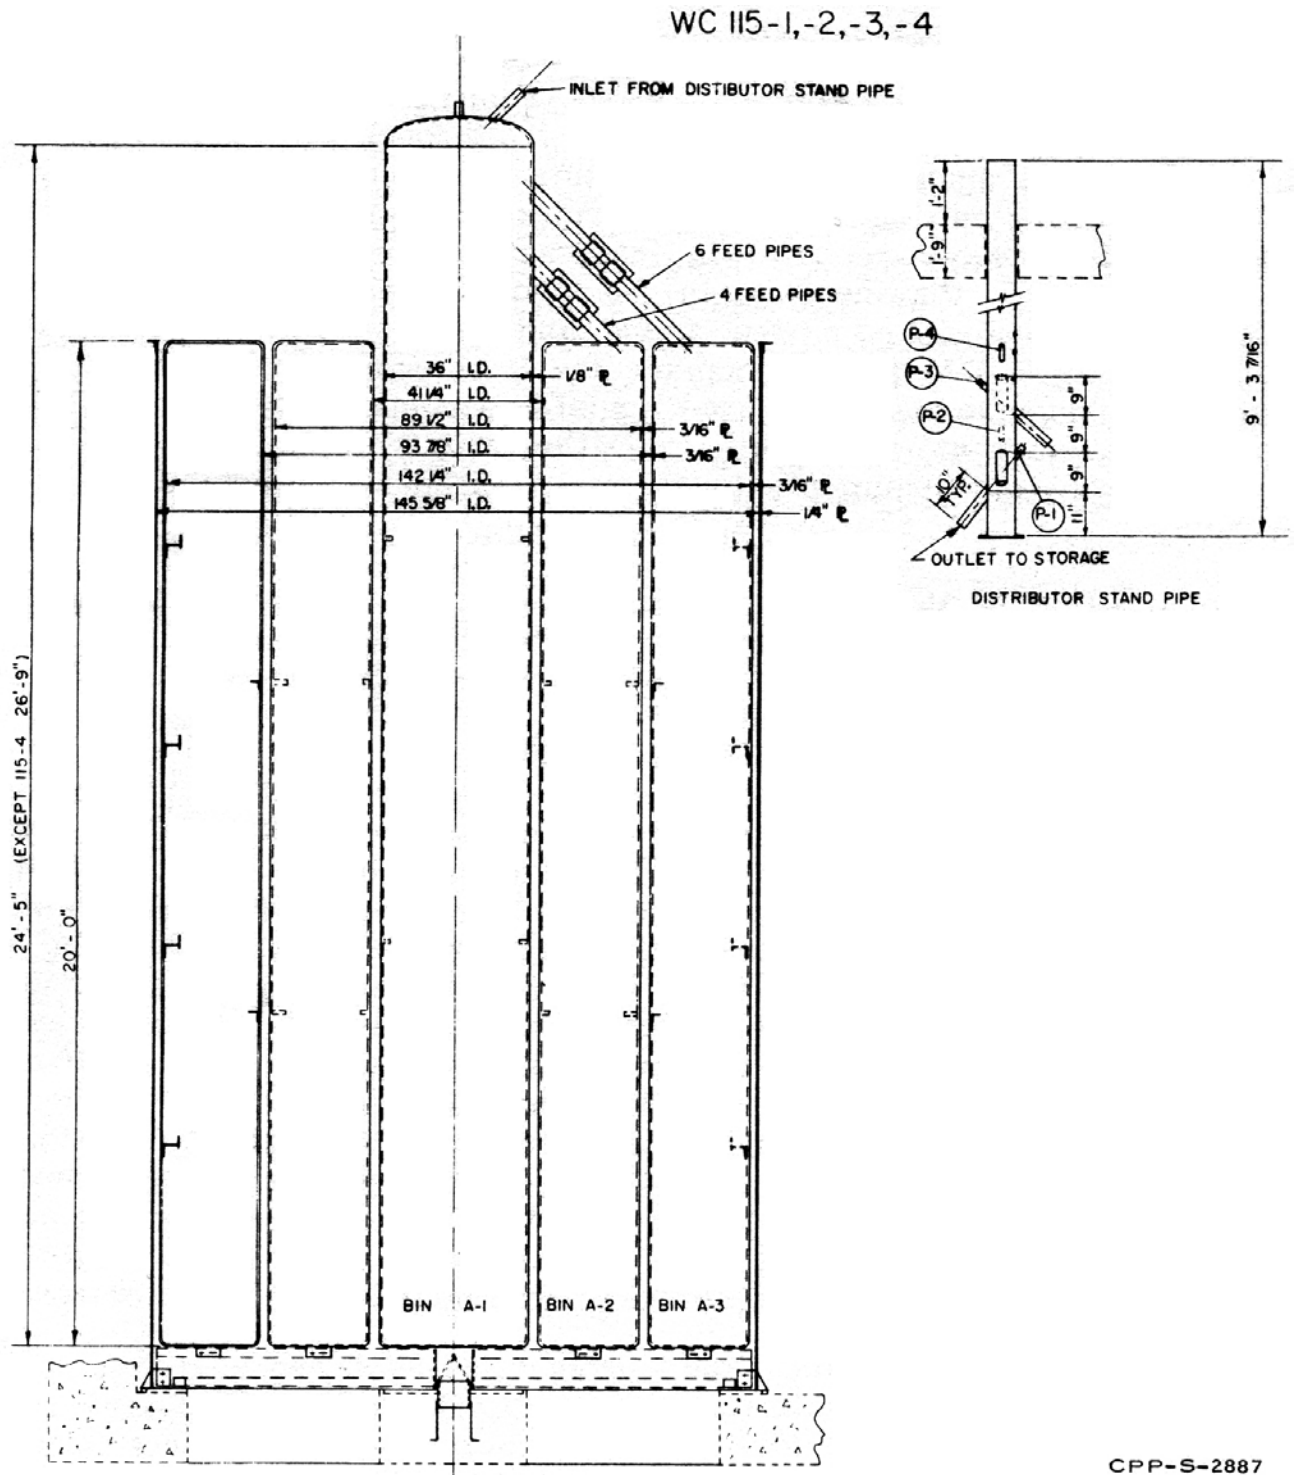
Figure A-1. Sectional Elevation of Calcined Solids Storage Bin Set I Bin.⁷

Also known as Bin Set 1 or CPP-729, CSSF I consists of four composite bins (VES-WCS-115-1, -2, -3, and -4). Each bin in CSSF I contains three sub-bins identified as A-1, A-2, and A-3 as numbered from inside to outside. See Figure A-1 for details.² The facility design was completed by the Fluor Corporation of Los Angeles, California. The bins were fabricated of Type 405 stainless steel in 1959 by Oscar Krenz, of Berkeley.¹

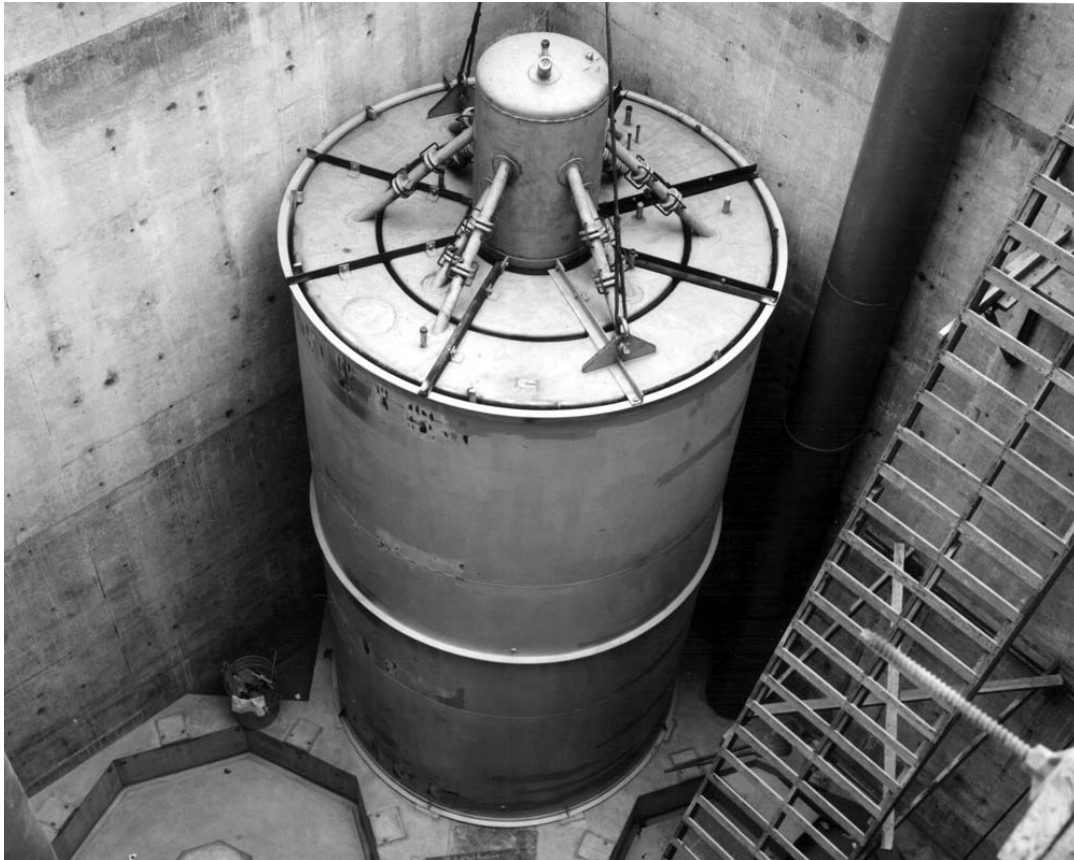
Figure A-2. Calcine storage Bin VES-WCS-115-2 in Calcined Solids Storage Facility I (59-5283).

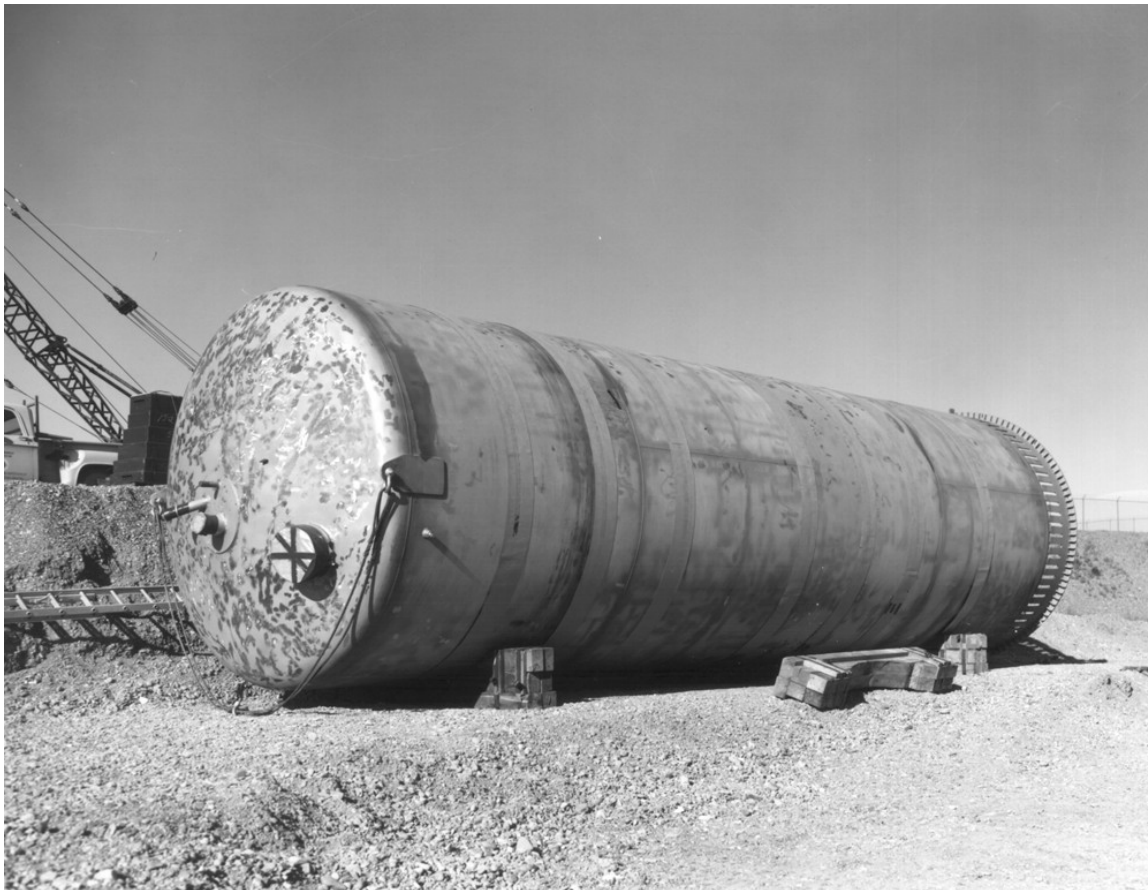
Figure A-3. Calcine storage Bin VES-WCS-136-2 in Calcined Solids Storage Facility II (65-5256).

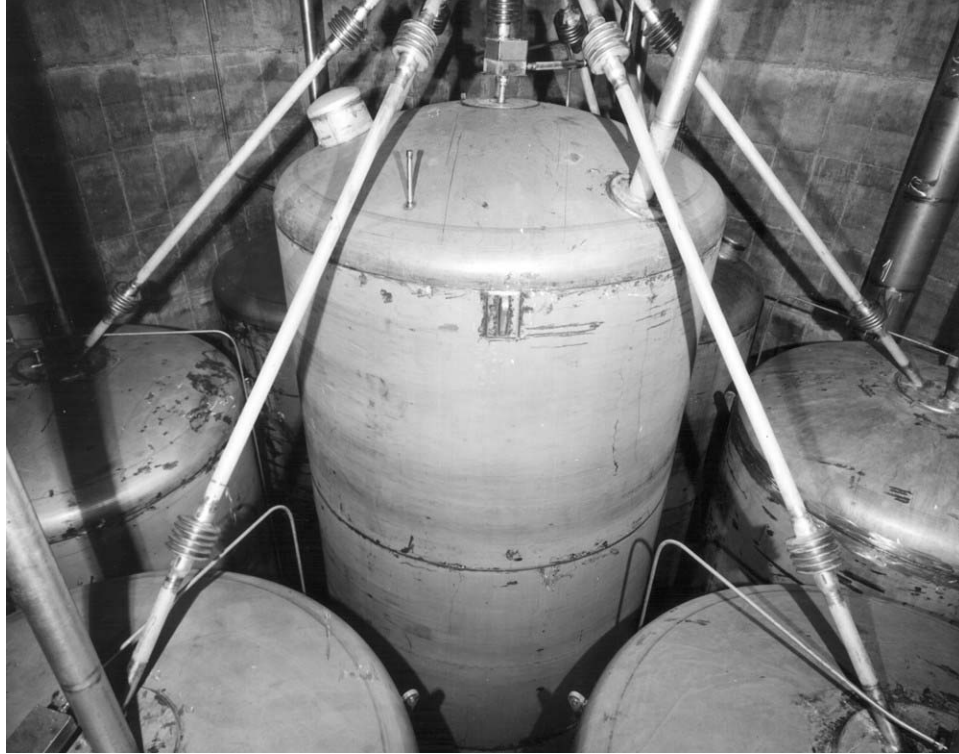
Figure A-4. Center Bin VES-WCS-139 (also known as VES-WCS-140-7) in interior of Calcined Solids Storage Facility III (71-4954).

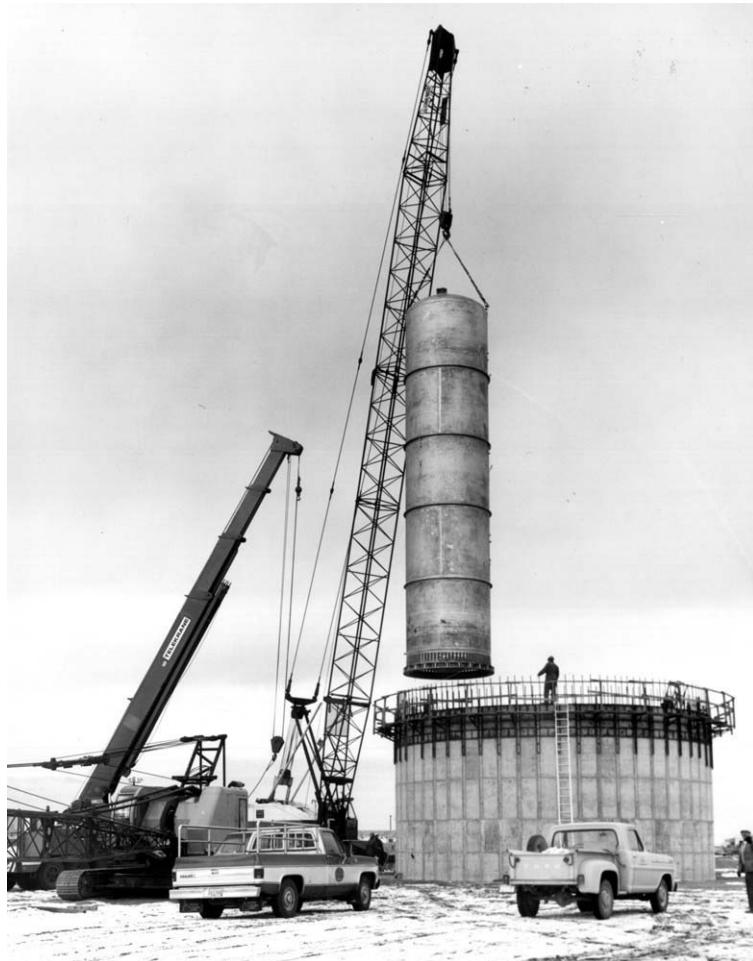
Figure A-5. Installation of Bin VES-WS4-142 in Calcined Solids Storage Facility IV (76-4518).

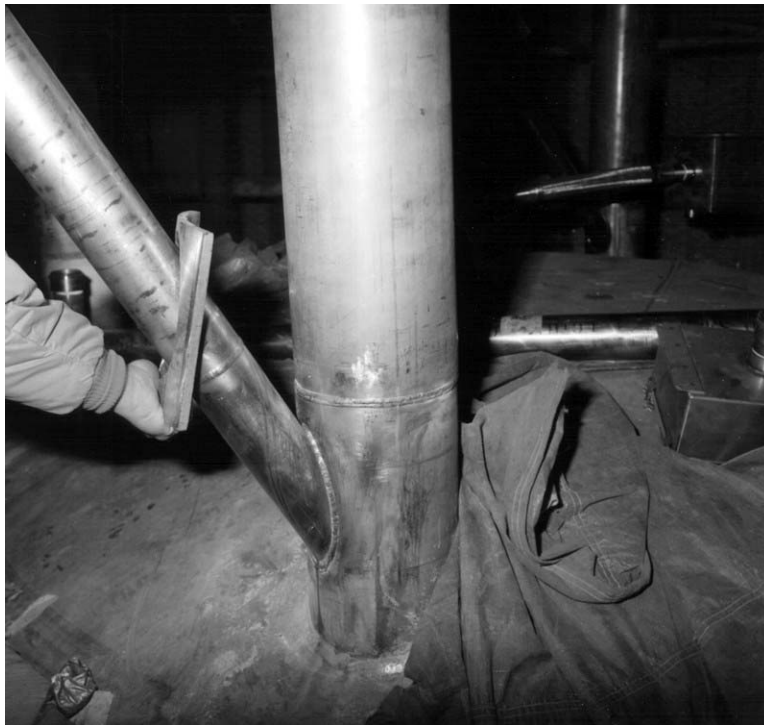
Figure A-6. Typical vessel connections on bin in the Calcined Solids Storage Facility V (81-851).

Figure A-6 shows the attachment make-up of a typical tank nozzle, fill line, and retrieval connection for one of the bins.

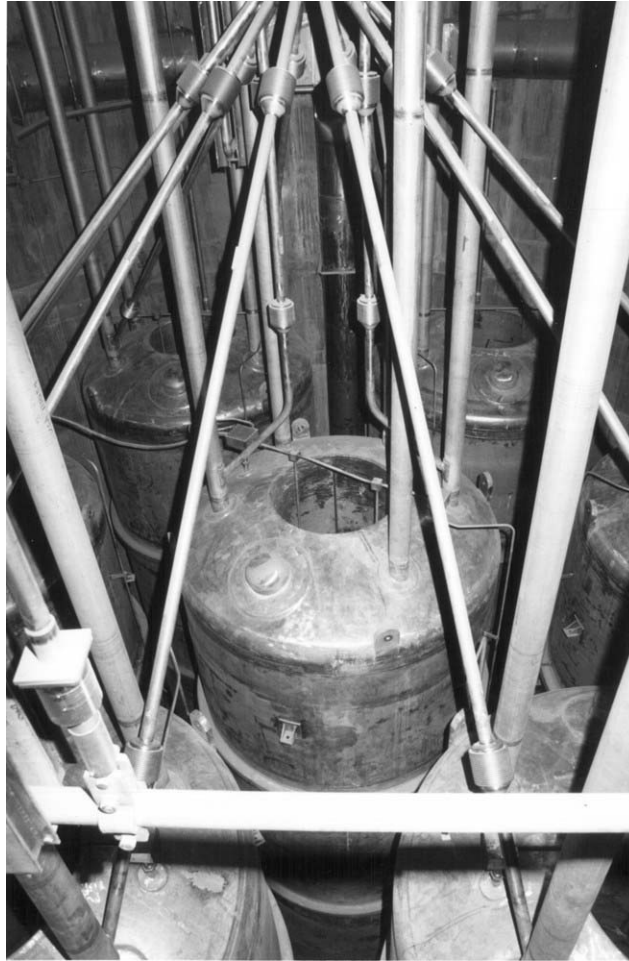
Figure A-7. Distribution piping for Calcine Solids Storage Facility VI (84-680-1-6).

Figure A-7 is a top view of the distribution piping for CSSF VI. The annular bin design is typical of bins in both CSSF V and CSSF VI.
