Long Term Corrosion/Degradation Test Six Year Results

*M. K. Adler Flitton
C. W. Bishop
M. E. Delwiche
T. S. Yoder*

September 2004

*Idaho National Engineering and Environmental Laboratory
Bechtel BWXT Idaho, LLC*

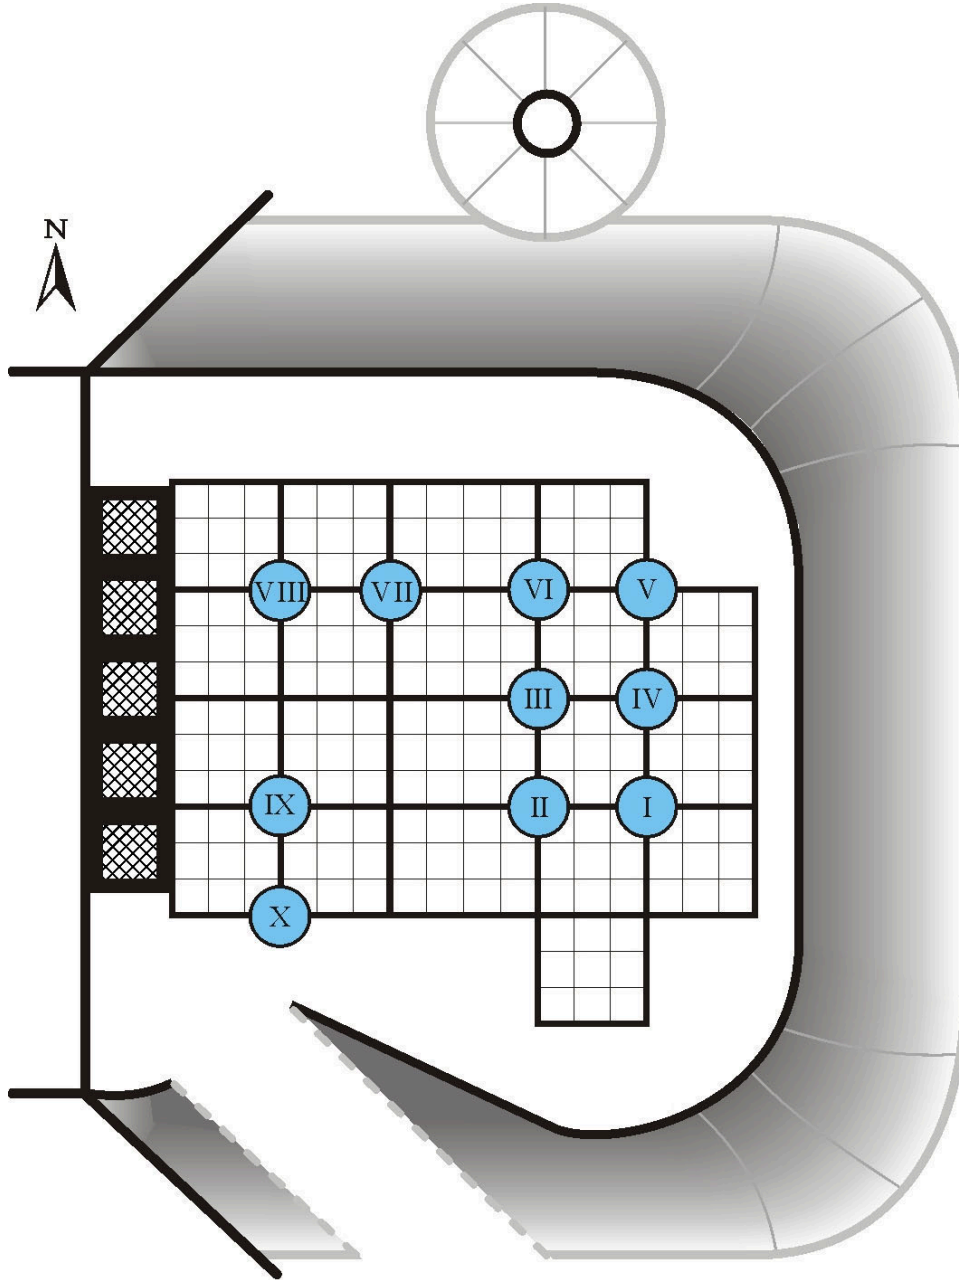
Figure 1-3. Locations for placement of coupon arrays and probe arrays at the corrosion test berm.

The test plan (Adler-Flitton, et al. 2001) calls for burial of coupons and/or probes at as many as ten designated locations in the berm, as shown in Figure 1-3. Each set of 36 coupons, after assembly, is referred to in this report as a coupon array. Each set of six probes and associated instrumentation is referred to as a probe array. In general, two arrays of coupons or probes make up one set and will be

buried at each location, one array at 4 ft deep and one array at 10 ft deep. In some instances, a probe array and a coupon array might be buried at the same location at the same depth. Some of the locations can be used more than once; for example, if two coupon arrays are removed for evaluation after only a year or a few years, new arrays can be installed at that location as part of the ongoing test.

The configuration shown in Figure1-3 arranges the coupon/probe placement locations in a grid within the berm, with spacing of 15-ft center to center. The berm size is limited and the placement arrangement is purposefully non-random to optimize the number of arrays that can be placed in the berm. This arrangement separates the coupon arrays (edge to edge) by a minimum of 10 ft, so that retrieval of

In general, coupon arrays are buried at depths of 4 ft and 10 ft at each of the designated locations in the berm, as shown in Figure 1-3. The 4- and 10-ft burial depths were chosen to represent the activated core components that are buried from 4 ft to a maximum of 20 ft below the surface in the SDA. The 4-ft depth provides a high level of exposure to changing environmental conditions, while the 10-ft depth more closely represents actual conditions for waste buried at the SDA. At each location, a hole was drilled using a drill rig equipped with a 6-ft-diameter auger (see Figure 2-5). Coupon arrays, each consisting of six polypropylene rod assemblies, were placed in the holes at the 10-ft depth, with nine inches separation between the rods. Following burial of each coupon array at the 10-ft level, the 6-ft diameter hole was back-filled in 8-in. lifts with Spreading Area B soil and manually compacted to approximately the 4-ft level, at which point the second coupon array was placed. The hole was then back-filled to the surface in 8-in. lifts with manual compaction. Figure 2-6 shows a typical coupon array placed in a hole. The emplacement procedure is documented in “Corrosion Coupon Installation,” TPR-1659.

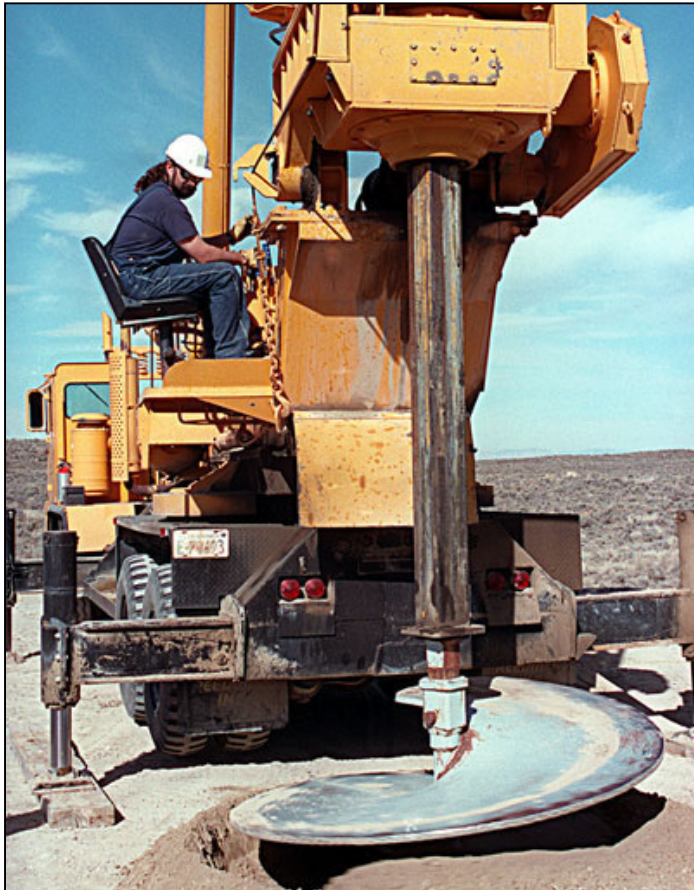
Figure 2-5. Drill rig with 6-ft-diameter auger.

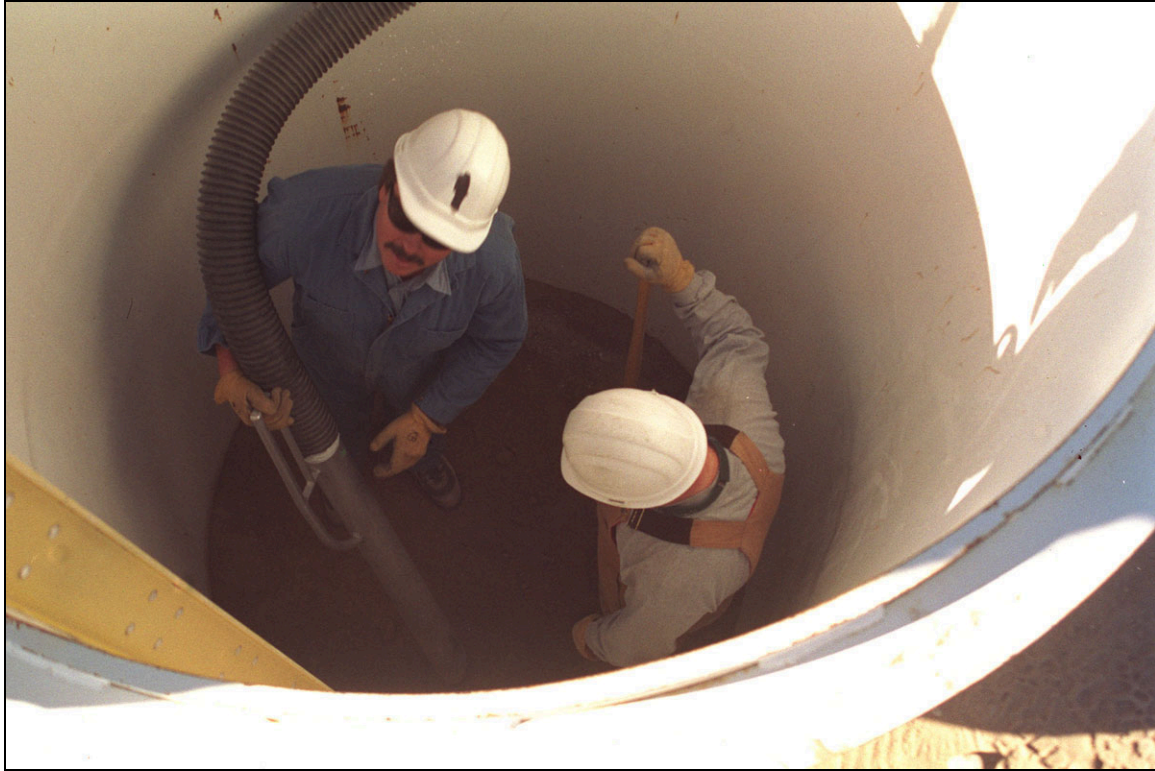
Figure 2-7. Soil Vacuum extraction – hose end.
Workers vacuum soil while in the cave-in-protection sleeve.

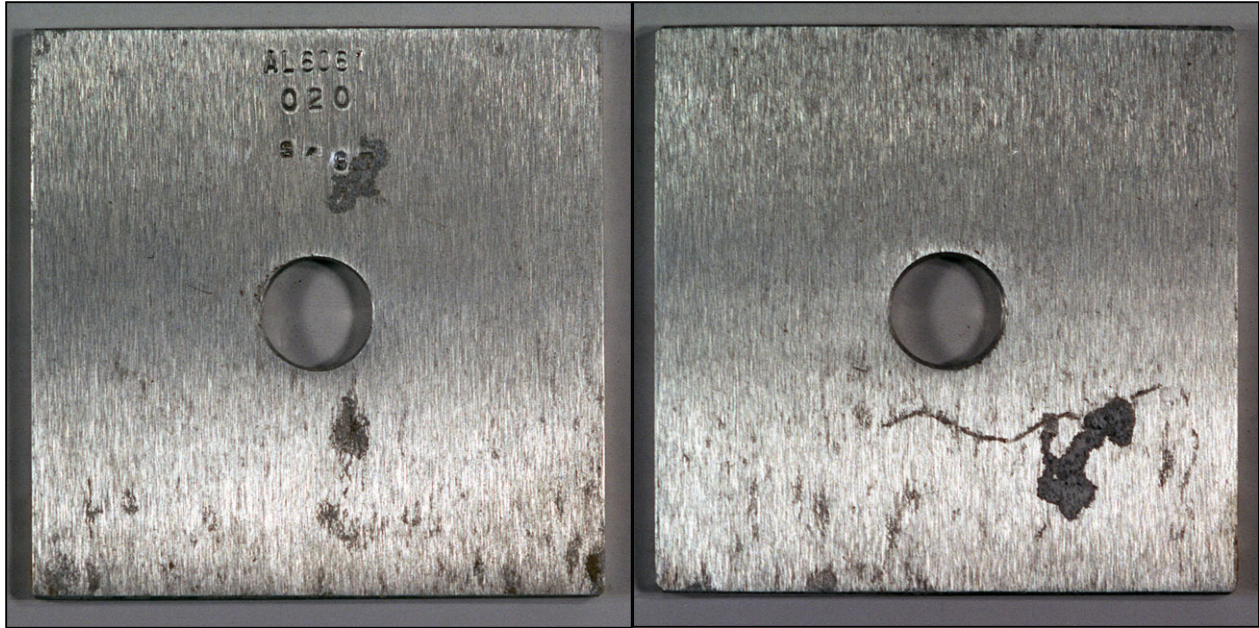
Figure 3-1. Aluminum coupon (#3497) before cleaning. 6-yr exposure at 4-ft front and back views.

Level below surface		Maximum pit depth	
Ft	m	Sample number	μ m
4	1.22	3497	218
10	3.05	3500	212

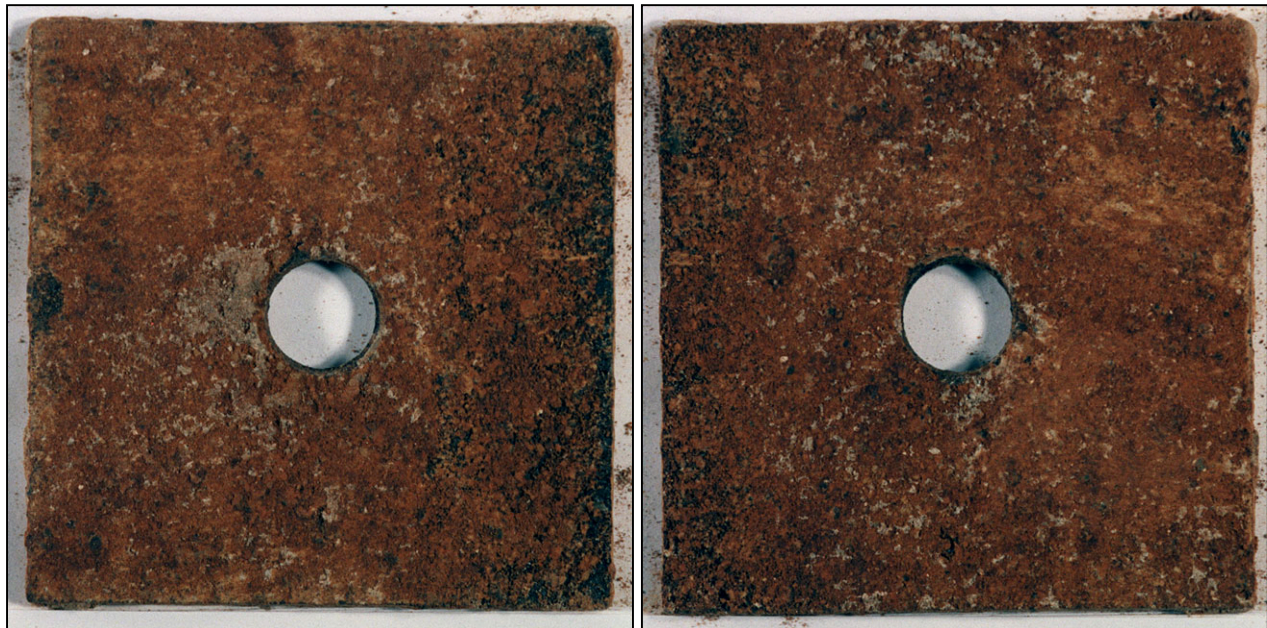
Figure 3-7. Carbon steel coupon (#3348) before cleaning. 6-yr exposure at 10-ft, front and back views.

Level below surface		Maximum pit depth	
Ft	m	Sample number	μ m
4	1.22	3343	504
10	3.05	3347	379

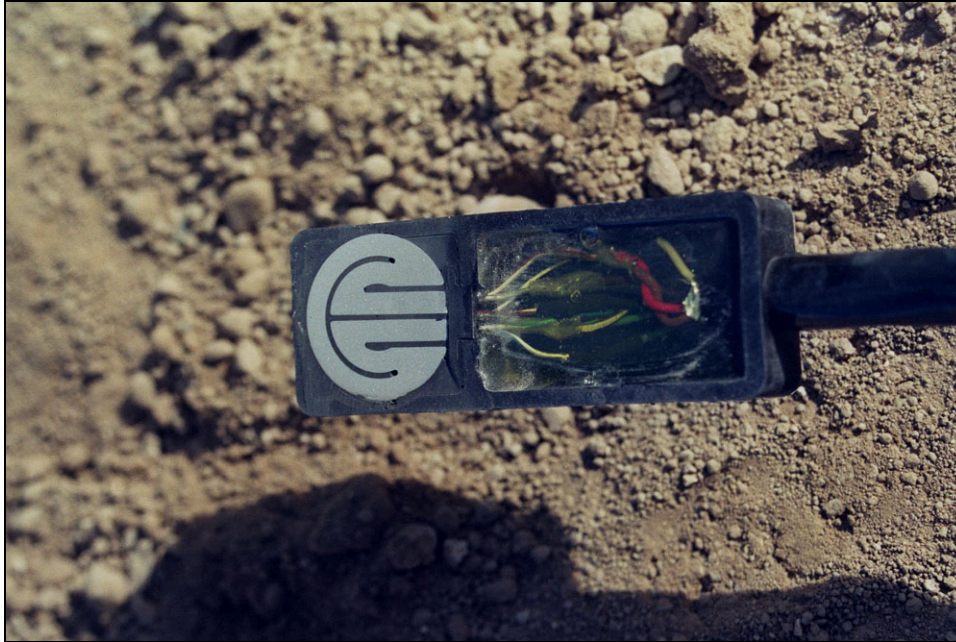
Figure 4-2. Electrical Resistance (E/R) probe. Photo shows the probe just before installation at the corrosion test berm.

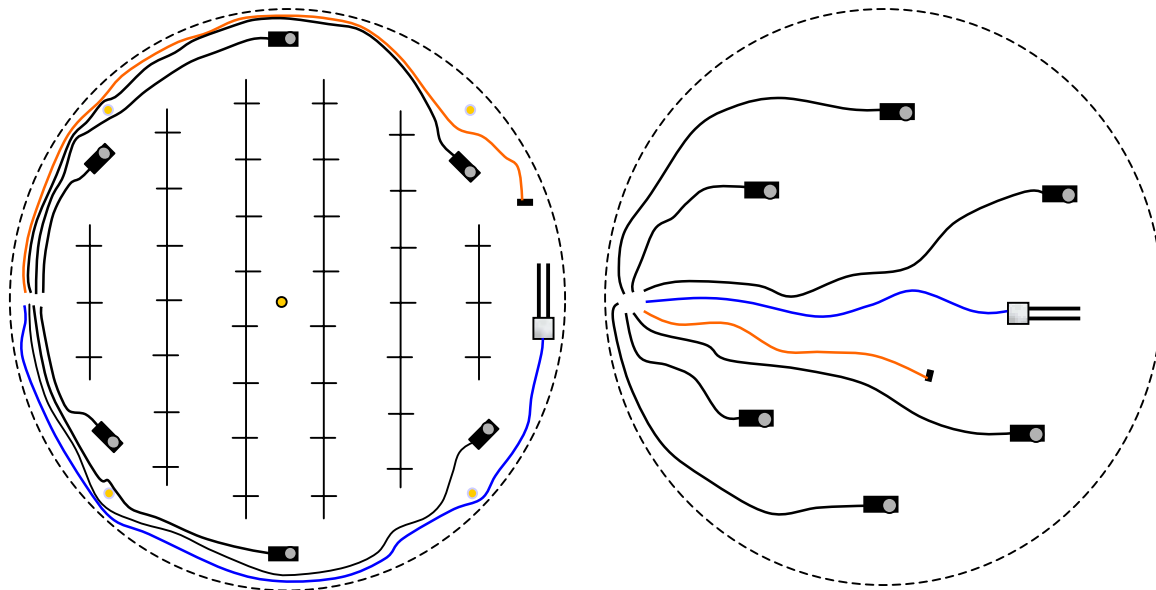
The probes arrays are arranged at the berm location dependent upon whether the probe array is placed with a coupon array or just as a probe array. In instances where a probe array and a coupon array are buried together at the same location and depth, as shown on the left in Figure 4-3, the probes are placed in the 6-ft-diameter hole along with the coupons. Where a probe array is placed in a location separately, as shown on the right in Figure 4-3, a 2-ft-diameter hole will be sufficient as a minimum. Procedures for placement, backfilling, and compaction are the same for the probe arrays as for the coupon arrays.

Figure 4-3. Probe array configurations. The left shows installation with a coupon array, the right shows installation without a coupon array.

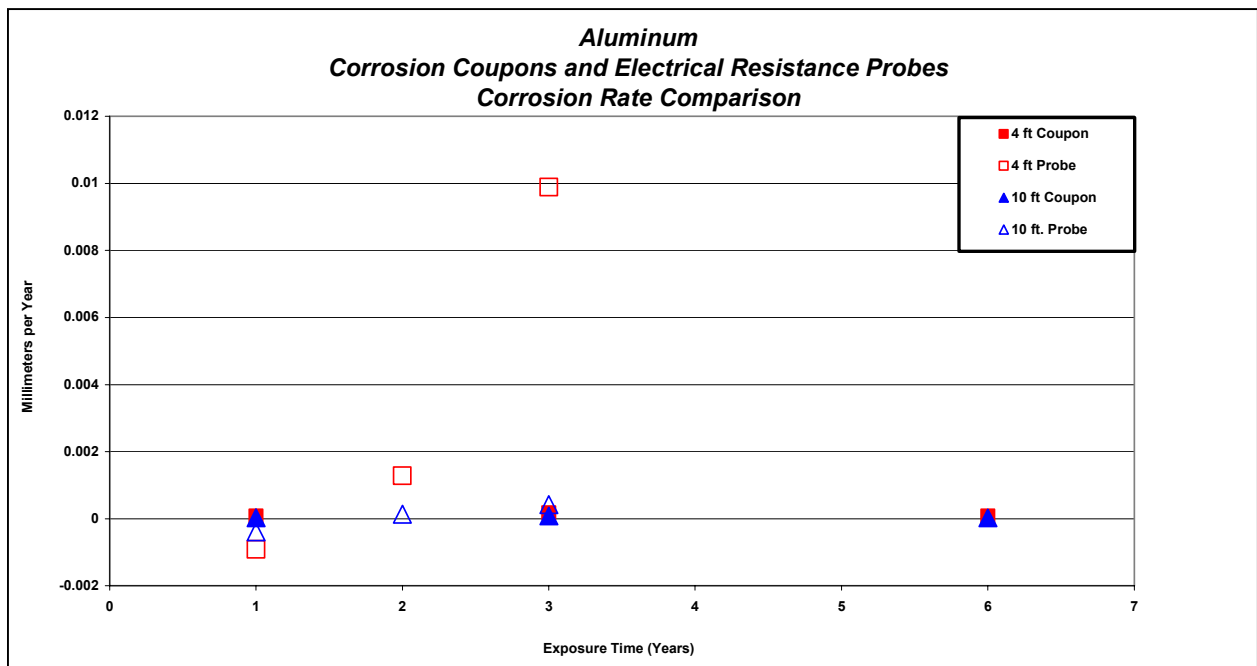
Level below surface		Location II		Location III	
(ft)	(m)	(MPY)	(mm/y)	(MPY)	(mm/y)
4	1.22	0.5566	0.0141	0.2237	0.0057
10	3.05	0.0149	0.0004	0.1274	0.0032

Figure 4-4. Aluminum E/R probes vs. coupons.

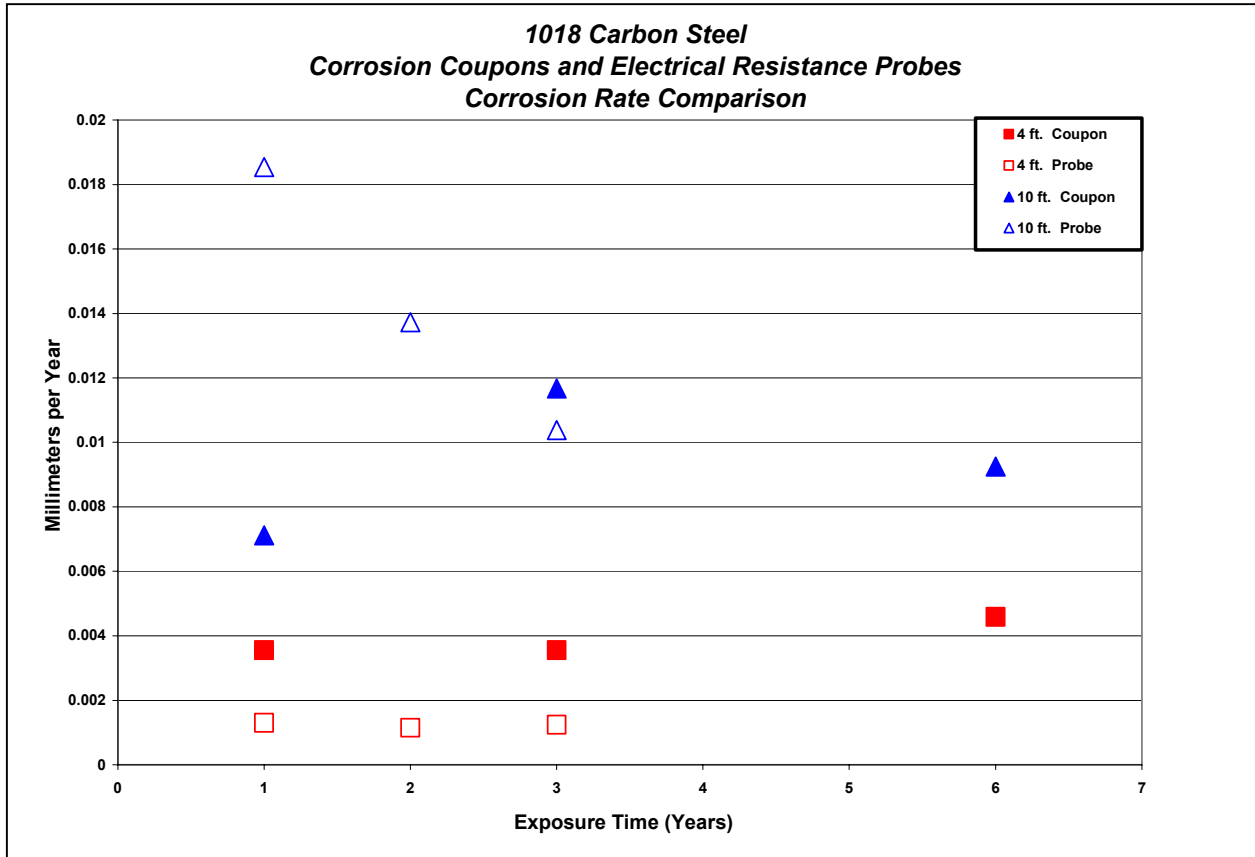
Level below surface		Location II		Location III	
(ft)	(m)	(MPY)	(mm/y)	(MPY)	(mm/y)
4	1.22	0.0485	0.0012	0.0329	0.0008
10	3.05	0.3511	0.0089	0.7333	0.0186

Figure 4-5. Carbon steel E/R probes vs. coupon

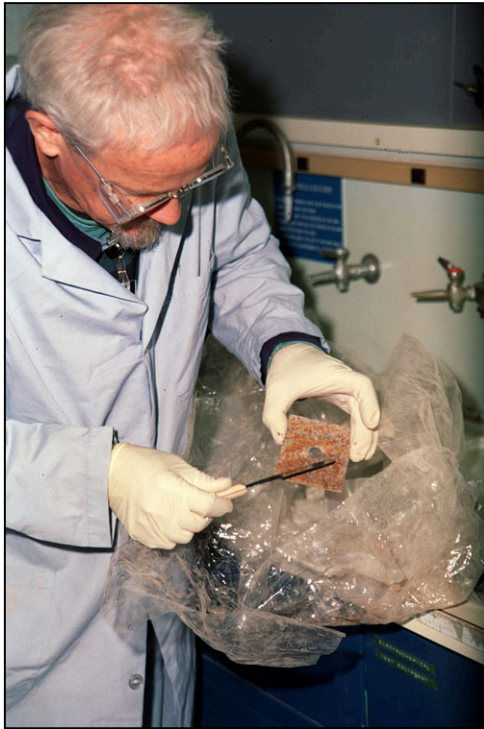
Coupons were processed as described in reports from previous sample years. Repeatability of this process is critical to comparison of data points. All soil particles and loose debris were removed from coupons with sterile implements, see Figure 6-1. This process was particularly critical when handling heavily corroded coupons such as carbon steel, beryllium, and aluminum.

Figure 6-1. Removal of soil and loose debris for microbial testing.

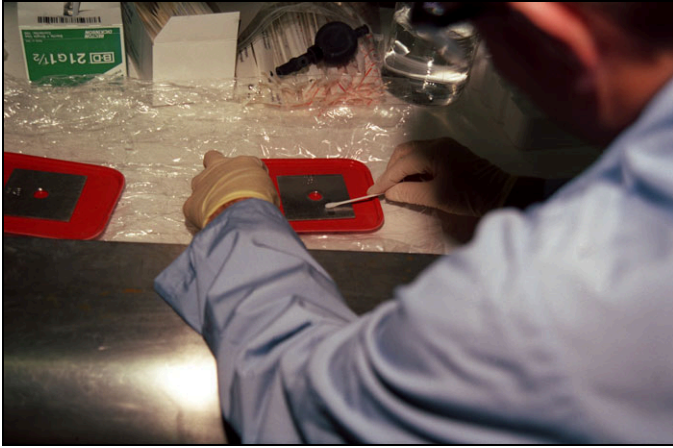
Figure 6-2. Swabbing corrosion coupon for enrichments.

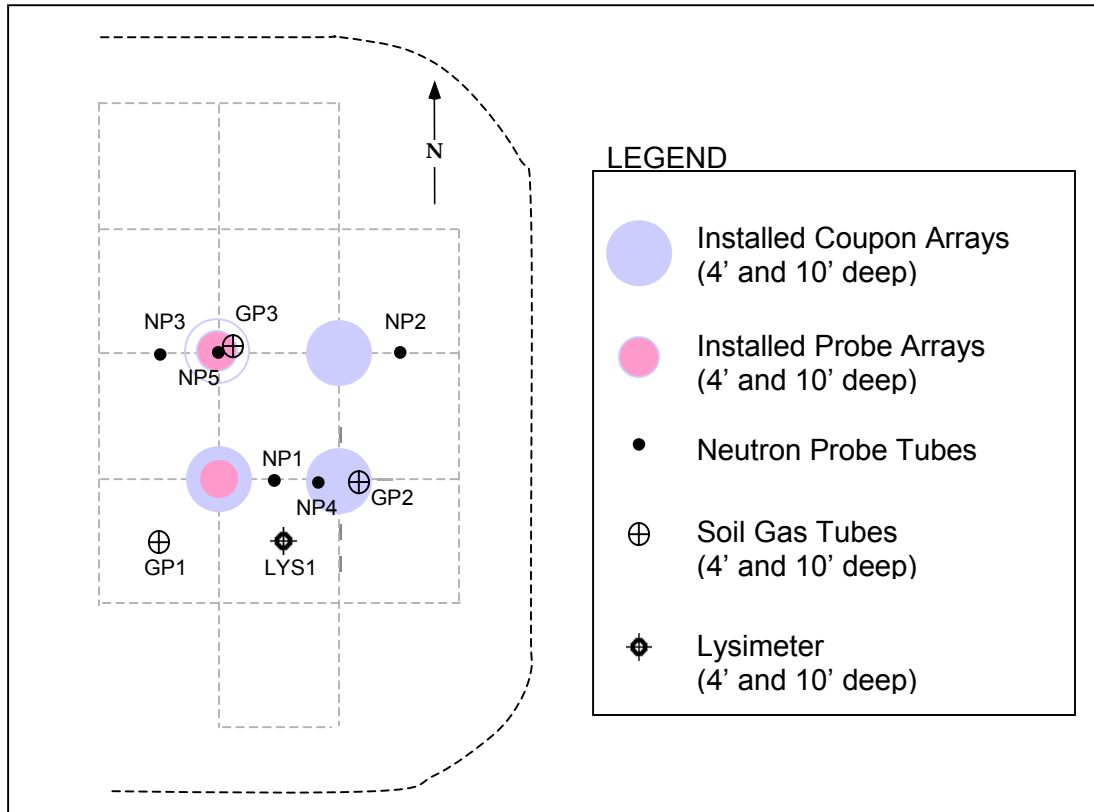
The test plan calls for field monitoring at the berm to collect data on precipitation, soil moisture, soil-water chemistry, soil-gas composition, and soil temperature. All field monitoring called out by the test plan is necessary to correlate the corrosion rate data with the SDA environment. Soil moisture and soil chemistry are potentially the strongest influencing factors in underground corrosion at the test location. Field monitoring data have been collected sporadically during the test, depending on the levels of support funding. With the installation of the probe arrays, additional support instrumentation is now available for monitoring. See Figure 7-1 for the arrangement of arrays and sampling ports at the corrosion test berm.

Figure 7-1. Arrangement of coupon arrays, probe arrays and support instrumentation.

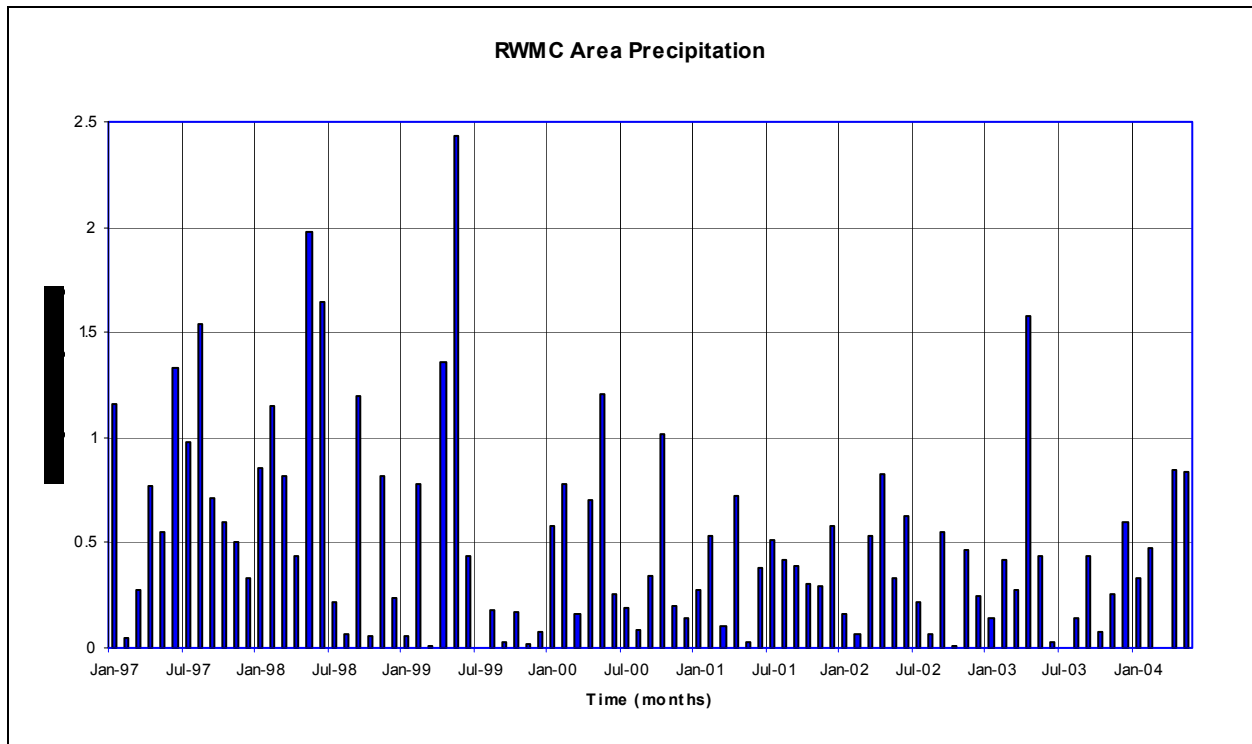
Figure 7-2. Graph showing monthly precipitation totals for the years 1997 through May 2004.

Year	Total Annual Precipitation (inch)	Months with precipitation totaling 1 inch or more
1997	8.8	3 (1 >1.5 in)
1998	9.5	4 (2 >1.5 in.)
1999	5.56	2 (1 > 2 in.)
2000	5.67	1
2001	4.53	0
2002	4.12	0
2003	4.40	1 (> 1.5 in.)
2004 (1/2 year)	2.85	0

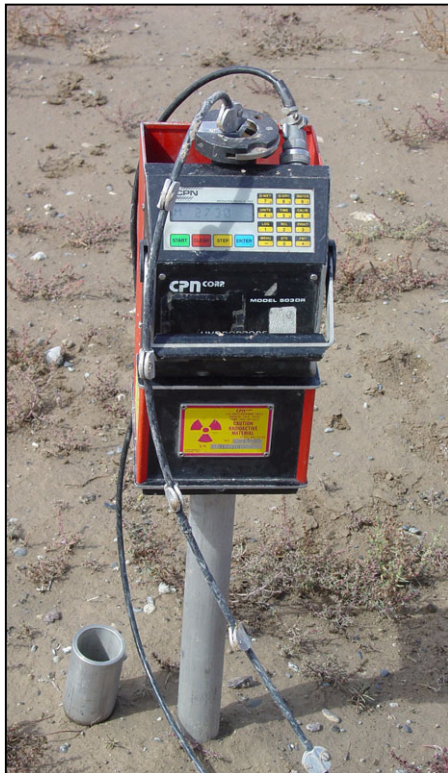
A CPN 503DR hydroprobe neutron moisture gauge with an Am/Be source is used to collect the moisture data (see Figure 7-3). The gauge operates by emitting fast neutrons that are thermalized or slowed when they collide with hydrogen atoms. The probe detector counts the thermalized (slowed) neutrons, and the neutron counts are calibrated to the specific soil to provide volumetric moisture content measurements.

Figure 7-3. CPN 503DR hydroprobe neutron moisture gauge.
