Comparison Of Cleaning Methods For Analysis Of Underground Beryllium Corrosion

**National Association of Corrosion
Engineers 2006 Annual Conference**

March 2006

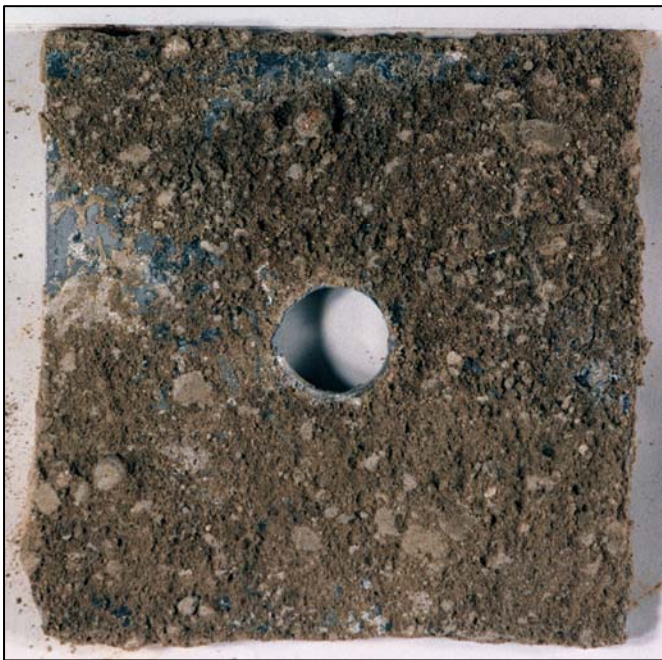
FIGURE 1 - Corroded Beryllium Coupon after Underground Exposure

The long-term corrosion testing implements direct corrosion testing (i.e., burying beryllium coupons in the soil, ASTM G 4). The beryllium corrosion coupons are retrieved after exposure to the underground environment. Following the procedures from Test Method ASTM G 1, the beryllium corrosion product and adjacent soils tightly adheres to the metal base requiring chemical cleaning after the simple brush-wash and rinse cycle. Figures 1 and 2 show the corroded beryllium coupon after exposure to soil environment and after cleaning.

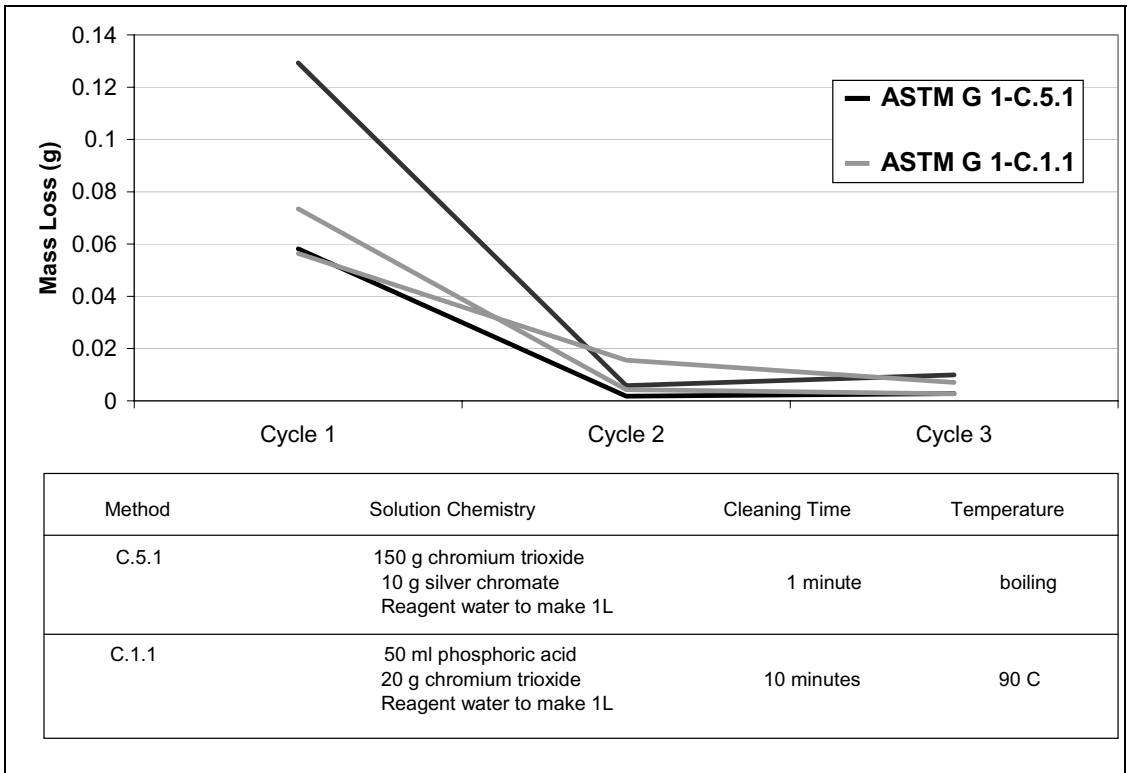
FIGURE 3 – Beryllium Coupon Cleaning Curves and Procedures

The exposed beryllium coupons were cleaned following ASTM G 1. First cycle cleaning, water wash and brush, did not remove all of the adhering corrosion products. Chemical cleaning was then applied to all exposed coupons following ASTM G 1-C.5.1 *Magnesium and Magnesium Alloys* or ASTM G 1-C.1.1 *Aluminum and Aluminum Alloys*. Figure 3 shows the typical cleaning process for the beryllium coupons. The cleaning curves do not indicate a difference in method effectiveness.
