Concrete Shield Performance of the VSC- 17 Spent Nuclear Fuel Cask

International High-Level Radioactive Waste Management Conference

April 2006

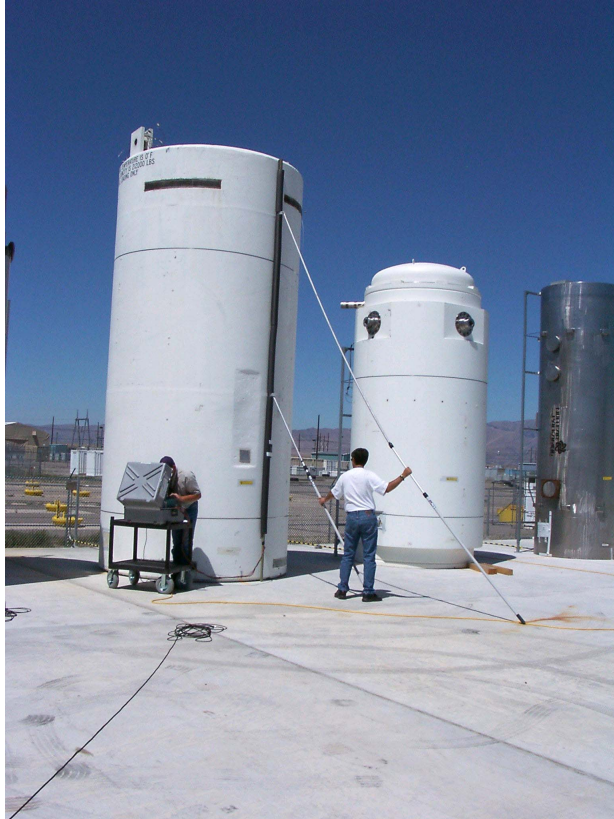
8.8-degree intervals. The zero point corresponds to the south lifting lug, and 90 degrees corresponds to the nameplate position on the cask. The data acquisition system recorded values every second and reported the maximum and minimum value for that period. Data were taken as three sets of 30-second periods for each radial position. The test was performed operationally as shown in Figure 3. This image shows the thermocouple rake being supported against the cask surface by extension poles.

Upper air vent at the 45-degree radial position

Fig. 3. Thermocouple measurements were taken using a thermocouple ladder.

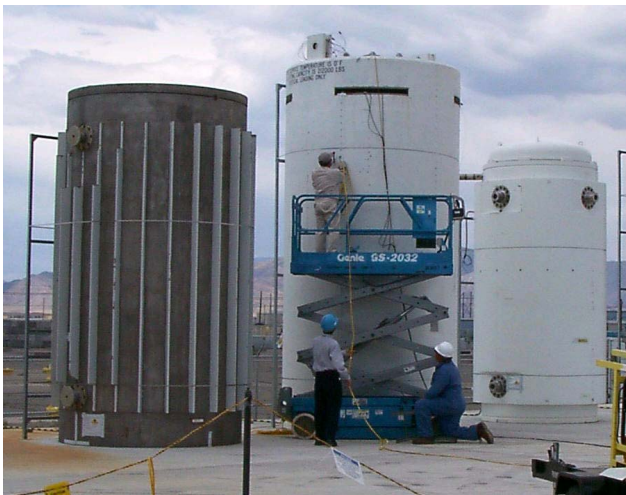
Since performing nondestructive examination in 2003, the cask was fitted with a conduit support structure that extended out sufficiently to interfere with making thermocouple contact readings between 210 degrees to 340 degrees. See Figure 4. Therefore, only 27 of the planned 41 radial positions were accessible. The test indicated limited variation in temperature on the cask surface.

Instrument conduit
support structure

Fig. 4. Electrical conduit is visible from behind the VSC-17 cask.

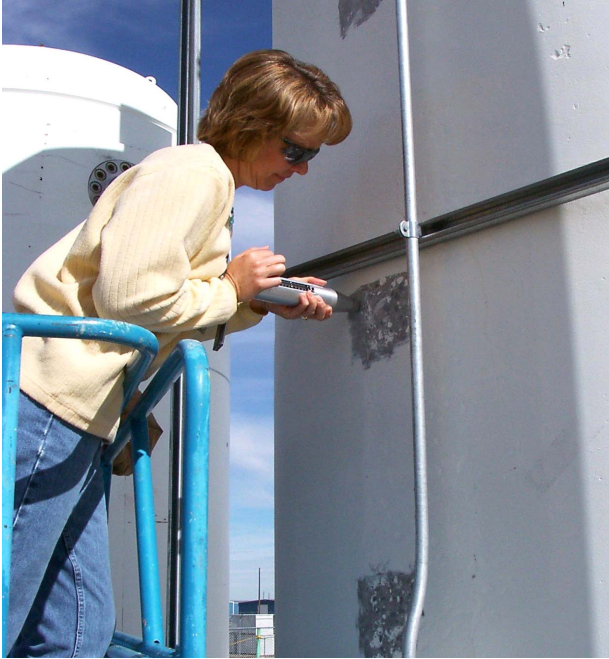
locations. Figure 7 shows testing being performed at the 270-degree position. What may appear to be residual paint in the work areas is actually exposed aggregate. The 90 and 270-degree radial locations have flat areas that were ground off to provide space for nameplate installation. Grinding the 30-cm (1-ft)-wide × 90-cm (3-ft)-high flats exposed the larger gravel aggregate.

Schmidt rebound hammer testing was performed at 70 locations on the concrete exterior surface of the VSC-17 VCC. Test interval spacing was at 20 cm (8 in.) for 10 positions below the 45-degree upper air vent where greater porosity was expected to be found. A test interval of 20 cm (8 in.) was also used at 90 degrees for 12 positions below the top of the cask because this portion of the cask was expected to have good porosity. The smaller test intervals used at the 45 and 90-degree positions provided a set of values to compare to the ultrasonic testing performed in these same locations. Twenty hammer impacts were performed at each location (twice the minimum required by the ASTM C805-02 method).

Fig. 7. Schmidt rebound hammer testing on the VSC-17 cask.

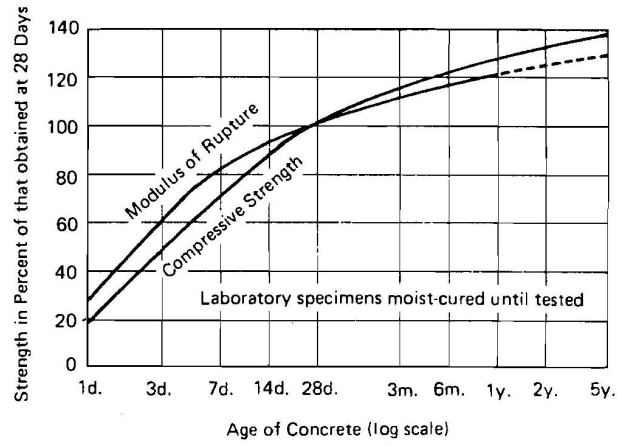
To gauge the readings received by hammer testing, a standard concrete test specimen was rebound tested and then broken at the INL Materials Testing Laboratory. The adjusted average rebound value for the first specimen was 37.1, while the second was 35.3. These specimens broke at 4,895 and 4,570 psi, respectively. When extrapolated, the average value indicated for compressive strength of the VSC-17 shield concrete is approximately 6,600 psi. In typical circumstances, concrete gains compressive strength as it ages, but the expected increase is typically about 20%. For the concrete used to construct the VSC-17 shield, that value should be on the order of 5,400 to 5,500 psi. In moist cured concrete, the value may increase by as much as 40%, which would project the 28-day average values from the cask fabrication pour from 4,509 psi to 6,312 psi at 5 years (Figure 9).

Fig. 9. Age-strength relationships for moist-cured concrete.⁴

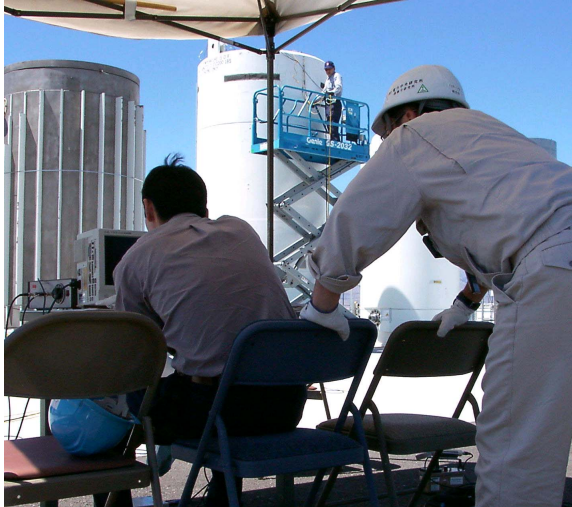
In August 2005 CRIEPI and their subcontract team from LAZOC Sensing Technology joined the INL project team to perform ultrasonic testing on the VSC-17. Figure 11 shows the CRIEPI team applying sensors to the VSC-17 and gathering data.

Fig. 11. CRIEPI and LAZOC Inc. representatives performed ultrasonic testing in August 2005.

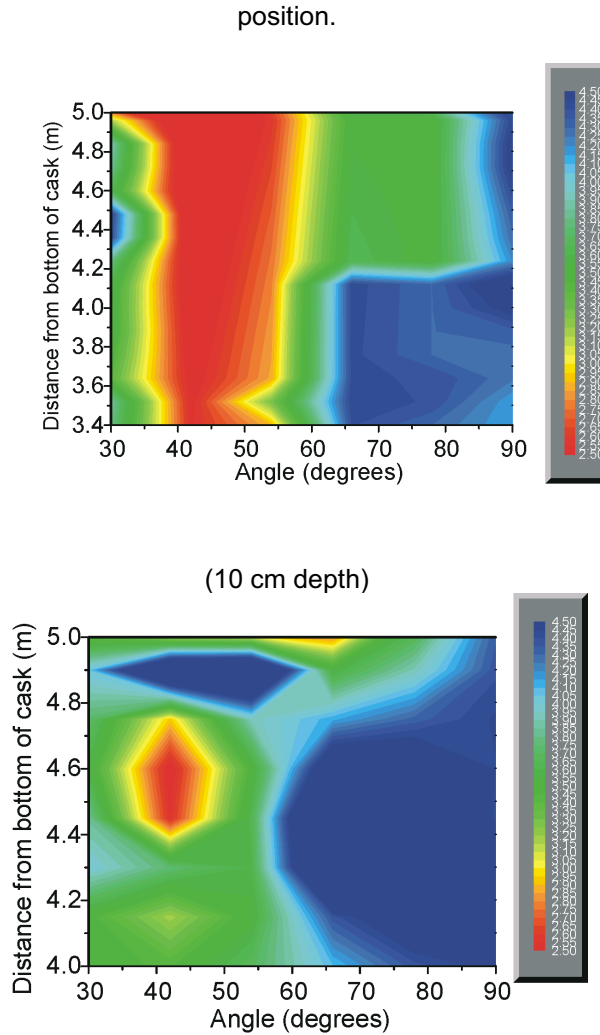
Figure 13 shows the wave propagation velocity distribution at 10 cm (4 in.) and 20 cm (8 in.) depths on the upper part of VSC-17 cask in the 30 to 90 degrees radial positions. It appears that the concrete beneath the upper 45-degree air vent has a very low wave propagation velocity, indicating that there may be variability in its density or localized cracking. Because the Schmidt hammer test did not indicate surface damage in this area, it is likely that the concrete at 10 cm (4 in.) (reinforced concrete bars disposition) and 20 cm (8 in.) resulted in greater porosity due to the difficulty of curing or pouring concrete. The upper air vent structure could have complicated the fabrication of the shield just under the vent and has likely caused the localized radiation hot spot at the 52-degree radial

Fig. 13. Surface wave propagation distribution on upper part of VSC-17 cask (Sector 30-90 degrees).

Variations in the radiation field between the lower and upper sections do not conclusively result from the construction of the cask. There is no indication that the lower material is denser or stronger based on ultrasonic and hammer testing. There is a substantial indication that the radiation hot spot identified under the 45 to 52-degree upper vent is a construction artifact. This is possibly a void underneath the metal vent shielding offset that was not completely filled in with concrete.

Ultrasonic testing indicated a flaw under the 45-degree vent that could be a product of either manufacturing or aging.
