# Induction Furnace Testing of the Durability of Prototype Crucibles in a Molten Metal Environment

*U.S. Department of Energy, Albany Research Center,  
Albany OR*

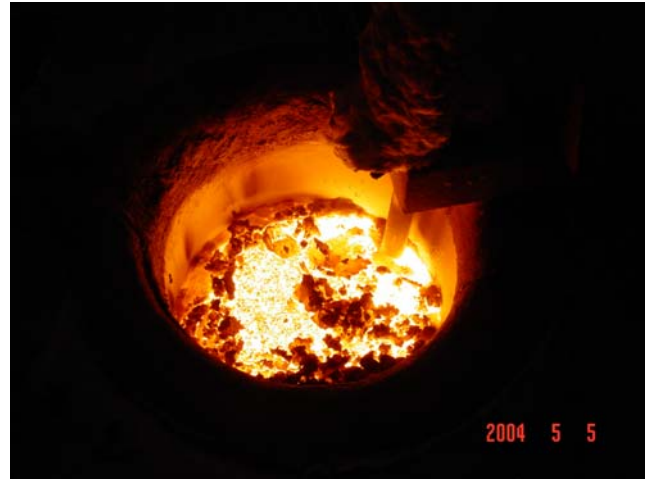
Figure 1: Example of the typical appearance of the melt is shown above. Note the dross (darker material inside the crucible) that remained on the surfaces of the melts for the majority of each of the tests. The immersion thermocouple used to monitor and control the bath temperature is also evident in the photo.

The typical appearance of a melt during a run is shown in Figure 1. In each case the melt surface was generally covered in a base metal oxide (dross). The dross was cleared occasionally to take samples; however, no effort was made to remove all of the oxide except just before the heat was cast. An example of a crucible after casting is shown in Figure 2 which is typical of all the melts. Note that some of the dross was still attached at the melt line. This thick dross "ring" is somewhat different than what would develop during more typical foundry practice of charge, melt, pour, repeat. However, it presents a more aggressive environment to test the crucible under. Table I gives the chemistry of the melts at the end of each 2h run as well as the order of melting. A loss of Cr and Mn was observed. During the third melt the heat was observed to be excessively drossy as compared to the previous two melts. The manganese level was observed to have fallen below 0.1 weight percent at the end of this melt. The manganese loss was accompanied by a significant drop in chrome (a loss of 1.85 weight percent chrome from melts 2-to-3 vs. a loss of only 0.55 weight percent from melts 1-to-2). It is well known that the oxidation potential for the formation of manganese oxide is greater than that for the formation of chrome oxide [3]. It is likely that preferred formation of manganese oxide in the dross or on the charge during melt-in helps to minimize the loss of chrome through oxidation. Apparently, a manganese level greater than 0.09 and perhaps greater than 0.16 weight percent is insufficient to form the Mn-rich dross layer on a melt of 17-4PH. As a result of the third melt, the Cr level had dropped to below the specification

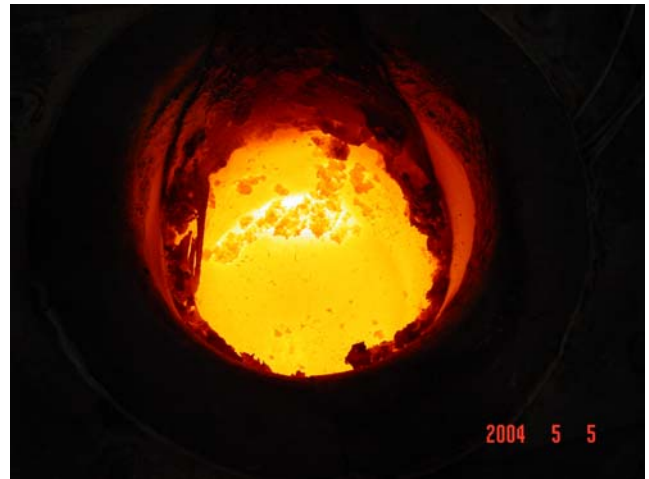
Figure 2: An example of a test crucible is shown above after pouring off the heat. Note the heavy dross left at the melt line.

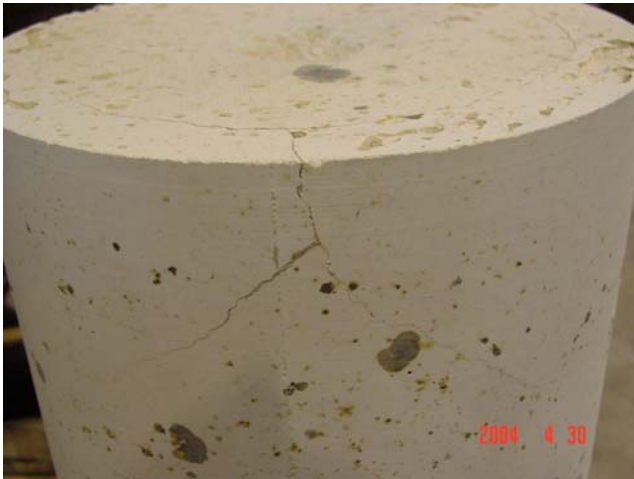
Figure 3: An example of conditions typically observed on many crucibles after testing is shown above (note the cracks). The dark spots were simply “discoloration” from an unknown source and not evidence of metal penetration.

All of the crucibles cracked to some extent as a result of the thermal cycle and/or extraction from the coil box (Figure 3). This seems to be normal in our experience. Crucible D056 cracked just above the melt line while melting the charge which is unusual. Crucible 043 cracked on the bottom during the run and a small amount of molten metal leaked into the dry ram. This may have been due to unevenness in the dry ram below the crucible.

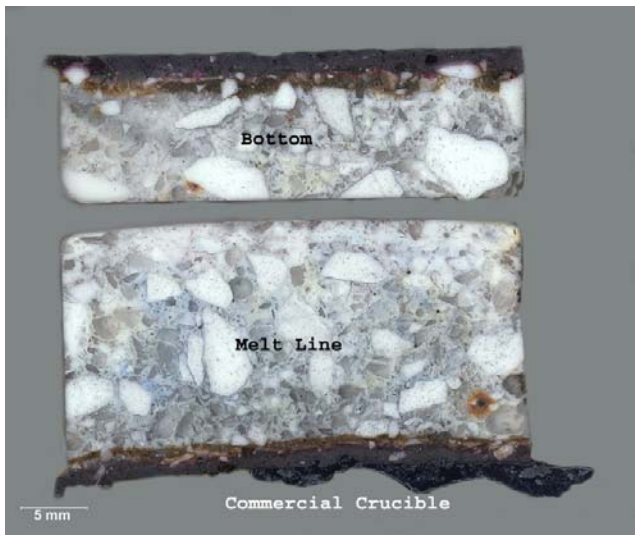
Figure 7: Photomacrograph of the core sample cross sections are shown above. No evidence of erosion of the crucible was observed. Note that the back side of the bottom sample had been cut off to facilitate mounting.

Photomicrographs of cross sections through the crucible bore samples are shown in Figures 4-7. In general, all but the commercial crucible showed obvious erosion at the melt line. It should be noted, however, that the commercial crucible was

the third in the melt order and the cross buildup during this melt was very heavy. Perhaps the cross could have formed a heavy, viscous layer at the melt line where the heavy erosion was observed on the other crucibles.

The third crucible tested was a commercially available unit. This crucible consisted of a silica-magnesia matrix with an alumina aggregate. It should be noted that the alumina aggregate appeared to be quite a bit finer on the inside (metal side) of this crucible. There was a distinct lack of penetration or erosion at the melt line (Figure 7) and with the exception of some chrome rich drossy material that was adherent, the bottom crucible section remained untouched by the molten metal (Figure 10).

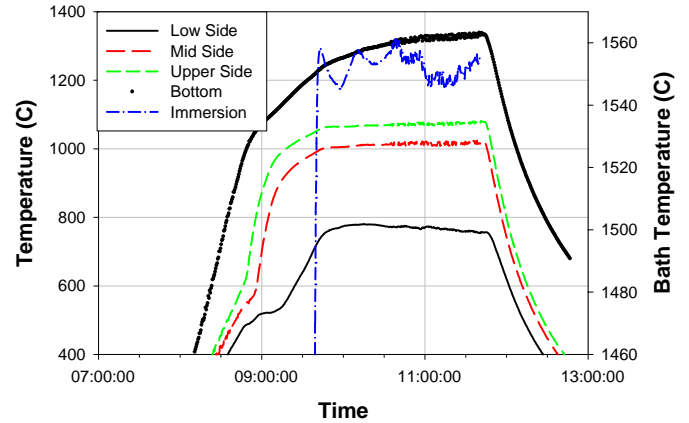
**Commercial Crucible**

Figure 15: The crucible outside temperature (left axis) and bath temperature (right axis) are shown versus time in the plot shown above.

The thermocouple data from each of the melt tests are shown in Figures 13-16. The temperatures on the outside of the crucible ranged from about 800C at the upper wall to over 1300C on the crucible bottom. Note that the upper thermocouple was above the melt line. Considering that the average metal temperature during the melt was 1540C, the temperature gradient through the crucible wall was observed to be on the order of 300-500C. In general, the immersion thermocouple was quite useful for maintaining the bath temperature. In each of the plots, one can see how the immersion thermocouple responded to manual changes in KW settings. Dip readings were also taken at various times during the runs as a secondary check of the temperature. In most cases, these readings were lower than the immersion readings and as such are only reported for crucible 048. This disparity in temperature readings was likely due to a buildup of metal and dross on the tip of probes (dip probes were reused several times) as well as the location of the reading (always near the bath surface, as opposed to an inch or two submersed). During the initial test of crucible 048, a gradual fall of the bath temperature was observed. Meanwhile, the dip readings were beginning to read above that of the immersion readings. Further investigation revealed that the immersion thermocouple junction was just at the bath surface and starting to fall below due to dross formation. Immersing the probe further into the bath corrected this problem, giving a truer reading. A corrected version of the immersion readings is also given in the plot. The average temperature over each of the runs was about 1540C (~2800F).

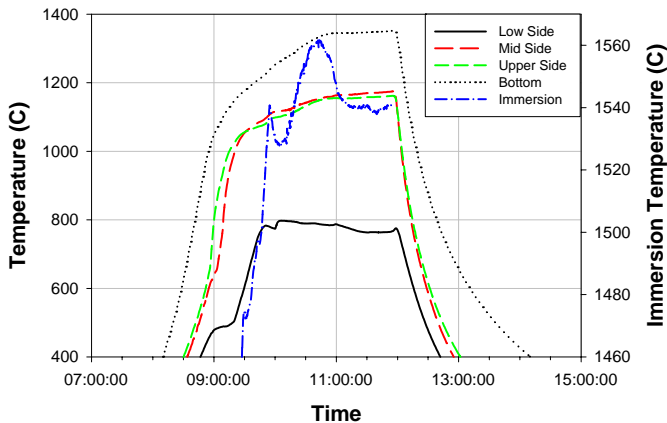
**Test Crucible 056**

Figure 14: The crucible outside temperature (left axis) and bath temperature (right axis) are shown versus time in the plot shown above.

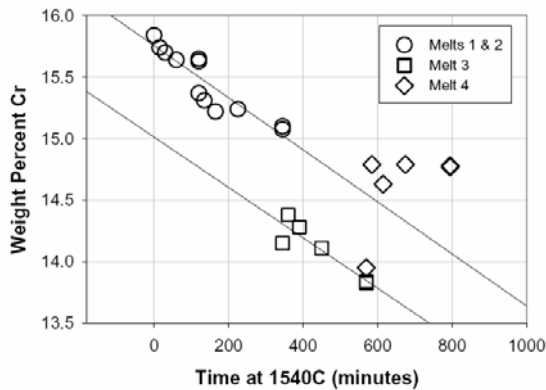
Figure 17: Weight percent chrome is plotted above as a function of hold time at 1540C. Melts 1 and 2 are grouped together while 3 and 4 are plotted separate. Two regression lines are plotted: one for melts 1 and 2, a second for melt 3.

During melt processing of each of the heats, melt samples were taken at melt hold times of 0, 15, 30, 60, and 120 minutes. The results of the chrome analysis are shown in Figure 17. Melts 1 and 2 are grouped together and a linear regression line fits the data well. Melts 3 and 4 are plotted separately. A linear regression line has been fit to the melt 3 data. It is clear from the plot that melts 3 and 4 are distinctly different from the combined results of melts 1 and 2. Ferrochrome and manganese additions were added at the beginning of melt 4 which explains the different results for this heat. The evidence from this plot suggests that something was different during the third melt heat up. The only other
