High Temperature Erosion Testing in a Gasifier Environment

J. Tylczak¹, J. Rawers¹, and T. Adler¹

¹Albany Research Center, USA

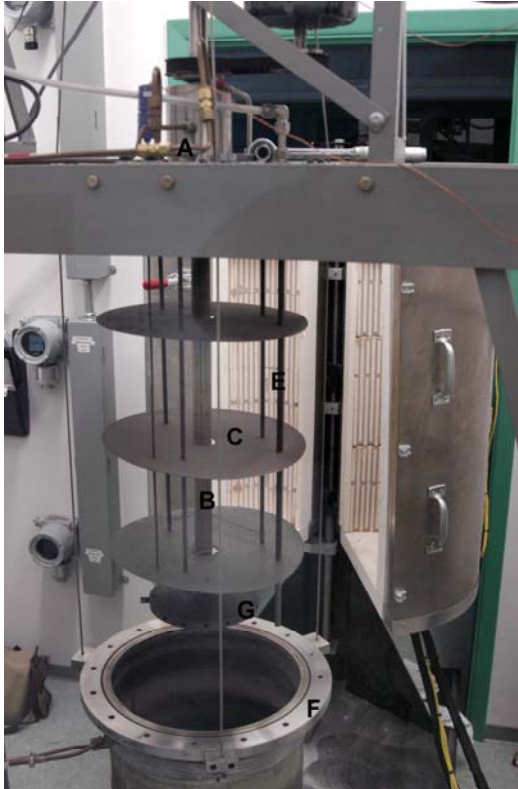
Components of HAET apparatus:

- A Lid
- B Drive shaft
- C Heat shields
- D Abrasive feed tube
- E Gas inlet/outlet tubes
- F Retort
- G Sample mounting disk
- H Samples

Figure 1. Picture showing an overall view of the HAET apparatus.

The HAET test apparatus, fig 1, was designed to simulate the abrasive material, hostile environment, and processing machinery/systems in the power industry, thus helping the industry identify materials that will minimize costly, dangerous, and frustrating wear problems.

The lid (A) holds the drive shaft (B), heat shields (C), abrasive feed tube (D), and gas inlet/ outlet tubes (E). Prior to operation, the retort (F) was brought up to the lid of the apparatus, creating an enclosed test environment. The long drive shaft (B), which is driven by a variable speed motor and supported by both a bearing and a gas tight feed through, is inserted vertically through the lid. The drive shaft holds and rotates the central assembly's sample mounting disk (G). The drive shaft provides the velocity component of the abrasion test.

The test samples (H) were attached to a 17-cm diameter sample mounting disk (G) which was at the lower end of the drive shaft (B). The distance from the lid (A) to the sample mounting disk is about 63 cm. Test samples (12 x 10 mm) were capacitive discharge welded to 6.4 mm diameter 304 SS stubs. These stubs, with the samples attached, were inserted in the periphery of the sample mounting disks and locked into place with wires that were fed through holes in both the disks and the stubs, as shown in figure 2. The disk/sample assembly looks somewhat like a ceiling fan made with small sample "blades". For a sample erodent impact velocity of 20 m/sec eight samples at a time attached to the mounting disk.

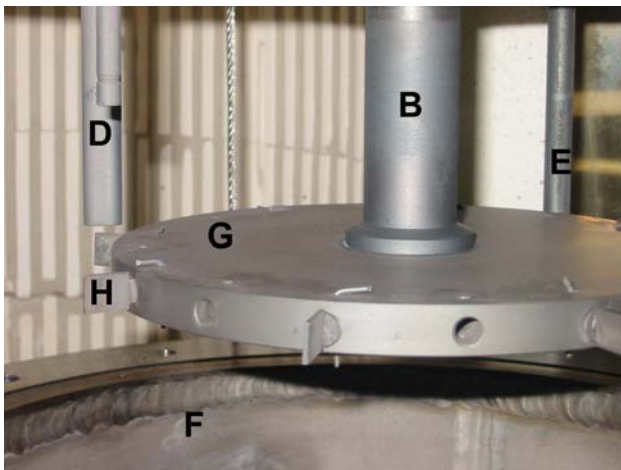
Figure 2. Parts associated with HAET apparatus. Note in this case the test specimens are mounted in alternating locations in mounting disk for testing at 20m/sec erosion velocity.

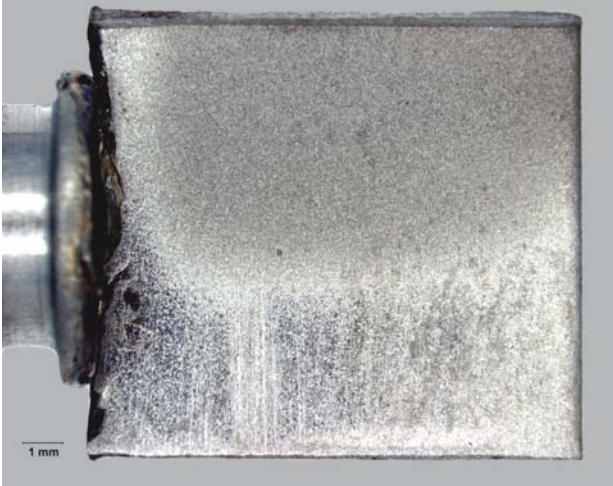
Figure 3. . A Waspaloy sample after room temperature testing that shows the typical roughing of the surface during testing.

All of the materials tested at room temperature with an erosion velocity of 20 m/sec performed well. The visual inspection of each sample noted no more than a roughing of the upper 3/5th of the surface that was exposed to the erosion. Figure 3 shows a typical sample after testing at room temperature. The lack of corrosion and much erosion was further verified when the samples were weighed and very low levels of weight loss were measured.

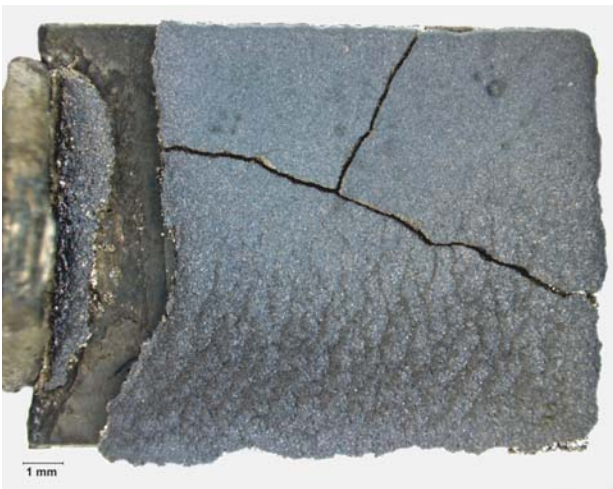
Figure 4. The 9 Cr 1 Mo sample after testing at 700°C. The thick fragile upper scale is partially removed exposing the next layer of scale.

While 9 Cr 1 Mo steel performed essentially the same as other materials at room temperature, this was visually the worst performing material tested at 700°C. Both the corrosion and the erosion/corrosion specimens showed virtually no differences. In both cases there was a thick outer scale that sloughed off easily during handling. Figure 4 shows a 9 Cr 1 Mo steel sample after testing. The upper thick layer of scale has broken free showing a lower more adherent layer below. On the eroded/corroded sample there was some discoloration of the outer layer where the erosion took place, along with some smoothing of this outer rough scale. Below the outer scale was a thick dark inner scale. This scale was very smooth, still showing polishing features of its preparation. Finally below this layer was the metal with a thin layer of corrosion on the surface. The metal was mostly consumed during the test.

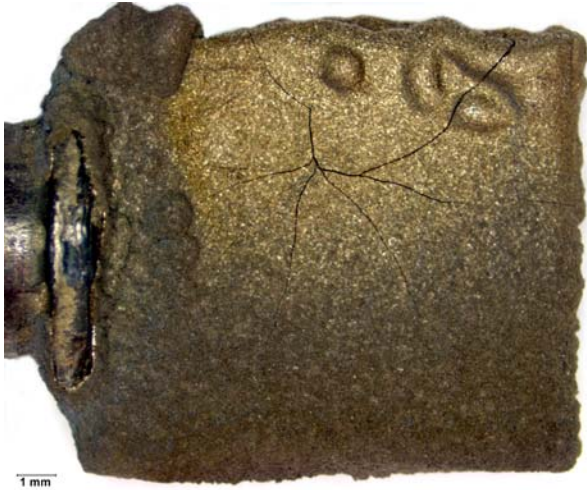
Figure 5. Waspaloy sample eroded at 700°C in a gasifier environment. Specimen shows cracking emanating from the erosion/corrosion zone.

The Waspaloy after the 700°C test showed a corroded surface with a fairly thick rough scale that had a fine surface structure. The eroded/corroded surface showed a similar scale away from the erosion zone. At the erosion zone, figure 5, the surface appeared smoother due to the erosion impact. It was shinier and gold in color. Cracks were also seen radiating from the erosion zone, caused by the stresses as this compacted scale layer cooled off.

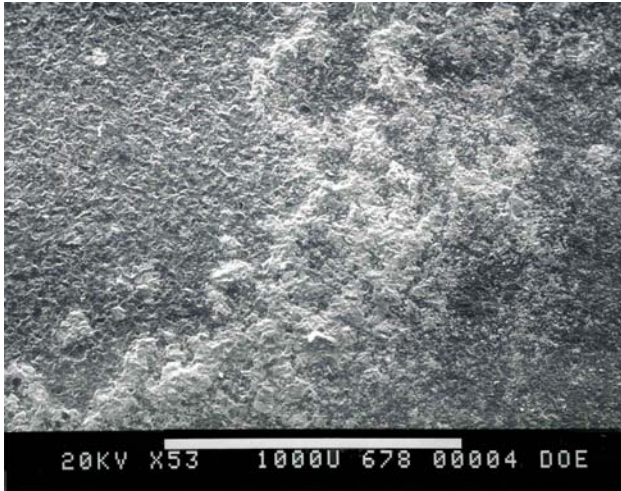
Figure 6. Fe₃Al specimen, showing eroded/corroded zone in upper left and transition to just corroded area.

The eroded/corroded surface showed a generally beaten surface with fragments of silica embedded in it. EDS analysis of the surface generally verified this observation with about 15 pct silica, while Al percentage was enriched from the 1 to 3 ratio found in the base alloy, and 5 pct S was the last element found in any large amounts. Since the EDS used

does not detect oxygen, it is surmised that S is associated with Fe, while the excess Al is an alumina compound. EDS showed that a light-colored scale area, as shown in fig 6, below the eroded/corroded zone consisted of FeS compound. Below this, the remaining surface was generally Al, presumed to be alumina, and some Si, presumed to be silica from the abrasive. It is thought that the alumina should be the general protective surface but the impact with the silica breaks the fairly brittle alumina and removes it.

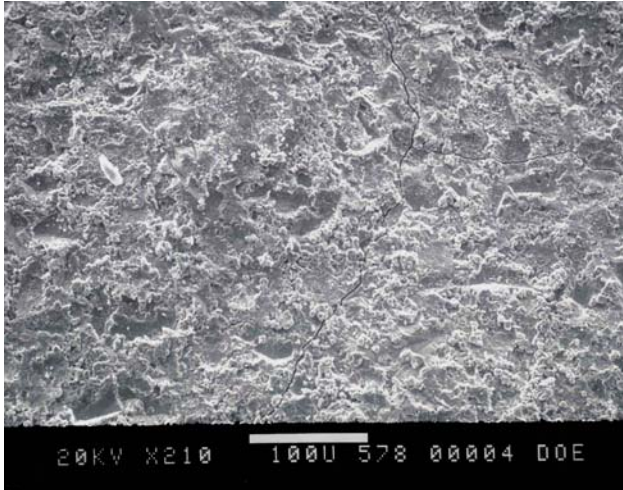
Figure 7. SEM image of HR-160 showing compacted surface scale from erosion/corrosion process.

The HR-160 sample, fig 7, showed various corroded/scale layers. Using EDS analysis on the different scale layers it was found that in the eroded/corroded region the thick scale layers were largely a (Fe, Ni)S compound. As the layers got thicker the ratio of Ni increased. Only in areas of thin scale was much Cr found. The metal in these thin scale areas was predominately Cr, with half as much Fe, a quarter as much Ni, and lower amounts of Co. The metal ratios continued to show a (Cr, Fe, Ni, Co)S compound was being formed. Along with the metals and S forming the surface scale, silica was mixed with the scale. Moving away from the eroded/corroded region the scale layer thinned out and the silica content decreased.

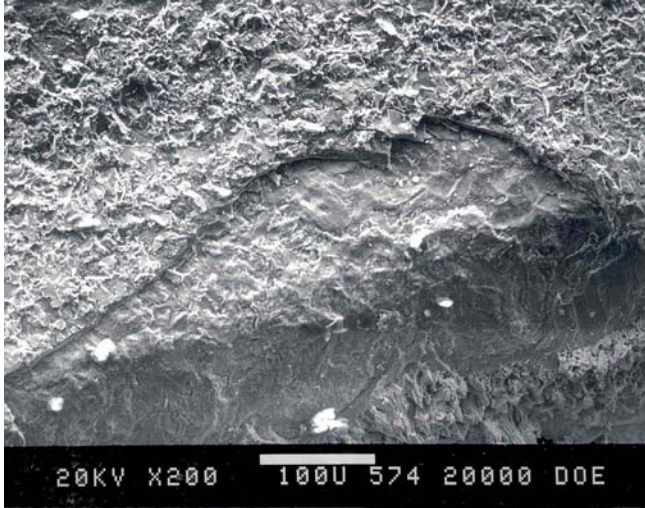
Figure 8. Image of edge of the eroded/corroded zone from the Waspaloy specimen. Picture shows a small area where the outer scale has been removed showing the two inner scale layers.

The Waspaloy showed at least three different scale layers. In the eroded/corroded region the process of erosion thinned the thick outer scale. This outer scale was of similar composition across the surface, being a high Ni, Fe, Mo, Co, Cr sulfide. This outer scale was fairly fragile and easily removed. Below this outer thick layer was a thin scale layer

of varying composition. In this region there were areas that showed Mo, up to 14 pct, along with the Ni, Mo, Fe, and Cr. Below this layer was at least one further that showed fair amounts of Ti (up to 9 pct) and Cr (up to 40 pct) with some Ni and Fe. Fig 8 shows an area in the erosion/corrosion zone where the outer scale has been removed. The second layer of scale shows damage from the impact of the erodent. The impact-scale can be compared to the non-impact scale by looking down the corner of the specimen.
