# DEMOLISHING A COLD-WAR-ERA FUEL-STORAGE BASIN SUPERSTRUCTURE LADEN WITH ASBESTOS

To Be Presented at WM09 Conference

### Demolishing a Cold-War-Era Fuel-Storage Basin Superstructure Laden With Asbestos - 9475

The K East (KE) Basin facilities are located near the north end of the Hanford Site's 100 K area. The facilities were built in 1950 as part of the KE Reactor complex and constructed within 400 meters of the Columbia River, which is the largest river in the Pacific Northwest and by volume the fourth largest river in the United States. The basin, located adjacent to the reactor, was used for the underwater storage of irradiated nuclear fuel discharged from the reactor. The basin was covered by a superstructure comprising steel columns and beams, concrete, and cement asbestos board (CAB) siding. The project's mission was to complete demolition of the structure over the KE Basin within six months of turnover from facility deactivation activities.

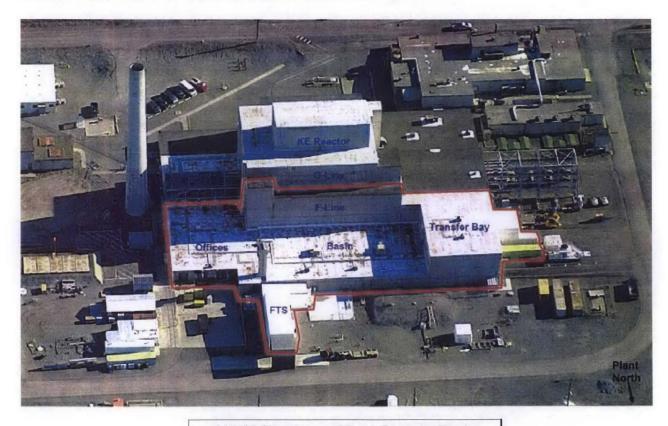
105KE Reactor and Fuel Storage Basin

Fig. 1. This aerial view shows the superstructure covering the KE Basin facilities.

The project scope included the KE Basin superstructure covering of the basin proper, the Fuel Transfer Station (FTS), the office complex, the transfer bay and the F-to-G line portion where the superstructure is attached to the main reactor building (Fig. 1). The basin's superstructure was primarily steel columns and beams covered with cement asbestos board (CAB) siding and CAB/built up roof. The superstructure built immediately over the basins and transfer bay ranged from 5 meters to 12 meters high and was 23 meters wide and 71 meters long. The F-G Line, or reactor basin interface area, ranged in height from 12 to 22 meters high, 5 meters wide, and 71 meters long. The office area was 5 meters high, 17 meters wide and 22 meters long. The FTS annex was a metal-skinned steel structure built in the early 1980s.

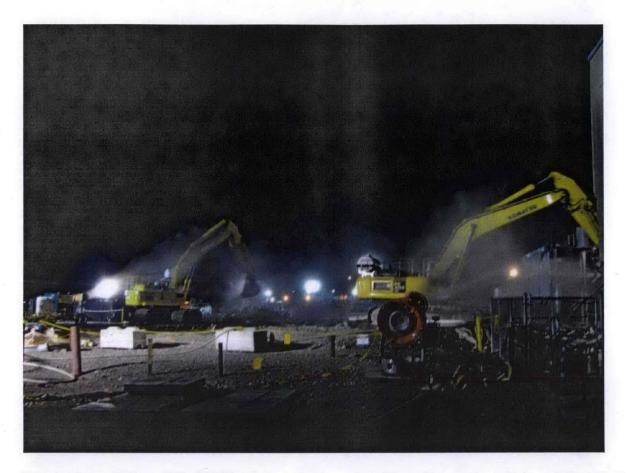
Fig. 2. Demolition of the KE Basin's superstructure literally continued round-the-clock.

The demolition progressed with two 10-hour shifts. The day crew focused on demolition because the lighting provided better working conditions, especially with the high-reach operations. The night shift demolition crew's focus was on removing waste and packaging the material demolished during the day shift (Fig. 2).

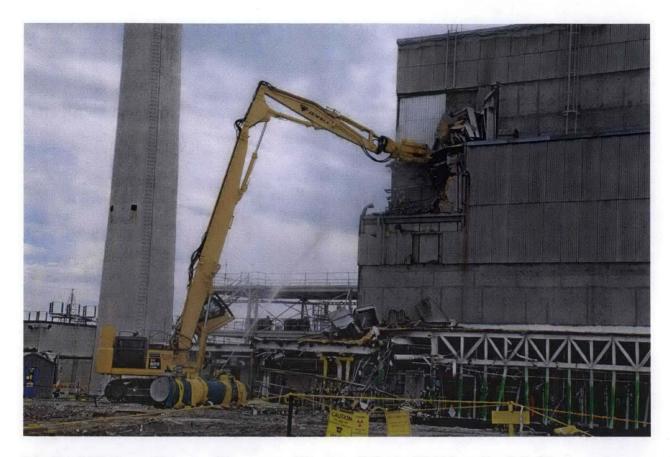
Fig. 3. A high-reach excavator was used to demolish the F-G (reactor interface area) area.

The taller sections of the project were removed by a high-reach demolition excavator (Fig. 3). This equipment provided a safe method to bring the building to the ground while minimizing damage to the reactor wall as the floors were structurally "tied" into the reactor wall. All piping and conduit penetrations of the wall were isolated during demolition preparation activities, so there was no concern about damaging the wall or items on the other side of the wall.

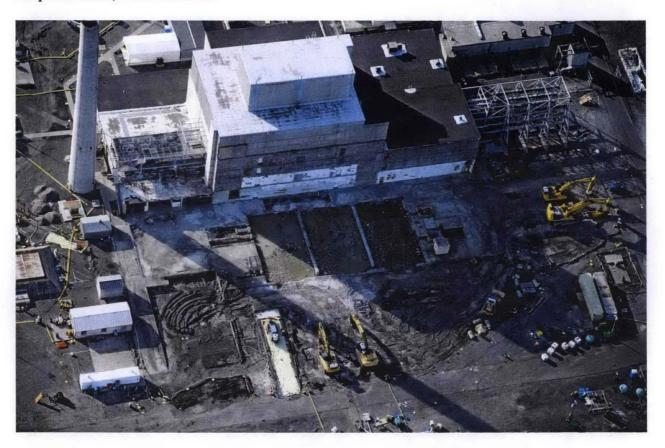
Fig. 4. The superstructure has been completely removed to slab-on-grade.

At the conclusion of the basin superstructure demolition activities (Fig. 4), the area was prepared for phase three, basin removal.
