# Butt Joint Tool Commissioning

N. N. Martovetsky

December 7, 2007

Re: Butt joint tool commissioning

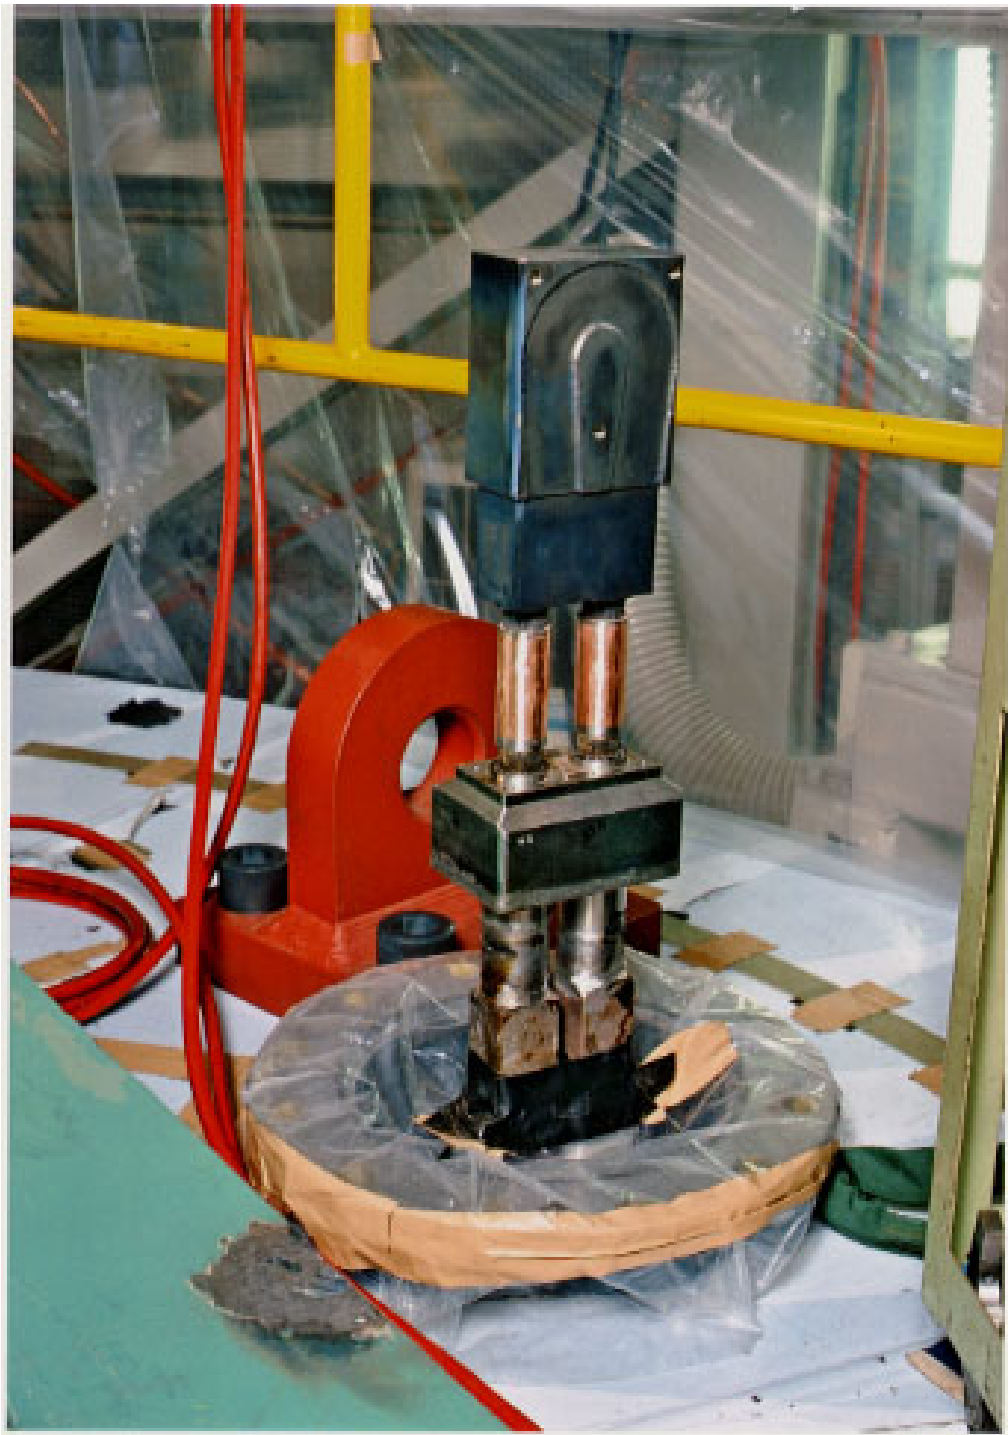
Fig.1. CSMC butt joint which joins two layers by a hairpin jumper, so two interfaces are in the joint. The joint interfaces are difficult to see after bonding. They are in the middle of the copper sleeves (Courtesy of Y. Takahashi).

The CS butt joint has to carry the hoop load. The straight length of the joint is only 320 mm, and the vacuum chamber around the joint has to have a split in the clamp shell. These requirements are challenging. Fig.1 presents a CSMC joint, and Fig.2 shows a CS butt joint.

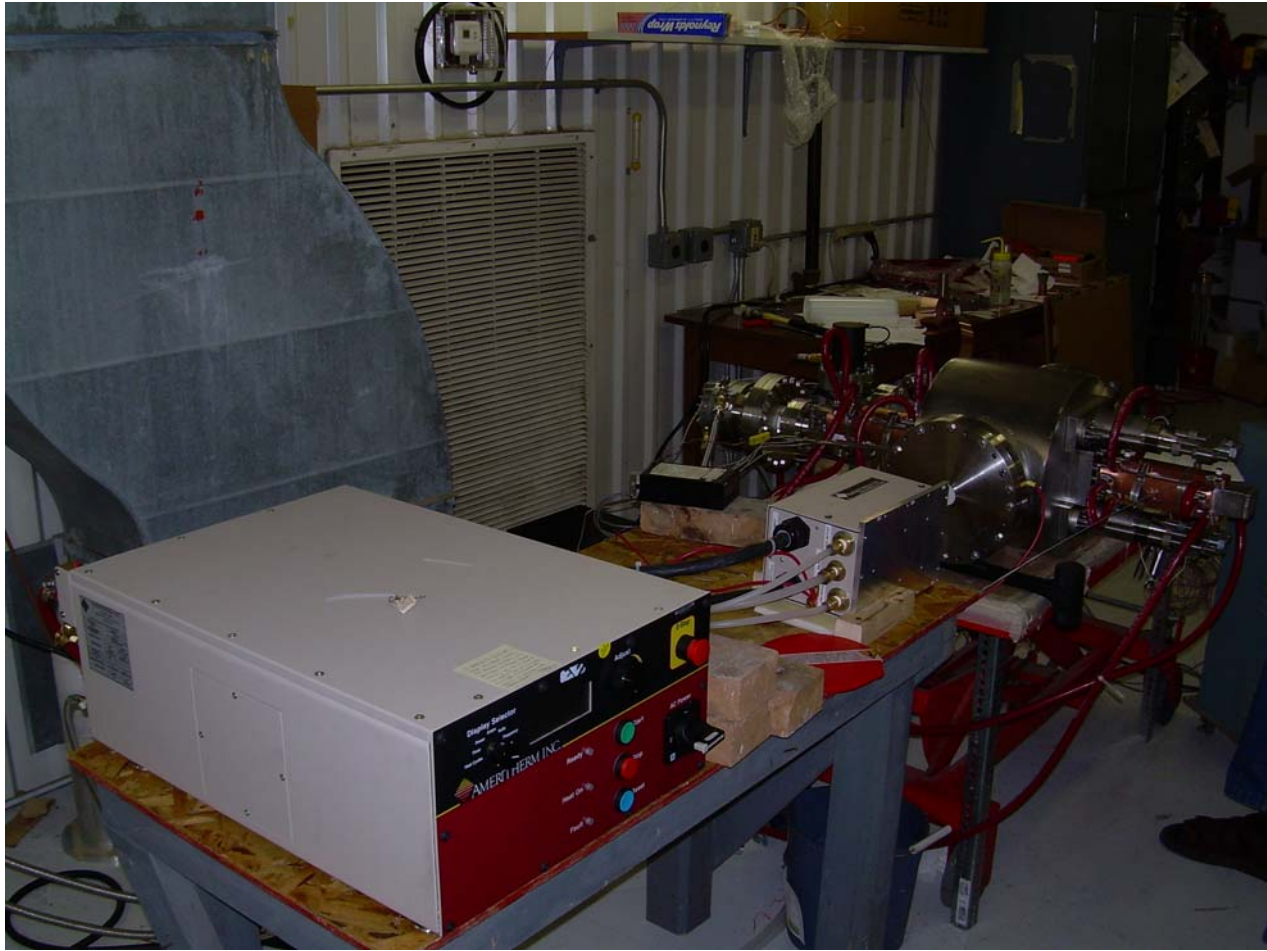
Fig. 4. The butt joint joining system shown from the side of the power supply and the remote station, connected to the induction heater coil.

The induction power supply and heating station are seen in Fig. 4.

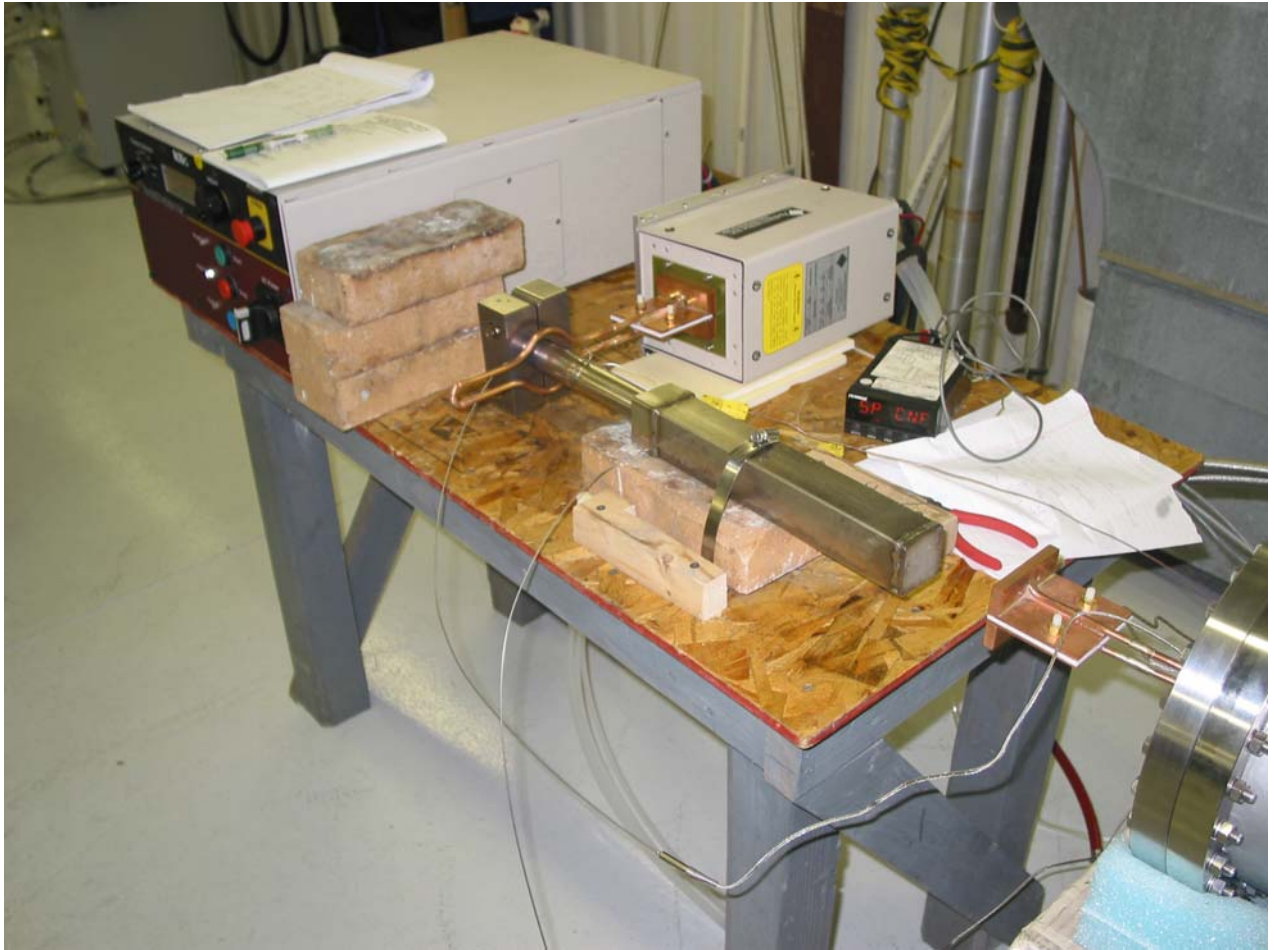
Fig. 9. A bench test with a clamp near induction coil to check heating efficiency.

Thus we learned that with the existing setting of the machine, the copper sleeve and the cable do not absorb the heat effectively from the induction power supply. Therefore, something needed to be done to improve the heating efficiency. We realized that in our configuration the copper sleeves were held by the 4340 steel clamps and the clamps would absorb significant amount of power from the power supply. If they readily transfer heat to the copper sleeve, it is all we want. We set up a simple and quick arrangement as shown in Fig. 9 and reran the test.

During this test, the power supply was able to find a resonance frequency at about 401 kHz, and we were able to reach about 360 C after 20 min of running. At 100% of the voltage, the current was about 22%, which is significantly lower than the optimal current in the loop (typically better than 70%). It was clear that the steel clamp receives most of the heat, not the copper. We decided to proceed with our coil inside the vessel. Although 360 C is far away from desired 750 C, we thought that: 1) the vacuum would help to reduce the heat loss, and 2) the energy deposition in the working piece would double since there would be two clamps, one on each side instead of just one as in our bench test, so may be we were already within requirements.

We assembled the piece as shown in Fig. 9 and tried to run the test. Unfortunately, the power supply could not find a resonance again. We contacted Dan Phelan again and he told us that the power supply works OK, but our coil and the working piece are outside the optimal parameters of the power supply therefore something needs to be changed. He asked us to measure the inductance of the coil, which we did and sent him the data. He said that the inductances are too small and recommended that we introduce a

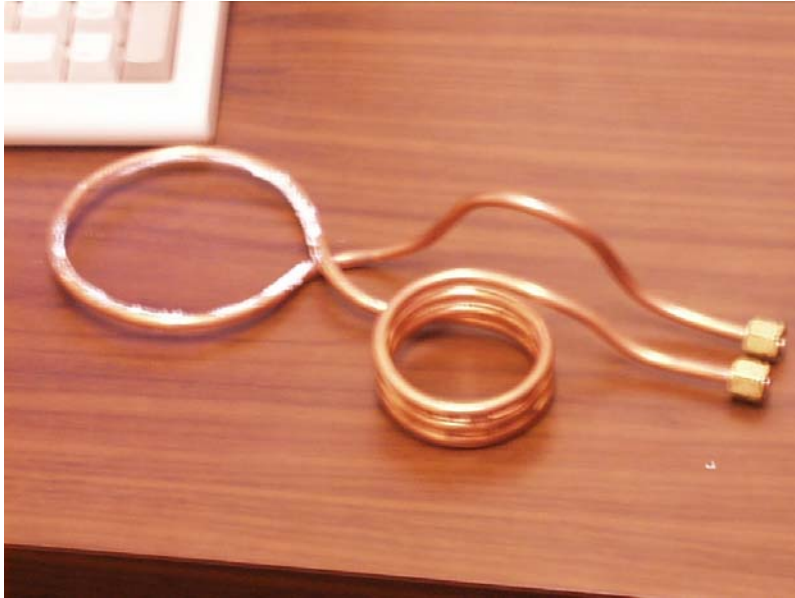
Fig. 10. An example of an induction coil with a parasitic inductance.

parasitic inductance. Marc Sipes, Ameritherm, sent a photo illustrating the idea of the parasitic inductance, Fig. 10.

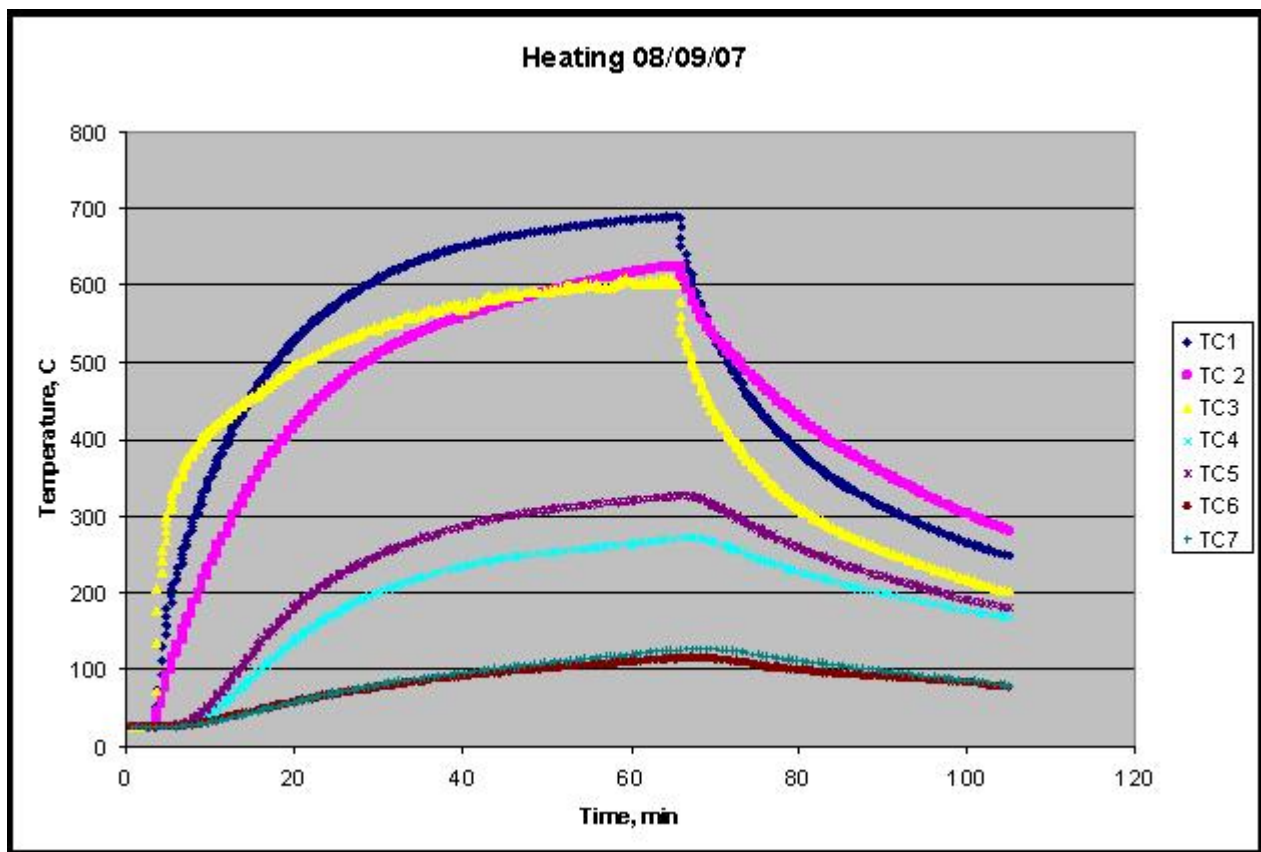
Fig. 12. Temperature traces from the 8/9/07 run.

The trace of temperatures from this run is given in Fig. 12. We did not log the temperature of the vessel wall itself, but a fan blowing ambient air kept the temperature of the vessel at 62 C or below. It was too hot to touch, but not a safety concern.

After about 65 min elapsed time, the PS shut down due to internal interlock activation (overcurrent or overheating). The overheating for the water is usually set about 90-95 C, according to Ameritherm engineers. We checked the temperature of the cooling water by touch and it was not particularly hot, so we assumed that the interlock activated due to overcurrent in the PS. The frequency of the circuit was 296 kHz and the current at 100% voltage was 61-62%. , According to Ameritherm, this is less than optimal but much better than in the previous runs.

Comparing these results with what we achieved on 8/9/07 (see Fig. 12), we see insignificant improvement in time, and the temperature between the interface and the sleeve under the steel clamp was much more uniform than on 08/09, where this distance was 25 mm. Fig. 14 (top) shows that the right thermocouple, TC3, was not 25 mm away from the interface, but rather 13 mm away. I am suspicious that for the particular run on Fig. 15, the left thermocouple was also 13 mm away, not 25 mm as Fig. 14 suggests.

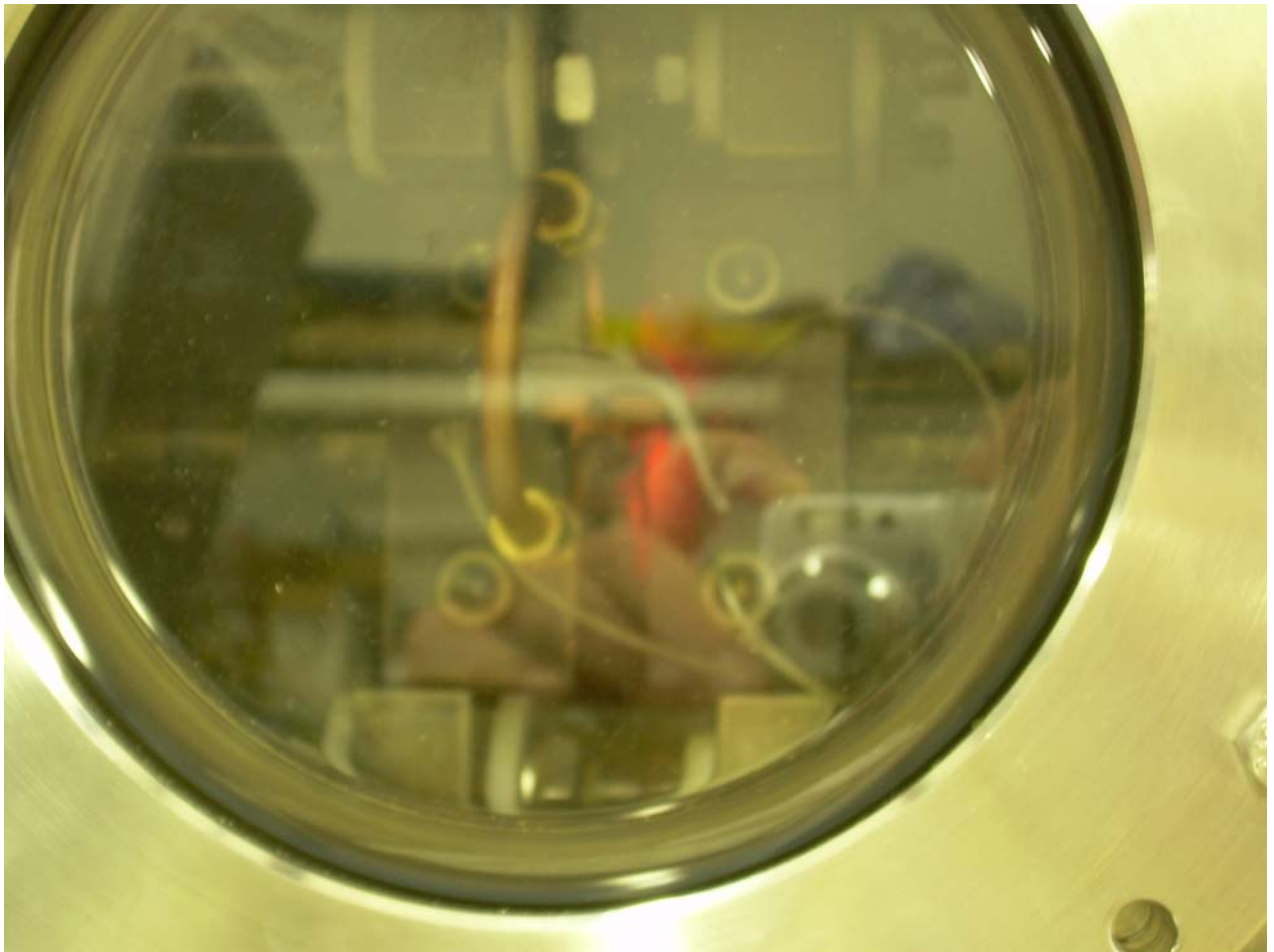
Fig. 13. Butt joint tool during the 08/09/07 run. The glow comes mostly from the clamps.

A significant fraction of the heat came from the clamps. Despite the poor quality, the picture in Fig. 13 (taken from the outside the vessel viewport) shows a glow coming from the clamps, particularly from the right one, and not much from the working piece.

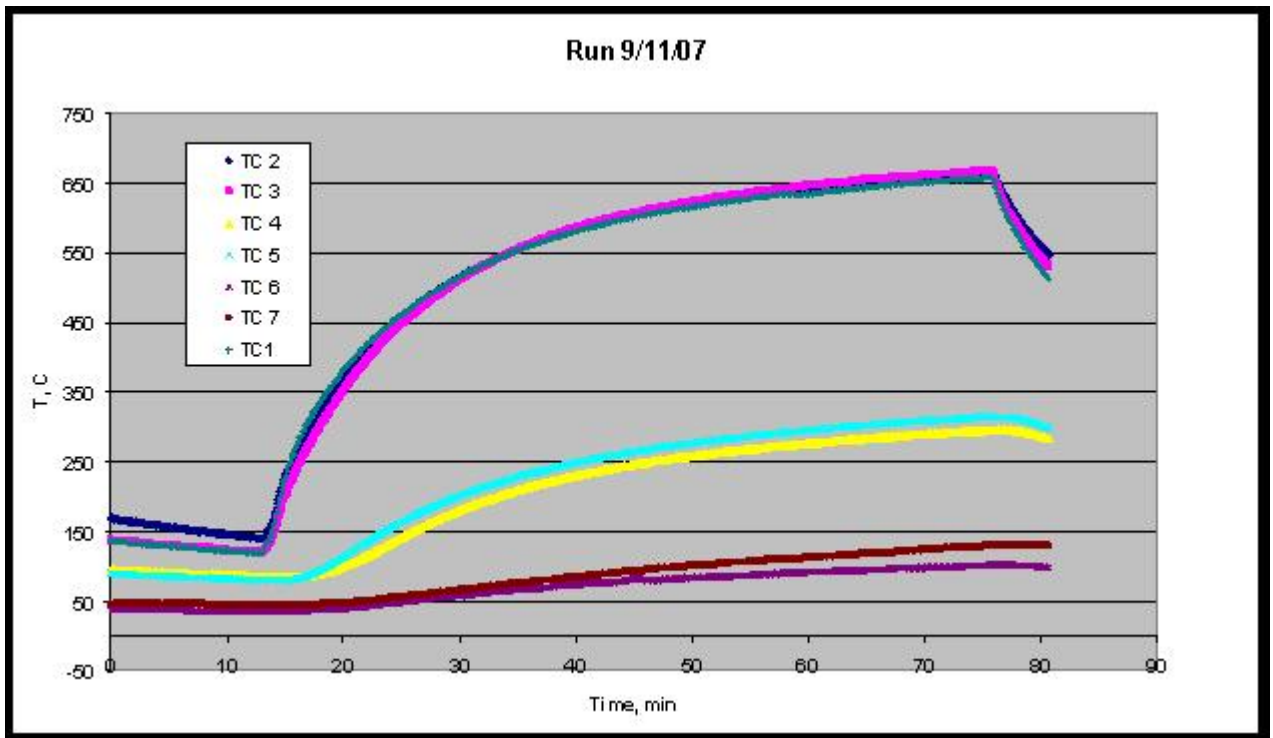
Fig. 15. Temperature traces for the 9/11 run.

The results of this run are shown in Fig. 15. Again, after 75 min, the interlock activated due to the current exceeding the allowed limit and shut down the power supply.

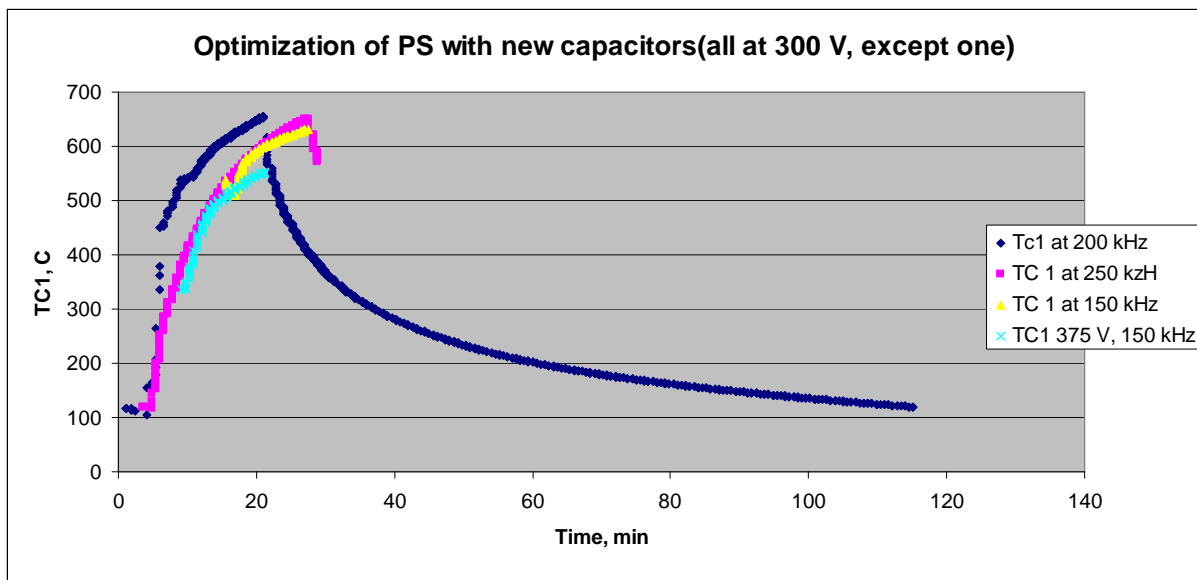
Fig. 16. Optimization of the PS with new capacitors and the steel hot ring 1.

The frequency of the PS was 215 kHz and 200 kHz inductor setting was a little better than 150 or 250 kHz. Increasing of the voltage from 300 to 375 V did not help either. The results are shown in Fig. 16. So, the optimum is somewhere around 300 V and 200 kHz. The current at 100% voltage was at the level of 72%, and at 375 V and 150 kHz it was 55% or so. That shows that the optimum operation is quite sensitive to the settings. But the improvement was obvious; we could reach almost 700 C in 15 minutes or faster.

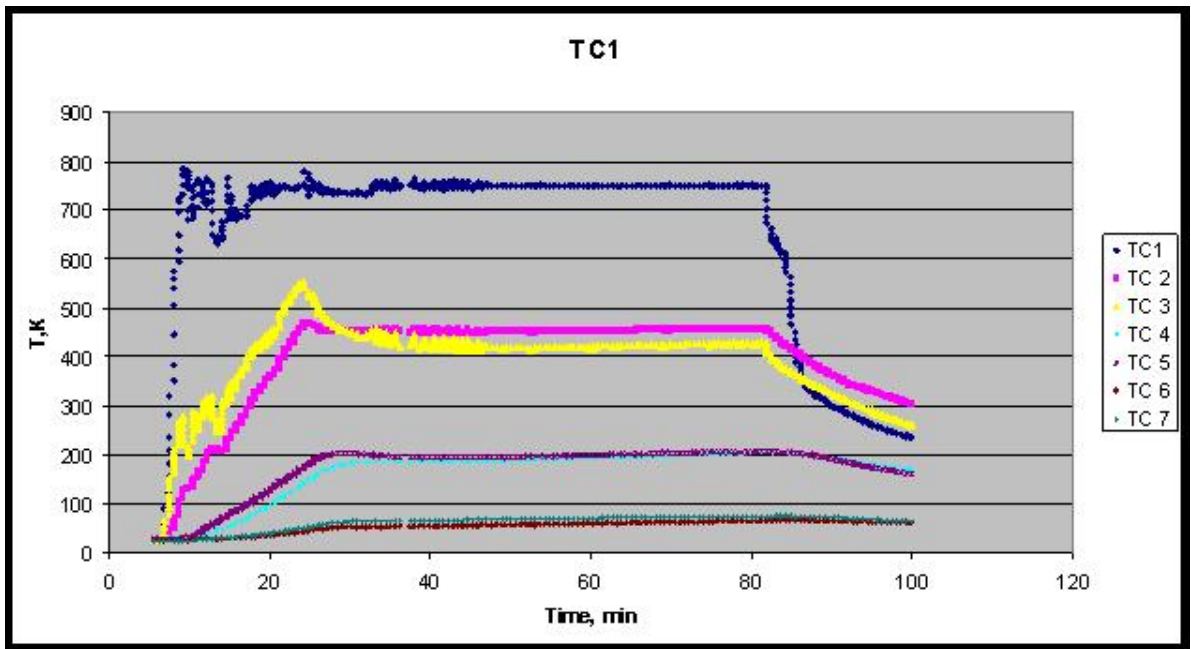
Fig. 19. Temperature traces with the “hot ring 1” installed Sept 21, 2007.

This run took place on the 9/21/07 and showed that indeed the temperature of the butt joint sleeve went up to the desired level very fast. The current at 100% of the voltage was at 72-74 %, which is in the ball park of what Ameritherm told us the optimum should be. After reaching the controlled temperature on the surface of the sleeve 750 C, the power regulated correspondingly. The temperature traces are shown in Fig. 19.

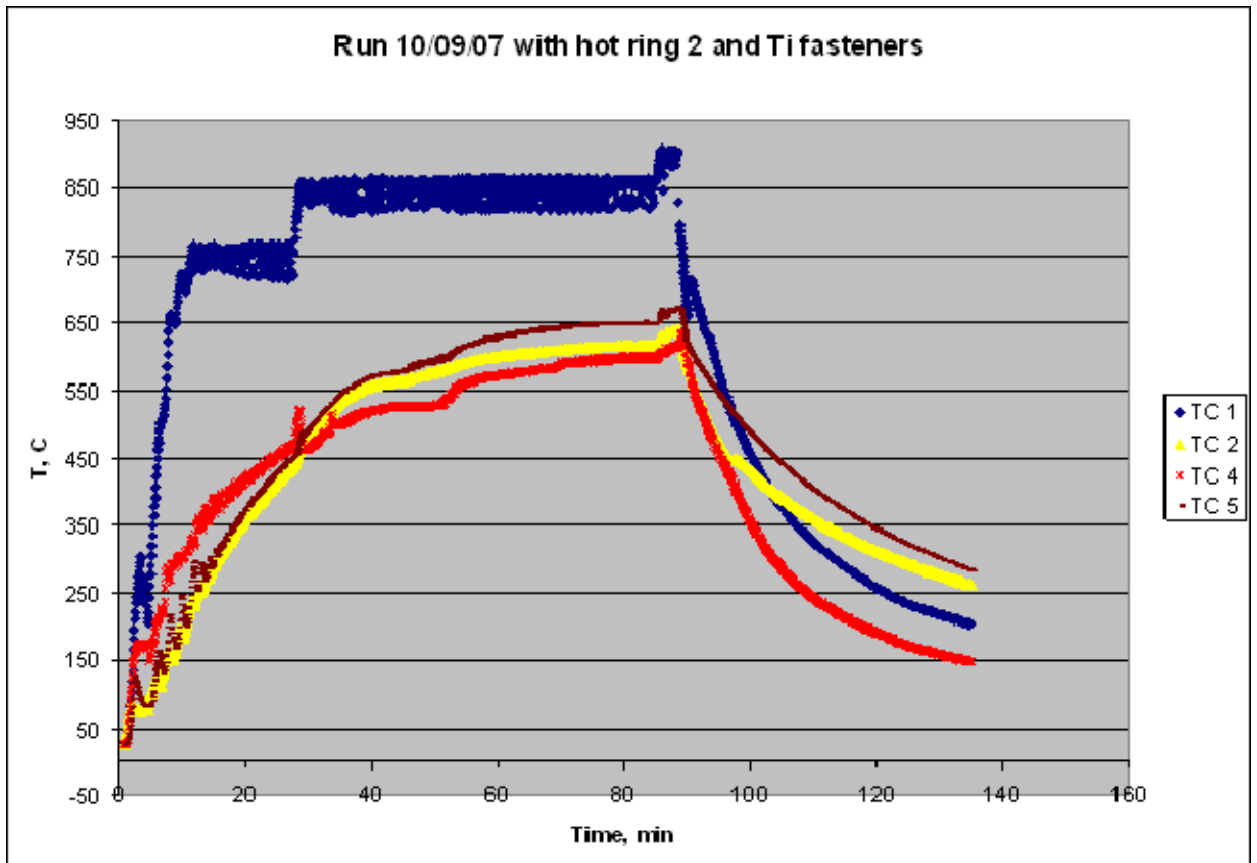
Fig. 22. A successful run with hot ring 2.

Our next trial was with Ti screws and a new hot ring 2, with the same design as before. The temperature traces are shown in Fig. 22.

The thermocouple 2 was inside the middle of the butt joint, about 13-15 mm deep. The TC1 was the thermocouple on the copper sleeve surface and TC1 was the control thermocouple, as usual. The thermocouple inside the sleeve was TC4. The TC2 was the thermocouple touching the sleeve 25 mm away from the joint, routed through the left block and TC5 is the thermocouple touching copper sleeve 20-25 mm away from the joint routed through the right block.

As we can see, the surface of the sleeve gets hot from the hot ring very fast, which is a good improvement. But the temperature inside the sleeve would not go above 480 C in 30 min of “cooking” because the power supply is programmed to maintain the temperature on the surface at whatever we ask (750 C in this case) for the first 30 min. We could see that it took very little energy to maintain 750 C at the surface, and the power supply was constantly turning on and off. That means that the all power was going to the hot ring and not much into the cable. After 30 min we dialed 850 C on the surface, and we got it, but the temperature inside the cable rose to only 600 C after 85 minutes of “cooking”. That suggests that there is a very powerful heat removal along the cable and relatively weak conductance across the cable. This was unexpected; we did not expect that the temperature gradient across the tightly compacted cable could be that high.

We can also see from Fig. 22 that when the power was turned off, the temperature inside copper sleeve dropped faster than outside. This was very much unexpected. Again the only rational explanation to that is that the longitudinal thermal conductivity is much greater than the transverse conductivity. So while the surface has a large hot mass attached to it (the clamps), the inner part of the cable just gives away heat through the longitudinal conductance and cools off faster than the sleeve surface where cooling is slowed down by large amount of heat stored by the clamps.
