FINAL REPORT

MITIGATING THE IMPACTS OF UNCONTROLLED AIR FLOW ON INDOOR ENVIRONMENTAL QUALITY AND ENERGY DEMAND IN NON-RESIDENTIAL BUILDINGS

NYSERDA Agreement #6770
DOE Contract #DE-FC-36-02GO12012

April 26, 2007

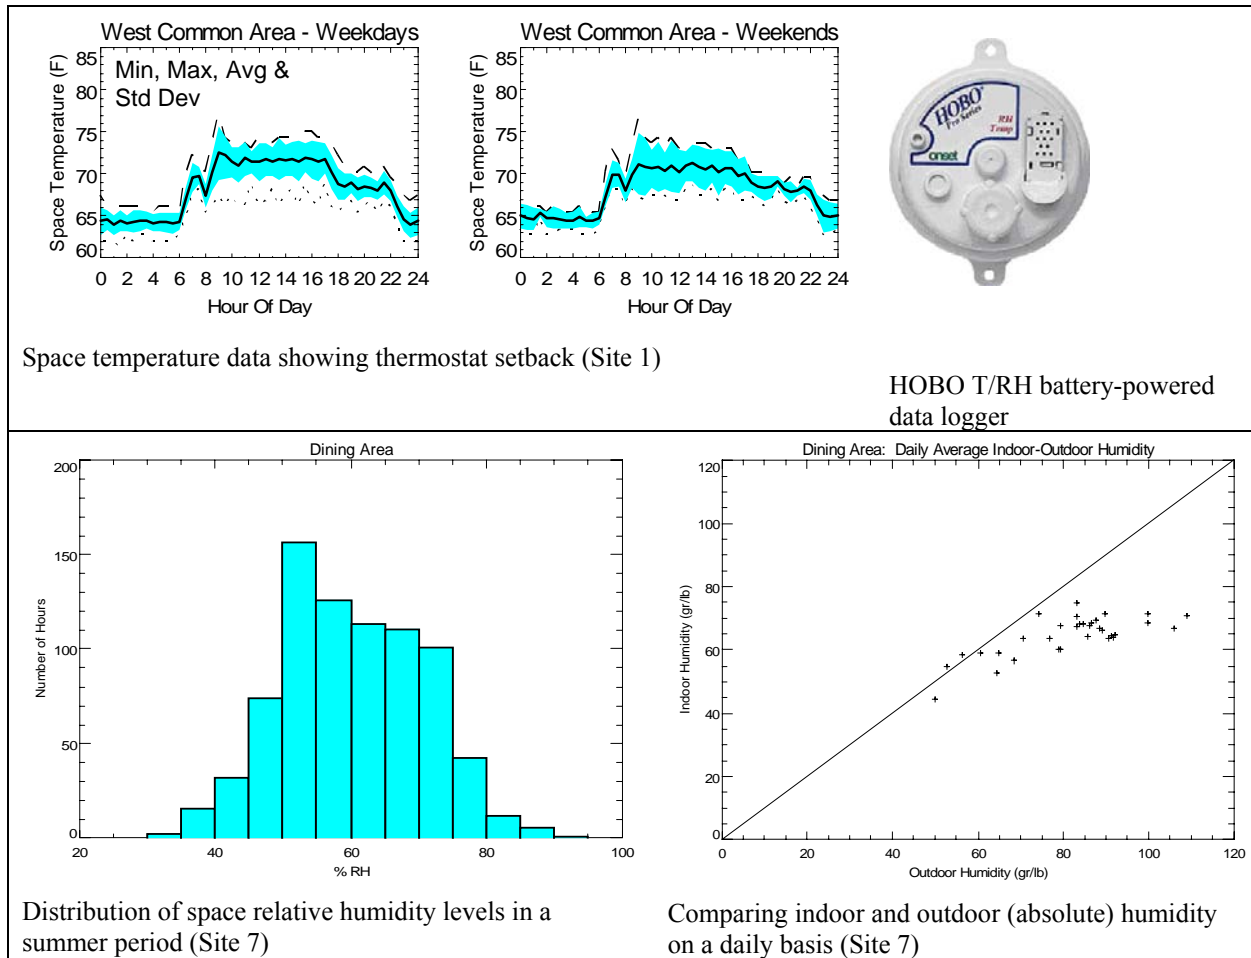
The data from these temperature sensors were used to verify temperature set points as well as to determine heating setback and cooling setup schedules. The T/RH data were used to track humidity levels in the space, which was of particular interest in the summer period. At many sites, outdoor humidity data from a nearby airport weather station was compared to the indoor humidity data to determine the humidity response characteristic.

Figure 2-8. Measuring and Analyzing Space Conditions (Temperature and Humidity)

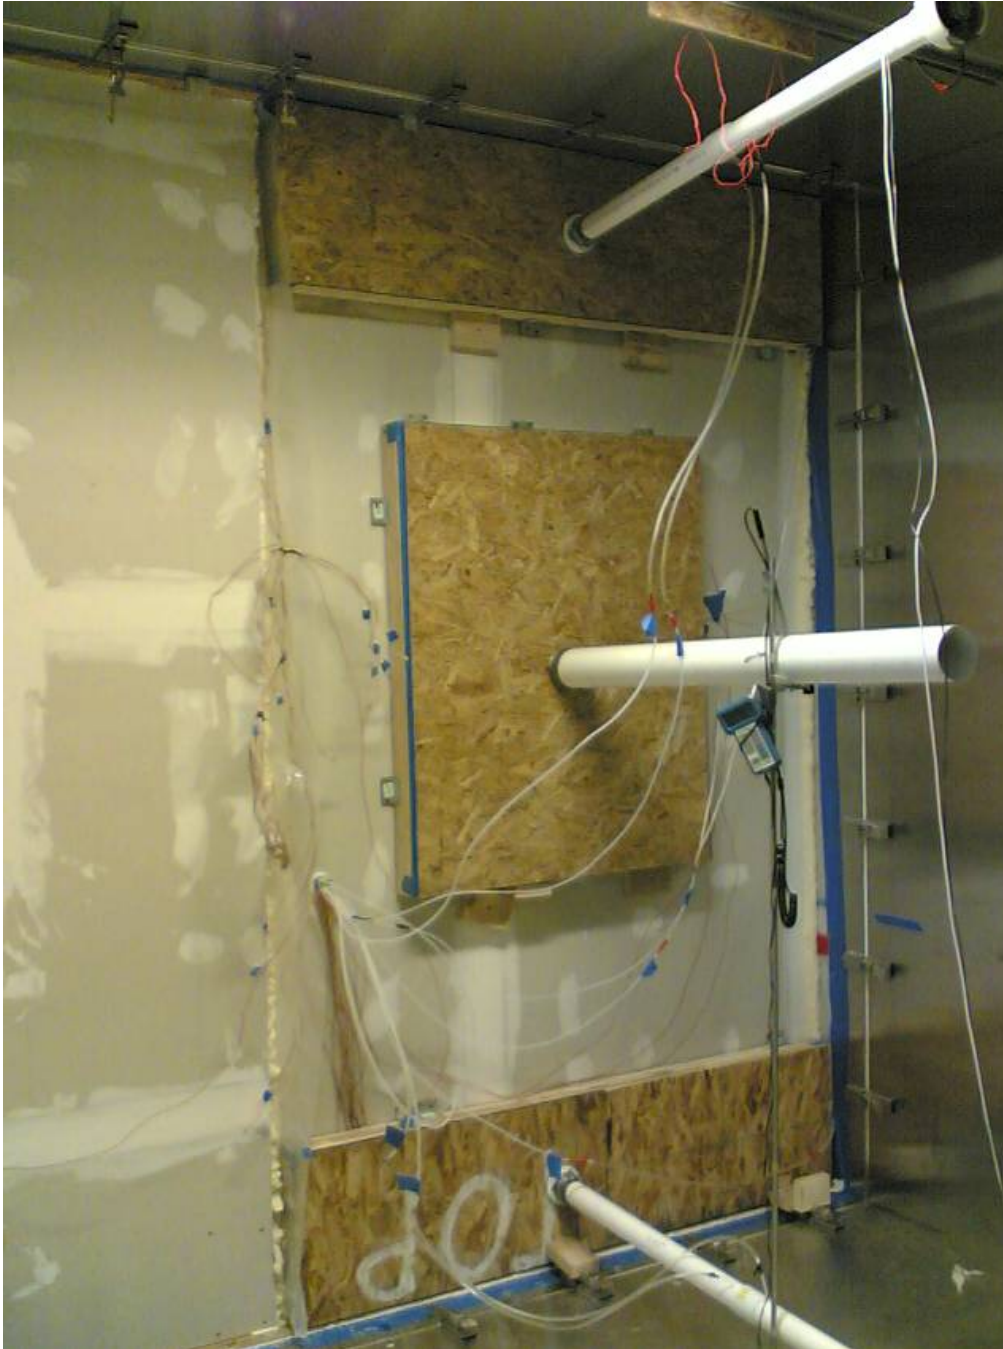
Measurements were made to determine the air leakage paths and overall air tightness of each of the two walls using specially designed boxes to cover leakage sites on the wall (Figure 4-24).

Figure 4-24. Experimental Setup to Measure Air Leakage for Various Wall Sections

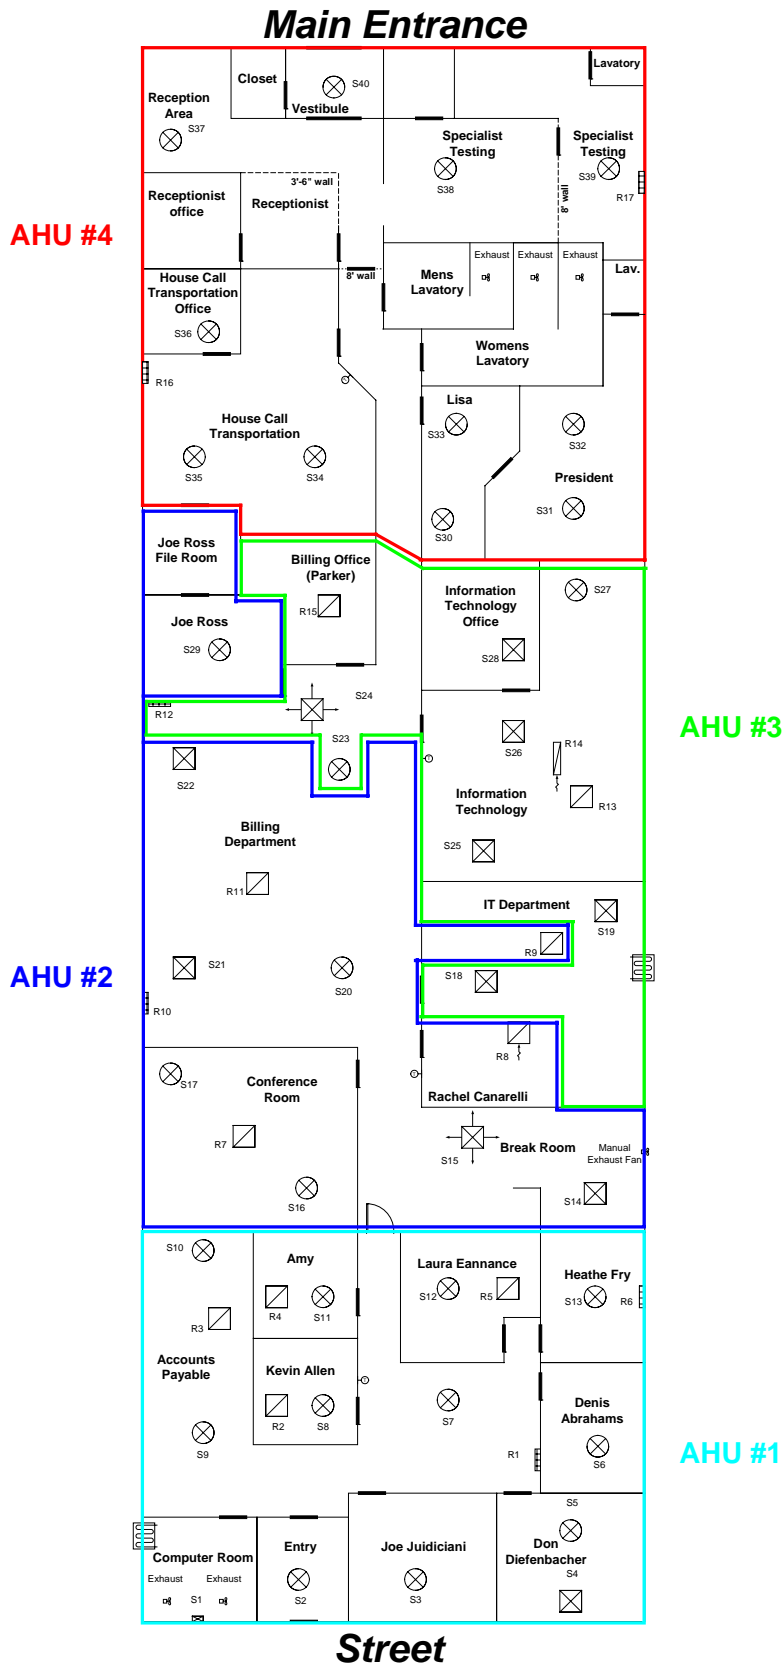
Figure A4-8. AHU Zones within Building

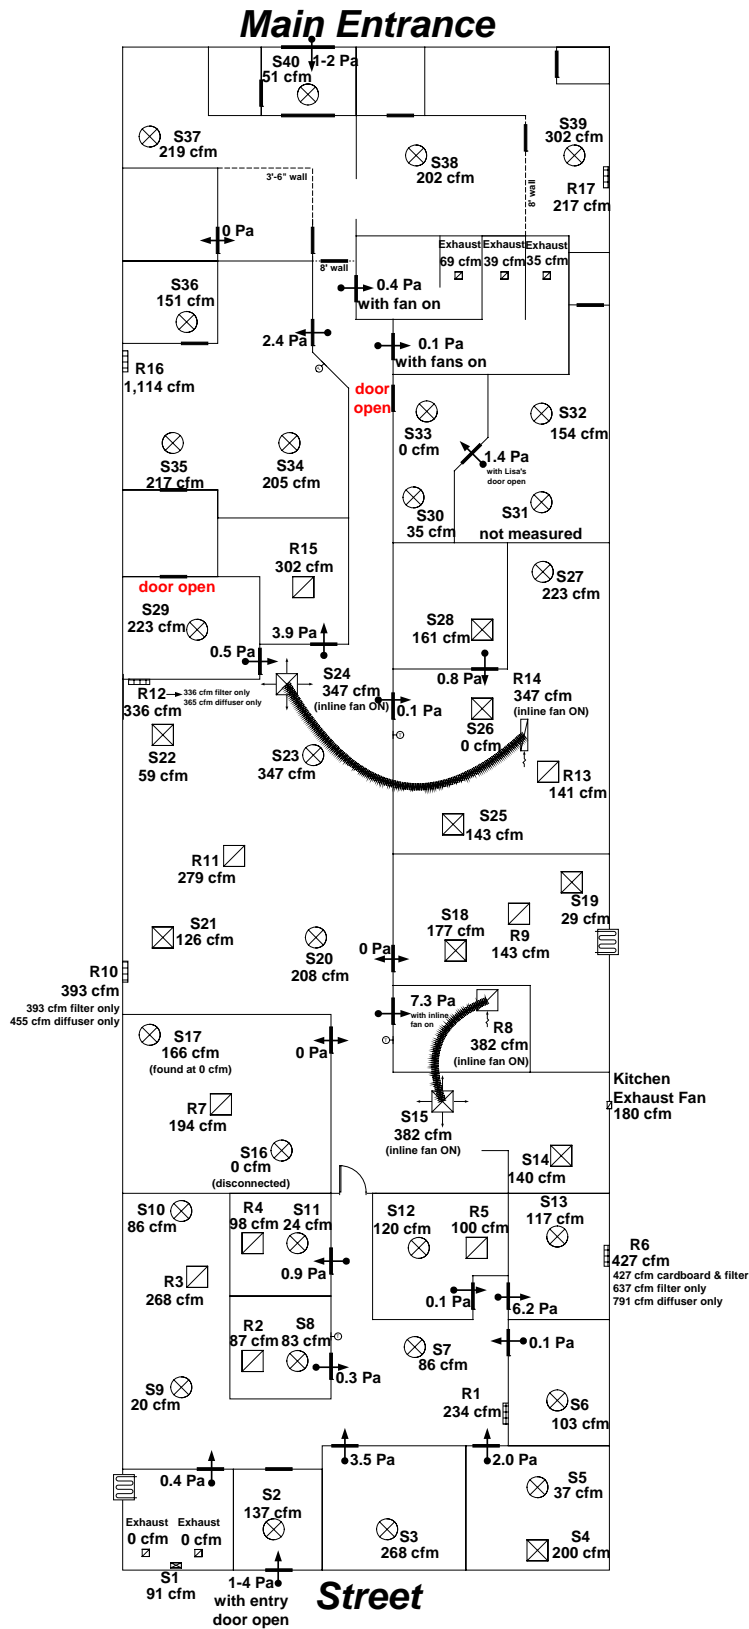
Figure A4-15. Pressure Differences between Rooms with AHU Fans On

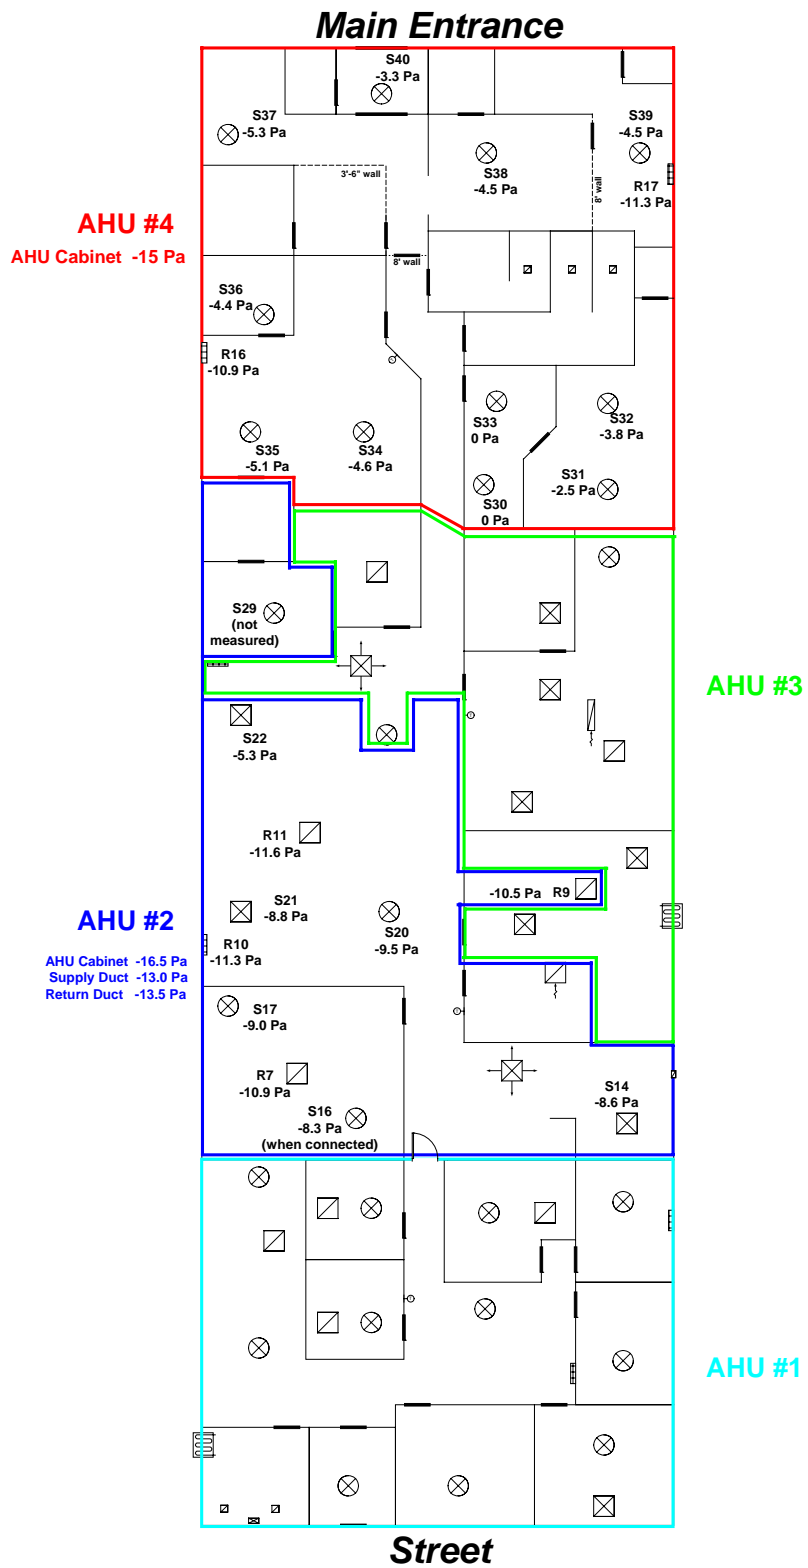
AHU #2 Duct System Depressurized 16.5 Pa	
Diffuser Label	Pressure at Diffusers (Pa)
S14	-8.6
S16	-8.3
S17	-9.0
S20	-9.5
S21	-8.8
S22	-5.3
S29	0.0
R7	-10.9
R9	-10.5
R11	-11.6

Figure A4-18. Diffuser Pressure Mapping with AHUs Depressurized

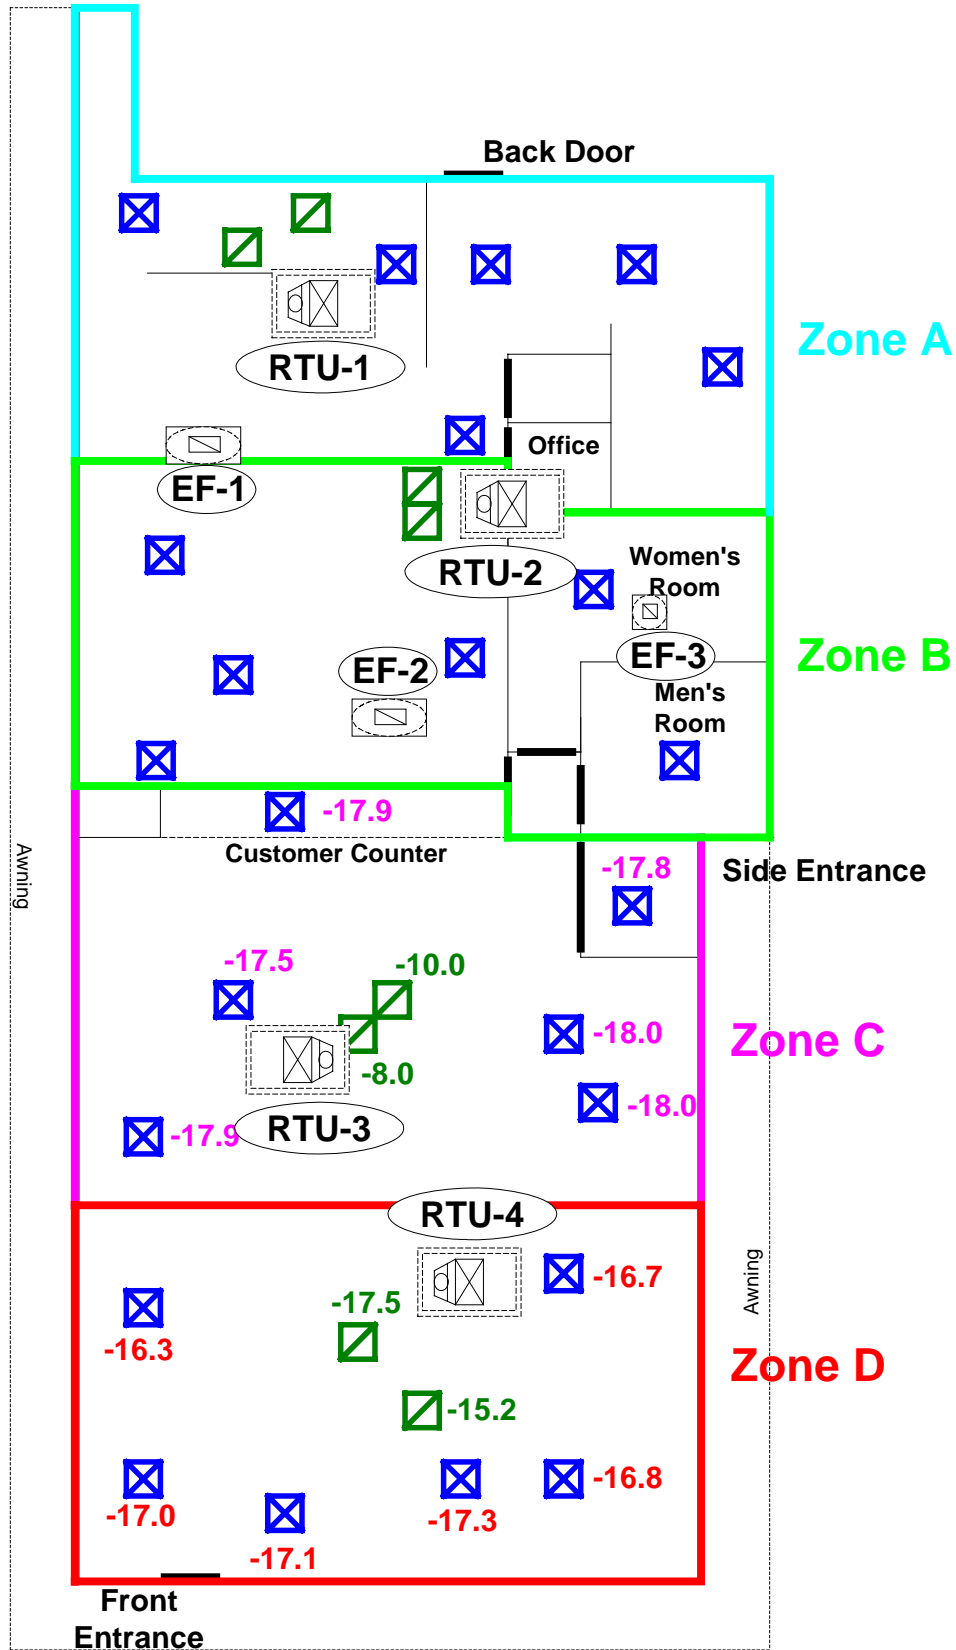
While supply and return ducts were depressurized, static pressures were taken at all corresponding supply and return diffusers. Figure A7-19 shows the resulting pressures measured at each diffuser with the ductwork for RTU-3 and RTU-4 depressurized. The uniformity of the pressures at the diffusers implies that leaks are uniformly spread around the systems. Table A7-9 summarizes the results.

Figure A7-19. Supply/Return Pressure Mapping while System Depressurized

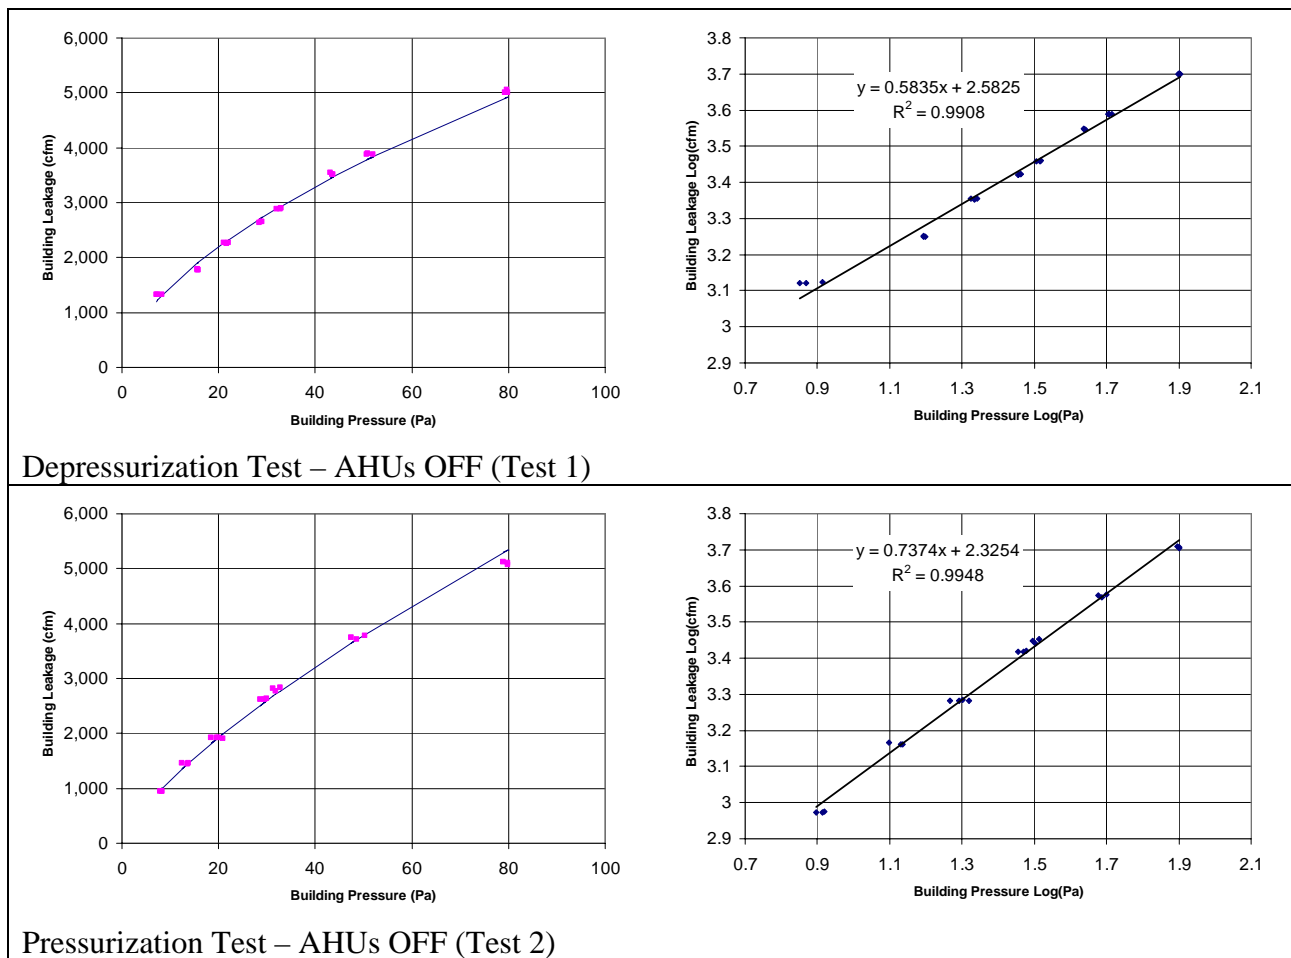
Figure A11-9. Office Section: Variation of Building Leakage with Pressure: $cfm = K(\Delta P)^n$

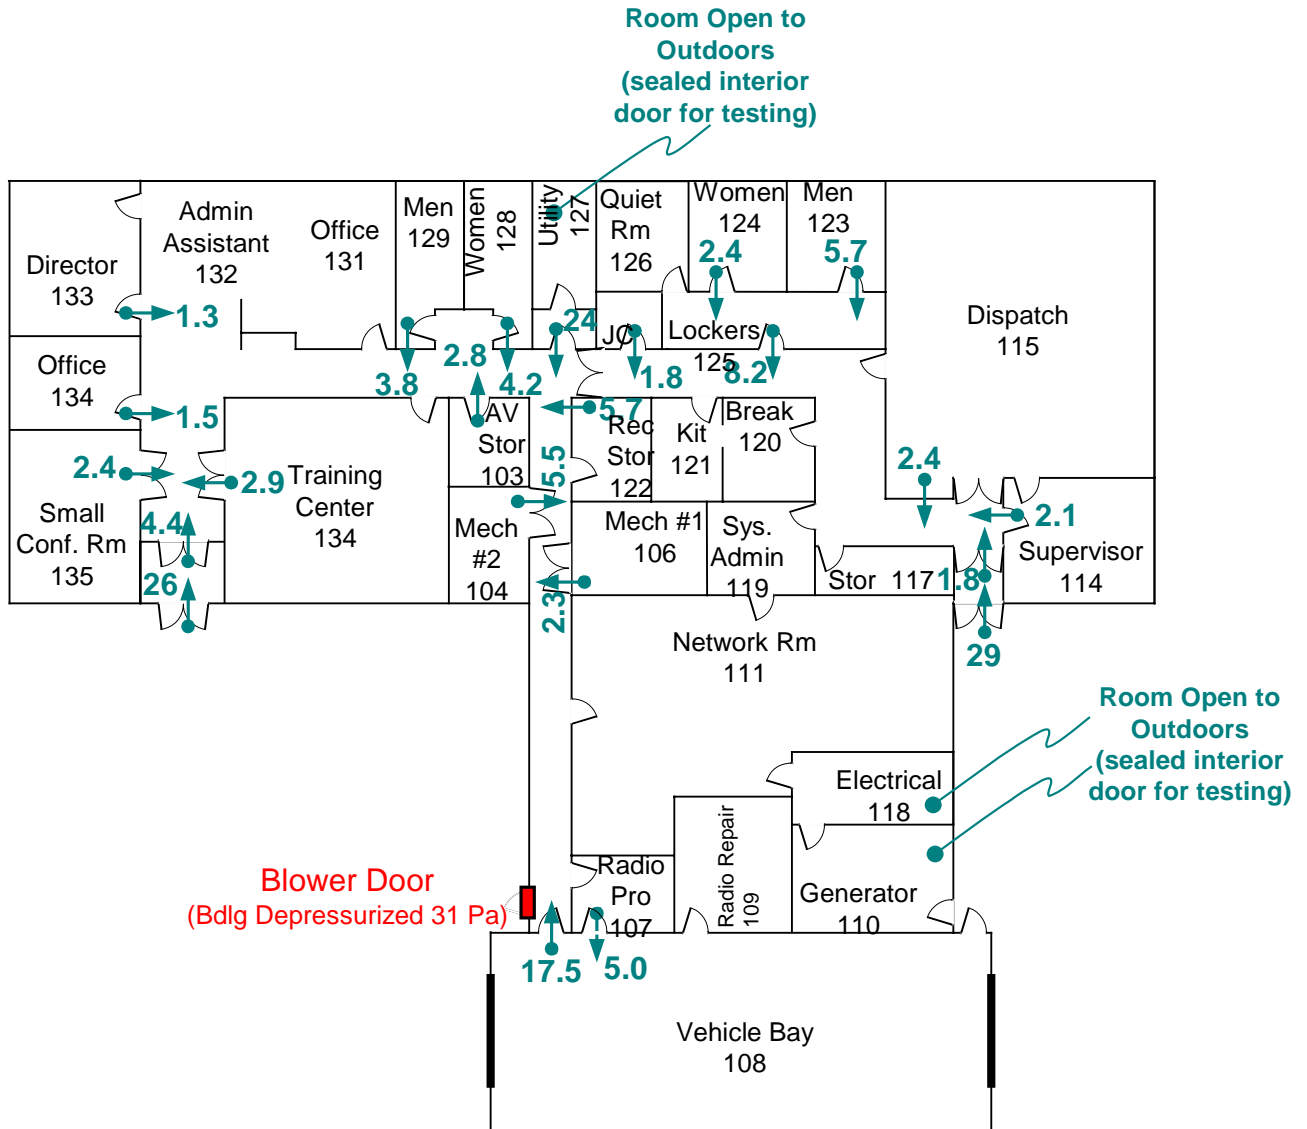
Figure A14-14. First Floor Room-to-Corridor Pressures with Building Depressurized

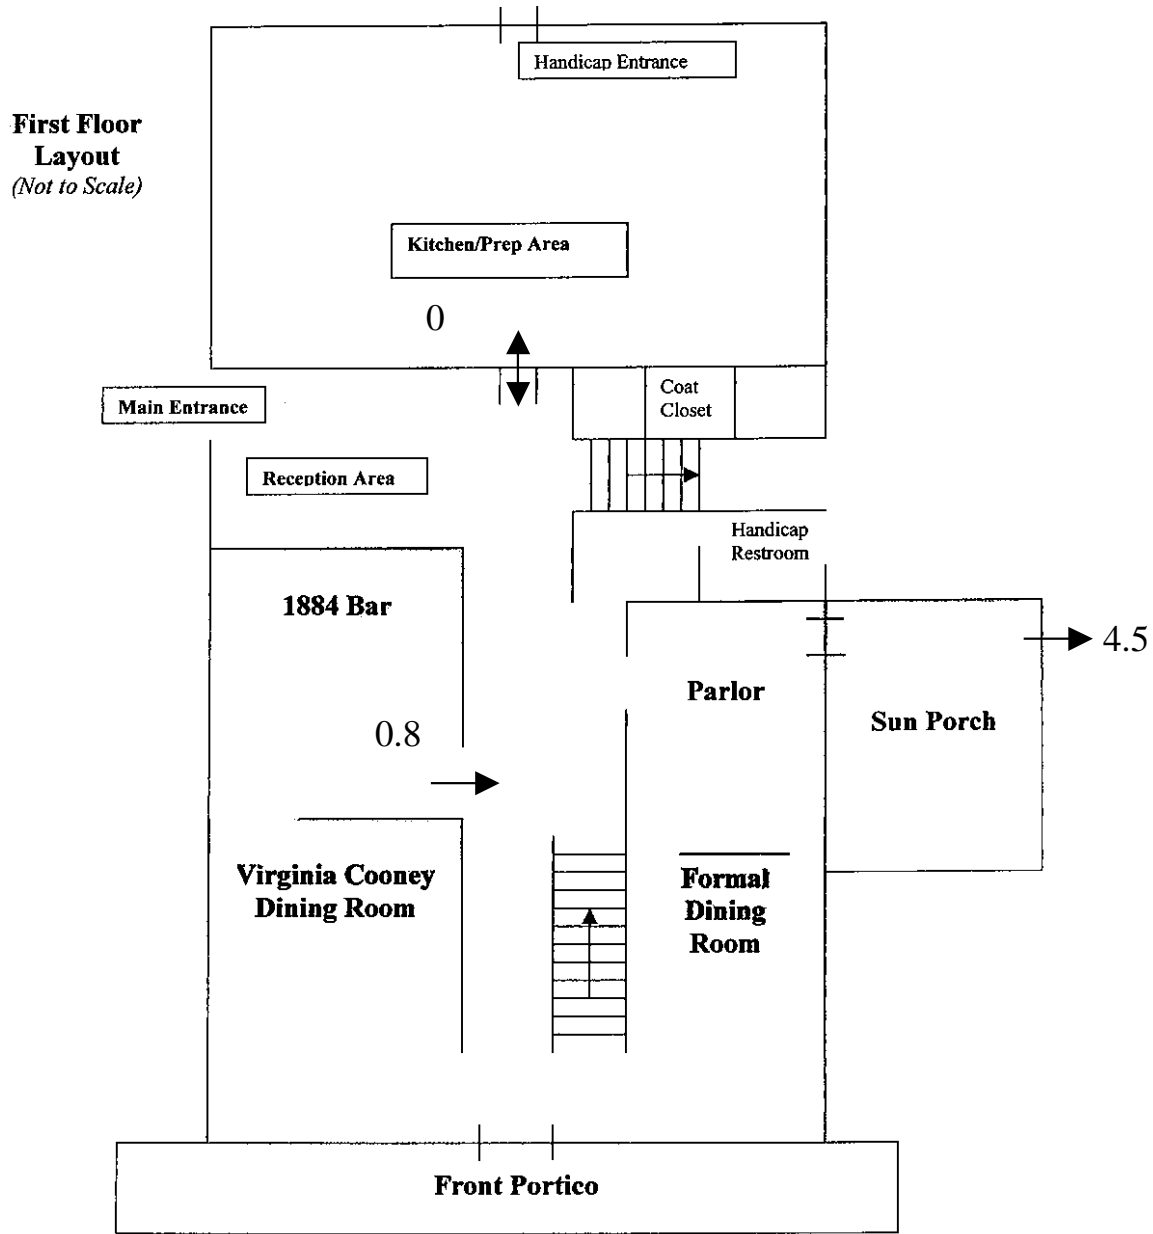
Figure A17-11. Pressure Mapping with Building Depressurized to 4.5 Pa – First Floor

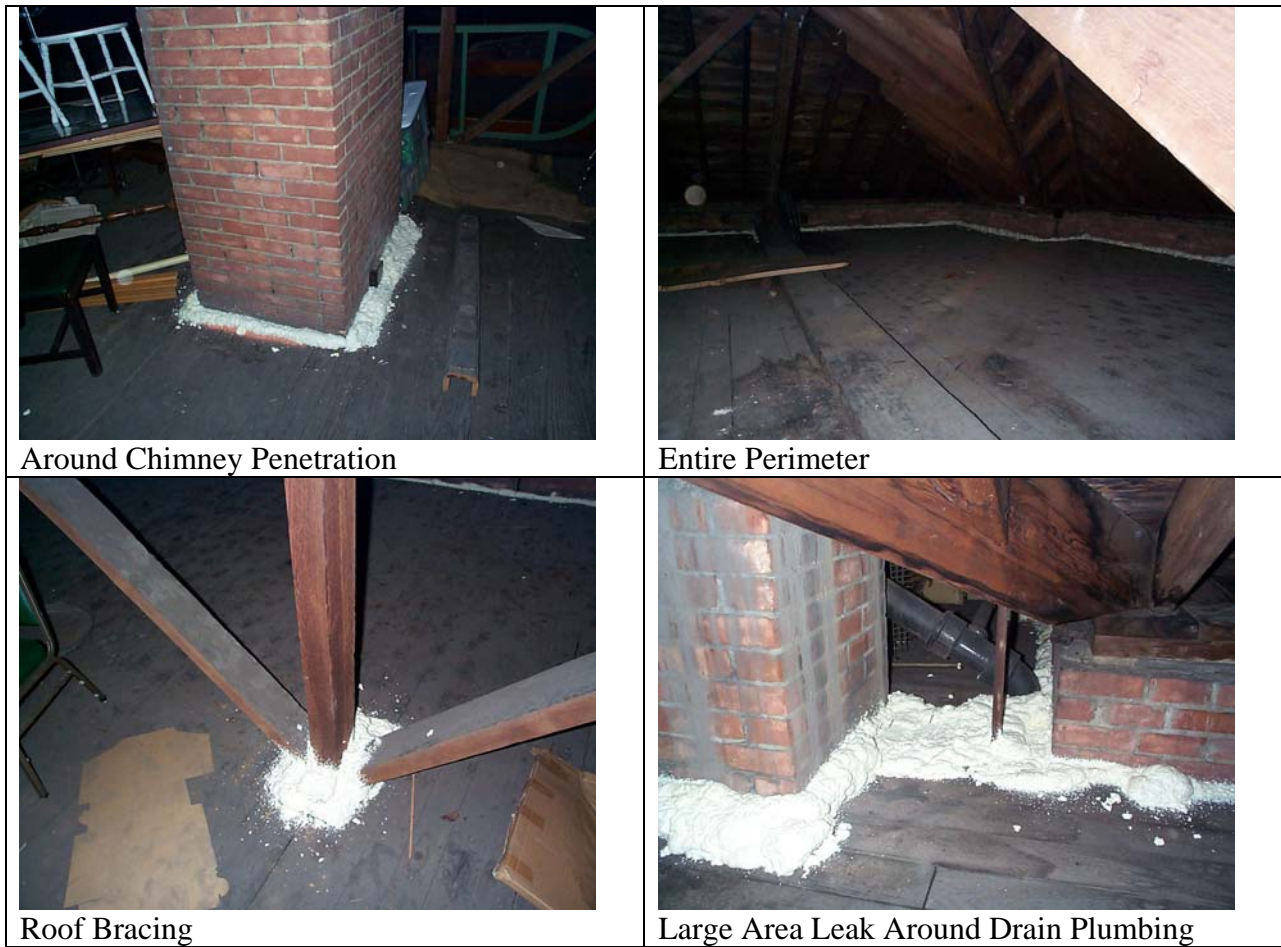
Figure A17-32. Different Types of Leaks Sealed with Expandable Foam
