Degradation of ZnO Window Layer for CIGS by Damp-Heat Exposure

Conference Paper
NREL/CP-520-42792
August 2008

Degradation of ZnO-based window layers for thin-film CIGS by accelerated stress exposures

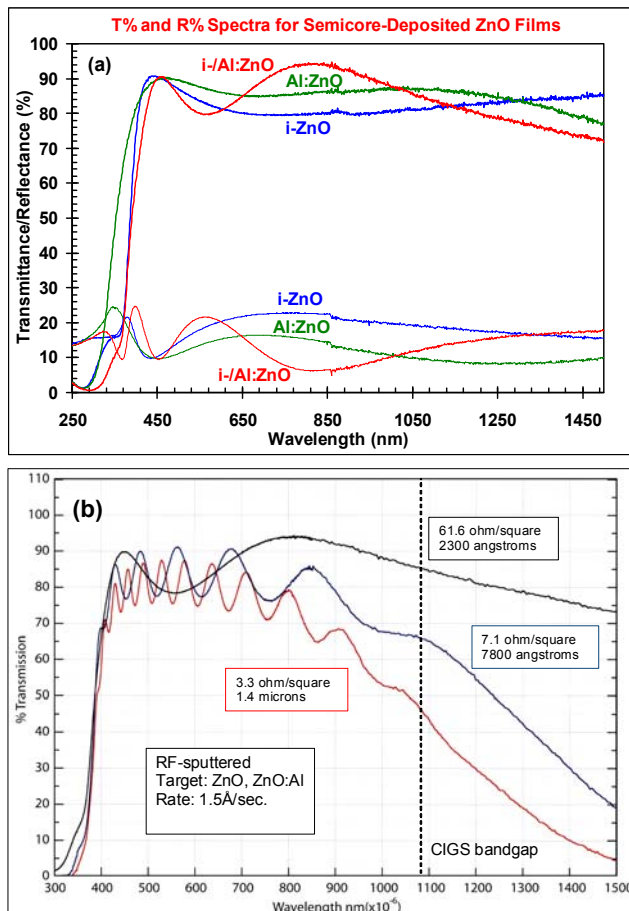
Fig. 1. Transmittance and reflectance spectra for (a) single-layer intrinsic, Al-doped, and bilayer intrinsic/Al-doped ZnO (i-ZnO, Al:ZnO, and i-/Al:ZnO) on glass plates, and (b) three bilayer i-/Al-ZnO films of different sheet resistance and thickness.³⁵

The ZnO-based thin films exhibited different transmittance and reflectance spectra depending primarily on their carrier concentration and film thickness. Figure 1a shows the transmittance spectra for the Semicore-deposited IZO, AZO, and BZO. Doping with Al in AZO produced the free-carrier absorption band at >1000 nm. When the IZO and AZO were combined to BZO bilayer, which showed a bandgap of 3.3-3.4 eV, greater free-carrier absorption band and optical effect were observed as seen in Fig. 1a. The effects were more obvious when the film was thicker and R_{\square} lower, as shown in Fig. 1b where the CIGS bandgap was also marked.³⁵ As a note, NREL's CIGS solar cell devices normally use the ~ 0.2 - μm BZO. The transmittance and reflectance spectra for three Al:Zn_{1-x}Mg_xO ($x = 0, 0.01, 0.1$) ZMO films prepared on the ATC 2200-V sputtering system are given in Fig. 2. At 0.3 and 0.5 μm thick, the optical effect of interference patterns appeared, similar to those shown in Fig. 1b.

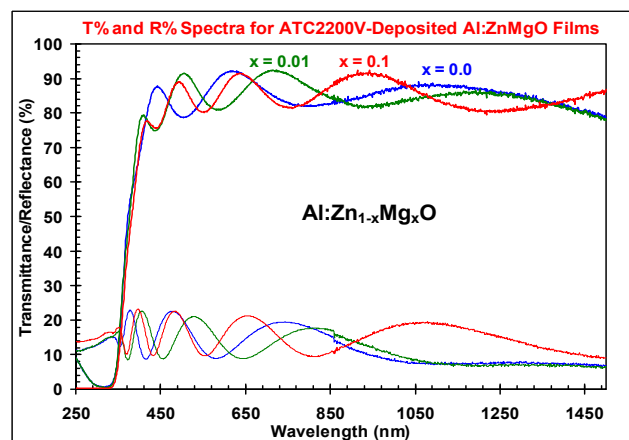
Fig. 2. Transmittance and reflectance spectra for Al-doped Zn_{1-x}Mg_xO films ($x = 0, 0.01, \text{ and } 0.1$) sputter-deposited on 1-mm-thick glass plates.

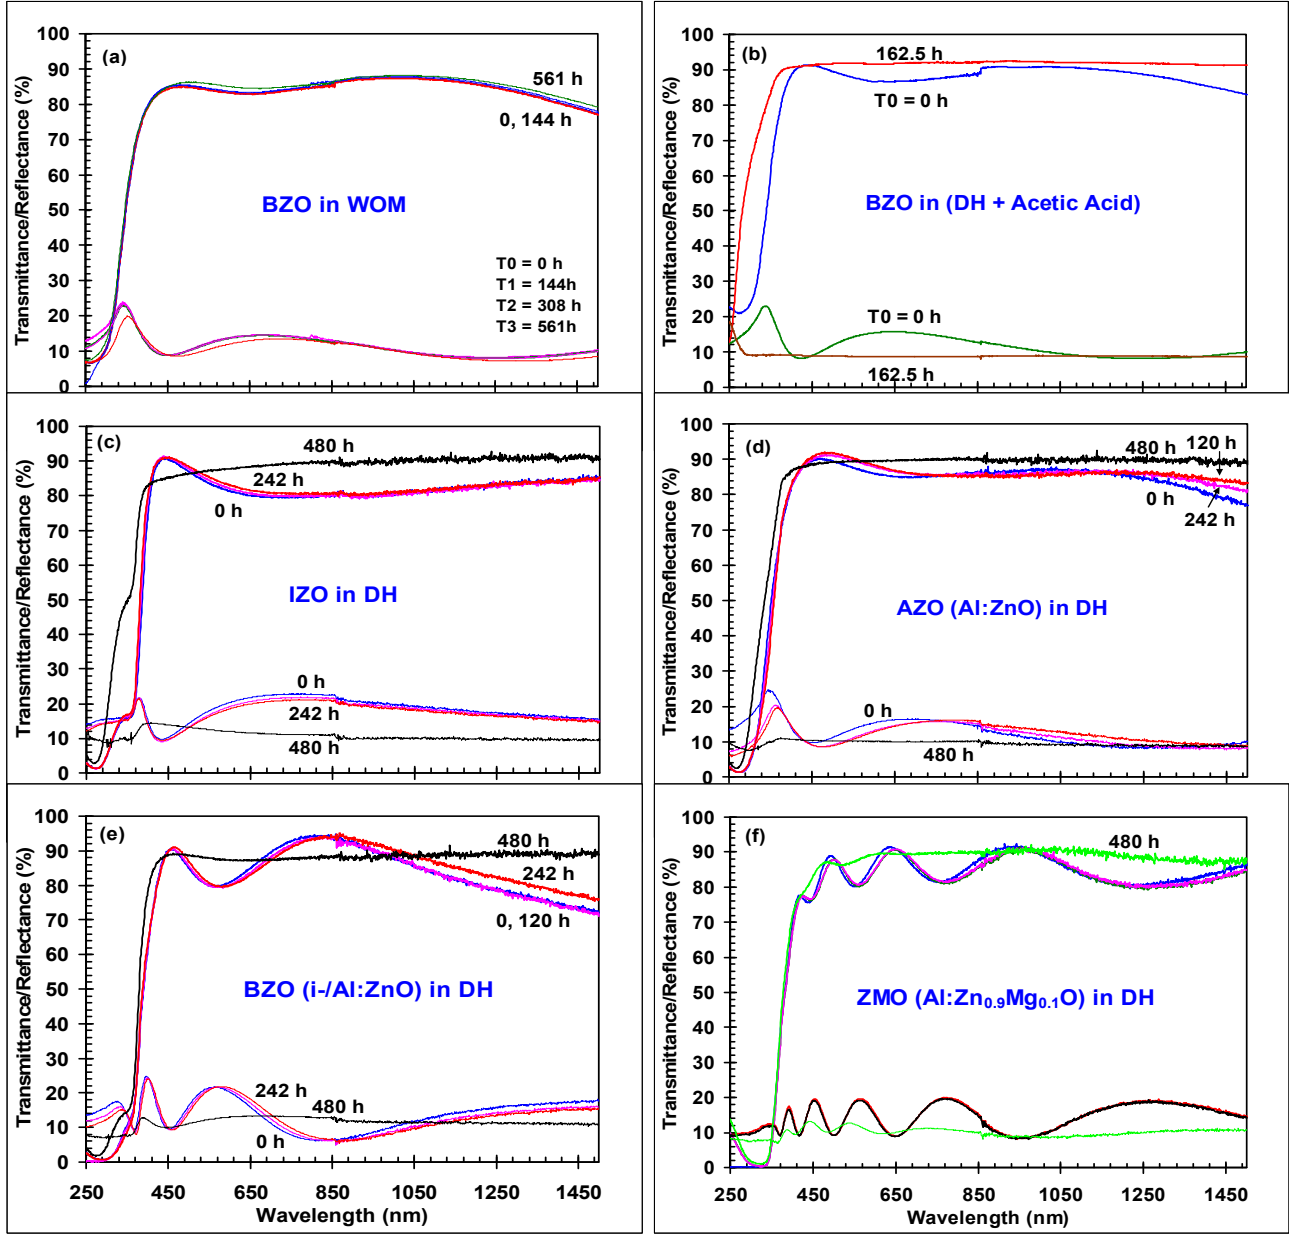
Fig. 3. Transmittance and reflectance spectra for various ZnO and ZMO films on glass upon accelerated exposure tests: (a) in the weatherometer, (b) in damp heat with acetic acid vapor, and (c-f) in damp heat.

Figure 3 illustrates the observed optical changes for some of the samples subjected to the three AET conditions. The BZO films that were in the first experiment showed that the degrading effect was the least for WOM exposure (Fig. 3a) and the greatest for DH exposure in the presence of acetic acid vapor (Fig. 3b).²² The acetic acid was intentionally introduced to simulate the possible presence of the acid from thermal processing and photothermal degradation of the ethylene-vinyl acetate (EVA) encapsulant commonly used in PV module encapsulation.³⁶ Its presence in DH likely accelerated or facilitated the hydrolysis of ZnO into Zn(OH)₂. When exposed in DH without acetic acid vapor, all of the ZnO and ZMO samples turned from initially clear into hazy white and became highly resistive after 480 h, and their transmittance and reflectance spectra became flat and almost identical (Figs. 3c-3f). The originally conductive ZnO (AZO and BZO) and ZMO films also lost their characteristic free-carrier absorption tail bands.²³

half for the second experiment) and their degradation rates upon accelerated exposures, mostly in DH and one in the WOM. The actual data of sheet resistance for the second experiment samples were given in ref. 23. The two samples treated briefly with PDMS were also indicated. By assuming a linear degradation, which appeared to be valid as shown in Fig. 4 for most samples before they became highly resistive, their degradation rates were calculated and given at the bottom line of Table 1. The samples that were rapidly degraded in DH in the presence of acetic acid vapor (see Fig. 3b) are not tabulated here.

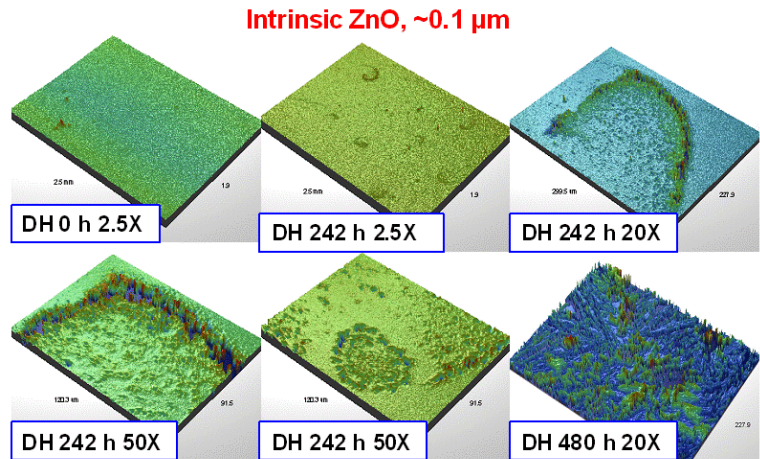
Fig. 7. Optical micro-images for the sample of intrinsic ZnO (IZO-11), showing the progressive morphological degradation as the DH exposure time increased to 480 h. The magnification factors are indicated.

The ZnO and ZMO films were examined periodically during the course of DH exposures, in addition to the optical, electrical, and structural measurements described above, with optical micro-imaging using a WYKO interference microscope, which became available in the second experiment, for the initiation and propagation of the defecting patterns and regions as a function of DH exposure time. More than 1000 micro-images were taken. A few of the images are illustrated here. Figure 7 shows the progressive morphological degradation for the single-layer i-ZnO sample (IZO-11) at four stages, as the DH exposure time increased to 480 h. The initially grainy but fairly smooth surface started to show some small spikes that appeared in a random manner upon DH exposure in the first ~100 h. The number of spikes increased along with the appearance of full or partial ring-like features that showed ditch-like cutting into the depth of the film as the DH time increased (e.g., 240 h). The ring features are suspected to arise from the finite water droplets condensed from the moisture, which were observed when the cool films were just loaded into the hot steamy DH chamber. As the degradation progressed further, the film disintegrated greatly into fabric-like features at DH 480 h and was difficult to be micro-photographed because of large loss of light reflection from the rough surface. This morphological degradation process and pattern development was essentially the same for all ZnO-based films as observed in this study, as further illustrated in Fig. 8 for the single-layer AZO-21, bilayer BZO-31, and two ZMO films. The changing rate of the morphological images shows that bilayer BZO-31 at $0.2 \mu\text{m}$ degraded more slowly than the single-layer IZO-11 and AZO-21 at $0.1 \mu\text{m}$, consistent with the electrical degradation rates given in Table 1. Similar surface morphological degradations were also observed for the two samples of $\text{Al}:\text{Zn}_{1-x}\text{Mg}_x\text{O}$ alloy at DH 242 h, as seen in Fig. 8 (bottom row). At 10% of MgO ($x = 0.1$), the $\text{Al}:\text{Zn}_{0.9}\text{Mg}_{0.1}\text{O}$ (ZMO-501) was originally insulating and, upon DH exposure, exhibited localized spot-wise material loss (see the second image from right of the bottom row), suggesting the MgO-ZnO was not fully alloyed in the co-sputtering process.

These close observations allow a generalization of the degrading process induced by the DH as follows. The first sign of degradation started at a few small spots or areas with the appearance of irregular circles and spikes (e.g., Figs. 7 and 8 at 120~242 h). As the DH exposure increased, the hydrolysis-induced corrosion circles, spikes, and pop-ups increased and became more widely spread (e.g., Figs. 7 and 8 at DH 242 h). Finally, especially for ZnO-based films, severe disintegration resulted (e.g., Fig. 7 at DH 480 h). This thermal hydrolytic process might have started from the surface of the film as well as at the grain boundary and progressed downward and inward. If this was the case, then it would take longer exposure time to allow the “ditches” (e.g., Figs. 7 and 8, leftmost figure at the bottom row) to grow deeper to break up the electrical conducting path on a thicker ZnO film, and to break up the better grain crystallites on a ZnO film made at higher temperature. In addition, visible delaminations were seen on some ZnO films after 480 h DH exposure, suggesting the destruction of the bonding at the interface between the ZnO layer and glass substrate.

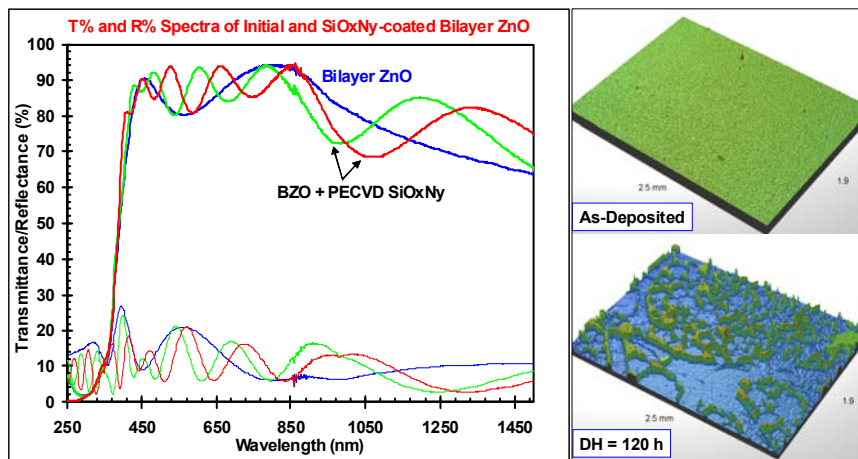
Fig. 10. (Left) Transmittance and reflectance spectra for a bilayer ZnO film before and after coating with a SiO_xN_y layer by PECVD, (right) optical micro-images for the SiO_xN_y -coated BZO before (top) and after (bottom) 120 h exposure in damp heat.

The second was a physical mitigation method that deposited on the BZO surface a moisture-blocking silicon oxynitride (SiO_xN_y) by the PECVD method. The SiO_xN_y as a “barrier oxide” coating has been studied several years at NREL to block moisture vapor transmission through polymer films of the “back foils” for PV module encapsulation applications.^{34,37,38} SiO_2 is another barrier oxide commonly used in multi-layer films by the packaging industry. Figure 10 shows the significant changes in transmittance and reflectance spectra of a BZO film upon coating with a thin layer ($\sim 0.4 \mu\text{m}$) of SiO_xN_y .

Whether the SiO_xN_y can be also used as antireflection coating, in addition to the physical protecting layer, remains to be investigated. Upon DH exposure, however, the SiO_xN_y coating layer was largely cracked, visibly flaked, and partially lost due to poor adhesion to the ZnO surface, and possibly internal stress also, as seen in the optical micro-images shown in Fig. 10. By chemically modifying the BZO surface, it is possible to improve the adhesion thereby reducing the stress of the SiO_xN_y . More work has been undertaken in the mitigation studies
