LOCALIZED CORROSION OF AUSTENITIC STAINLESS STEEL
EXPOSED TO MIXTURES OF PLUTONIUM OXIDE AND CHLORIDE SALTS

P. E. Zapp, J. M. Duffey, K. A. Dunn, R. R. Livingston, and D. Z. Nelson
Savannah River National Laboratory
Aiken, SC 29808

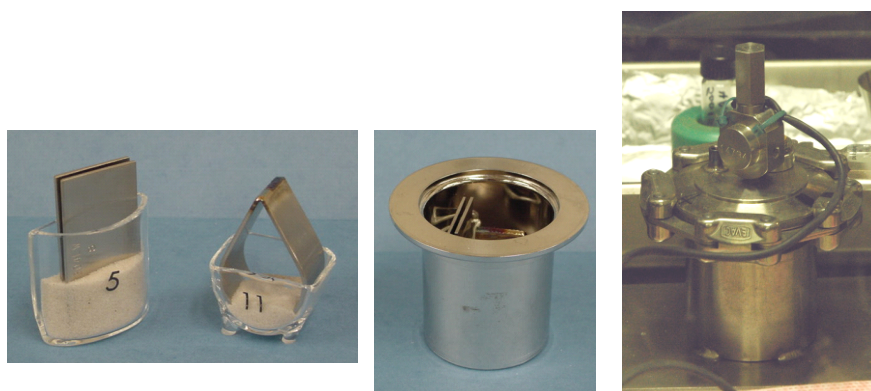
Figure 1. Flat and teardrop coupons in glass inserts, open test container, and sealed container.

Figure 1 shows the coupons in their glass boats or inserts and an open test container with coupons. One 304L flat coupon and one 316L flat coupon were placed side by side in one glass insert. Enough oxide/salt mixture was added between and around the coupons to cover the lower half of each coupon. Several grams of oxide/salt mixture were added to a second glass insert, and one teardrop coupon was placed in this second glass insert on top of the oxide/salt mixture. Several more

The test container for the small-scale tests was a 2-inch-diameter, 2.5-inch-tall stainless steel can sealed with a metal gasket. The container was equipped with a pressure transducer for continuous pressure monitoring during an exposure and a valve for acquiring gas samples periodically (Figure 1). Glass inserts were used to hold small (several cubic-centimeter) volumes of oxide/salt mixture in close contact with the test coupons.

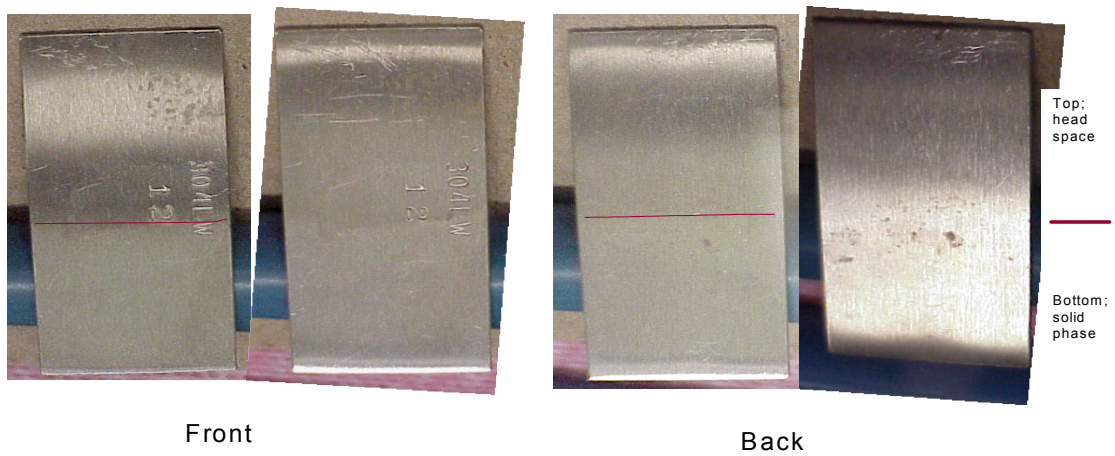
Figure 2. Flat coupon 304L – 12 from container 1b-2, with slight staining; scratches from post-test handling. In this and subsequent figures, the red line or curve denotes the highest level of the plutonium oxide/chloride salt mixture on the coupon.

Figures 2 and 3 show coupons 304L-12 and 316L – 81 from container 1b-2 respectively after exposure to the high-salt-content mixture for 150 days. The coupons appear uncorroded, with only slight staining or altering of reflectivity to indicate contact with the solid mixture. Neither coupon had measurable pits. Microscopic examination confirmed that the visible spot on the back of 304L – 12 was not a pit with measurable depth but is a stain. Scratches in the headspace area of the coupons were caused by post-exposure handling.

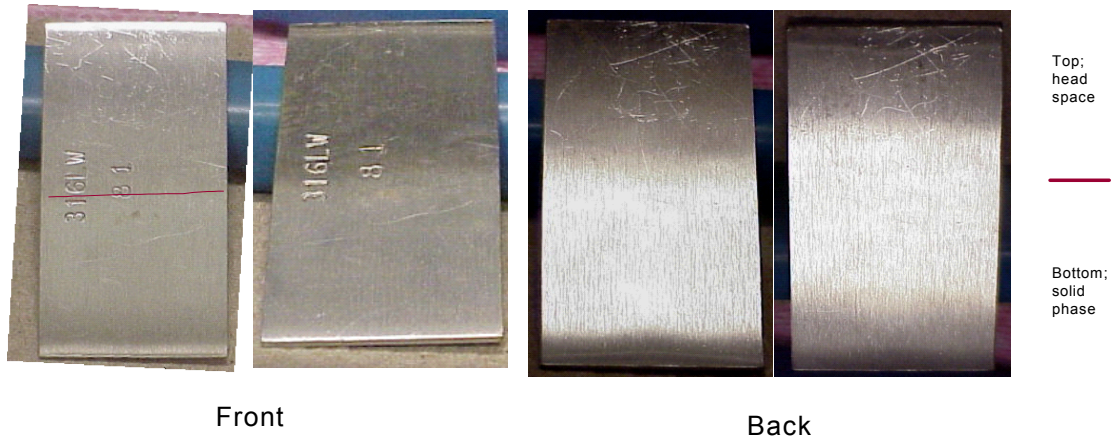
Figure 3. Flat coupon 316L – 81 from container 1b-2,, no corrosion; scratches from post-test handling.

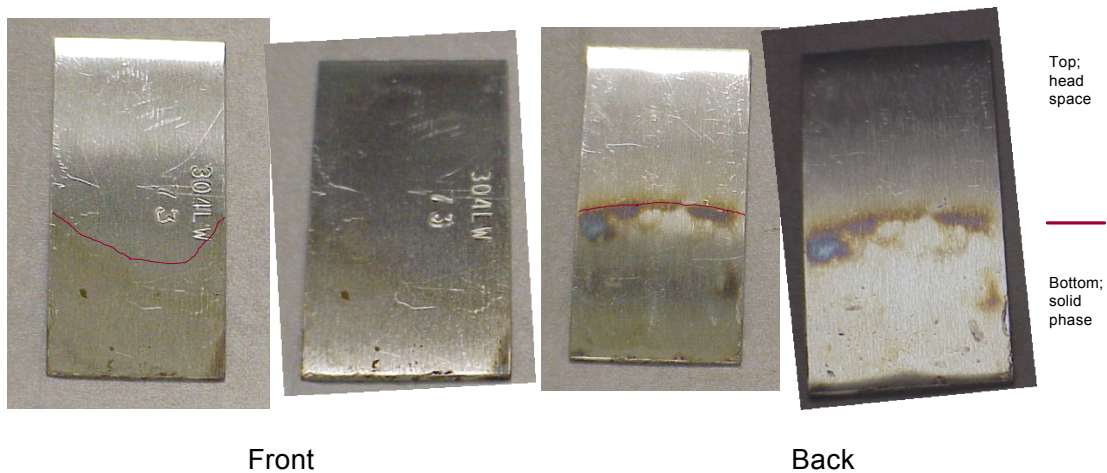
Figure 4. Coupon 304L – 73 from container 5a-2, staining at and below interface between solid mixture and headspace gas.

Figures 4 and 5 show images of coupons 304L – 73 and 316L – 13 from container 5a-2 exposed to a 5 wt % magnesium-rich ER salt for 168 days. Both coupons showed considerable staining of the metal that was in contact with solid mixture. Microscopic examination revealed no measurable pitting. There is some attack at the bottom edge of both coupons, but corrosion at edges is not quantified because of the indeterminate starting surface for the attack.

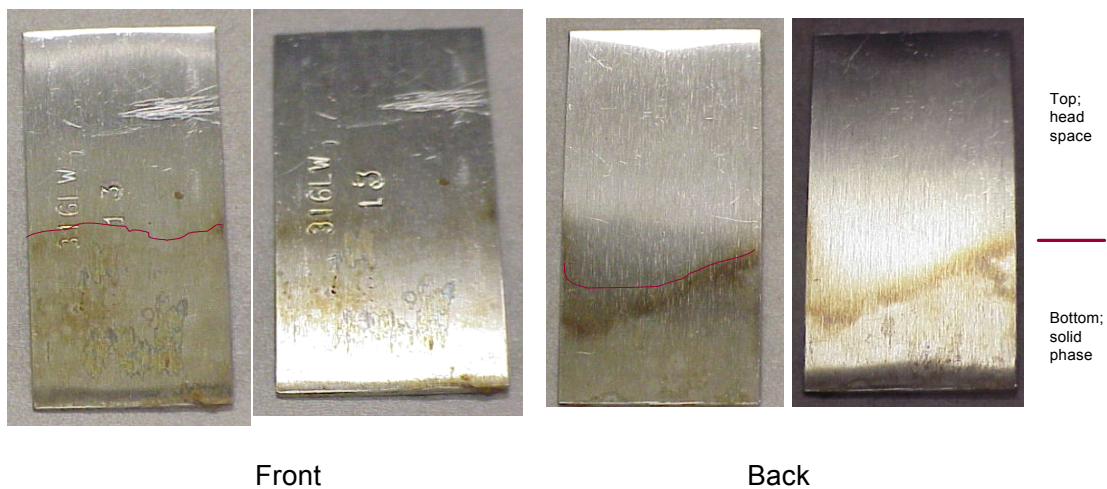
Figure 5. Coupon 316L – 13 from container 5a-2,, staining mainly at and below interface.

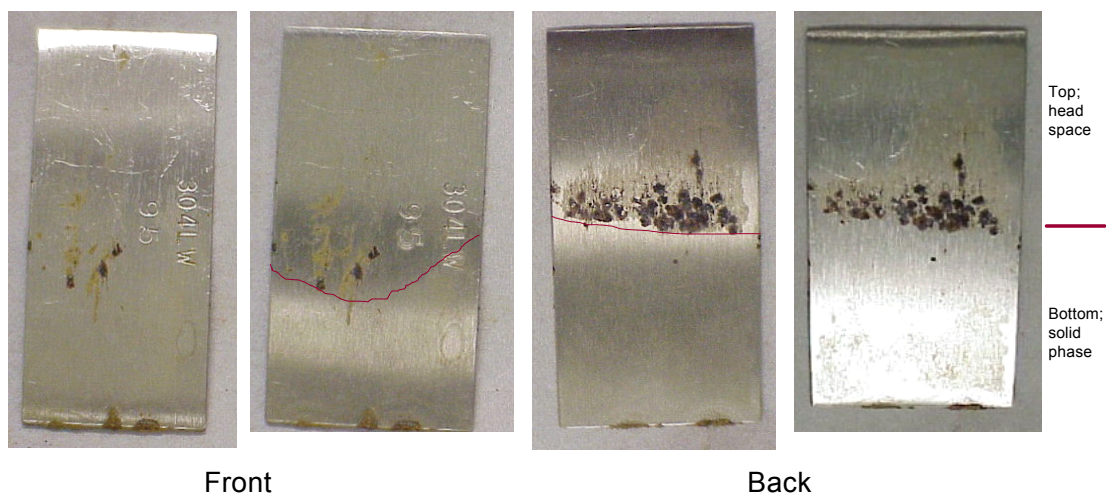
Figure 6. Coupon 304L – 95 from container 4a-3,, pitting in the headspace area, edge attack at bottom.

Coupons from containers 4a-3 (0.2 wt % CaCl_2) and 4b-1 (0.92 wt % CaCl_2) had obvious pitting corrosion along with a superficial general corrosion or staining. Figures 6 and 7 show images of the coupons from container 4a-3. Coupon 304L – 95 has extensive pitting on the back face in metal just above and following along the solid mixture/headspace gas interface (Figure 6). Pit depths ranged from 10 to 100 μm . There is also attack at the bottom edge of the coupon. Coupon 316L – 75 is similarly pitted (from 20 to 100 μm in depth) at and above the interface, but also has a large pit clearly visible on the front face in the solid contact region (Figure 7). That pit measured 80 μm in depth and is surrounded by a ring of deposited corrosion product. Edge attack at the bottom of 316L – 75 is also visible.

The relative level of hydration of CaCl_2 appears to play a role in the character of the pitting attack in the series 4a and 4b exposures through its control of the relative humidity of the headspace gas. As Figures 6 and 8 show, the pitting attack in the 304L flat coupon exposed to mixture 4a-3 is predominantly found in the region of headspace contact, while the pitting in the 304L coupon exposed to mixture 4b-1 is predominantly in the solid contact region. The associated 316L flat coupons show a similar but less pronounced tendency. Table 3 shows that the calculated initial water content for the 4a-3 mixture greatly exceeded the water content for full hydration of the 0.2 wt % CaCl_2 . In the case of mixture 4b-1, the water loading was not sufficient to fully hydrate the 0.92 wt % CaCl_2 . Thus the water content in container 4a-3 that was in excess of that needed for full hydration of the CaCl_2 would have been available to raise the humidity of the headspace gas. The water content in container 4b-1 however would have been mostly captured by the hydration of the higher CaCl_2 concentration. Container 4b-1's headspace gas would have a lower relative humidity. The higher relative humidity may have then led to the formation of a corrosive electrolyte on the stainless steel in contact with the headspace gas in container 4a-3. Such a corrosive electrolyte could have been absent in the drier atmosphere of container 4b-1, leading to the observed distribution of pitting.

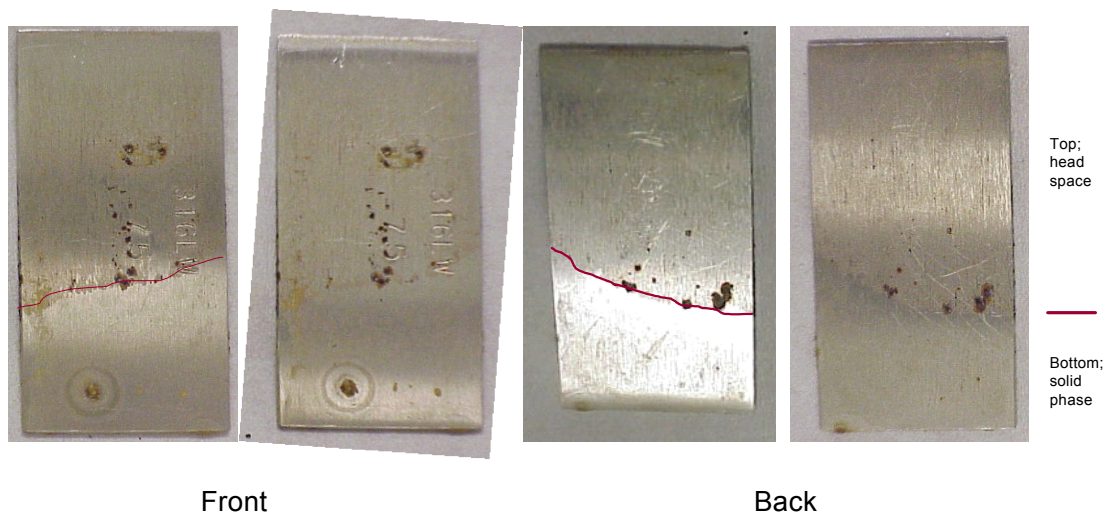
Figure 7. Coupon 316L – 75 from container 4a-3,, large pit on front face in solid contact area and pitting in the headspace region.

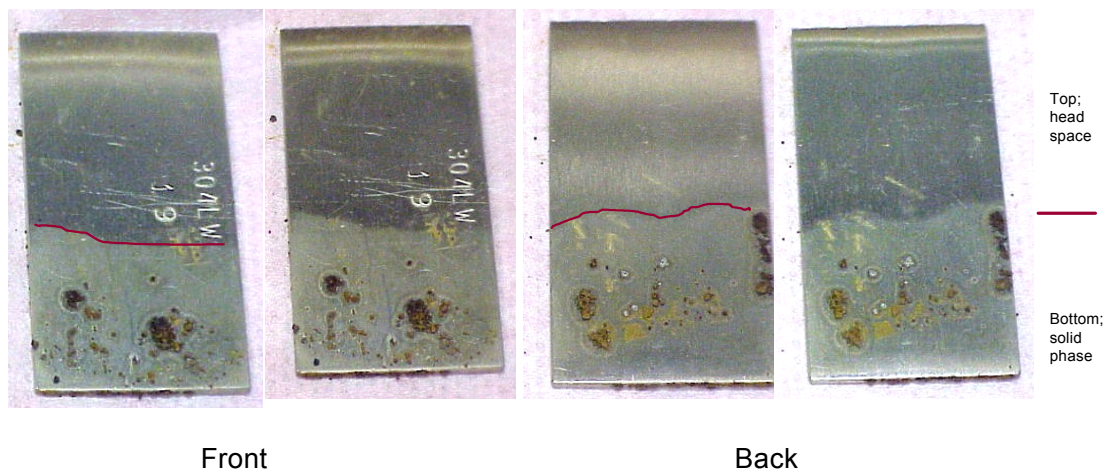
Figure 8. Coupon 304L – 19 from container 4b-1, , extensive pitting in the solid contact region, but not in the headspace region.

Coupons from container 4b-1 were exposed to the oxide/salt mixture for 193 days. As in the container 4a-3 coupons, there was considerable pitting, as Figures 8 and 19 show for coupons 304L – 19 and 316L – 88, respectively. However, the pitting attack in these coupons was seen entirely in the solid contact region, with no attack in the headspace gas region. The coupons were also generally stained or discolored in the solid contact region, but not in the headspace gas region. Pit depths ranged from 20 to 40 μm in coupon 304L – 19 and from 20 to 60 μm in 316L – 88.

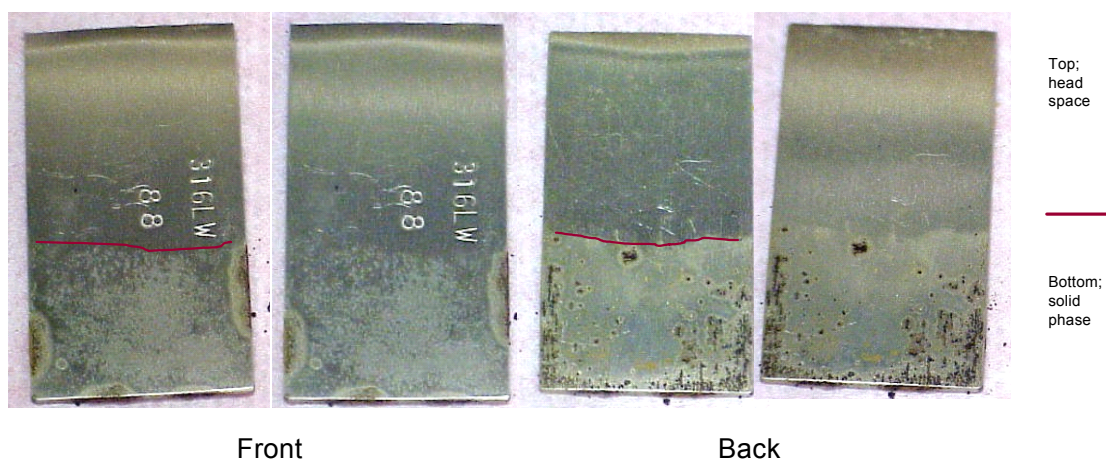
Figure 9. Coupon 316L – 88 from container 4b-1,, pitting in the solid contact region, but no attack in headspace gas region.

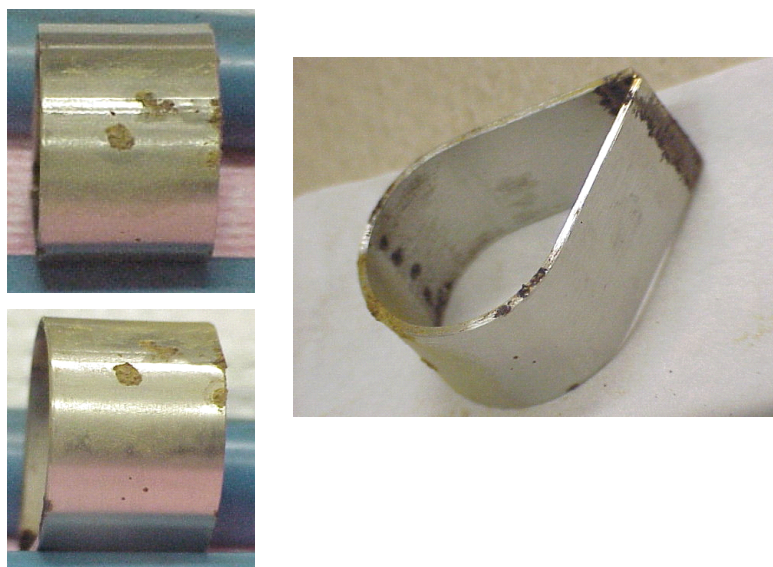
Figure 10. Container 4a-3 teardrop coupon 304L – 23 showing pitting in the metal in contact with the oxide/salt mixture. Corrosion is also evident in the heat-affected zone of the closure weld at the coupon tip, which was not in contact with the solid mixture.

In general, all teardrop coupons had staining and pitting similar in extent as was seen in their companion flat coupons. Some teardrop coupons had general staining or corrosion in the heat-affected zones of their closure weld. Figures 10 and 11 show examples of the pitting and staining in teardrop coupons exposed in the solid contact positions in containers 4a-3 and 4b-1. These images were made before acid cleaning of the coupons. Pitting is visible on the outer and inner curved surfaces of the coupons as well as at edges.

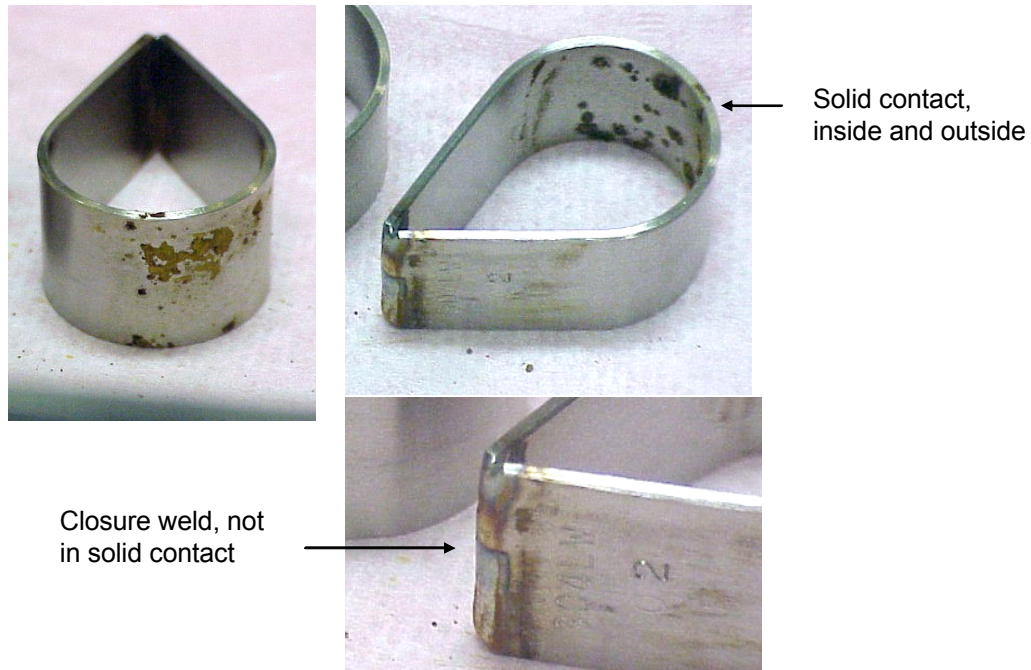
Figure 11. Container 4b-1 teardrop coupon 304L – 02 showing pitting inside and outside in metal in solid contact; no evidence of cracking; staining near closure weld.

electrolyte did form in container 4b-1, and considerable corrosion is evident in the stressed region of its teardrop coupon (Figure 11). The reason for the absence of cracking in this instance is not known, but further testing at elevated temperature (of the order of 70°C) must be conducted to draw conclusions on the corrosivity of the 0.92 wt% CaCl₂ mixture or, indeed, of those mixtures that contain MgCl₂.

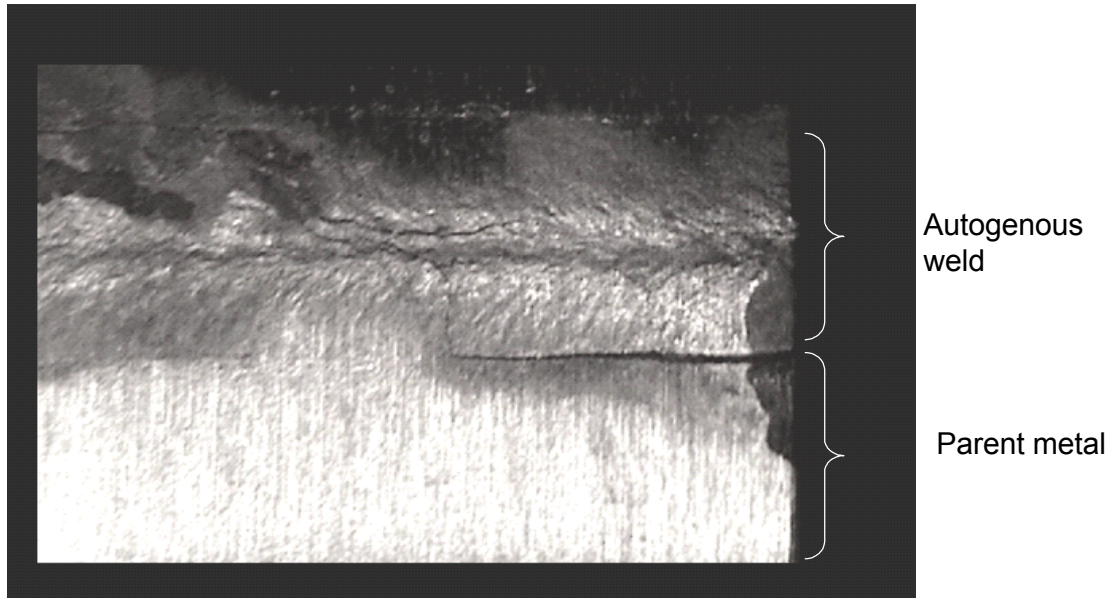
Figure 12. Photomicrograph of teardrop coupon 304L – 23, showing branched cracking near and within the autogenous weld; possible crack initiation site in area of localized corrosion at right edge of coupon. Approximately 10X magnification.

Stress corrosion cracking was initially revealed in the container 4a-3 solid contact teardrop coupon 304L – 23, through dye penetrant testing. Optical microscopy, scanning electron microscopy, and optical metallography were used to examine the path and nature of the cracking. The cracking extended across more than half the width of the coupon and was associated with the transverse autogenous weld. Figure 12 is an optical micrograph that shows the cracking starting at the edge of the coupon in a localized area of general corrosion and propagating along the interface between the weld and the parent metal, that is in the weld heat-affected zone. Figure 13 shows the entire crack path on the coupon surface in a composite scanning electron micrograph. The crack was highly branched as it crossed through weld metal and continued its path along the opposite weld/parent metal interface. Optical metallography of one cross-section of the coupon reveals the propagation of the crack along the interface (Figure 14) and, in a second cross-section, propagation through the weld metal into the parent metal (Figures 15 and 16). The enlargement in Figure 14 shows what appears to be intergranular cracking. The highest magnification image (Figure 17) shows the extensive cracking paths across parent metal grains. This transgranular nature of the cracking is characteristic of chloride-induced SCC in austenitic stainless steel. The cracking terminates at a depth where stress analysis predicts that the tensile stress falls to zero.⁴

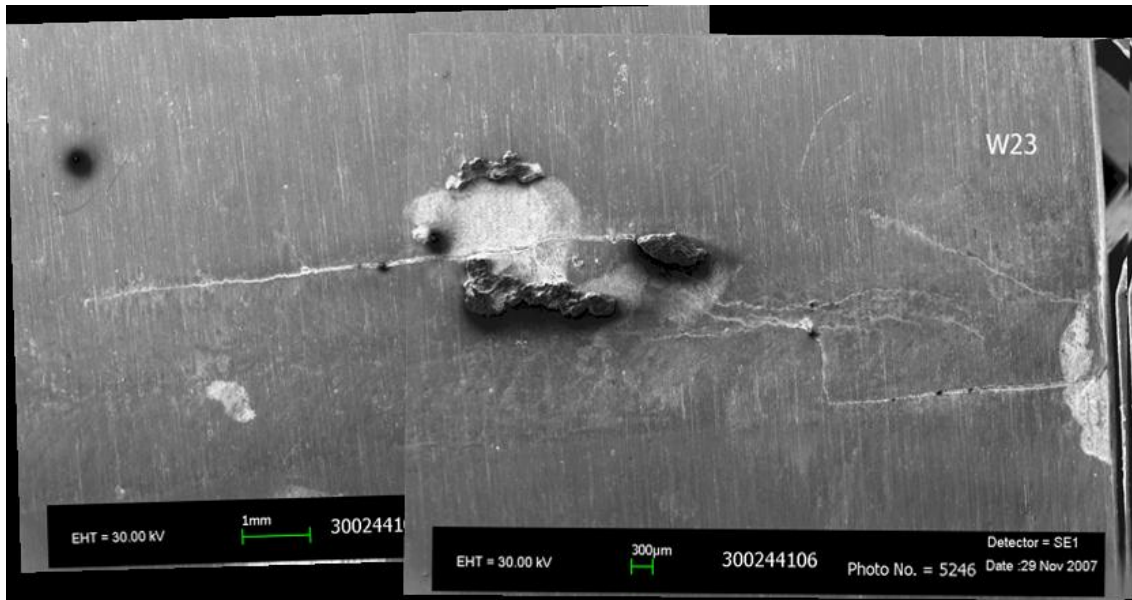
Figure 13. Composite scanning electron micrographs of coupon 304L-23 showing full extent of cracking on outside (convex) surface.

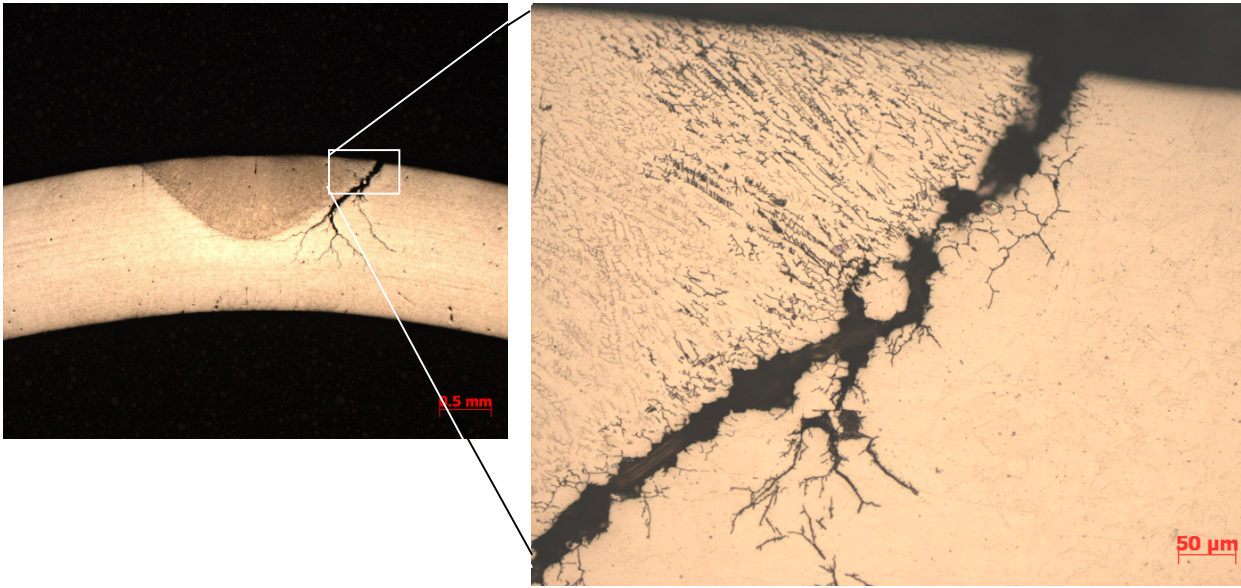
Figure 14. Optical micrographs of a cross-section through teardrop coupon 304L-23 showing cracking along the weld/parent metal interface.

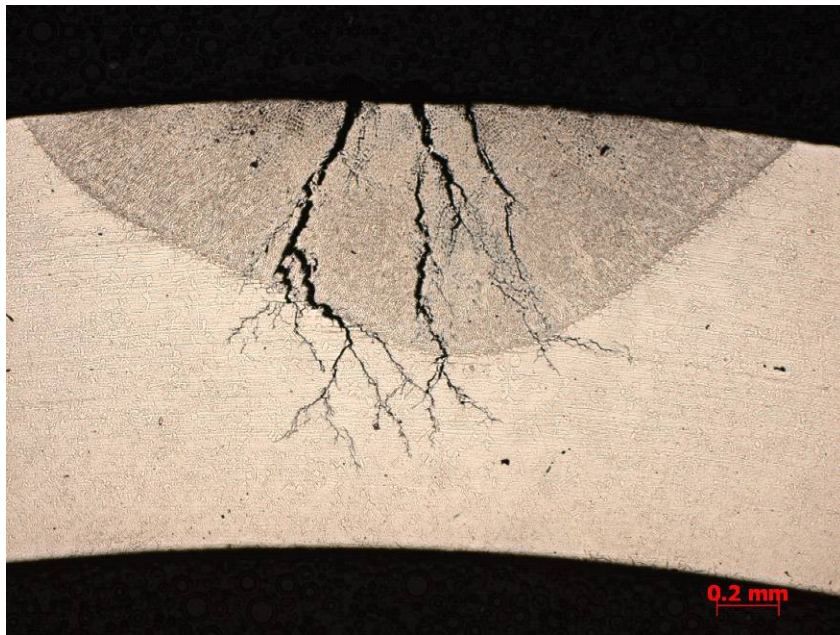
Figure 15. Optical micrograph of a second cross-section of coupon 304L – 23, showing propagation of multiple cracks through the weld metal into the parent metal.

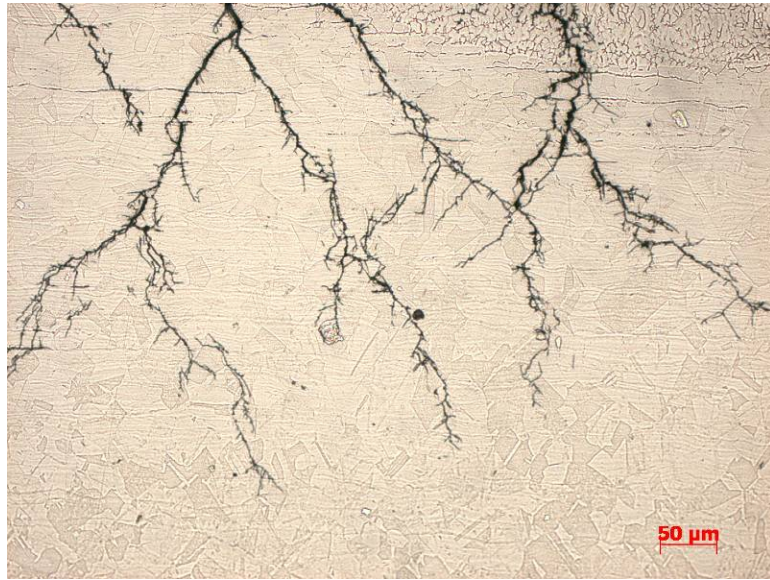
Figure 16. Optical micrograph showing transgranular nature of the cracking.

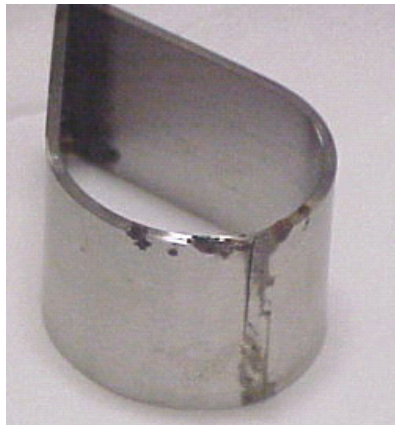
Figure 17. Stress corrosion cracking along the autogenous weld in coupon 304L – 20 from container 4a-2

SCC occurred in a second series 4a test coupon, 304L – 20 from container 4a-2, which was exposed for 335 days or about twice the exposure of container 4a-3. Figure 17 shows the prominent stress corrosion cracks at the weld metal/parent metal interfaces of the coupon. A third series 4a container, container 4a-1, held 316L stainless teardrop coupons in both the solid contact and headspace positions for 506 days. Although teardrop coupon 316L – 40 experienced extensive pitting and localized general corrosion visual inspection revealed no cracking.
