SRNS-STI-2008-00154

Sodium Aluminosilicate Fouling and Cleaning of Decontaminated Salt Solution Coalescers

October 28, 2008

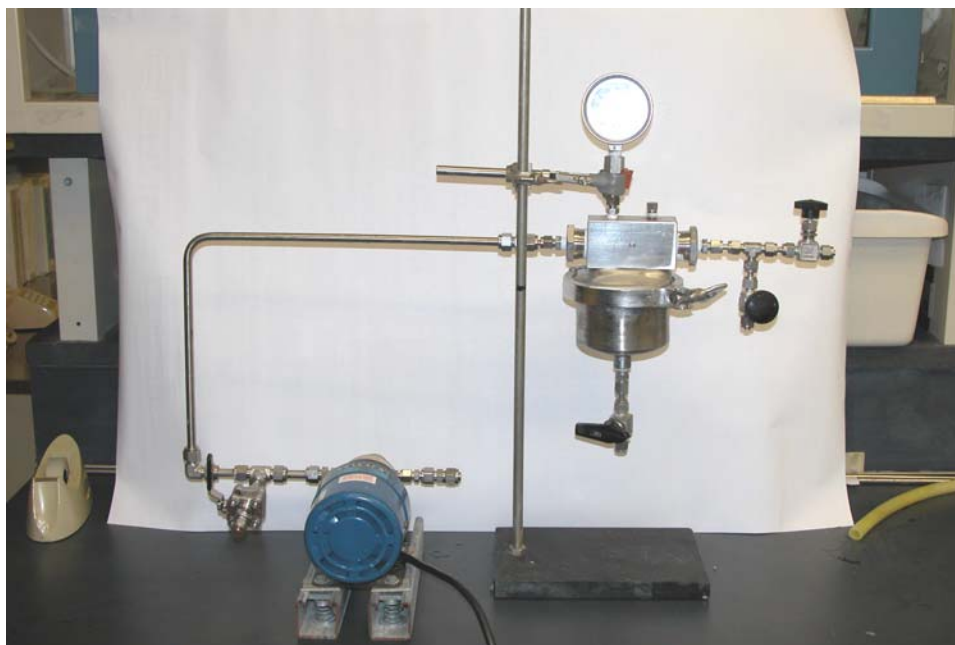
Figure 1 shows the bench-scale coalescer unit. The housing is manufactured by Pall Trinity Corp. (part # 5HD4886-799) and is designed to hold a 1 inch cartridge filter. Personnel modified the unit to hold a 1 inch coalescer element. They obtained a 40-inch, unused coalescer element from MCU personnel. They cut a 1 inch section from the coalescer, soaked it in Isopar[®] L, and placed it in the housing.

Figure 1. Bench-Scale Coalescer Unit

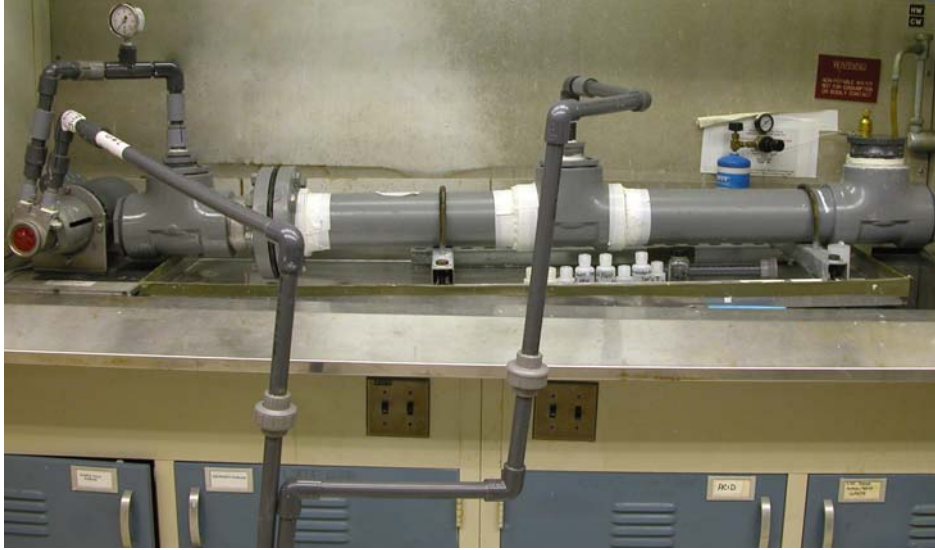
The authors obtained a full-scale coalescer element used and “plugged” during MCU simulant testing. (During facility operations, the high alarm pressure for the coalescer was 18 psig. When pressure exceeded this value, Operations stopped use and removed the element. They shipped this element to SRNL.) SRNL installed the element in the apparatus previously used for coalescer testing at Wright Industries, Inc., and in more recent SRNL testing (see Figure 2).⁴

Figure 2. Full-Scale Coalescer Test Unit

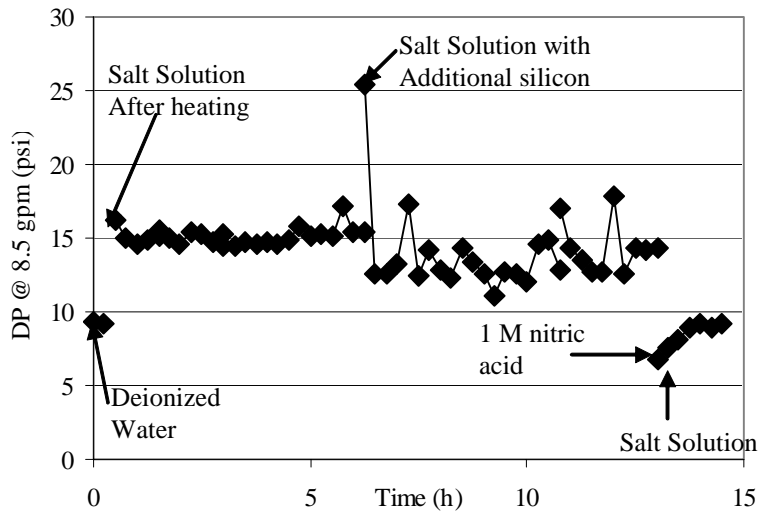
Figure 3 shows the equivalent pressure drop of the coalescer as a function of time. In this figure, we normalized the measured pressure drop to the equivalent pressure drop for a 40 inch coalescer element at 8.5 gpm. We multiplied the measured pressure drop by the ratio of flow rates (8.5 gpm/test flow rate) and divided by 40 (to account for the difference in coalescer

Figure 3. Coalescer Pressure Drop

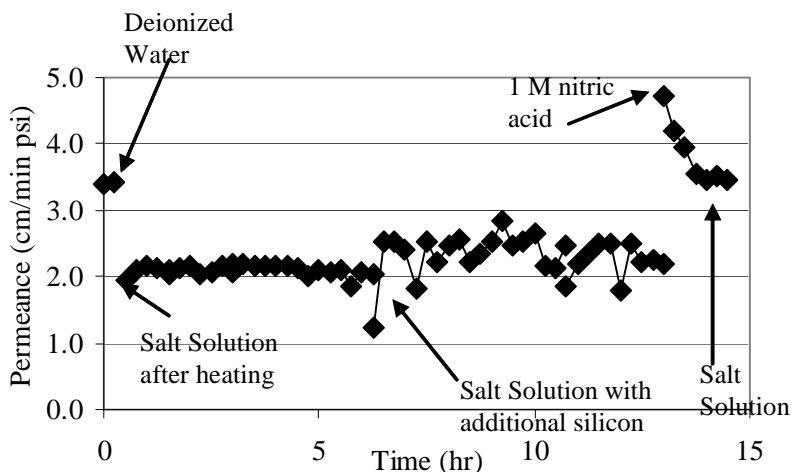
length). Figure 4 shows the same data plotted in terms of filter permeance, or flux divided by pressure drop. Permeance is the coalescer flux divided by the pressure drop. This parameter allows one to compare measurements taken at different flow rates and pressure drops. The pressure drop of the salt solution was approximately twice that of the water. Given that the viscosity of the salt solution is ~ 2 cp and the viscosity of deionized was is ~ 1 cp, one expects a 2X increase. After cleaning with nitric acid, the pressure drop decreased ~ 2.5 X. The pressure drop for fresh salt solution after cleaning was half that of salt solution with sodium aluminosilicate.

Figure 4. Coalescer Permeance

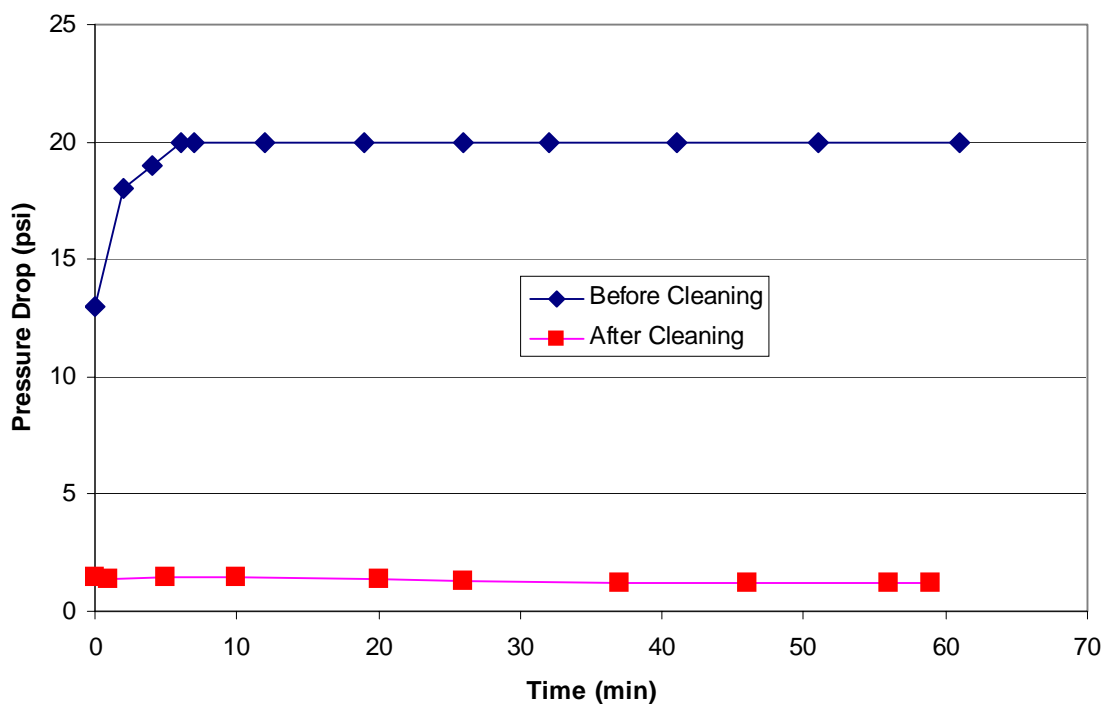
The simulated salt solution had a density of 1.2 g/mL (@ 20.8 °C), a pH of 14, and a turbidity of 0.21 – 0.36 NTU. Personnel recirculated the salt solution through the coalescer for approximately one hour. The steady-state feed pressure measured 20 psi (see Figure 5), in reasonable agreement with the performance reported by the facility in earlier operations for this element. They stopped the pumping and drained the coalescer housing and piping.

Figure 5. Pressure Drop across Coalescer before and After Cleaning.

After eight hours, they drained the acid from the soak and recirculated 0.85 M nitric acid through the coalescer for 25 minutes. The low pressure (i.e., less than resolution of pressure gauge) (see Figure 5) indicates that the cleaning solution removed a significant fraction of the contaminants that were fouling the coalescer.

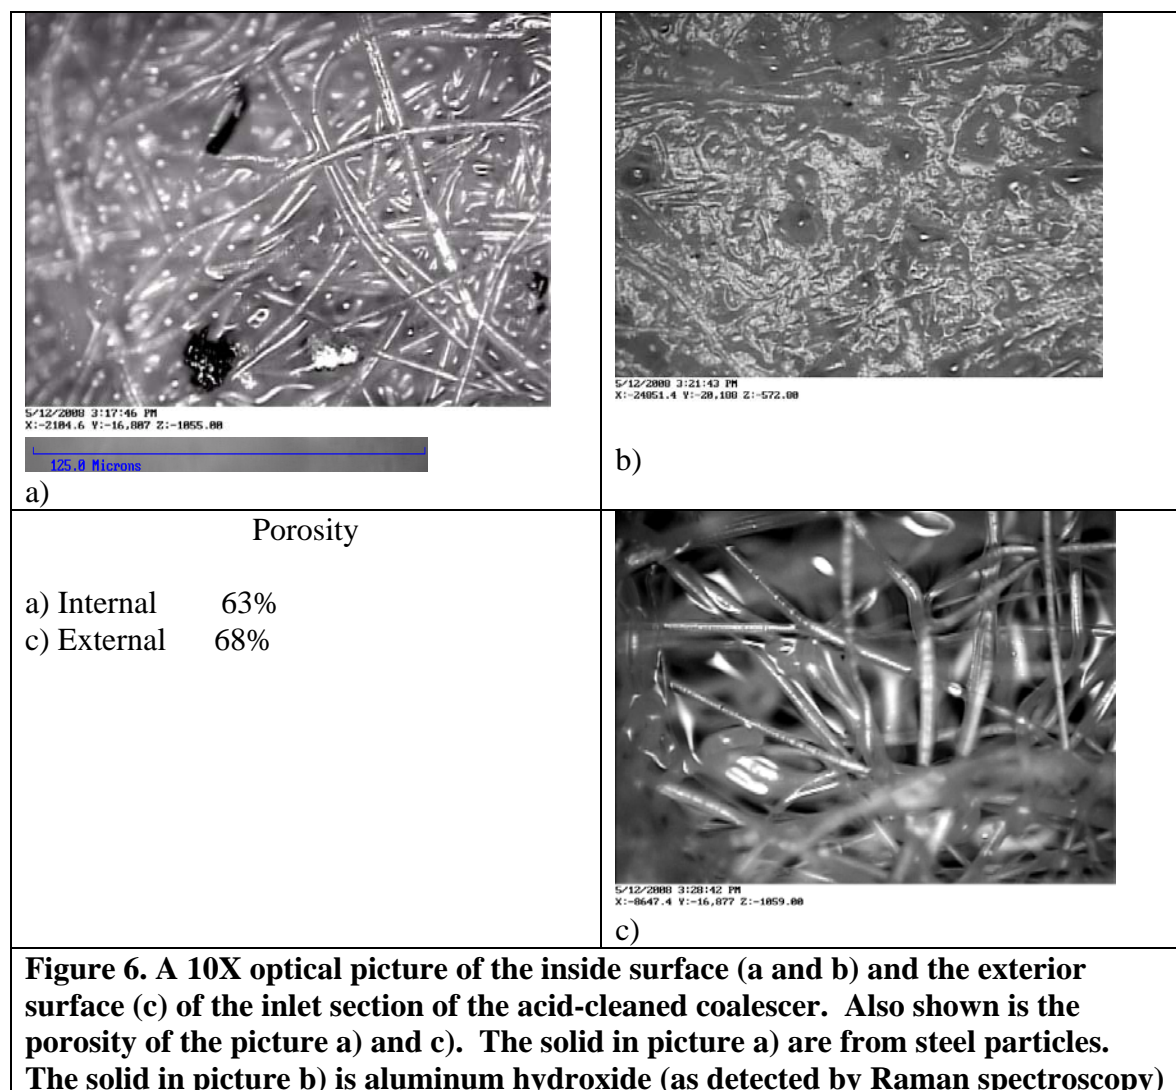
To ensure the absence of particles throughout the coalescer (and not the selective cleaning of a region), researchers cut small portions from different locations along the coalescer. The sections were examined under an optical microscope at 10X magnification to observe the pore space between the coalescer fibers. One of the authors used image software (JIMAGE) to calculate the free space in the coalescer. Figure 6 shows pictures of the interior surface (inside diameter) and exterior surface (outside diameter) at the inlet section of the coalescer. The inside surface of the coalescer was wet (containing both water and Modifierⁱ as verified by FTIR: See Figure 7). The water resided between the fibers. The Modifier was found sorbed on the fiber. At the inlet of coalescer, some areas (~20% of the visible area at the entrance considered to be 5 inches from the inlet to the coalescer) were still covered with a layer of solids (as shown in Figure 6b) and others had few solids (Figure 6a). The exterior surface was drier (as shown in Figure 6c). However, the calculated porosity of the interior and exterior surfaces were similar 63% (picture a) versus 68% (picture b).

Figure 6. A 10X optical picture of the inside surface (a and b) and the exterior surface (c) of the inlet section of the acid-cleaned coalescer. Also shown is the porosity of the picture a) and c). The solid in picture a) are from steel particles. The solid in picture b) is aluminum hydroxide (as detected by Raman spectroscopy)

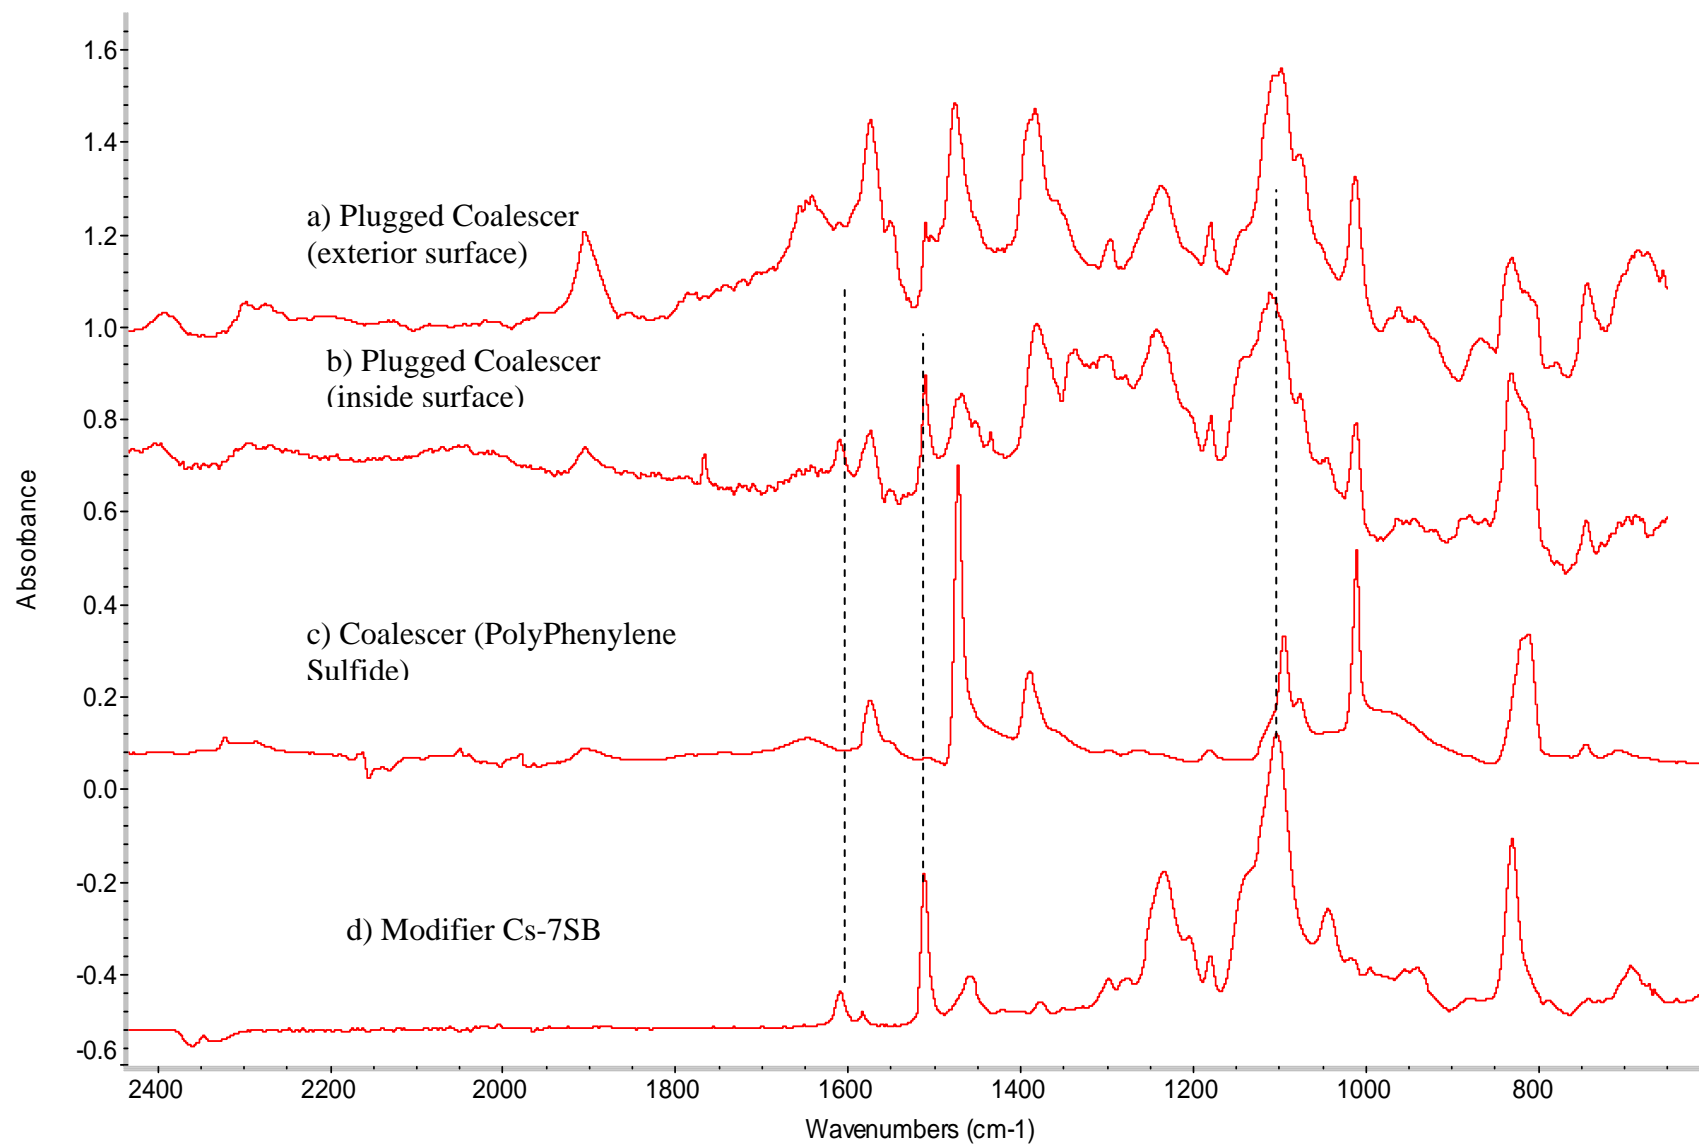
Figure 7. The FTIR microscopic spectra of the exterior and interior surfaces of the plugged coalescer.

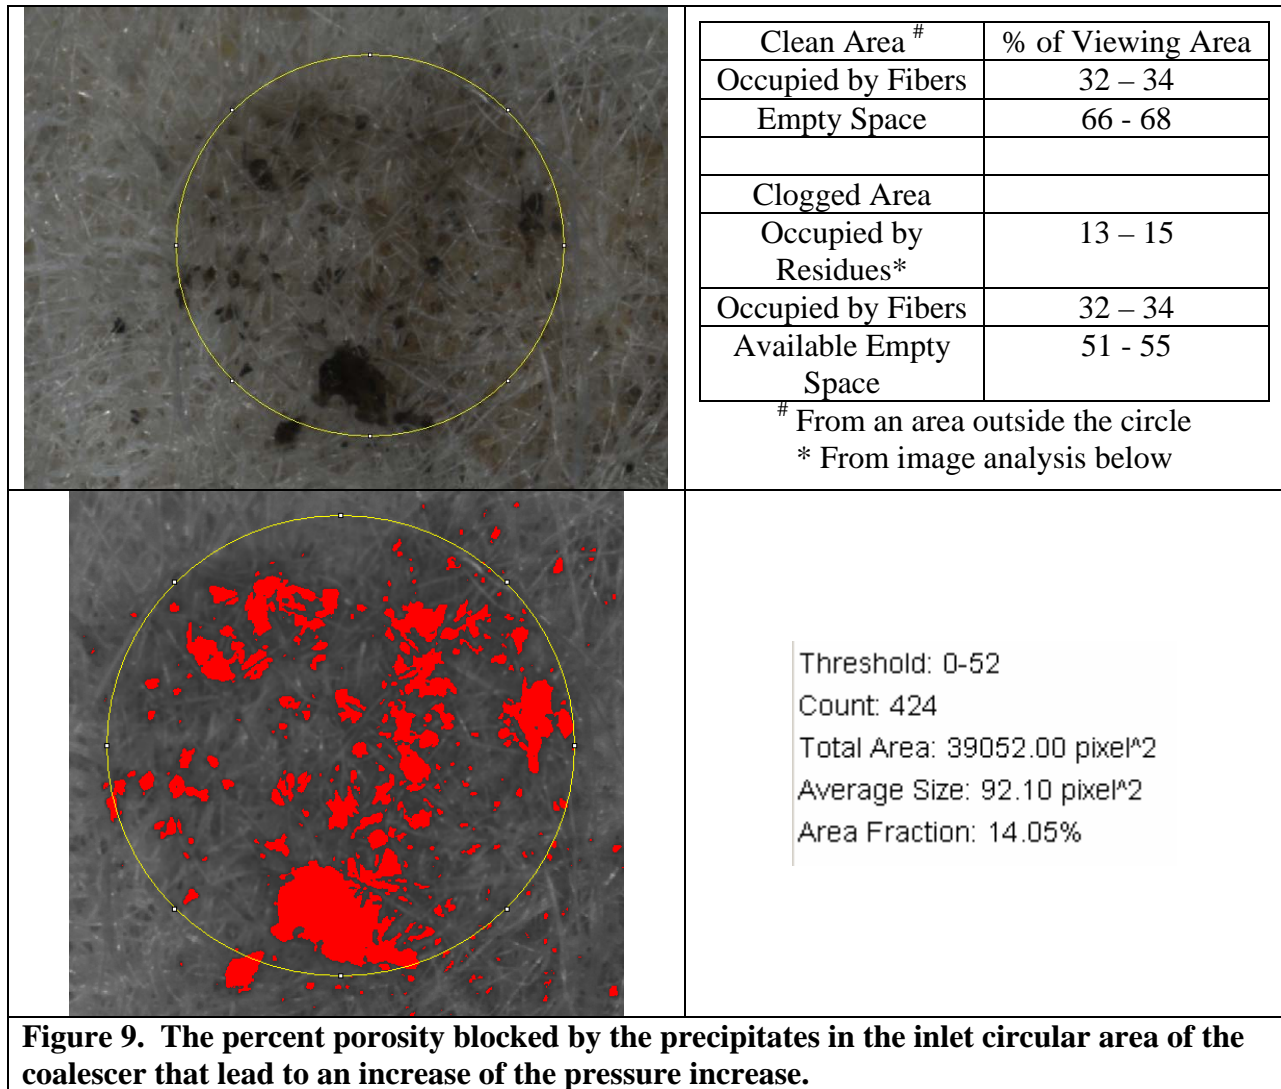
Researchers calculated the percent of porosity blocked by the precipitated particles in the inlet circular area of a coalescer that experience a pressure increase during service. Figure 9 shows a picture a 2.5 mm circular of the coalescer (area exposed by the porous stainless steel inner tube). Imaging software was then used to calculate the percent viewing area occupied by the precipitates. In this picture, the precipitates occupy 13 – 15% of the viewing area. This reduces the porosity to 50% compare to the 65% area available in the “as received” coalescer. The calculation does not include any fiber diameter increase due to adsorption which requires a higher magnification.
