Results of Experiment to Determine Corrosion Rates for 304L in HB-Line Dissolver Vessel Ventilation System

Savannah River National Laboratory
Materials Science and Technology Directorate

Publication Date: February 2008

DOCUMENT: WSRC-STI-2007-00723

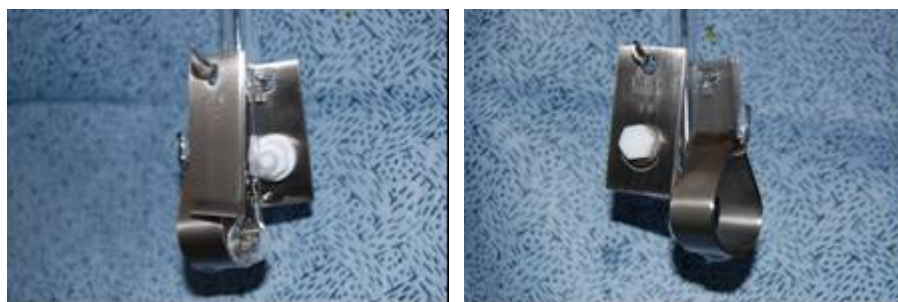
Figure 9. Test 1 Scrubber

| Solution | Position | Description |
|---|--|--|
| | D | Shiny metallic finish, no pitting or crevice corrosion |

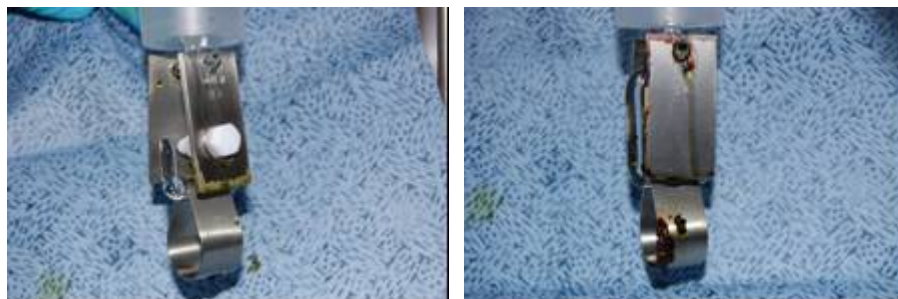
Figure 14. Test 3 Post Condenser

| Solution | Position | Description |
|---|--|--|
| | C | Shiny metallic finish, no pitting or crevice corrosion |

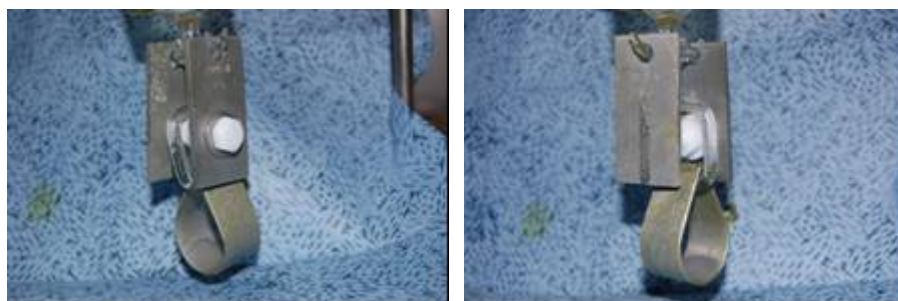
Figure 15. Test 3 Condenser

| Solution | Position | Description |
|---|--|--|
| | B | Mottled appearance, broad shallow pits, possible IGA, some crevice corrosion Heavy corrosion along edge, pitting especially along edge and in weld, some crevice corrosion |

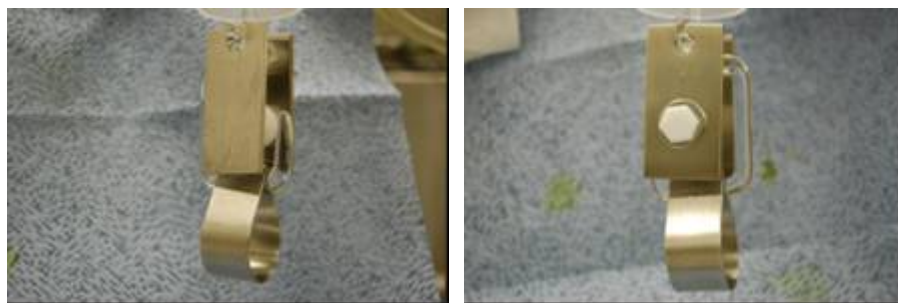
Figure 18. Test 4 Post Condenser

| Solution | Position | Description |
|---|--|--|
| | C | Shiny metallic finish, no pitting or crevice corrosion |

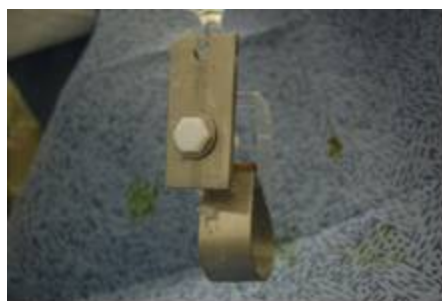
Figure 19. Test 4 Condenser

| Solution | Position | Description |
|---|--|--|
| | B | Slight mottled appearance, some rust staining along bottom edge |
