PNNL-17522

Technology Review of Nondestructive Methods for Examination of Water Intrusion Areas on Hanford's Double- Shell Waste Tanks

April 2008

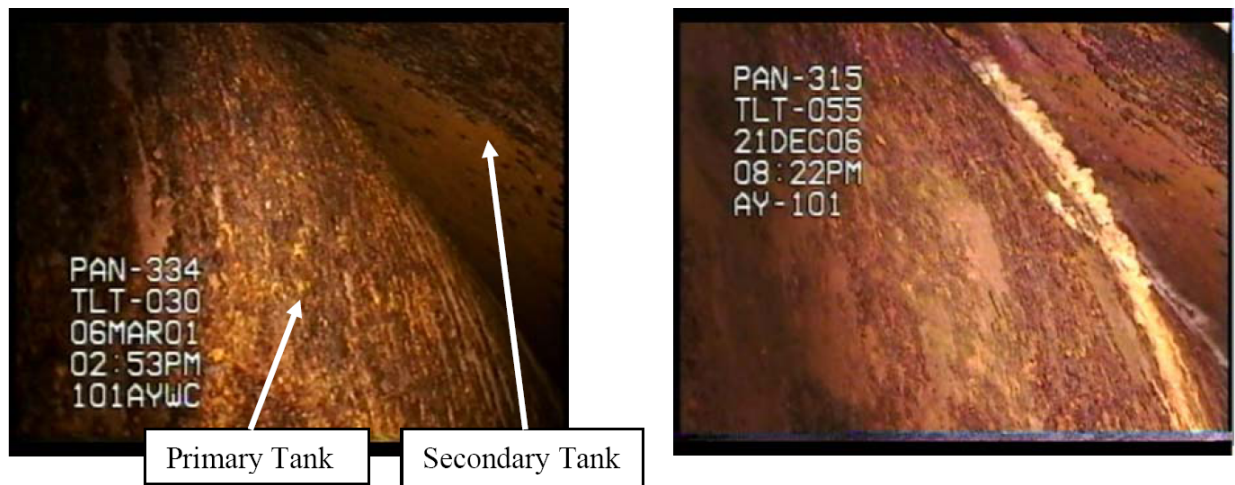
Figure 1. Mineral Build-up in Converging Area of Primary and Secondary Upper Portion of Tank. Left photo taken in 2001, right taken in 2006.

The AY tank farm was constructed in the Hanford 200 East Area between 1968 and 1970. The farm contains two double-shell tanks (DSTs), 241-AY-101 (AY-101) and 241-AY-102 (AY-102), each with a capacity of 1,000,000 gallons. The tanks were designed to store highly radioactive waste from the PUREX plant. AY-101 entered service in April 1971. Video inspections in early 2001 showed corrosion in various locations on the walls of the annulus. The annulus ventilation system had been inoperable for roughly 10 years leading to a hypothesis that the corrosion was the result of water intrusion into the annulus areas without ventilation to remove it. After examinations, AY-101 was deemed fit for use in 2003 (RPP-13361^(a)), which was independently reviewed (Stewart et al. 2003). The annulus of AY-101 showed signs of water intrusion and additional rust and mineral deposits during UT inspections performed in 2006. This report does not address the source of the water but concentrates on the possible paths. Figure 1 provides photos taken of the upper portion of the primary tank (converging with the secondary tank) in the same location in 2001 and again in 2006 showing additional intrusion with heavy mineral deposits.^(b)

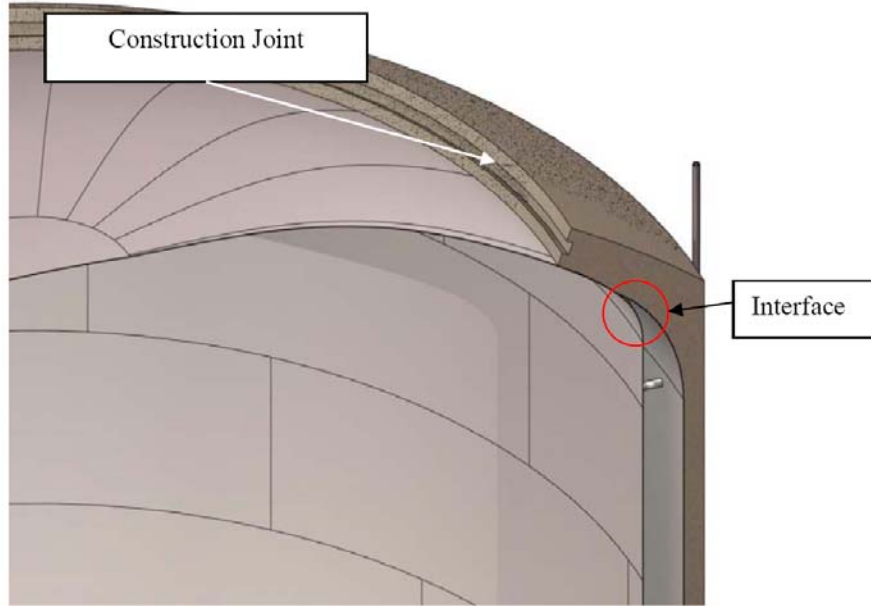
Figure 3. Concrete Construction Joint

Current hypotheses concerning how the water intrusion into the annulus is taking place include leakage through a construction joint located just above the upper haunch area where the primary and secondary tank converge and the interface between risers in the primary tank dome and the surrounding concrete. These possible intrusion areas are shown graphically in Figure 3 and Figure 4, respectively. In this report, higher consideration was given to the intrusion developing from the construction joint instead of the risers. Therefore, techniques were evaluated that would analyze the concrete at the joint instead of attempting to analyze through the riser wall-to-concrete interface. Albeit valuable data may be ascertained using techniques (especially acoustic) that could be acquired by sensing the riser to concrete interface or areas between risers, PNNL made a general (unsubstantiated) assumption that the interface between the riser and surrounding concrete would not provide reliable data with regard to the surrounding rebar. It may however provide an indication of coupling between the riser and concrete indicating a possible leak path. This could further be explored during mock-up construction.

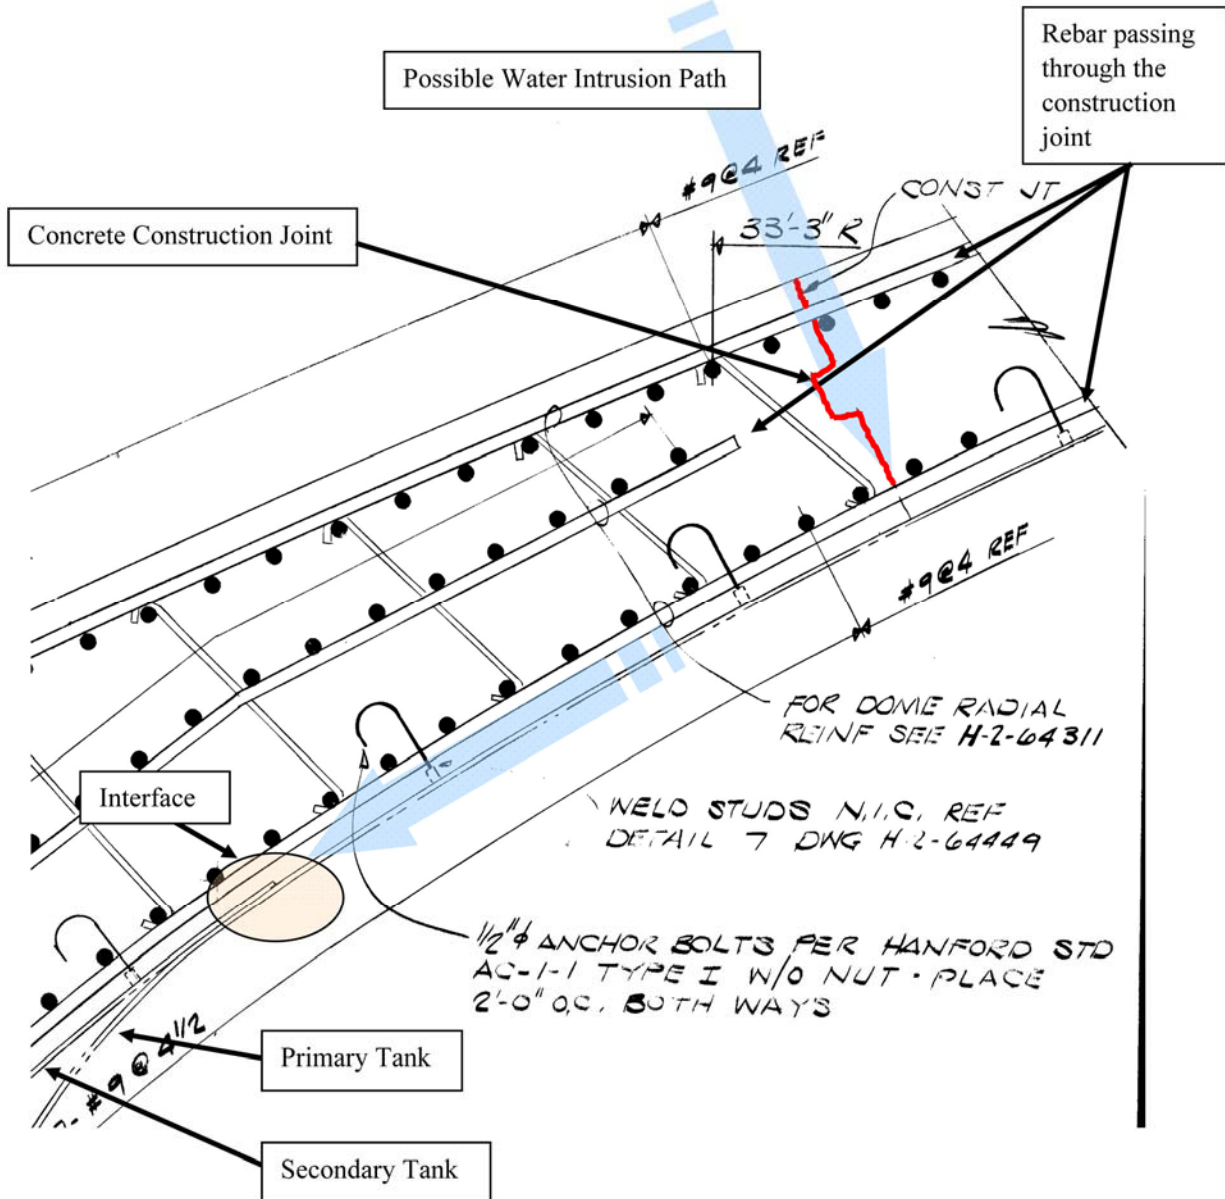
Figure 5. Upper Haunch and Concrete Construction Joint

Figure 5 provides the drawing of the construction joint and the location of the rebar. At least two rebar traverse the construction joint equally spaced around the tank. Water intrusion in the area of the construction joint could increase the likelihood of corrosion as water would be in direct contact with the rebar. Corrosion products that build up in this area could cause concrete degradation in the form of spalling.

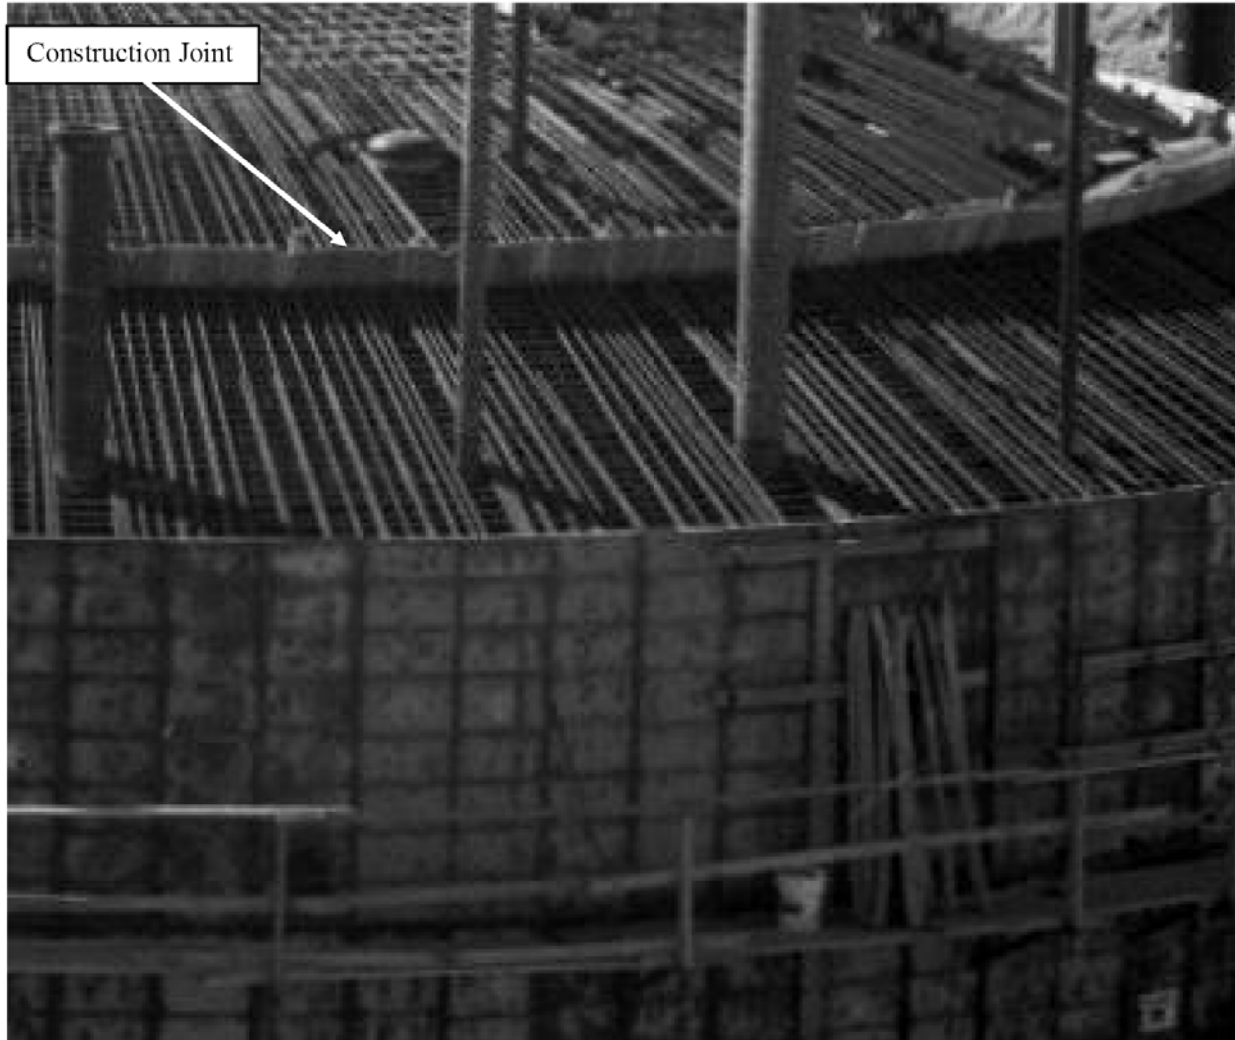
Figure 6. Example of Concrete Construction of the Tank Dome Showing the Location of the Construction Joint, 241-SY Tank Farm

An early photograph (Figure 6) shows the method used to place concrete on the tank dome of 241-SY-101 (the same method was used for the AY tanks). This photo shows the radial traversing rebar as not disconnected at the construction joint, but continuing directly through the form used to contain the concrete. Typically when this type of construction joint is used, wood that is used to contain the concrete during placement is removed after the concrete is set using bars and hammers. Any remaining wood that is held by the concrete (seeping around the form, etc.) is removed by sandblasting the wood away and roughing the concrete for the next placement.

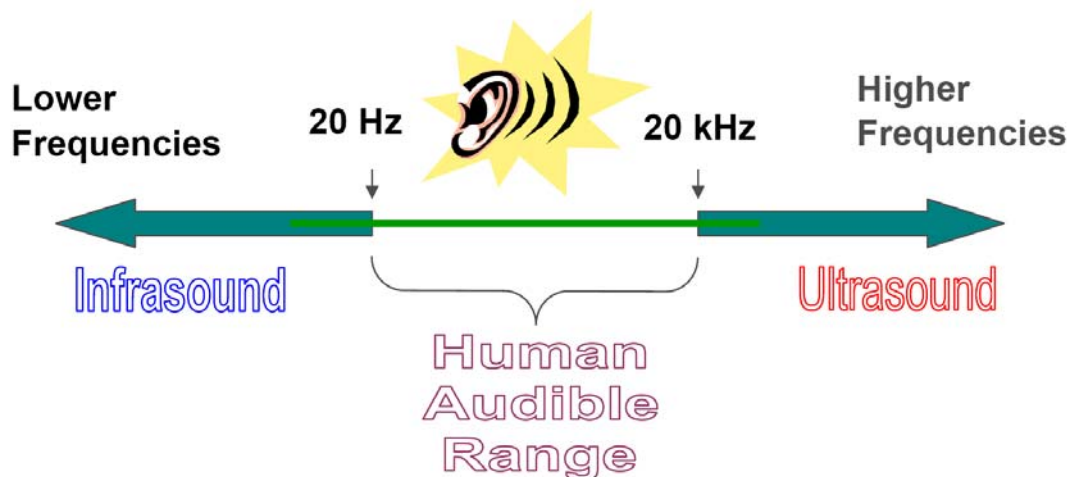
Figure 7. Broad Acoustic Frequency Bands Associated with Stress Wave Propagation

Active acoustic NDE uses stress waves to probe structures. The stress wave methods identified in ACI 228.2R represent a subset of the general class of methods that utilizes acoustic wave propagation. Stress waves can also be described as strain wave propagation within the elastic limits of a material. Generically speaking, stress wave methods involve an elastic excitation and a receiver to monitor the response. Figure 7 illustrates the broad frequency bands for acoustic wave propagation.

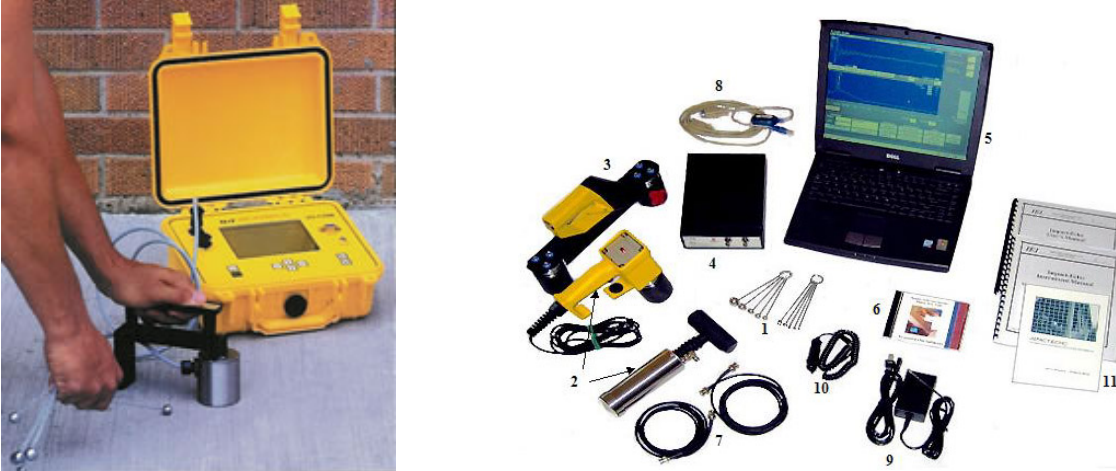
Figure 8. Commercial Impact-Echo Instrumentation. A mechanical impact provides the excitation and an acoustic transducer senses the stress wave response of the concrete. Images courtesy of Impact-Echo Instruments, LLC.

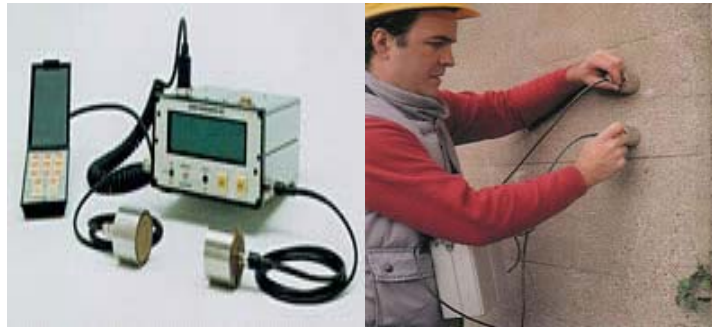
Figure 9. Example of Ultrasonic Pitch-Catch Inspection System Applied in the Single-Sided Mode

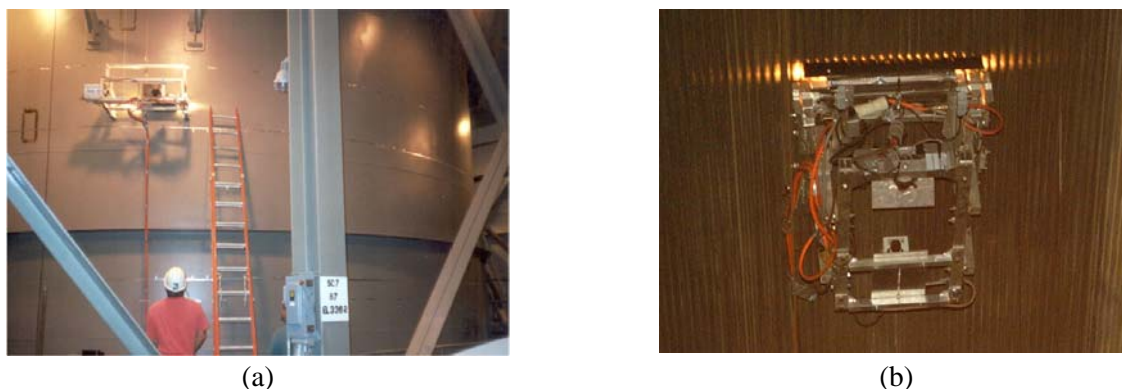
Figure 10. Example of Thermal NDE System for the Inspection of (a) Tank Wall and (b) Boiler Section. Images courtesy of Therm-Tech Services, Inc.

Figure 10 illustrates a system that uses a step-heating excitation to rapidly inspect metallic tank walls and sections of a boiler. From a data analysis perspective there are several analogies to acoustic NDE. In both cases the measurement involves the excitation and monitoring of accessible surfaces (a time-varying boundary condition) with the relative impedance at internal boundaries controlling the energy propagation (wave mechanics for acoustics and diffusion for heat transfer). Knowledge of material properties

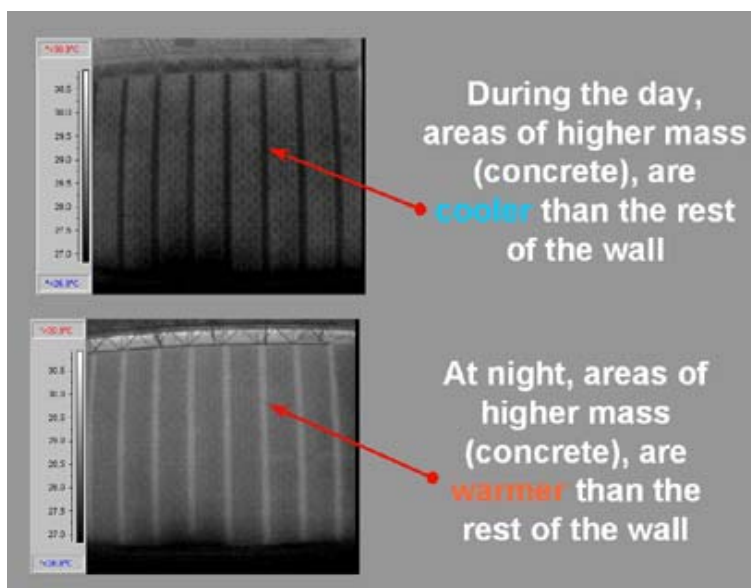
Figure 11. Thermographic Inspection of a Concrete Wall Using Diurnal Cycle to Detect Large Voids. Images courtesy of Stockton Infrared Thermographic Services, Inc.

The use of thermography for relatively gross structural defects is straightforward and often requires minimal analysis. In this case, gross voids in the as-fabricated condition are easily detected and often quantified. Figure 11 illustrates the use of thermography to locate gross structural voids in a concrete wall. In this case the wall contained 50 percent voids. When considering the use of this technology for the quantification of more subtle damage, it is advisable to conduct a careful method analysis to assess the anticipated sensitivity. Thermal NDE has been successfully applied in the detection of metal wall losses of less than 5 percent. While the detailed heterogeneity and heat transfer properties determine the limits of detection, a good rule of thumb is that it is difficult to size voids that are deeper than approximately two times the lateral extent (i.e., length of the void parallel to the surface). Detection at greater depths is sometimes possible.

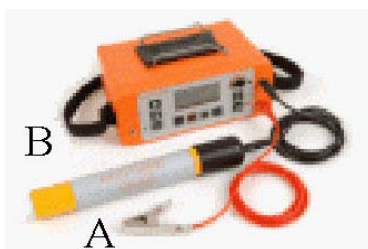
Figure 12. Half-Cell Instrumentation. (A) Electrical rebar contact, (B) reference half-cell which inductively couples to the rebar through the concrete. Image courtesy of Elcometer Instruments Ltd.

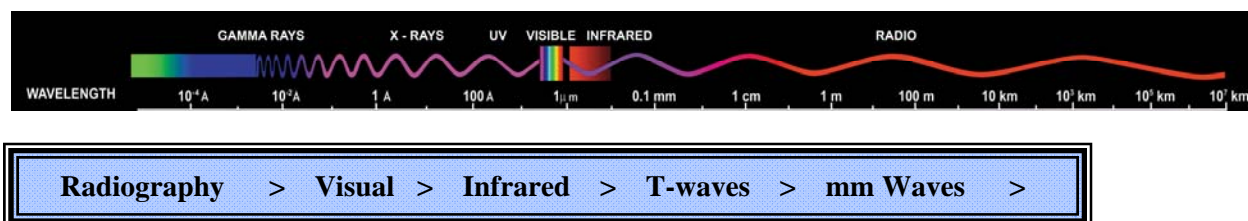
Figure 13. Bands of the Electromagnetic Spectrum

When discussing the more traditional (relative to those presented in Section 2.3) electromagnetic NDE methods, it is useful to place them in the context of the electromagnetic spectrum (Figure 13). Note that while techniques utilizing radiation such as in the x-ray, visible, infrared bands are fundamentally treated as electromagnetic, in the context of concrete inspection methods that interrogate below the surface “electromagnetic techniques” involve frequencies from DC to around 10 GHz. Coupling or penetration is typically achieved through air. Regardless of the detailed coupling, each of these methods involves the excitation and monitoring of electromagnetic wave propagation within the structure. The analytical approaches to describing this interaction depend on the dielectric and resistivity properties and the geometry of the components. The presence of significant corrosion products introduces significant changes in both material properties and geometry.

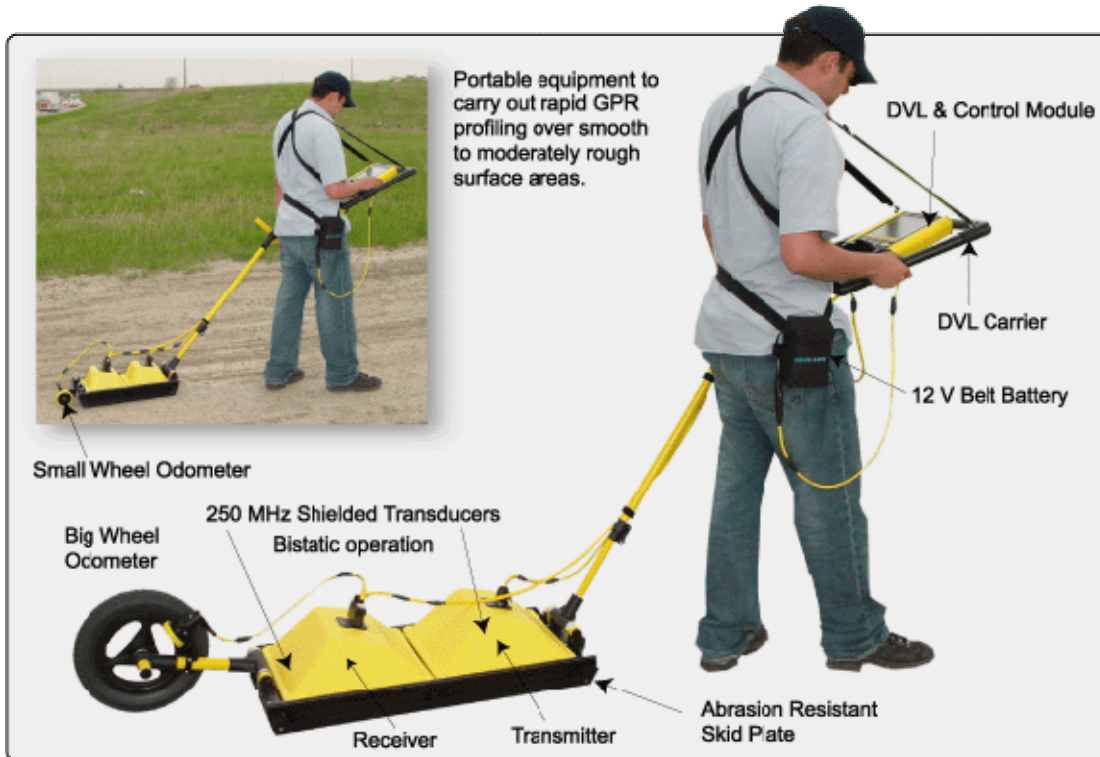
Figure 16. Portable Radar System from Geophysical Survey Systems, Inc. (GSSI) (<http://www.structurescan.com/>)

Commercial radar systems come in a wide variety of packages for different applications. Figure 15 and Figure 16 illustrate two such systems. Off-the-shelf radar instruments require manual scanning. Registration technique along the scan surface influences the spatial accuracy of measurements. The raw data obtained from these scans are typically presented in the time domain. Figure 17 illustrates time domain data from such a concrete scan with a series of rebar reflectors above one another. The x axis represents distance along which the antenna element was translated and the y axis represents the time delay in the reflected signal. The surface being scanned is located at the top of the chart. Thus, the sequential parabolas created at the top of the chart indicate a series of reflectors near the surface. The partial parabolas near the bottom of the chart indicate reflectors below the first set. Note the partial shadowing of the lower layer by the top layer and the complex patterns created by multiple reflections at the various interfaces. The detailed interpretation of this data is complex and requires certain assumptions about the underlying structure. Independent information regarding material properties and geometry can prove to be very valuable in gleaning additional insights into the condition of the structure.

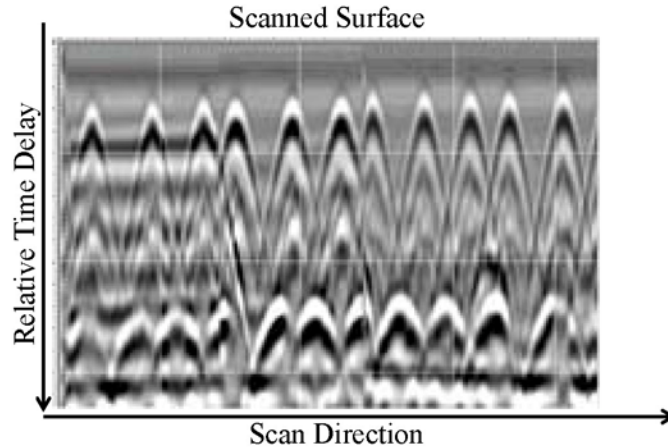
Figure 17. Time-Domain Representation of Radar Reflections from Rebar. The x axis represents distance along a scan axis. The y axis represents the relative time delay in the reflected signal. The surface being scanned is represented by the top of the chart. Thus, the sequential parabolas created at the top of the chart indicate a series of reflectors near the surface. The partial parabolas near the bottom of the chart indicate reflectors below the first set. Image obtained from <http://www.structurescan.com>.

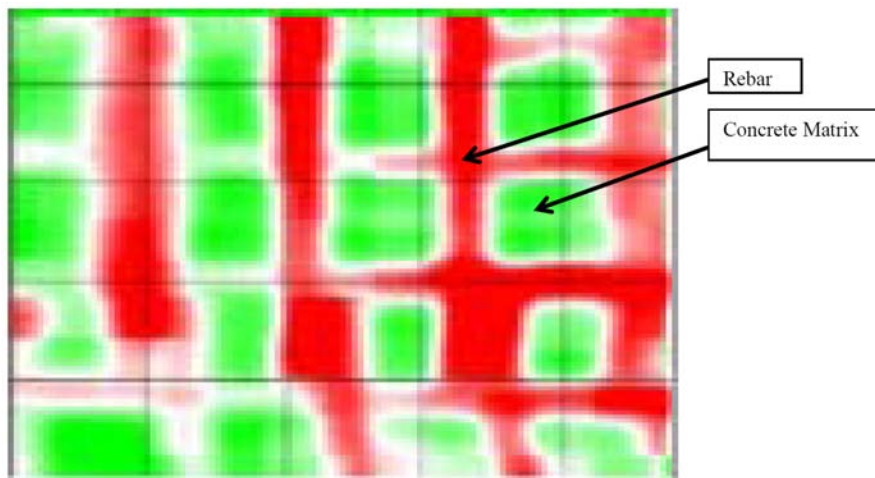
Figure 18. Example of Rendering in Plan View

Recent market offerings include three-dimensional renderings created by post-processing raw radar data. Figure 18 is an example of rendering in the plan view. Unfortunately the algorithms and underlying assumptions used in these reconstructions are proprietary, and it is not possible to assess the quality and limitations of the analytical methods used to generate the derived structural data. In addition, the data is not provided in formats that are compatible with structural analysis. However, appropriately designed studies, using mock-up concrete sections, would allow for an assessment of the accuracy and limitations of these algorithms as they might be applied to tank domes. PNNL owns a commercial radar unit (GSSI, structurescan) and has staff trained in its operation (Sheen et al. 2001, 2007).
