ORNL/TM-2009/021

# Effect of Intake Air Filter Condition on Vehicle Fuel Economy

February 2009

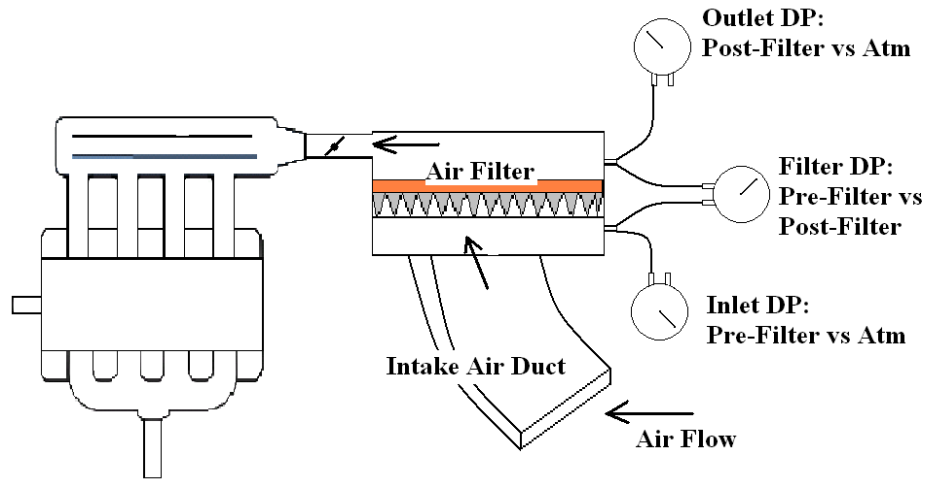
**Fig. 2.1. Pressure transducer setup for modern vehicles.**

The DPs measured were as follows (see also Fig. 2.1).

- Inlet DP—The pressure differential between the area just before the air filter and the atmosphere.
- Filter DP—The pressure differential between the area just before the air filter and the area just after the air filter.
- Outlet DP—The pressure differential between the area just after the air filter and the atmosphere.

These pressures were measured using three separate electronic delta P pressure transducers. Each transducer was able to measure 0 to 7.5 kPa (0 to 30 inches of water column). The sensors were calibrated before testing began using a water manometer. In a few experiments, the measured pressures exceeded the range of these sensors. This issue did not present itself as a significant problem until late in testing when “severe” test cases were explored (Sect. 3).

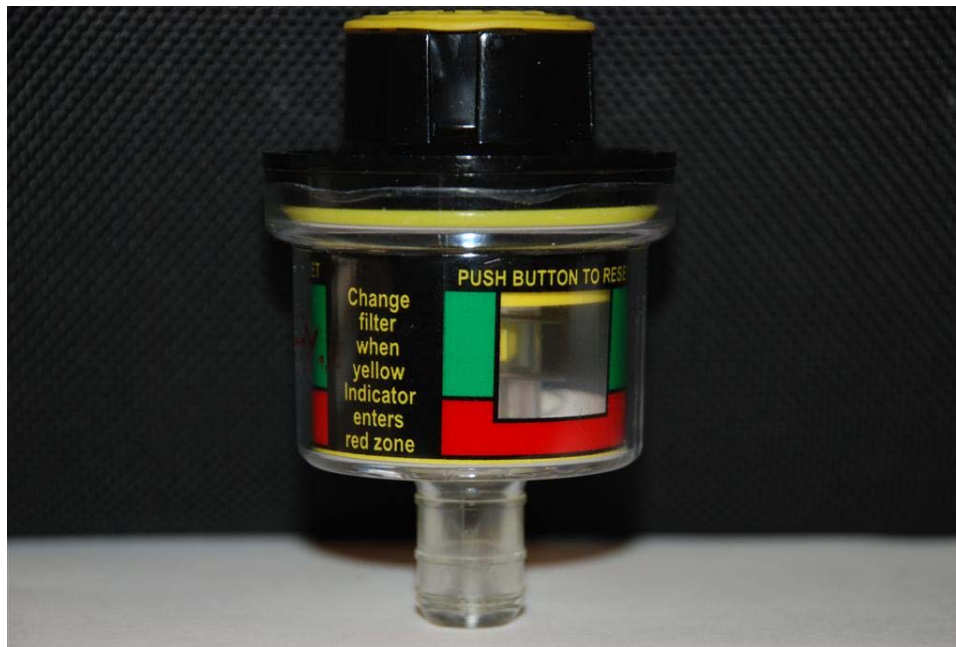
**Fig. 2.2. Air filter indicator.**

A factory OEM indicator was taken from a 2001 Chevrolet Silverado with 5.3L V8 and tested to find the Outlet DP required to “set” the indicator or move the yellow indicator into the red zone (see Fig. 2.2). Using a vacuum pump and water manometer to test the indicator, the authors determined that an Outlet DP of about 5.7 kPa was needed to set the indicator to the level corresponding to a clogged air filter.

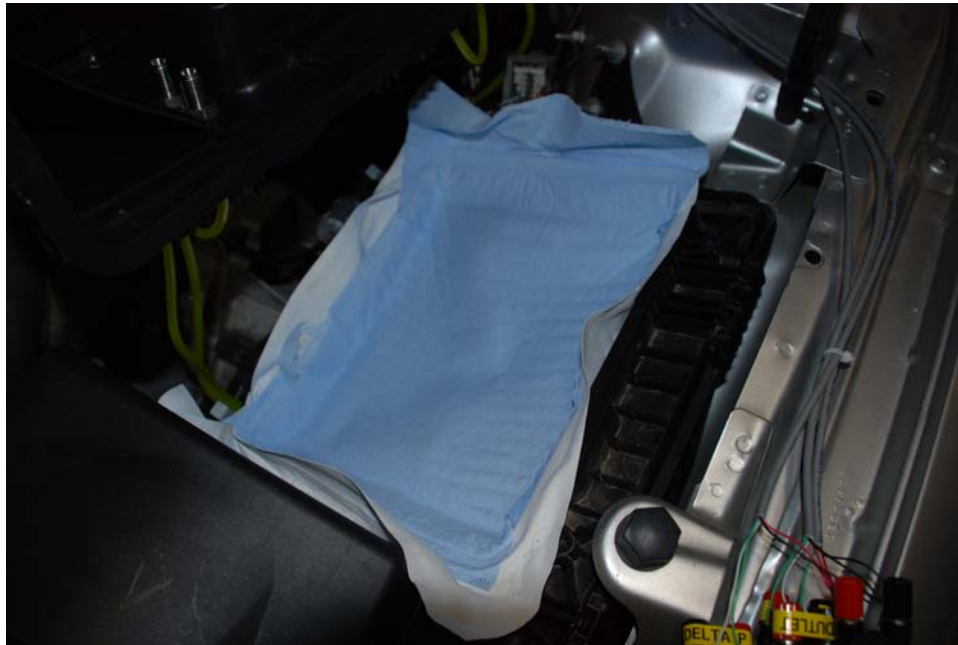
**Fig. 2.3. 2007 Buick Lucerne filter restriction.** Shop towels inserted into air box upstream of the air filter.

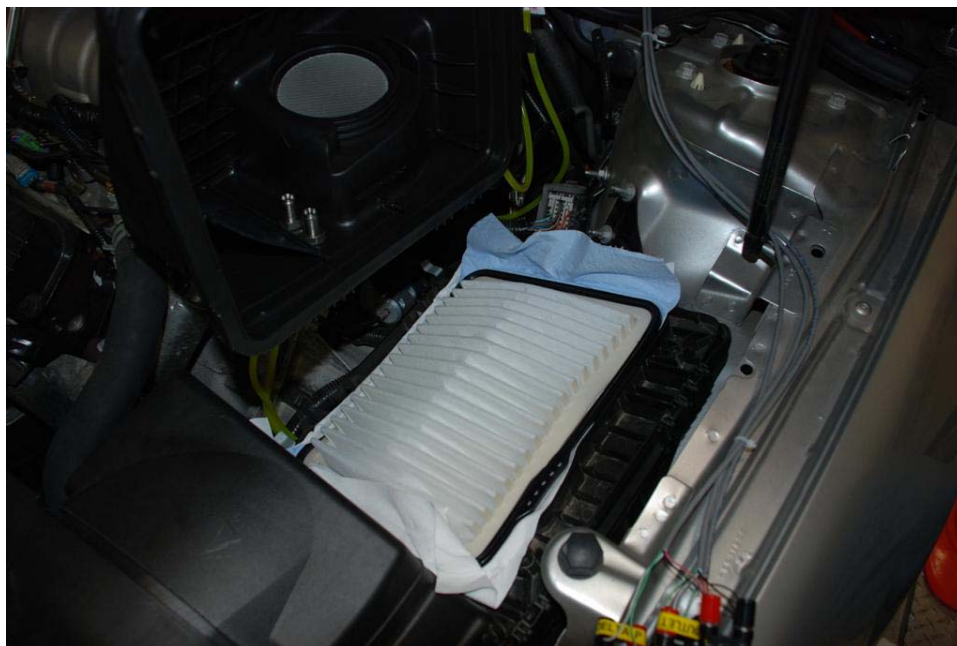
**Fig. 2.4. 2007 Buick Lucerne filter restriction.** Shop towels inserted into air box upstream of the air filter.

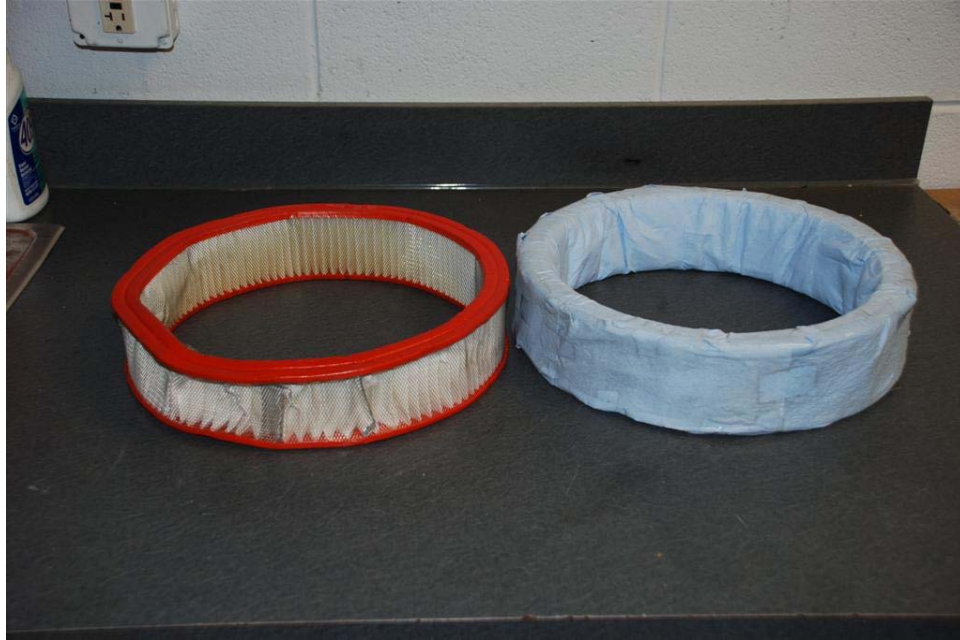
**Fig. 2.5. 1972 Pontiac Grandville air filter.** Filter on the left shows damage that occurred during “severely clogged” filter testing (see Sect. 3.3.1).

Wide-open throttle (WOT) tests were used to measure the changes in the filter pressure drop (Outlet DP). In a real-world application, the vacuum needed to set one of the air filter indicators would likely occur under heavy acceleration, such as merging onto an interstate, or climbing a steep grade. Therefore the level of restriction was set, using an artificial clogging technique described below, to achieve the desired Outlet DP during a WOT acceleration from idle to approximately 85 mph or a steady-speed (SS) WOT test in which the dynamometer was held at a fixed speed, 65 mph, and the throttle was held open for 10 seconds. Using these test procedures, the 2007 Buick Lucerne was configured to achieve an Outlet DP of approximately 7.0 kPa under the WOT acceleration and approximately 5.7 kPa under the SS WOT. Once the method for achieving this restriction was developed, it was used with each vehicle. Using this approach, the V8-equipped Dodge Charger showed a slightly higher Outlet DP than the V6 Lucerne, and the I4 Camry showed a slightly lower Outlet DP. The 1972 V8 Pontiac was restricted in a similar manner and level. It is important to note that all the modern vehicles used rectangular cartridge style air filters (Figs. 2.3 and 2.4), while the 1972 Pontiac used the cylindrical filter element common in that era (Fig. 2.5).

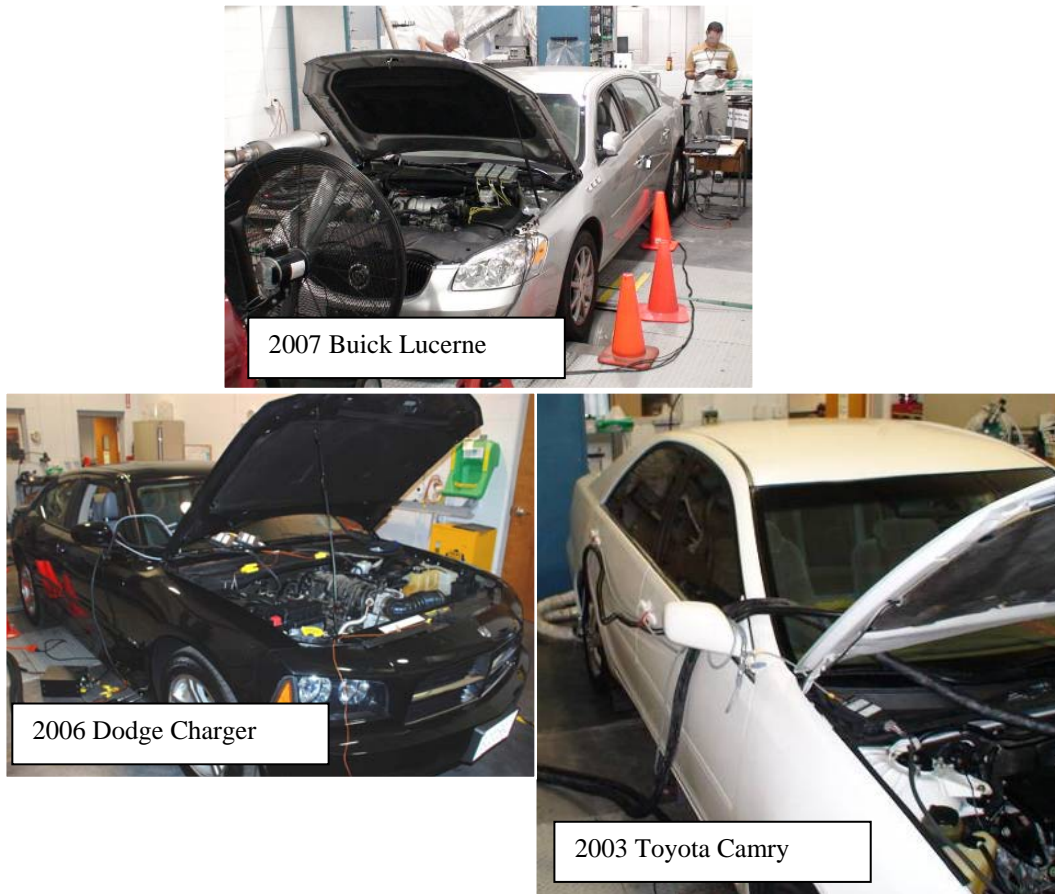
**Fig. 3.2. Newer vehicles tested.**

Each of the three newer vehicles listed in Sect. 2.2 was tested in the same manner to compare the effects of a clean versus a clogged filter. The vehicles are shown in Fig. 3.2. Each vehicle was instrumented with the electronic delta P pressure transducers reading Inlet DP, Filter DP, and Outlet DP during testing. The restriction level was initially set using the 2007 Buick Lucerne, equipped with a 3.8L V6, such that the maximum Outlet DP was about 7.0–7.2 kPa during the CRC E-60 WOT tests and about 5.7–6.0 kPa during the SS WOT tests. Both conditions would allow for a common air filter indicator to be set, indicating to the user that the vehicle’s air filter should be changed. Once the restriction level was determined, the same number and style of disposable shop towels were used for each vehicle to simulate a similar degree of clogging. This approach resulted in a slight variance of the Outlet DP depending on the

vehicle due to differences in filter area and engine displacement. In all cases the restriction was on the order of 6.0–7.0 kPa, adequate to set a common air filter indicator.

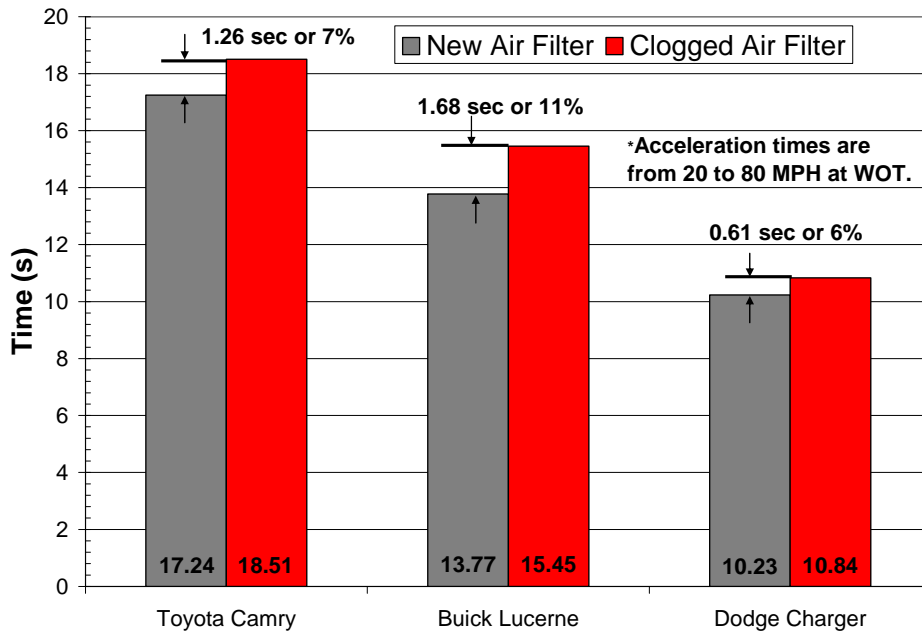
**Fig. 3.7. Acceleration time for CRC E-60 WOT tests.** Data are averaged from the five accelerations of the CRC E-60 cycle.

Figure 3.7 shows the acceleration times for the vehicles with both a clogged and new air filter. The data were analyzed from 20 to 80 mph to ensure that the vehicle was at WOT, removing any driver induced variability. The WOT protocol requires the vehicle to be accelerated at WOT from idle to 85 mph. The driver reported being able to “feel” the restriction created by the clogged filter and sense the decreased acceleration for both the Camry and Lucerne. The Charger was 0.6 seconds slower in the clogged state, but the driver reported no noticeable decrease in acceleration.

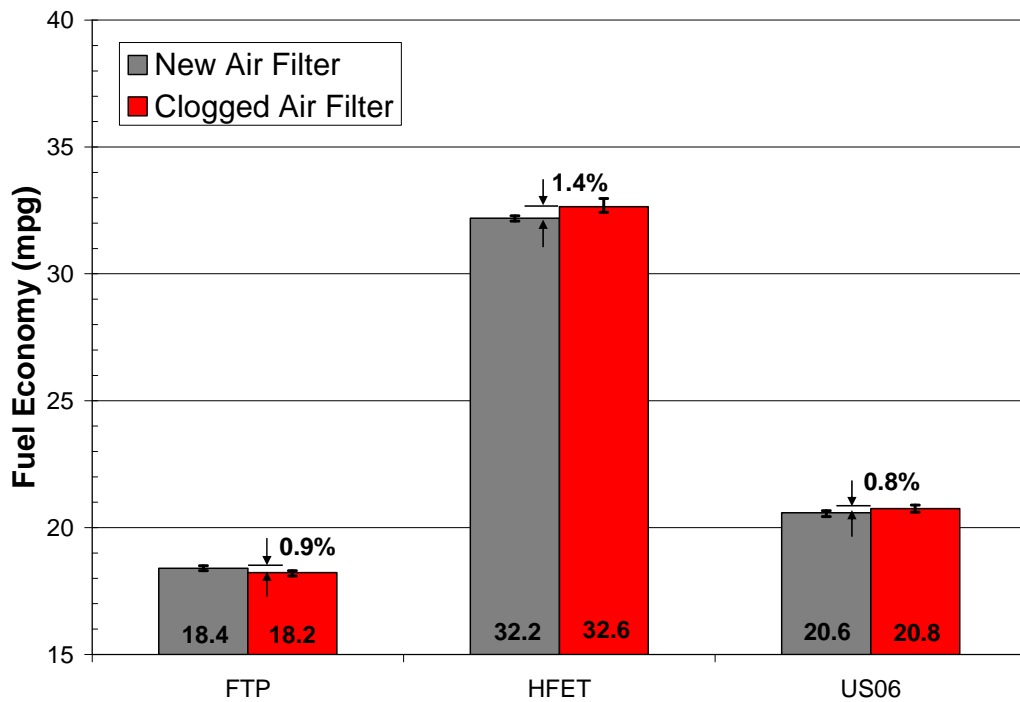
**Fig. 3.10. Fuel economy for 2006 Dodge Charger.** Data are averaged over the three tests conducted for each cycle and configuration. Range bars show the minimum and maximum for each data set.

Despite the filter restrictions, however, no significant changes in fuel economy were observed. Each vehicle was run through at least three rounds of FTP, HFET, and US06 tests with the new air filter, and the same protocol was repeated with the clogged air filter. The tests were conducted on consecutive days for each vehicle. This format was used to allow for the required soak time to perform a cold FTP each morning. The resulting fuel economy data for the vehicles are shown in Figs. 3.8, 3.9, and 3.10. Range bars in the figures show the minimum and maximum of the tests for each case, while the columns show the average. Test-to-test repeatability is within about 1.5%, and all of the variances between the new and clogged air filter cases are similarly within about 1.7%. The baseline fuel economies for the vehicles were all within 0–6% of unadjusted EPA certification database values ([www.epa.gov](http://www.epa.gov)) for similar vehicles.

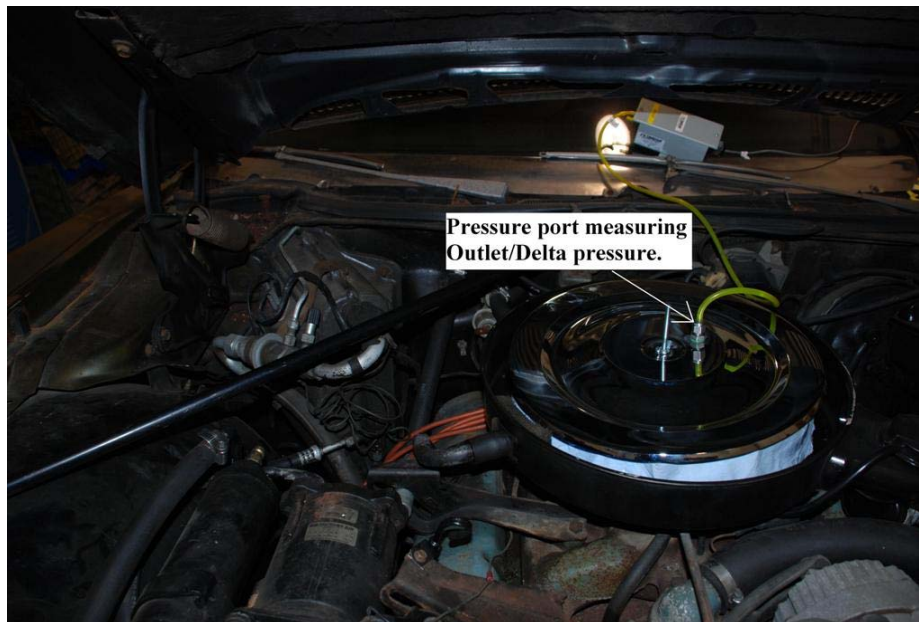
**Fig. 3.12. Pressure port location for 1972 Pontiac Grandville.**

To investigate the effect of a clogged air filter on a carbureted engine, a 1972 Pontiac Grandville with a 455ci V8 engine was also tested (Fig. 3.11). The Pontiac was only instrumented with the electronic delta P pressure transducer reading the Outlet DP during testing, configured so that it measured the pressure after the air filter and referenced that to the ambient air pressure. This setup is shown in Fig. 3.12.

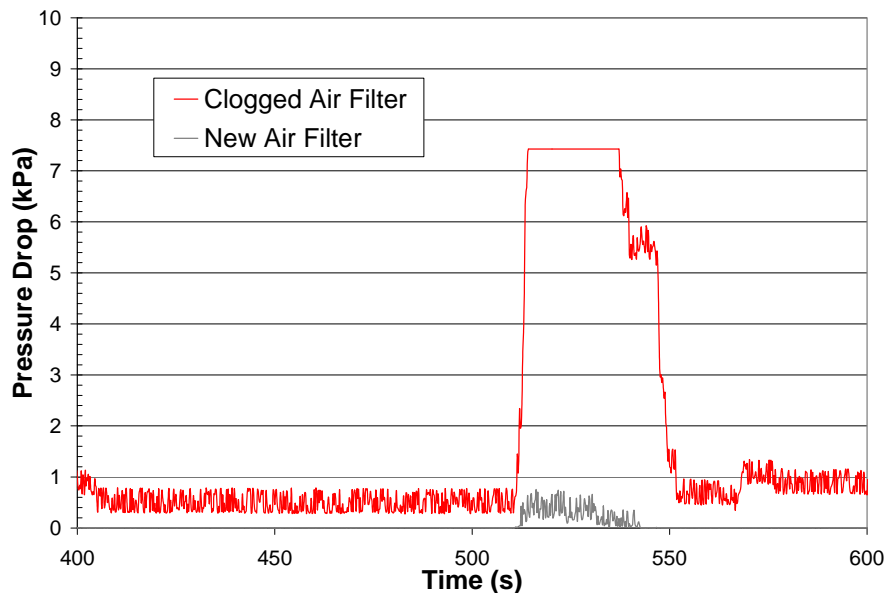
Fig. 3.13. Outlet DP for 1972 Pontiac Grandville during CRC E-60 WOT.

The Outlet DPs for the new filter and simulated clogged filter from the CRC E-60 WOT and SS WOT tests are shown in Figs. 3.13 and 3.14. The peak Outlet DP for the clogged filter is in excess of 7.5 kPa for the CRC E-60 WOT—the sensor is at its maximum range for each of the accelerations—while that for the new filter is less than 0.75 kPa under the same acceleration conditions. For the SS WOT tests, the clogged filter again showed an Outlet DP in excess of 7.5 kPa, while the new filter again showed less than 0.75 kPa under the same acceleration conditions. These results can be considered analogous to the Filter DP because the sensor was reading the post-filter pressure versus the ambient pressure. This means that, in both WOT cases, the clogged filter was exhibiting a pressure drop greater than 7.5 kPa across the air filter. Because of time constraints, we proceeded with testing rather than waiting to procure a sensor with a larger range.

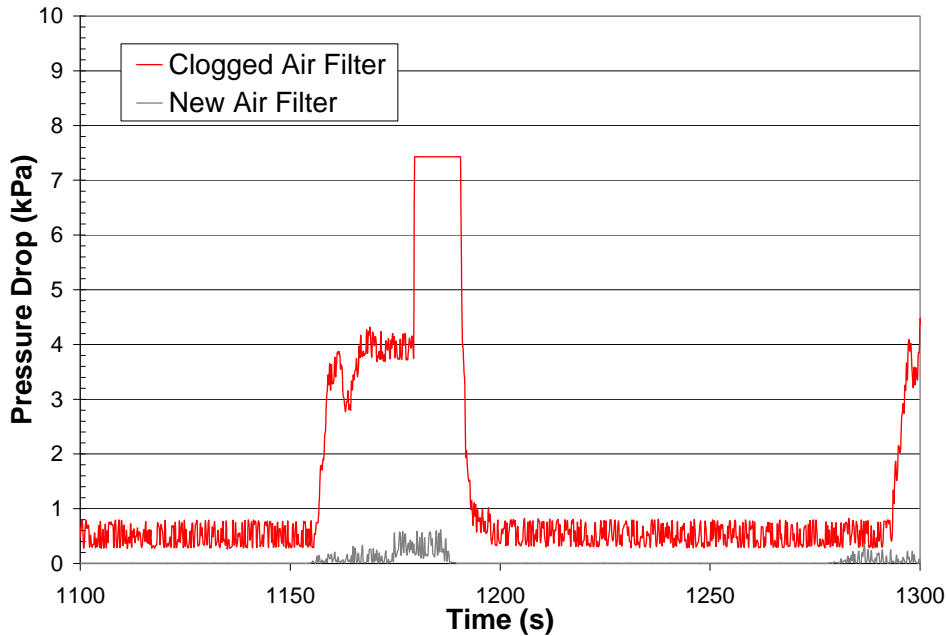
**Fig. 3.14. Outlet DP for 1972 Pontiac Grandville during SS WOT.**

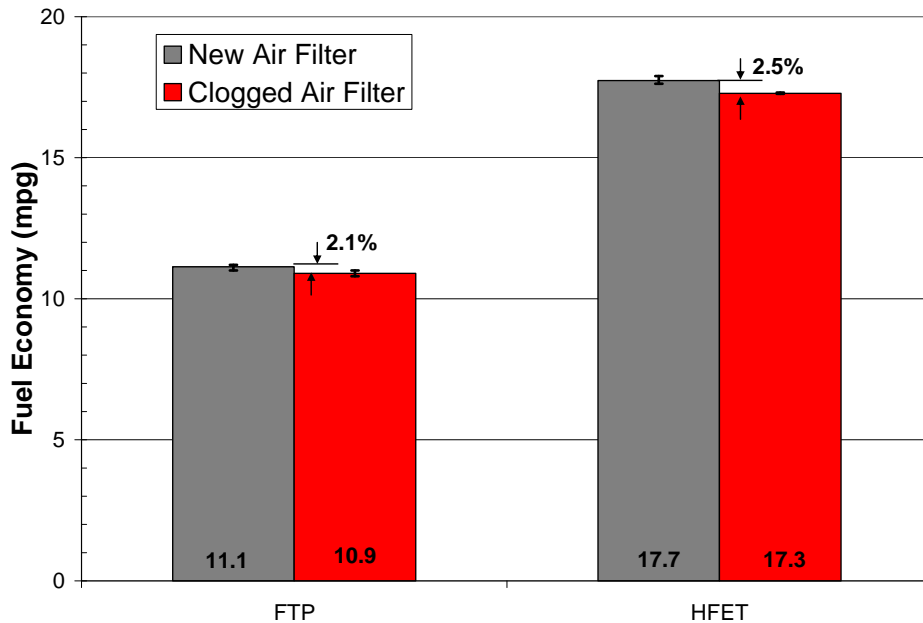
**Fig. 3.16. Fuel economy for 1972 Pontiac Grandville.** Data are averaged over the three tests conducted for each cycle and configuration. Range bars show the minimum and maximum for each data set.

attempts to complete that cycle with this vehicle. The US06 cycle requires aggressive accelerations and has extended periods of high speed operation (up to 80 mph). The 1972 Pontiac overheated during these high speed sections of the US06. Therefore, to avoid damaging the vehicle, the US06 tests were not conducted. The FTP and HFET tests were conducted on consecutive days, with each test being run once per day, similar to the other vehicles. This format was used to allow for the required soak time to perform a cold FTP each morning. The resulting fuel economy data for the Pontiac are shown in Fig. 3.16. Test-to-test repeatability is within about 1.8% for the Pontiac, and the new versus clogged cases show a drop of about 2%–2.5%. The level of filter clog tested appears to have a small effect on the fuel economy of this carbureted vehicle although it is not as dramatic as some of the fuel economy differences reported in the literature.<sup>3</sup>

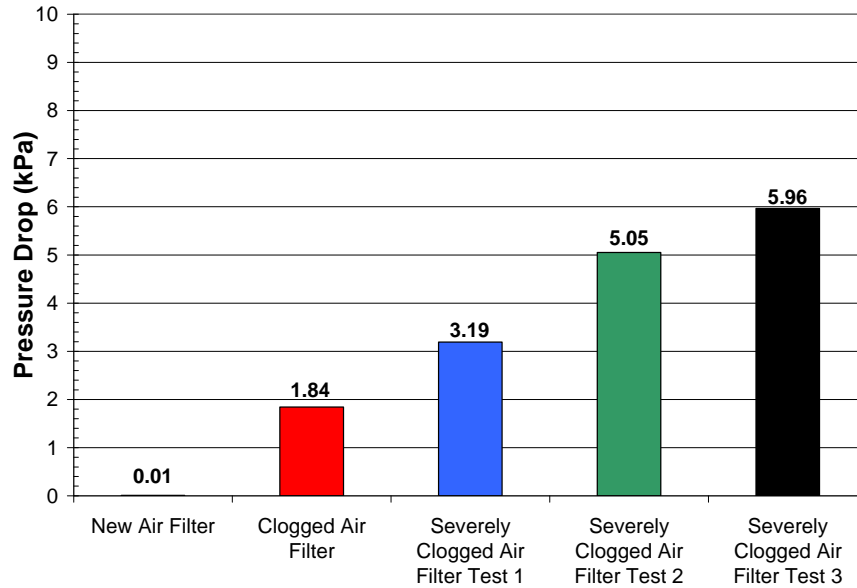
**Fig. 3.17. Air filter average Outlet DPs for 1972 Pontiac Grandville during double HFET.**

The filter restriction in the Severely Clogged Air Filter Test 3 configuration (black column, Fig.3.17) was so severe that the driver had to consciously drive the vehicle in a manner that would not increase the throttle fast enough to cause a rich misfire condition during the HFET cycle. Once rich misfire was encountered, the vehicle was not able to maintain speed, and therefore, the test was invalid. The Filter Test 3 configuration also resulted in the air filter being crushed by the air filter cover. Figure 3.18 shows a picture of the air filter after removal of the shop towels.

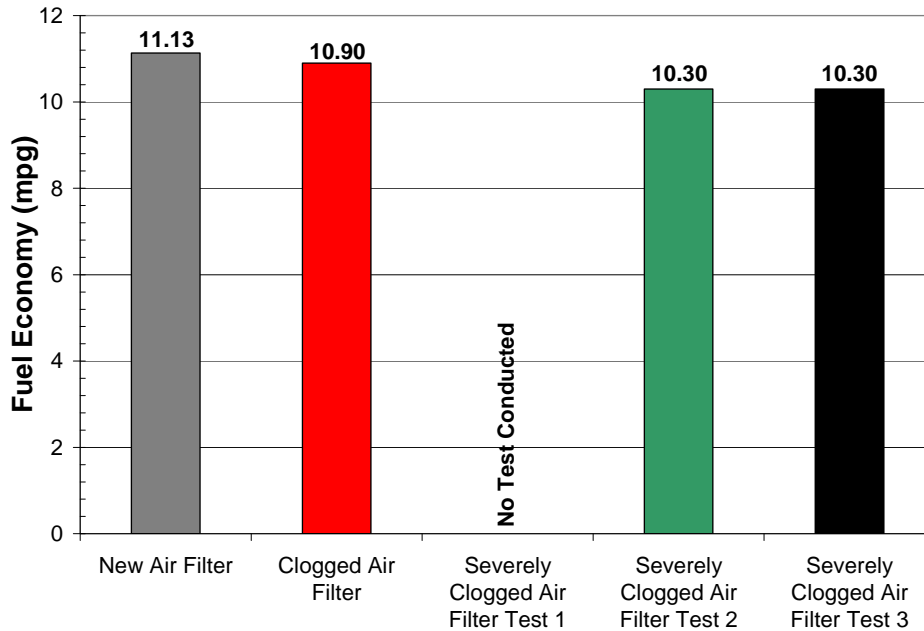
**Fig. 3.19. FTP fuel economy for 1972 Pontiac Grandville.**

For each of the tests simulating severely clogged filters, fuel economy was calculated for the FTP and HFET cycles. However, due to the nature of the cold FTP tests that were being conducted, time constraints did not allow for the vehicle to be prepared for a cold FTP for the Severely Clogged Air Filter Test 1 setup. Each incremental increase in restriction resulted in an incremental decrease in fuel economy for the HFET, but FTP fuel economy was not affected as severely by the restriction. Figure 3.19 shows the FTP fuel economy for the different stages of testing. Figure 3.20 shows the same information for the HFET.

The initial change in fuel economy from the new air filter to the clogged air filter resulted in an FTP fuel economy decrease of 2.1%. The HFET fuel economy initially decreased 2.5% from the new air filter to the clogged air filter.

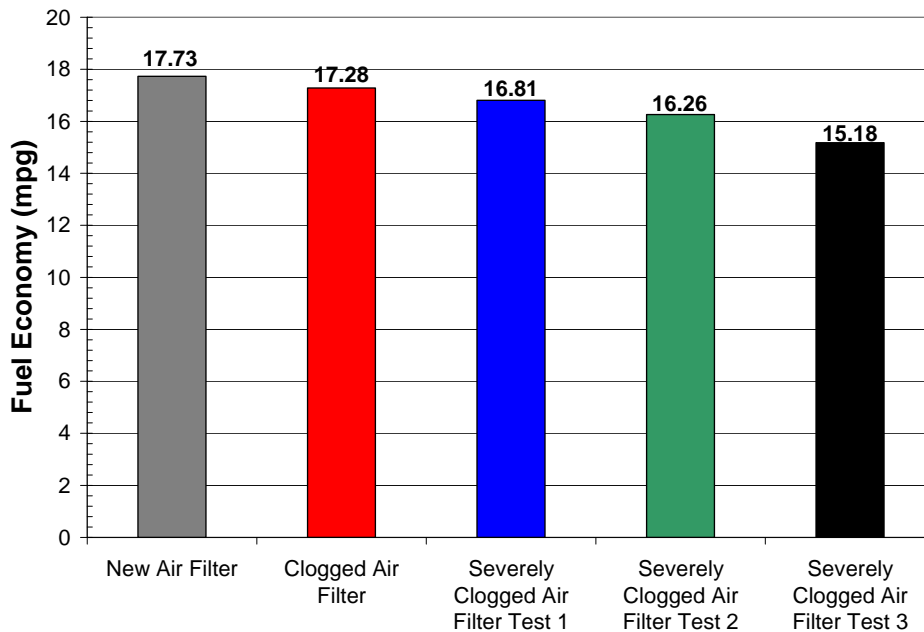
**Fig. 3.20. HFET fuel economy for 1972 Pontiac Grandville.**

Clogged Air Filter Test 2, but the HFET fuel economy continued to decrease another 6% compared to Test 2 and showed a 14.4% decrease compared to the new air filter.

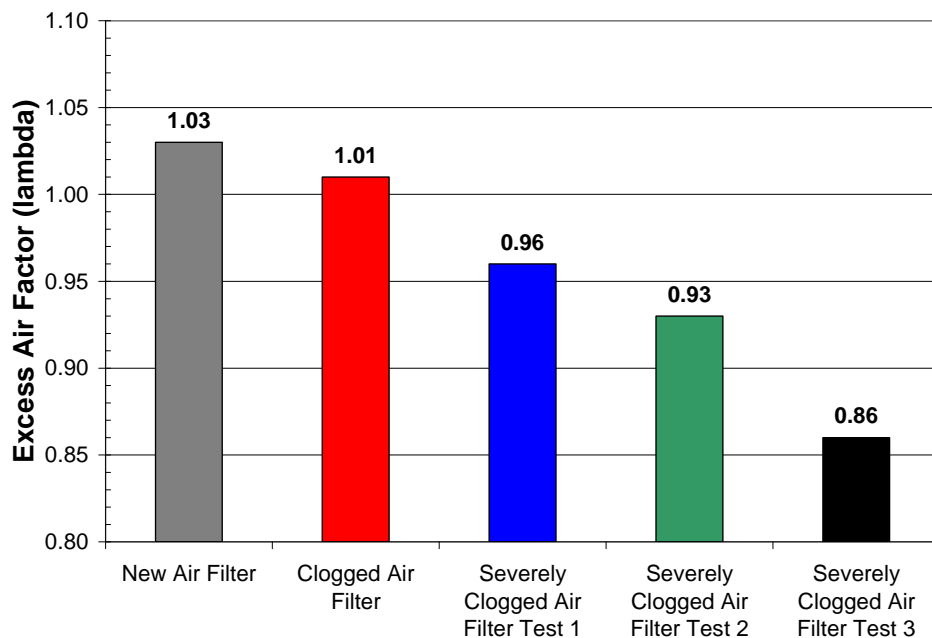
**Fig. 3.21. Average double HFET lambda for 1972 Pontiac Grandville.**

The restriction for Severely Clogged Air Filter Test 3 was so severe that the vehicle would not accelerate past about 70–75 mph, and the driver had to consciously control the rate of change of the throttle to avoid rich misfire conditions. The HFET, like all certification tests, requires that the vehicle be operated over a defined cycle. If the vehicle is unable to meet the speed and acceleration requirements of the cycle, the test is deemed invalid. The maximum speed of the HFET cycle is about 60 mph, and further restriction would not allow the vehicle to meet the accelerations required during the cycle, invalidating the test. Therefore, this level of restriction was determined as the maximum possible restriction that could be tested. Figure 3.21 shows the average lambda (actual AFR divided by stoichiometric AFR) for the double HFETs conducted. The severely clogged air filter results in a much richer AFR (lambda < 1 = rich, lambda > 1 = lean). The trace file collected for the severely clogged filter test runs showed rich excursions to nearly 0.60 lambda during some of the accelerations of the cycle.

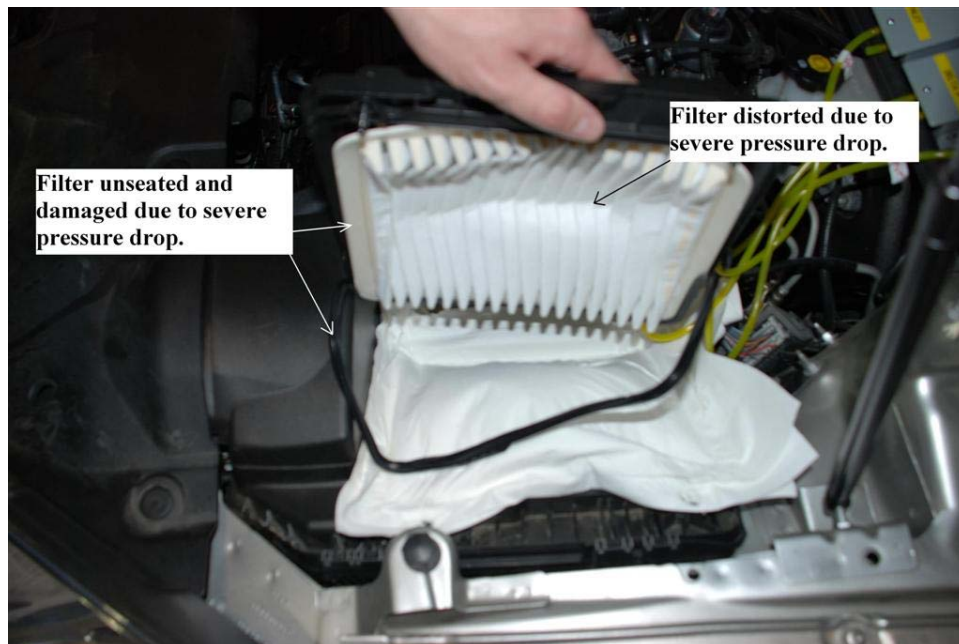
**Fig. 3.22. Damaged air filter from severely clogged air filter testing, 2007 Buick Lucerne.**

After observing the effect of continuously increased restrictions on the fuel economy of the 1972 Pontiac, the authors decided that a greater level of restriction should also be investigated on one of the newer vehicles. Thus the 2007 Buick Lucerne was retested to explore the effects of a more severely clogged air filter on its fuel economy. The approach was to clog the air filter so severely that the vehicle would barely be able to follow the HFET cycle, similar to the final test of the Pontiac. This objective was not achievable. Before that level of restriction could be reached, the filter was pulled out of its seat in the air box due to the large pressure drop (Fig. 3.22). The average Outlet DP for the double HFET test is shown in Fig. 3.23 as Severely Clogged Air Filter Test 1. With the filter being dislodged during the test, the Severely Clogged Air Filter Test 1 data represent a test in which the air flow restriction was probably not consistent for the entire test.

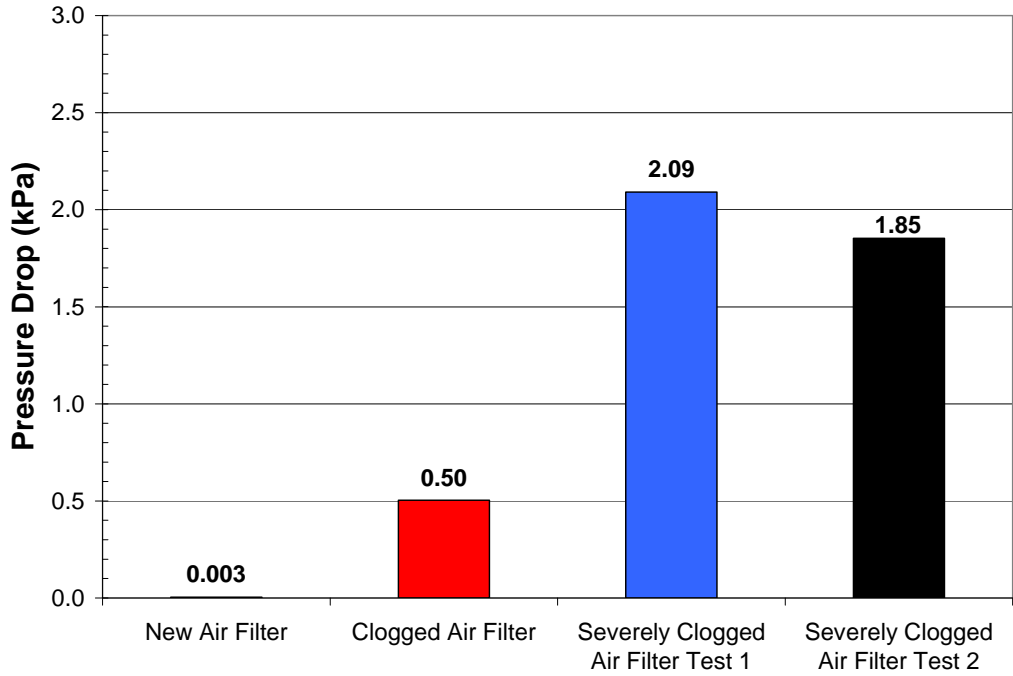
Fig. 3.23. Air filter average double HFET Outlet DP for 2007 Buick Lucerne.

Data were collected for another test in which the level of restriction was higher than previously tested but not so high as to unseat the filter element. The Outlet DP related to this level of restriction is shown in Fig. 3.23 as Severely Clogged Air Filter Test 2.

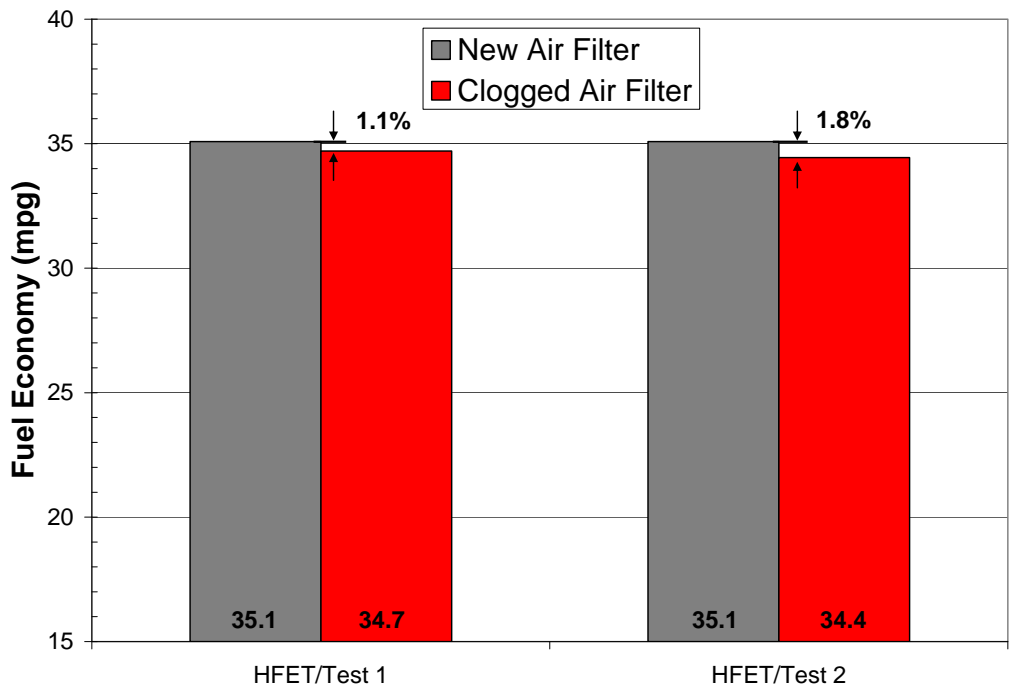
Fig. 3.24. Severely clogged air filter fuel economy for 2007 Buick Lucerne.

The Lucerne was only tested over the double HFET cycle for these severely clogged filter simulation tests. The effects of the simulated severely clogged filter on the Lucerne's fuel economy were not significant—less than 2%. These values are within the range for the series of tests that were conducted during the initial testing. Figure 3.24 shows the fuel economy of Severely Clogged Air Filter Test 1 and Test 2 versus the new air filter over the HFET cycle. The Lucerne's control system maintained a consistent AFR ( $\lambda = 1.0$ ) in all the tests conducted, regardless of air filter condition.
