Accelerating PV Cost Effectiveness Through Systems Design, Engineering, and Quality Assurance

**Final Subcontract Report
June 2007**

Jonathan Botkin
*PowerLight Corporation
Berkeley, California*

Subcontract Report
NREL/SR-520-42420
December 2007

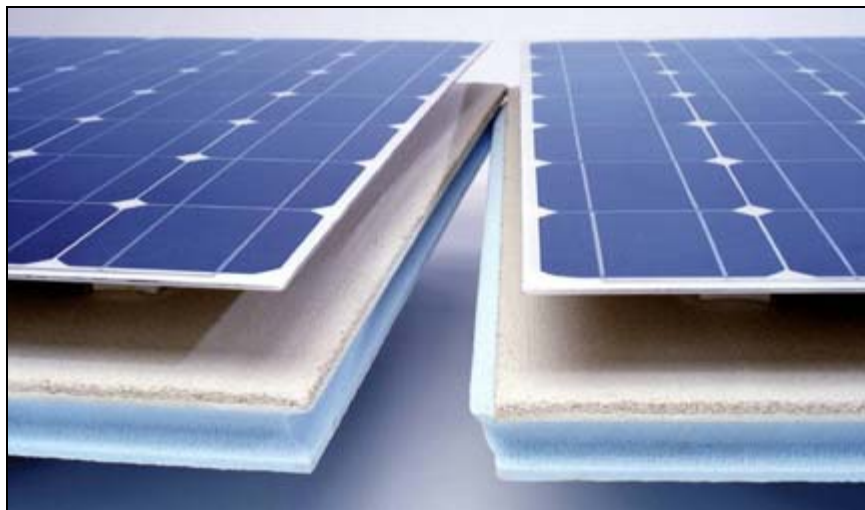
PowerLight manufactures its flagship product, the PowerGuard(R) tile, in a facility in Berkeley, California. PowerGuard building-integrated photovoltaic roofing tiles generate electricity from solar energy. A PowerGuard tile consists of a flat plate photovoltaic (PV) laminate mounted onto a flat, rigid, extruded polystyrene (XPS) board. The XPS board is covered with a cementitious coating. Two edges of the XPS board are routed into a tongue profile, while the other two edges are given a groove profile. This design allows PowerGuard tiles to be assembled adjacent to each other in an interlocking fashion, as shown in Figure 1 below.

Figure 1: PowerGuard tiles showing interlocking tongue and groove profile.

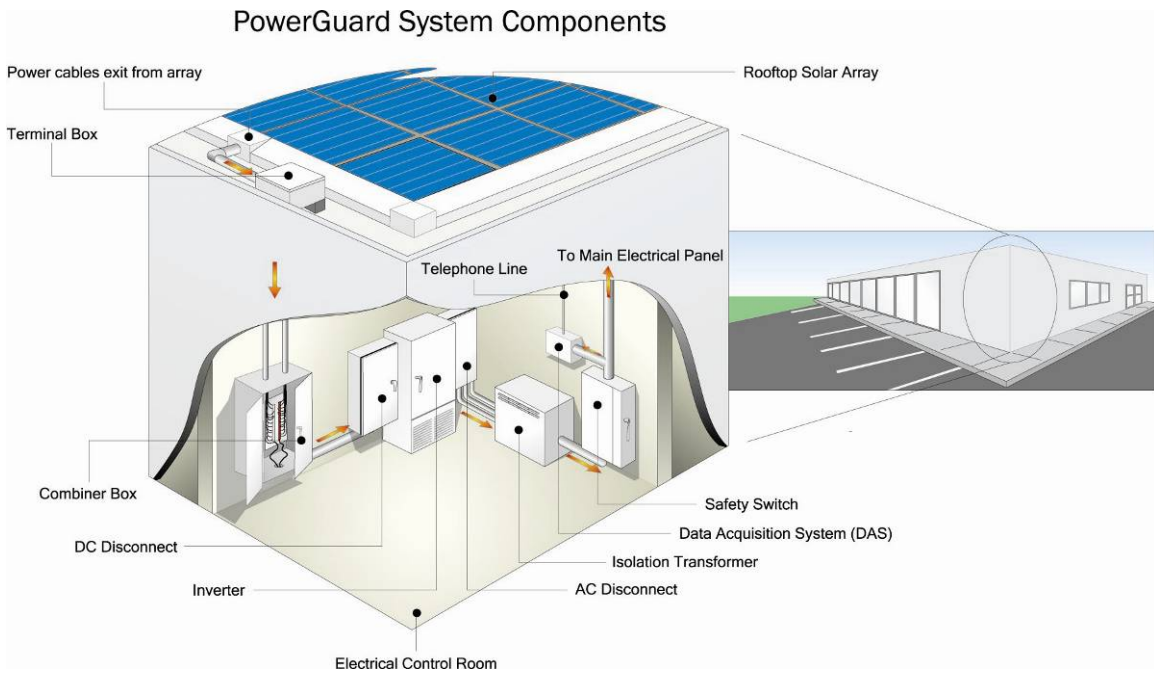
Figure 2: Building cross-section showing PowerGuard System Components.

Adjacent tiles are tied together electrically through connectors supplied on each PV module, thus creating an electrical string of PV modules. One or more strings are then electrically connected in parallel at a remote location creating a solar electric array. The resulting DC current from the array is passed through a DC/AC inverter and isolation transformer before being tied into the building's electric distribution panel. Figure 2 depicts the system components for a PowerGuard array.

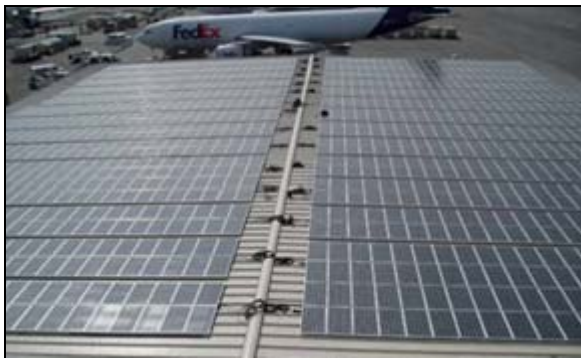
Figure 3: RMR System.

PowerLight also manufactures a PV mounting system for metal roofs called PowerLight Metal Roof System (RMR), using custom clips, shown in Figure 3, and a 10-degree sloped PV mounting system for flat roofs, RFT10, shown in Figure 4.

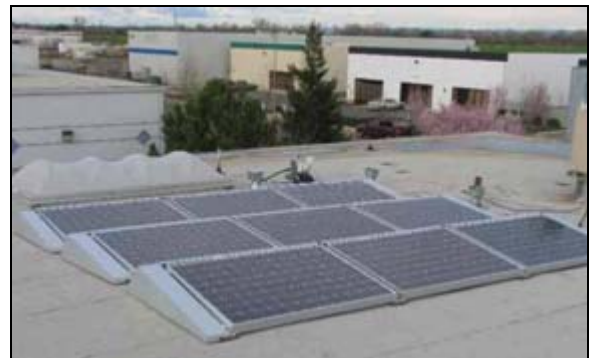
Figure 4: RFT10 Array.

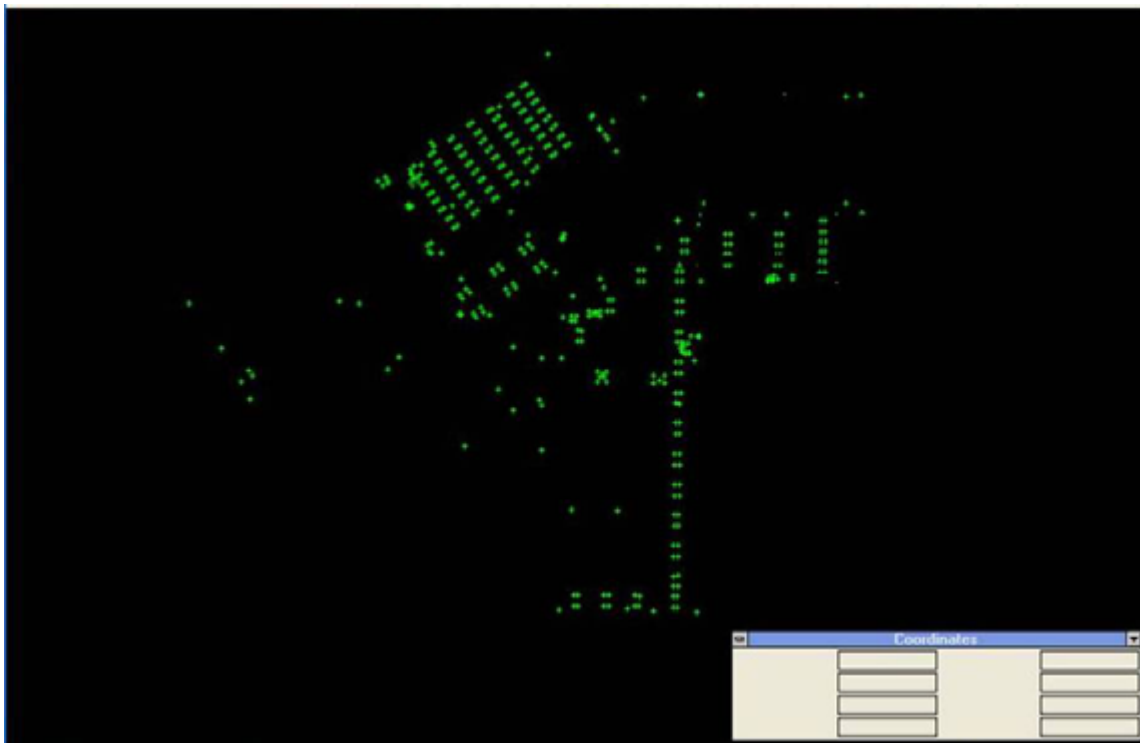
When the audit is completed, the data is downloaded into a computer, which then interprets the information and produces a site layout. The layout includes all the various features and places them on predetermined layers within the layout drawing. This file is then opened in AutoCAD, where the array designer can then start to populate the site with PV modules. Figure 5 shows the raw data as downloaded from the GPS unit. The automatic translation into a site layout is shown in Figure 6. These images are from actual site audits performed recently by the PowerLight audit team with the new tools.

Figure 5: Raw data points downloaded from GPS unit.

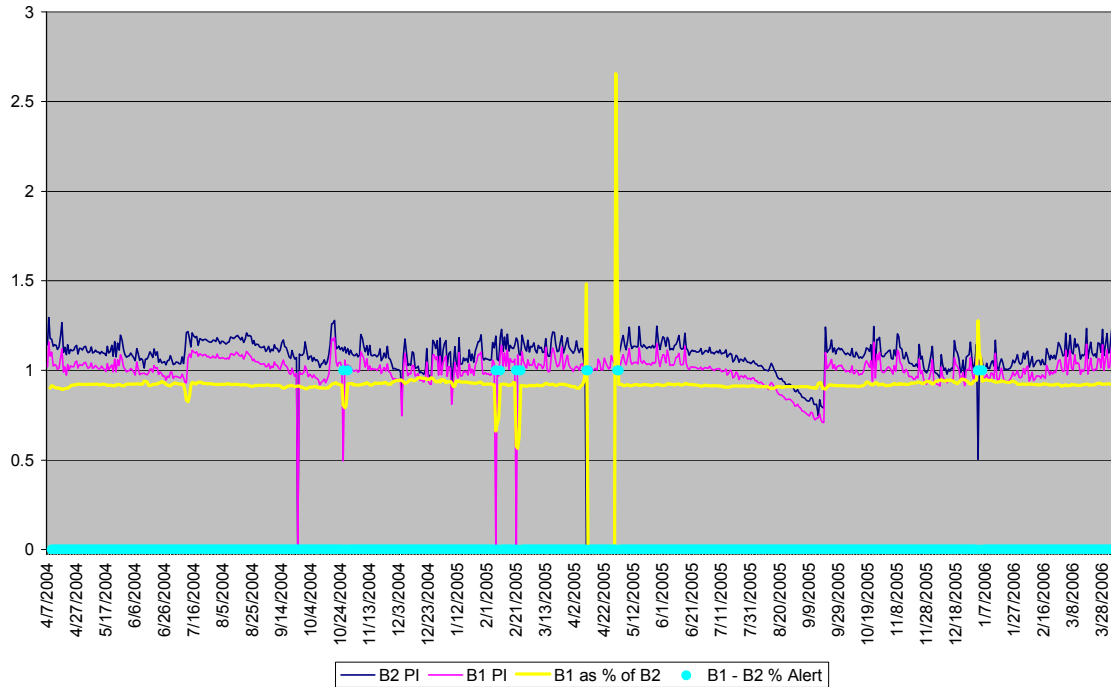
Figure 8: Comparison of kWh/kWac ratio for two sites in close proximity to each other.

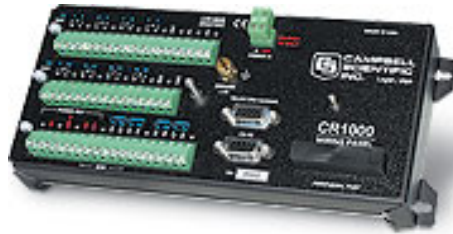
PowerLight has begun installing Campbell CR1000 loggers, shown in Figure 9, at customers' sites as part of the hardware improvements to the monitoring systems.

Figure 9: Campbell CR1000 Data Logger.

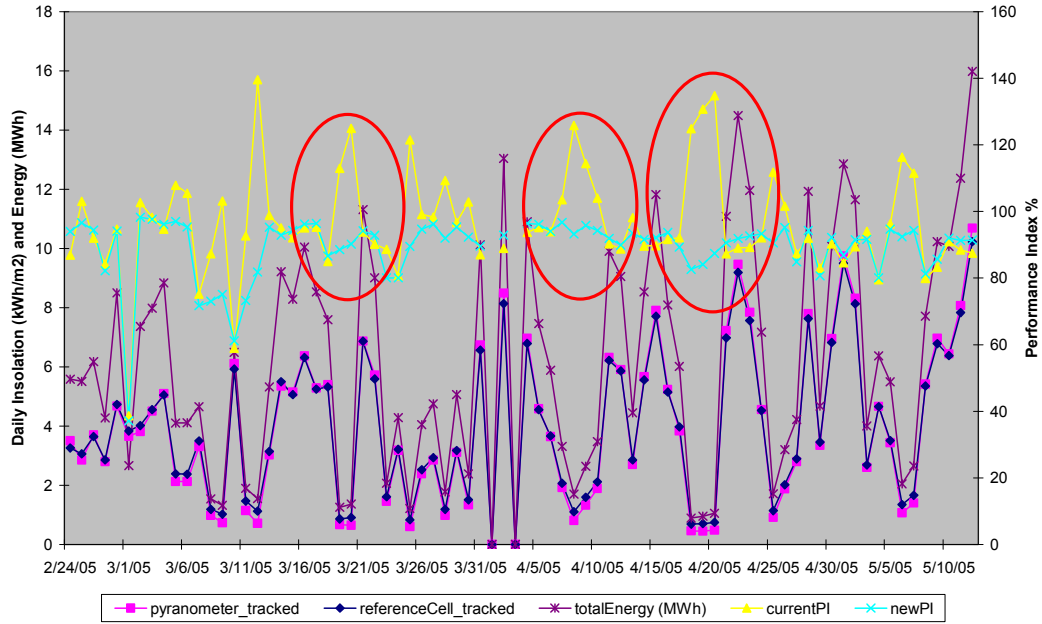
To determine whether replacing pyranometers with reference cells will improve PI evaluation, we monitored five sites with both types of sensors at each location. The data from the reference cell produced a steadier calculation of PI for all sites. Figure 10 shows the comparison between PI as calculated using pyranometer data and PI as calculated using reference cell data for a sample site. The circled regions highlight the steadier nature of the PI calculated with reference cell irradiance data.

Figure 10: Comparison of site performance index using a reference cell and pyranometer.

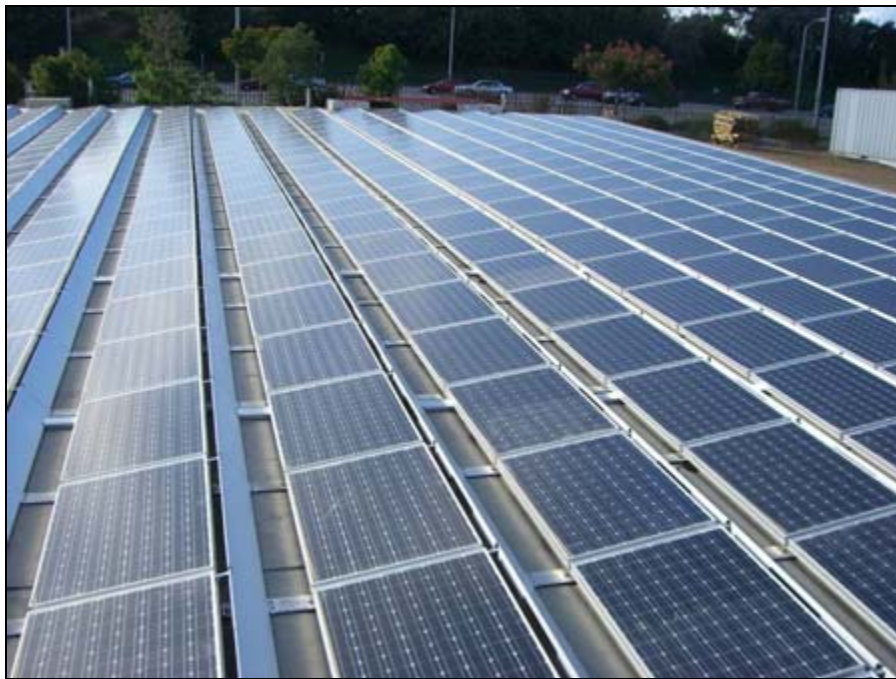
Figure 11: Completed Phase I RFT10 installation – 654 kWp system.

Figure 11 and Figure 12 show photos of RFT10 systems during installation and after completion.

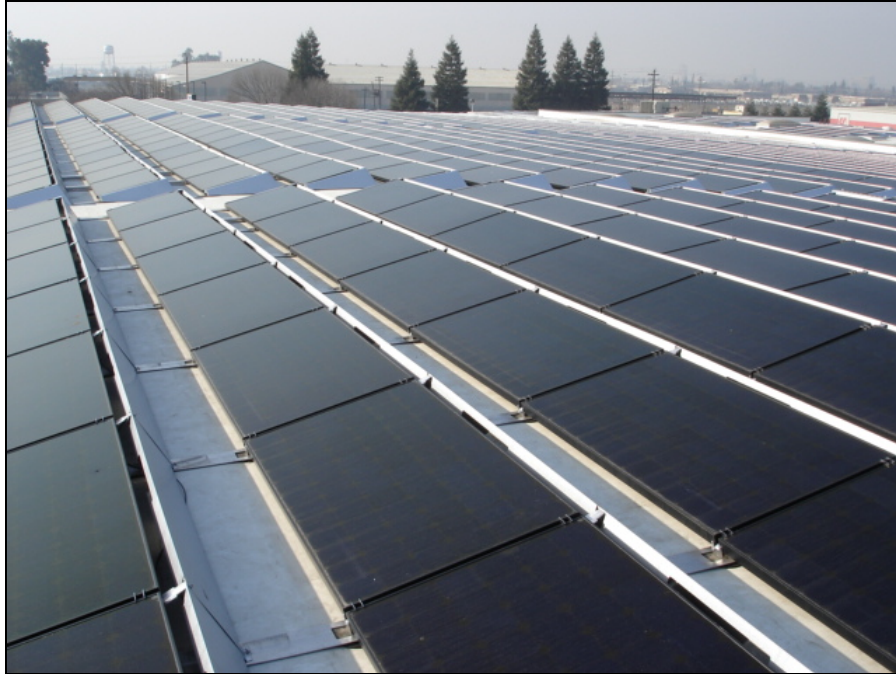
Figure 12: Installed Phase II universal RFT10 system – 1MWp system.

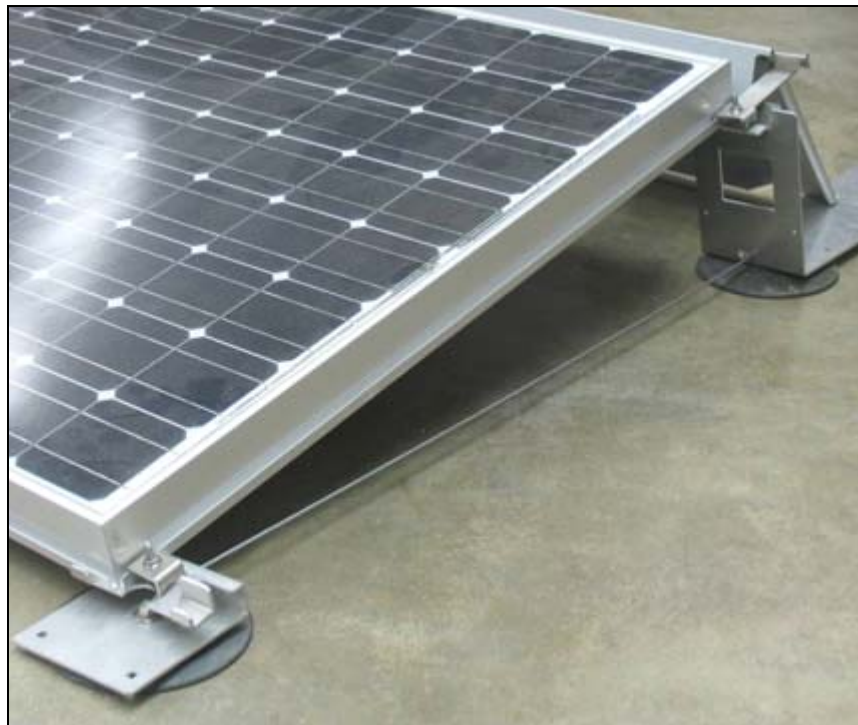
The changes to the RFT10 design are shown below. A wire rope was incorporated into the design to allow the array to transfer lateral loads, as discussed above. The wire rope and connection are shown in Figure 13 and Figure 14. At each end of the wire rope, a swaged-on ball engages a keyhole slot that is stamped into each end of each support piece.

Figure 13: Prototype parts with securement features.

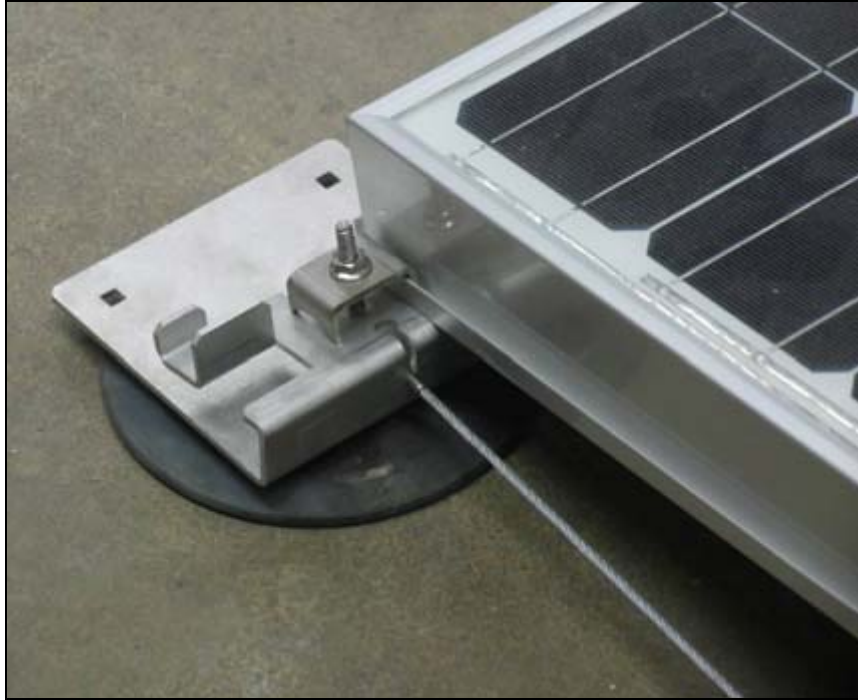
Figure 14: Southern support with keyhole slot and spreader bar attachment points.

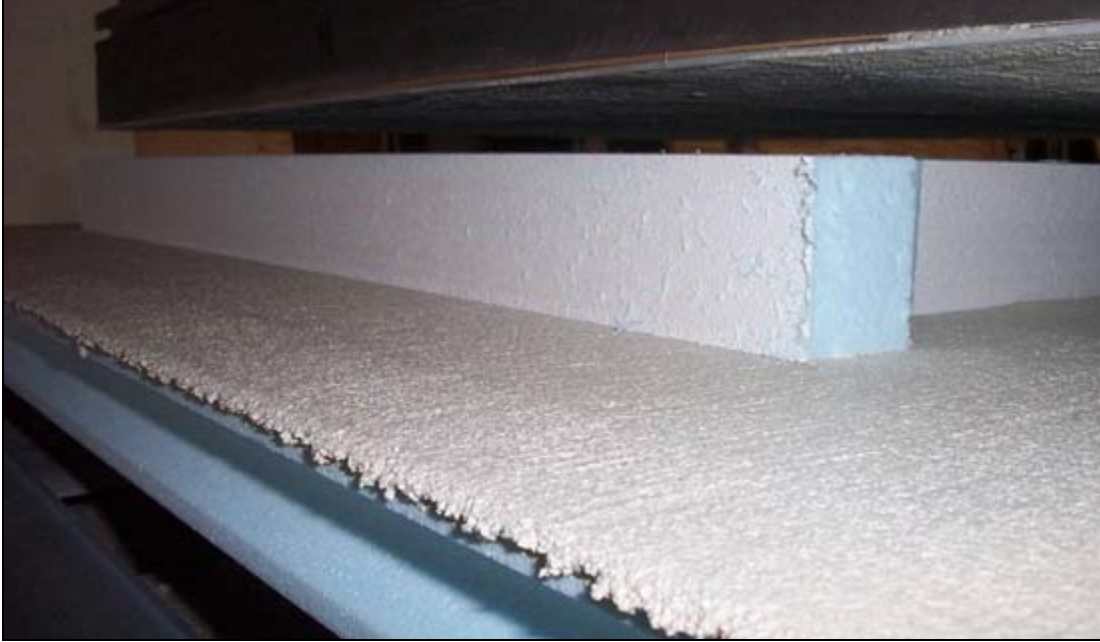
Figure15: New tile on production line.

Production of the new tile design was implemented during Phase II with very few problems. Photographs of the new tiles during production are in Figure 15 through Figure 18.

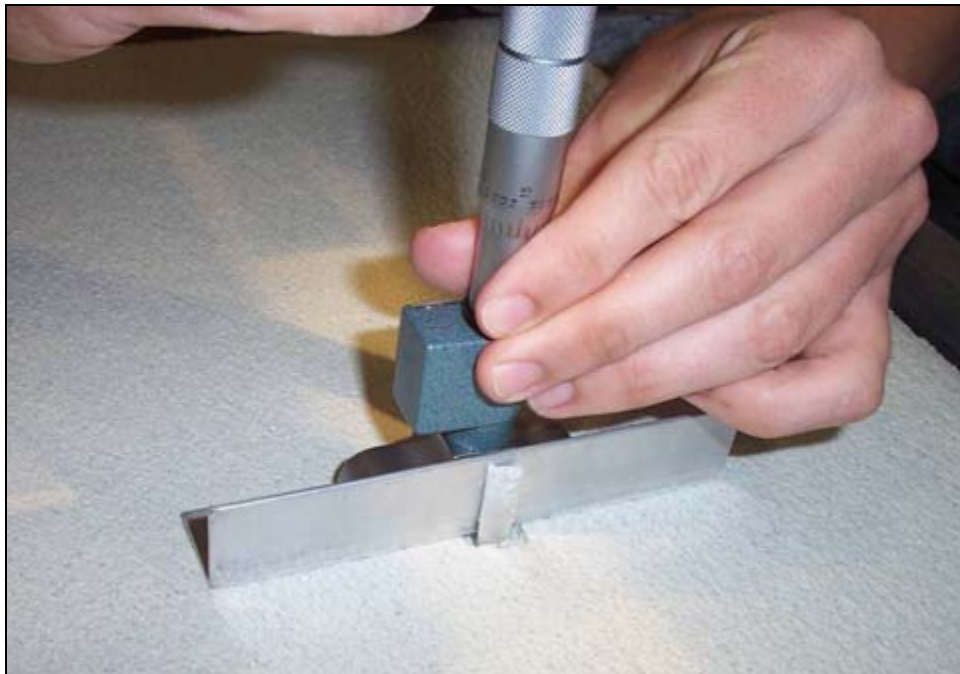
Figure 16: Measuring coating thickness during pilot production.

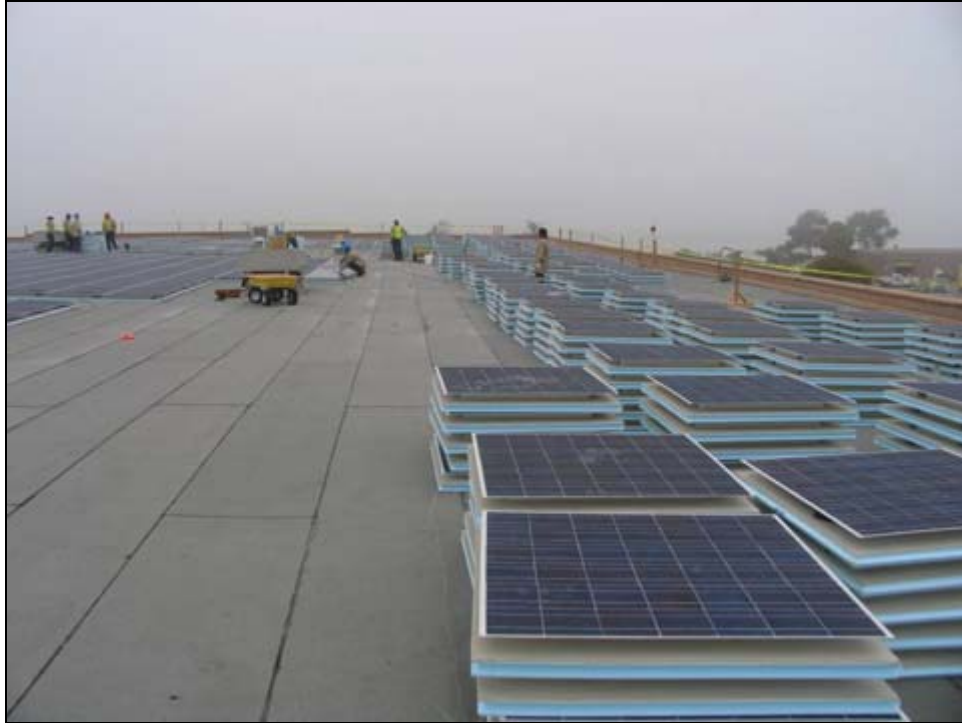
Figure 17: New tiles being installed.

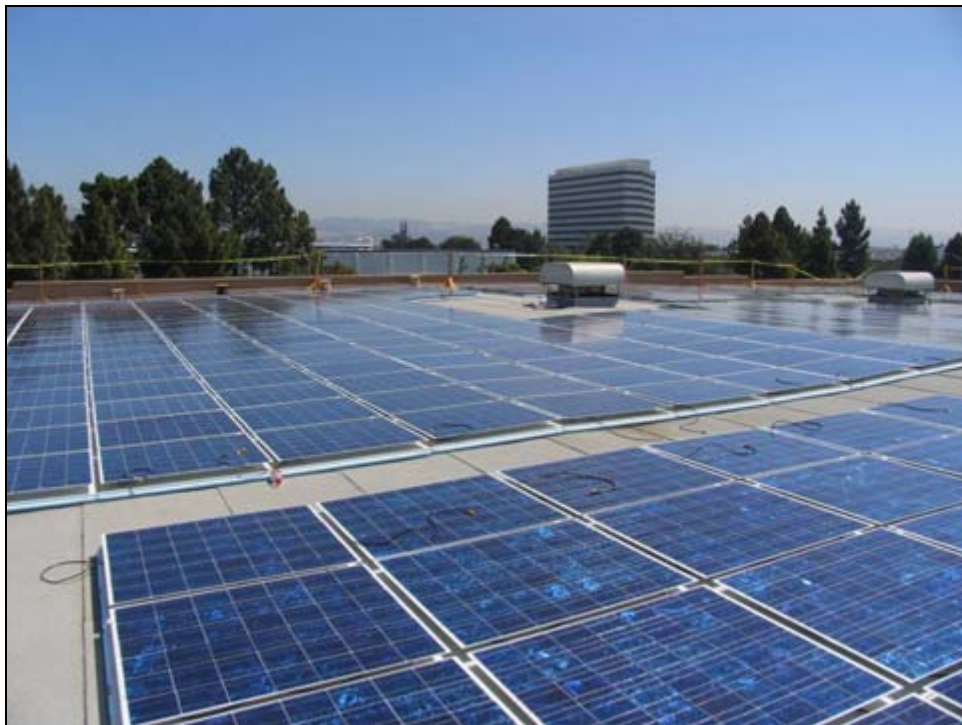
Figure18: New tiles installed prior to wiring.

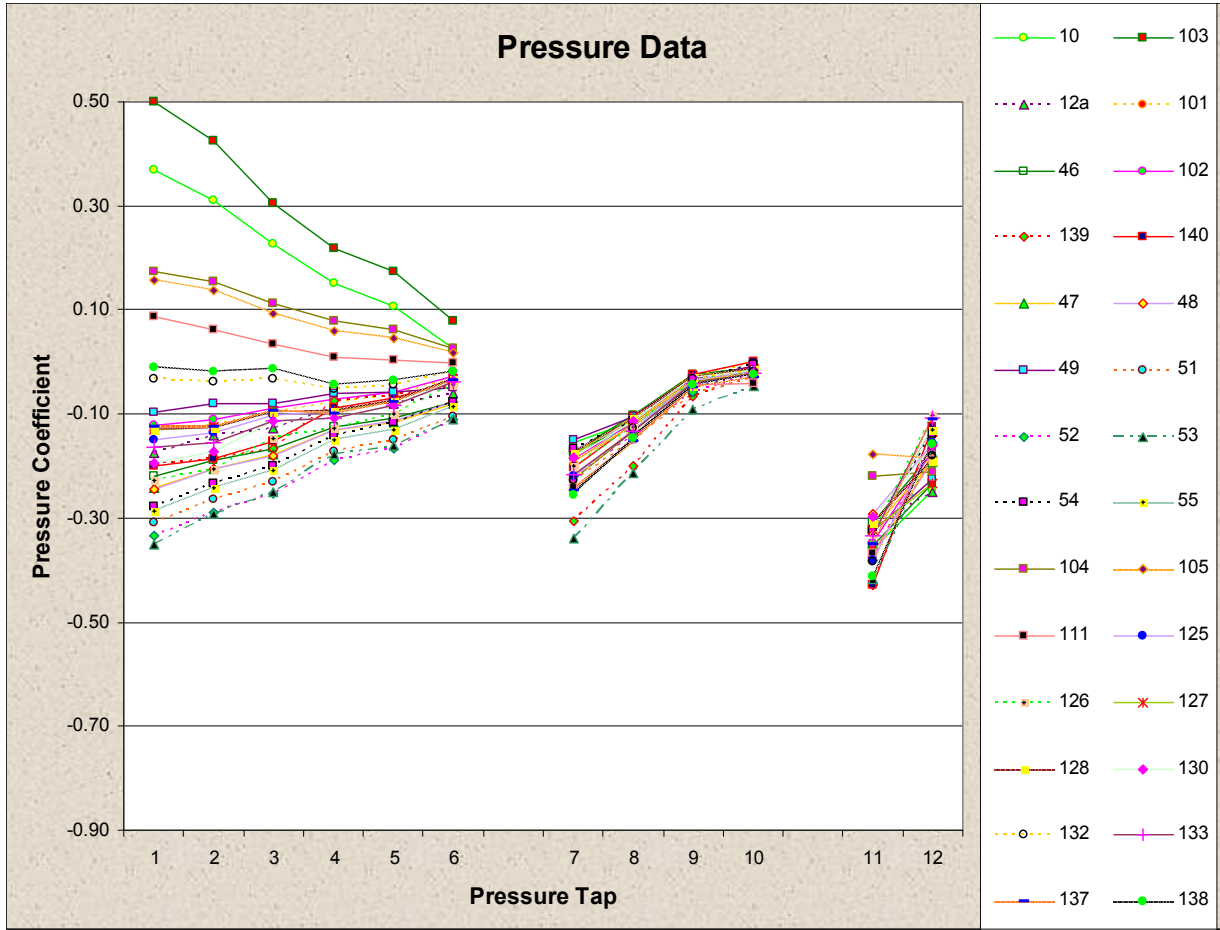
An example test results are shown in Figure 19. The data shows pressure measurements above and below the tile. The desired result is one in which the pressures below the tile are less than the pressures above, creating a downward force. If that cannot be achieved, the goal is to minimize the magnitude of the upward force.

Figure 19: Example of pressure measurements from the wind tunnel.

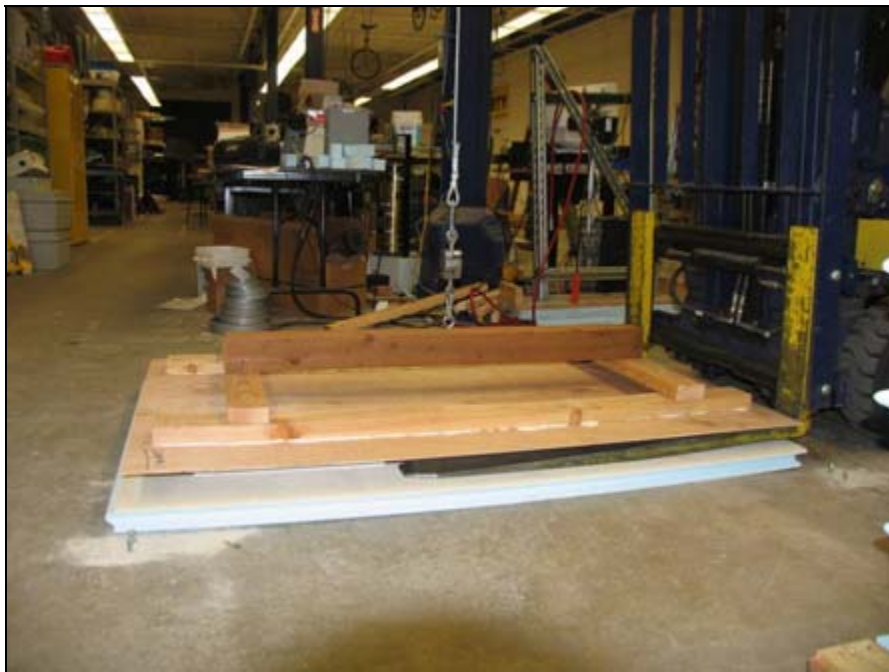
Testing consisted of a destructive tensile test on the tiles to ensure the tiles can meet an uplift requirement of 50 lbs per square foot (psf). The test setup is shown in Figure 20.

Figure 20: Tensile test of PowerGuard tile made with continuous process.

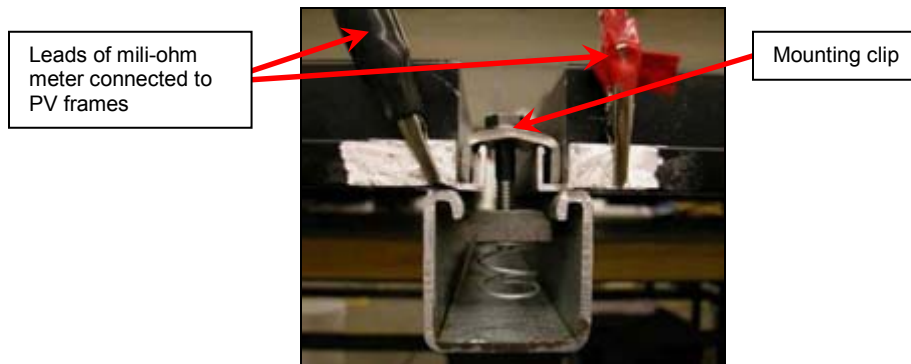
UL 1703 specifies that the resistance between accessible conductive components in a PV system cannot exceed 0.1 Ohms. PowerLight evaluated the clip assemblies to ensure that the resistance was below this value. In this test, leads of a highly sensitive milli-ohmmeter are connected to two adjacent PV frames to measure the resistance across the clip assembly, as shown in Figure 21

Figure 21: Ground testing of mounting clip and frames.

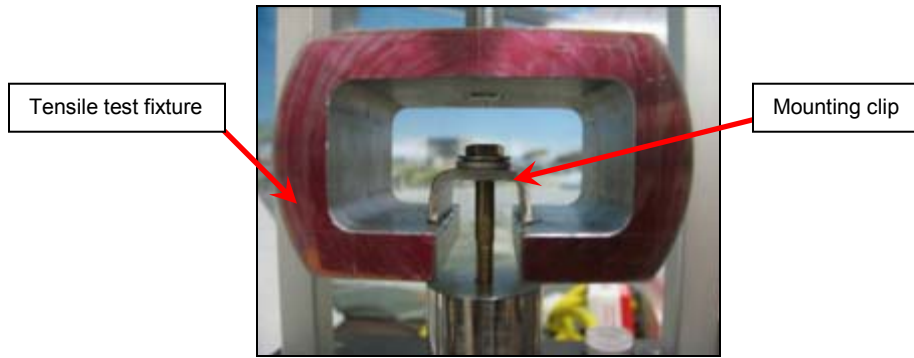
UL requires that PV modules pass a loading test where 45 psf is applied to the module surface. Permeable PV roofing systems typically have excellent pressure equalization, resulting in lower wind loads on the module. PowerLight tested the IFF and EFF clips in a tensile test, as shown in Figure 22. A vertical load was slowly applied until failure occurred, and the load causing failure was recorded and compared to the UL requirement.

Figure 22: Mounting clip uplift test.

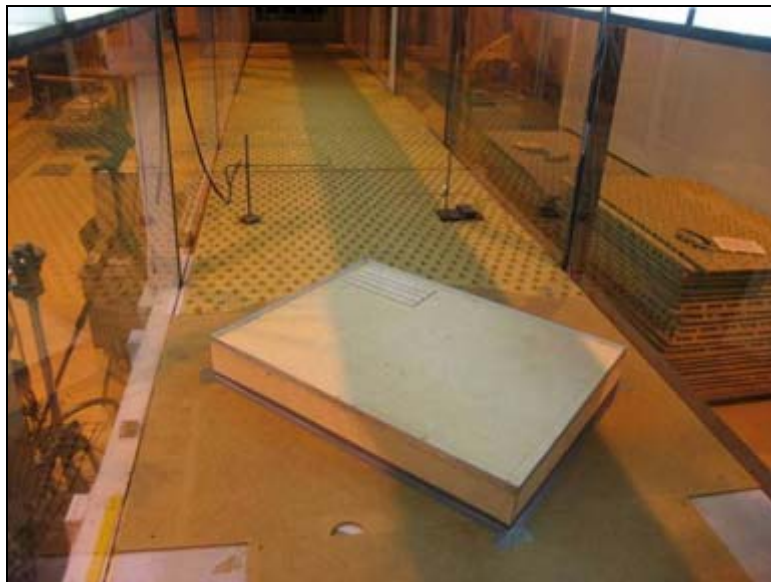
For each test configuration, the array was set up on the model building, and the wind speed in the tunnel was slowly increased until failure occurred. In some cases, failure occurred due to tile lifting around the edges of the array, and, in others, the entire model array slid on the roof surface. Figure 24 shows a typical test configuration.

Figure 24: Wind tunnel model for an RFT10 array installed on the edge of a building.

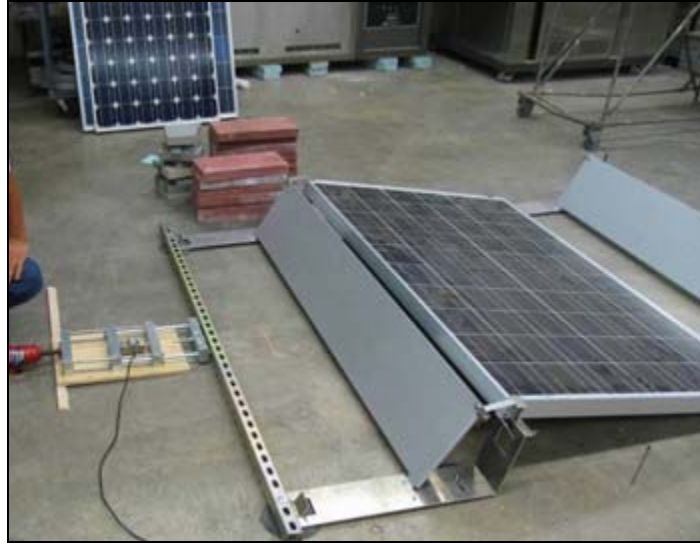
Four types of structural loading tests were performed on RFT10 assemblies. First, a lateral compressive load in the north-south direction was applied to a RFT10, as shown in Figure 25. The force was applied at the north end of the tile, while the south end was restrained. The purpose of the test was to simulate a strong wind hitting the north end of the array, causing the first row of tiles to be pushed into the interior sections of array. The force was increased until some part of the structure yielded. The force and displacement were then measured.

Figure 25: Lateral load test on RFT10 assembly. A compressive load is applied to the north side of the tile.

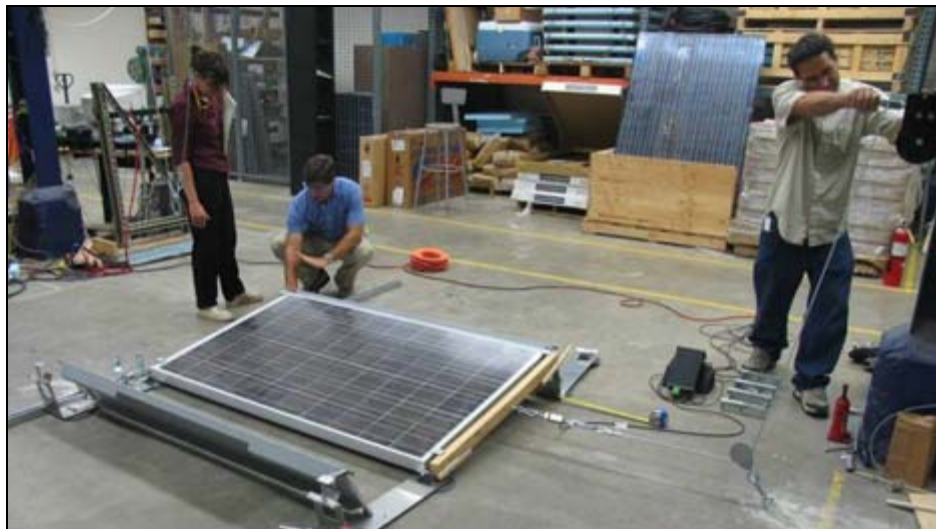
In a second test, a lateral compressive load was applied to the east side of a tile with the west side restrained. This configuration simulated a wind load hitting the outer eastern edge of the array. As before, the force was increased until some part of the structure yielded. The force and displacement were measured. A photo of the test set up is shown in Figure 26.

Figure 26: Lateral load test on an RFT10 assembly. A tensile load is applied to the east side of the assembly.

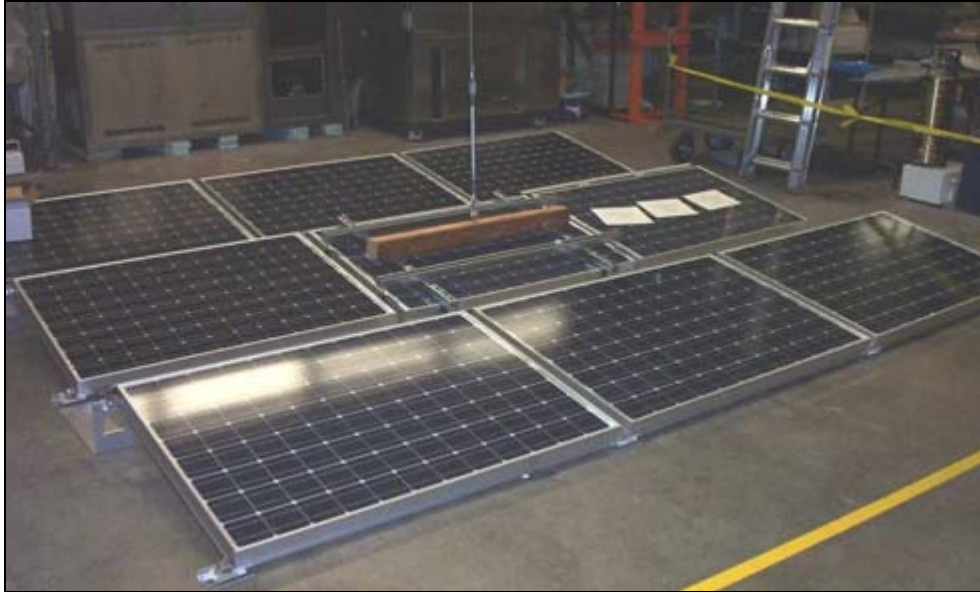
The third test simulated wind uplift failure. The purpose of this test was to ensure that the retaining clips were sufficiently strong to keep the PV module from being pulled loose under the most severe uplift loads that might be encountered. A photo of the test set up is shown in Figure 27.

Figure 27: Uplift test on RFT10 tiles with vertical force is applied to the center tile.

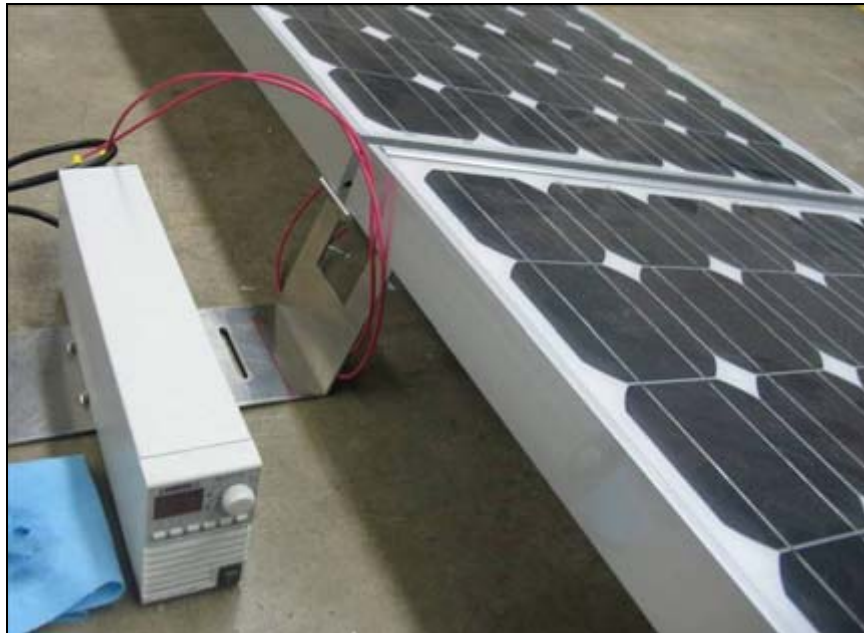
The RFT10 assembly has many accessible conductive components that must maintain a reliable bond to earth ground. A test was conducted to verify that the resistance across the assembly was below an industry-established maximum of 0.1 Ohms. A photo of the test set up is shown in Figure 28.

Figure 28: Grounding test on an RFT10 assembly.

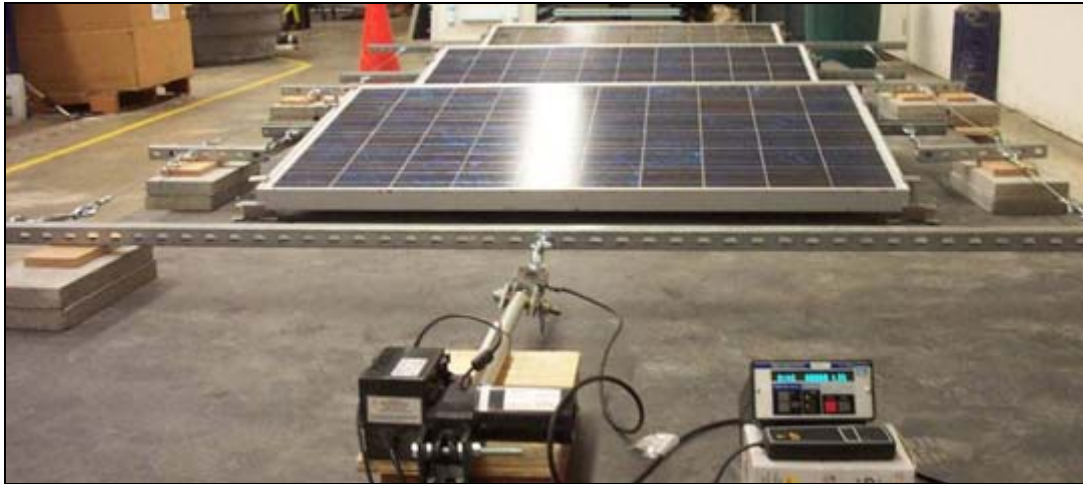
First, friction coefficients between the assembly and various roofing surfaces were measured. A horizontal load was applied evenly to the sides of three tiles until motion occurred. The load causing motion was automatically captured by the data collection system and used to calculate the friction coefficient on a membrane roof. A photo of the test set up is shown in Figure 29. A typical low value was chosen for further evaluation of system performance in a seismic event.

Figure 29: Friction test on an RFT10 assembly.

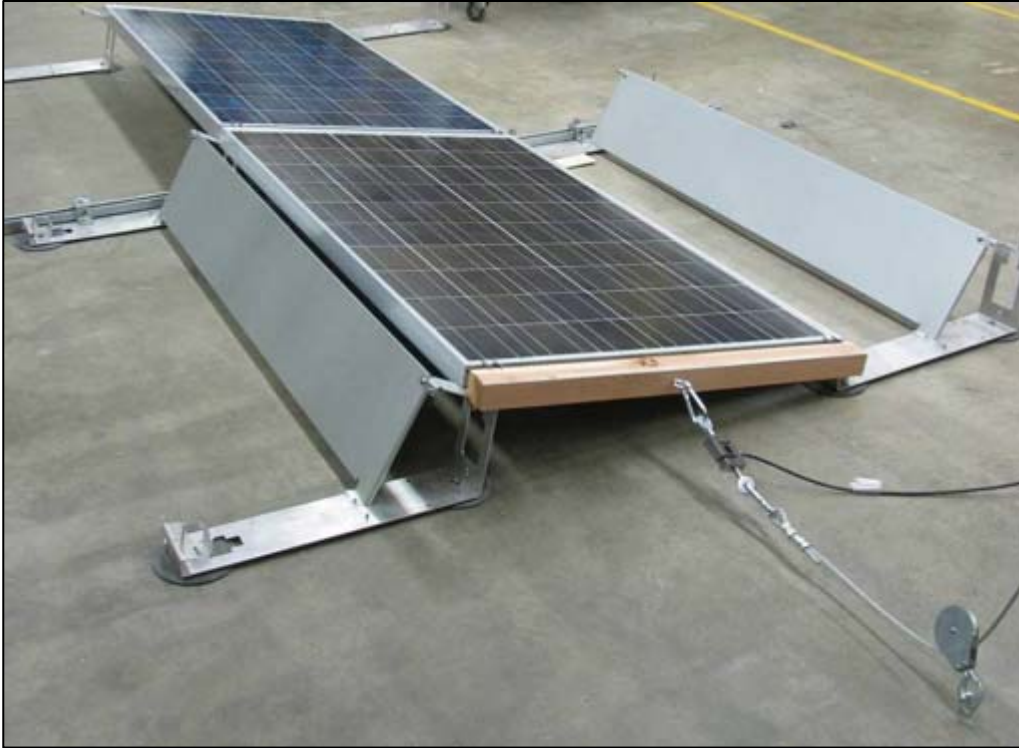
way, so this failure mode has been eliminated. The actual failure load was not determined because the PV module itself failed before the mounting system failed. This was considered a very successful result.

Figure 30: Lateral load test on RFT10 universal design.

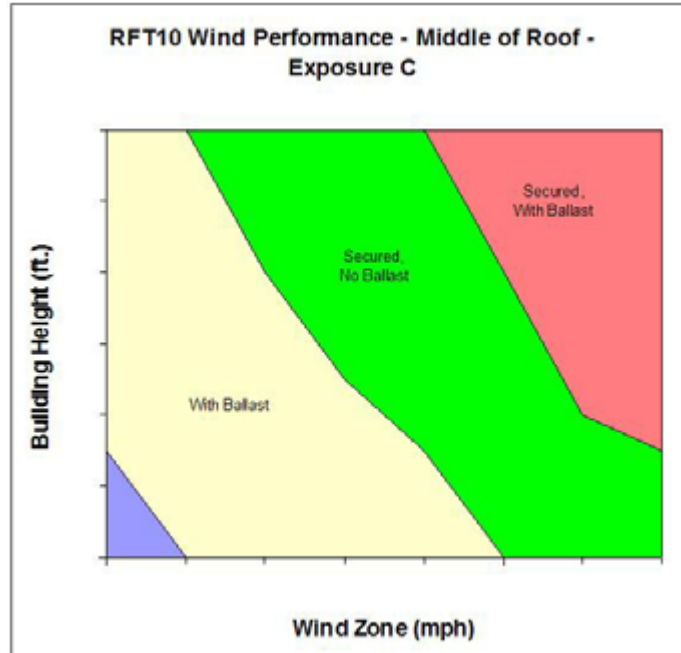
The wind tunnel test results provided a failure velocity and failure mode for each configuration that was tested. A safety factor was applied to all failure velocities. PowerLight reviewed the results extensively to identify worst-case conditions and to identify the dominant trends in the data. The results were then incorporated into a series of charts to be used as guidelines for array design.

Figure 31: Wind design chart for RFT10 arrays in the middle of the roof in Exposure C.

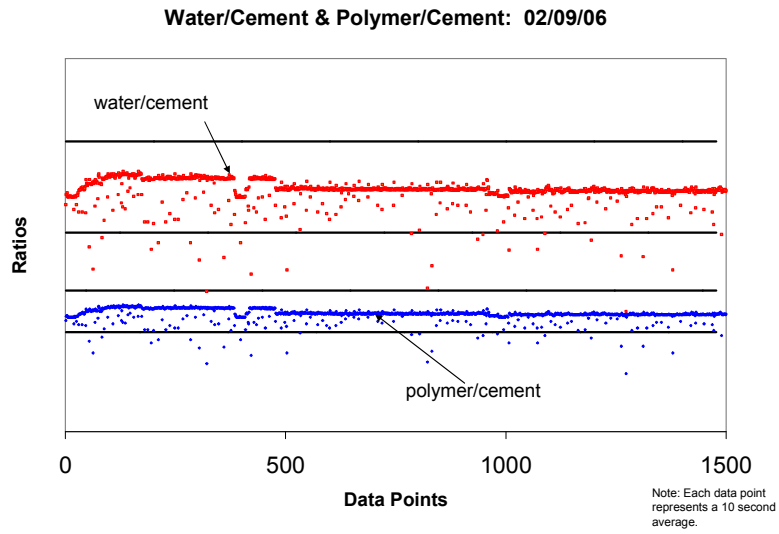
The greatest impact on the measured yield of PowerGuard tiles was achieved through the implementation of the error-proofed mixing systems. Two parameters are monitored as primary indicators of coating quality: the polymer-to-cement ratio and the water-to-cement ratio. The new monitoring system collects data on material flow and calculates these parameters in real time. A plot of these parameters is then stored for each day of production, providing traceable information for each lot of PowerGuard backerboards made. Figure 32 shows a typical plot from one production run. A solid line is displayed above and below each parameter plot showing the acceptable range for that parameter. The system is programmed to start collecting data when the flow rate exceeds a threshold level. This produces the slight scatter of outlying points each time the system starts and stops.

Figure 32: Typical plot from coating monitoring station.

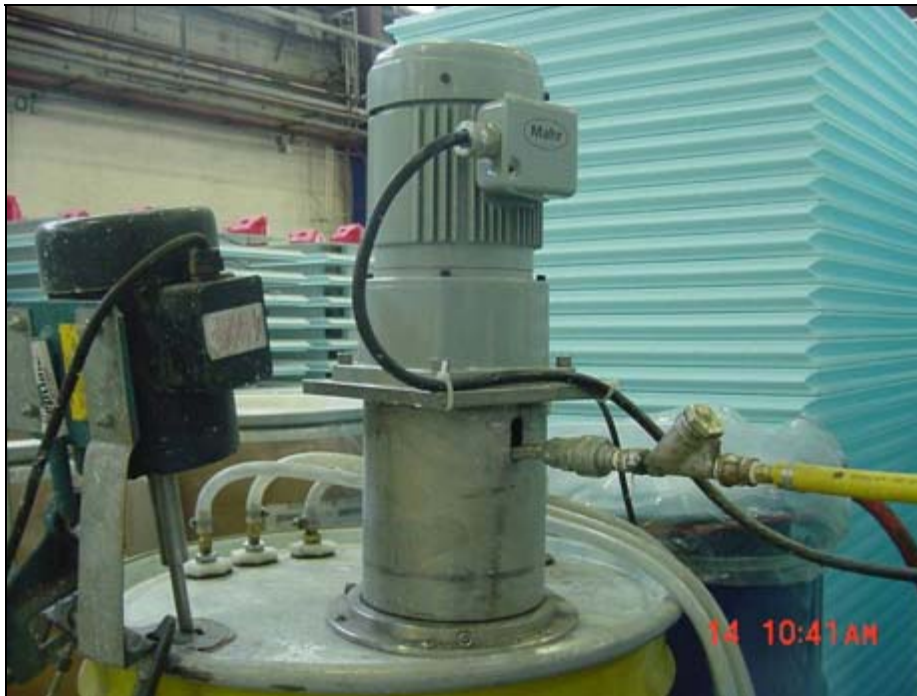
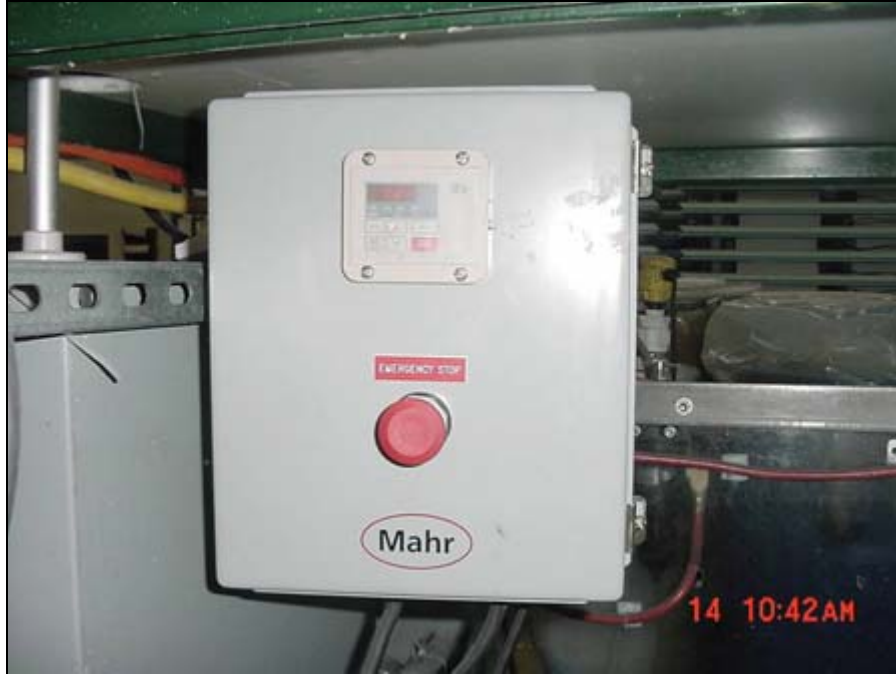
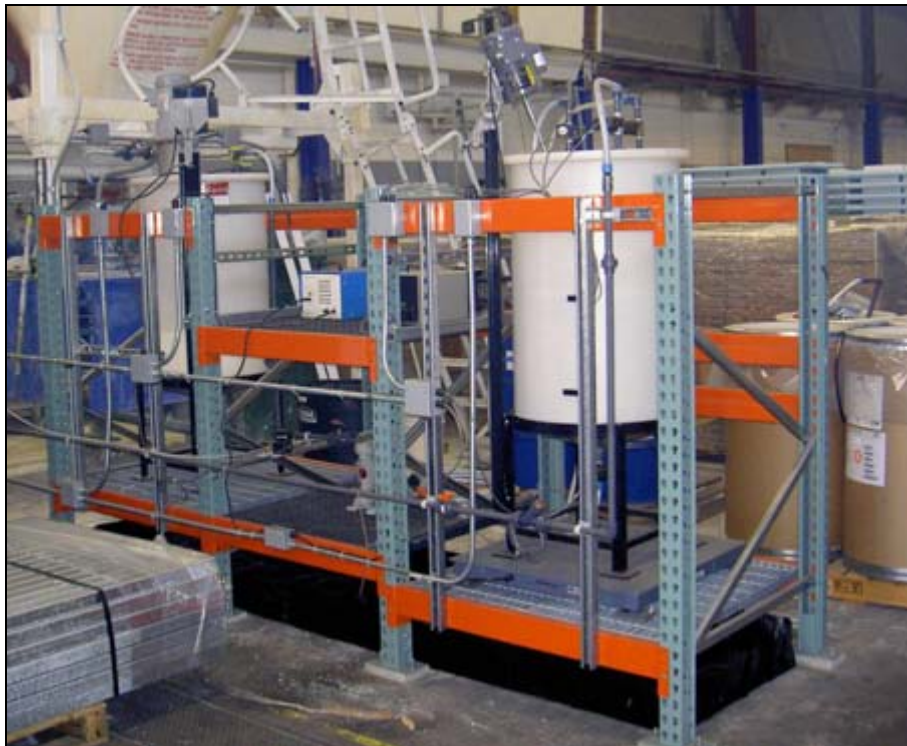
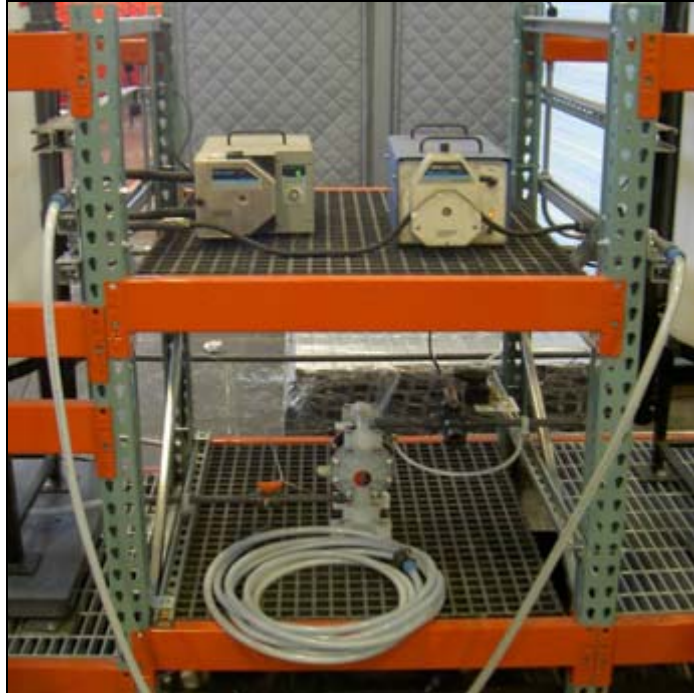
Figure 33 through Figure 36 show the new mixed liquid pumping station that was implemented in Phase I.

Figure 33: New pumping station for mixed liquids.

Figure 34: Control panel for pumping station.

Figure 35: New liquid metering system.

Figure 36: Transfer pumps.

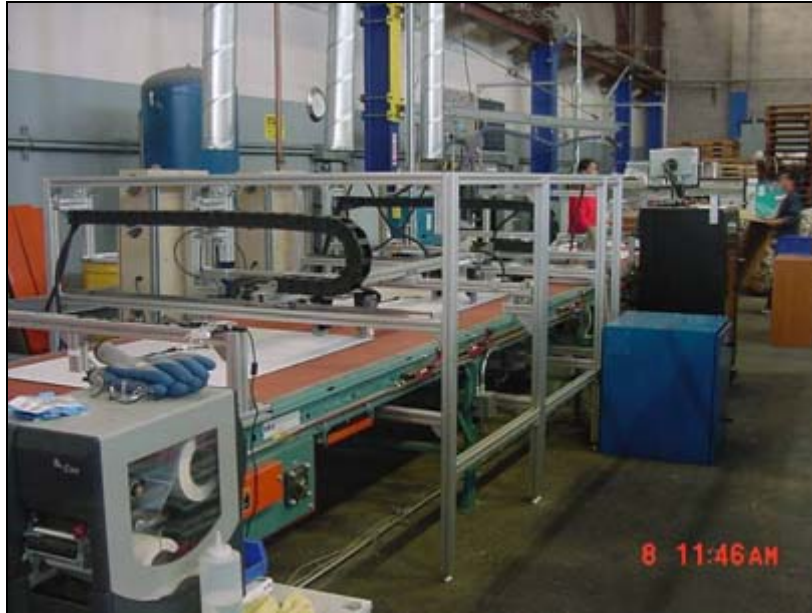
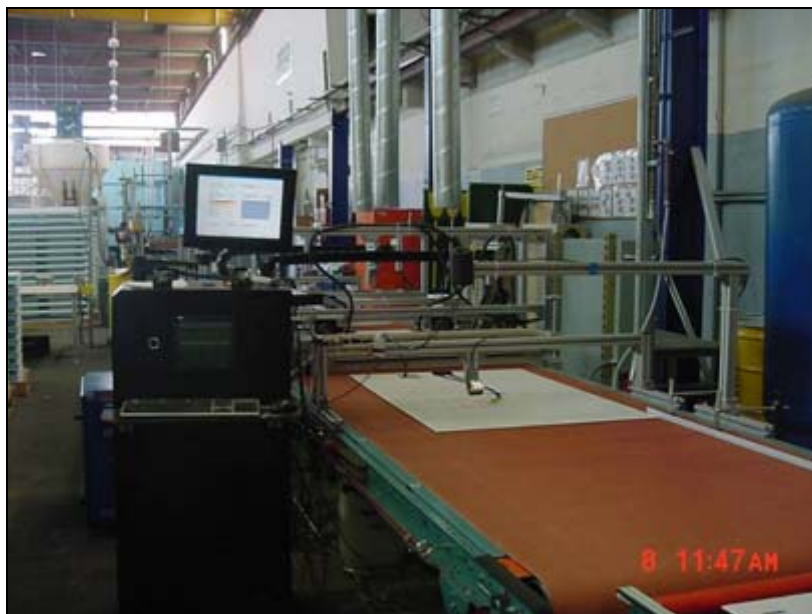
The implementation of the new PV preparation line also improved PowerLight's quality control in this area, though it is difficult to quantify the improvement as there was no way to measure the quality previously. The new equipment provides consistent and effective cleaning and surface treatment for the PV modules prior to the final assembly process for PowerGuard tiles. The surface treatment function is used only for modules that have a PET backing material. While the PV modules are being processed, the system also scans and stores the serial numbers so that each module can be tracked to its final installation site. These improvements help ensure that product performance and reliability will be maximized throughout the life of the product. Figure 37 and Figure 38 show the new PV preparation line.

Figure 37: PV preparation line.

Figure 38: PV preparation line, showing operator station and bar-code scanner.
