Accelerating PV Cost Effectiveness Through Systems Design, Engineering, and Quality Assurance

**Final Subcontract Report
June 2007**

Jonathan Botkin
*PowerLight Corporation
Berkeley, California*

Subcontract Report
NREL/SR-520-42420
December 2007

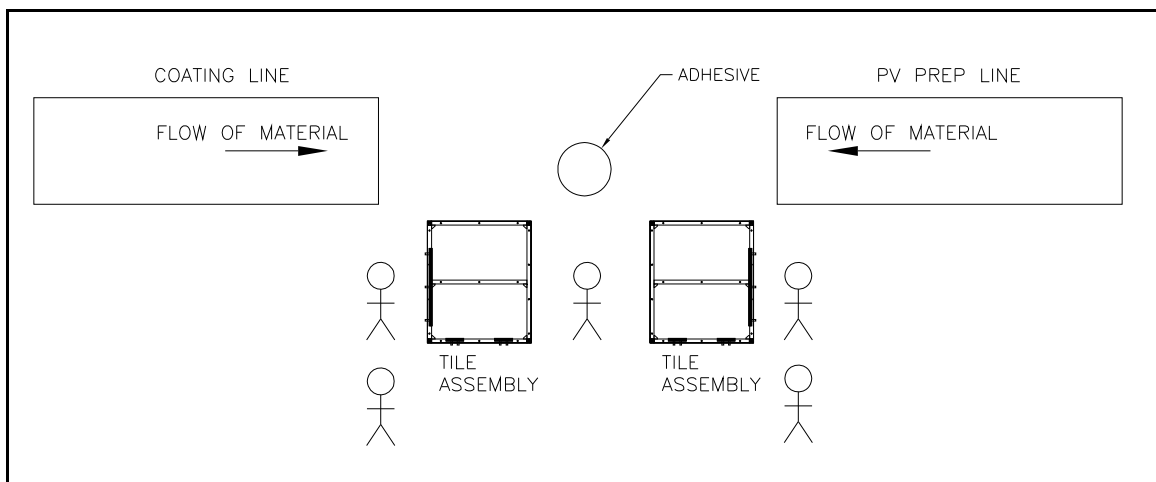
After trying out several layouts, the workers agreed that one of them worked better than the other options. Once the equipment layout was decided on, the associated electric and pneumatic connections were moved to provide power for the new setup. The final layout is shown in Figure 39.

Figure 39: Tile Assembly Layout after Kaizen Event.

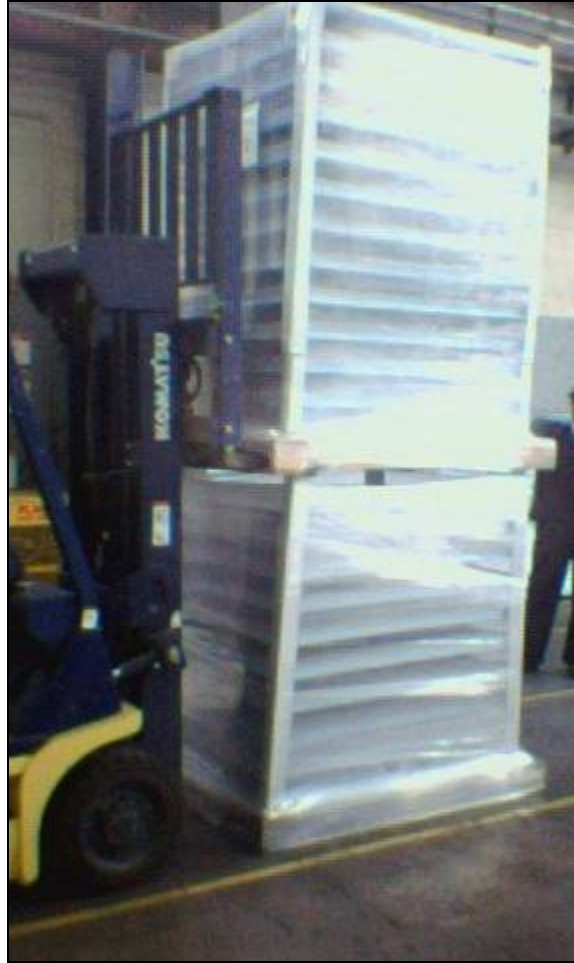
Since reusable containers proved infeasible at this time, PowerLight looked for ways to increase shipping density and, thereby, achieve the site-waste and cost reduction goals. PowerGuard tiles were generally stacked 12 high on each pallet. This was primarily done to allow workers to stack the tiles easily in the factory and to unstack them easily at the job site. A stack of twelve PowerGuard tiles is approximately 60 inches high. Shipping containers would allow a stack as high as eight feet, but unstacking a pallet this high becomes nontrivial. PowerLight investigated the possibility of taking two pallets with stacks of PowerGuard tiles and placing one on top of the other for shipping. When the stacks were unloaded from the truck, the two pallets could be separated either prior to lifting to the roof or after they had been lifted to the roof. PowerLight investigated the use of corner supports that were strong enough to support the second stack on top of the first one. Corner supports were found that were made from recycled plastic bags and were easily strong enough to provide the needed support. Figure 41 shows an initial test of these supports.

Figure 41: Test of corner supports in double stacked pallets.

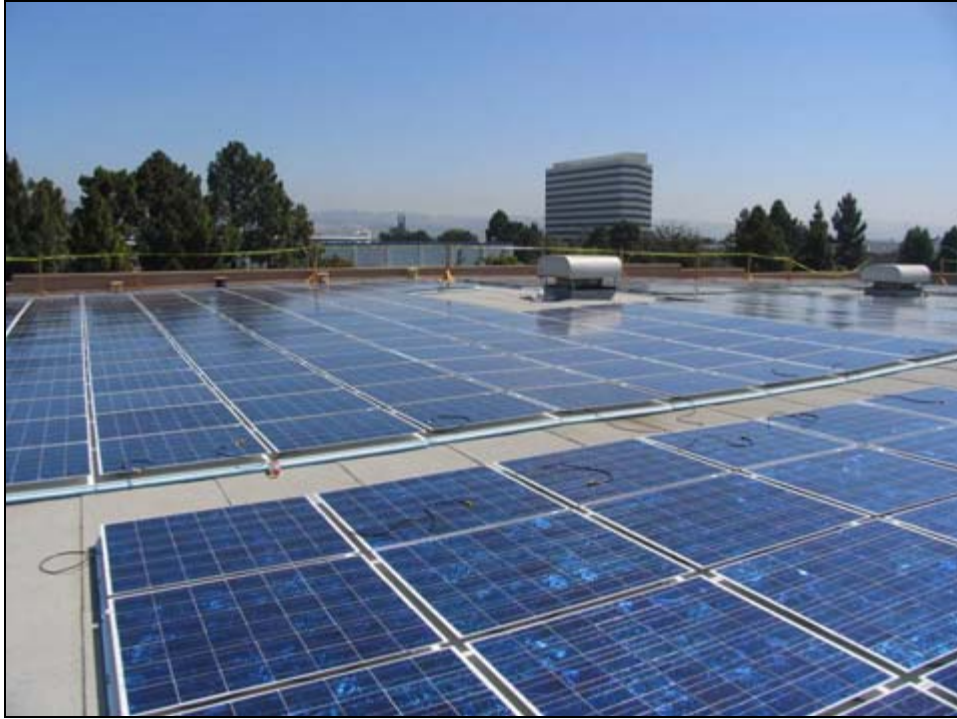
Figure 42: Demonstration array with reduced coating thickness during installation.

The workers appreciated the lower weight of the new tiles, which made them easier to handle. Figure 42 shows the array with the reduced coating thickness during installation. Figure 43 shows a close-up of the difference in coating thickness between a standard PowerGuard backerboard and the new backerboard.

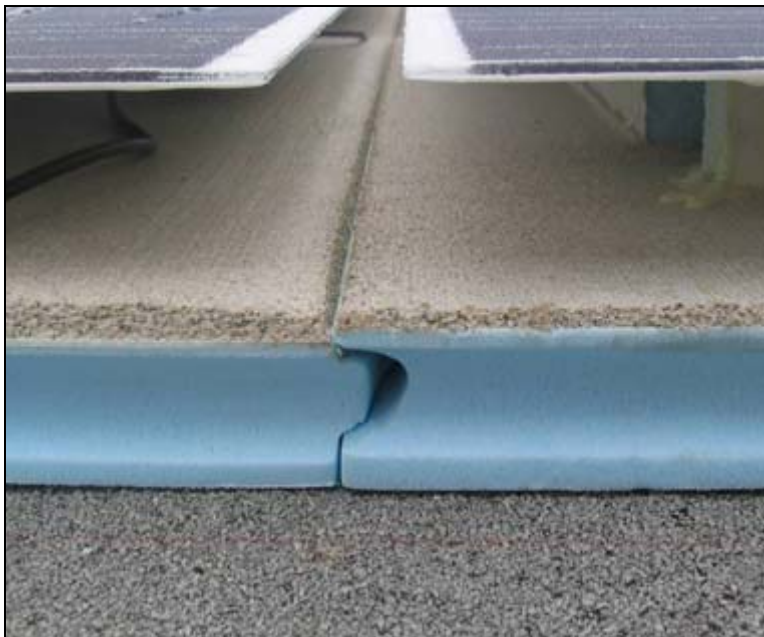
Figure 43: PowerGuard tile with reduced coating thickness (on right).

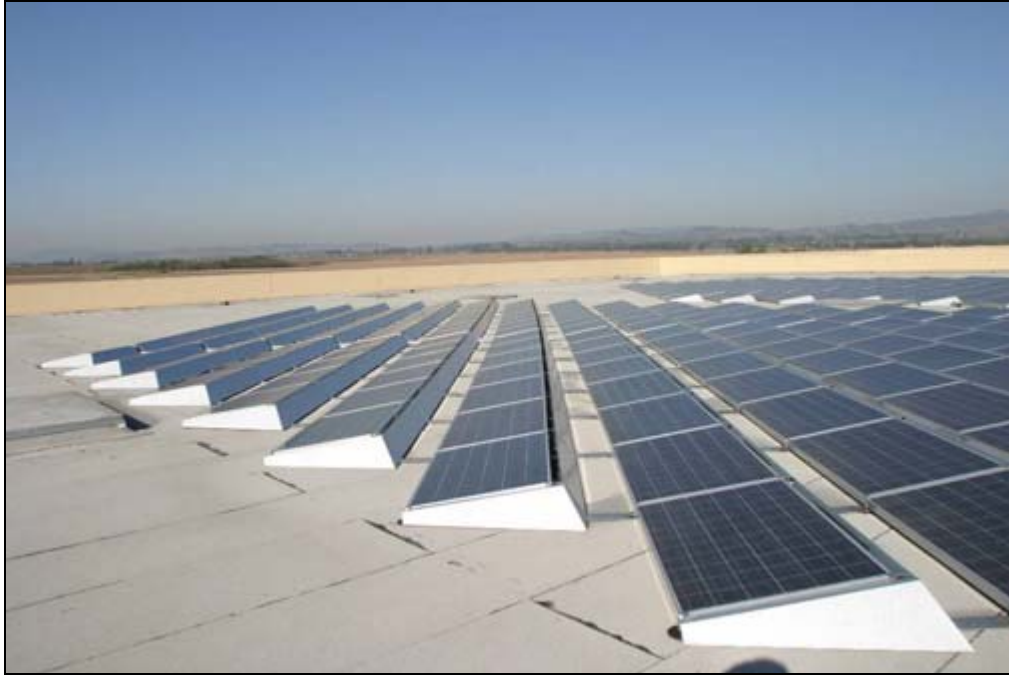
Figure 44: Phase I commercial demonstration project.

Commercial demonstration projects with RFT10 were installed in Phase I and Phase II. In September 2005, PowerLight completed the installation of the first large-scale arrays of RFT10, as shown in Figure 44. Lessons learned during this installation were used in the development of the universal RFT10 design, as described previously in Section 2.2.

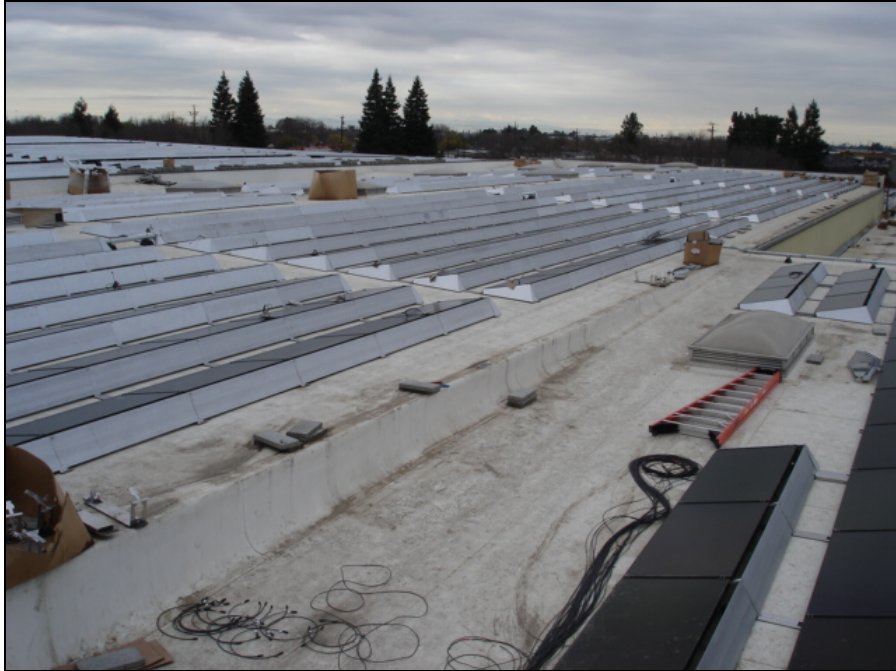
Figure 45: Commercial demonstration site under construction.

The Phase II changes made to the RFT10 product were extremely well received by the installation crews. The new mounting method was easier to install, and it made it easier to maintain array alignment. The installation was subject to several delays and problems unrelated to the array design itself. However, these problems made it difficult to obtain an accurate measurement of installation labor. The impression of the installers was that the new design could be installed in a lot less time than the previous design. Subsequent jobs that have been installed in February and March of 2007 have confirmed this impression. Photos of the project under construction and completed are shown in Figure 45 and Figure 46.

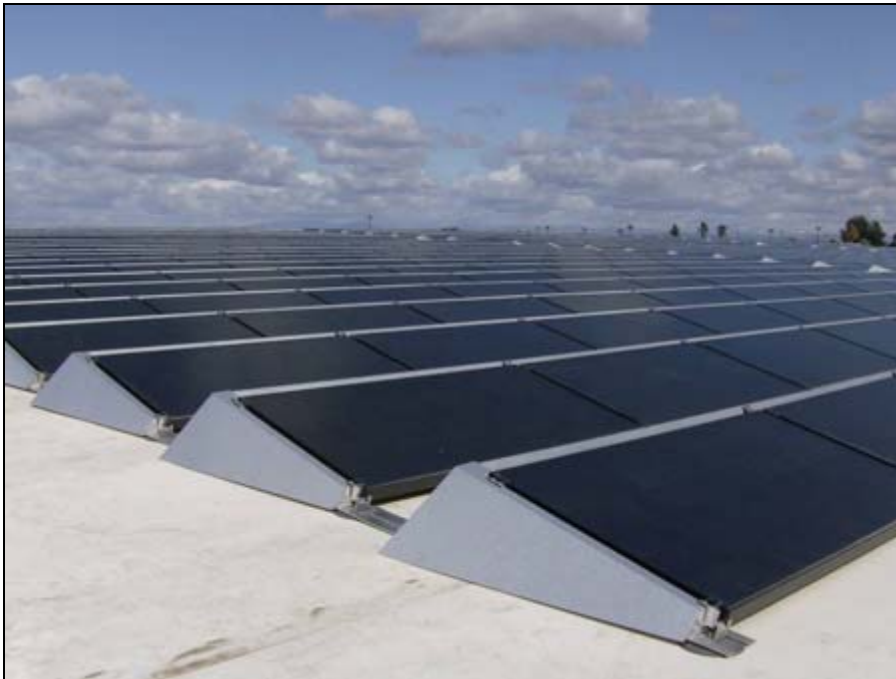
Figure 46: 1-MWp array completed.

In addition to reducing installation labor and making the installation easier, the new design reduced overall balance-of-system cost. The mounting hardware cost was reduced by 70% compared to the commercial demonstration projects that were installed during Phase I of this project. This is a far greater improvement than hoped for. Overall system cost was reduced by nearly 10% from the Phase I commercial demonstration. PowerLight is very proud of the success that we have had with this new product.
