**Pacific Northwest
National Laboratory**

Radiochemical Processing Laboratory High-Level Vault Characterization Report

October 2007

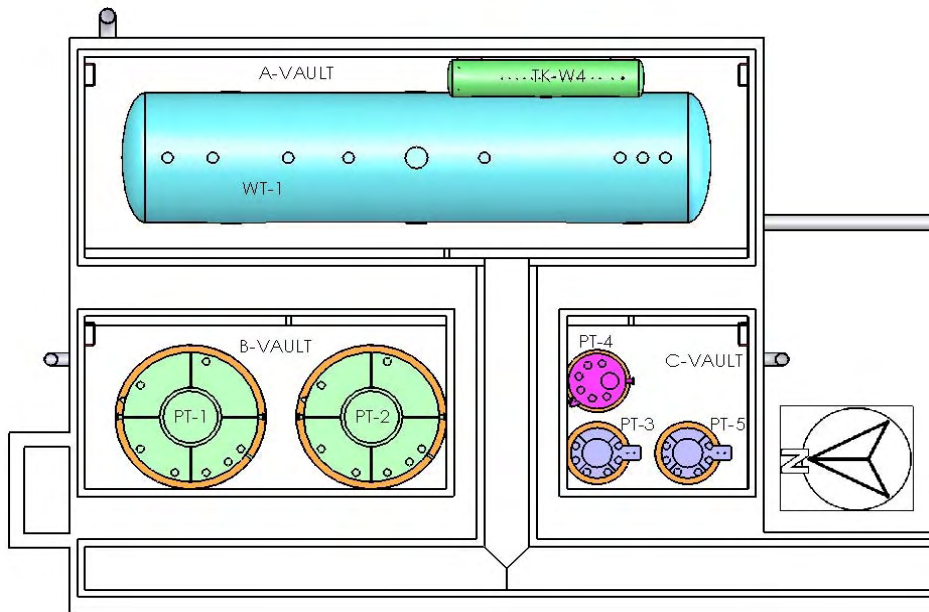
Figure 2.1. Overhead View of HLV

The HLV is a complex of three separate vaults and seven tanks designed to contain radioactively contaminated process and waste solutions generated by the 324 and 325 Buildings in the Hanford Site 300 Area. An overhead view is provided below in Figure 2.1. A description of the vaults and tanks are summarized in Table 2.1.

The HLV consists of three below-grade concrete vaults. Each vault has a stainless steel floor tray that extends one foot or more up the wall. Each floor tray has a trench along one side, and a sump positioned in the middle of the trench. The floor and trench are sloped slightly to direct any water infiltrating the vaults to the sumps. Each sump is equipped with a level monitoring gauge and a system for removing liquid. The top of the HLV is covered by concrete blocks approximately two feet thick. The concrete blocks are protected by a weather barrier constructed of insulated roofing material.

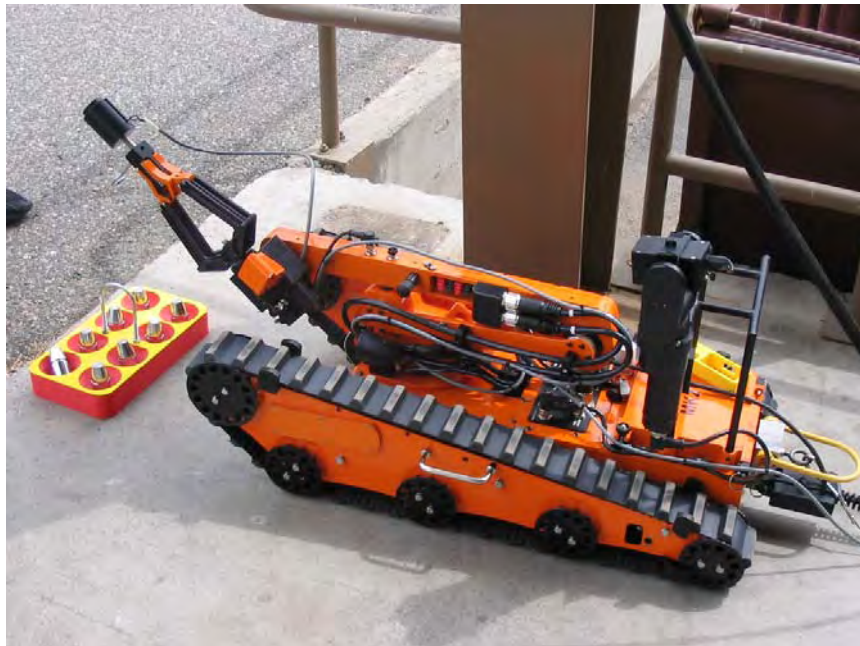
Figure 3.1. ROV and Associated Sampling Equipment

The Allen-Vanguard Mark II remotely operated vehicle (ROV) shown in Figure 3.1 was selected for use in the HLV characterization effort.

The tracked crawler unit is approximately 36-inches long, 17-inches wide and 22-inches high with the manipulator fully stowed. It has a 38-inch reach, 3 cameras, and 3 lights. Command signals are transmitted to the vehicle and video signals returned to the control station via a copper-wire tether. It is powered by a field-replaceable, on-board battery which that allows for mission times of several hours. Field life of the battery depends on the level of vehicle activity. As most characterization activities occurred over several days, a low current battery charge maintainer was used to recharge the on-board battery overnight when the vehicle was not in use.

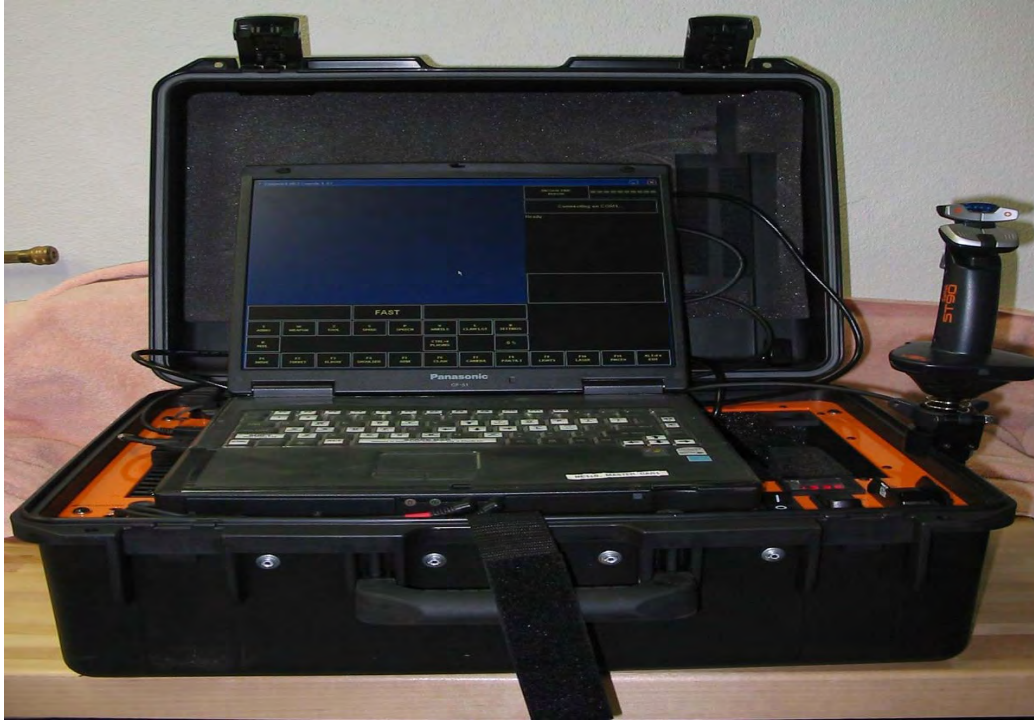
Figure 3.2. ROV Control Station

The ROV control station shown in Figure 3.2 was provided by the manufacturer and included a laptop computer which that displayed vehicle status and controls and the current video image from the vehicle.

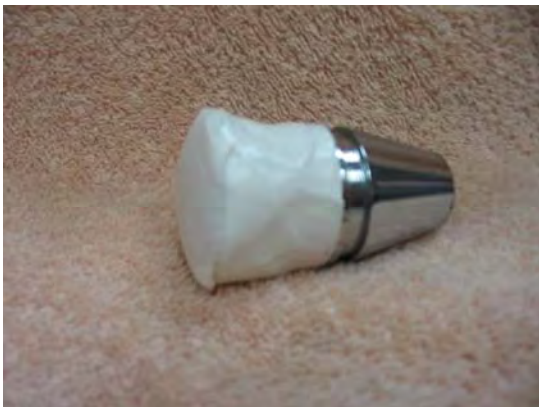
Figure 3.3. Billet Sampler

Removable contamination smears were obtained within the vault using metal billet-type samplers (Figure 3.3). A rapid prototyped ABS plastic sample tray suspended from a U-bolt was used to transport the sample billets (Figure 3.4).

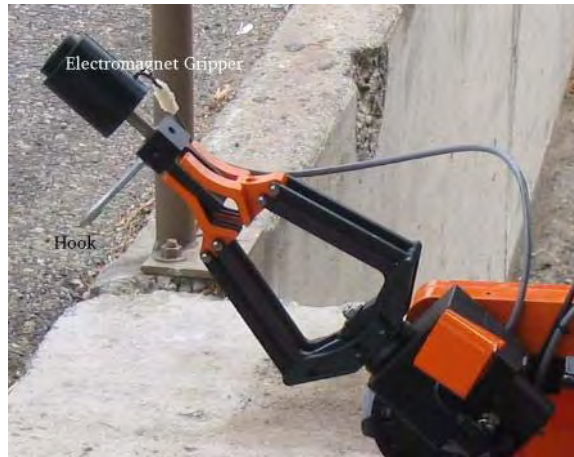
Figure 3.5. End Effector

A sampling end-effector consisting of an electro-magnet gripper and a hook was carried in the ROV manipulator arm gripper (Figure 3.5). The electromagnet was powered by a built-in tool power circuit on the ROV.

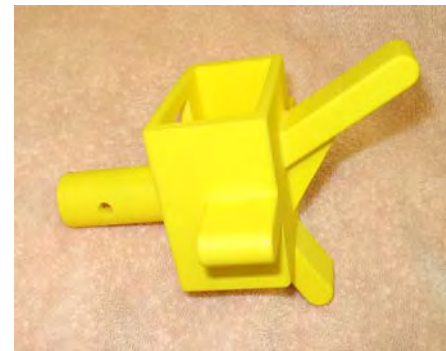
Figure 3.6. Sampling Tool

A sample head for the poles is shown in Figure 3.6. This sample head served as both a dosimeter holder and a smear sample media mounting location.

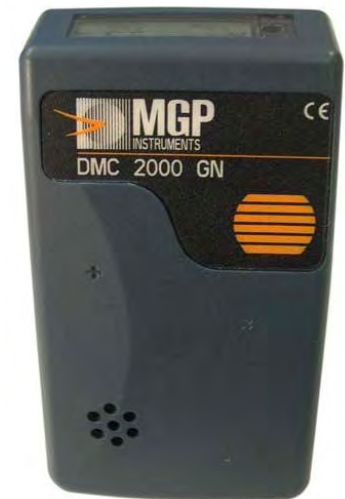
Figure 3.7. DMC 2000 Series Electronic Dosimeter

The DMC 2000 series electronic dosimeter equipped with the CTM 2000 transmitter for remote data logging was used to obtain beta/gamma radiation dose information within the HLV (Figure 3.7). The radiation dose measurements were transmitted via radio signals to the control station and recorded.

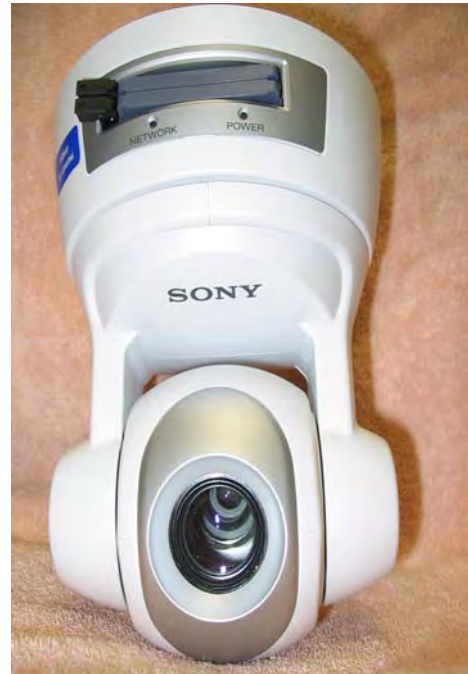
Figure 3.8. Sony Camera

The platform-mounted lighting system provided improved overall lighting within the HLV, resulting in improved image quality. The accompanying video camera provided an overview of ROV operations, which is an important aid to the operator of the ROV. The camera system was a Sony SNC-RZ30N network camera (Figure 3.8) that

was enclosed in a Sony-provided sealed dome enclosure. This is a pan/tilt/zoom camera with a web interface for control of the camera.

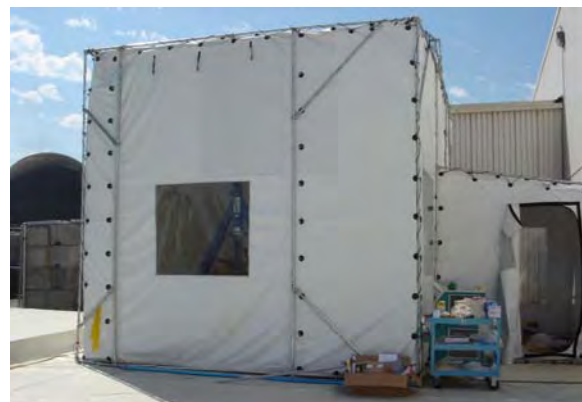
Figure 3.9. Containment Installed over HLV

A portable work structure (containment) was used during the characterization activities (Figure 3.9). The primary purpose of the containment was to provide radiological contamination control and protection to staff, and sampling equipment and instrumentation from inclement weather. Wind and snow loading were considered in the design. Ventilation for the greenhouse was provided by the HLV open cover block.

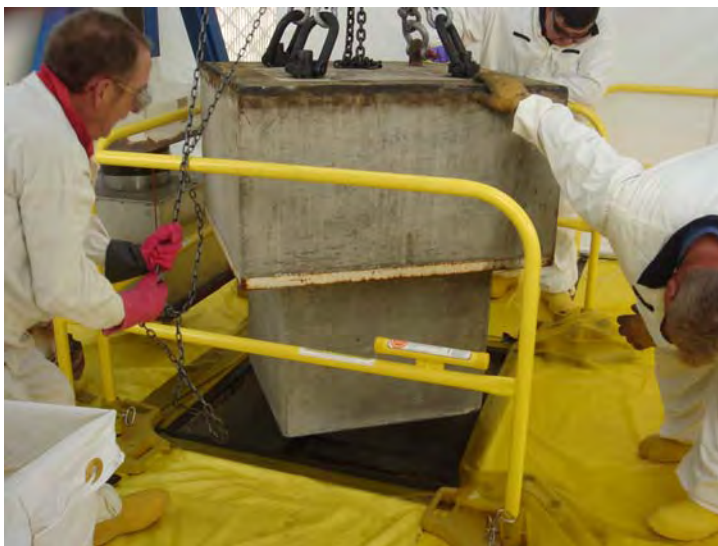
Figure 4.1. Vault Access Cover Block Removal

remote dose reading using extended reach instrumentation over the opening. Then thorough characterization sampling and video documentation of each HLV was performed. The ROV, hand-held reach tools, and associated sampling equipment were inserted into the HLV via an open access cover block (Figures 4.1, 4.2, and 4.3). The ROV was equipped with a robotic arm that was used to transport and maneuver radiological survey and characterization sampling equipment around the interior of the HLV. Hand-held extension tools manipulated through the HLV access openings were also used to obtain radiological dose rates and characterization samples.

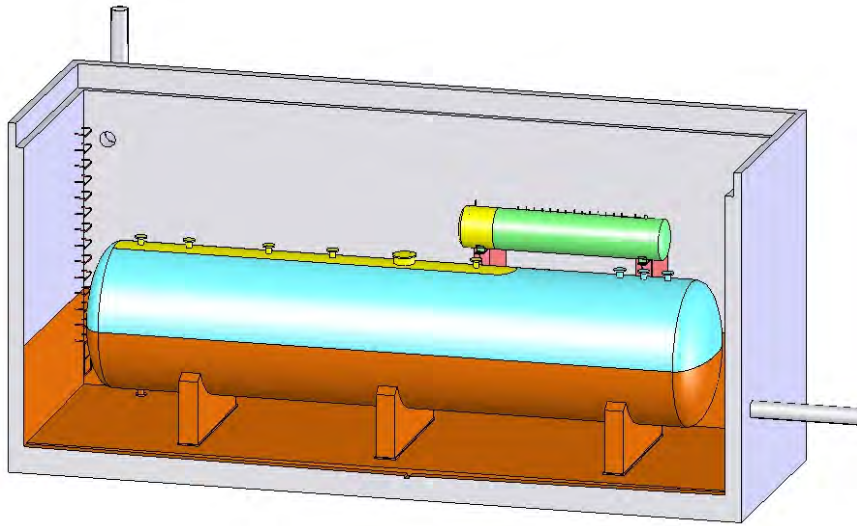
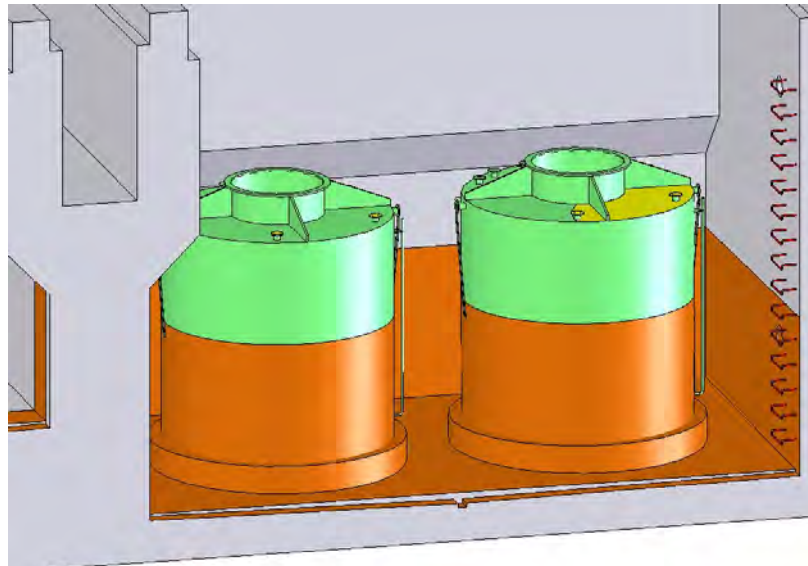
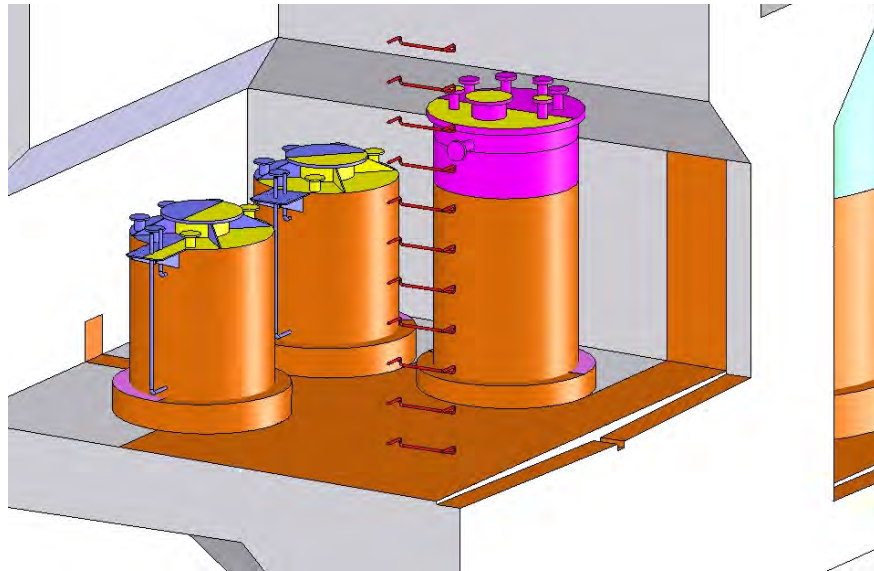
Prior to installing the sampling equipment, the HLV sampling maps were reviewed, and sampling methods and ROV access limitations discussed. The orange-colored portions of Figures 5.1, 5.2 and 5.3 identify the areas accessible to the ROV.

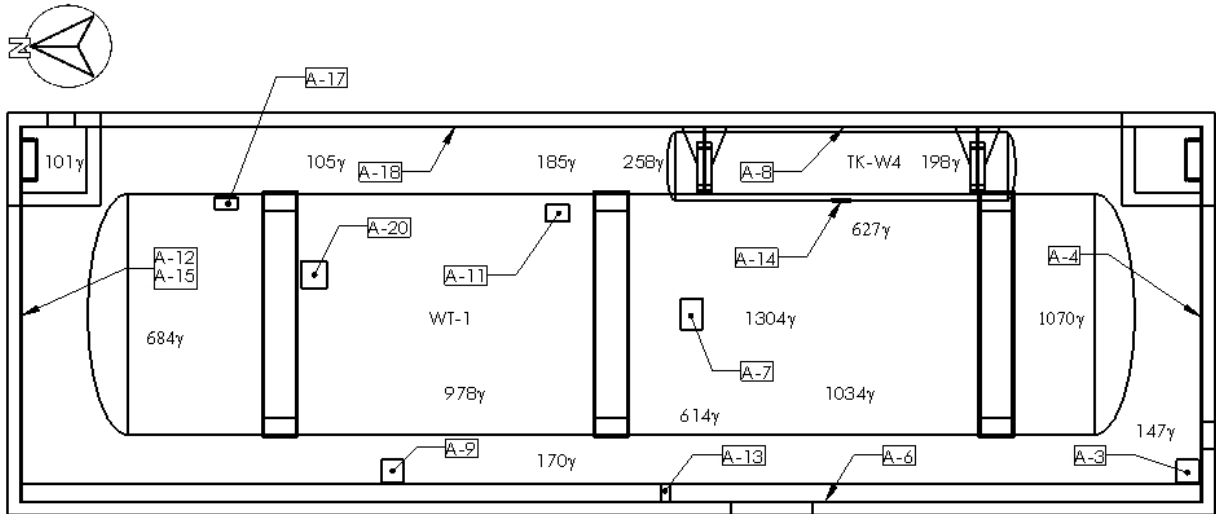
Figure 5.4. Drawing of A-Vault

General area dose rates within each vault are shown in the following drawings. Appendix A contains detailed dose rate and sampling information. The alpha-numeric references in the Figures 5.4, 5.5, and 5-6 correspond to smear sample locations that may be reviewed in Appendix A.

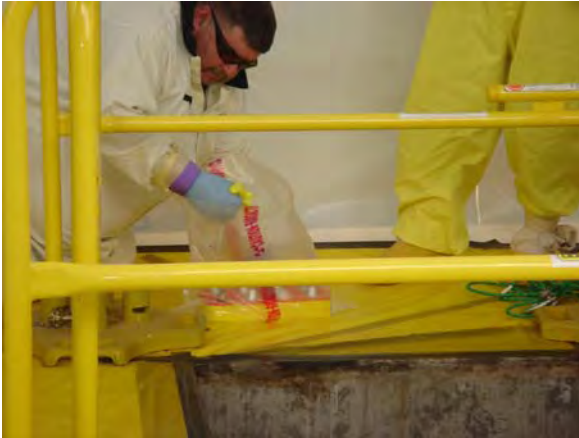
Figure 5.7. Sample Tray Retrieval from HLV

In most cases, the operator could determine, via video camera, a clean area on the target surface after the samples were taken. The sampling information was recorded on the sampling data table, location map, and field logs at the time of sampling. Once the samples were collected, they were retrieved from the HLV through the open cover block (Figures 5.7 and 5.8) and transported to a radiological fumehood within the facility.

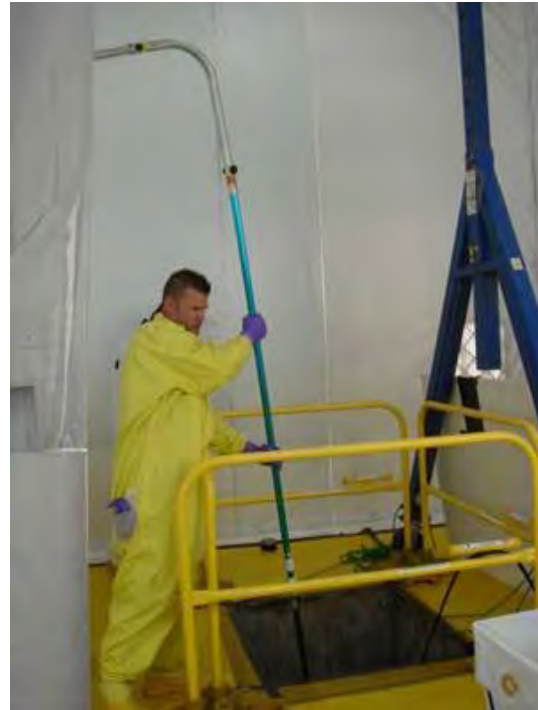
Figure 5.8. Extended Reach Sampling Tool Retrieval from HLV

Smear samples were also obtained utilizing an extended reach tool lowered into the HLV and manipulated through the open cover block. The end of the extended reach tool was equipped with a small plastic sampler designed with multiple protrusions which were used as attachment points for smear media. The plastic sampler was lowered into the HLV, placed against the target surface, and then moved back and forth.

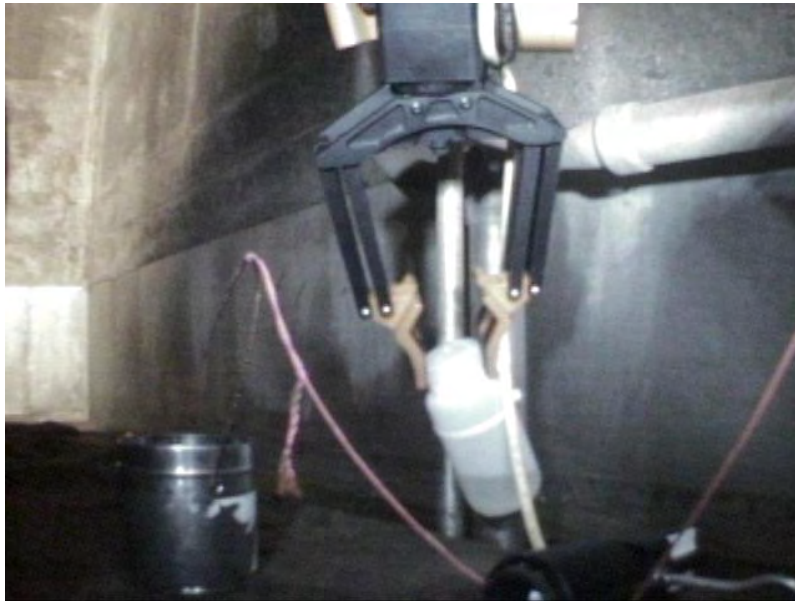
Figure 5.9. Liquid Sampler

Liquid samples were obtained using a 250-mL plastic bottle with a screw cap. These bottles were prepared for use by drilling a vent hole in the cap and an inlet hole in the side of the bottle about 2 cm from the bottom of the bottle. The hole in the side was marked with an indelible black pen for ready identification by the operator. To acquire a liquid sample, one of these bottles was placed in a small metal can equipped with a wire lifting bail. The bottle and metal can were lowered into the vault and placed on the floor. The ROV transported the metal can/bottle to the sampling location. With the aid of video cameras, the bottle was removed from the can, submerged in liquid, returned to the can, and then retrieved from the HLV through the open cover block. The liquid sampler is shown in Figure 5.9.

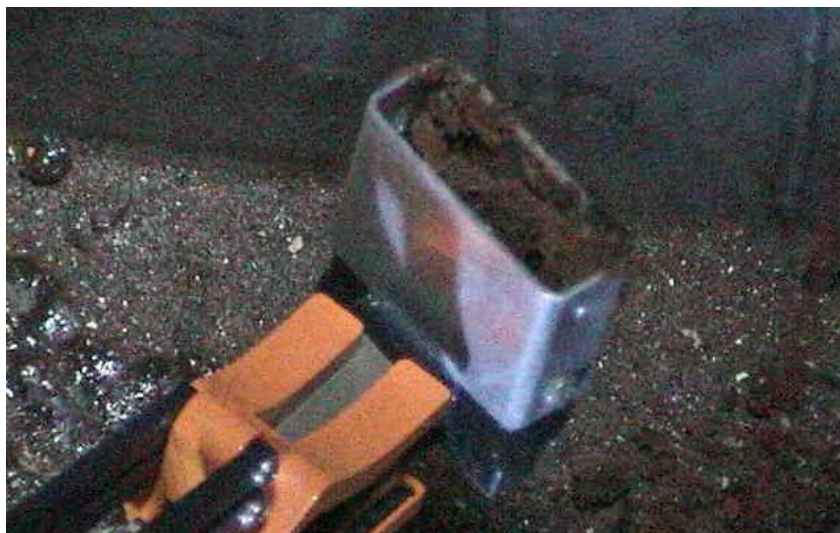
Figure 5.10. Debris Sampler

Debris (soil) samples were obtained utilizing a small metal shop-made scoop (Figure 5.10). The scoop was designed with an opening in which to capture a small amount of floor debris. The scoop was transported to the sampling location and dragged across the HLV floor until the cavity was filled with soil. The metal scoop was transported and manipulated similarly to the liquid bottle sampler.

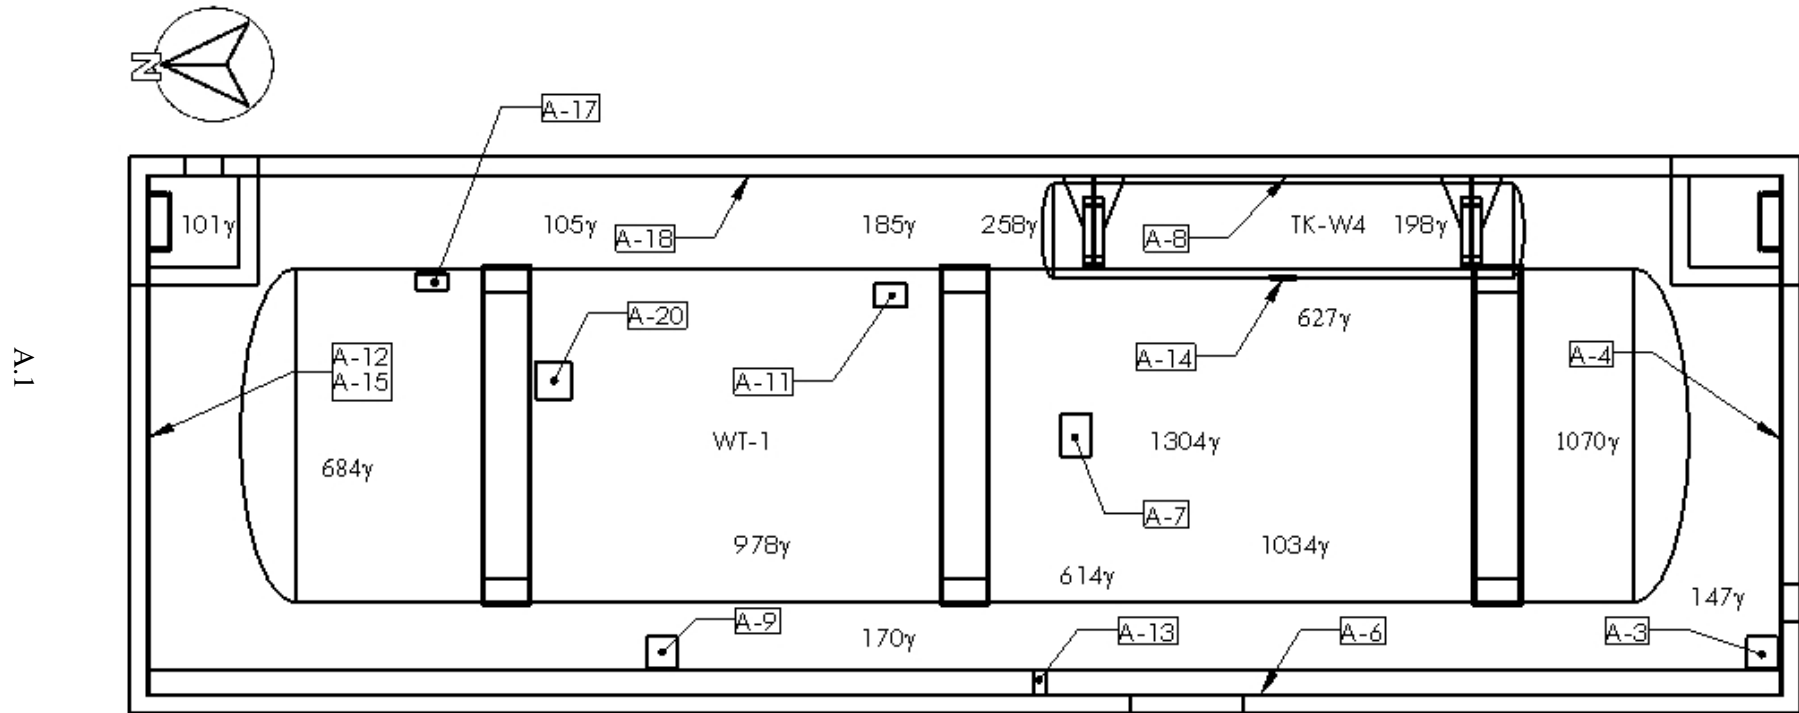
Table A.1. A-Vault Overhead Diagram and Sample Information

*Unless otherwise noted, all dose rates were recorded on the vehicle, approximately 12 inches above the vault floor, not at the height of the smear.

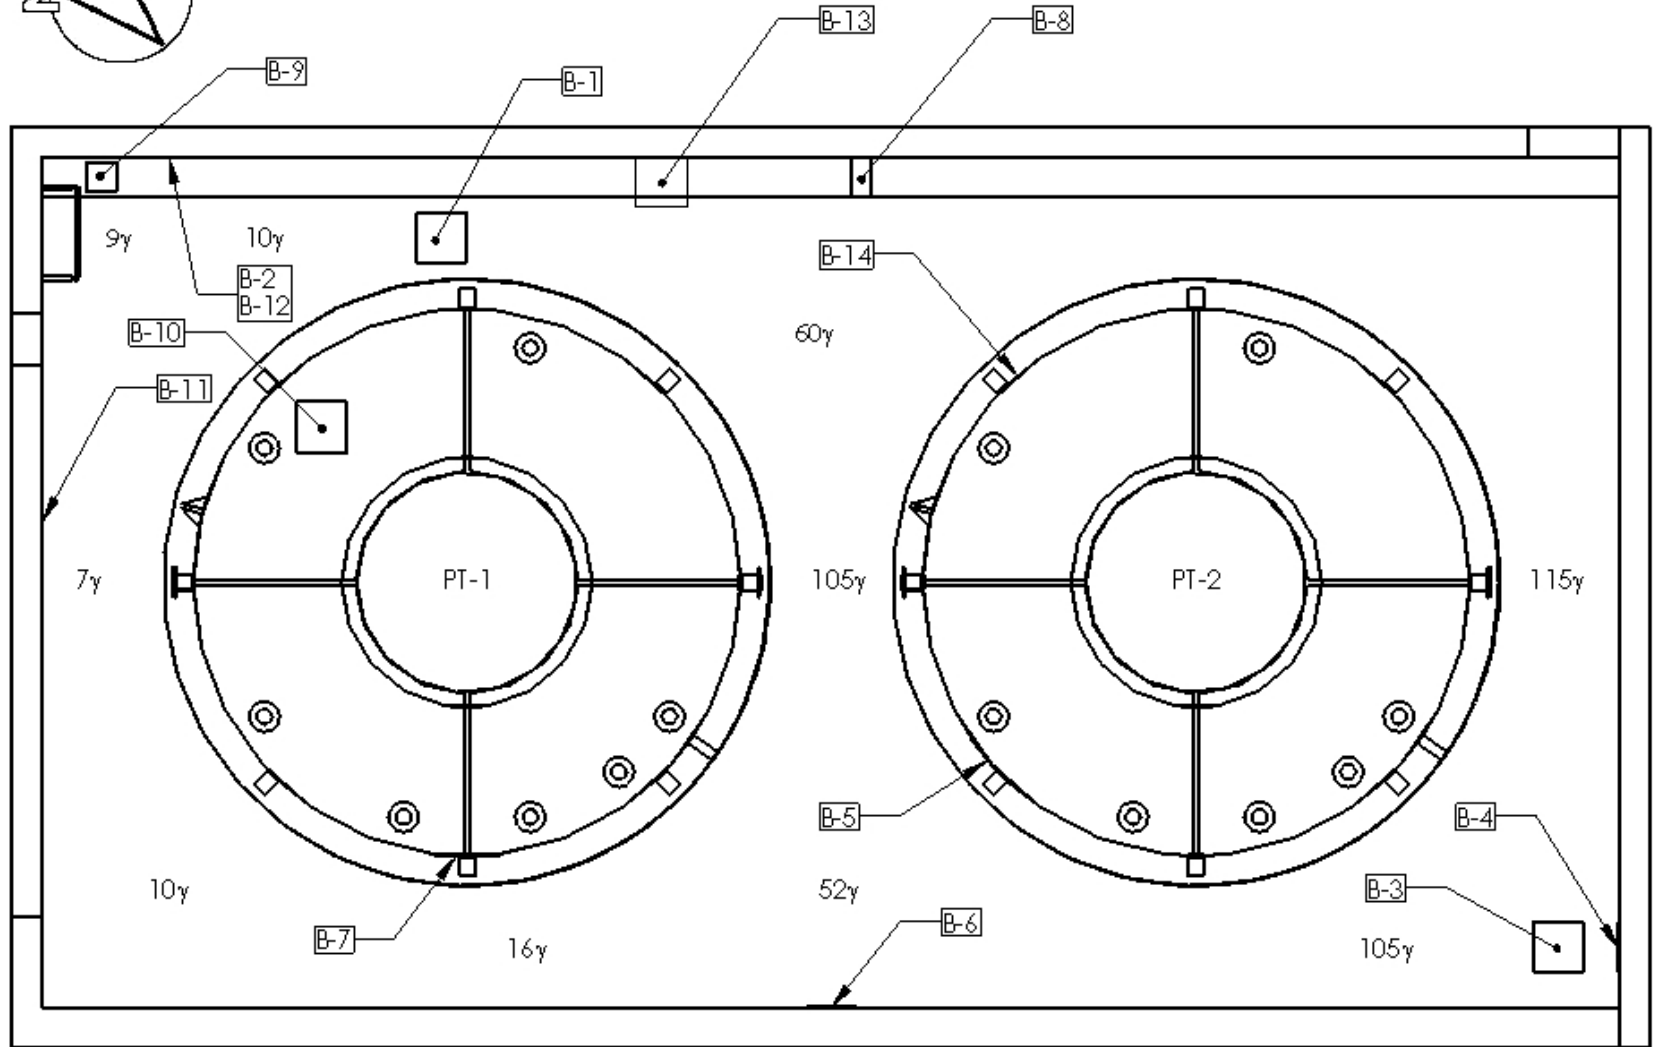
Table A.2. B-Vault Overhead Diagram and Sample Information

*Unless otherwise noted, all dose rates were recorded on the vehicle, approximately 12 inches above the vault floor, not at the height of the smear.

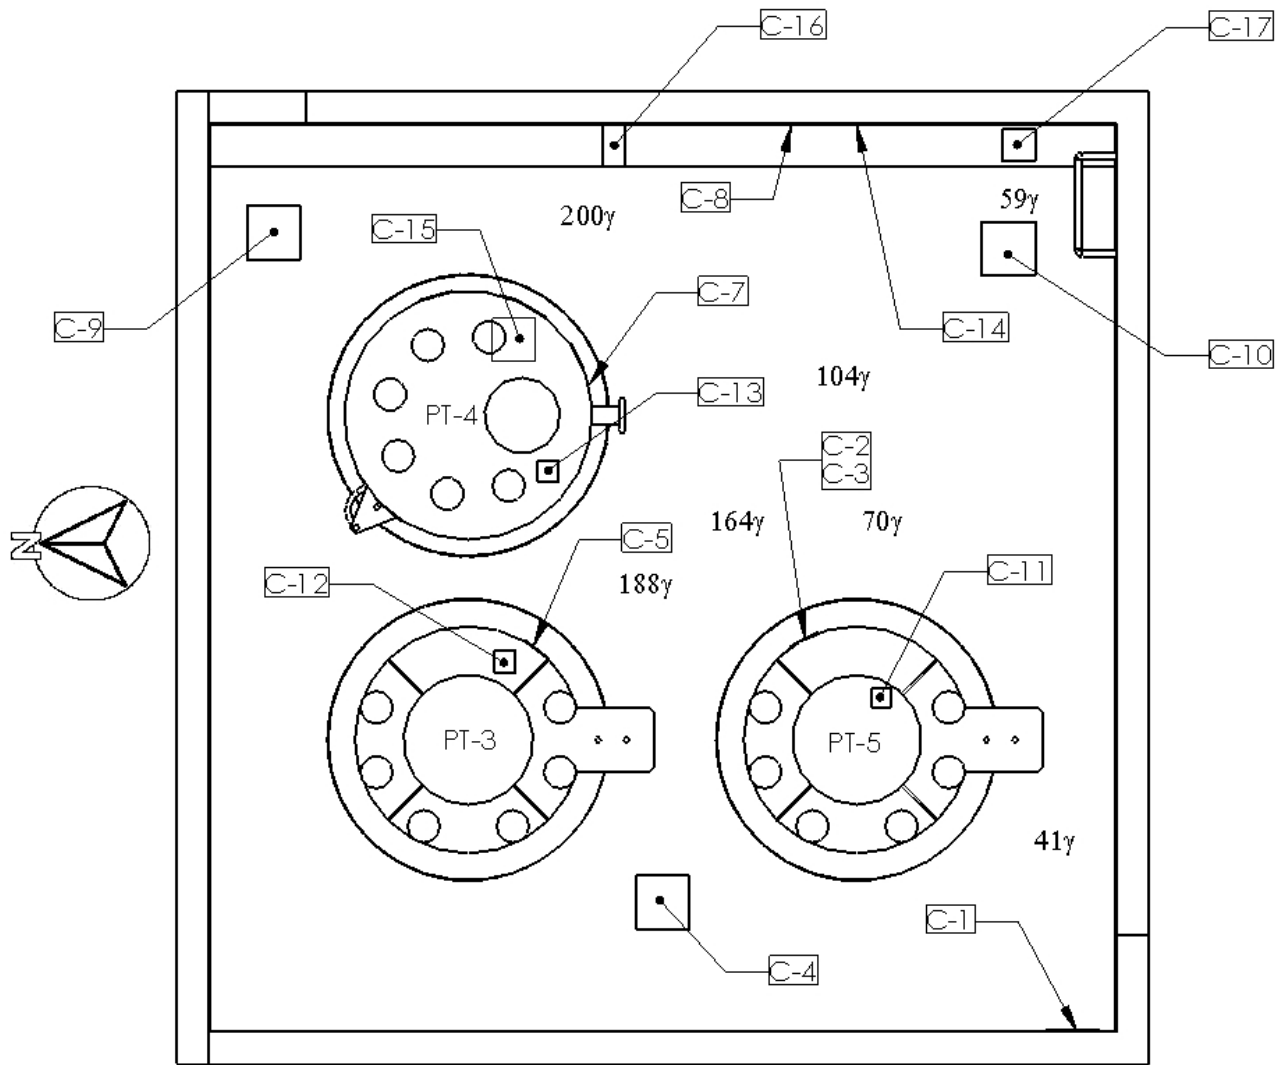
Table A.3. C-Vault Overhead Diagram and Sample Information

*Unless otherwise noted, all dose rates were recorded on the vehicle, approximately 12 inches above the vault floor, not at the height of the smear. Robot dosimeter power failure after C-6.

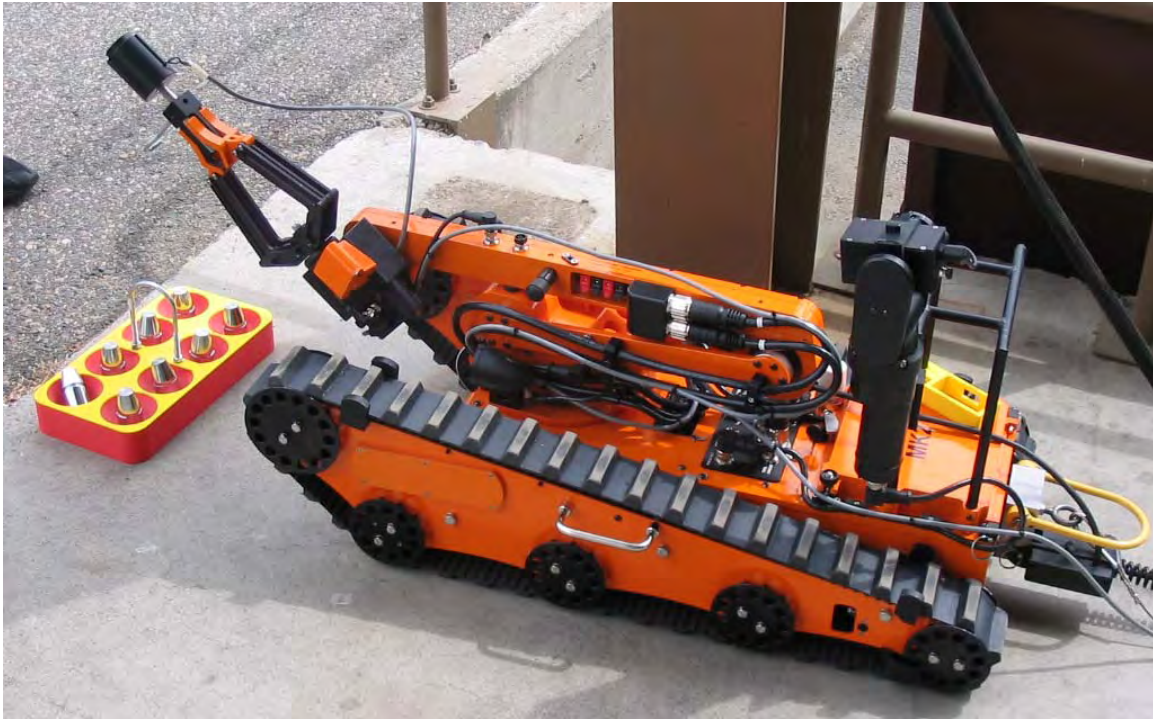
Figure C.1. Vanguard Mark II ROV

The Allen-Vanguard Mark II ROV was selected for use in the HLV characterization effort. This family of remotely operated vehicles (ROV) is used primarily for explosive-related law-enforcement activities, and was extensively evaluated by the Battelle Memorial Institute (National Institute of Justice 2000). The favorable performance of the Vanguard ROV in these tests, in combination with the availability and adaptability of the design, led to the selection. The ROV unit and attached components performed most of the in-vault work. The ROV was operated and data was collected from a remotely located control station. The operators used handheld poles to position the ROV sampling devices near the vault-access ports. A photograph of the ROV is shown in Figure C.1.

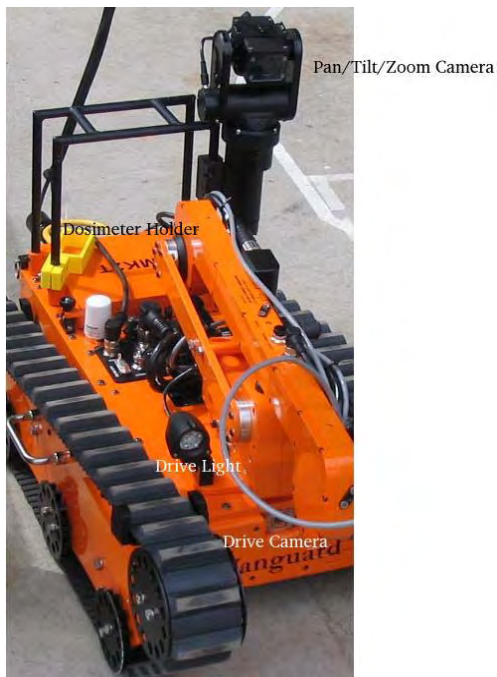
Figure C.2. ROV Camera locations

The unit has three onboard cameras and two onboard lighting systems, which provide capability for an overview visualization of work taking place within the vault. One camera is mounted low and in front of the vehicle in a fixed, forward-facing configuration. This camera is normally used for driving the vehicle. A second camera is mounted to the wrist of the robot, approximately coaxially with the gripper. This allows the operator to verify that items are within the gripper jaws before closing the gripper. The third camera is a pan/tilt/zoom unit mounted fairly high up, near the back of the vehicle. This allows the operator to observe the arm configuration, tether position and orientation, view items beside the vehicle, and drive in reverse. Lighting is provided through the wrist-mounted camera. Lighting is also available on the base of the main turret for the manipulator, which provides lighting for the driving camera. Camera and lighting locations are shown in Figures C.2 and C.3.

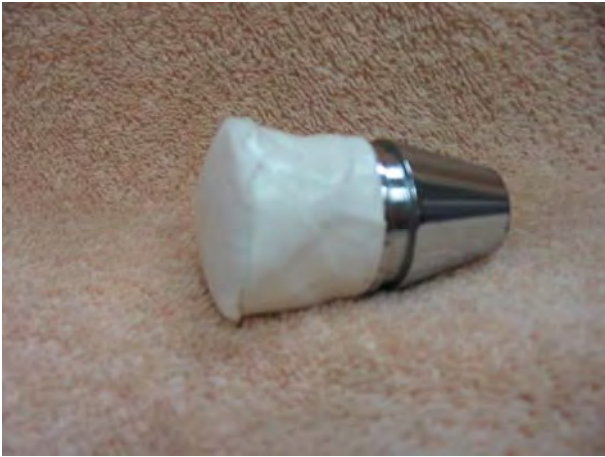
Figure C.4. Sampler

Removable contamination smears were obtained within the vault using metal billet-type samplers. The samplers are relatively simple turnings fabricated from Tajima PQB-400 14 oz. plumb bobs. The pointed end was cut off to produce a flat surface 3/4-inch in diameter. This flat surface provided a convenient location to apply identification numbers to the samplers, and a mating surface for the magnet that was used to transport them. The plastic hangar and other hardware were removed from the large end. That end was then machined off to produce a smooth, rounded surface to which the sampling media was attached. The rubber bumper was removed from the transition region between the cylindrical and conical portions of the sampler, and a nylon cable tie applied in its place. The head of the cable was intended to prevent the samplers from rolling should these be dropped.

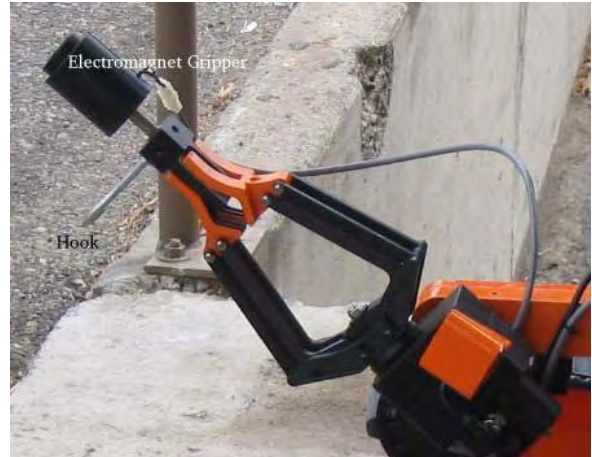
Figure C.6. Sampling End-Effector

A sampling end-effector, consisting of an electromagnetic gripper and a hook, was carried in the ROV-manipulator arm gripper. The sampling end-effector was machined out of high-strength Delrin plastic. The gripper portion of the end-effector was machined to have a +-shaped cross section that meshed well with the gripper jaws. A hole was drilled and tapped just outboard of the gripper, to which a hook could be threaded. This hook allowed the operator to carry the sampler tray via a loop fixed to the tray. A second hole in the end of the gripper block allowed an electromagnet, surrounded by a Delrin guide, to attach to the end of the gripper. The electromagnet was powered by an operator-controlled tool power circuit built into the robot. This allowed the ROV to transport and maneuver the samplers within the vault. Each sampler was numbered and sample information was recorded to prevent reuse of previously used sampler numbers. The sampler and end-effector are shown in Figures C.4 and C.5. The billet samplers were stored and transported via the sampler tray shown in Figure C.6.

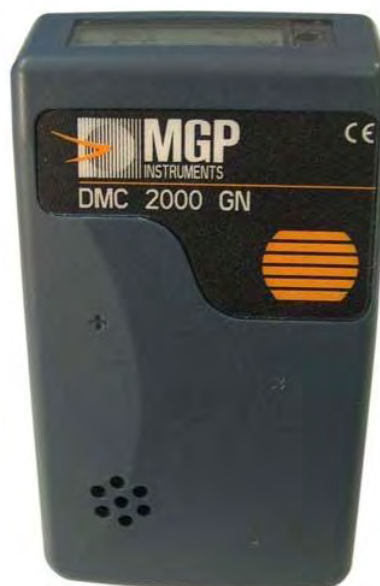
Figure C.7. MGP 2000 Dosimeter

The DMC 2000 series electronic dosimeter was selected as the onboard dose-rate measurement system. This compact instrument was primarily designed to be worn by individuals working in areas where real-time measurement of the prevailing radiation dose was desirable. The DMC 2000 was also equipped with the CTM 2000 transmitter for remote data logging. This combination of instruments was extensively evaluated by PNNL () and demonstrated superior performance. Other dose-measurement systems, such as the RO-7 and AMP-100, were considered, but not implemented due the difficulties associated with mobility and remote data logging. The DMC 2000 is shown in Figure C.7.

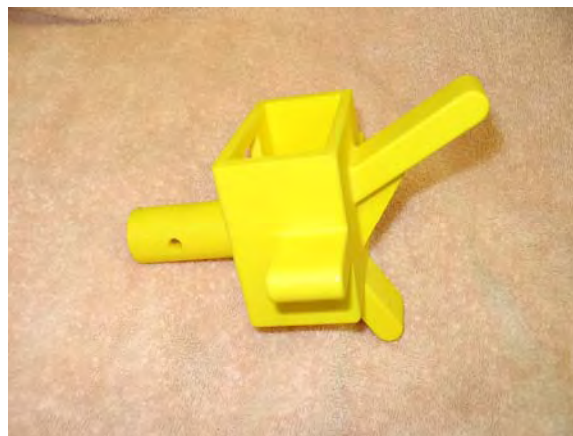
Figure C.8. Pole-End Smear/Dosimeter Holder

A telescoping pole—commonly sold and used for swimming pool maintenance—was used to obtain additional characterization samples. The pole was inserted into the vault-access opening and manipulated by hand with the aid of video cameras. The telescoping pole was sturdy, lightweight, and extended up to 16 feet in length. Straight and curved fixed-length segments and an end tool, which served as both a dosimeter holder and a removable contamination-smear sampler, were designed and fabricated for use with the telescoping poles. The pole-end tool is shown in Figure C.8.

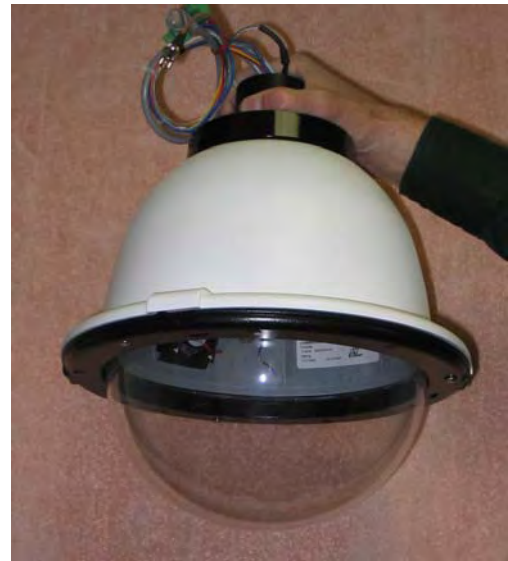
Figure C.9. Sony Camera Enclosure

The camera system was a Sony SNC-RZ30N network camera, which was enclosed in a Sony-provided sealed-dome enclosure. The enclosure and camera are shown in Figures C.9 and C.10. The camera was equipped with pan/tilt/zoom capability and a web interface for control of the camera. The camera allowed still images to be saved to the computer. Images were captured in this way to record significant events that occurred during the operation. The camera also provided an analog-output signal, which was displayed at the vault access point and at the control station (where the signal was also recorded). Unfortunately, the overlay of visible time/date stamps onto the camera image was not possible.

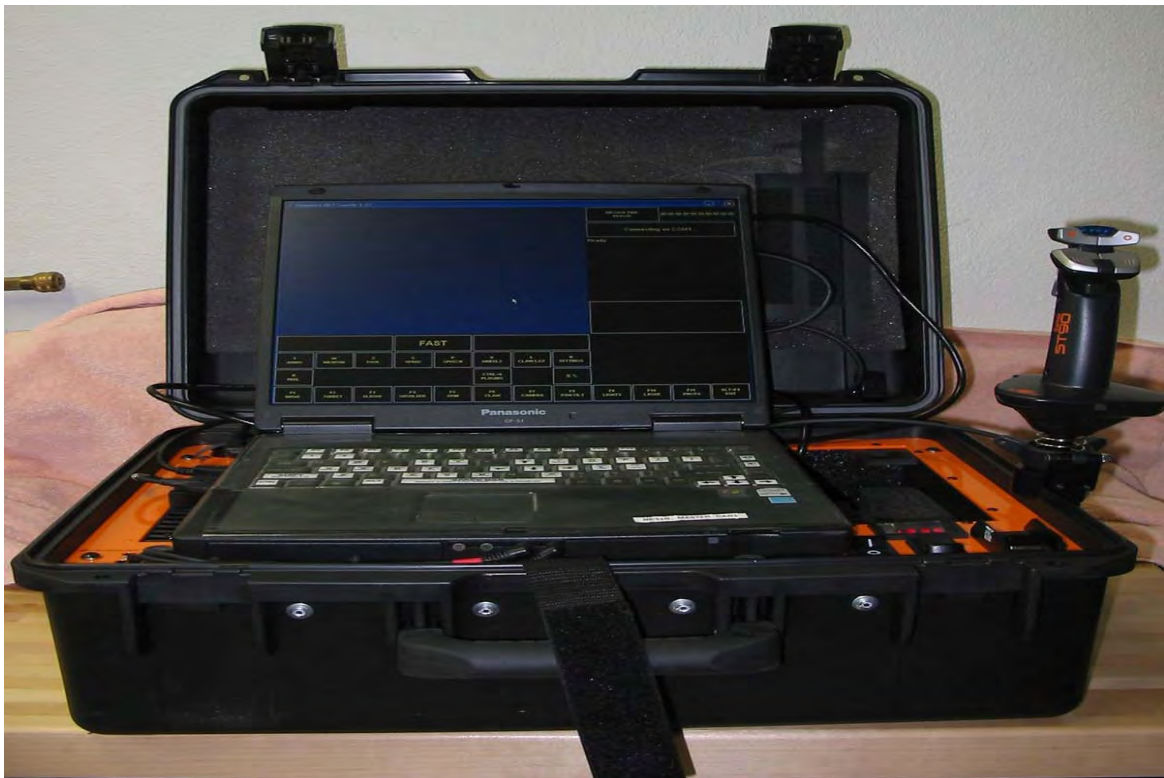
Figure C.11. ROV Control Station

The ROV-control station was provided by the ROV manufacturer, and included a laptop computer, which displayed vehicle status and controls, and the current video image from the vehicle. The displayed images were captured and saved to the laptop hard drive. In addition, images were captured during deployments. The ROV control station is shown in Figures C.11 and C.12.

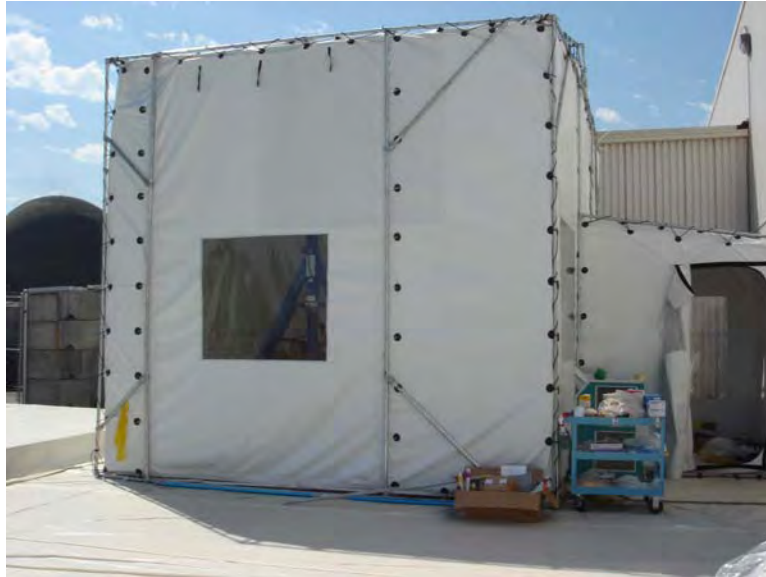
Figure C.13. Containment Installed over High Level Vault

The vaults were exhausted via the RPL Radioactive Exhaust Ventilation System, and the existing system design and configuration was adequate to exhaust the containment and the vault being accessed.

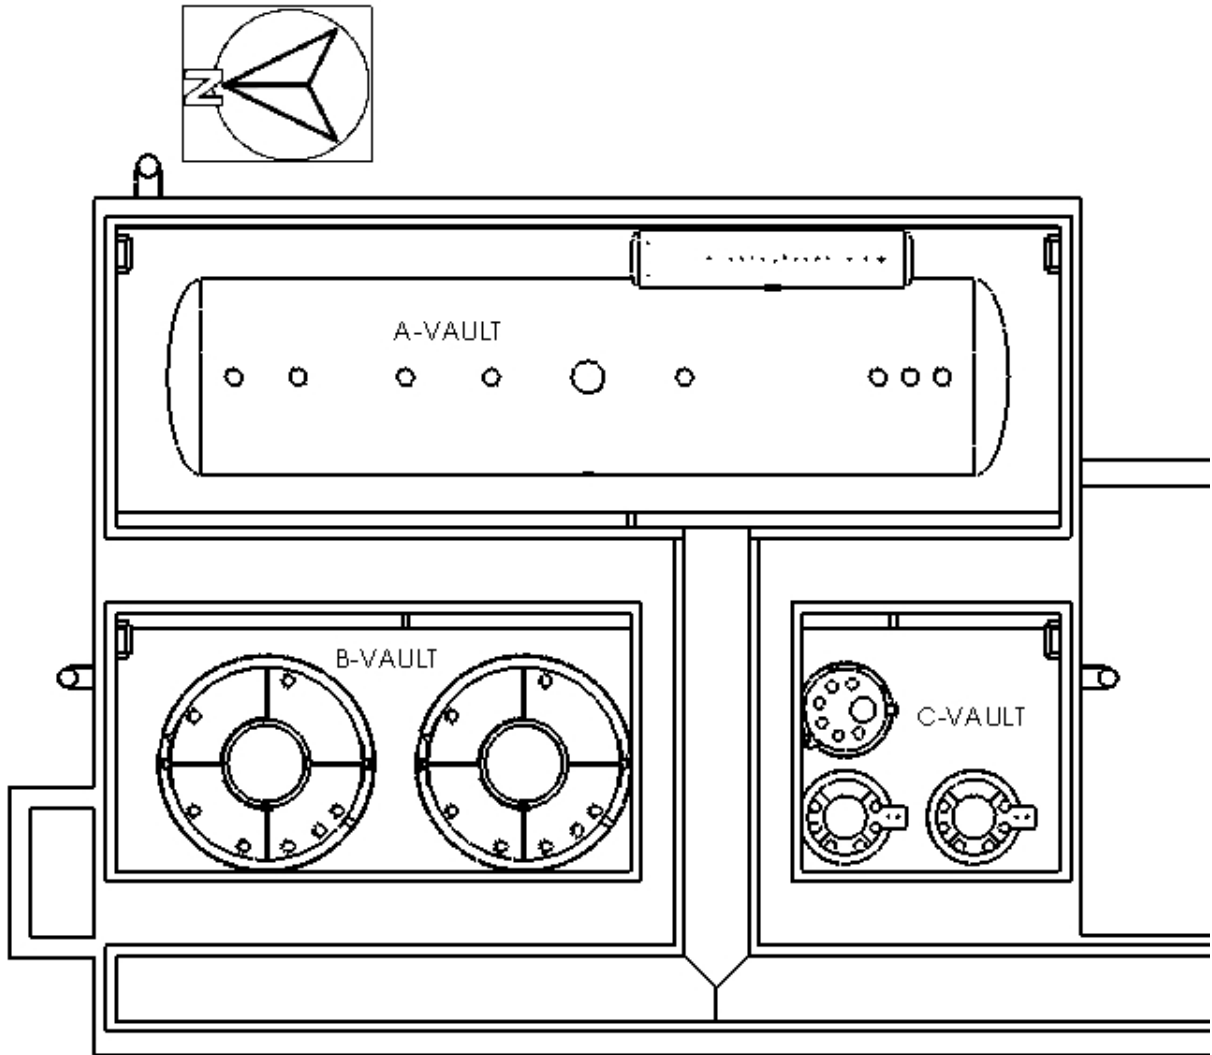
Illustration 1: RPL Vaults Configuration

The vaults were accessed in the reverse of alphabetical order. A layout sketch of the three vaults is shown as Illustration 1. The following sections describe the highlights of the work in each vault in the order that they were inspected.

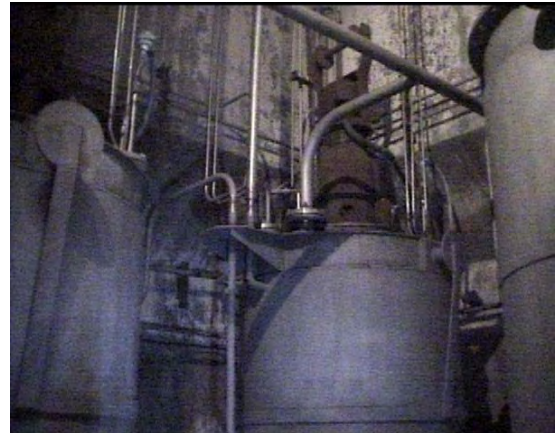
Illustration 3: C-Vault Tanks

The “missing” tank left sufficient open space in the vault that it was possible to deploy the ROV into this vault. Illustration 3 was taken by the ROV during the deployment and shows the three tanks in the vault. The access point is directly overhead.

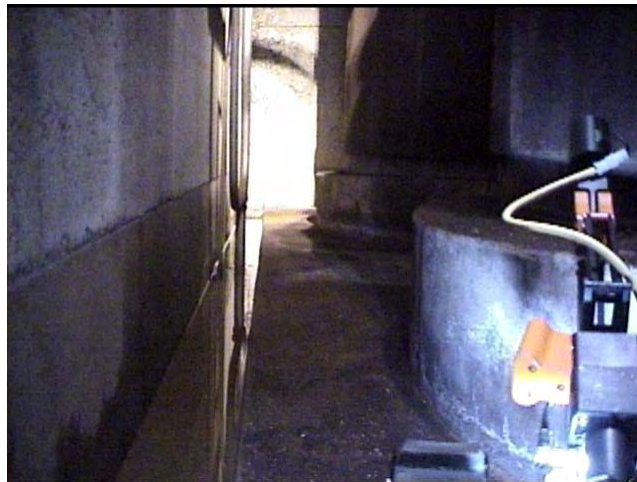
Illustration 12: Trench and Sump as Seen by ROV

Illustrations 12 and 13 and 14 provide “robot's eye” views of the trench and sump from the ROV's initial position at the insertion location. Illustration 15 shows the ROV shortly after insertion into the vault.

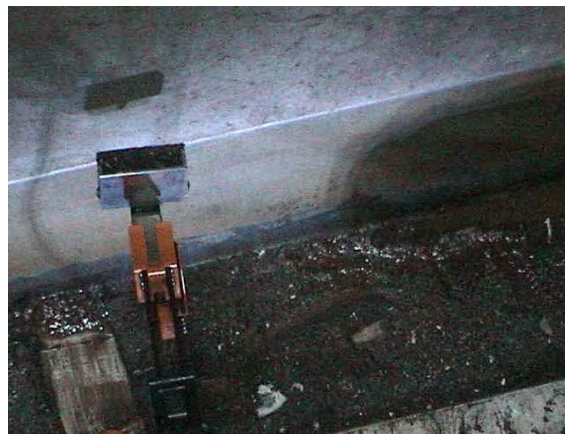
Illustration 35: Smear & Dose Rate Sample - Top of PT-1

This concluded sampling activities with the ROV. The next sampling activity was the use of the pole samplers to collect removable contamination and dose rate samples at selected locations within the vault.

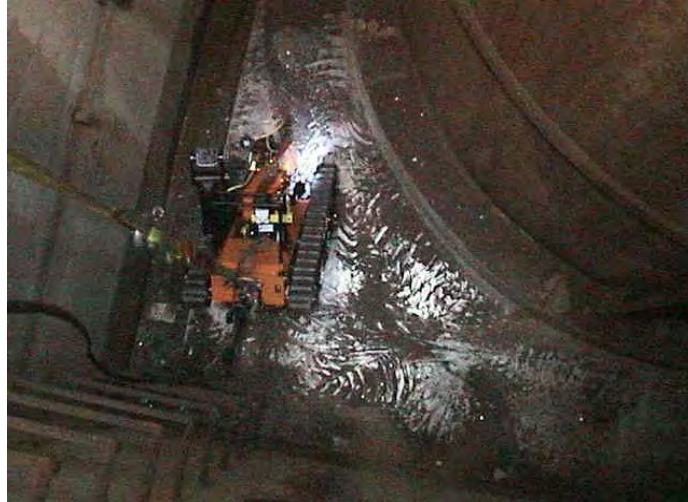
Illustration 39: ROV retrieval from B-Vault

The vehicle was then retrieved from the vault as shown in illustration 39.

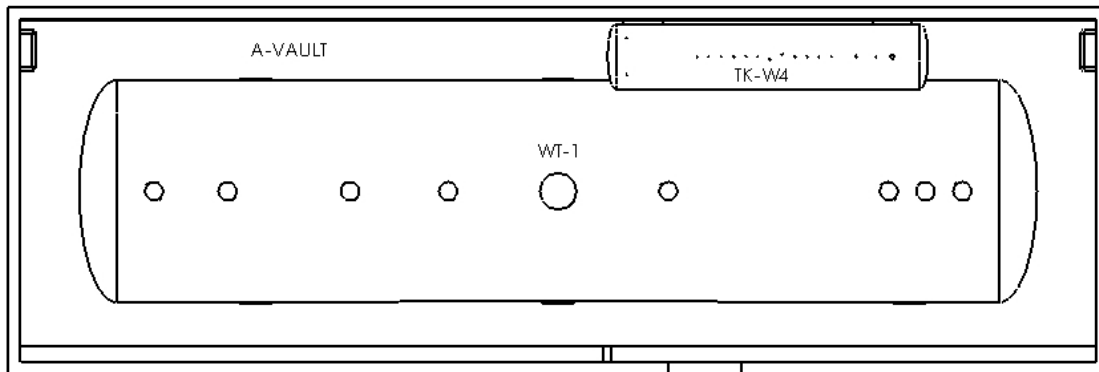
Illustration 40: A-Vault Plan View

The final vault characterized was A-Vault. A sketch of the vault layout is shown below. Access to A-Vault was in the upper-left (Northeast) corner of the vault.
